# Replaceable Unbonded Tendons for Post-Tensioned Bridges

**Final Report**

**December 2017**

Florida Department of Transportation (FDOT)

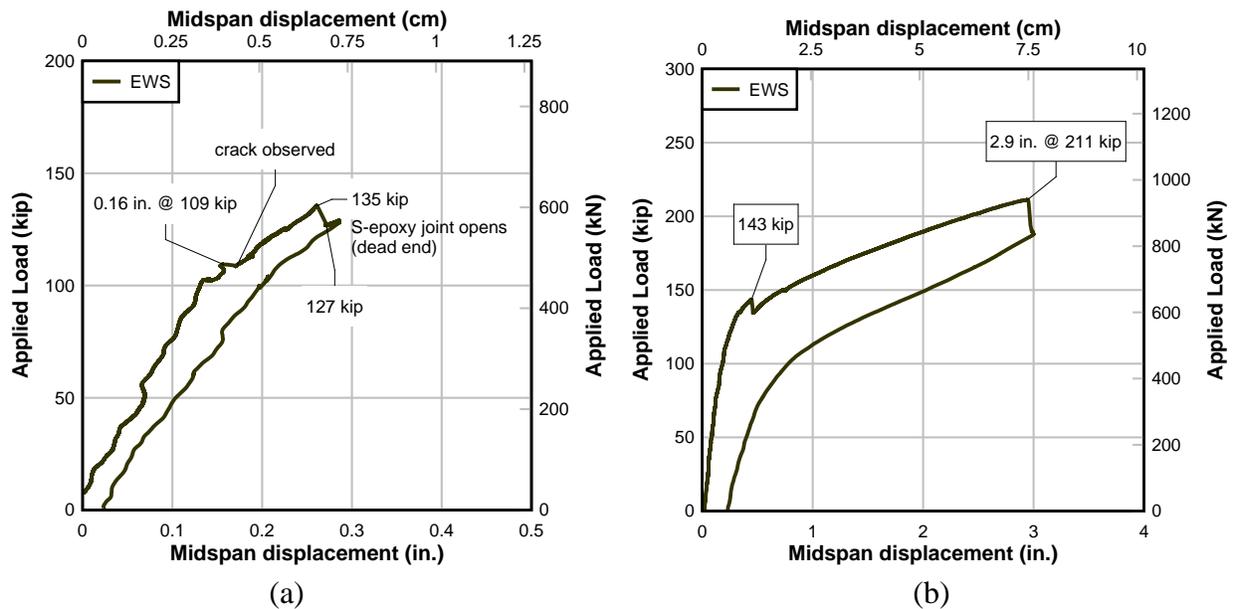
Figure 11-3 EWS (a) elastic behavior and (b) ultimate strength behavior

A three-point static flexure test was performed on specimen EWS (Figure 11-3). Although there was slight variations in the load displacement plot, the behavior was essentially linear up to cracking. The beam was visually inspected as load application was continued, but no significant out-of-alignment was observed.

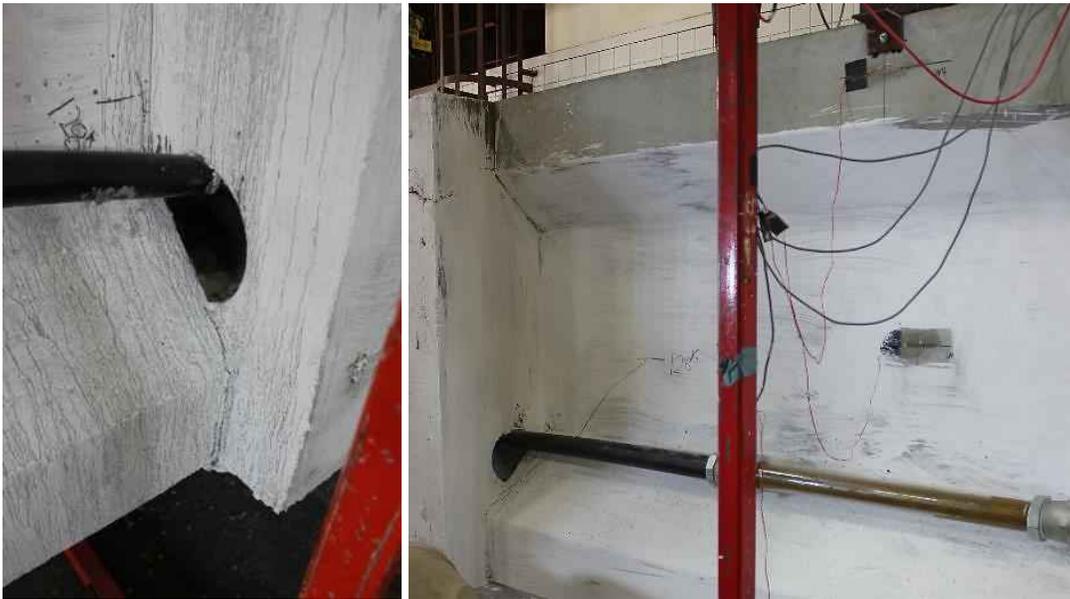
Figure 11-4 EWS: south deviation block

At approximately 135 kip, a loud pop was heard, accompanied by a sudden load drop of approximately 8 kip. The south epoxy joint was observed to open on one side of the beam; the opposite beam face of the south epoxy joint appeared to remain closed (Figure 11-4). The north epoxy joint was inspected; it appeared intact. The specimen was unloaded to 100 kip, and the load was held. Cracks were again marked and the beam was completely unloaded to allow installation of string pots. Two string pots were installed on the south deviation block— one on each face of the beam –across the epoxy joint (Figure 11-5).

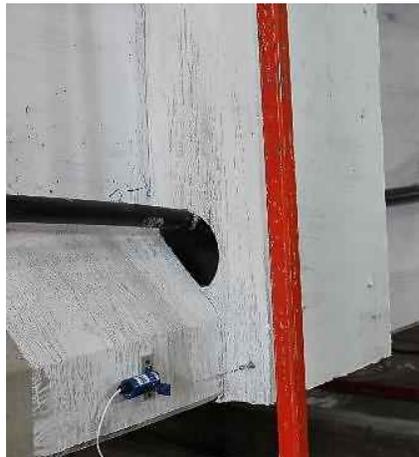
Figure 11-5 EWS: string pots installed

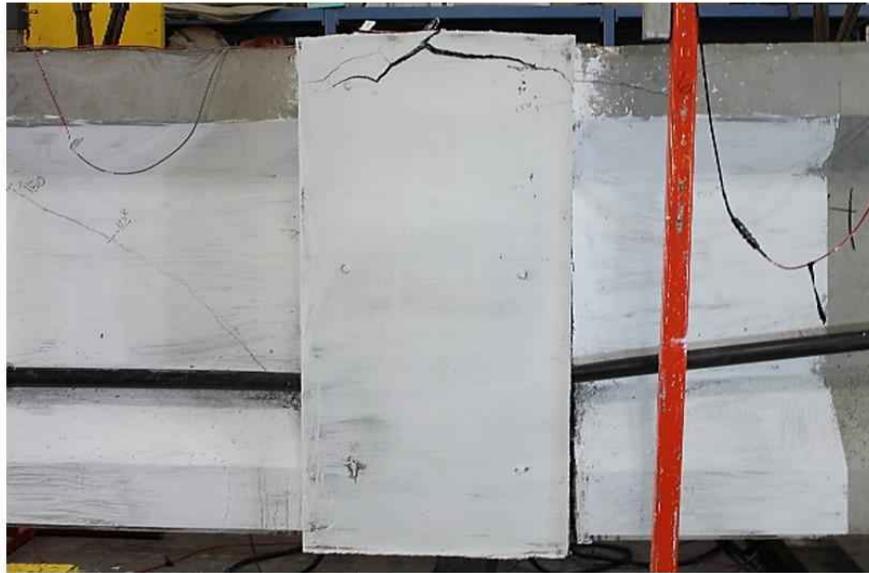
Figure 11-7 Compression failure at north epoxy joint (beam shown under load)

With the beam completely unloaded, load application was resumed at 0.2 kip/sec. At approximately 143 kip, the north epoxy joint was observed to open suddenly with an audible report. Subsequent to this event, the hollow-core tendon load cells were observed to measure an increase in the tendon force as load application continued. At 150 kip, the load was held and cracks marked. Cracks were observed at deviators running parallel to beam axis, near epoxy joints. Load application was resumed at 0.2 kip/sec until crushing of the concrete in the compression zone occurred approximately above the north epoxy joint at approximately 211 kip.

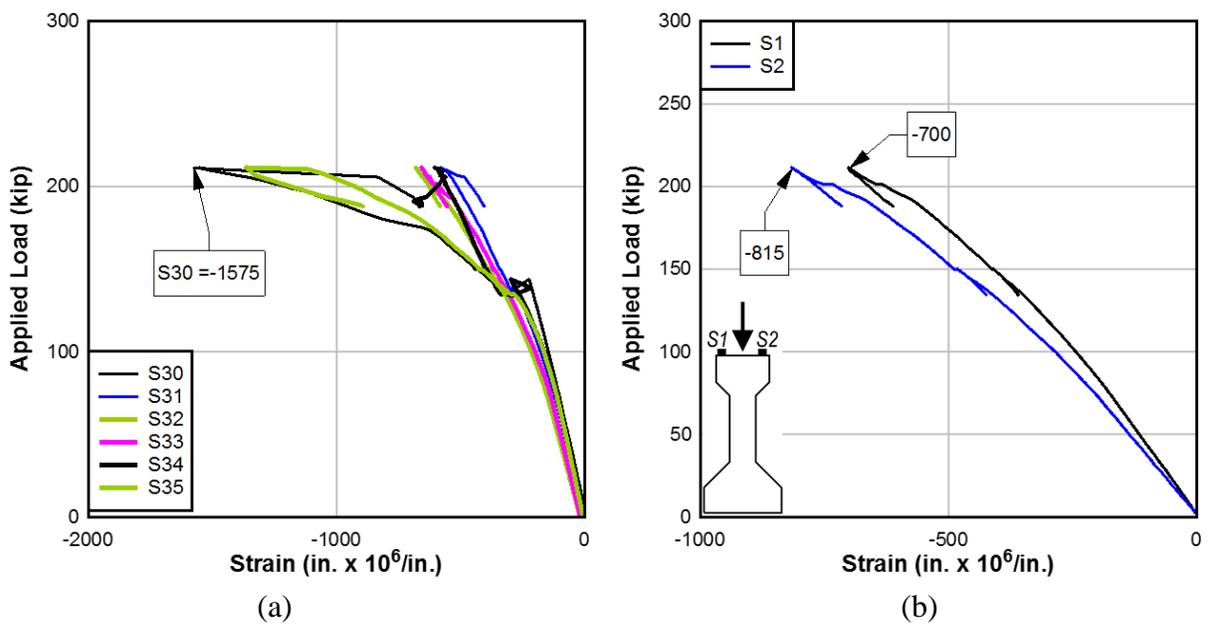
Figure 11-8 EWS: strain (a) along top, and (b) at load point

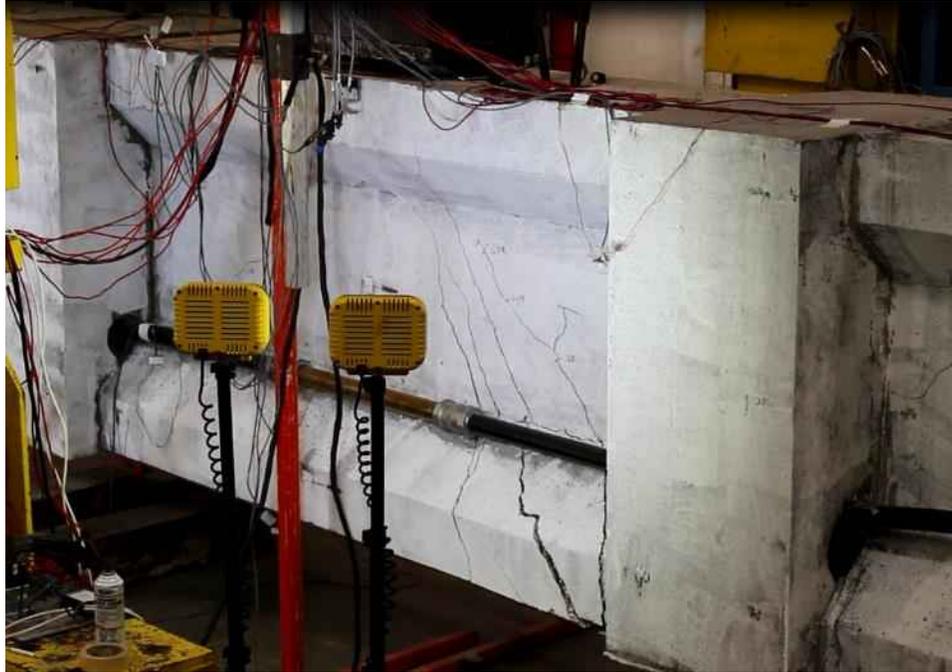
Figure 11-11 EWC near ultimate load

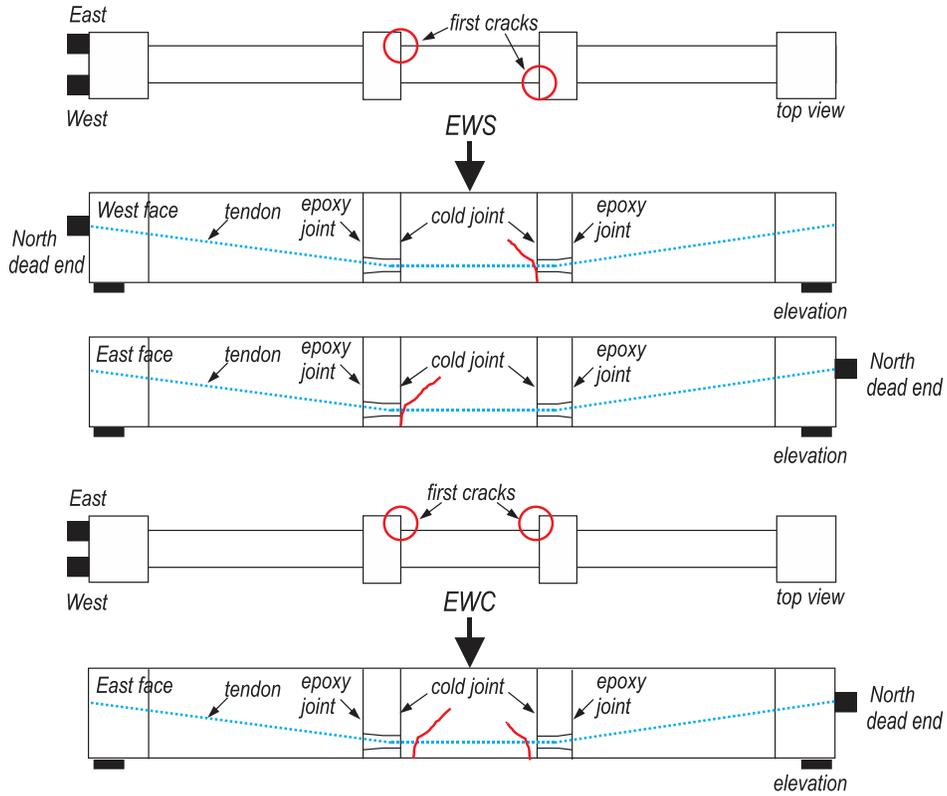
Figure 11-13 External tendon specimens: first crack locations

As loading progressed in both specimens beyond service level loads, the epoxy joints opened at each deviator block and primary crack opening occurred at the epoxy joints, which had no reinforcement across the joint (Figure 11-14). The cracks at the precast cold joints—across which ran mild steel reinforcement and nonprestressed prestressing strand—did not continue to elongate.

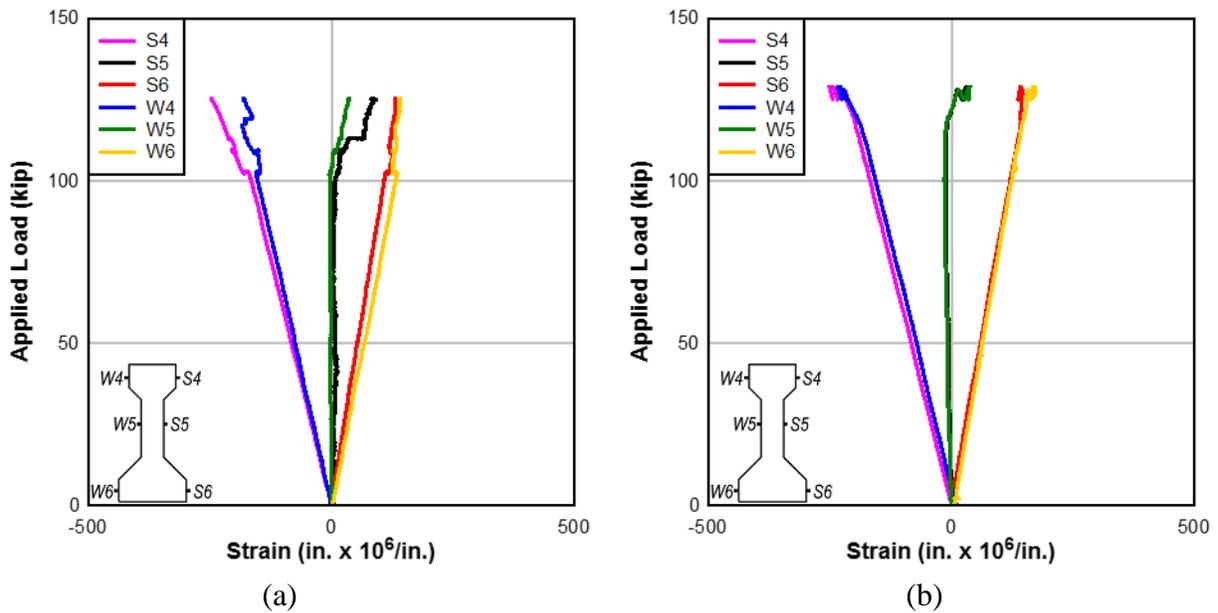
Figure 11-14 Strain profiles for (a) EWS and (b) EWC

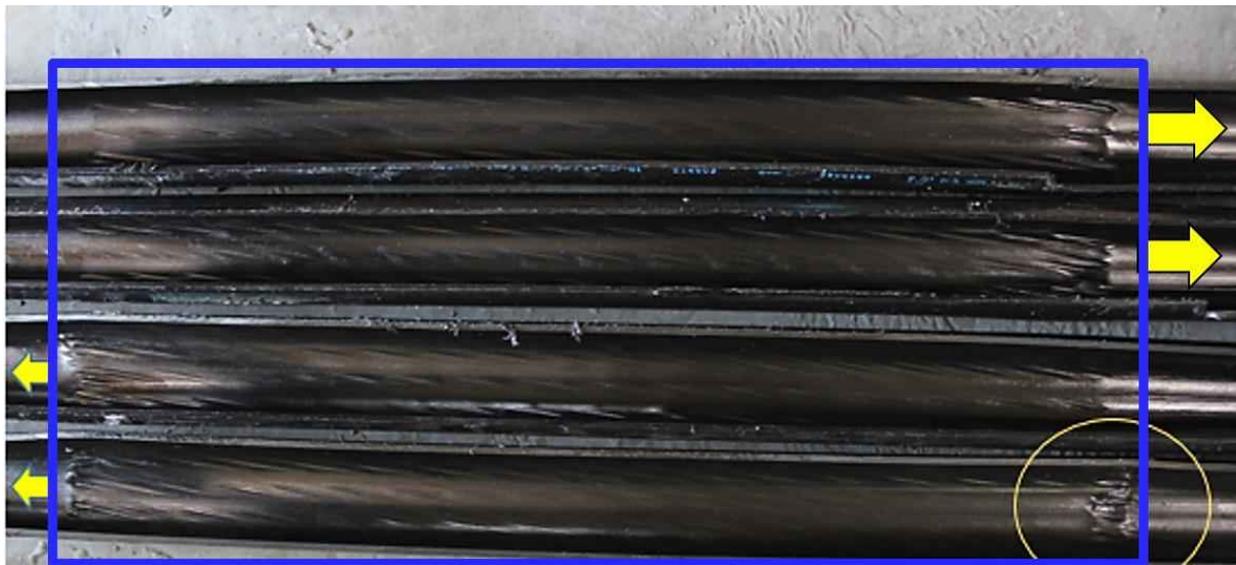
Figure 11-19 EWS: interior surface of duct in contact with strand at diablo

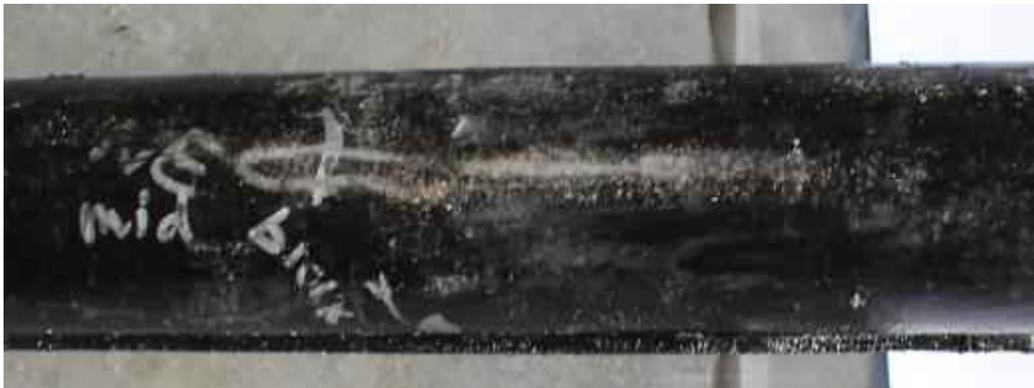
Inspection of the duct and strand of specimen EWC was similarly conducted following an ultimate load test. Focus was paid to the length of tendon at each diabolo. Evidence of light exterior surface wear was found at the NE diabolo (Figure 11-21); no gouging or severe exterior wear was found. Evidence of red oxide was found during inspection of the strands at several locations, including at the NE, NW, and SE diabolo (Figure 11-22, Figure 11-23, and Figure 11-24). The presence of red oxide on the outside wires, where a strand would most likely be in contact with other strand, may be evidence of fretting fatigue; because close inspection of the strand prior to installation was not conducted, it cannot be definitively confirmed.

Figure 11-21 EWC: exterior surface of duct at NE diabolo

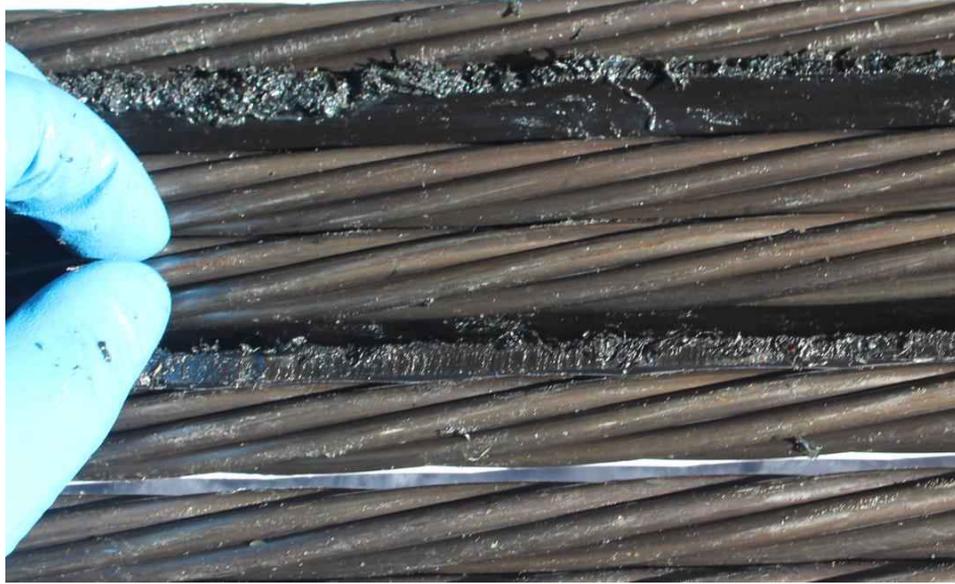
Figure 11-22 EWC: strands at NE diablo

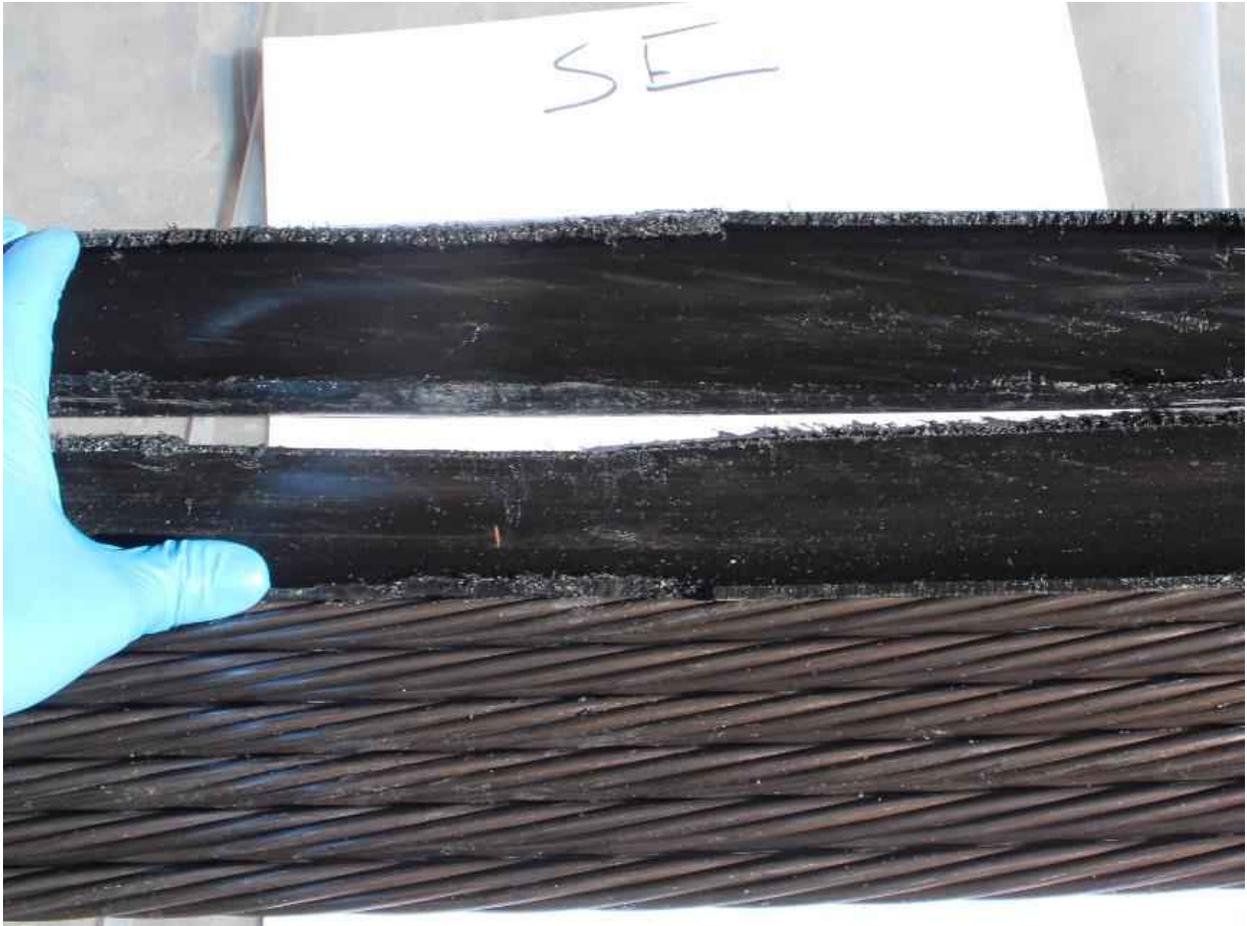
Figure 11-24 EWC: dissection of tendon at SE diablo

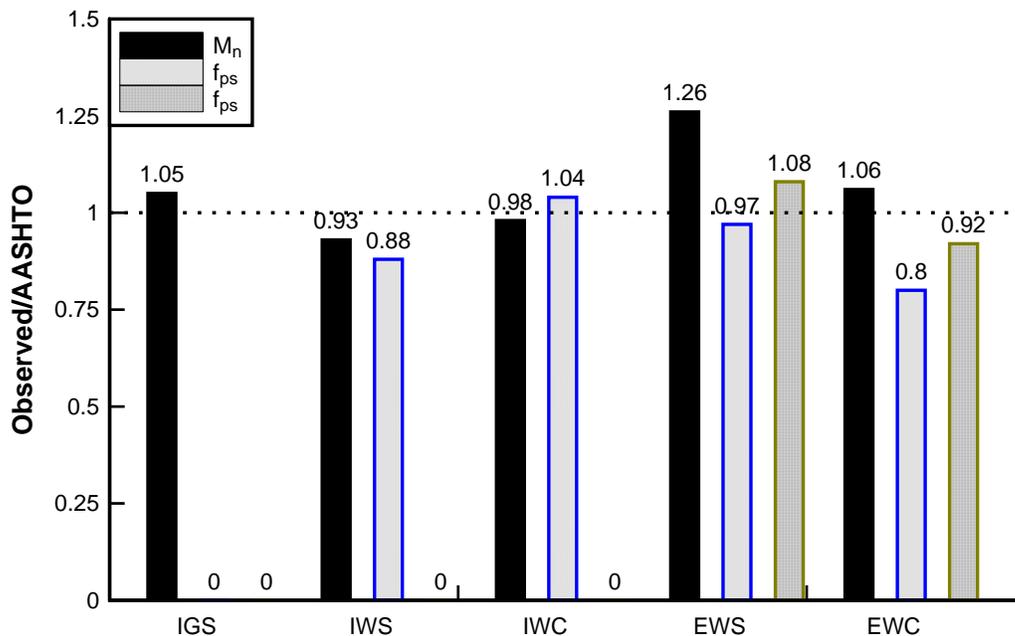
Figure 12-5 Ratio of observed to AASHTO-LRFD flexural strength and  $f_{ps}$

Figure 12-5 presents a comparison of the ultimate tendon stress and ultimate flexural strength to that expected using the AASHTO-LRFD equations. A reference line at 1.0 indicates a perfect match between the predicted and observed behavior. The existing AASHTO-LRFD adequately predicted the flexural strength of the bonded specimen (IGS), mixed tendon specimen (IWC) and unbonded specimens (EWS and EWC); the AASHTO-LRFD simplified approach for members with mixed tendons, on the other hand, did not adequately predict the flexural strength of specimen IWS. While the AASHTO-LRFD also suggests a detailed analysis considering strain compatibility, the provision allowing for a weighted approach to determine the ultimate unbonded tendon stress and strength. In some cases, this weighted approach could lead to an overestimation of member strength. Further discussion of the behavior of members with mixed tendons is given in the following sections.

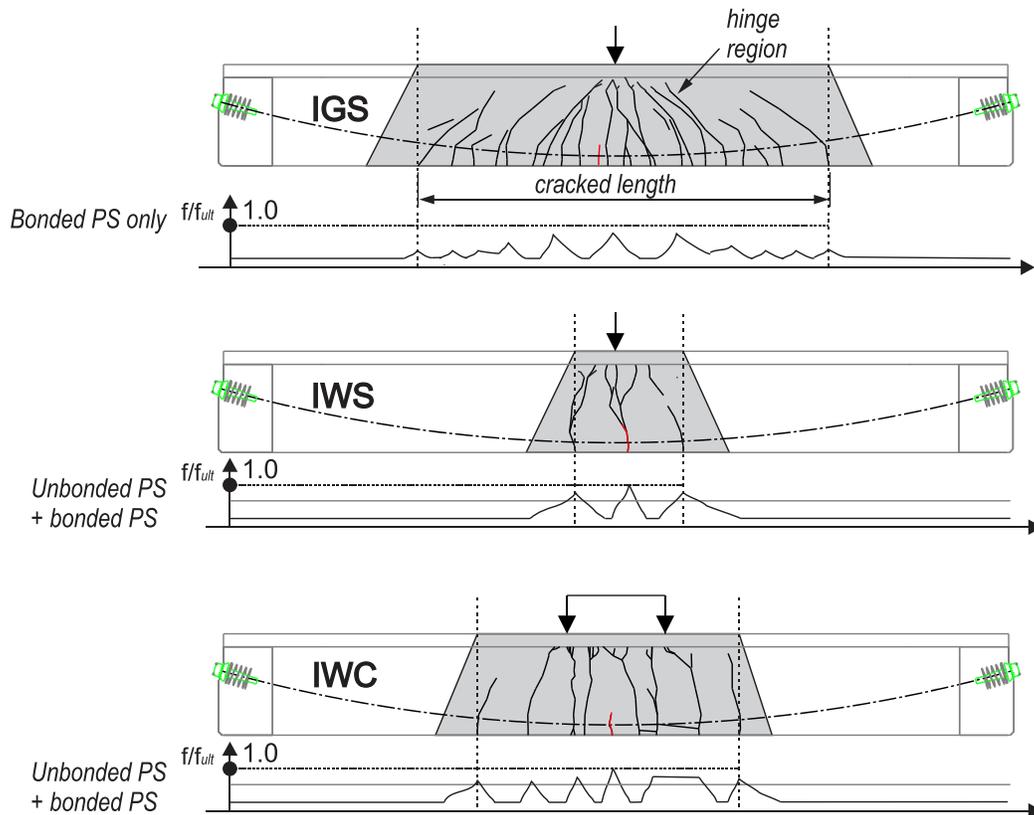
Figure 12-6 Tendon stress and hinge length for varying reinforcement combinations

Figure 12-6 presents three conceptual prestressing schemes. The first includes only bonded prestressed reinforcement, in which the prestressing is assumed to form a perfect bond with the concrete. The concentrated strain increases at crack locations result in localized yielding of the steel prior to reaching the limiting compressive strain of the concrete as illustrated by the stress plot below the beam. Although difficult to measure exactly, these localized points of yielded steel, taken together, are generally considered to define the hinge length. In contrast, members constructed entirely with unbonded reinforcement form a single crack at the point of maximum moment. The increase in strain caused by the crack opening would theoretically result in a uniform increase in strain over the entire length of the unbonded tendon. Since there is no localized yielding, the hinge length is concentrated at the single crack and is responsible for controlling the deformation of the member as loading increases; this is the least desirable behavior. If the two types of tendons are combined, however, cracking will be better distributed than the member with unbonded tendons alone, but perhaps have a shorter hinge length than the member with all bonded prestressing. Furthermore, the bonded prestressing and unbonded prestressing will almost certainly have different  $f_{ps}$  values at the ultimate flexural strength. The relative quantities of bonded and unbonded prestressing will dictate the size and influence of the hinge length.

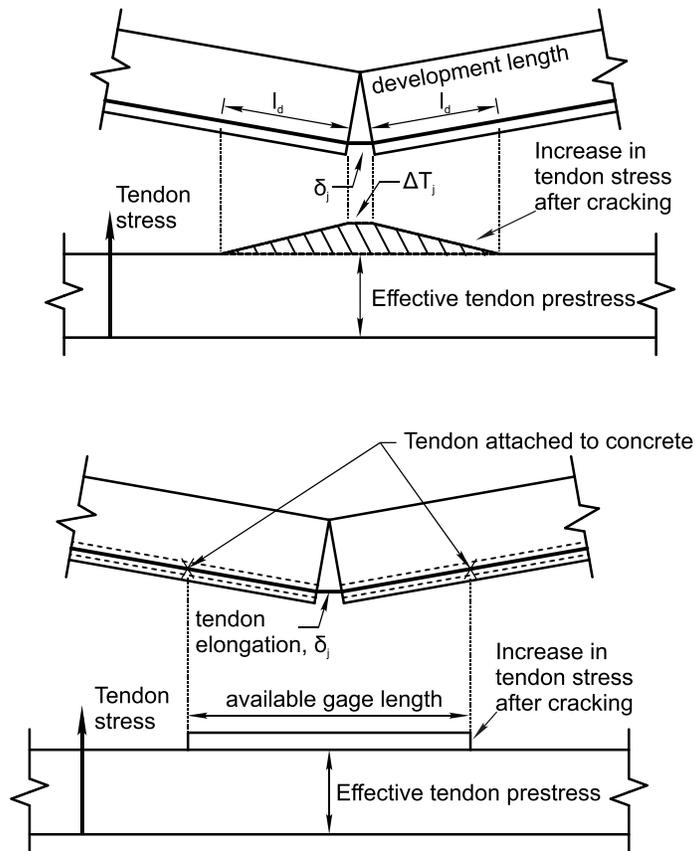
Figure 12-8 Tendon force increase: bonded vs. unbonded (MacGregor et al. 1989)

Tendon elongation – and, by association, the ultimate tendon stress – at the hinge is a function of both the maximum curvature and the gage length, a.k.a. hinge length. The hinge length is defined as the length of the tensile steel undergoing elongation under the opening joint, and is dependent on the bond condition of the reinforcement. Figure 12-8 compares the hinge behavior for bonded members and unbonded members, respectively (MacGregor et al. 1989). The affected region – or gage length - of the bonded tendon is assumed to be limited to the joint opening plus twice the bond re-development length of the reinforcement. In contrast, an unbonded tendon experiences the stress increase along the length of tendon between attachment points (or anchors, in our case).

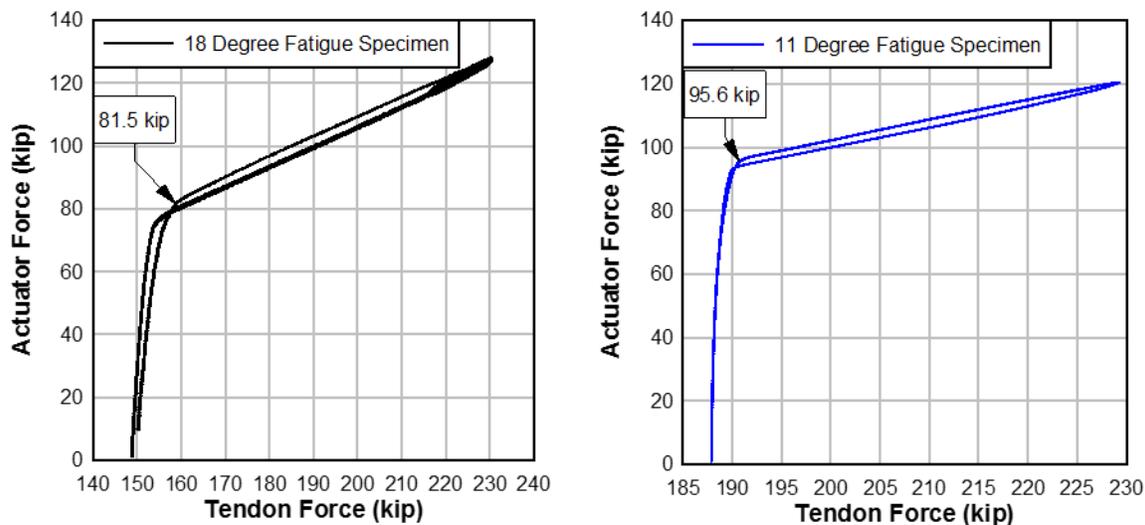
Figure 13-1 Initial static ramp test for both fatigue specimens

The static test results were used to determine the actuator force needed to achieve the upper (228.5 kip) and lower (213.4 kip) target tendon force. For F1, the initial actuator force range was determined to be 125 kip to 115 kip and for F2 the actuator force range was determined to be 120 kip to 109 kip.

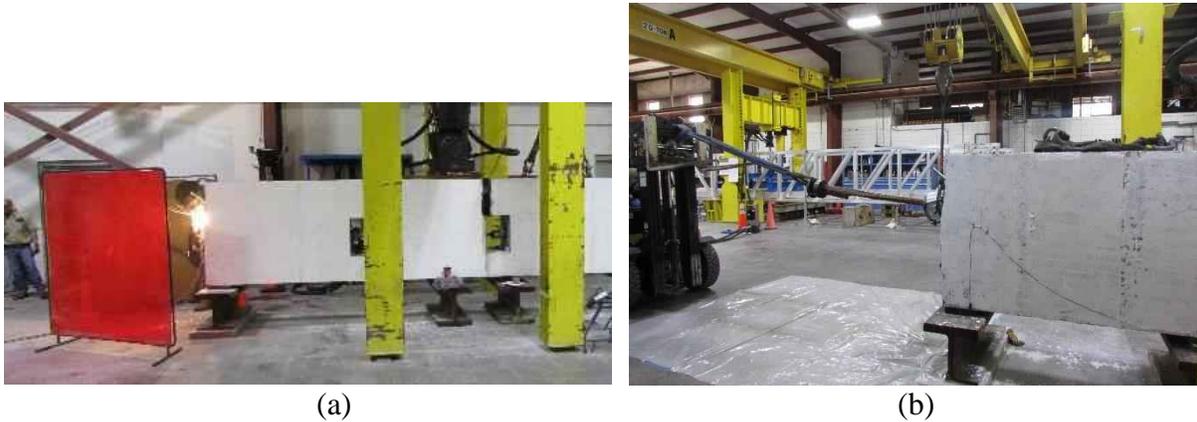
F1 tendon was detensioned at the live end in the opposite order it was stressed, starting with strand 6 and ending with strand 1. The tendon force readings (Figure 13-12) were taken during the entire detensioning procedure. The tendon was removed for inspection upon completion of detensioning (Figure 13-13).

Figure 13-13 Dissection of F1 (a) detensioning and (b) tendon removal

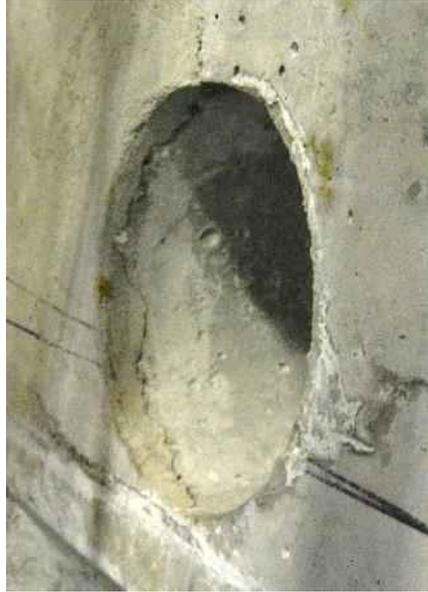
Following tendon removal, specimen F1 was separated and inspected for damage. The deviator exit at the dead end was of interest due to spalling that occurred when the formwork was removed. No observable degradation of the specimen, however, was noted during the inspection. The concrete repair (Figure 13-14) was inspected and remained intact at the end of cyclic loading with signs of minor wear.

Figure 13-14 Concrete repair for specimen F1 at the end of cyclic loading

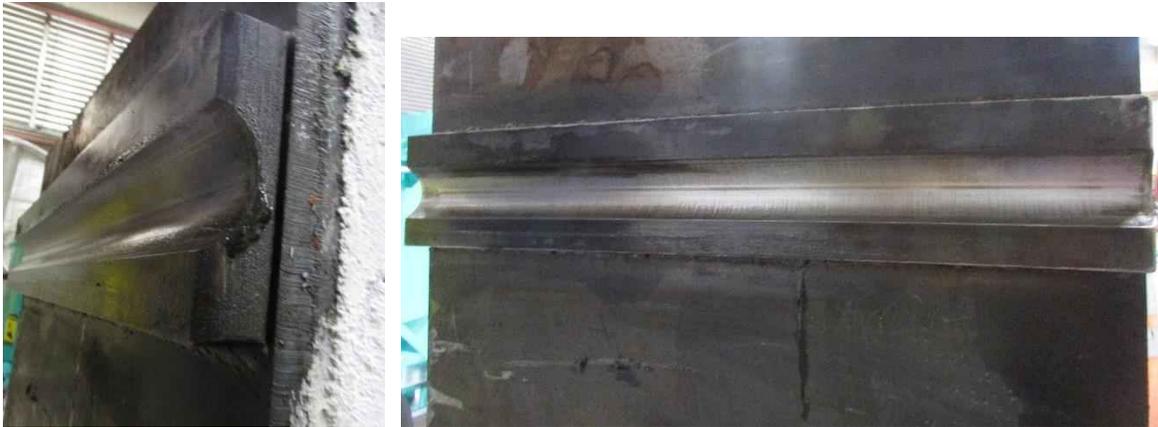
The mechanical hinge was lubricated at the start of the cyclic loading and only moderate wear was visually noted following the fatigue test indicating that the hinge had performed its intended purpose for this experiment by providing smooth, relatively friction-free rotation during the cyclic loading (Figure 13-15 and Figure 13-16).

Figure 13-15 Mechanical hinge post-dissection – dead end segment

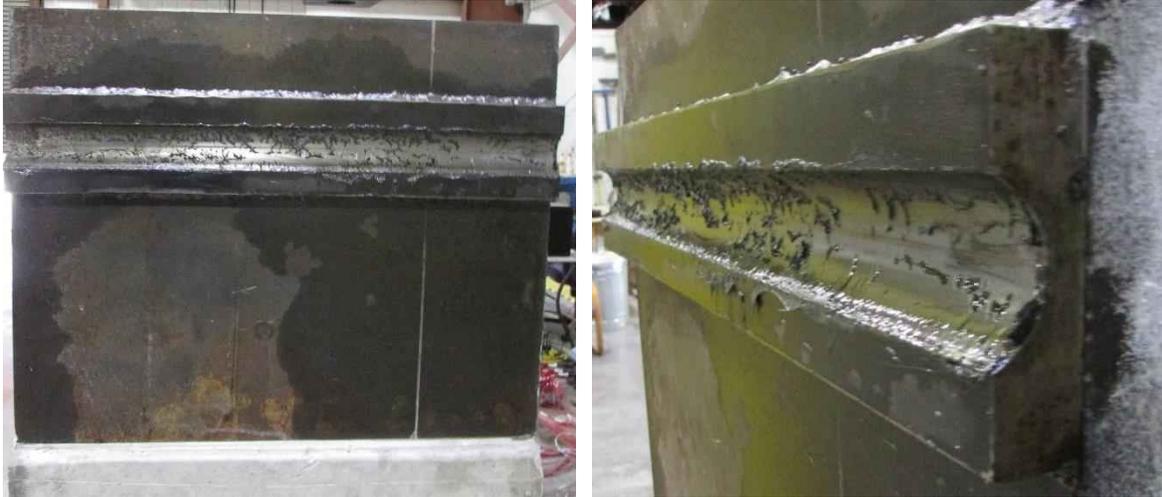
Figure 13-16 Mechanical hinge post-dissection – live end segment

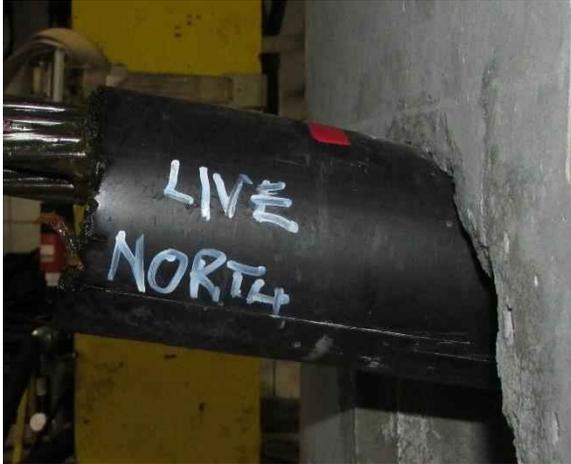
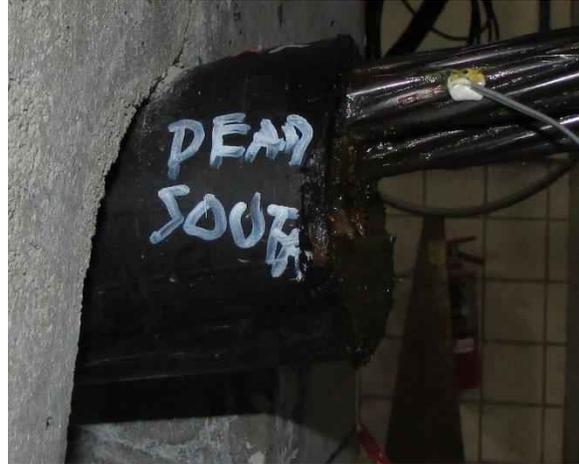
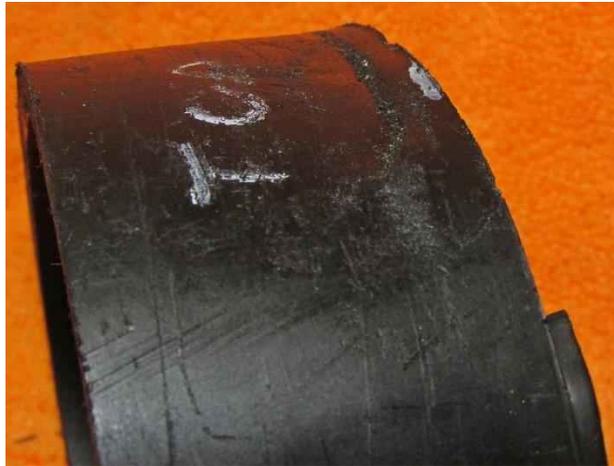
It is theorized that the pinching (Figure 13-19) was due to lack of clearance between concrete and duct at the exit point of the duct. This creates an abrupt tendon angle change leading to a stress concentration. The higher stress concentrations due to pinching led to significant duct wear, which was about three times deeper than the live end. This only occurred at the south end of the deviator for this specimen. It is not clear why the pinching did not occur at the opposite end of this deviator or on specimen F2. One possibility is that the deviator form insert was misaligned during construction; extra attention was placed on the construction of specimen F2 to ensure there would be no misalignment. This location was repaired after construction due to spalling that occurred as the diabolo form insert was being extracted, which could have contributed to the problem. Because the other deviator exit locations did not exhibit this behavior, it is concluded that the geometry selected for the diabolo was adequate. Nevertheless, providing additional flare curvature beyond that provided for this design would allow more tolerance for misalignment during construction. Furthermore, inspection of the deviator would be prudent prior to tendon installation to ensure that pinching does not occur.

Figure 13-19 HDPE pipe at deviator corner (a) live end (b) dead end (c) pinched duct at dead end

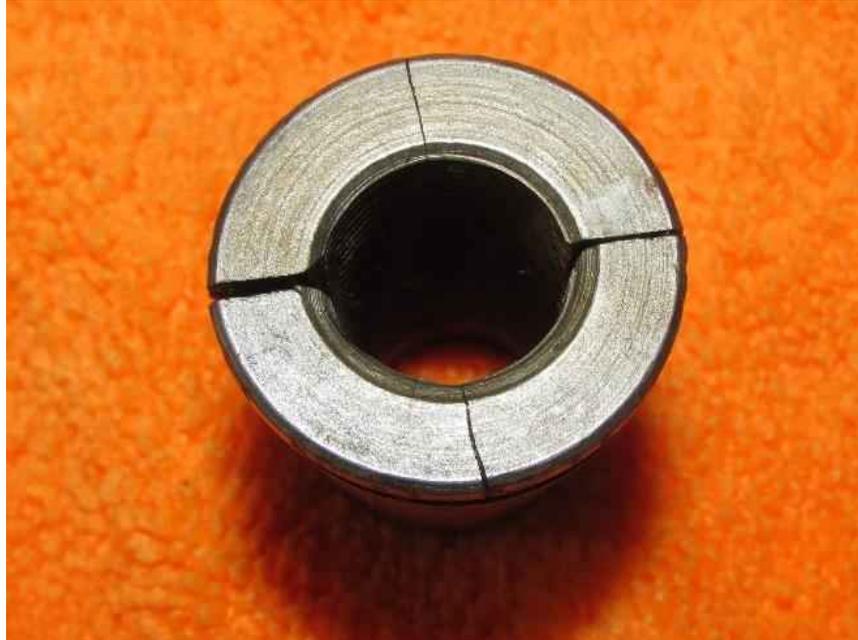
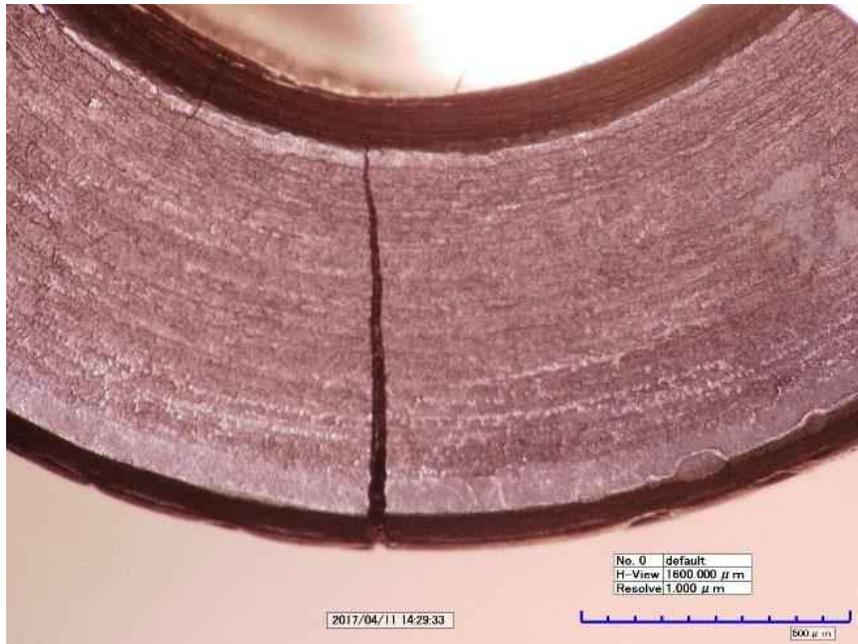
Wedges were inspected at the end of cyclic loading (Figure 13-20) and displayed typical hairline longitudinal cracks from the strand seating process. No signs of fatigue damage were found on the wedges.

Figure 13-20 Wedge inspection post-cyclic loading for specimen F1

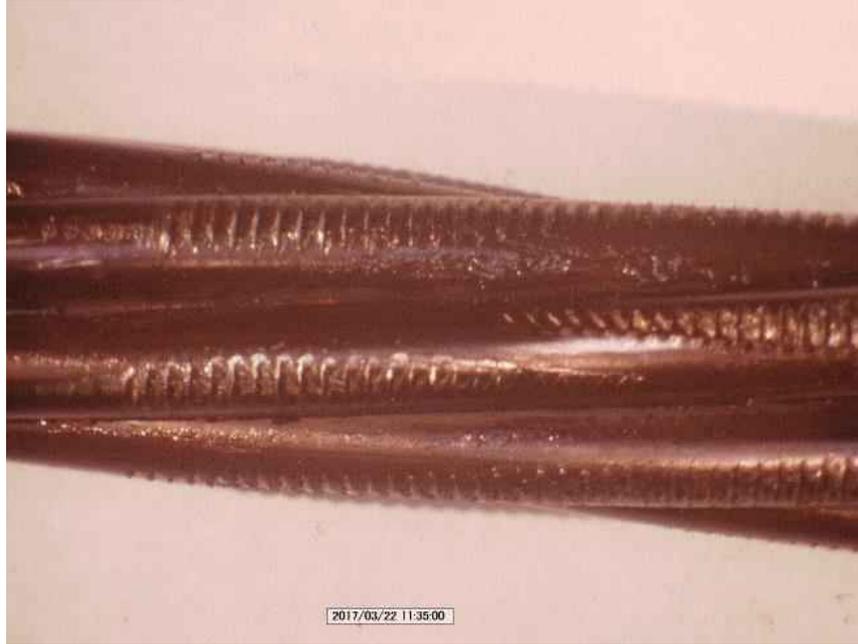
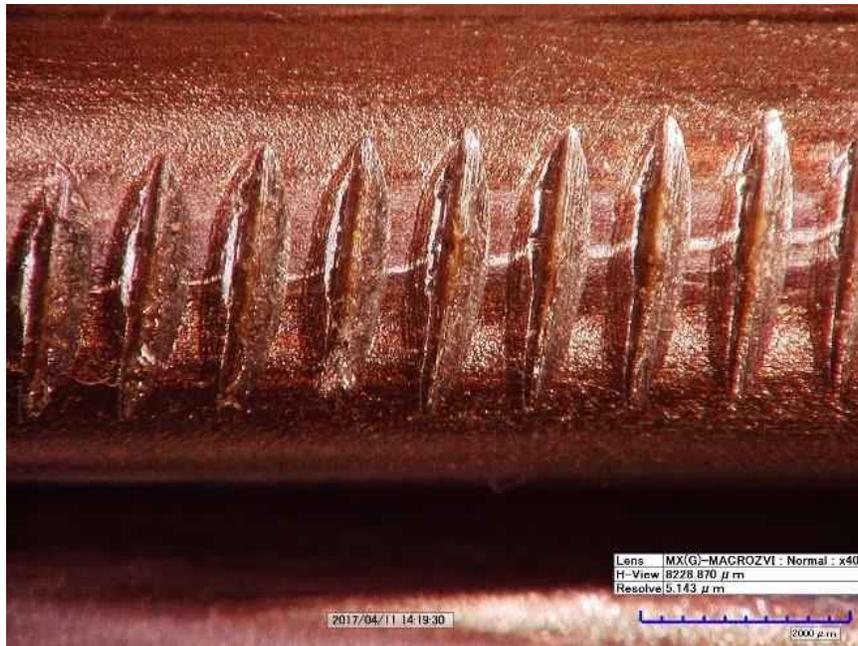
Impressions on the prestressing strands from wedge serrations were visually inspected under a 40 $\times$  microscope. The strands had evenly spaced ductile impressions with no cracking at the corners, indicating successful wedge seating (Figure 13-21). Wedge impressions gradually lengthened from the front of the wedge and maintained a consistent width before tapering to a shorter length near the wide portion of the wedge (Figure 13-22).

Figure 13-21 Wedge serration impressions on strands following cyclic loading

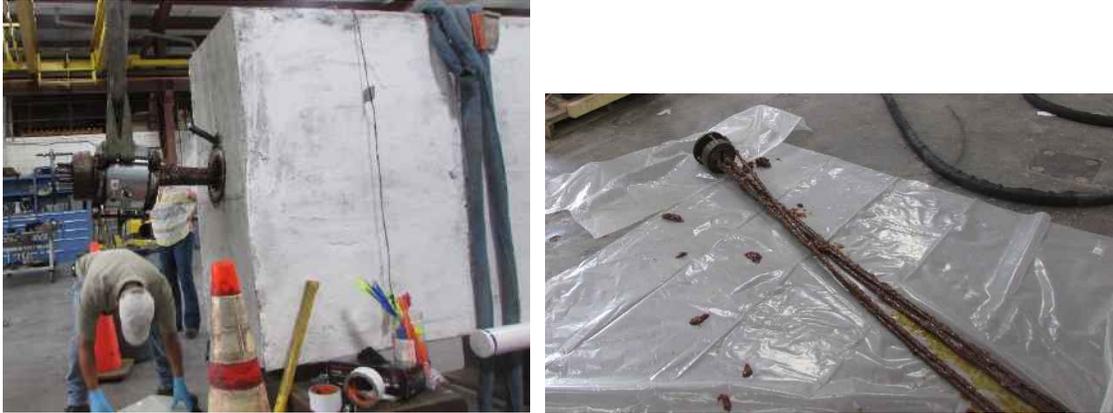
F2 was detensioned in the same manner as F1. Tendon force readings were continuously taken and the results of the detensioning are shown in Figure 13-23. The tendon was completely removed once detensioning was completed (Figure 13-24).

Figure 13-24 Tendon removal from F2

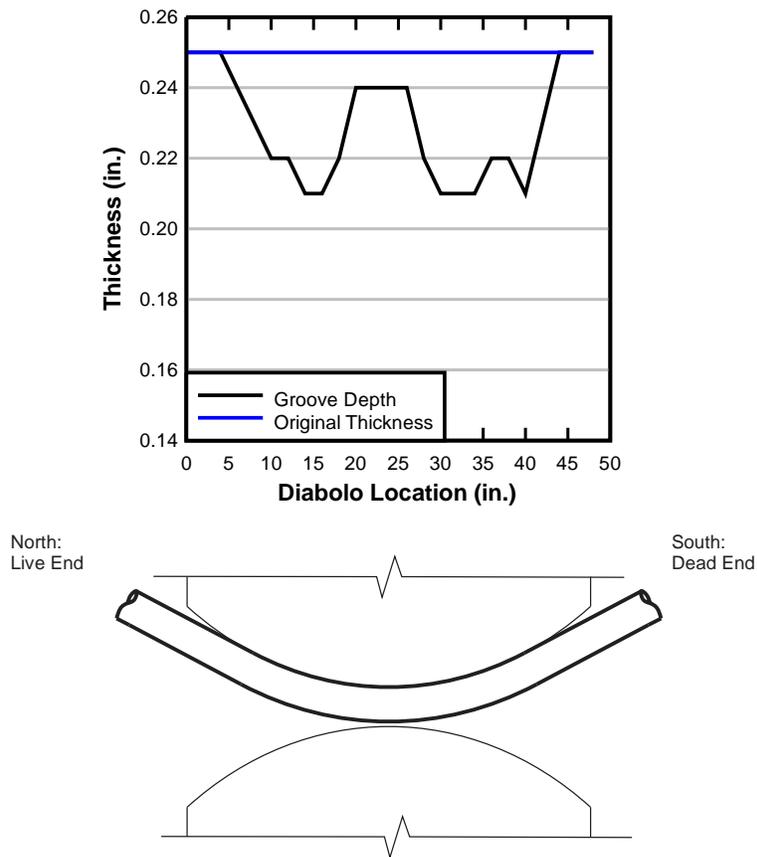
Figure 13-25 HDPE Pipe Thickness along length of deviator for F2

The HDPE pipe section located inside the deviator of F2 was removed for dissection and inspected for wear. The pipe was cut into 2-in. lengths and the thickness at the deepest groove for each piece was measured (Figure 13-25). The strands contacted the pipe 6 in. into the deviator from the live end side and contacted the pipe 4 in. in the deviator from the dead end side. The maximum thickness loss was 16% of the original pipe thickness, which occurred at approximately 16 in. from each end of the deviator and away from the midpoint. This is confirmed by visual observation of the duct at those two locations (Figure 13-26).

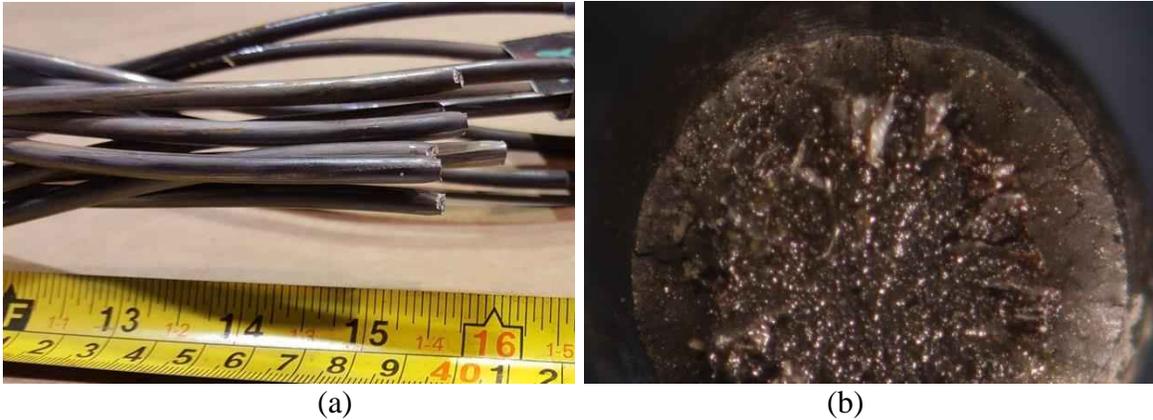
Test results are shown in (Table 13-3). The control results indicate that the prestressing strand used in the fatigue test initially met the strength and ductility requirements of ASTM A416. As shown in Figure 13-28, necking with a cup/cone fracture surface was observed in the individual wires, indicating a ductile failure mode.

Figure 13-28 Fracture surfaces of control specimens (a) c-2 (b) magnified fracture surface

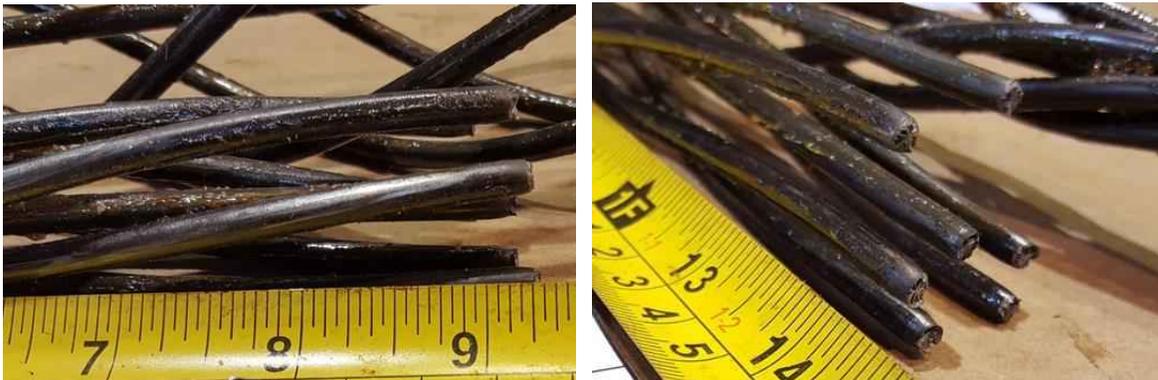
Figure 13-29 Specimen F1 strand ductile failures after tensile tests

Strands from specimen F1 (18-degree tendon deviation angle) all experienced ductile failure modes (Figure 13-29) and satisfied ASTM A416 strength and ductility requirements. The average breaking strength was 62.6 kip, which was 106.5% of the minimum ultimate strength. Fretting fatigue is dependent on the slip amplitude; if the slip is too small or too large there will be no fretting fatigue. The larger tendon deviation angle of this specimen appears to have provided sufficient friction force between the deviator and tendon to prevent the strands from slipping at a magnitude that might generate fretting fatigue.

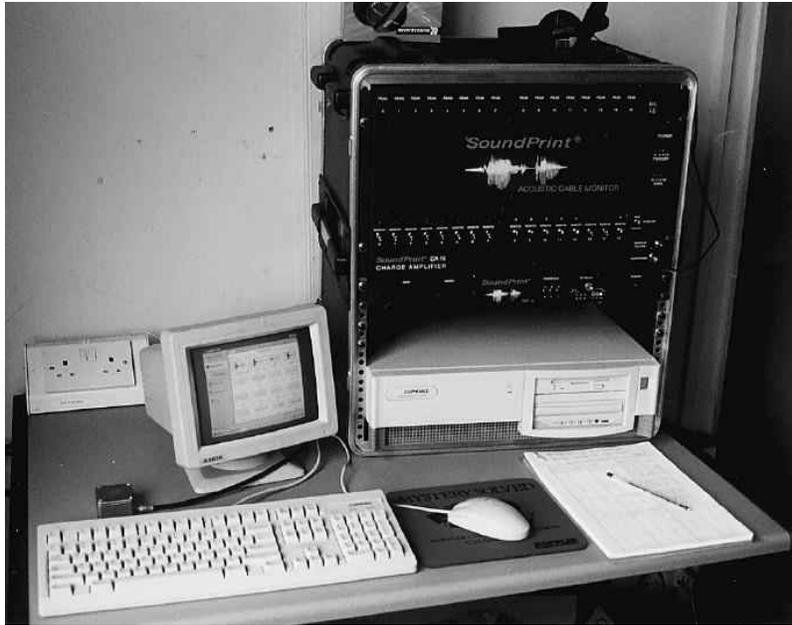
Figure 3-7 SoundPrint® acoustic monitoring system

**Experimental Validation.** Cullington et al. (2001) conducted an extensive examination on the operation of a SoundPrint<sup>®</sup> acoustic monitoring system (Piezo-electric AE sensors, data acquisition and signal processing unit, shown in Figure 3-7) for breakage detection of wires in bonded post-tensioned bridges. An external wire break device (containing a stressed strand with anchorage plates) was attached to the concrete surface of a full-scale bridge to mimic a genuine wire breakage event. The anchorage plates were acoustically coupled to the concrete surface to ensure transmission of the acoustic event (generated by wire breakage) into the bridge and a real wire break event was simulated by inducing breakage into the external wire. A symmetric array of AE sensors, placed at approximately 2 m intervals, was installed on the concrete surface to capture the events. Open and blind trials, by inducing wire breakage through grinding and accelerated corrosion, respectively, were conducted in both laboratory conditions and in-service environments, and most of the wire breakage events were successfully identified and located by the AE monitoring system.
