# Replaceable Unbonded Tendons for Post-Tensioned Bridges

**Final Report**

**December 2017**

Florida Department of Transportation (FDOT)

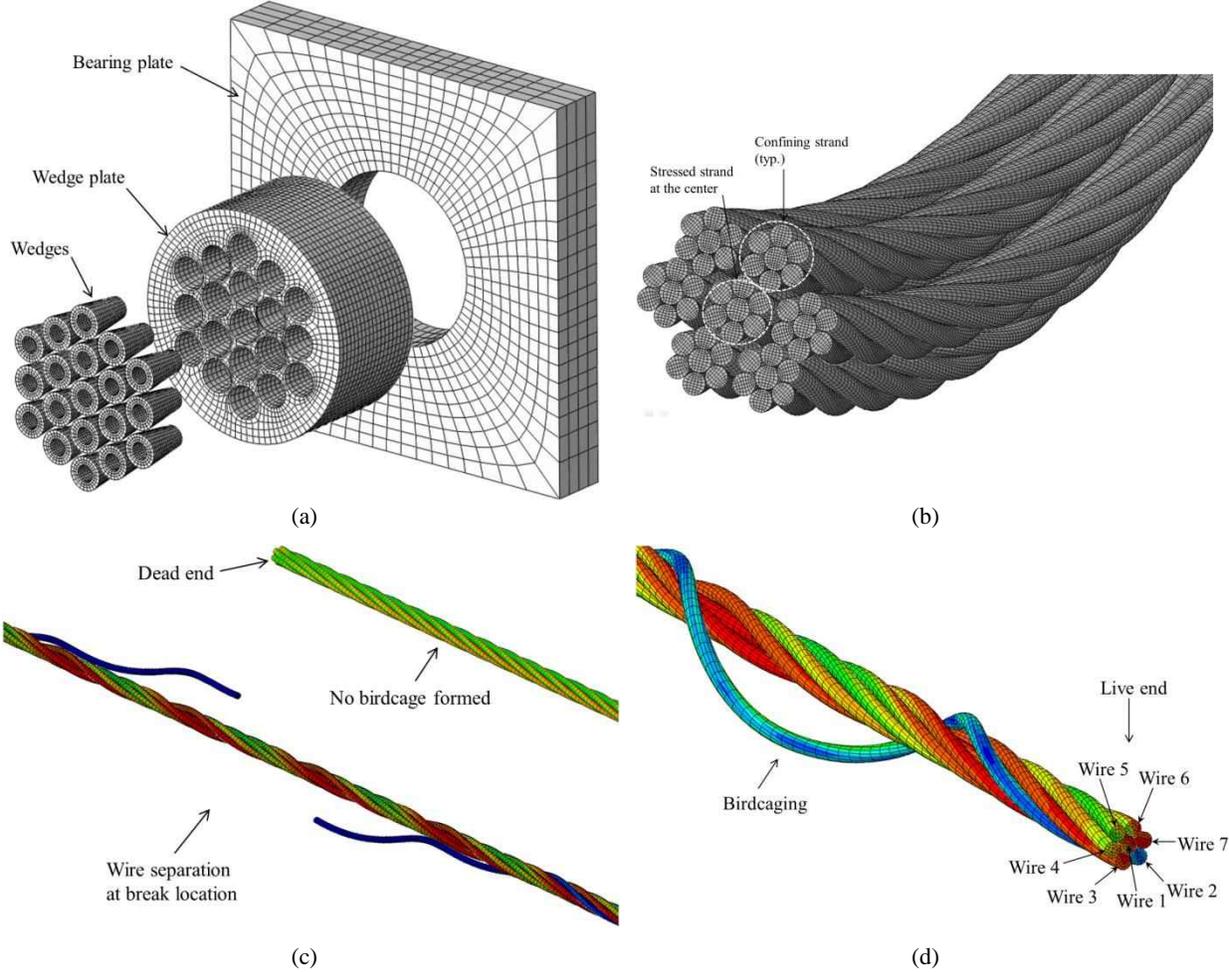
Figure 3-9 FE model: (a) anchorage; (b) multi-strand tendon; (c) wire break; (d) birdcaging

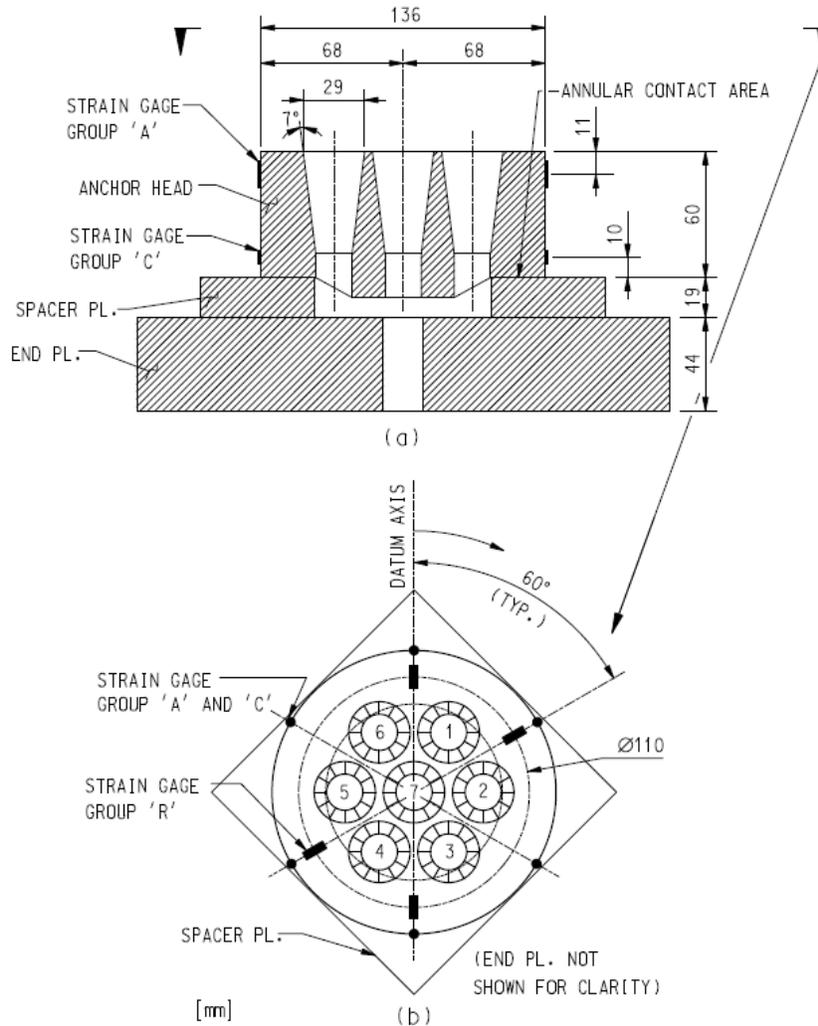
Figure 4-3 Strain gage placement on ECI 6-7 anchorage: (a) anchor head elevation; (b) plan

To obtain a thorough description of the state of strain developed at the external surface of the anchor head under loading, a total of 16 strain gages were installed at different locations on the anchor head (Figure 4-3). Four strain gages were mounted on the face of the anchor head to capture radial strains (indicated by strain gage group R). Axial and circumferential strains were measured by 12 strain gages (six in each group) as labeled by group A and C, respectively. The data from this arrangement of strain gages were used for finite element model calibration as the friction coefficients at the interfaces were adjusted to match the experimental strains at multiple locations in axial, radial, and circumferential directions.

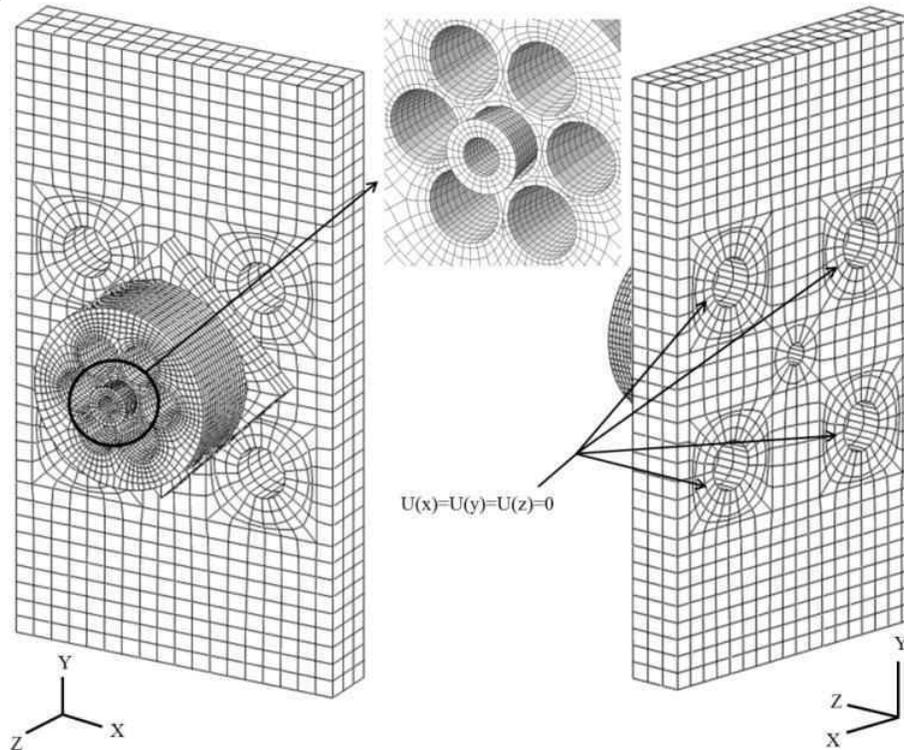
Figure 4-6 Discretization and boundary conditions of FE model for calibration

The model was discretized with quadratic hexahedral and quadratic tetrahedral elements. A mesh convergence study was performed to confirm the adequacy of discretization. The compressive load was applied on the wedge with displacement-controlled method using variable incremental steps. Idealized pinned boundary conditions were enforced at four bolt locations as shown in Figure 4-6.

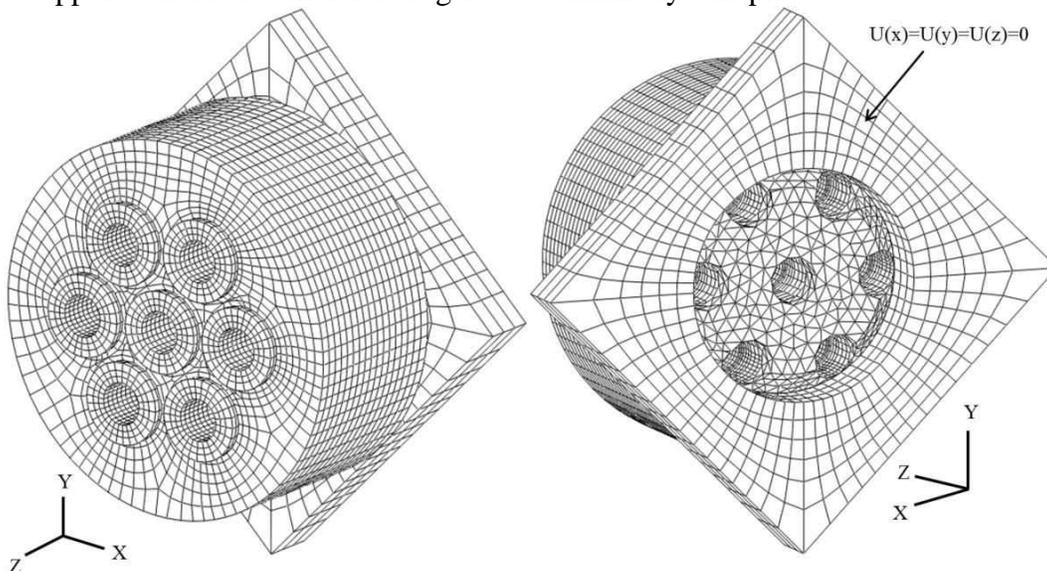
Figure 4-9 Discretization and boundary conditions of VSL ECI 6-7 anchor head

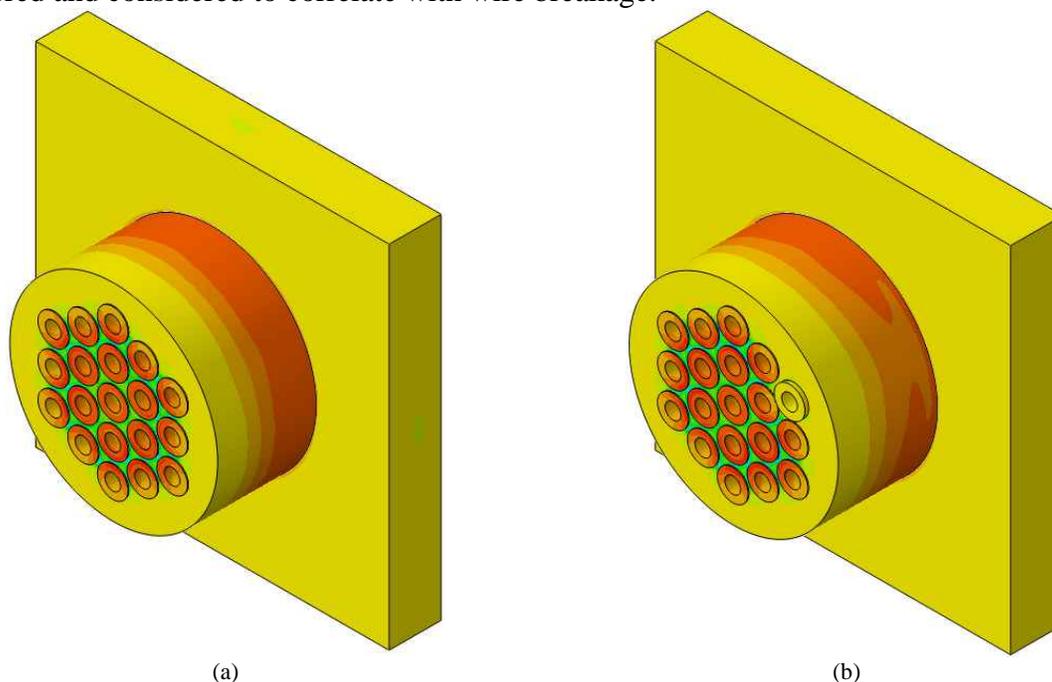
Figure 4-10 Strain distribution: (a) before breakage; (b) after wire break

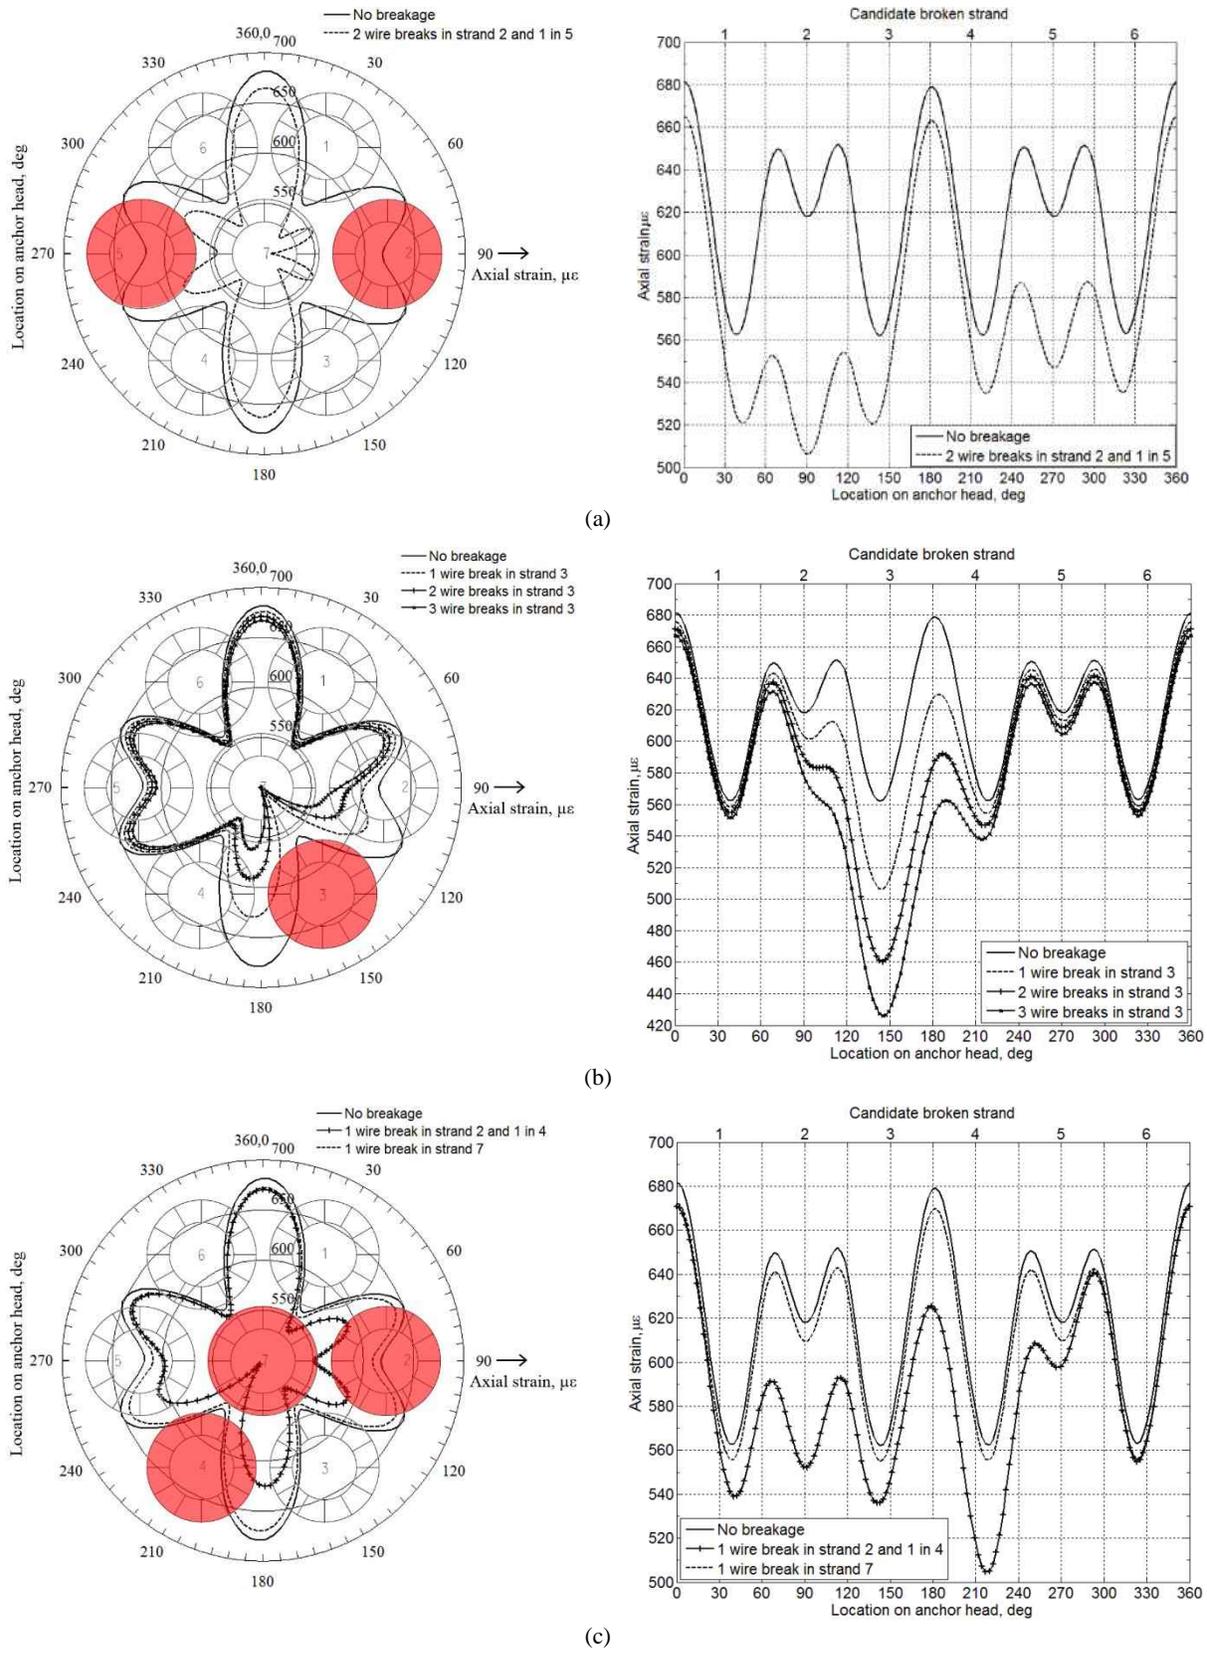
Figure 4-11 Comparison of axial strains in ECI 6-7 anchorage before and after wire breaks

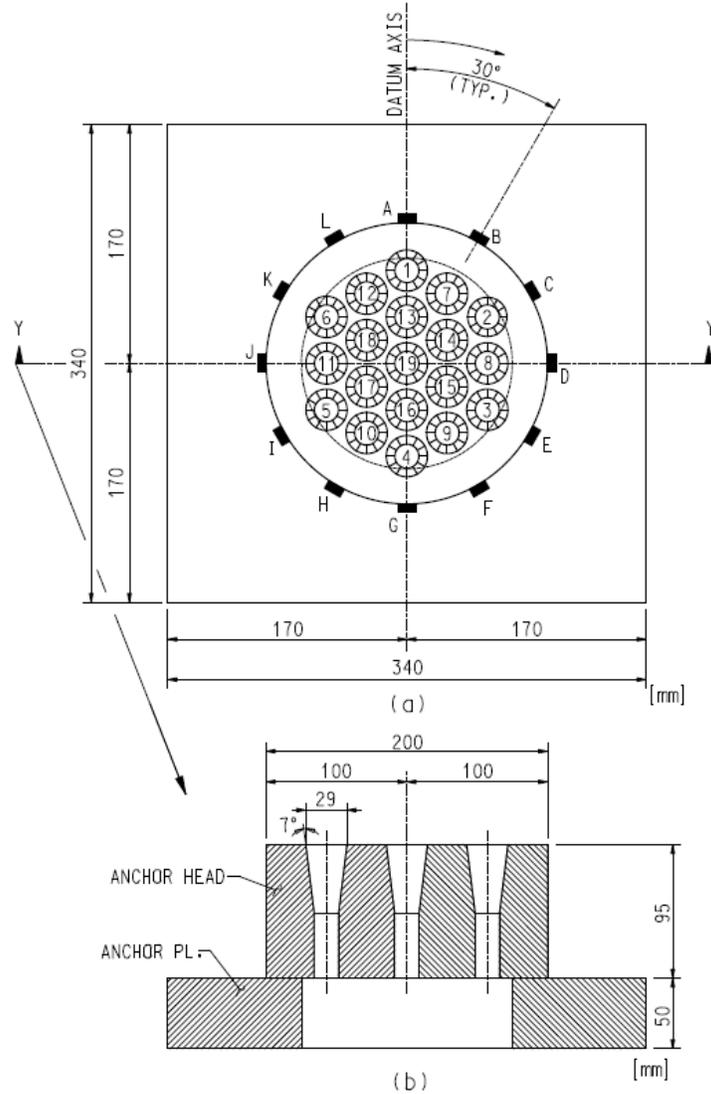
Figure 4-14 E 6-19 anchorage details: (a) top view; (b) section Y-Y

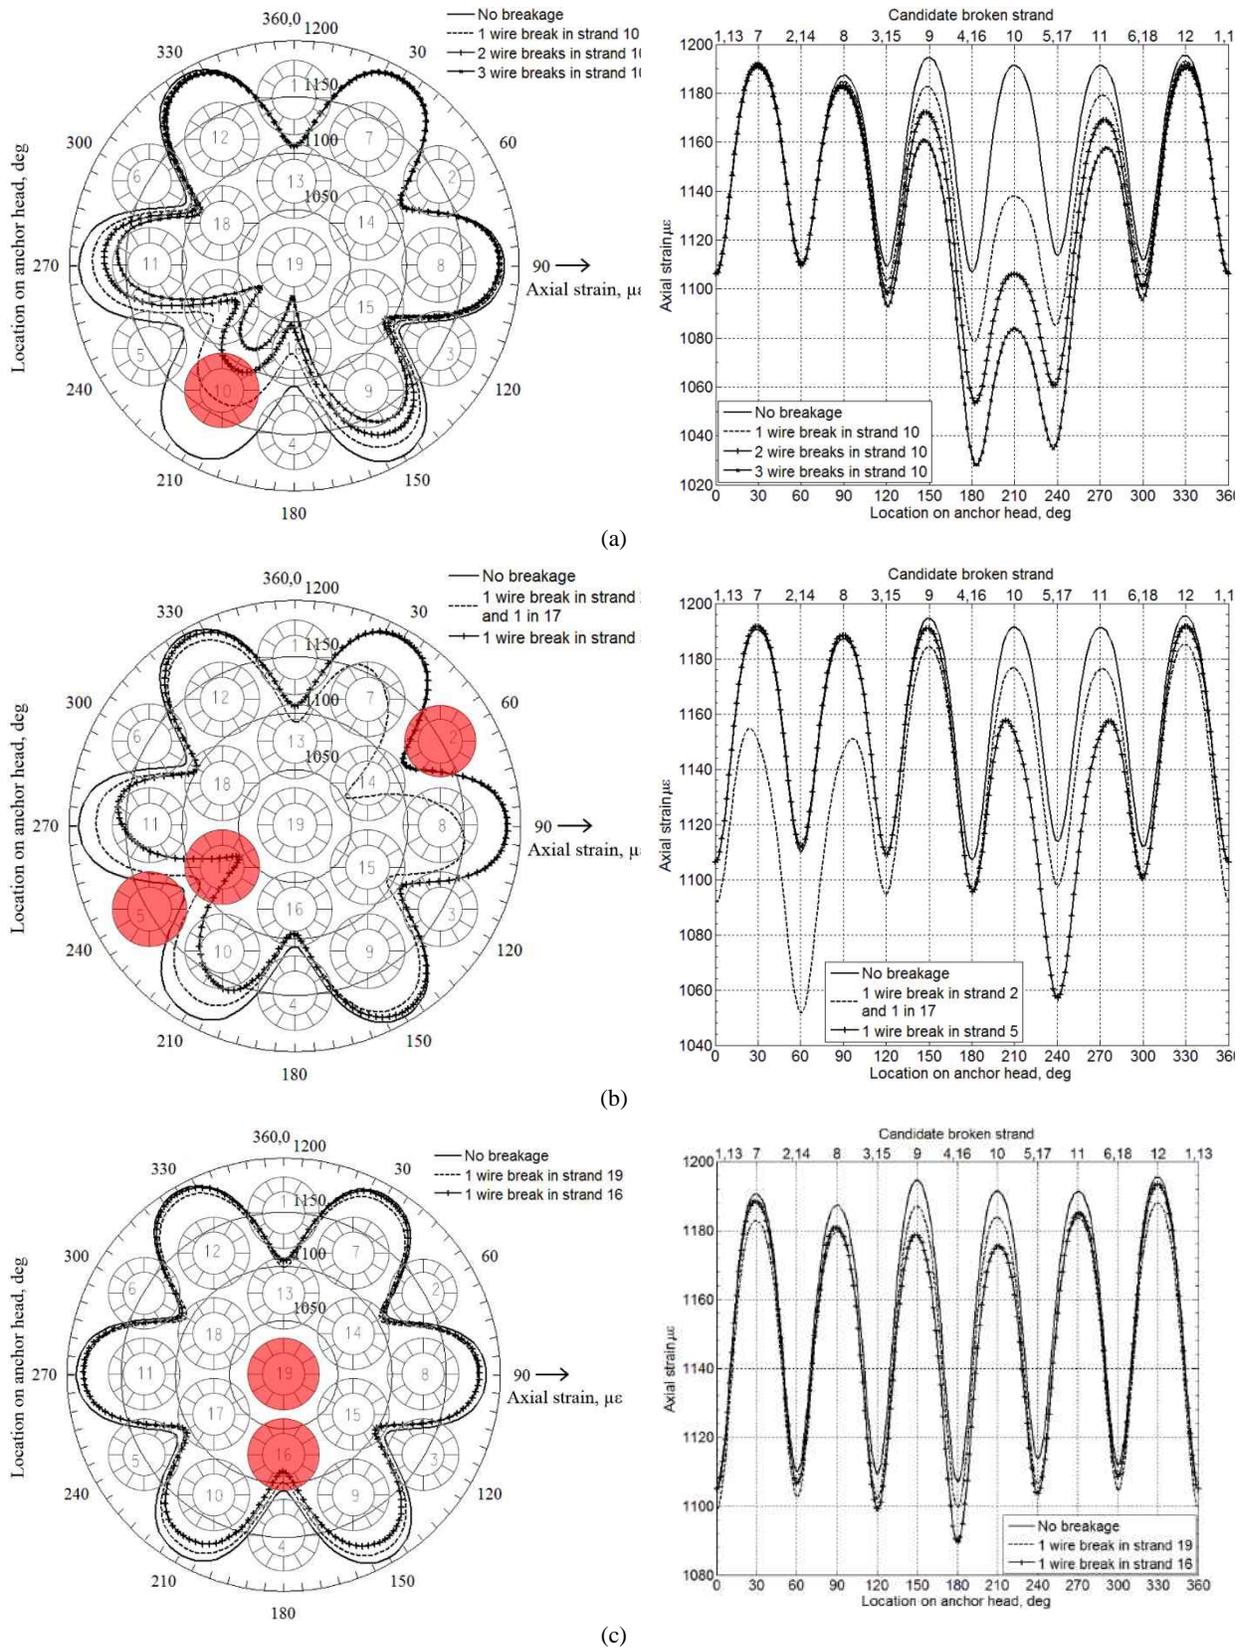
Figure 4-15 Comparison of axial strains in E 6-19 anchorage before and after wire breaks

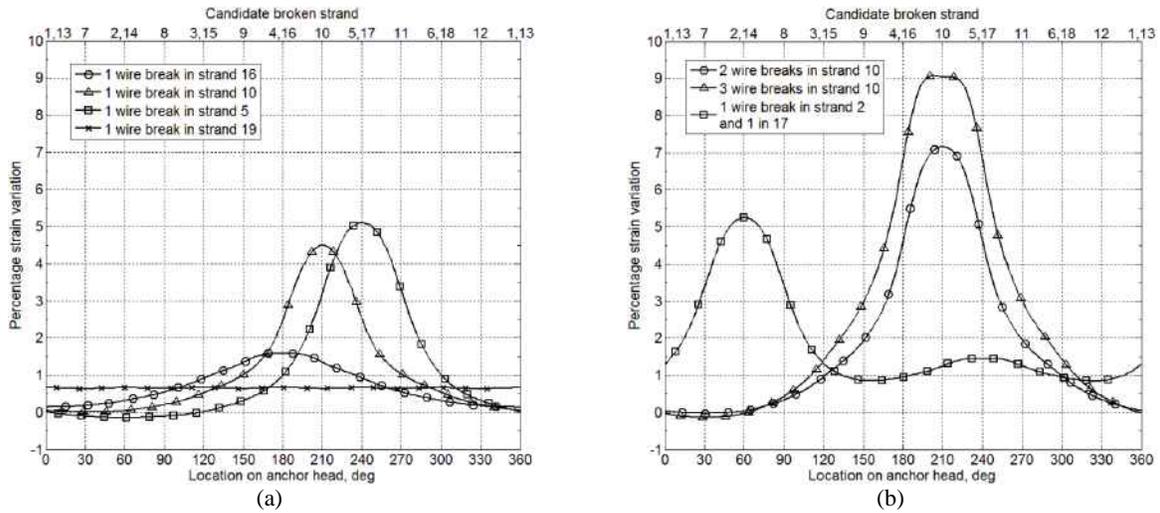
Figure 4-16 Strain variations in E 6-19: (a) single wire break; (b) multiple wire breaks

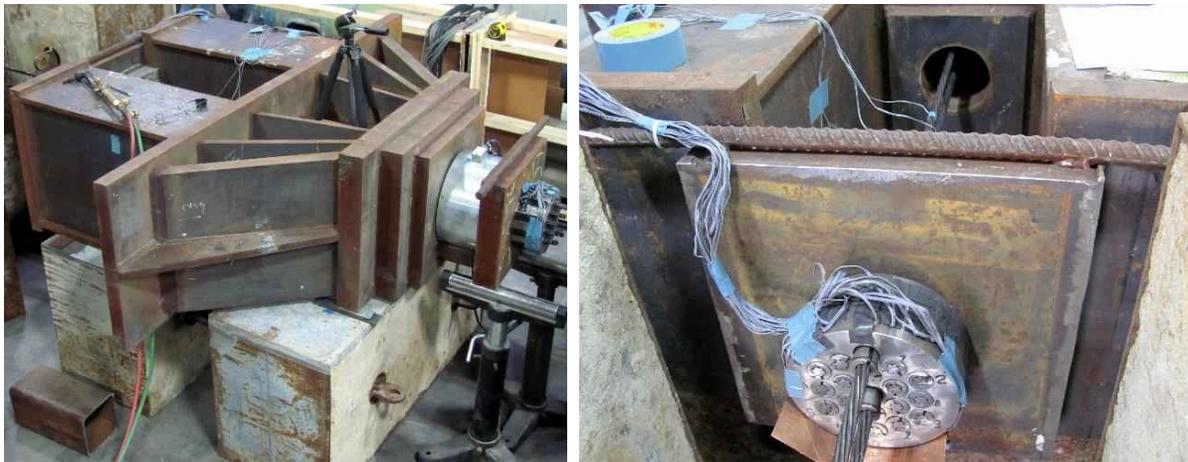
(a) Test frame

(b) Stressing end

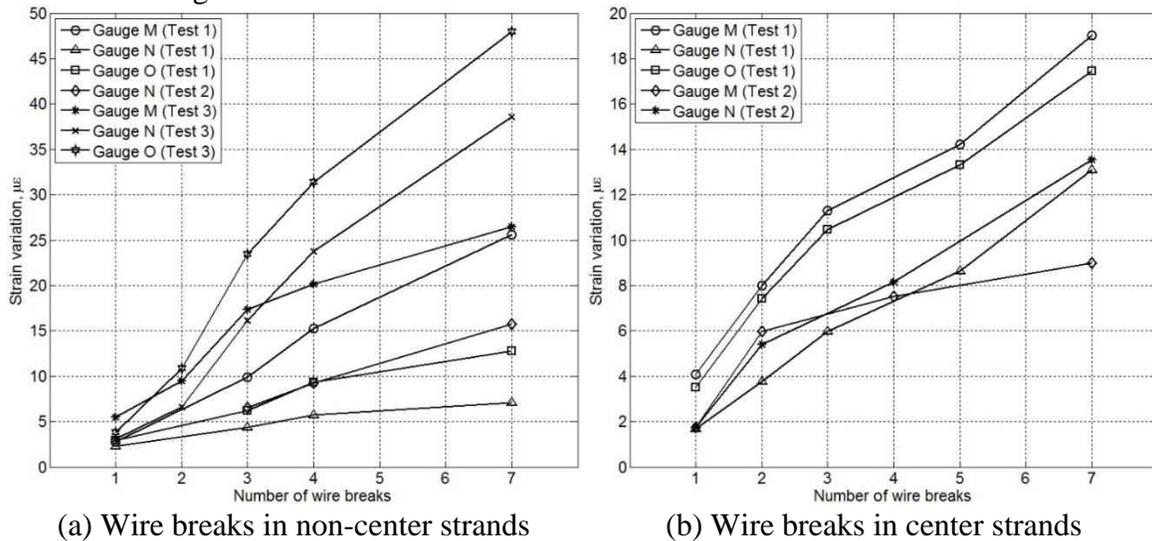
Figure 5-6 Circumferential strain variations due to wire breaks

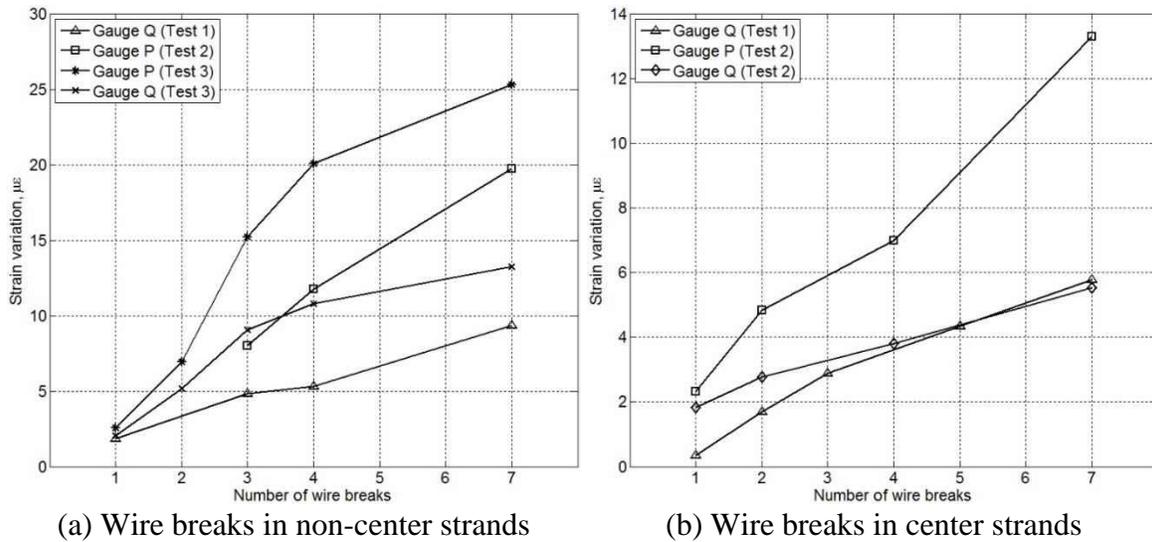
Figure 5-7 Radial strain variations due to wire breaks

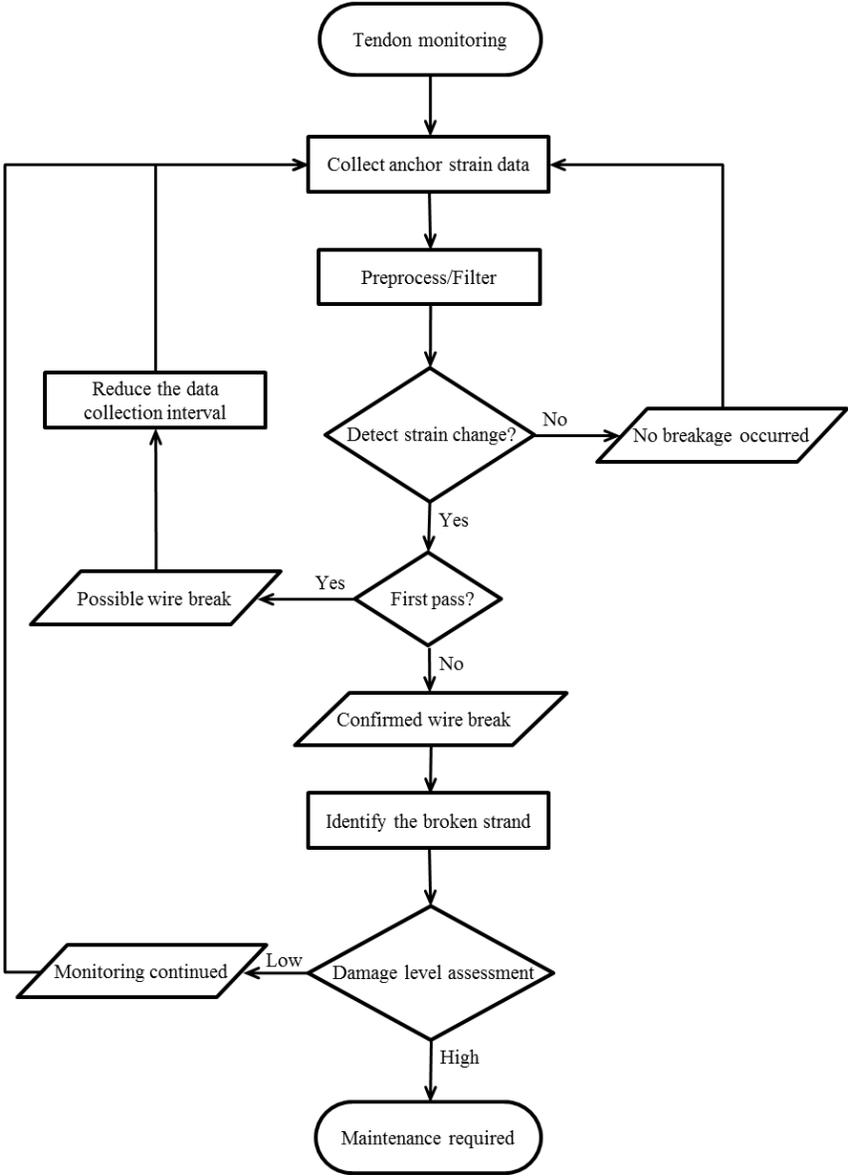
Figure 6-1 Wire breakage identification flowchart

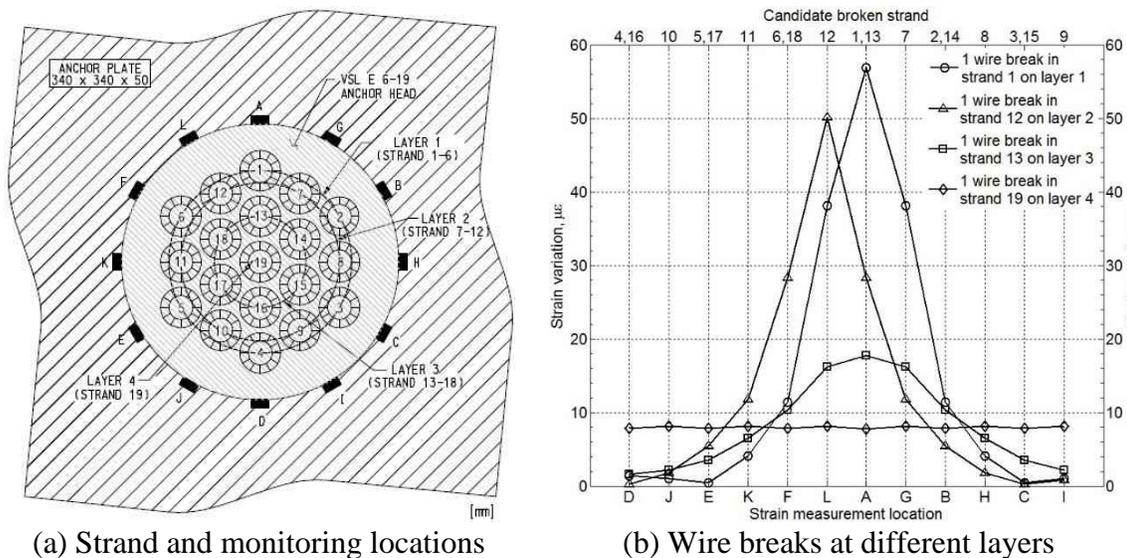
Figure 6-2 Monitoring locations and representative strain variations from FE analyses

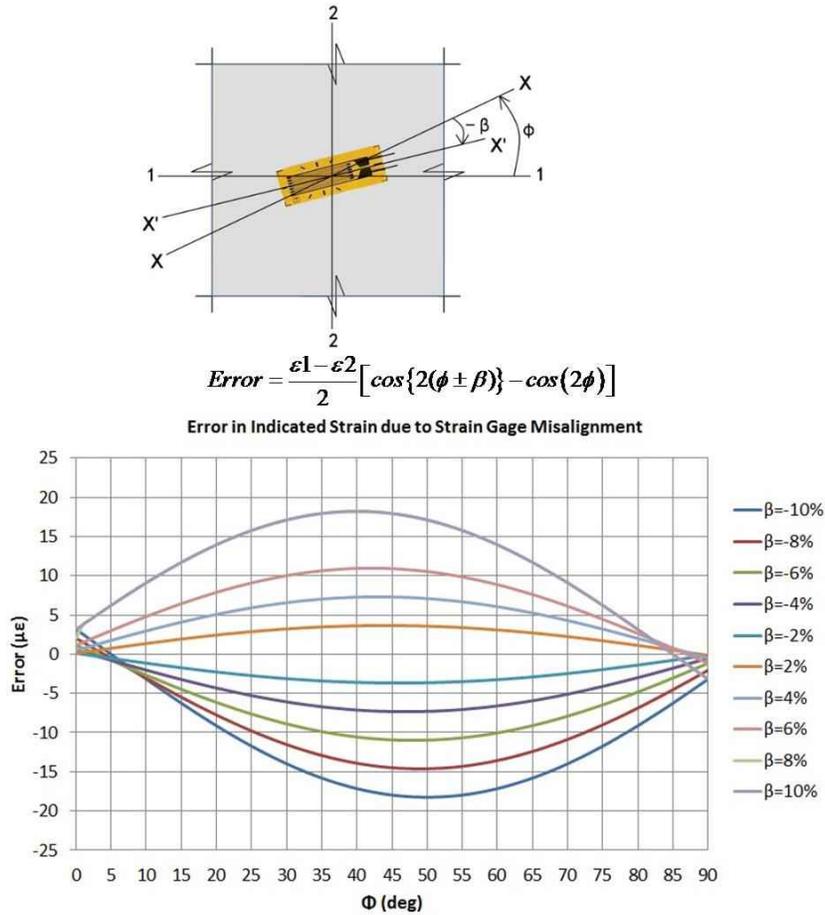
Figure 6-4 Error due to misalignment of strain gage

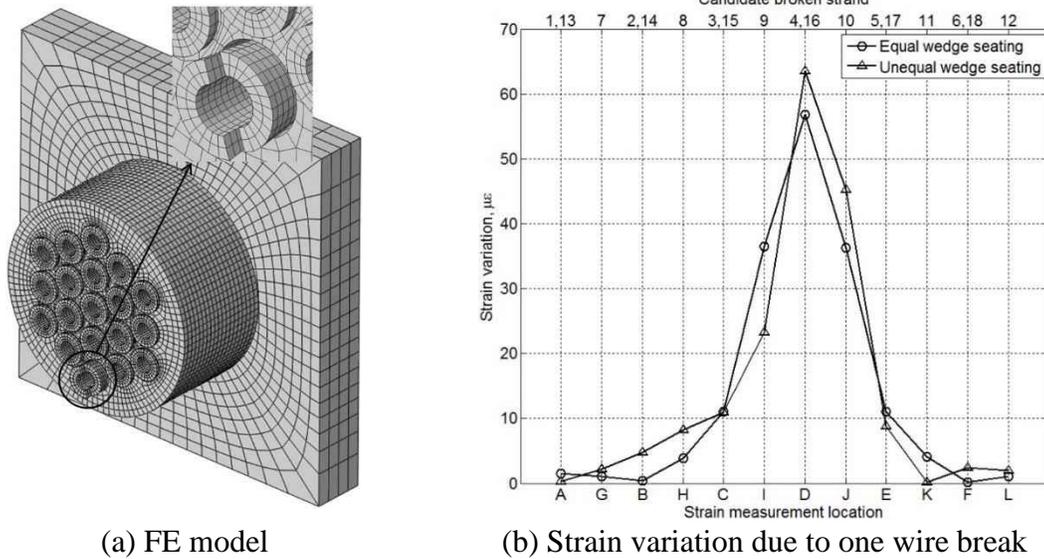
Figure 6-6 Differential wedge seating

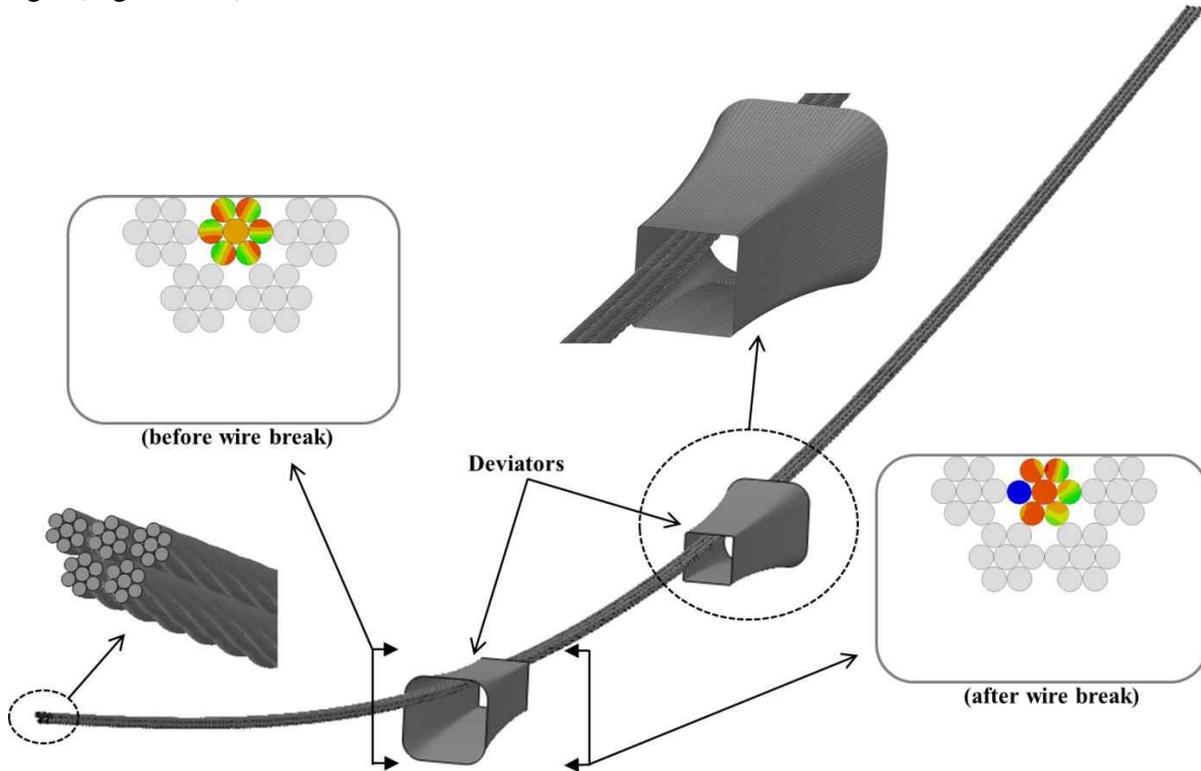
Figure 7-20 Deviated multi-strand tendon

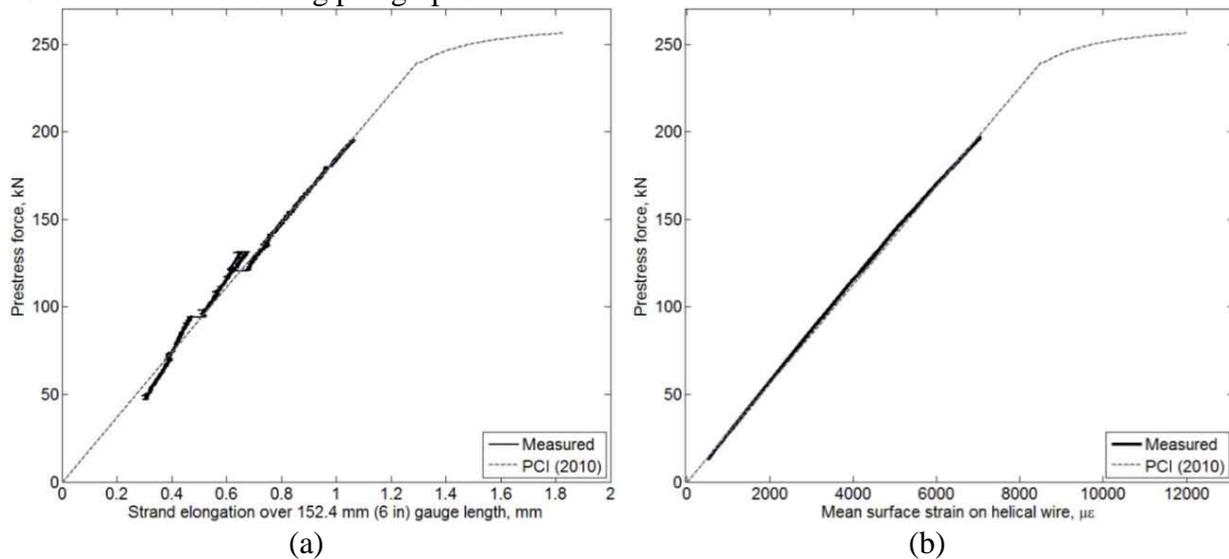
Figure 8-3 Stressing in Experiment 1: (a) load vs. elongation; (b) load vs. strain

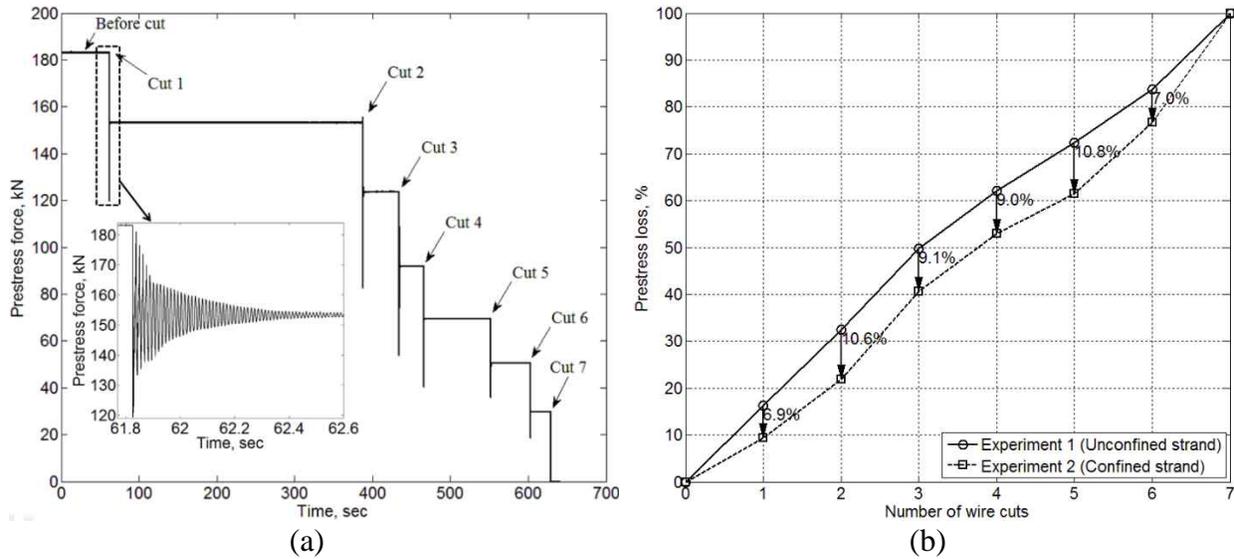
Figure 8-4 Global static response: (a) load history during wire cuts in *Experiment 1*; (b) comparison of prestress loss between *Experiment 1* and *Experiment 2*

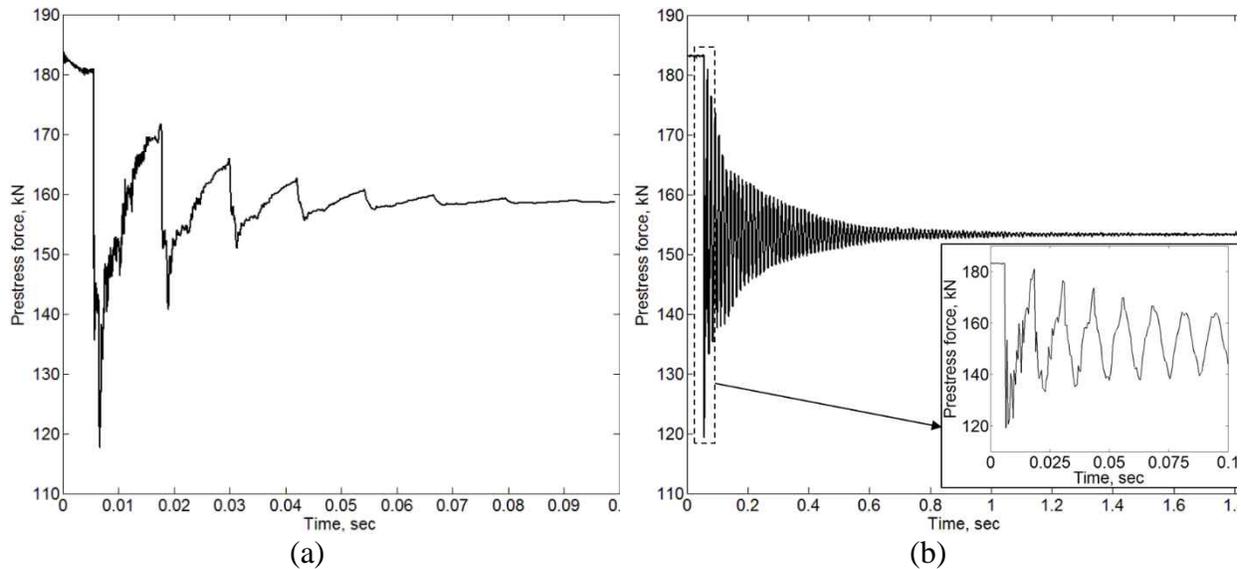
Figure 8-10 Change of prestress force after wire break in unconfined state: (a) FEA; (b) experiment

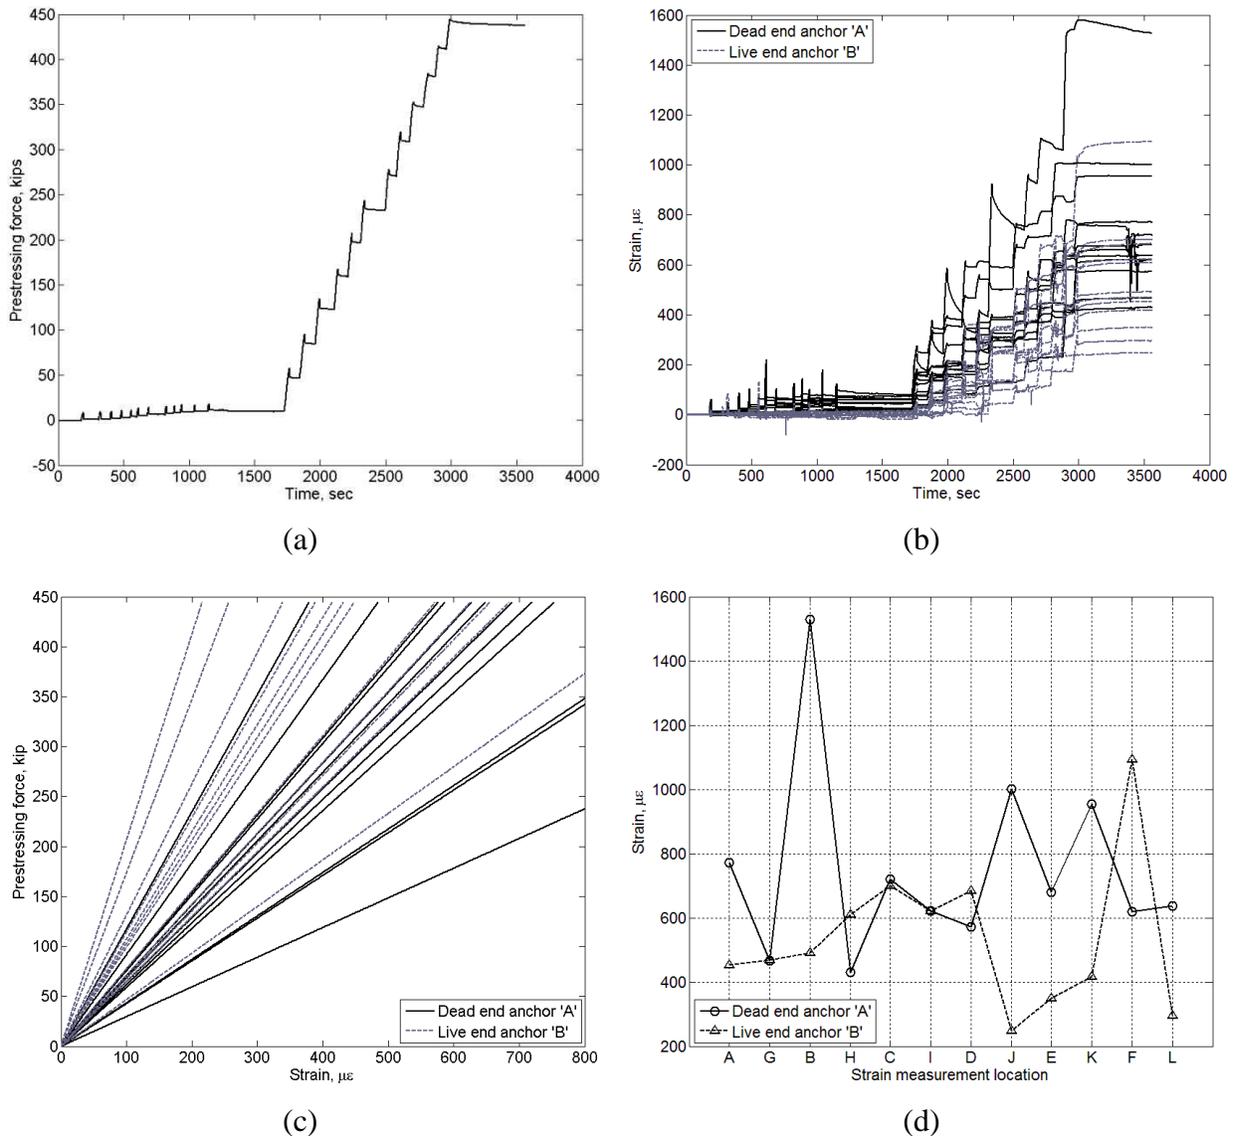
Figure 9-4 Post-tensioning: (a) load cell time history at dead end 'A'; (b) anchor strain time history; (c) anchor strain vs. prestressing force; (d) final strain at the end of post-tensioning

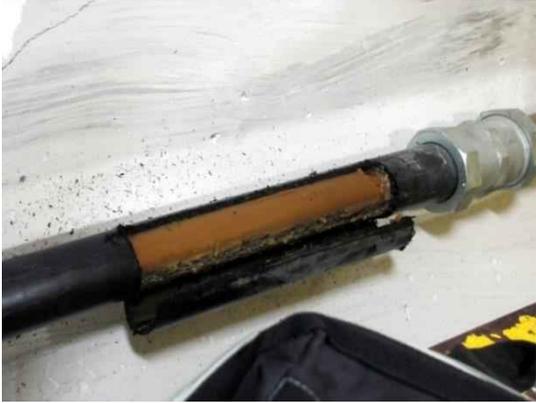
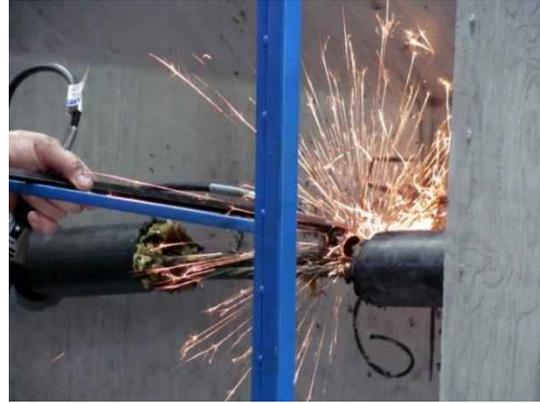
Figure 9-12 Cutting the strands

The tendon ducts were opened after unloading the beam to access the strands for making wire cuts (Figure 9-12a). The two tendons were cut at different locations to investigate the breakage detectability at different distances from the anchors: Tendon 1 was cut at about 36ft-4in away from anchor 'A1' (3ft-8in from anchor 'B1'), whereas Tendon 2 was cut at about 22ft-7in from anchor 'A2' (17ft-5in from anchor 'B2'). All 12 strands were cut wire-by-wire using a Dremel tool with rotating cutoff wheel of 31.75 mm (1.25 in) diameter. Again, the strands of the two tendons were alternately cut to avoid prestressing force imbalance. In case of some strand cuts, the wedges of the broken strands came out of the wedge plate immediately after the whole strand was severed (Figure 9-13), which confirmed the identification of the broken strand. The strain gage and load cell data were recorded at a higher sampling rate (2 kHz) during the cutting operation to capture the dynamic response of the broken strands (Appendix C) in addition to the static strain response of the anchors.

(a) exposing the duct to access the strands

(b) wire cuts with Dremel tool

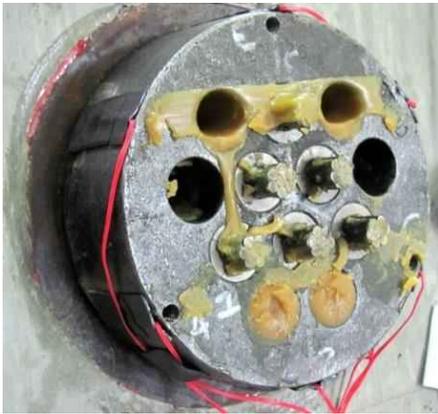
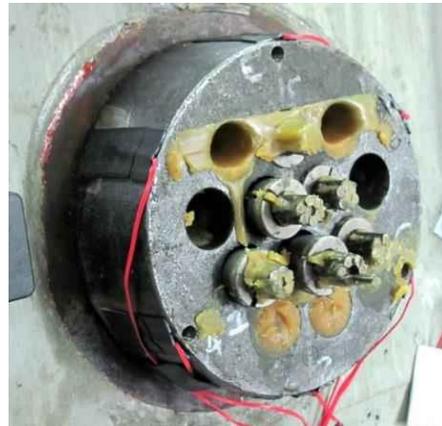
Figure 9-13 Wedge movement after strand cuts

(a) before strand cuts

(b) after strand cuts

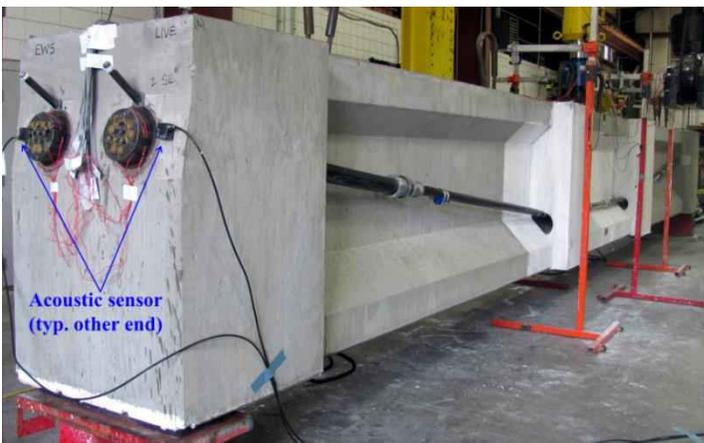
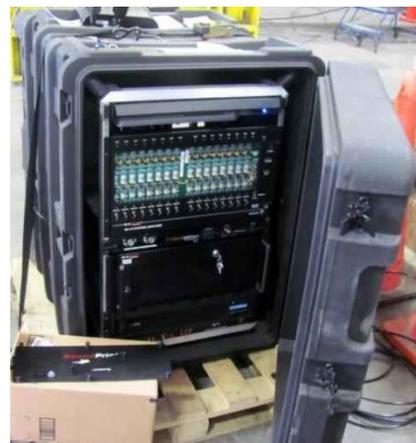
Figure 9-14 Acoustic monitoring

(a) acoustic sensor placement

(b) SoundPrint DAQ

In addition to the anchor strain measurements, four acoustic sensors (piezoelectric accelerometers of frequency range up to 22 kHz) were mounted to the concrete surface with cyanoacrylate adhesive, one next to each of the wedge plates (Figure 9-14). Through coaxial cable, the sensors were connected to a calibrated acoustic monitoring DAQ (Pure Technologies' SoundPrint acoustic monitoring system), where the captured signals were preprocessed and filtered. The data were then transmitted using standard internet protocols to a remote data processing center for further processing, event classification (possible wire break/wire break/confirmed wire break), and reporting.

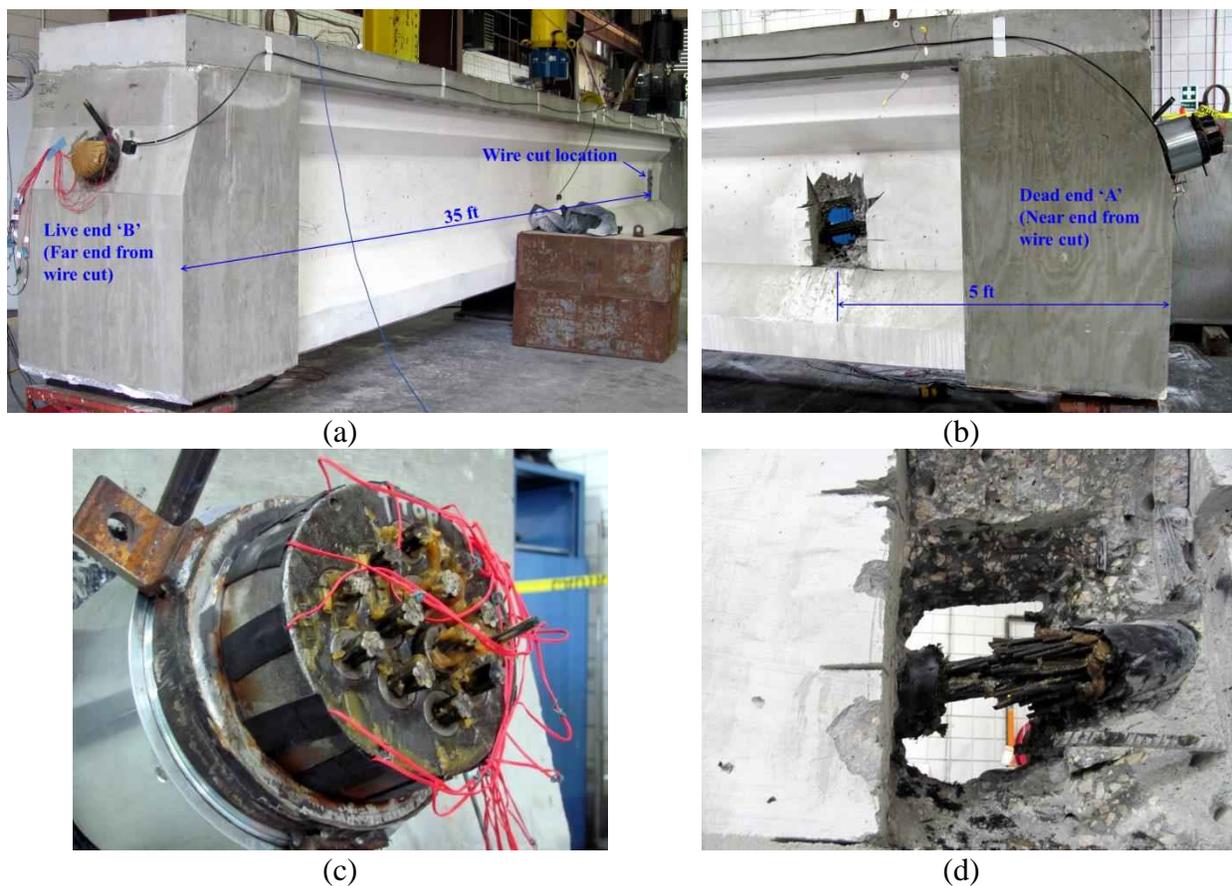
Figure 9-25 Test setup for internal unbonded specimen: (a) live end; (b) dead end and access window for wire cuts; (c) anchor instrumentation; (d) tendon close-up after strand cuts

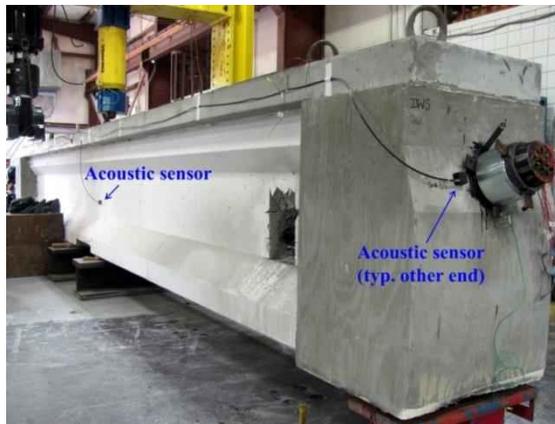
Figure 9-27 Acoustic sensor placement on internal unbonded tendon specimen

strand came out of the wedge plate at the near end anchor 'A' (Figure 9-26). The wedges at the far end anchor 'B', however, were visually unaffected by the strand cuts. In addition to the 12 strain gages, the three acoustic sensors were installed next to the wedge plates and at the midspan (Figure 9-27) to capture the wire break events.
