# Replaceable Unbonded Tendons for Post-Tensioned Bridges

**Final Report**

**December 2017**

Florida Department of Transportation (FDOT)

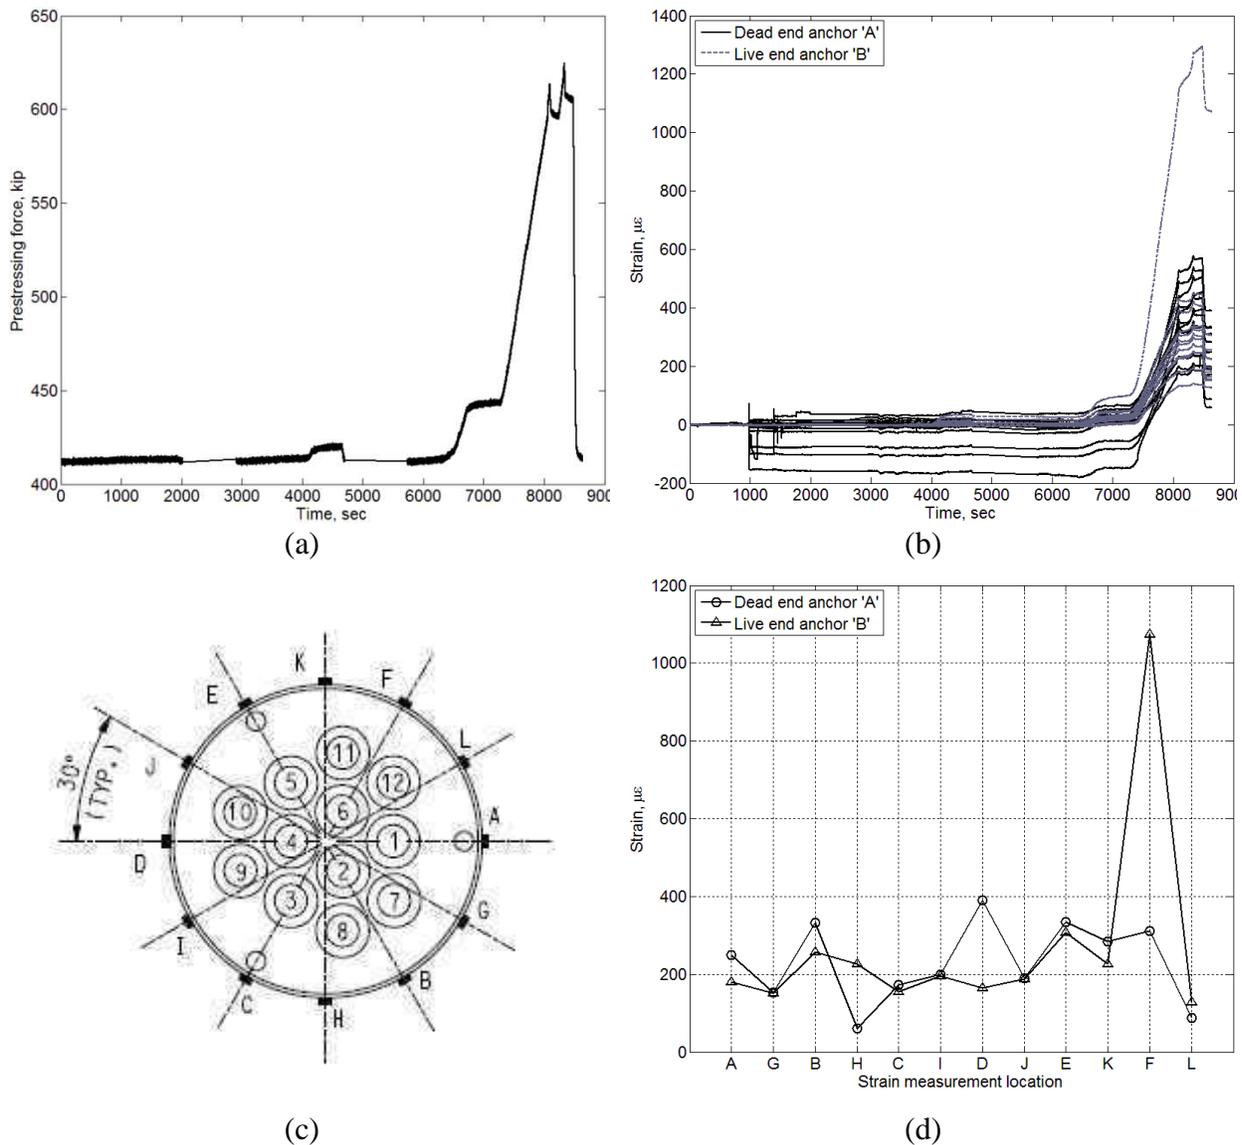
Figure 9-32 Beam loading: (a) load cell time history at dead end ‘A’; (b) anchor strain time history; (c) anchor instrumentation; (d) final strain at the end of load test

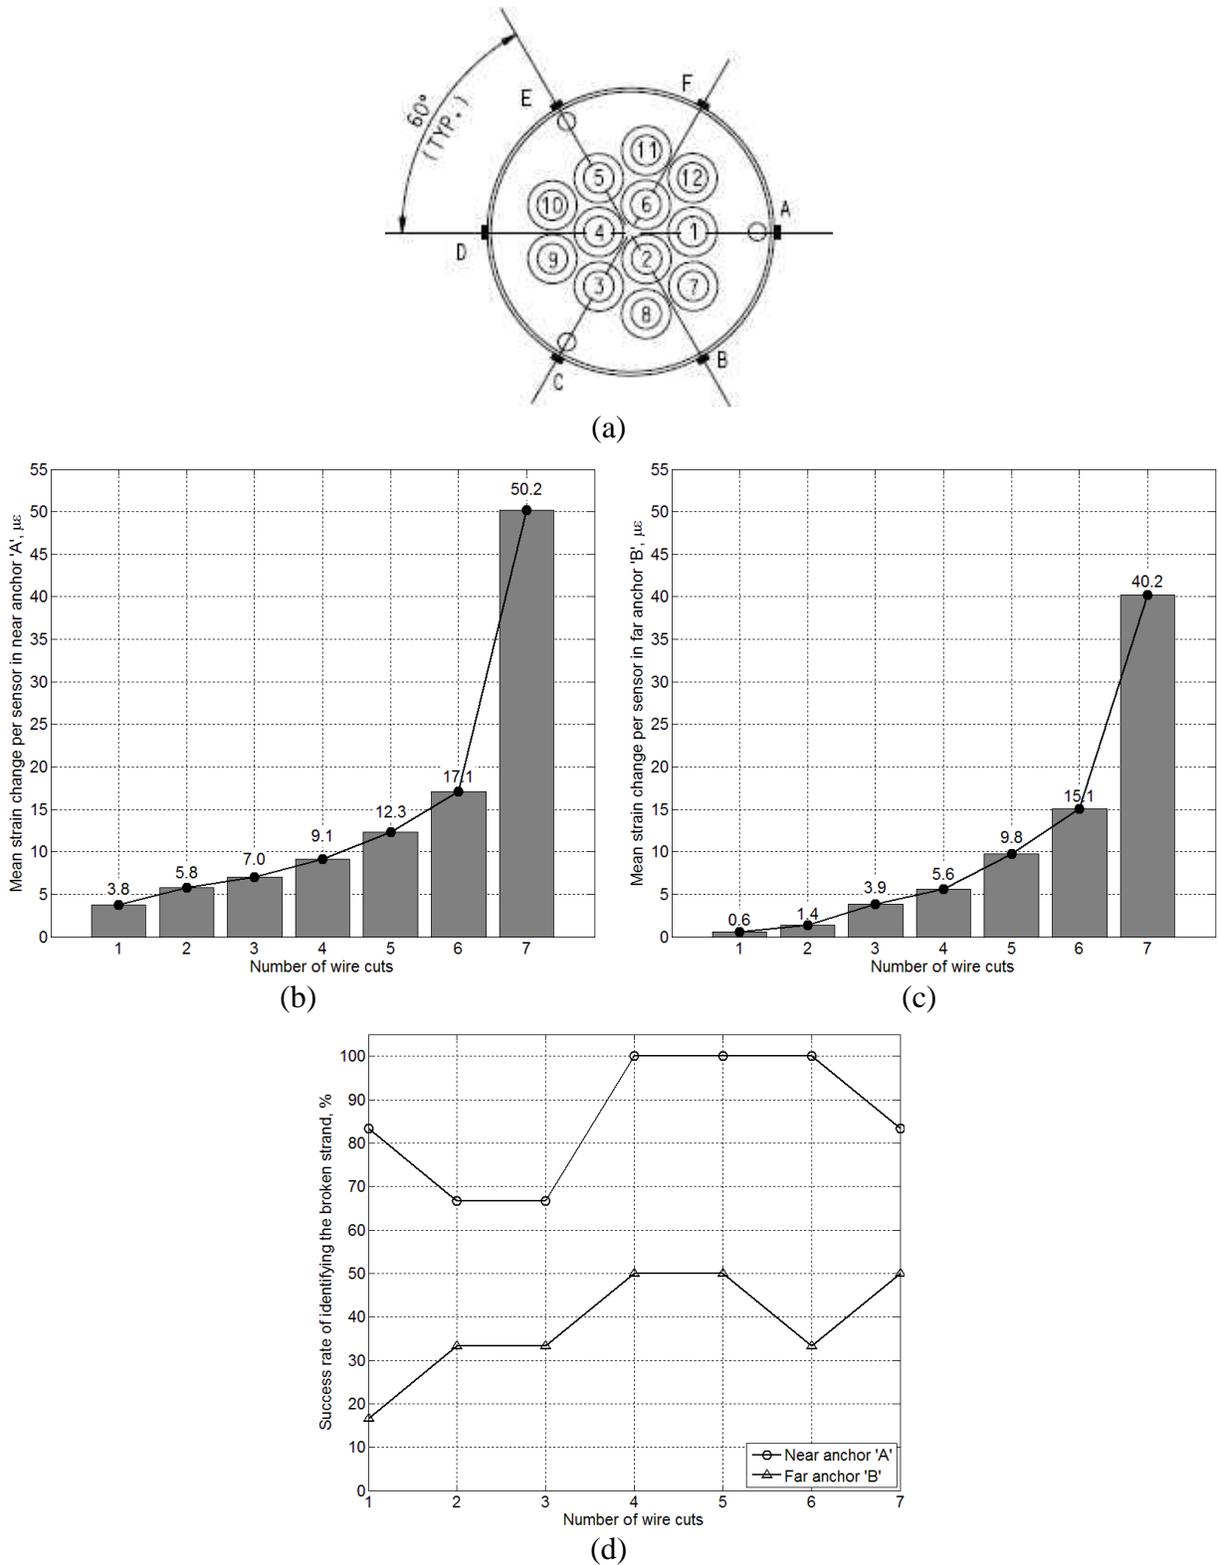
Figure 9-40 Performance of the algorithm with six sensors: (a) sensor layout; (b) strain change in near anchor 'A' for the first strand cut; (c) strain change in far anchor 'B' for the first strand cut; (d) success rate for all strand cuts

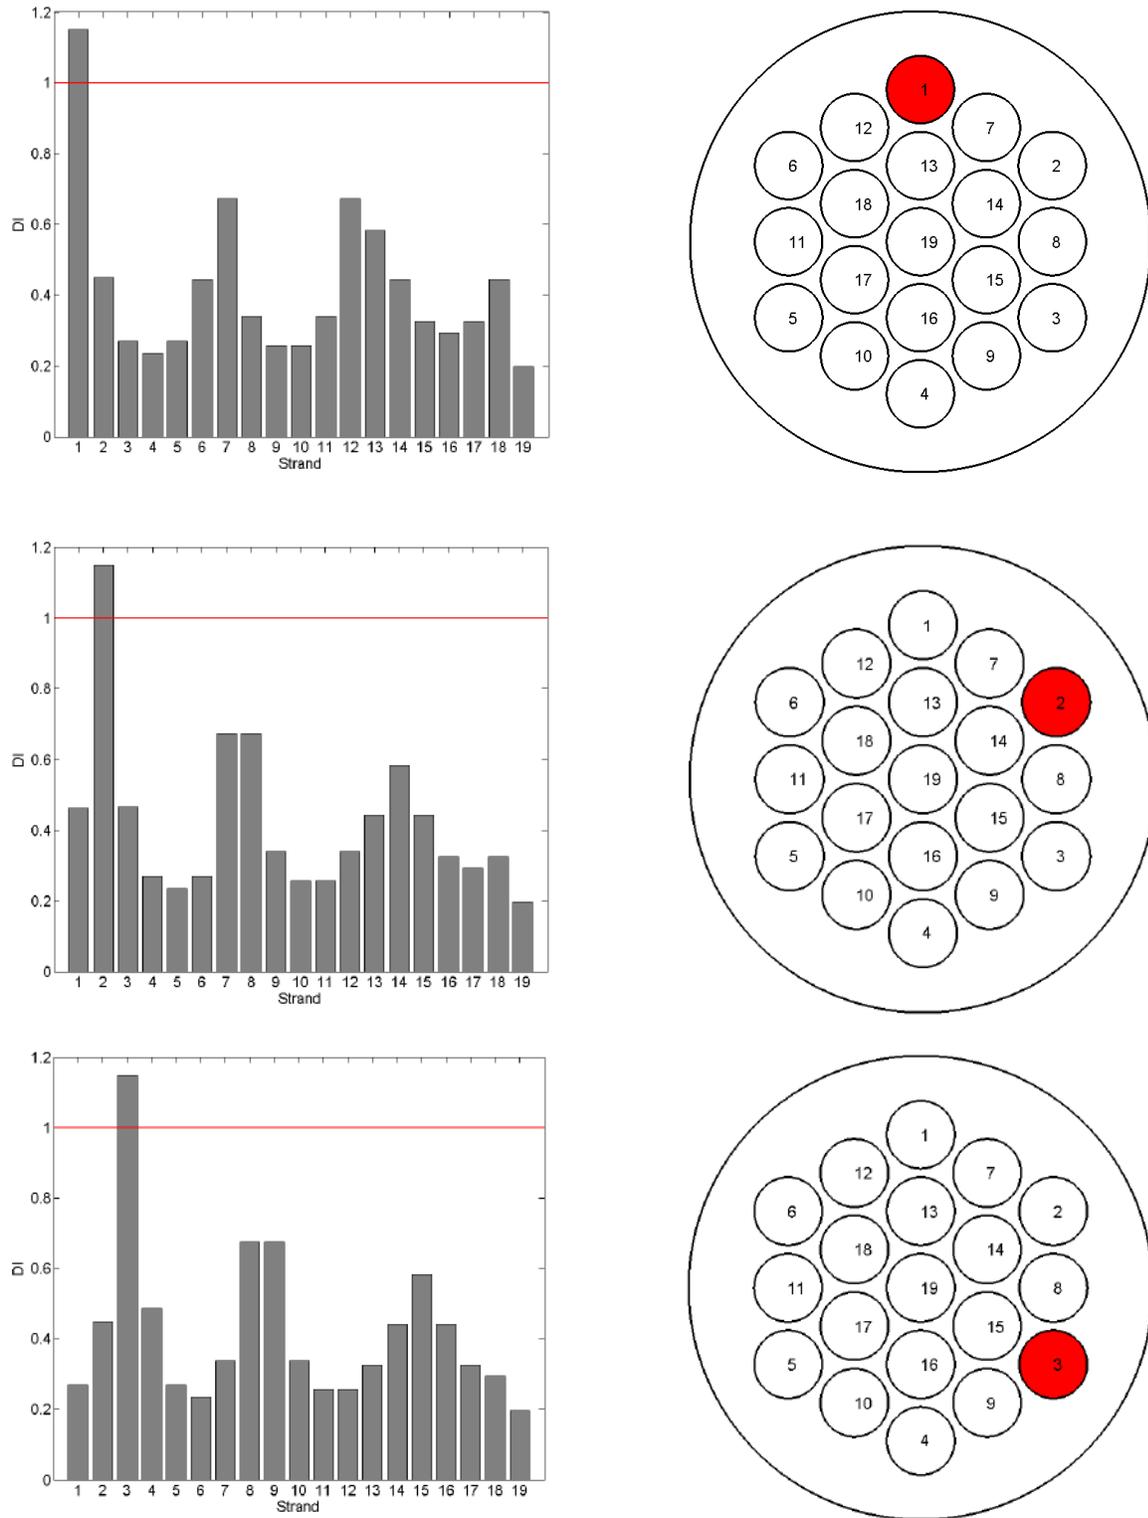
Figure F-70 Damage indices and visualization of tendon damage (Strand 1-Strand 3)
