**Post Grouting Drilled Shaft Tips**  
*Phase II*

**Principal Investigator: Gray Mullins**

**June 2004**

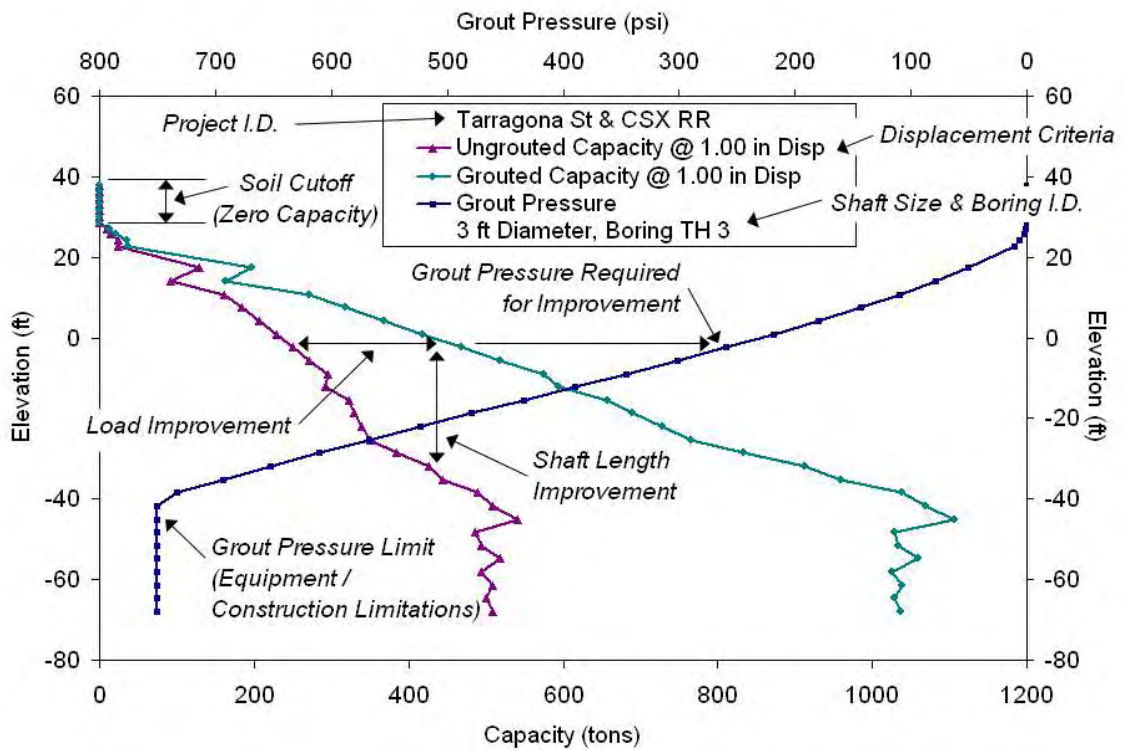
Figure 3-1 Detailed shaft capacity and grout pressure design curves.

The performance improvement can be evaluated either on the basis of load carrying capacity at a specific depth or on the basis of shaft length reduction for a given load. Figure 3-1 shows a typical design curve annotated to show these comparisons. The un-annotated curve was generated from the design software and provided to the contractors.

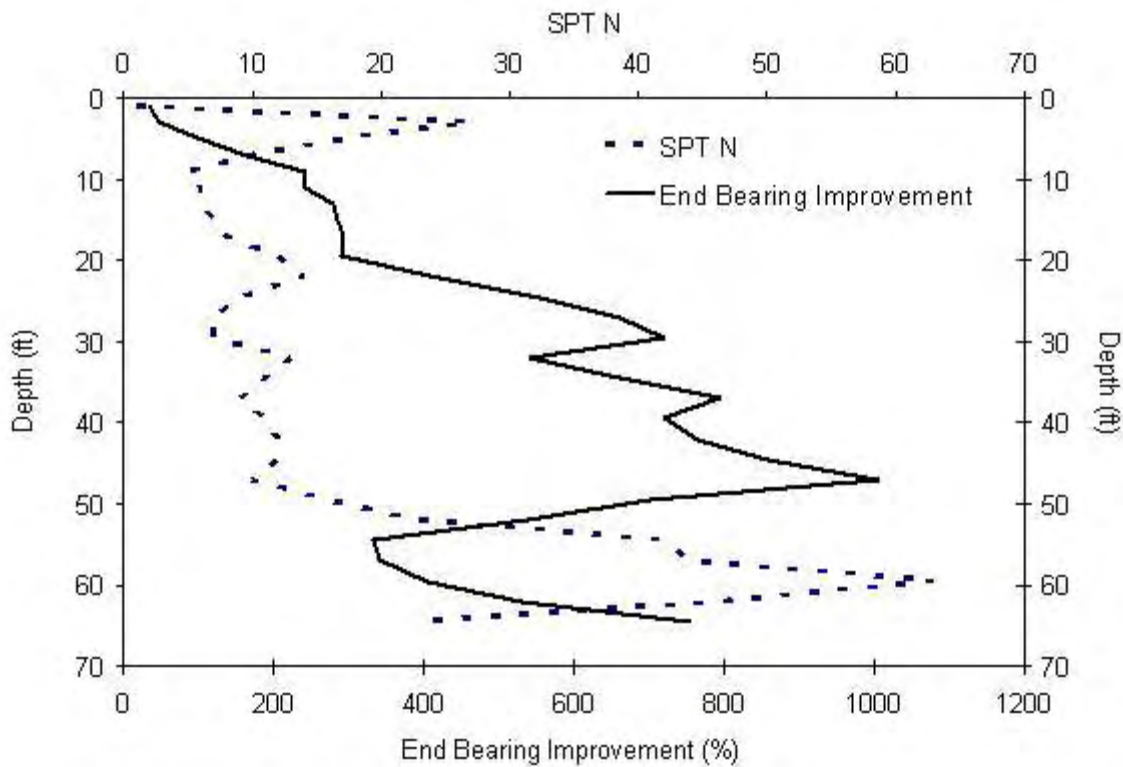
Figure 3-2 End Bearing Improvement with respect to depth and SPT N value.

For each project reviewed, the average end bearing improvement is reported. This average was derived from all lengths of shaft reported in a given design curve. This improvement was calculated as the difference between the grouted and ungrouted end bearing divided by the ungrouted end bearing. However, this average value is not truly representative of the actual improvement that would be realized but is an indicator of general improvement in that soil type. The actual improvement is dependent on the attainable grout pressure which is directly related to available side shear. The deeper a shaft is embedded, the more available side shear capacity and hence higher attainable grout pressure. Further, loose sands are more improvable than dense sands. Figure 3-2 shows the improvement as a function of depth for Boring PGAB-1 from the PGA Blvd Project in West Palm, FL. In general, the end bearing improvement increases with depth and decreases inversely proportional to relative density.

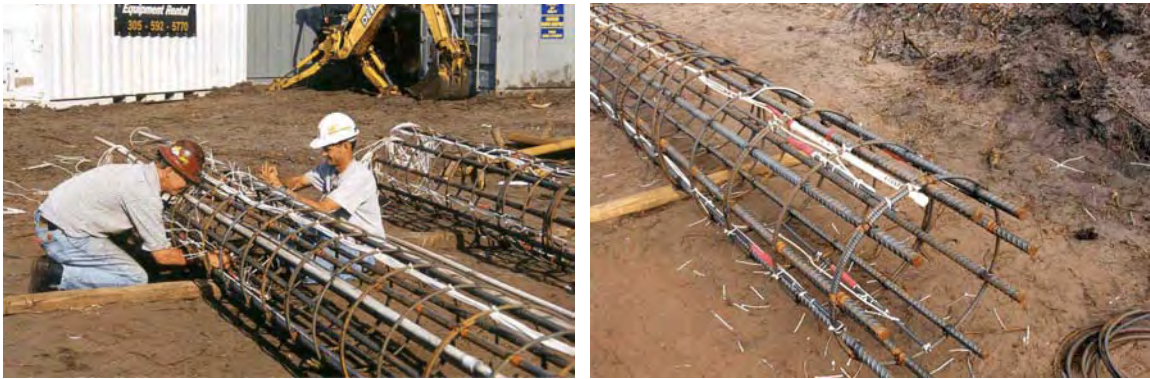
Figure 4-1 PGA Blvd: Installation of strain gages and toe accelerometer.

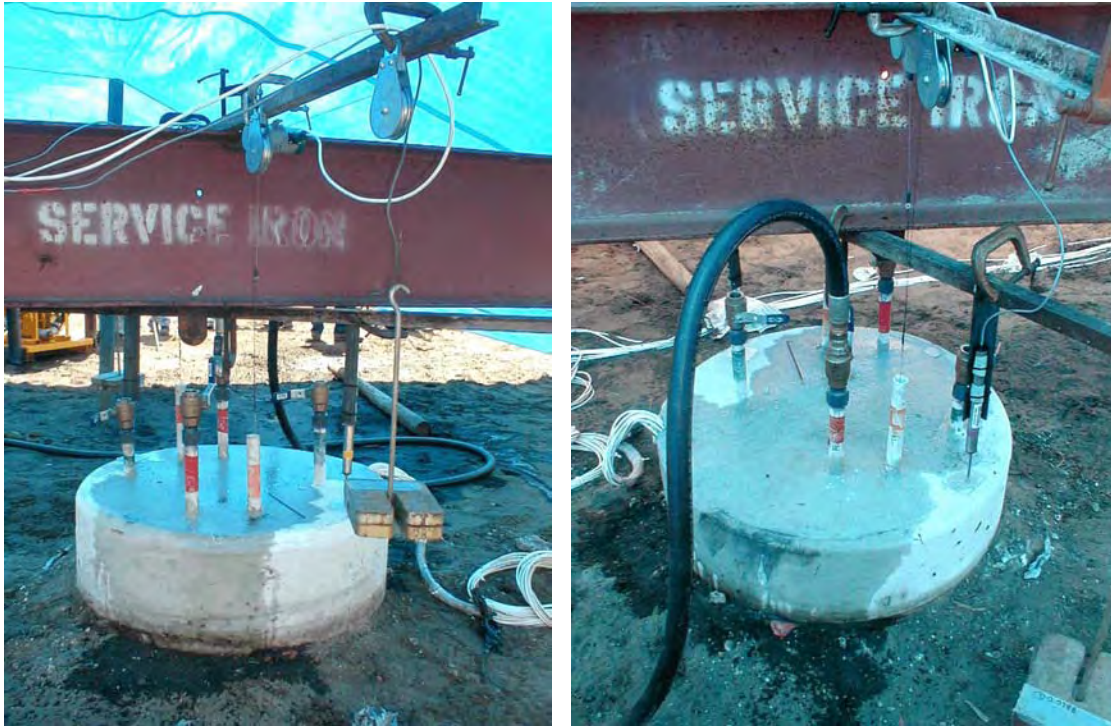
Figure 4-11 PGA Blvd: Post grout instrumentation setup.

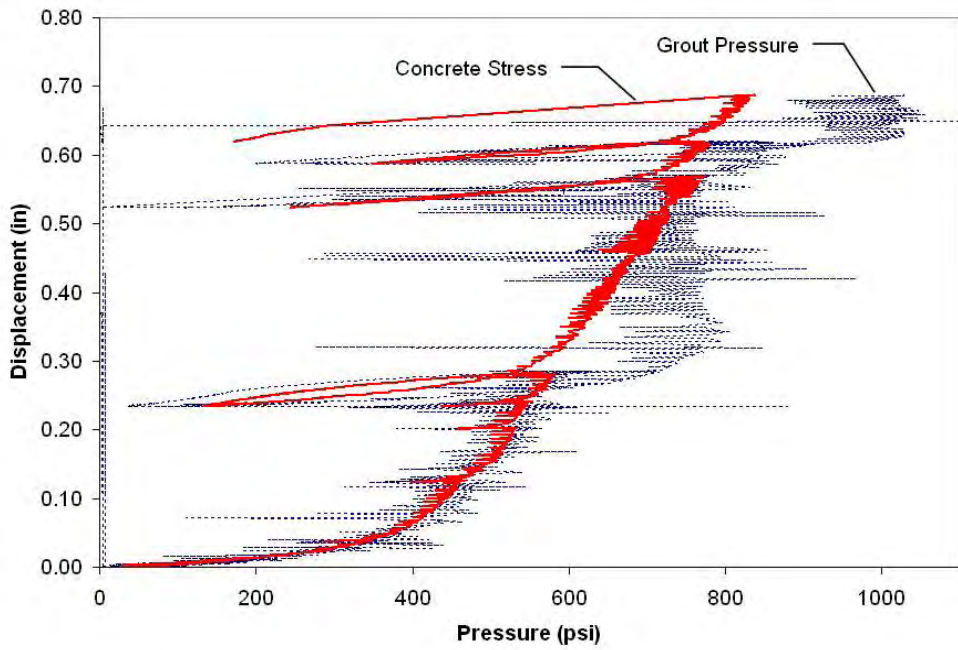
Figure 4-16 PGA Blvd: Shaft tip stress comparison with grout pump pressure.

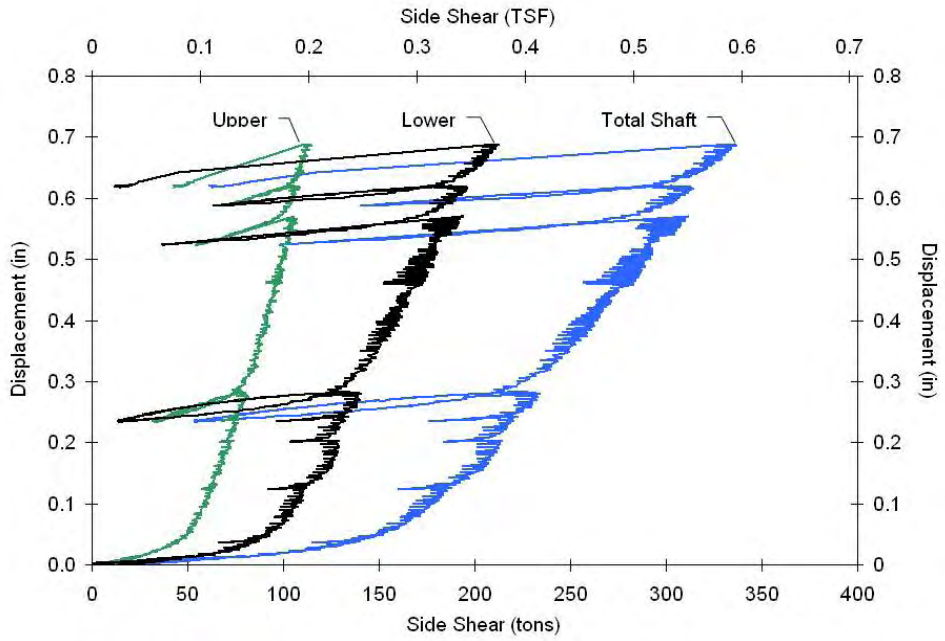
Figure 4-17 PGA Blvd: Side shear versus displacement during grouting.

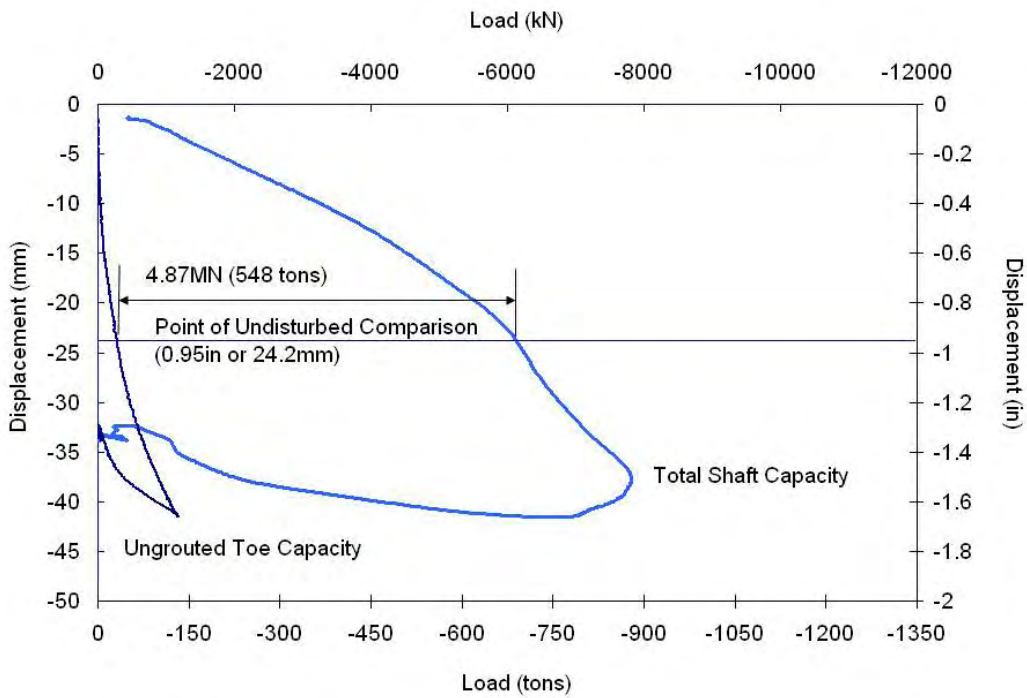
Figure 4-20 PGA Blvd: LT-1 total shaft and toe capacity curves.

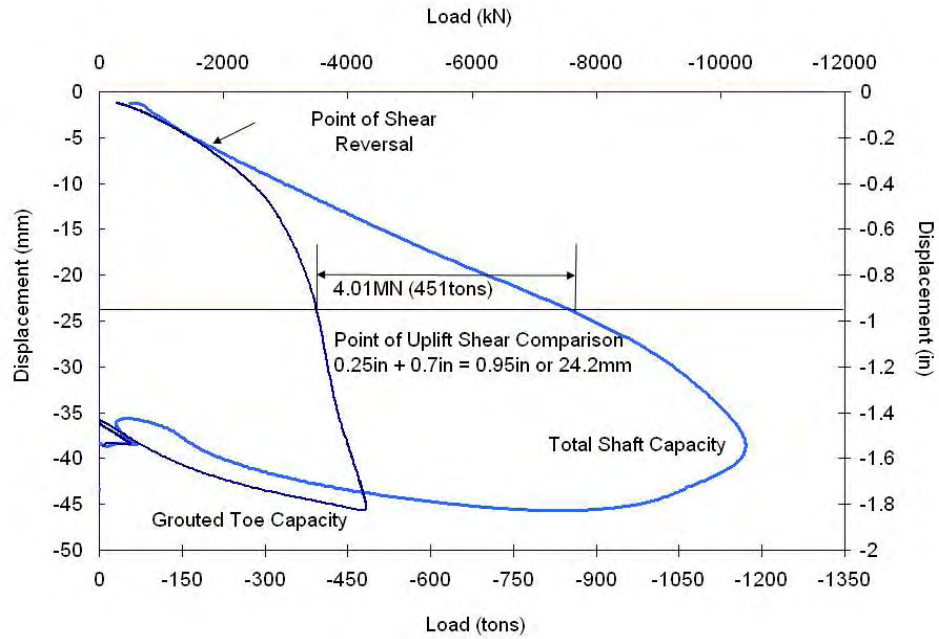
Figure 4-21 PGA Blvd: LT-2 total shaft and toe capacity curves.

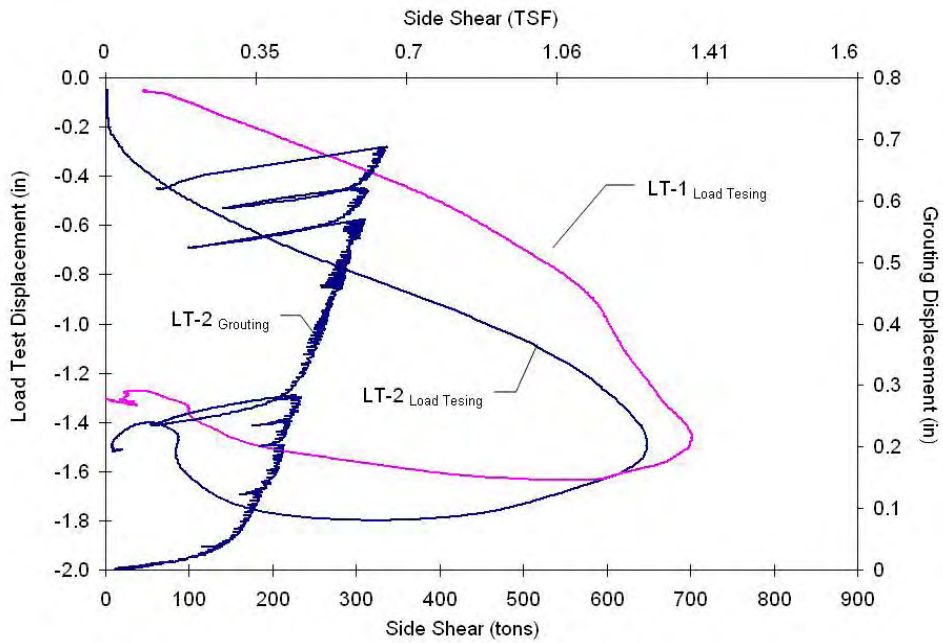
Figure 4-22 PGA Blvd: Side shear during load testing and grouting.

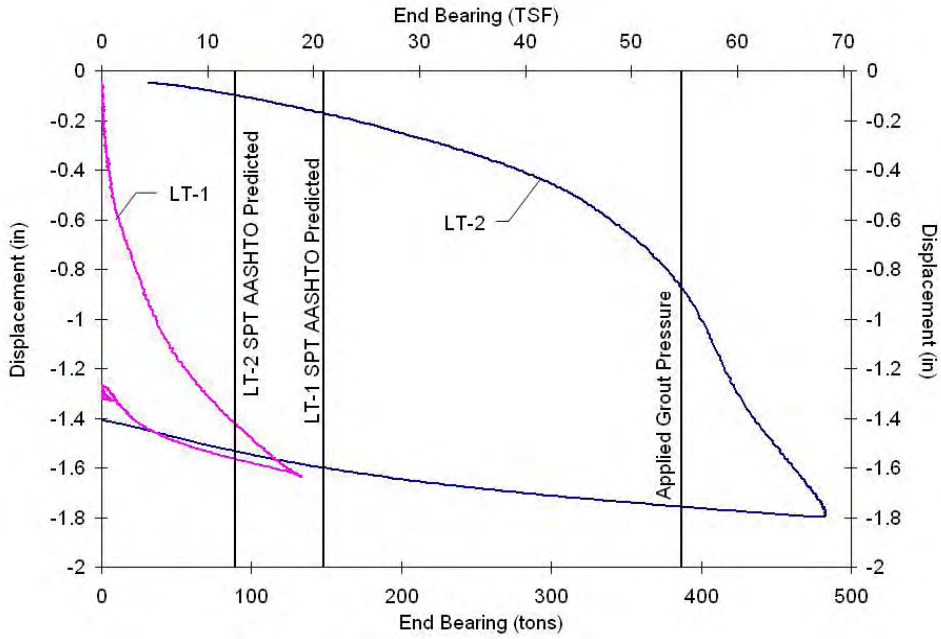
Figure 4-23 PGA Blvd: End bearing load plots with applied grout pressure and predicted AASHTO end bearing.

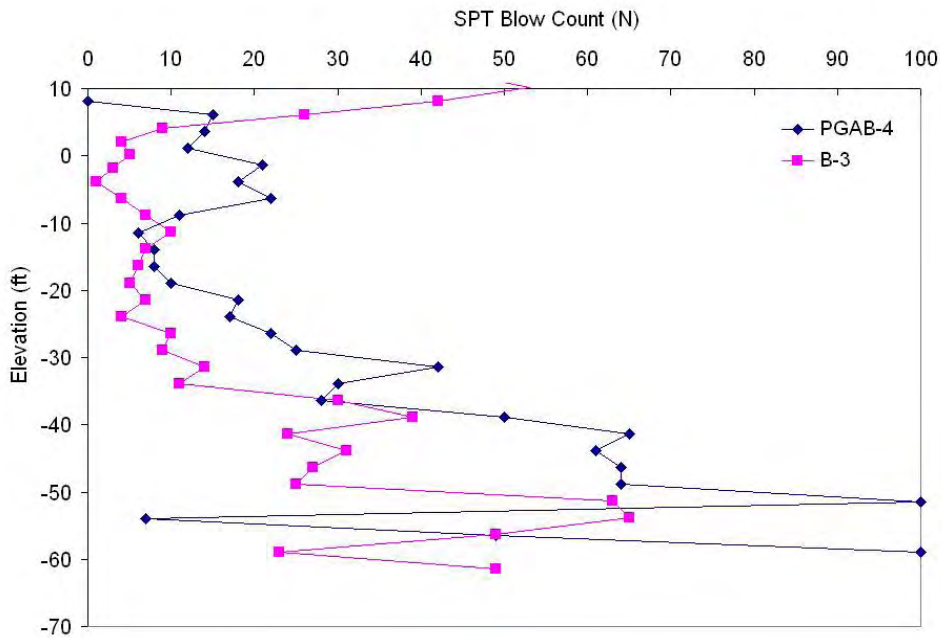
Figure 4-41 PGA Blvd: Variations in blow counts between manual and automatic hammers.

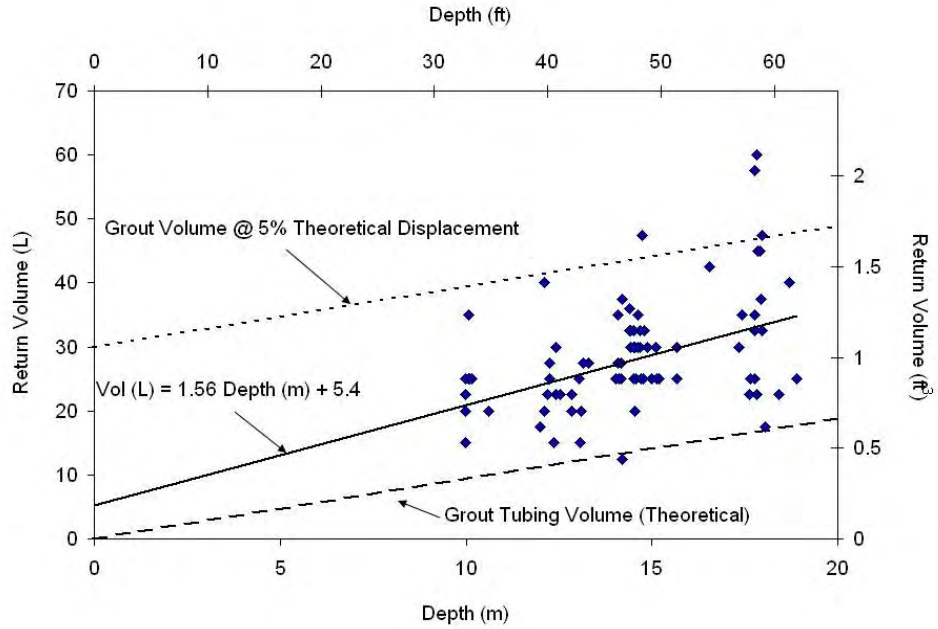
Figure 4-43 PGA Blvd: Volume of grout required to obtain return (no pressure).

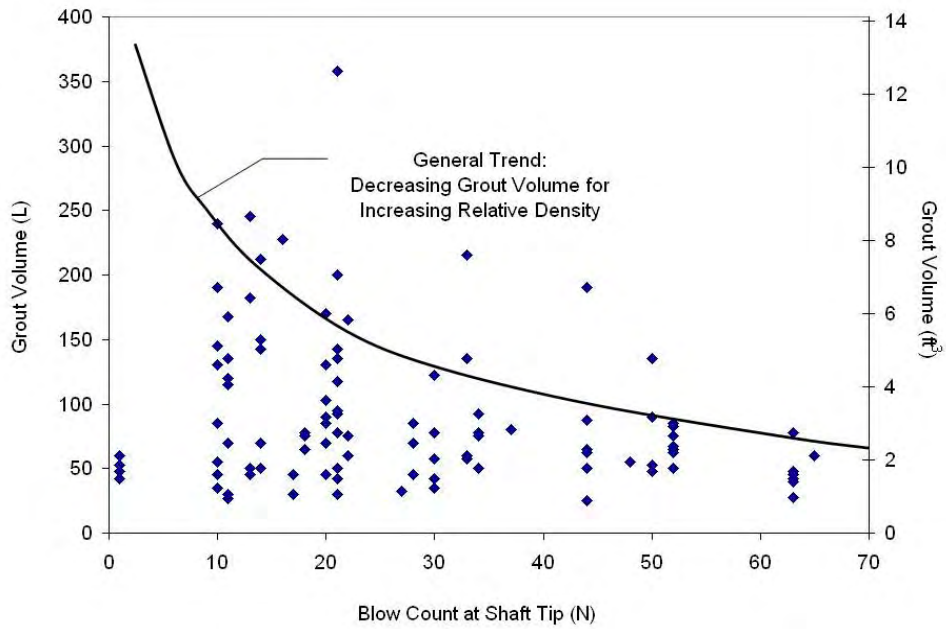
Figure 4-44 PGA Blvd: Net volume of grout placed beneath shaft tips.

with dense sand given the same side shear reaction. The difference lies in the amount of grout required to affect the soil modification to a similar density state. The dense sand beneath S-2 ( $N > 50$ ) and the net volume taken to grout ( $3 \text{ ft}^3$ ) are in line with that observed at the PGA Blvd project (Figure 4-44).

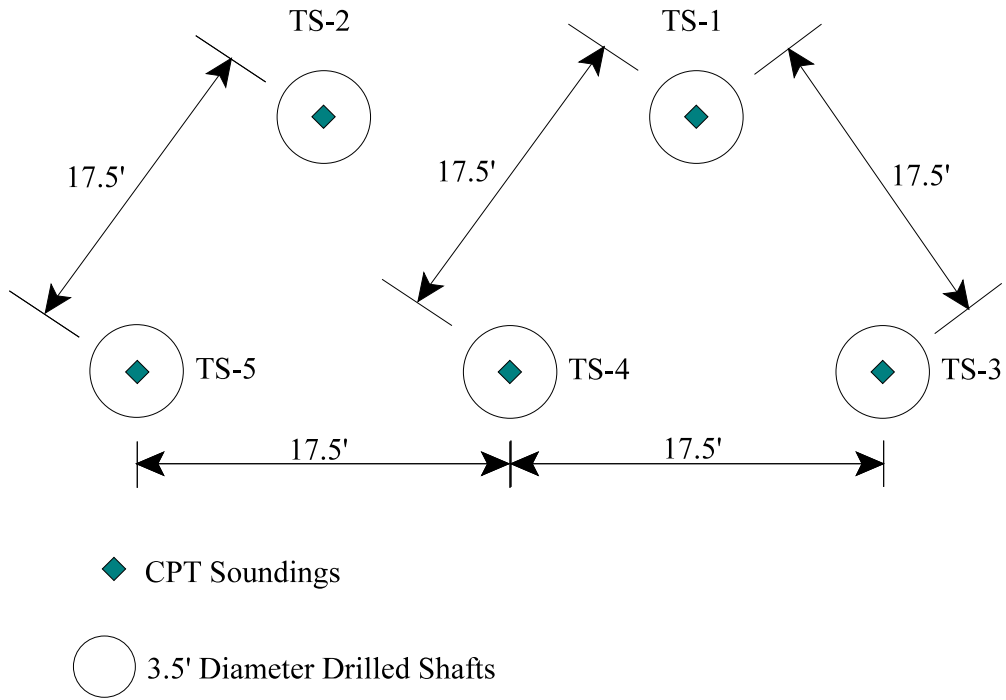
Figure 4-45 NGES Auburn test site layout.

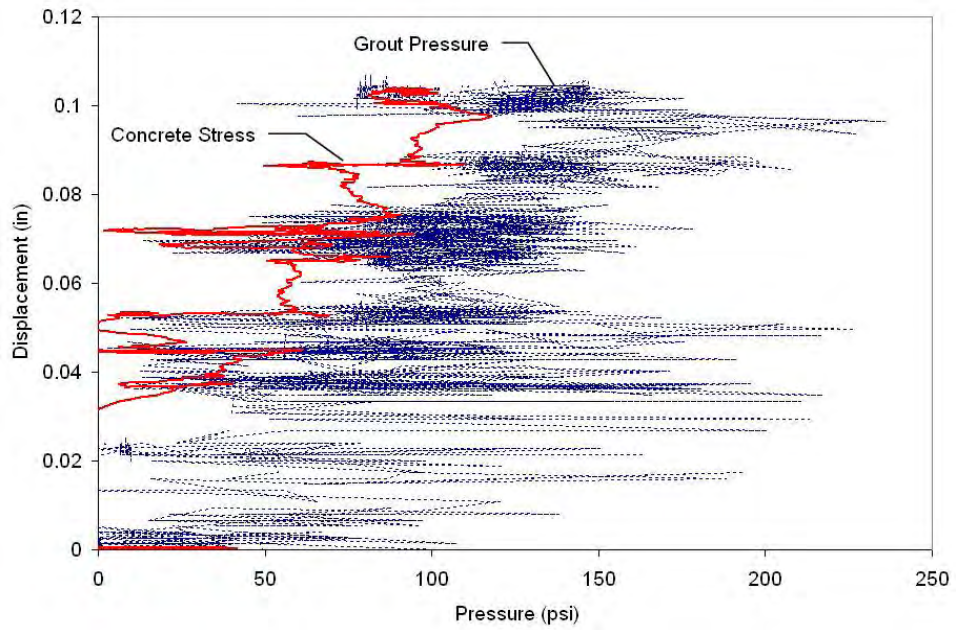
Figure 4-63 NGES Auburn: TS-1 grout pressure versus displacement.

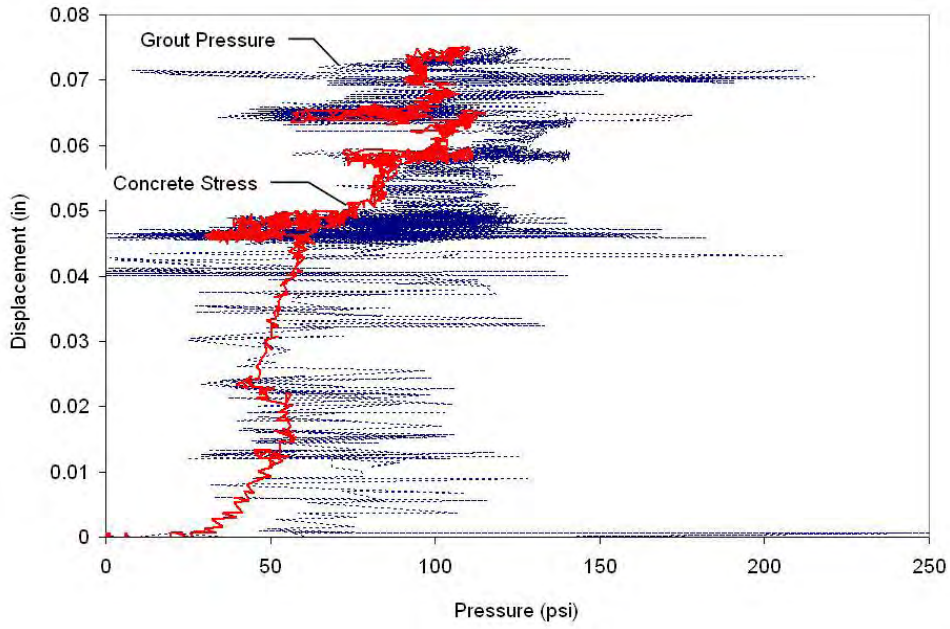
Figure 4-66 NGES Auburn: TS-5 grout pressure and concrete stress versus displacement.

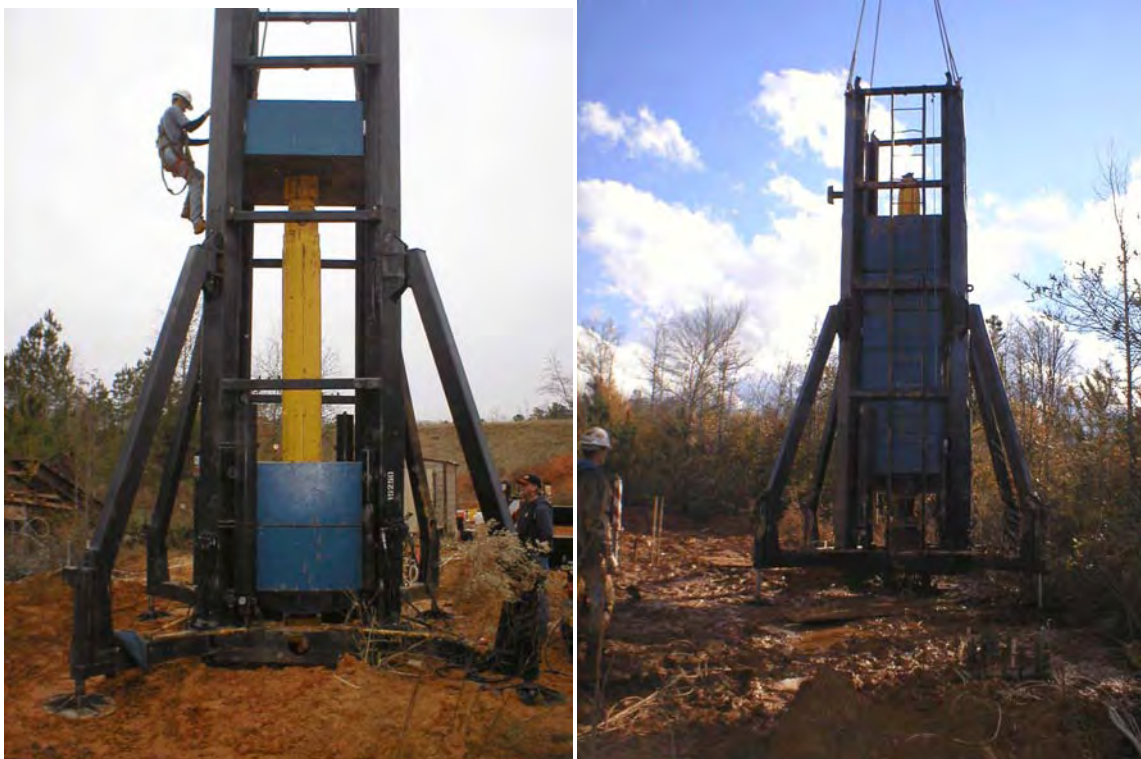
Figure 4-68 NGES Auburn: USF & FHWA's 4 MN Statnamic hydraulic catching device.

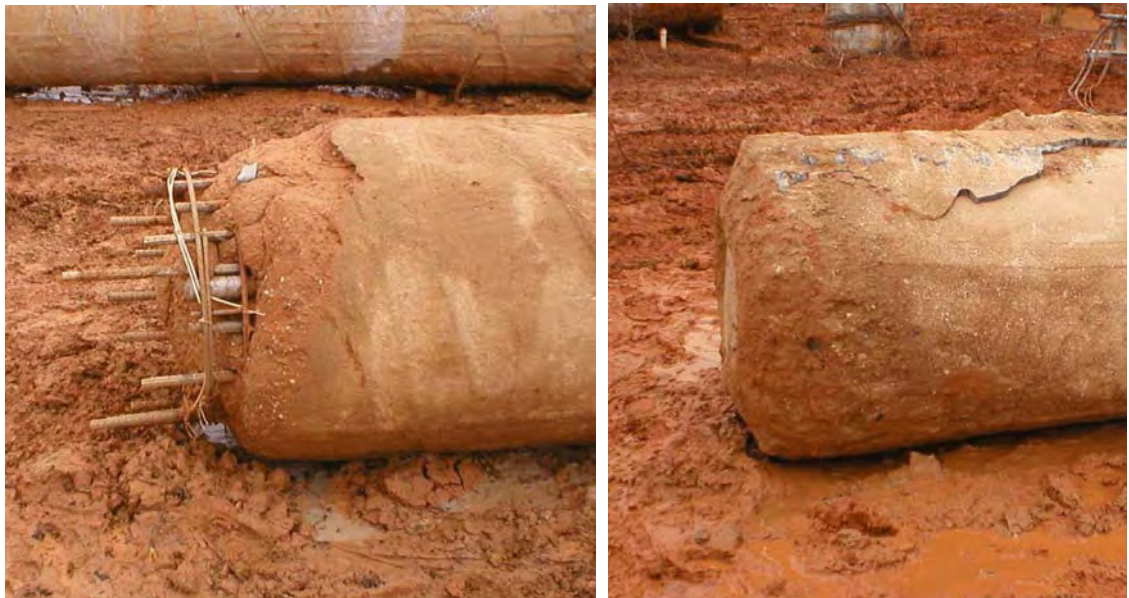
Figure 4-80 NGES Auburn: UngROUTED shaft vs. Grouted shaft.

The final phase of the multi-purpose research project at the NGES facility was to exhume the five test shafts for inspection. A 70 ton crane was brought in with a soil excavator to extract the five test shafts (17.3 ton deadload). Figure 4-76 through 4-79 show extraction of the test shafts. Each grouted test shafts showed the formation of a “grout-bulb” and grout migration up the side of the shafts. The ungrouted shaft, TS4, had reinforcement exposed at the bottom of the shaft. Figure 4-80 shows a comparison of an (a) ungrouted shaft versus a (b) grouted shaft from this test site.

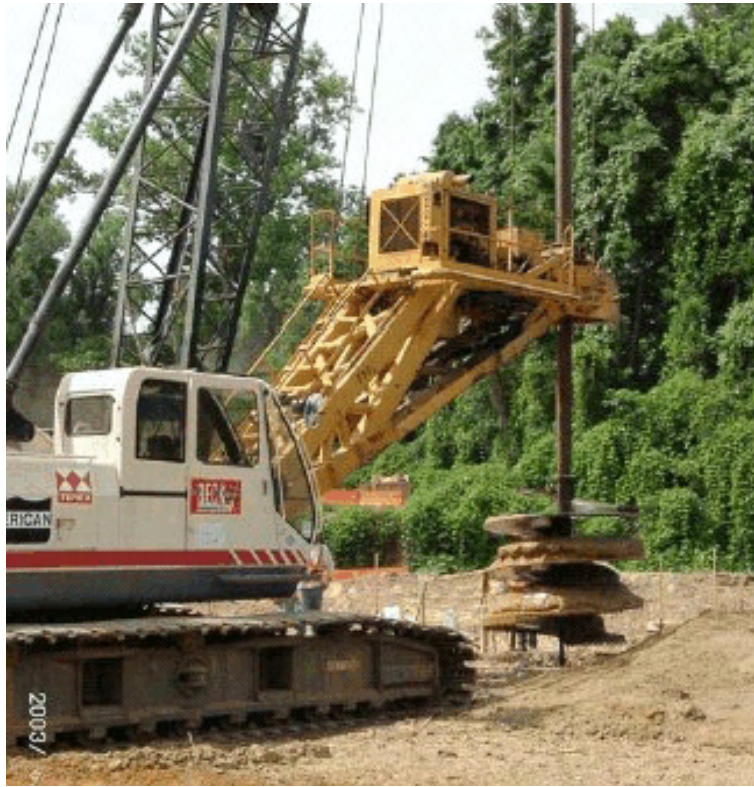
Figure 4-111 Natchez: Crane mounted drill rig.

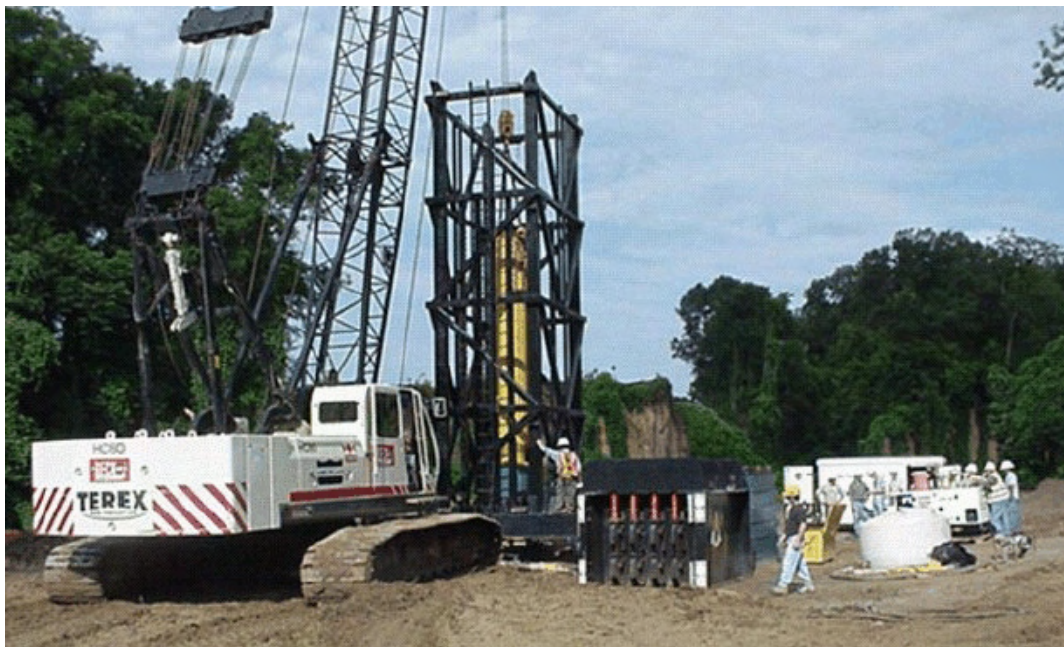
Figure 4-130 Natchez: Statnamic setup (continued).

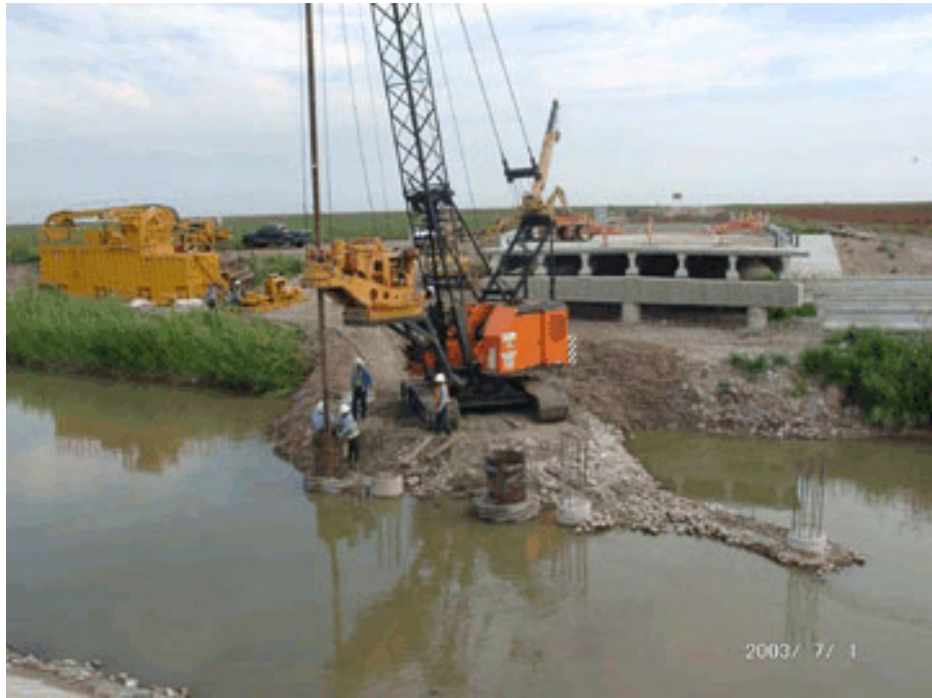
Figure 4-142 FM 507: Setup and drilling of the west shaft.

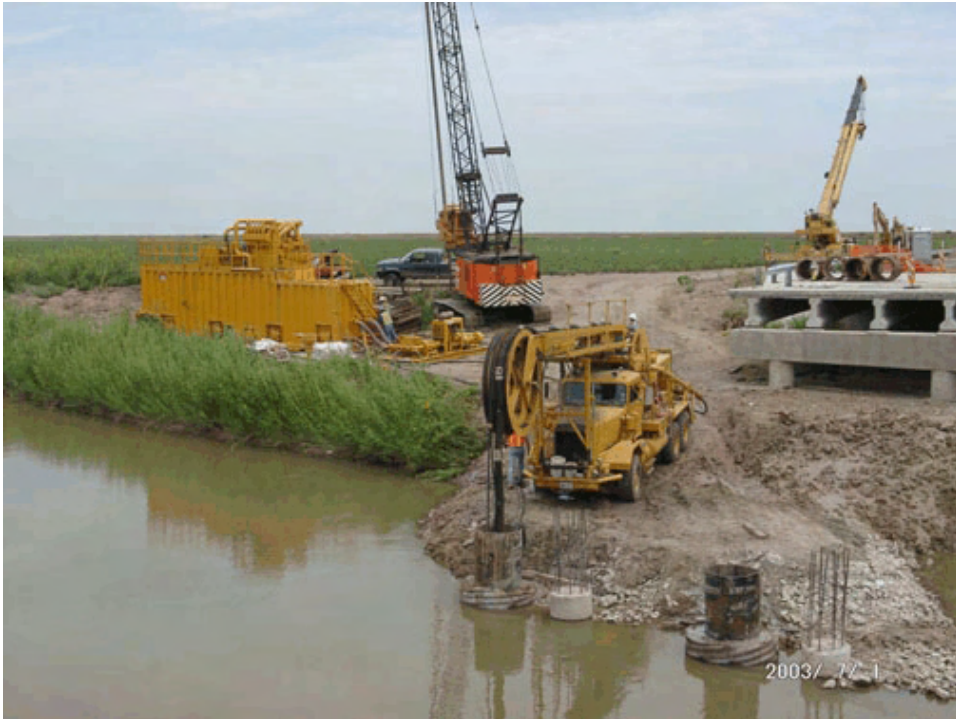
Figure 4-144 FM 507: De-sanding of the west shaft.

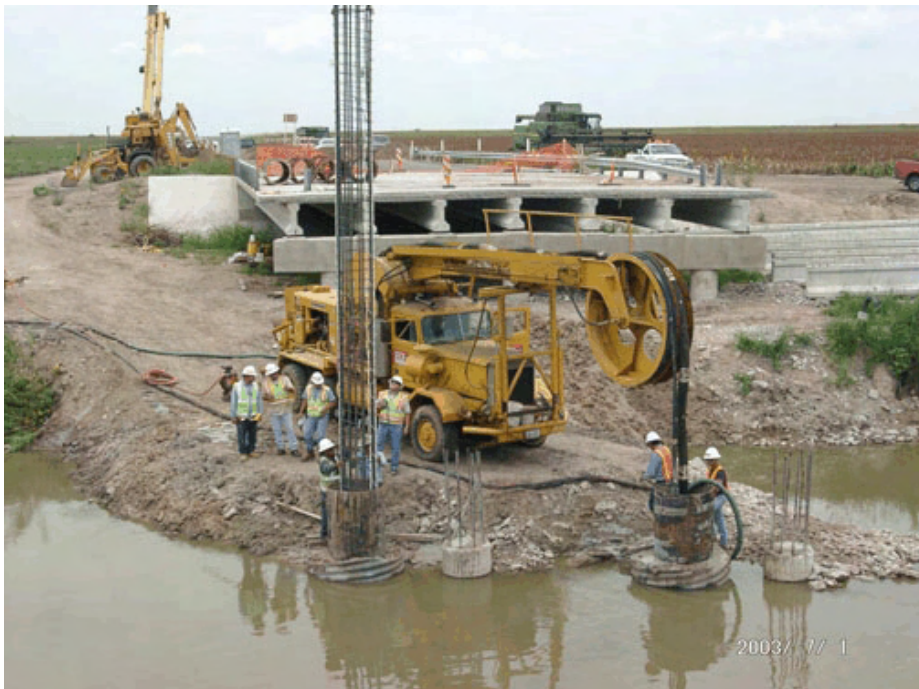
Figure 4-145 FM 507: Reinforcement cage placement in west shaft and de-sanding of east shaft.

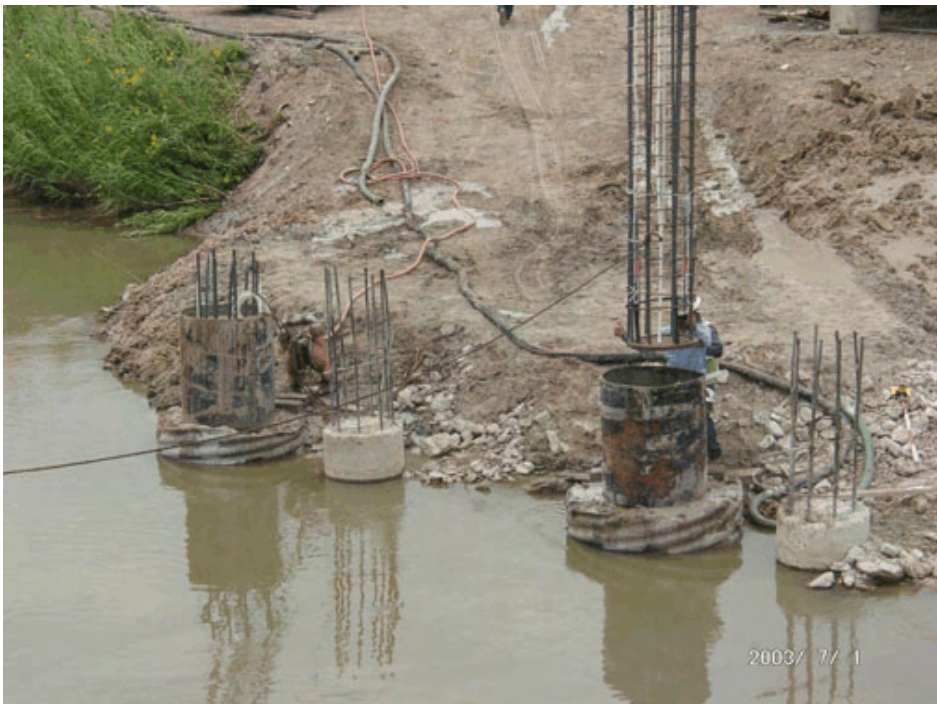
Figure 4-149 FM 507: East shaft cage placement.

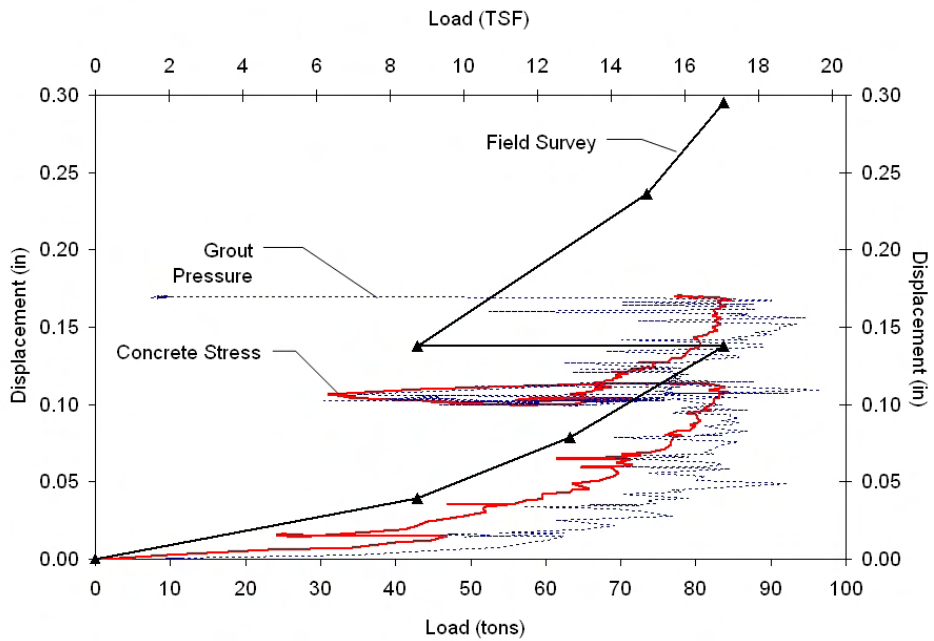
Figure 4-159 FM 507: West shaft load versus displacement.

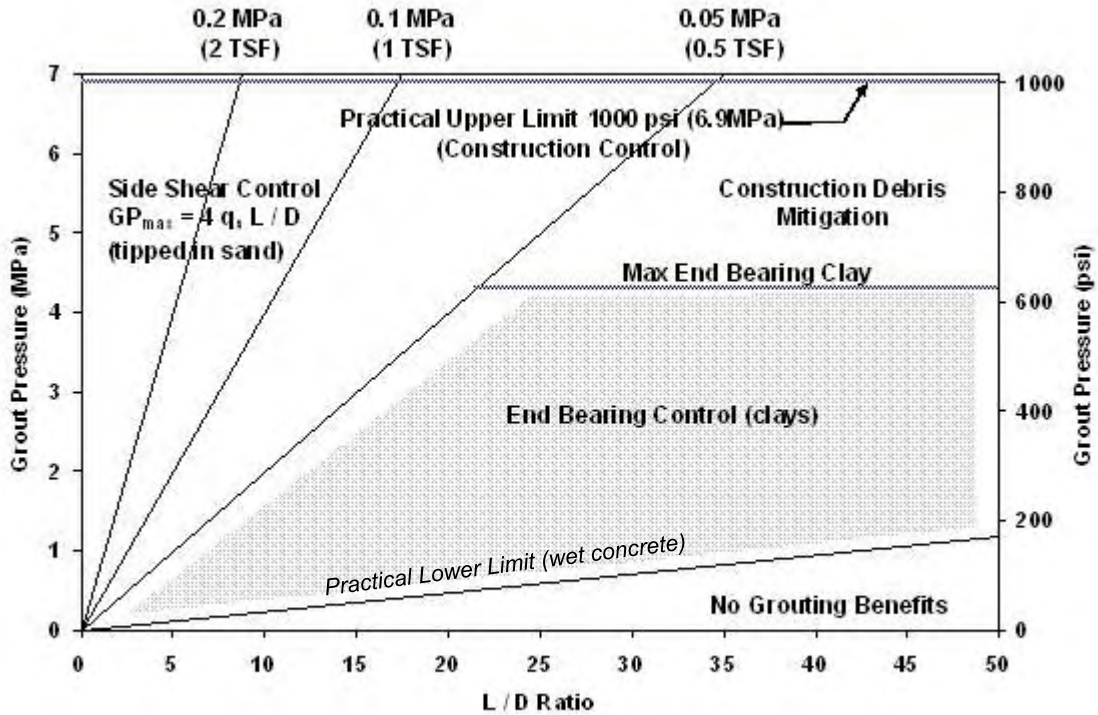
Figure 5-3 Pressure versus depth concept graph.

As the grout pressure is a function of tip area, unit side shear area, and shaft length, the expression for anticipated grout pressure can be simplified as follows:
