Florida Department of Transportation Research

Hillsboro Canal Bridge Monitoring

BDK75 977-16

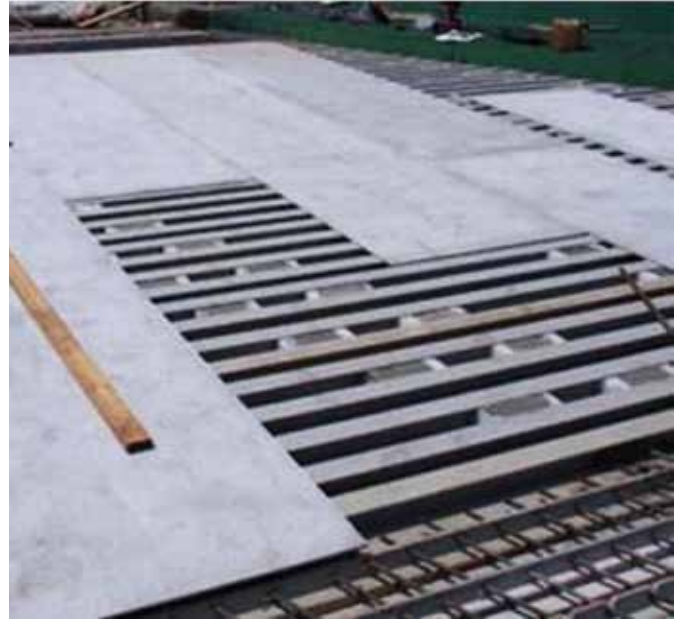
GFRP deck during installation shows the bottom layer, composed of interlocking I-beams. Top layer is being attached.

Several types of GFRP decks are available. For this project, a pultruded GFRP composite deck composed of a bottom panel with integral I-shaped webs, along with a top plate of the same material was selected. In addition to deck materials, a polymer concrete overlay was placed as a wearing surface to provide the necessary skid resistance. The deck was installed in August 2009.
