University of Florida
Civil and Coastal Engineering

Final Report

Hillsboro Canal Bridge Monitoring

Sponsor:
Florida Department of Transportation (FDOT)
Stephen Eudy – Project Manager

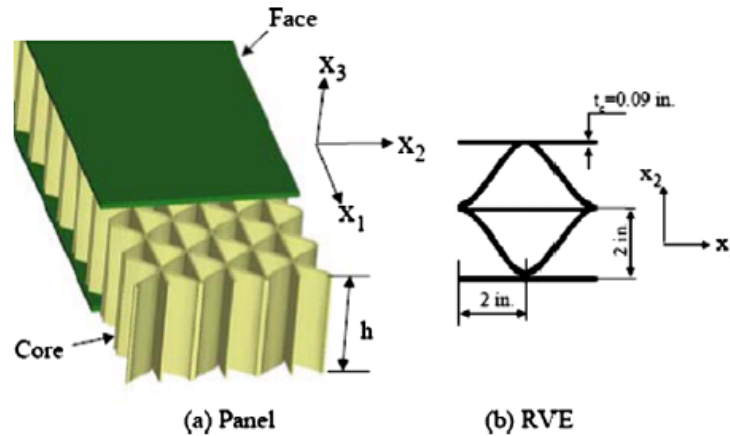
Figure 2 – Configuration of the core and faces of the GFRP panel and representative volume element (RVE)

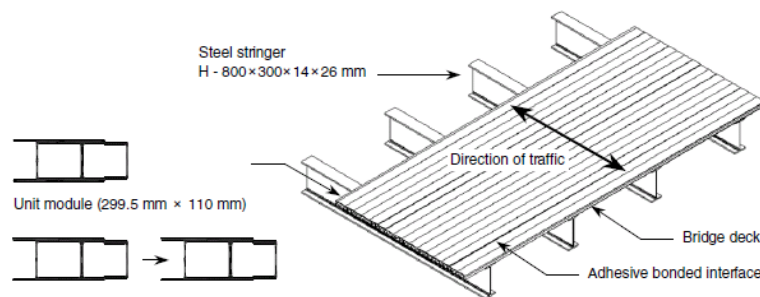
Figure 3 – Schematic of GFRP deck on steel stringers

Lee et al. (2007) conducted an experimental study on pultruded GFRP bridge decks used for light-weight vehicles. The GFRP deck used in this study was a rectangular dual-cell profile that was formed through a pultrusion process with E-glass fiber embedded in a polyester resin as shown in Figure 3.

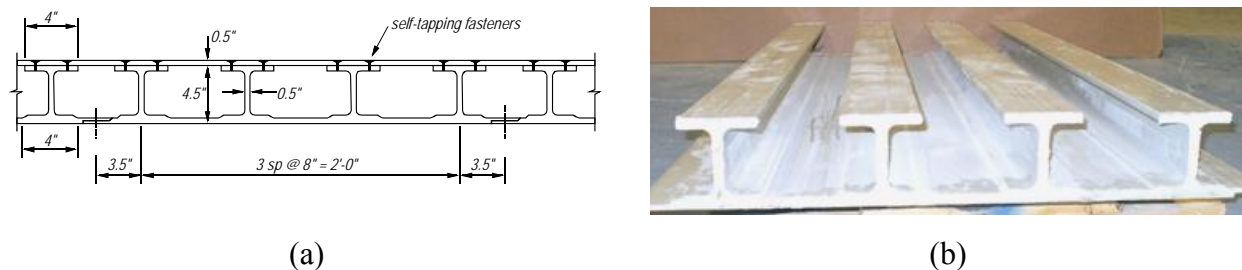
Figure 9 – GFRP deck configuration (a) typical section (b) single bottom panel section shown without top plate

Figure 9 shows the deck system used to replace the existing steel grid deck. The deck system is a pultruded GFRP composite deck composed of a bottom panel and top plate. E - glass fibers and isopolyester resin were used to fabricate the section; fiber lay-up and resin properties are proprietary. Bottom panels were manufactured in widths of approximately 2.5 ft and were composed of a 0.5-in. thick bottom plate pultruded integrally with four I-shaped webs. Bottom plates were thickened locally near each web to match the thickness of the top flange. To form the wearing surface, pultruded 0.5-in. thick GFRP plates were fastened to the top flanges of the bottom section using 1.75-in. long mechanical fasteners. Top plates were generally 35 in. to 48 in. wide and were placed perpendicular to the direction of the bottom panels. Pultrusion fabricated continuous sections were cut to fit the bridge. Adjacent bottom panels were joined by fastening the protruding portion to that of the adjacent panel with mechanical fasteners.

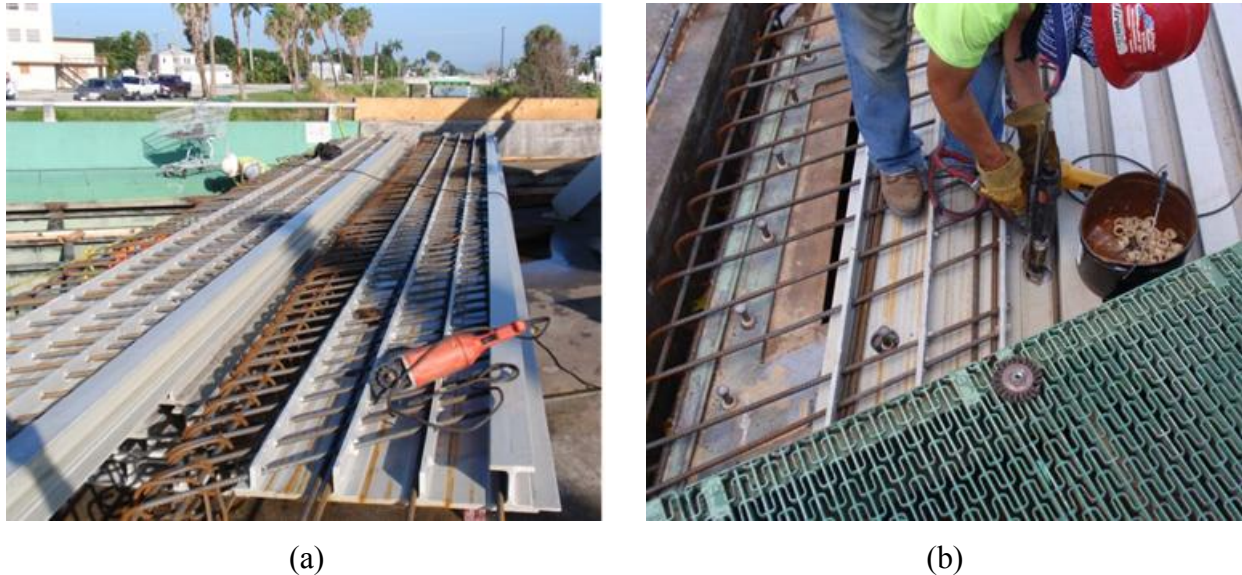
Figure 13 – Transition between GFRP deck and concrete deck (a) reinforcement for cast-in-place concrete (b) installation of welded headed stud

panel webs. Reinforcement for the pour was threaded through holes drilled in the webs and was welded to the existing end plate on the abutment.

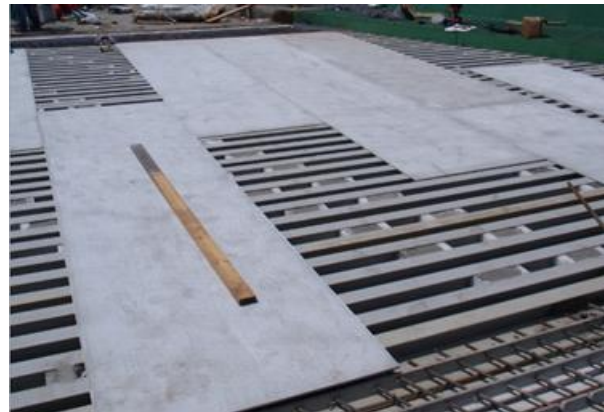
Figure 16 – Top GFRP plates

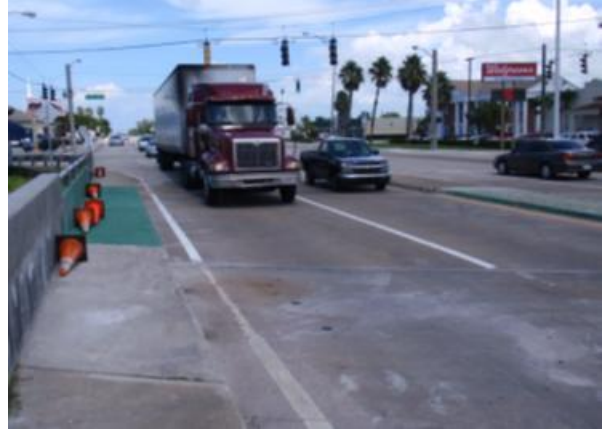
Figure 18 – Completed deck

After top plate installation, the existing median was reattached using the median anchors. After the installation of the median, a 0.5-in. thick overlay of polymer concrete (Figure 17) was placed on the top plates to create the wearing surface. Figure 18 shows the completed deck system open to traffic.

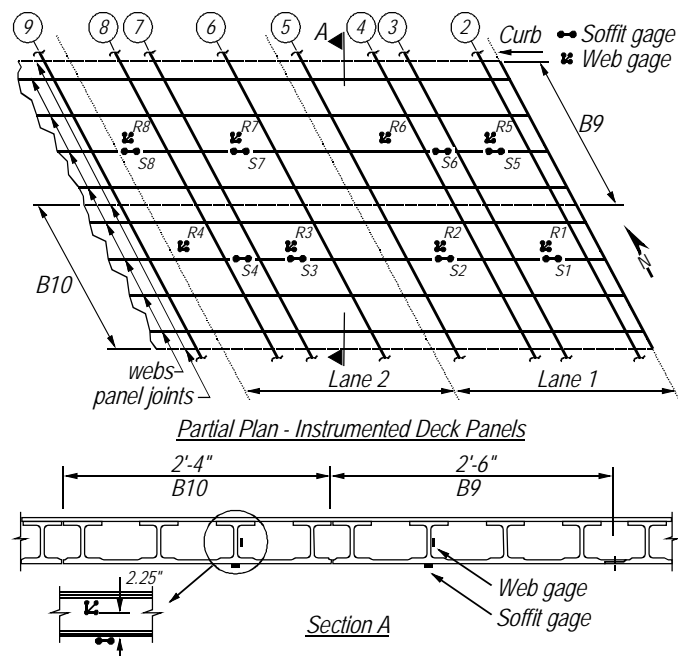
Figure 24 – Position of bonded strain gages and rosettes on GFRP deck

Gages S1, S2, S5 and S6 were intended for vehicles traveling in lane one and gages S3, S4, S7 and S8 for vehicles traveling in lane two. During the 2009 bridge test, it was observed that gages S3 and S8 were not working properly. The DAQ recording these two gages indicated large strains compared to other soffit gages, suggesting faulty installation or wire routing through the conduit leading to the DAQ.

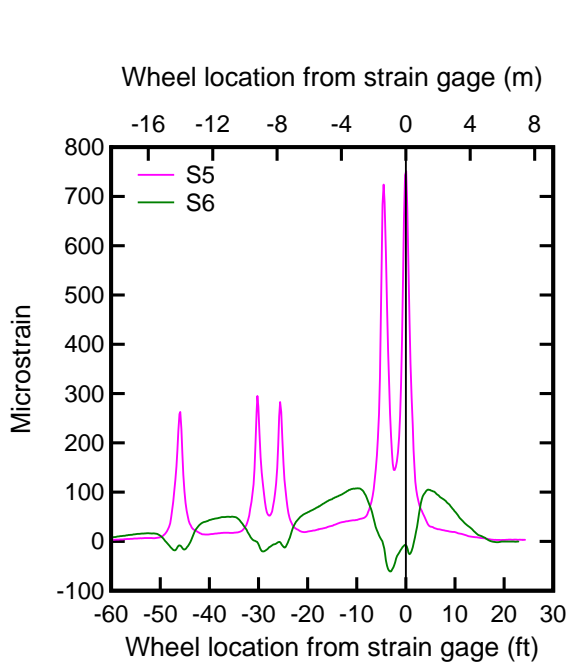
Figure 58 – Influence lines for gage S5 and S6 for TP1 (2009)

The maximum strain measured during the 2009 bridge test ($751 \mu\epsilon$) was recorded by gage S5 and corresponded to the maximum wheel load (18 kip) used during the test. During the 2010 bridge test, the maximum strain measured was $852 \mu\epsilon$, which was also recorded by gage S5. This represents an increase of 13%.

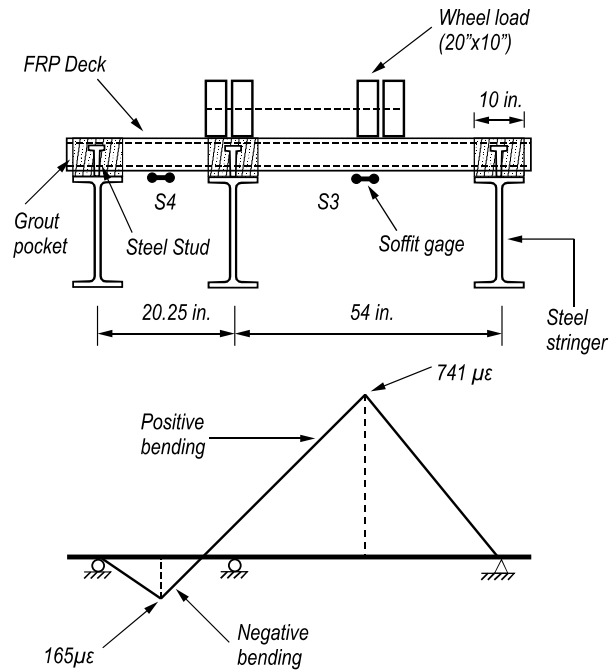
Figure 61 – Relative location of gages S3 and S4 and maximum strain

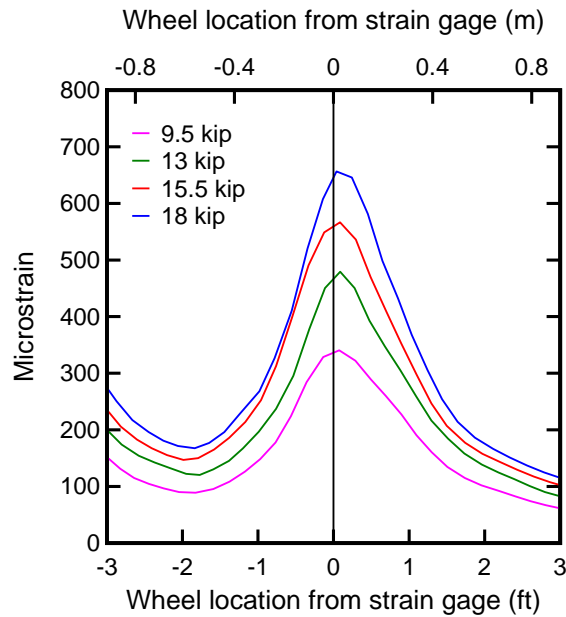
Figure 62 – Partial influence lines for soffit gage S7 at axle P5 (2009)

The influence lines also indicate that the effect of the wheel load on panel strain is localized. Figure 62 shows the influence line produced by gage S7 at axle P5. Strain decreased rapidly as the tire moved away from the gage. For example, strain decreased to half of the peak strain when P5 had moved to the adjacent web, which was 8 in. away. When the wheel moved to the next web (at 16 in.) the strain dropped to 27% of the peak strain. Strain dropped to 10% of its maximum value when the wheel moved to 32 in. from the strain gage. Similar behavior was noted in strain data from bonded gages recording positive bending.

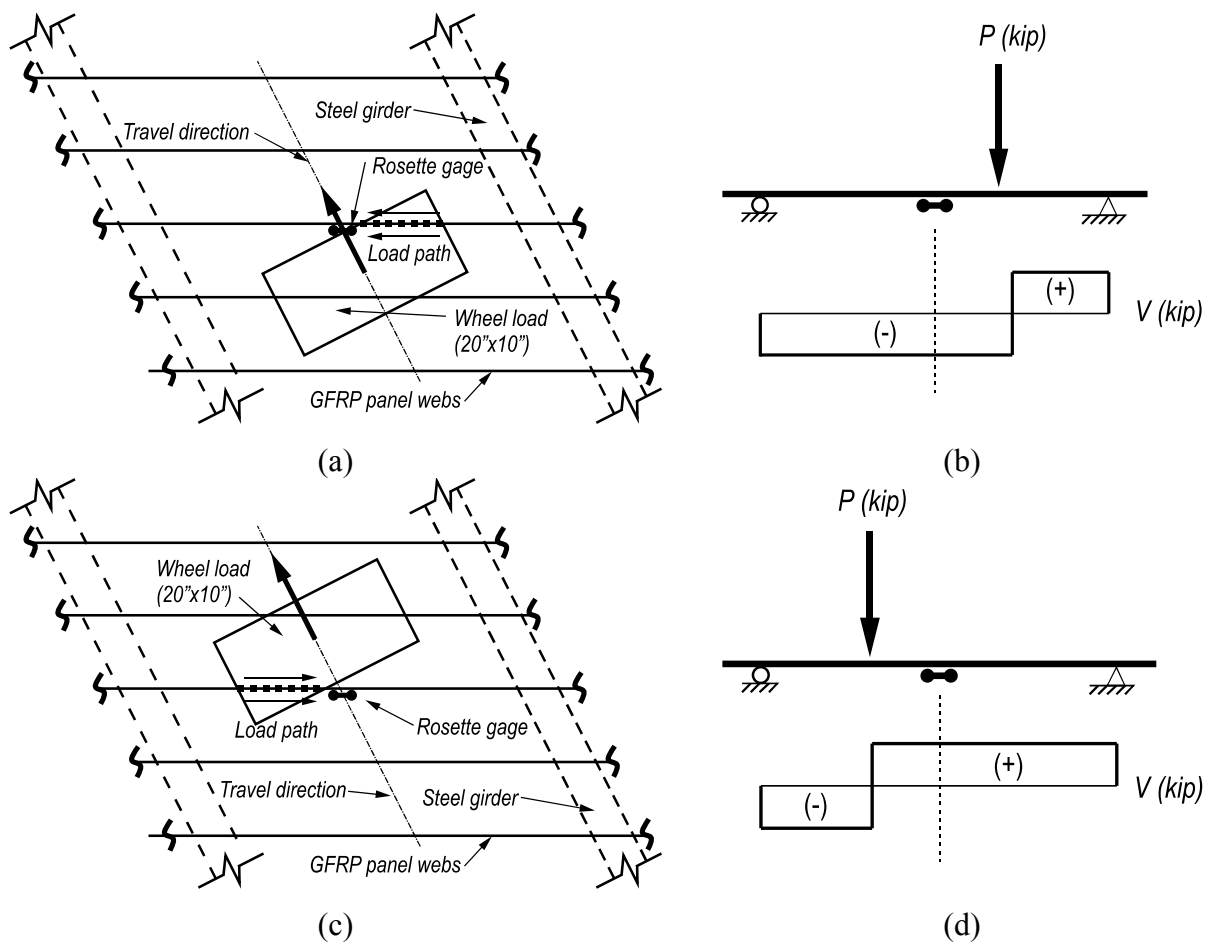
Figure 66 – Effect of wheel position on sign of shear strain (a) wheel position causing negative strain (b) shear diagram before wheel crosses gage (c) change in wheel position causing change in strain sign (d) shear diagram after wheel crosses gage.

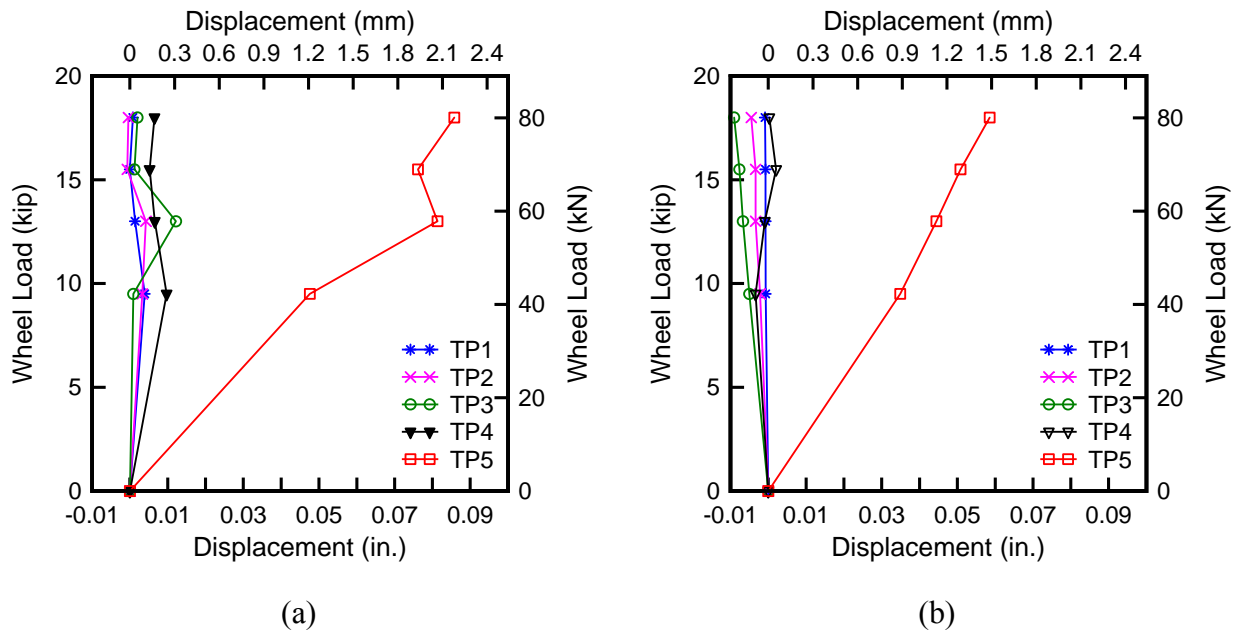
Figure 80 – Load – displacement for the bridge deck from (a) 2009 (b) 2010

AASHTO Section 2.5.2.6.2 specifies a service limit for deflection as span/800 for steel, aluminum, and or concrete, which is 0.06 in. for the deck span of 4 ft. Maximum deflection measured during the 2009 bridge test was 50% more than the service limit, but equal to the service limit in the 2010 bridge test measurements.

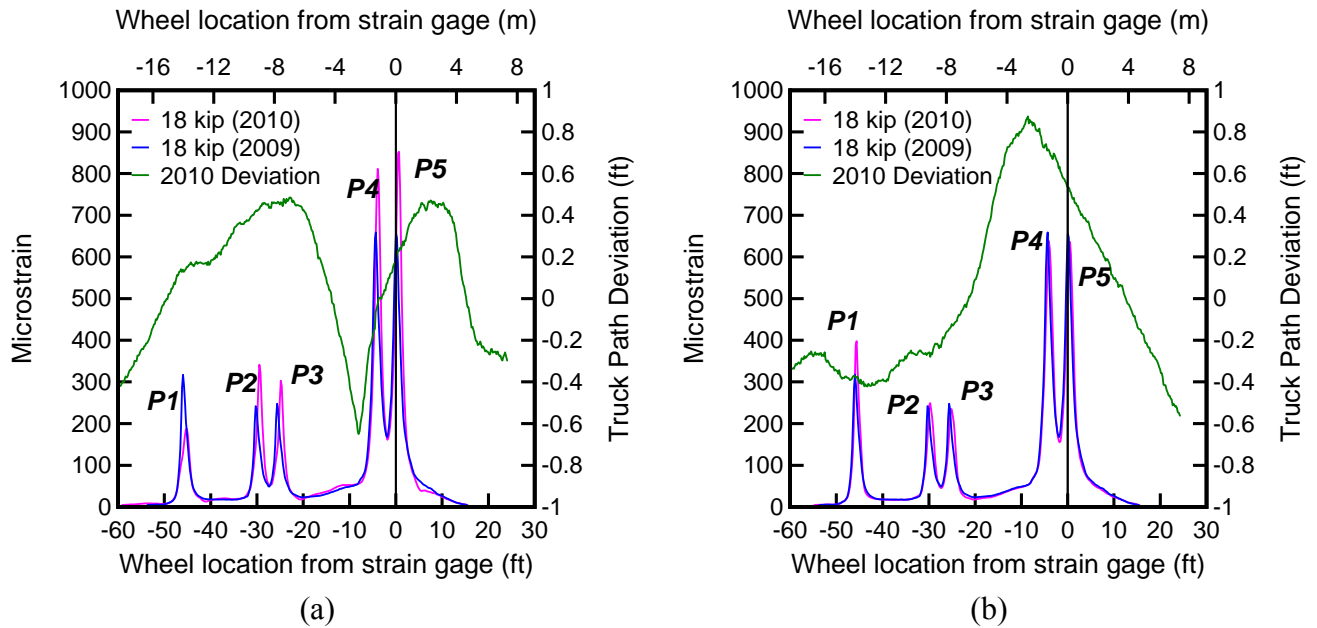
Figure 83 – Influence line and truck deviation for (a) gage S5 and (b) gage S7

Five truck paths (TP1 through TP5) were used for the bridge tests. While the paths were intended to be parallel to the curb, rolling the truck over the bridge with no transverse deviation was not possible. Consequently, this transverse deviation of the truck from its intended path was investigated using the GPS position data to determine how much difference in strain readings might be expected to occur between the 2009 and 2010 bridge tests. Influence lines for the maximum load case of the 2009 and 2010 bridge tests are presented in Figure 83 for gages S5 and S7. In addition, the truck path deviation is plotted; this deviation was determined using the GPS position data from both the 2009 and 2010 bridge tests. For comparison purposes, truck paths recorded during the 2009 bridge test are considered the reference paths. The plot shows the truck path deviation, which is the deviation of the 2010 truck paths from the 2009 reference paths. Positive deviation indicates that the truck passed closer to the gage of interest in 2010 than in 2009, leading to the possibility that any increase in strain could be an artifact of the truck position and not indicative of a loss of stiffness.

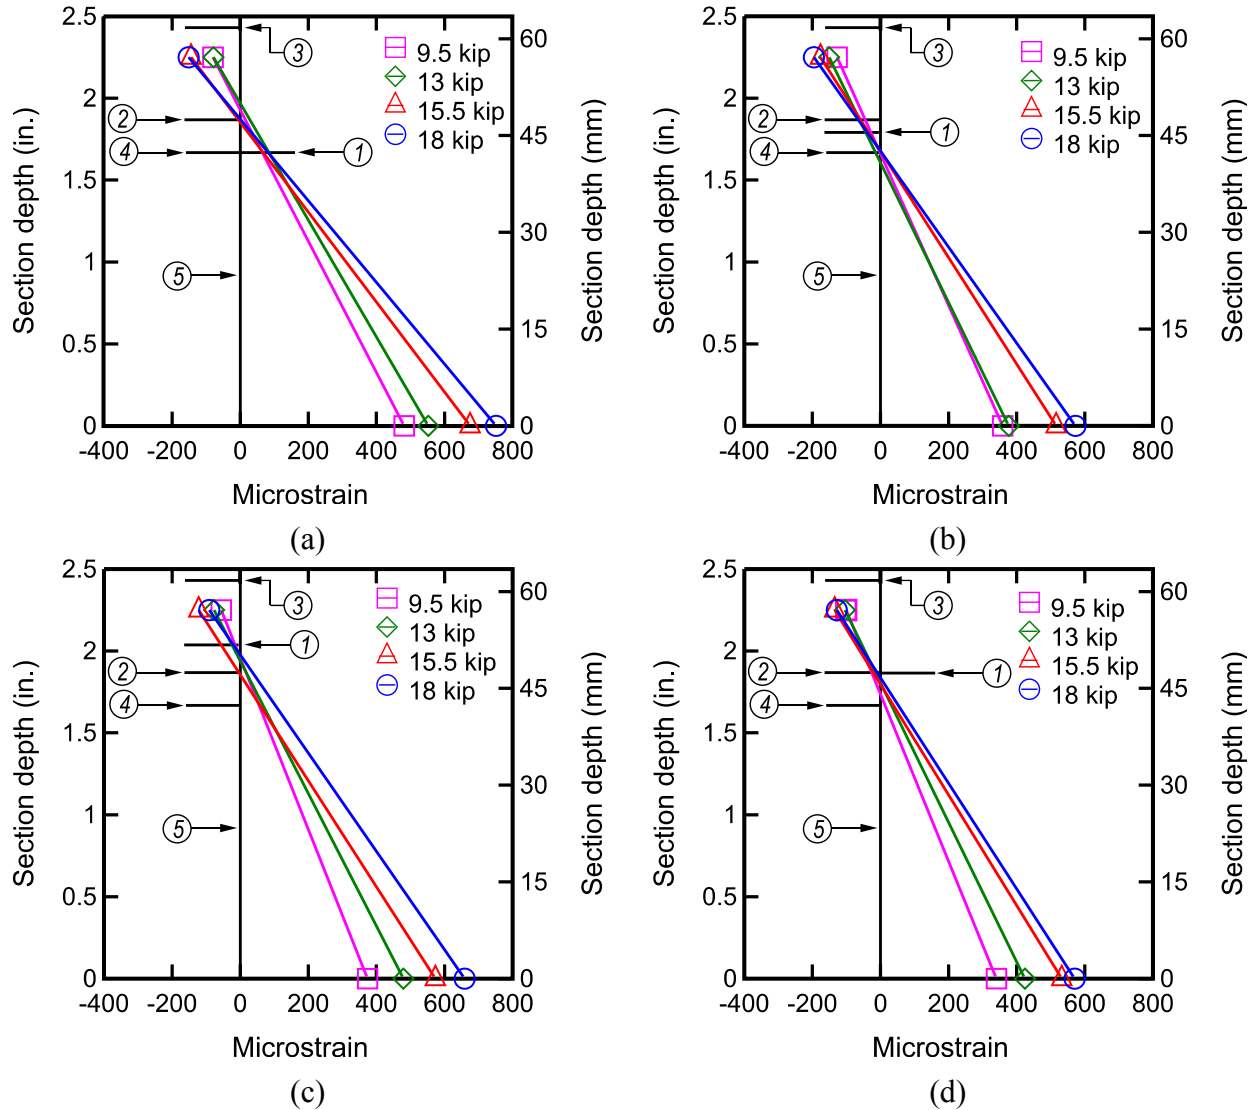
- ① - Measured
- ② - Calculated ignoring top plate
- ③ - Calculated including top plate
- ④ - Calculated ignoring top plate and using constant E
- ⑤ - Reference line for zero strain

Figure 86 – Composite behavior (2009) demonstrated by (a) Maximum strain in S5 and corresponding strain in R5 (b) Minimum strain in R5 and corresponding strain in S5 (c) Maximum strain in S7 and corresponding strain in R7 (d) Minimum strain in R7 and corresponding strain in S7

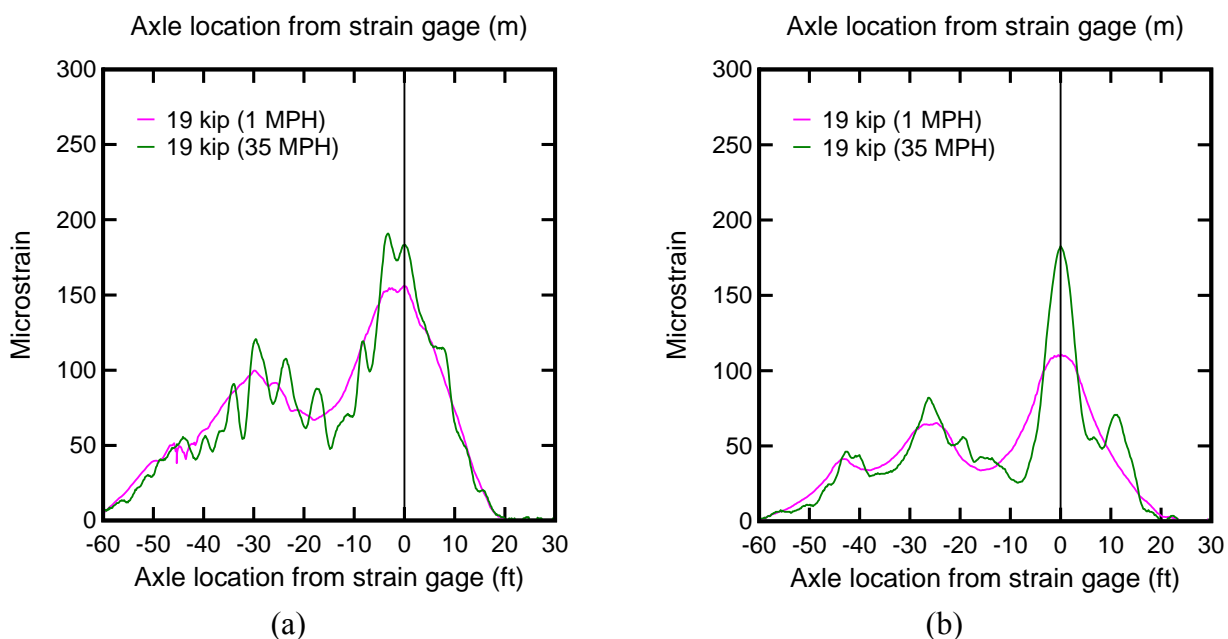
Figure 89 – Comparison of rolling and high speed bridge test data for (a) B1 (b) B3

Figure 89 compares the 35 mph and rolling test results for steel girder gages B1 and B3. Although the truck position was not tracked during the 35 mph test, the relative truck speeds were used to coordinate the truck position for comparative plotting. The figure shows that the high speed bridge test produced a strain pattern that was similar to that produced by the rolling bridge test. Strain peak locations were consistent between the two tests, with the magnitude of the strains at the peaks higher in the 35 mph test than the rolling test.

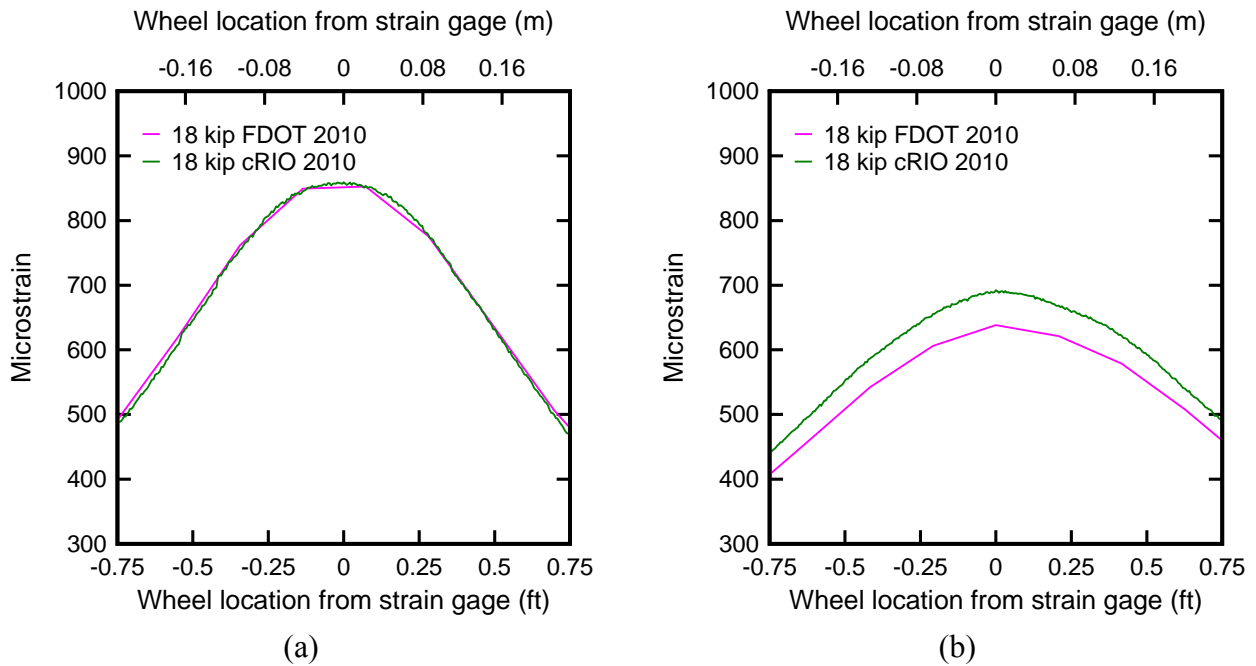
Figure 92 – Comparison of FDOT and cRIO peak strain measurements for (a) S5 (b) S7

strain. Figure 92b also indicates that there were no missing data points that could change the peak strain. The two gage/DAQ combinations recorded slightly different strains (54 $\mu\epsilon$ difference from Table 15) but the smoothness of the FDOT DAQ influence line is apparent. There are no indications that a peak data point may have been missed. This confirms that the differences between the peaks measured by the FDOT and cRIO DAQs were not due to the lower sampling rate of the FDOT DAQ.

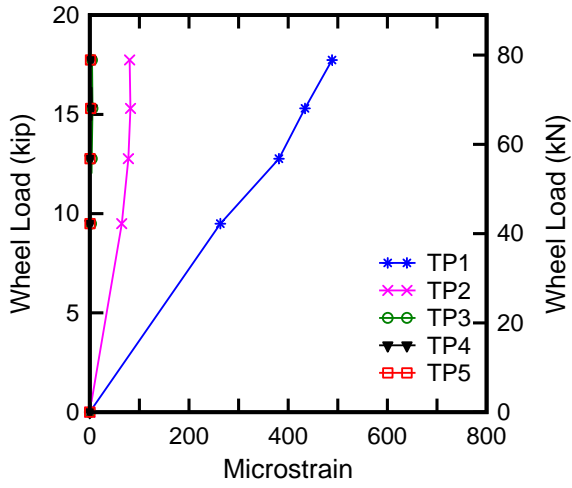
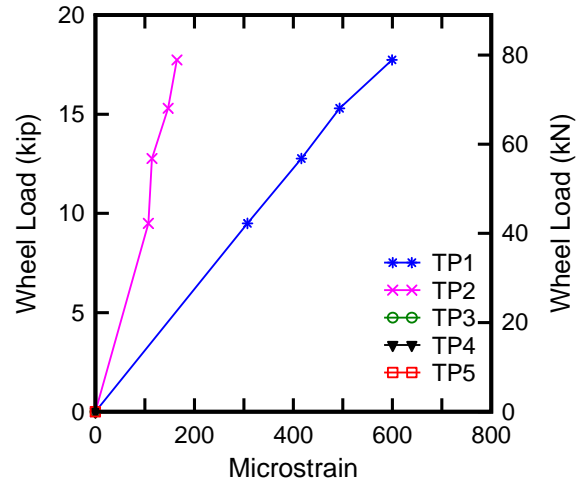
Figure 93 – Gage S1 load-strain calibration curve for (a) 2009 (b) 2010

These load – strain curves were generated from the rolling load tests and were intended to be used to convert strains recorded during the monitoring period into wheel loads. A linear regression was produced for the plot of the truck position that produced the highest strain. This regression was not forced through the origin because the slope of the regression line (wheel load divided by microstrain) was the important aspect of the analysis. Multiplication of the regression slope by the strain recorded during monitoring yielded the wheel load. This method did not account for dynamic effects.

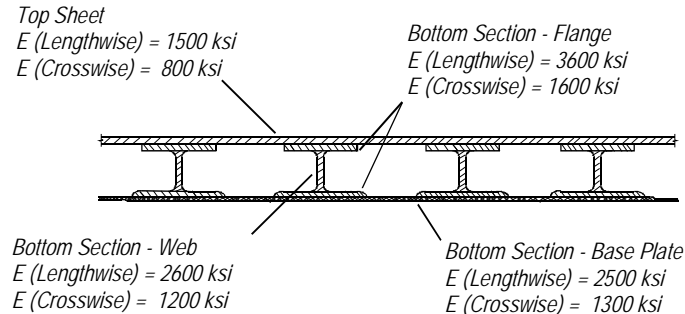
Figure 106 – GFRP deck Modulus map

A continuous beam of the same length as the instrumented panel (panel B9) was modeled using transformed section properties based on the varying moduli as shown in Figure 106. A reference modulus of elasticity of 2500 ksi (bottom panel) was chosen for the calculation of the transformed section properties. The maximum value of the modulus of elasticity (3600 ksi) occurs at the flanges of the bottom panel. Table 18 presents the transformed section properties calculated for use in the panel analysis.

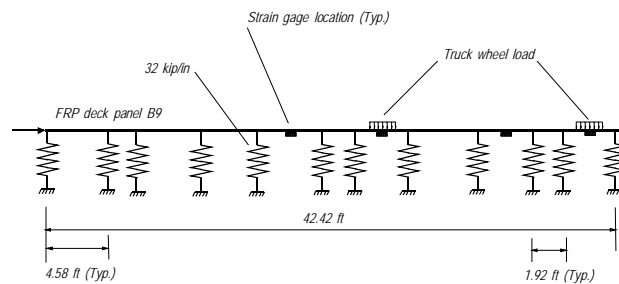
Figure 107 – GFRP bridge deck analysis

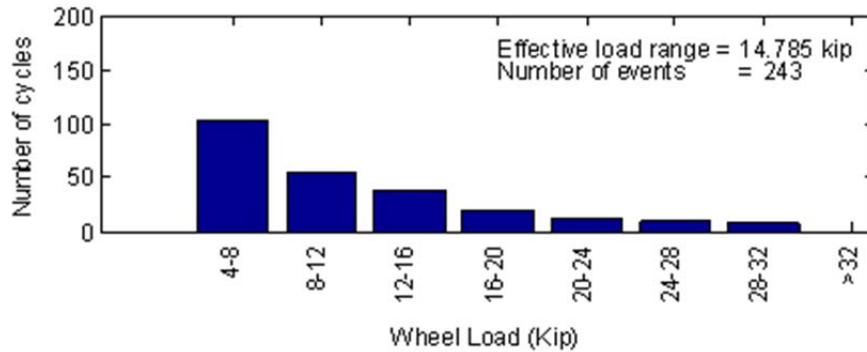
Figure 108 – Example histogram showing load occurrence distribution measured by a soffit gage between 7am and 6pm during one day

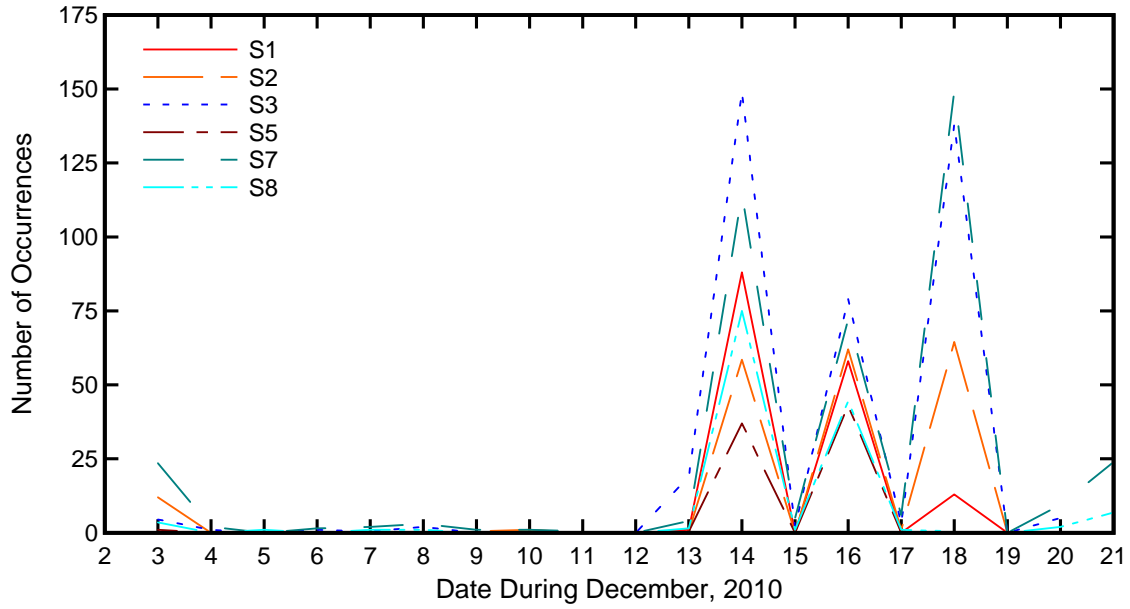
Figure 114 – Number of 16 kip or heavier loads recorded by soffit strain gages between 7am and 6pm daily

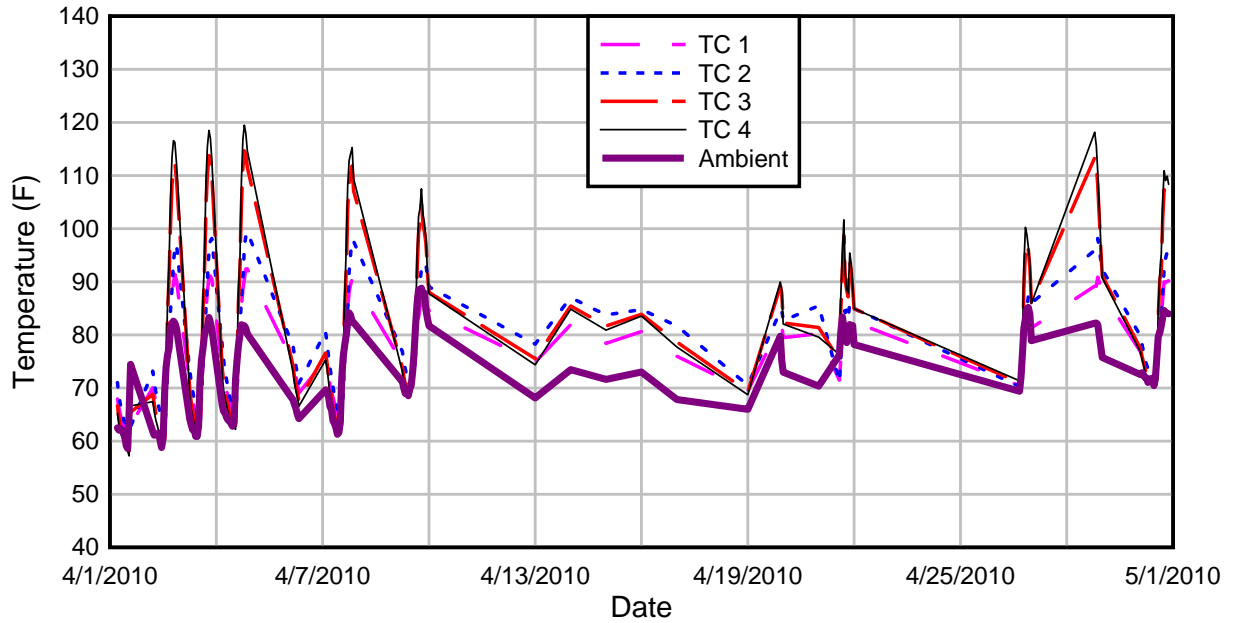
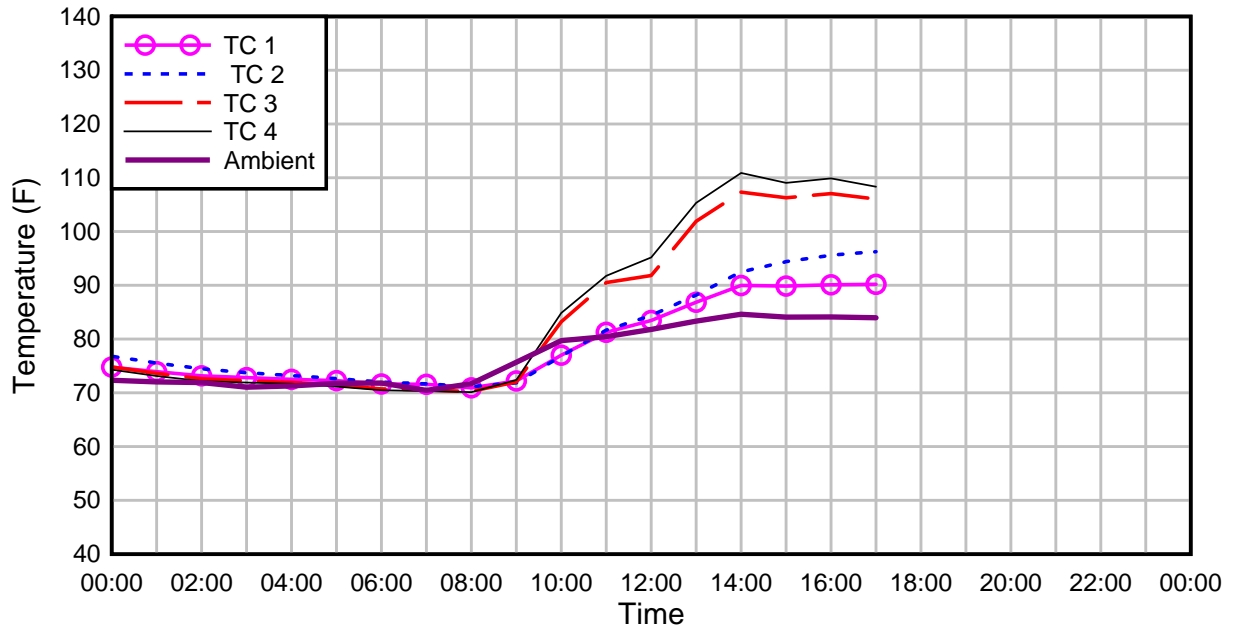
Figure 115 – Temperature measurements for (a) April, 2010 and (b) April 30, 2010

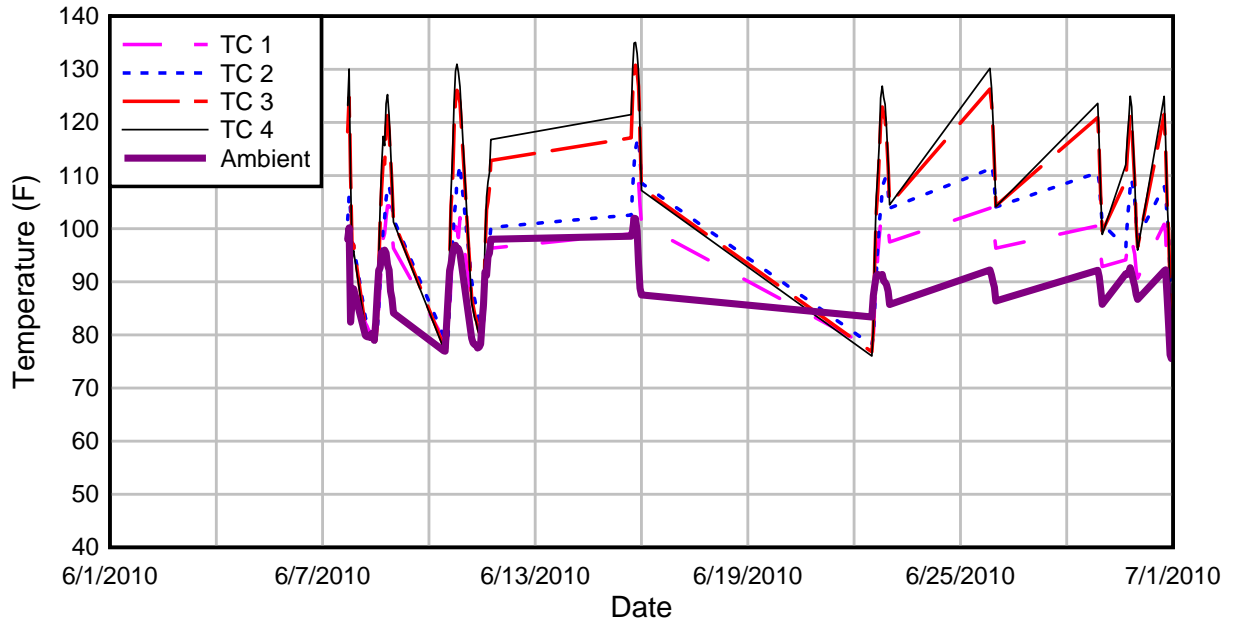
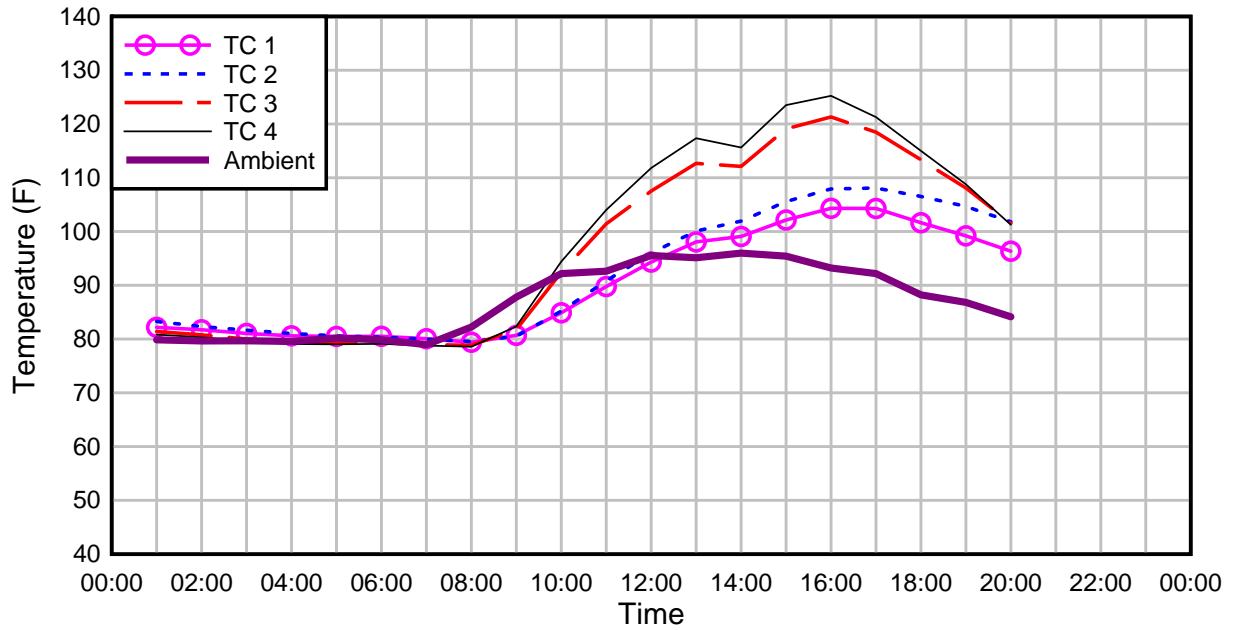
Figure 116 – Temperature measurements for (a) June, 2010 and (b) June 8, 2010

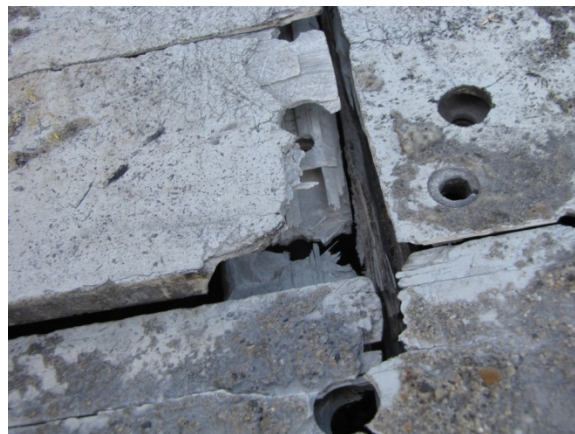
Figure 124 – Severe damage to top plates and webs
