Durability of CFRP Pretensioned Piles  
in Marine Environment  
Volume II

Rajan Sen, Satya Sukumar and Jose Rosas  
Department of Civil Engineering and Mechanics  
August 1995

A Report on a Research Project Sponsored by the  
Florida Department of Transportation in cooperation with  
the U.S. Department of Transportation  
Contract C-4478  
Tampa, Florida

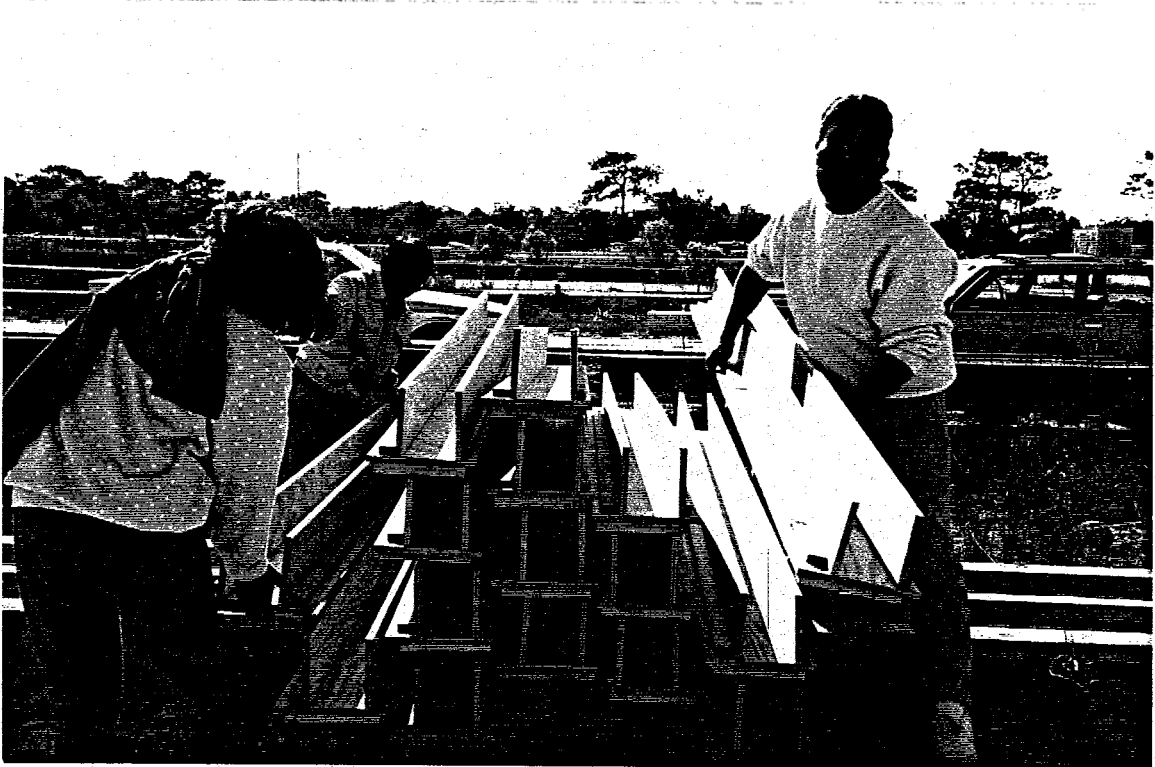
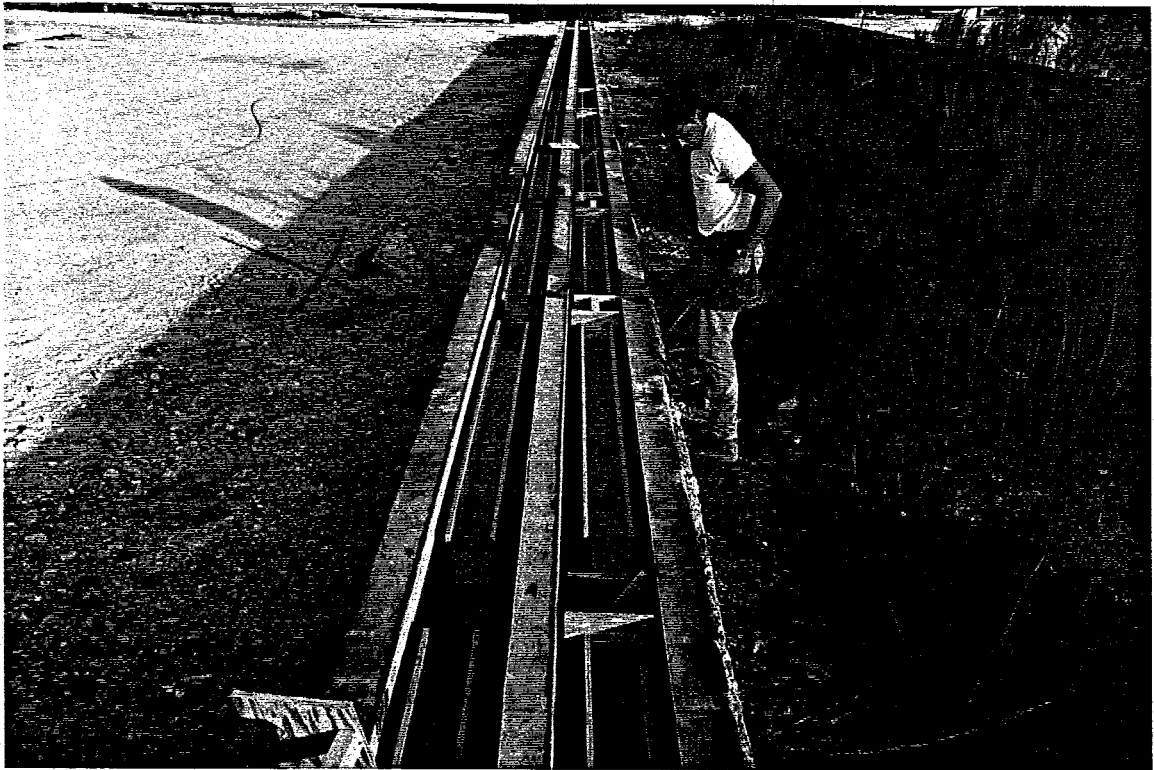
**Plate 1.** Installation of Formwork

**Plate 2.** Prestressing Bed with All Thirty Three Forms

and dead ends of the prestressing bed, respectively. Plates 1 and 2 show the formwork assembly and the thirty three assembled forms, respectively.

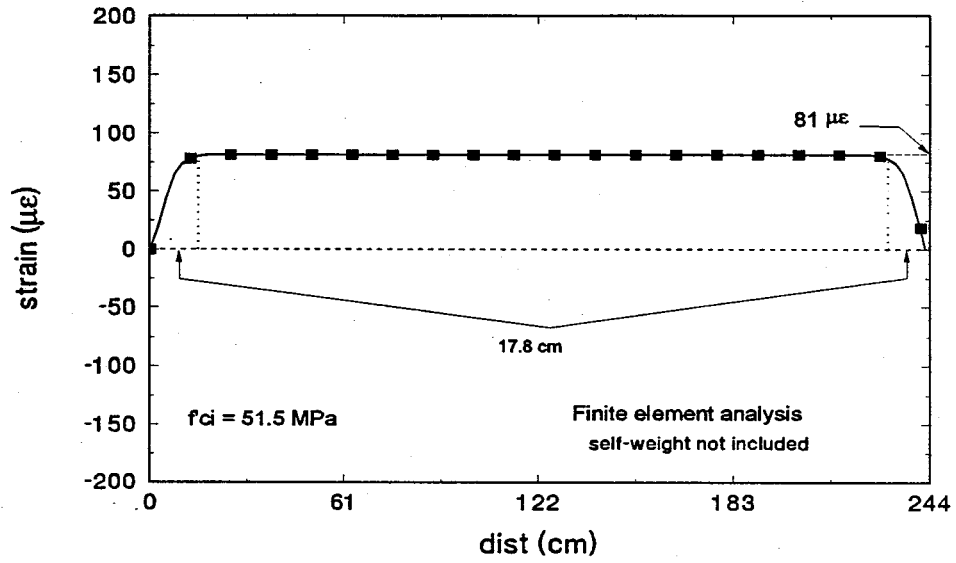
The results from the finite element analyses for the two meshes were identical and are shown in Figures 13 (without self weight) and Figure 14 (including self weight). The transfer

Figure 13. Finite Element Analysis Results

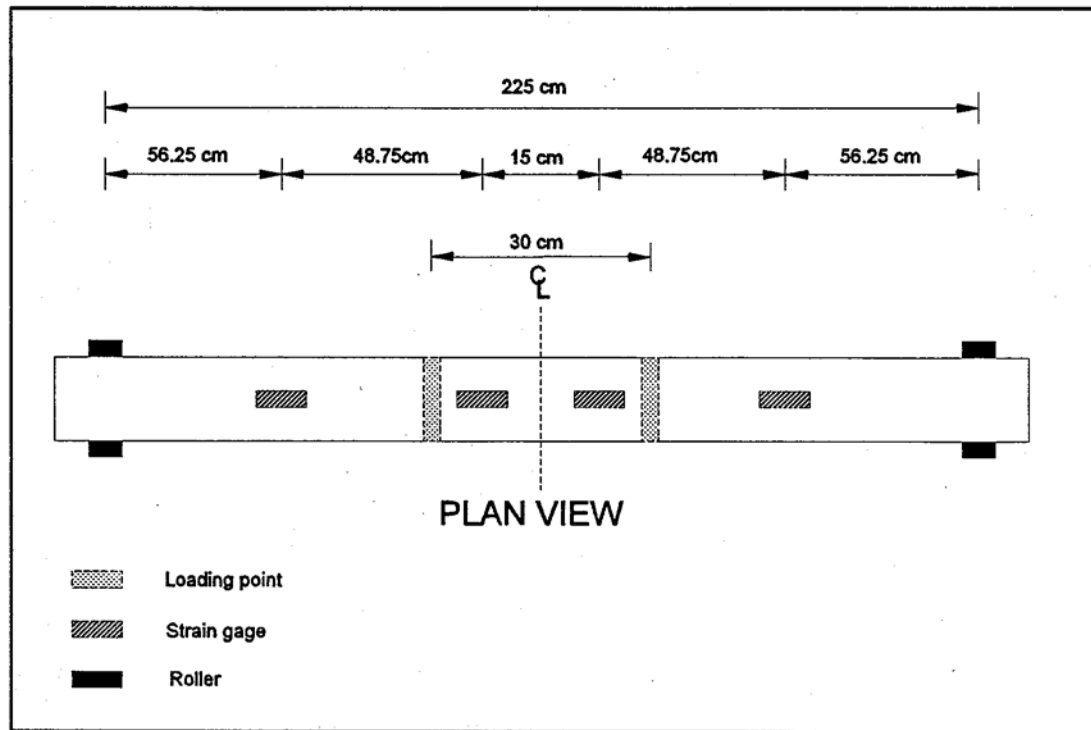
The concrete gages were placed at the quarter points and at 75 mm on either side of the centerline as can be seen in Figure 22.

**Figure 22.** Location of Concrete Gages

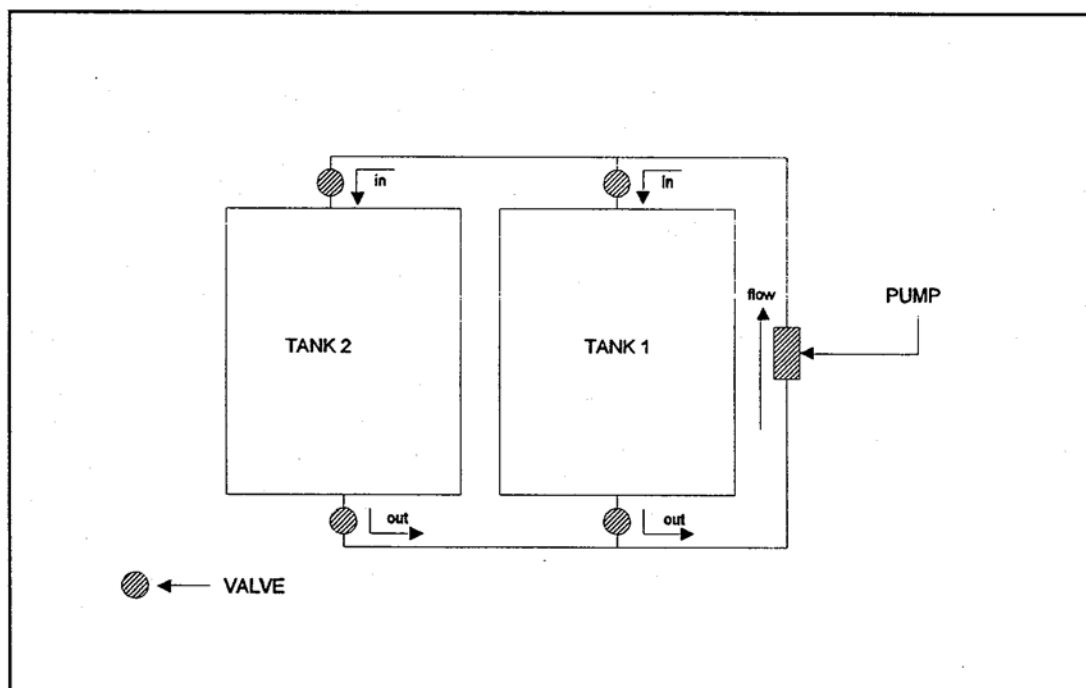
To simulate tide change conditions, water was pumped from the tank containing the CFRP specimens into a tank containing AFRP specimens that were also part of the overall study, Sen *et al* 1995. A plumbing system was designed and set up to carry out the tide changing operation once a week. During low tide periods, the water level was lowered to 150 mm and during high tide periods it was raised to 375 mm. Figure 36 shows a schematic of the plumbing system.

Figure 36. Schematic of Plumbing System
