2010 Interim Design Standard	Interim Date	Sheet No.
	07/01/10	1 of 2
CONCRETE SLAB REPLACEMENT	Inde	χ No. 1Ω

SLAB REPAIR AND REPLACEMENT CRITERIA

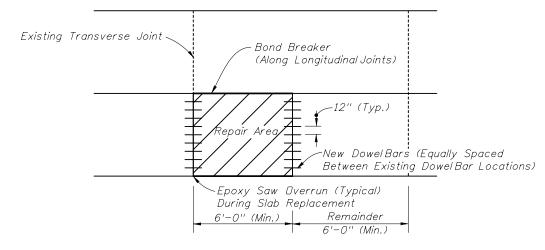
FIGURE 10.4 - PARTIAL SLAB FULL DEPTH REPLACEMENT

- 1. For Repair and Replacement Criteria see Sheet 2 of 2.
- 2. Full depth repairs consist of removing and replacing at least a portion of the existing slab to the bottom of the concrete.

Intersecting Random Cracks (Shattered Slab)	Cracking pat	terns that divide the slab into three or more segments.	Full Depth	Figure 10.3 and 10.4		
JOINT DEFICIENCIES						
	Light	spall width $\langle 1^{1}/_{2}^{"},\langle {}^{1}/_{3}^{"} $ slab depth, $\langle 12^{"} $ in length	None	Figure 10.4 and 10.5		
Spall Nonwheel Path	Moderate	$1\frac{1}{2}$ " (spall width <3", < $\frac{1}{3}$ slab depth, <12" in length	None	Figure 10.4 and 10.5		
	Severe	spall width >3'' or length >12''	Full Depth	Figure 10.4 and 10.5		
	Light	spall width $\langle 1^{1}/_{2}$ ", \langle than $^{1}/_{3}$ slab depth, \langle 12" in length	None	Figure 10.4 and 10.5		
Spall Wheel Path	Moderate	$1\frac{1}{2}$ " <spall <="" <3",="" <math="" width="">\frac{1}{3} slab depth, <12" in length</spall>	Full Depth	Figure 10.4 and 10.5		
	Severe	spall width >3" or length >12"	Full Depth	Figure 10.4 and 10.5		
SURFACE DETERIORATION			·
