FIGURE 10.4 - PARTIAL SLAB FULL DEPTH REPLACEMENT

CONCRETE SLAB REPL

| | INDEX NO. | SHEET NO. |
|---|---|---|
| LACEMENT | <i>308</i> | 1 1 |

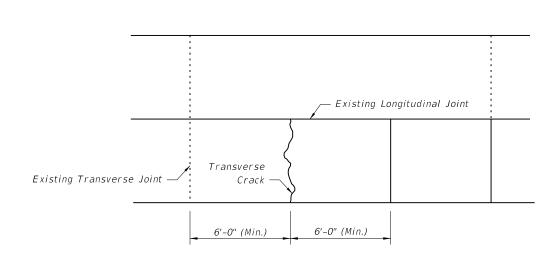
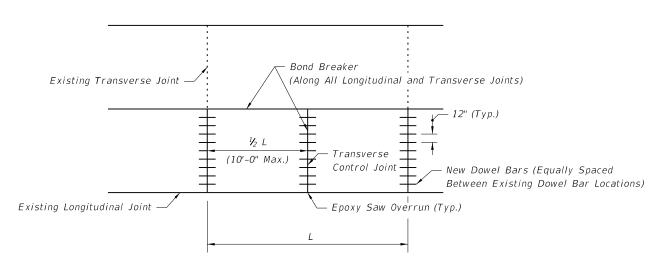
2. Full depth repairs consist of removing and replacing at least a portion of the existing

3. Repair boundaries shall be sawed full-depth with diamond saw blades. On hot days, it may not be possible to make this cut without first making a wide, pressure relief cut within the repair boundaries. A carbide-tipped wheel saw may be used for this purpose, but the wheel saw must not intrude on the adjacent lane, unless the lane is slated for repair. The wheel saw cuts produce a ragged edge that promotes excessive spalling along joints. Hence, if wheel saw cuts are made, diamond saw cuts must be made 18 in. outside the wheel saw cuts. To prevent damage to the base, the wheel saw must not be allowed

4. No additional base or subgrade material shall be added and all loose base or subgrade material shall be removed prior to placement of the new concrete slab. The concrete slab shall be placed to the full depth of the material removed. No additional compensation will be allowed for additional concrete required to bring proposed concrete slab up to finished

5. Removal of the damaged concrete pavement shall be by lifting. Any good concrete pavement which is damaged during removal of damaged areas shall be removed and

| | | SEVERITY/DESCRIPTION | REPAIR METHOD | REFERENCE |
|--|--|---|---|---|
| Corner Breaks | adjacent lo | the slab is separated by a crack that intersects the ngitudinal and transverse joint, describing an approximate ith the direction of traffic. | Full Depth | Figure 10.4 and 10.5 |
| Intersecting Random Cracks (Shattered Slab) | Cracking pa | atterns that divide the slab into three or more segments. | Full Depth | Figure 10.3 and 10.4 |
| | Severe | Flying debris deemed a traffic hazard | Full Depth | Figure 10.4 |
