FDOT DESIGN STANDARDS 2013	TEMPORARY DETOUR BRIDGE DETAILS - TIMBER PILE FOUNDATIONS	INDEX NO.	SHEET NO.
07/01/06				21610	1

FDOT DESIGN STANDARDS 2013	TEMPORARY DETOUR BRIDGE DETAILS - TIMBER PILE FOUNDATIONS	INDEX NO. 21610	SHEET NO. 2

FDOT DESIGN STANDARDS 2013	TEMPORARY DETOUR BRIDGE DETAILS - TIMBER PILE FOUNDATIONS	INDEX NO.	SHEET NO.
07/01/06				21610	3

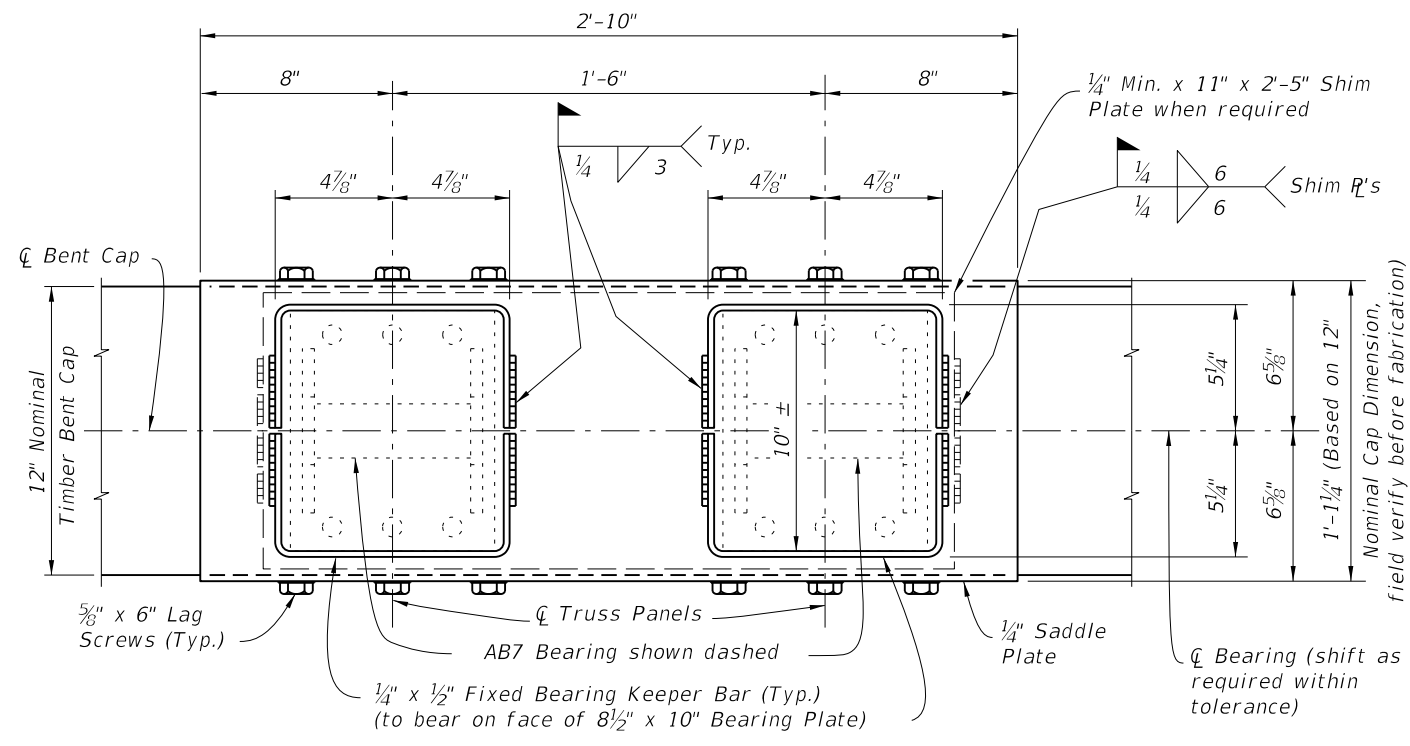
FIXED BEARING DETAILS

PLAN VIEW

ELEVATION VIEW OF SADDLE PLATE

END VIEW

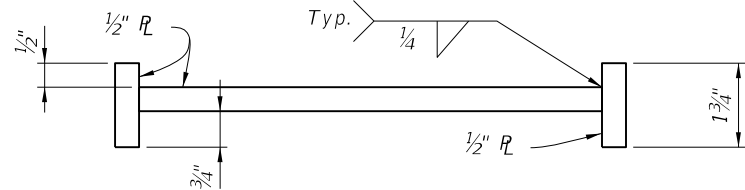
HOLD DOWN STRAP ASSEMBLY DETAIL

PLAN VIEW

ELEVATION VIEW
