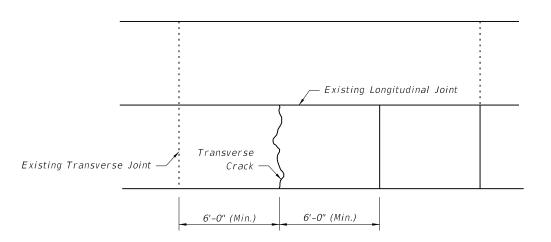
FIGURE 10.2 - REPAIR METHOD: NONE OR CLEAN AND SEAL

DISTRESS PATTERN	SEVERITY/DESCRIPTION		REPAIR METHOD	REFERENCE	
CRACKING					
	Light	$<\!V_{\!\!8}^{''}$ , no faulting, spalling $<\!V_{\!\!2}^{''}$ wide	None	Figure 10.2	
Longitudinal	Moderate	$V_8$ " <width <<math="">V_2", spalling &lt;3" wide</width>	Clean and Seal	Figure 10.2	
	Severe	width $>\frac{1}{2}$ ", spalling $>3$ " faulting $>\frac{1}{2}$ "	Replace	Figure 10.3	
Transverse	Light	$<\!V_{\!8}^{\prime\prime}$ , no faulting, spalling $<\!V_{\!2}^{\prime\prime}$ wide	None	Figure 10.2	
	Moderate	$V_8$ " <width <<math="">V_2", spalling &lt;3" wide</width>	Clean and Seal		
	Severe	width $> \frac{1}{2}$ ", spalling $> 3$ " faulting $> \frac{1}{2}$ "	Replace	Figure 10.3, 10.4 and 10.5	
Corner Breaks	adjacent lo	the slab is separated by a crack that intersects the ngitudinal and transverse joint, describing an approximate ith the direction of traffic.	Full Depth	Figure 10.4 and 10.5	
Intersecting Random Cracks (Shattered Slab)	Cracking patterns that divide the slab into three or more segments.		Full Depth	Figure 10.3 and 10.4

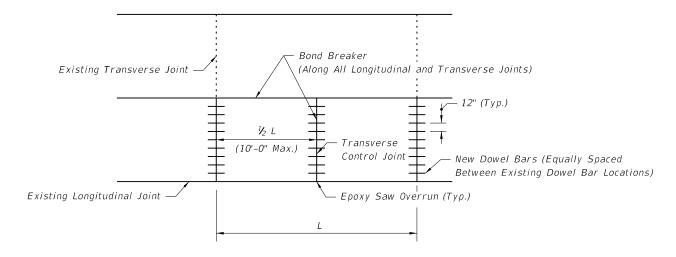
FIGURE 10.3 - FULL SLAB FULL DEPTH REPLACEMENT

Blowups		vement at transverse joints or cracks often d by shattering of the concrete.	Full Depth	Figure 10.3 and 10.4

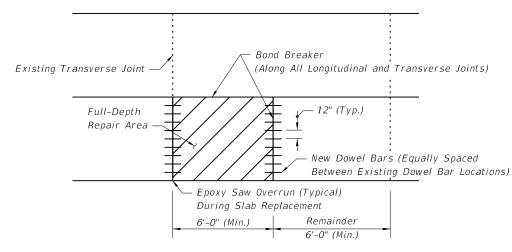
FIGURE 10.4 - PARTIAL SLAB FULL DEPTH REPLACEMENT

JOINT DEFICIENCIES					
Spall Nonwheel Path	Light	spall width <1 $V_2$ ", < $V_3$ slab depth, <12" in length	None	Figure 10.4 and 10.5	
	Moderate	$1lar{V_2}$ " <spall <="" <3",="" <math="" width="">rac{V_3}{3} slab depth, &lt;12" in length</spall>	None	Figure 10.4 and 10.5	
	Severe	spall width >3" or length >12"	Full Depth	Figure 10.4 and 10.5	
Spall Wheel Path	Light	spall width <1 $lar{V}_2$ ", <than <math="">lar{V}_3 slab depth, &lt;12" in length</than>	None	Figure 10.4 and 10.5	
	Moderate	$1\frac{1}{2}$ " <spall <="" <3",="" <math="" width="">\frac{1}{2}3 slab depth, &lt;12" in length</spall>	Full Depth	Figure 10.4 and 10.5	
	Severe	spall width >3" or length >12"	Full Depth	Figure 10.4 and 10.5	
URFACE DETERIORATION		•			
Pop Outs Nonwheel Path	Small pieces of surface pavement broken loose, normally ranging from 1 to 4 in. diameter and $\frac{1}{2}$ to 2 in. in depth.				
	Light	Not deemed to be a traffic hazard	Keep under observation

Severe	Flying debris deemed a traffic hazard	Full Depth	Figure 10.4	
Pop Outs Wheel Path	Small pieces of surface pavement broken loose, normally >3" diameter and 2" in depth.				
	Light	Deemed to be a traffic hazard	Full Depth	Figure 10.4	
	Severe	Flying debris deemed a traffic hazard	Full Depth	Figure 10.4	
ISCELLANEOUS DISTRESS	5				
Faulting	Elevation differences across joints or cracks.				
	Light Faulting <4/32"		None		
	Moderate	4 <faulting 32"<="" <16="" td=""><td>Grind</td><td></td></faulting>	Grind		
	Severe	Faulting >16/32"	Grind		
Lane To Shoulder Drop-Off	Light	0 <drop-off <1"<="" td=""><td>None</td><td></td></drop-off>	None		
	Moderate	1" <drop-off <3"<="" td=""><td>Build Up</td><td colspan="2">N/A</td></drop-off>	Build Up	N/A	
	Severe	drop-off >3 "	Build Up	1	
Water Bleeding Or Pumping	Seeping or ejection of water through joints or cracks.		Install appropriate drainage, edge drain, permeable subbase, reseal joints, etc.	N/A

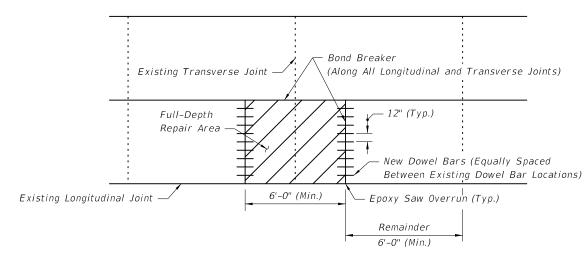
FIGURE 10.5 - FULL-DEPTH REPAIR ON BOTH SIDES OF THE JOINT
