FY 2018-19 STANDARD PLANS	TEMPORARY DETOUR BRIDGE TIMBER PILE FOUNDATIONS	INDEX 102-210	SHEET 2 of 3
---------------------------	----------	--------------	--	--	------------------	-----------------

LAST REVISION 07/01/06	DESCRIPTION:	FDOT FY 2018-19 STANDARD PLANS	TEMPORARY DETOUR BRIDGE TIMBER PILE FOUNDATIONS	INDEX 102-210	SHEET 3 of 3
---------------------------	--------------	--------------------------------------	--	------------------	-----------------

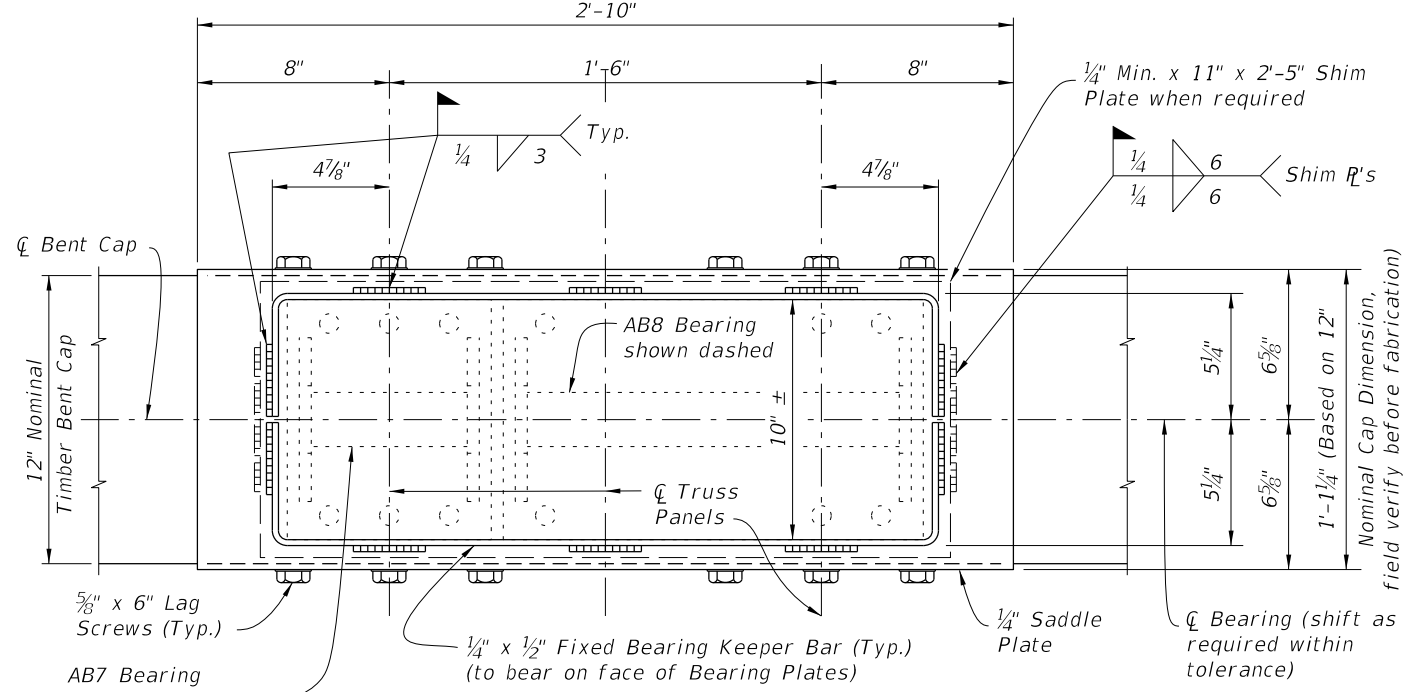
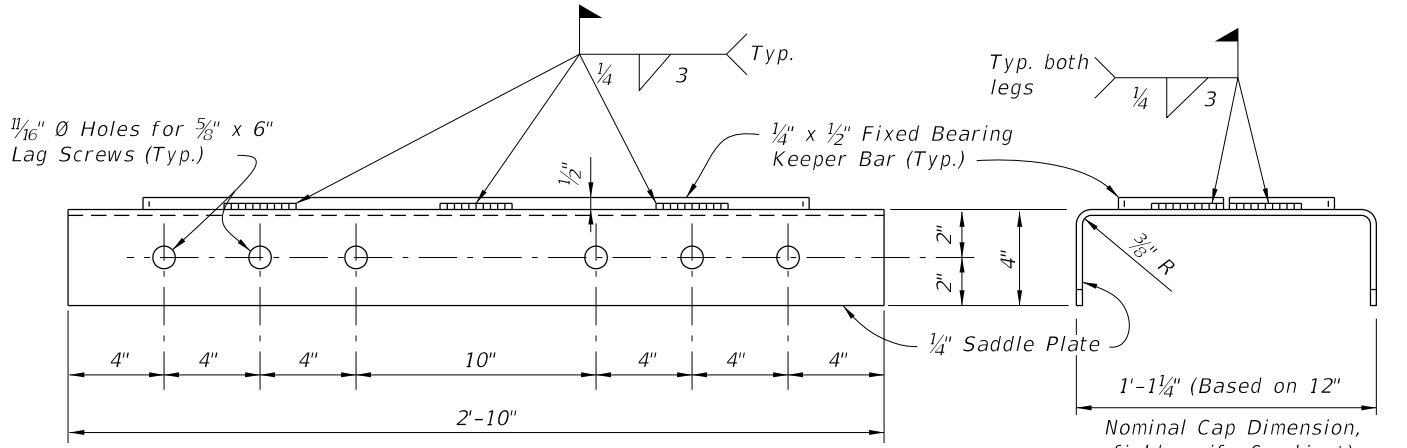
FIXED BEARING DETAILS

PLAN VIEW

ELEVATION VIEW OF SADDLE PLATE

END VIEW

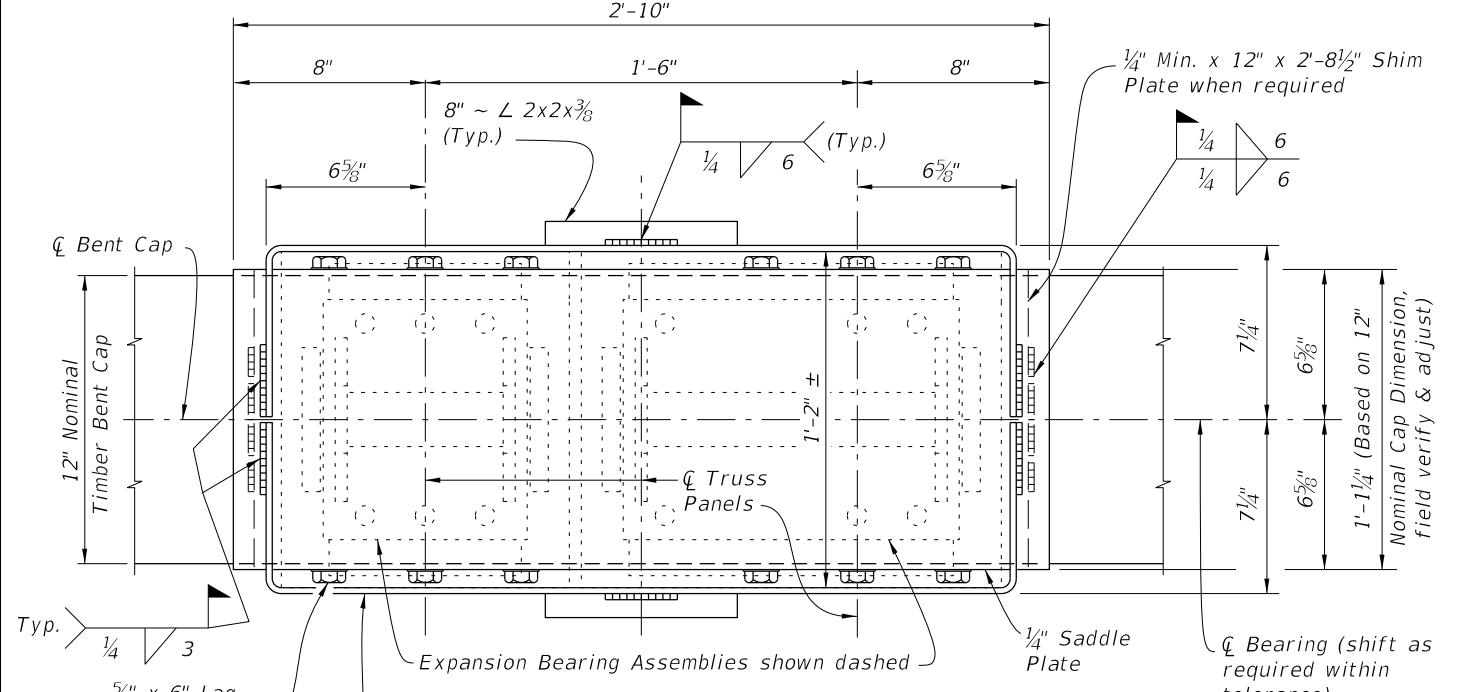
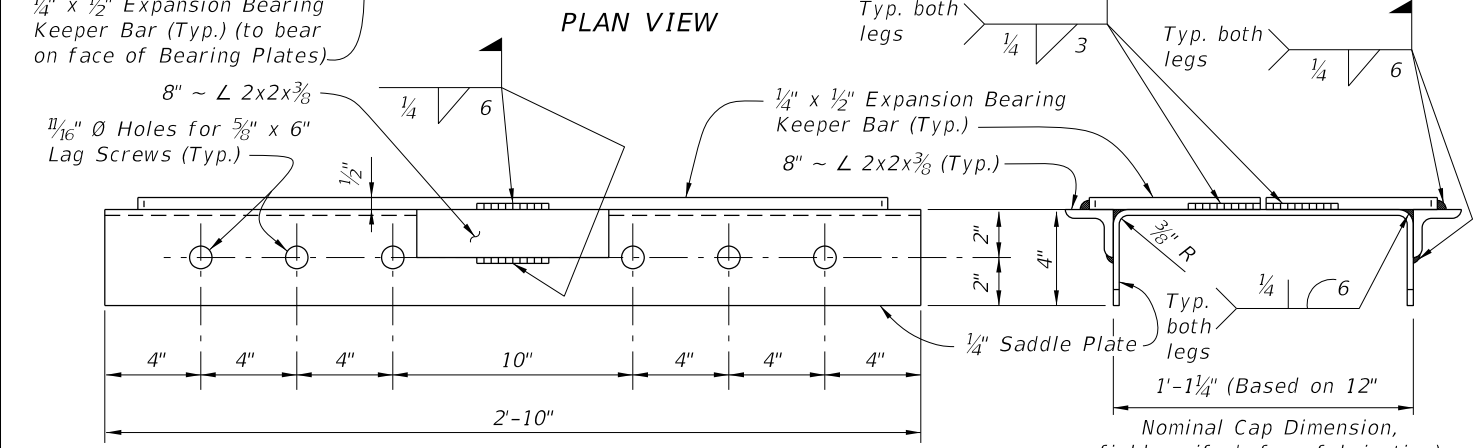
EXPANSION BEARING DETAILS

PLAN VIEW

ELEVATION VIEW OF SADDLE PLATE

END VIEW

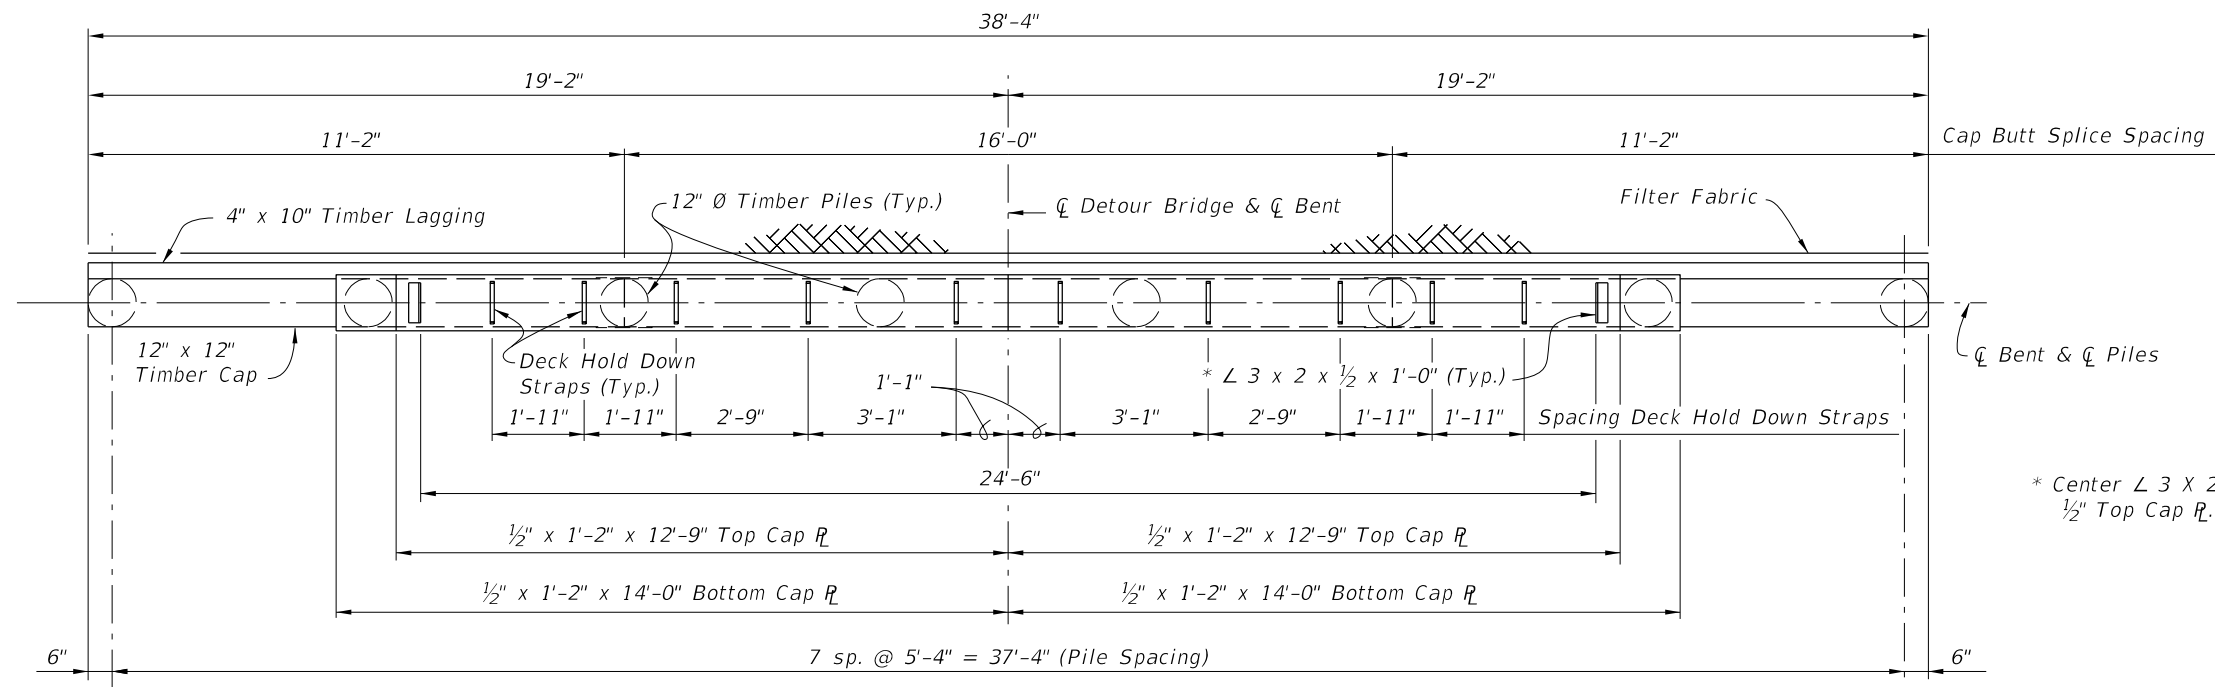
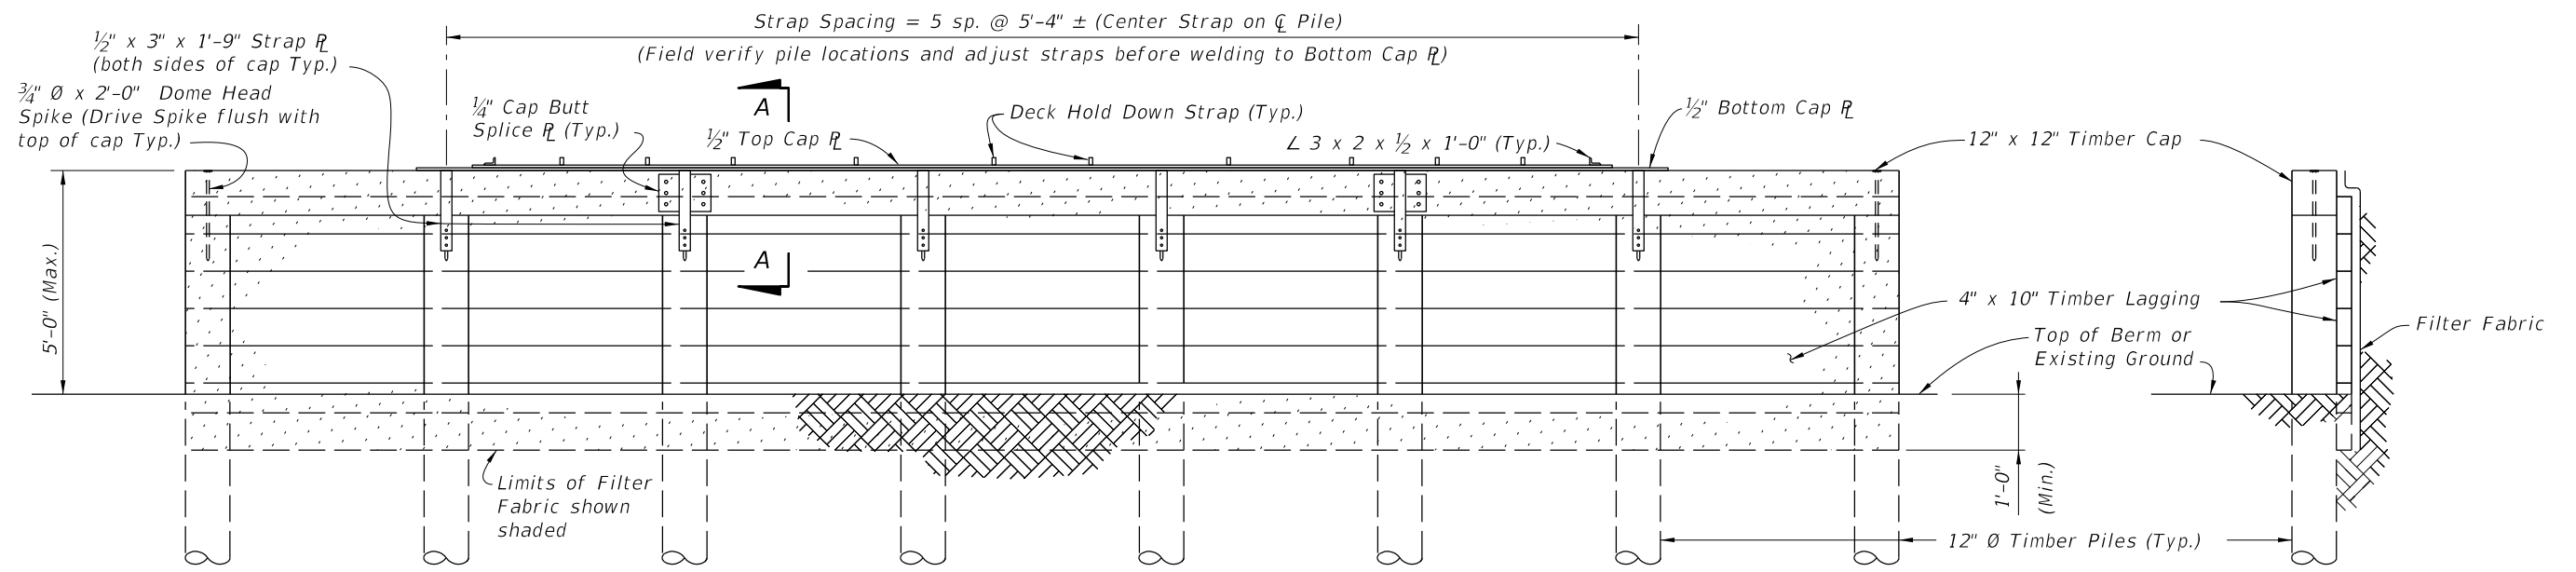
BACKWALL BENT DETAILS

PLAN VIEW

ELEVATION VIEW

END VIEW

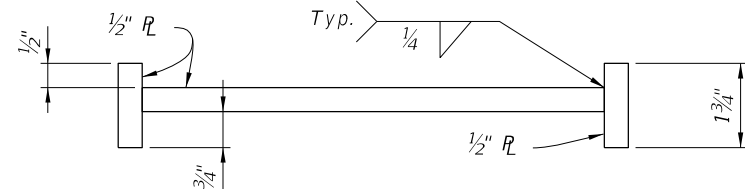
HOLD DOWN STRAP ASSEMBLY DETAIL

PLAN VIEW

ELEVATION VIEW
