FY 2019-20
 STANDARD PLANS

TEMPORARY DETOUR BRIDGE
 TIMBER PILE FOUNDATIONS

INDEX
 102-210

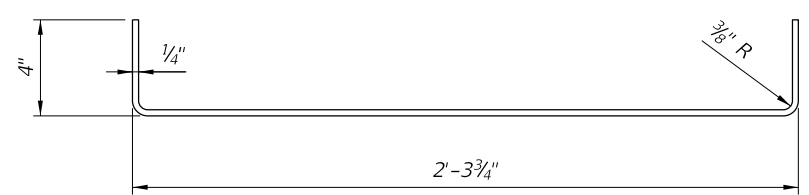
FIXED BEARING DETAILS

PLAN VIEW

ELEVATION VIEW OF SADDLE PLATE

END VIEW

FIXED BEARING KEEPER BAR DETAIL

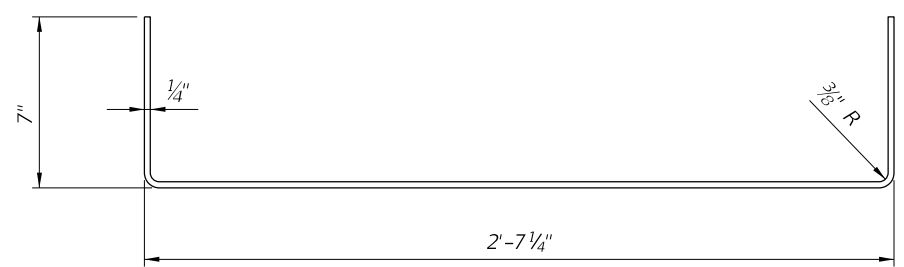
EXPANSION BEARING DETAILS

PLAN VIEW

ELEVATION VIEW OF SADDLE PLATE

END VIEW

EXPANSION BEARING KEEPER BAR DETAIL

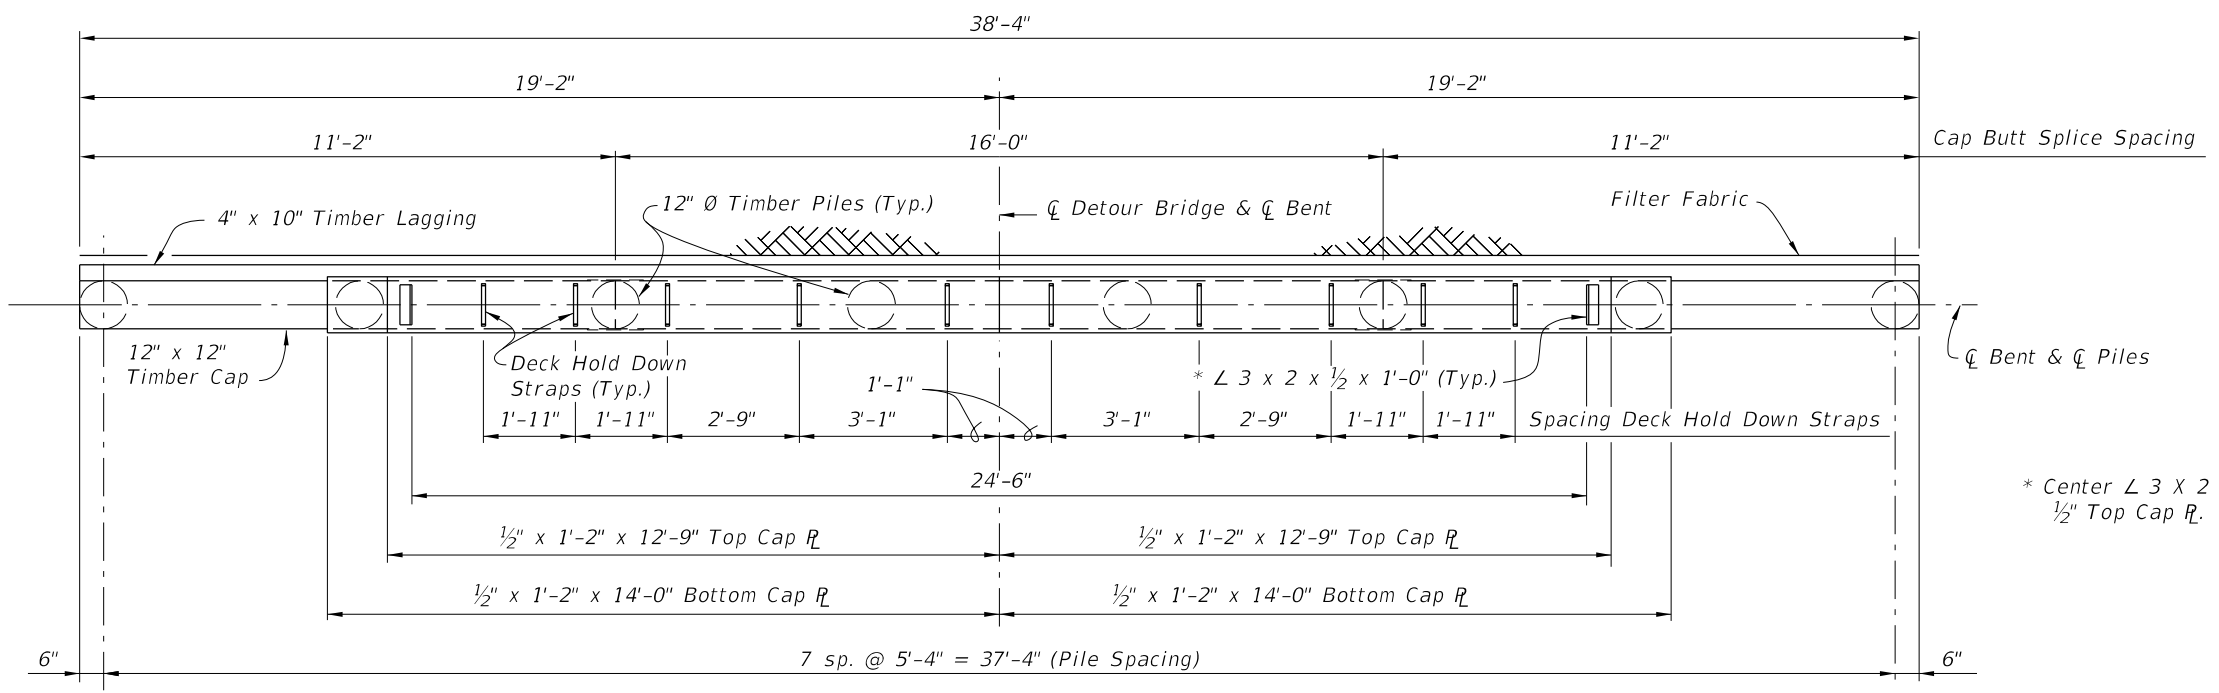
BACKWALL BENT DETAILS

PLAN VIEW

ELEVATION VIEW

END VIEW

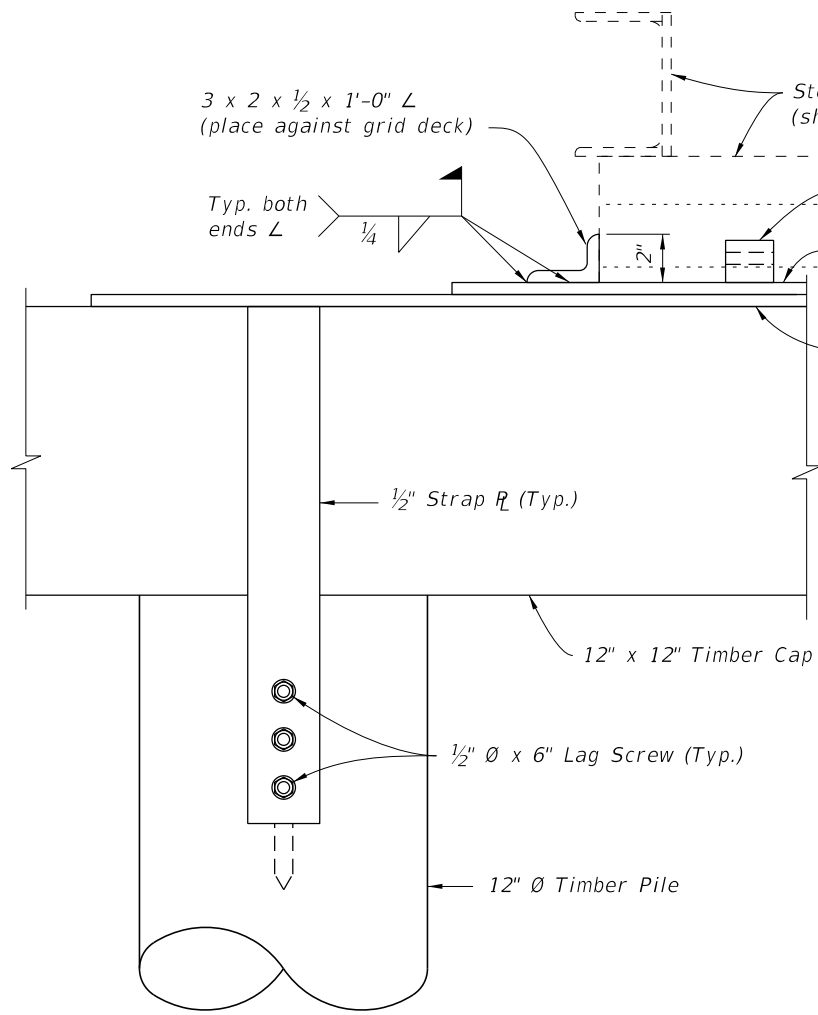
VIEW B-B
 (SHOWING END OF CAP PLATES)

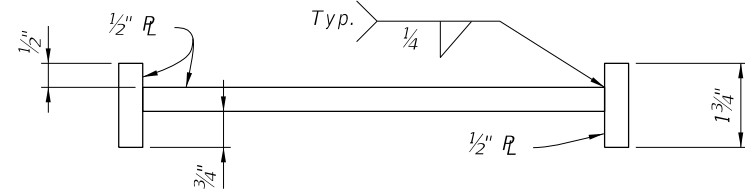
ELEVATION VIEW

HOLD DOWN STRAP ASSEMBLY DETAIL
