FY 2022-23 STANDARD PLANS	TEMPORARY DETOUR BRIDGE TIMBER PILE FOUNDATIONS	INDEX 102-210	SHEET 1 of 3
---------------------------	----------	--------------	--	--	------------------	-----------------

TEMPORARY DETOUR BRIDGE
 TIMBER PILE FOUNDATIONS

INDEX
 102-210

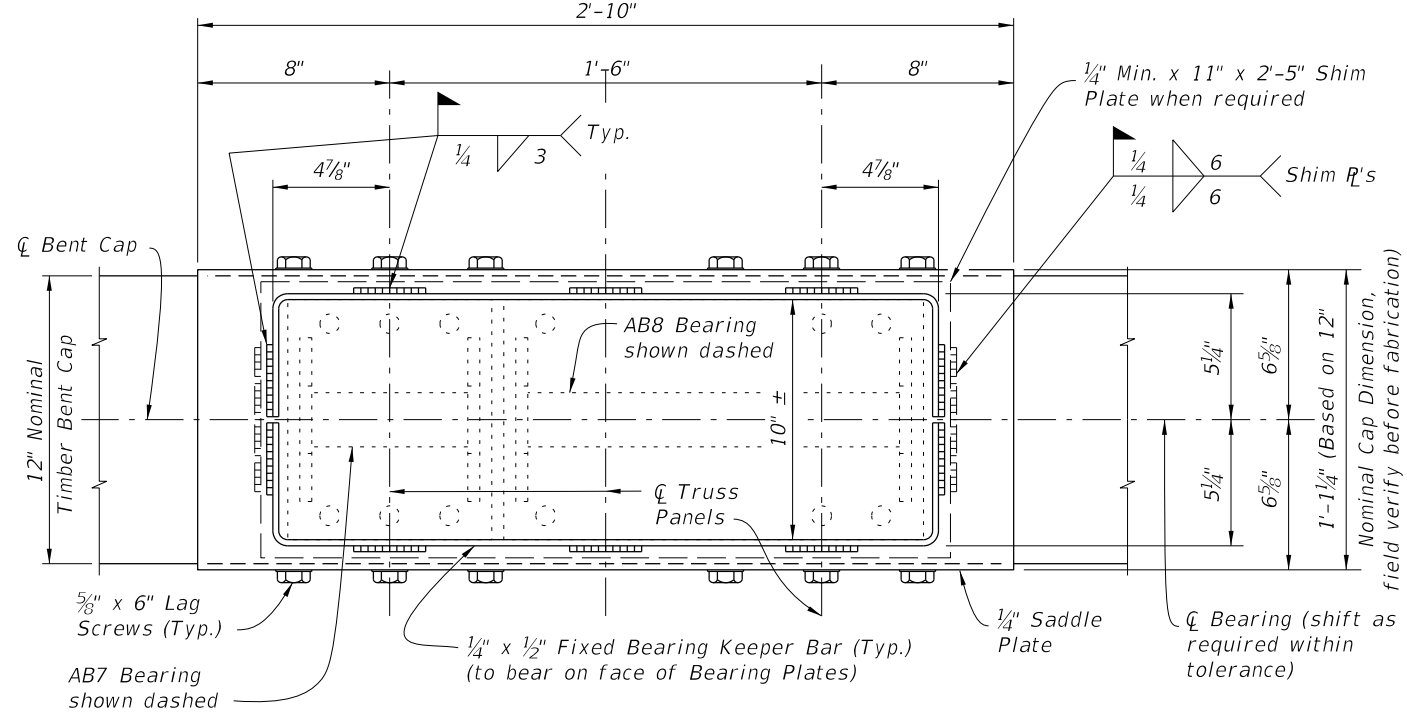
FIXED BEARING DETAILS

PLAN VIEW

ELEVATION VIEW OF SADDLE PLATE

END VIEW

FIXED BEARING KEEPER BAR DETAIL

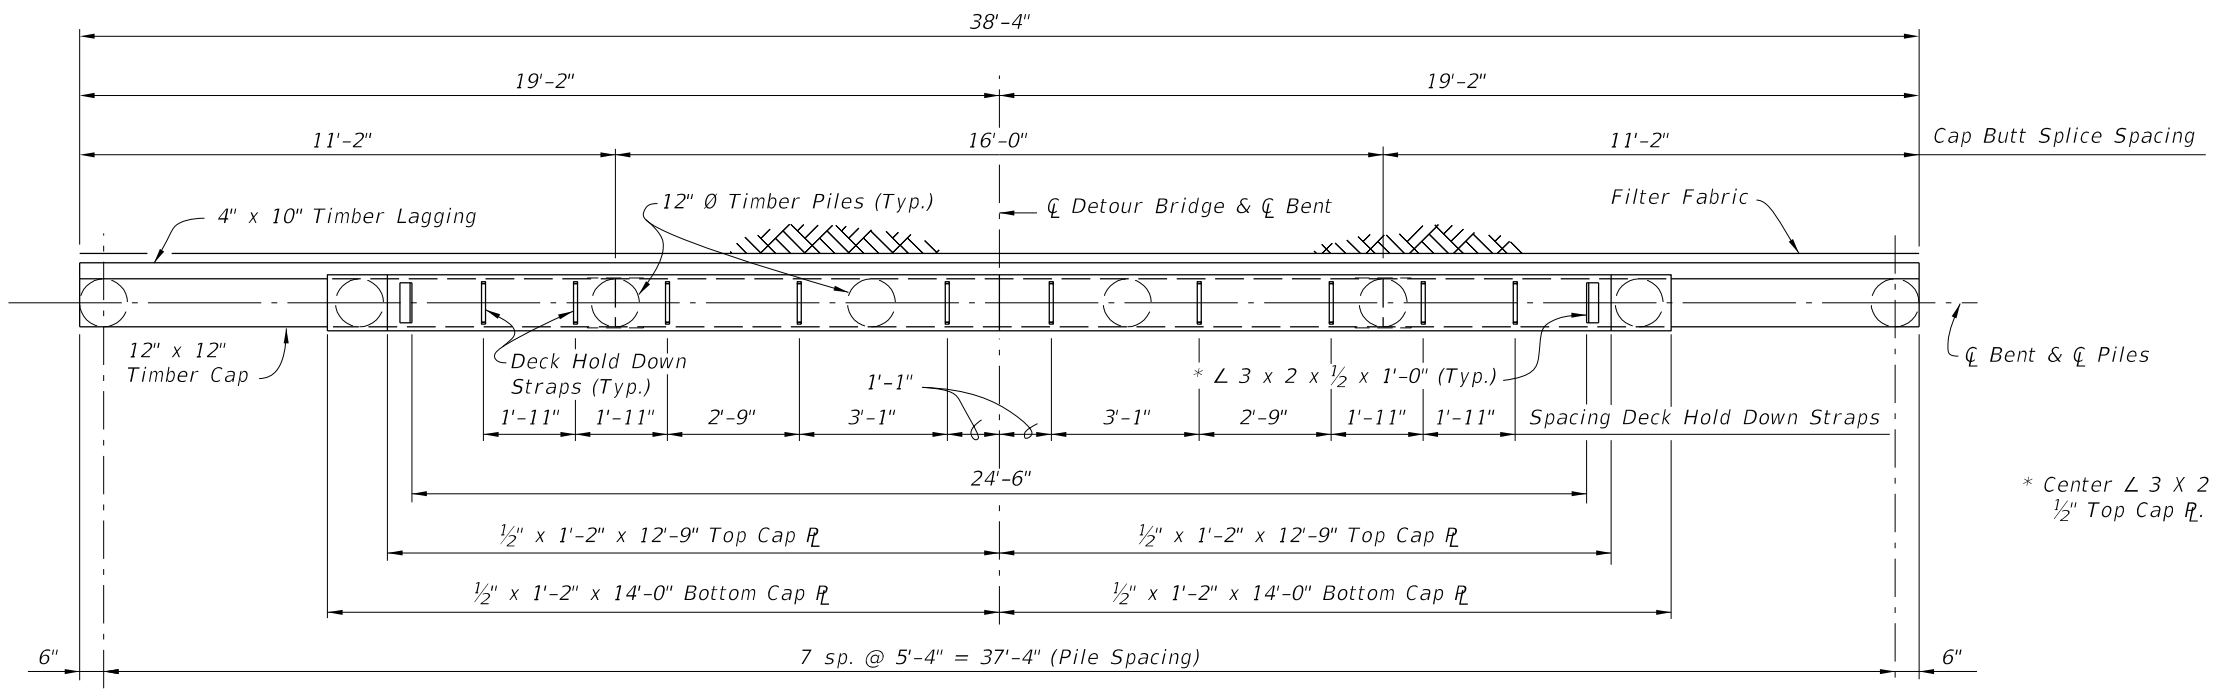
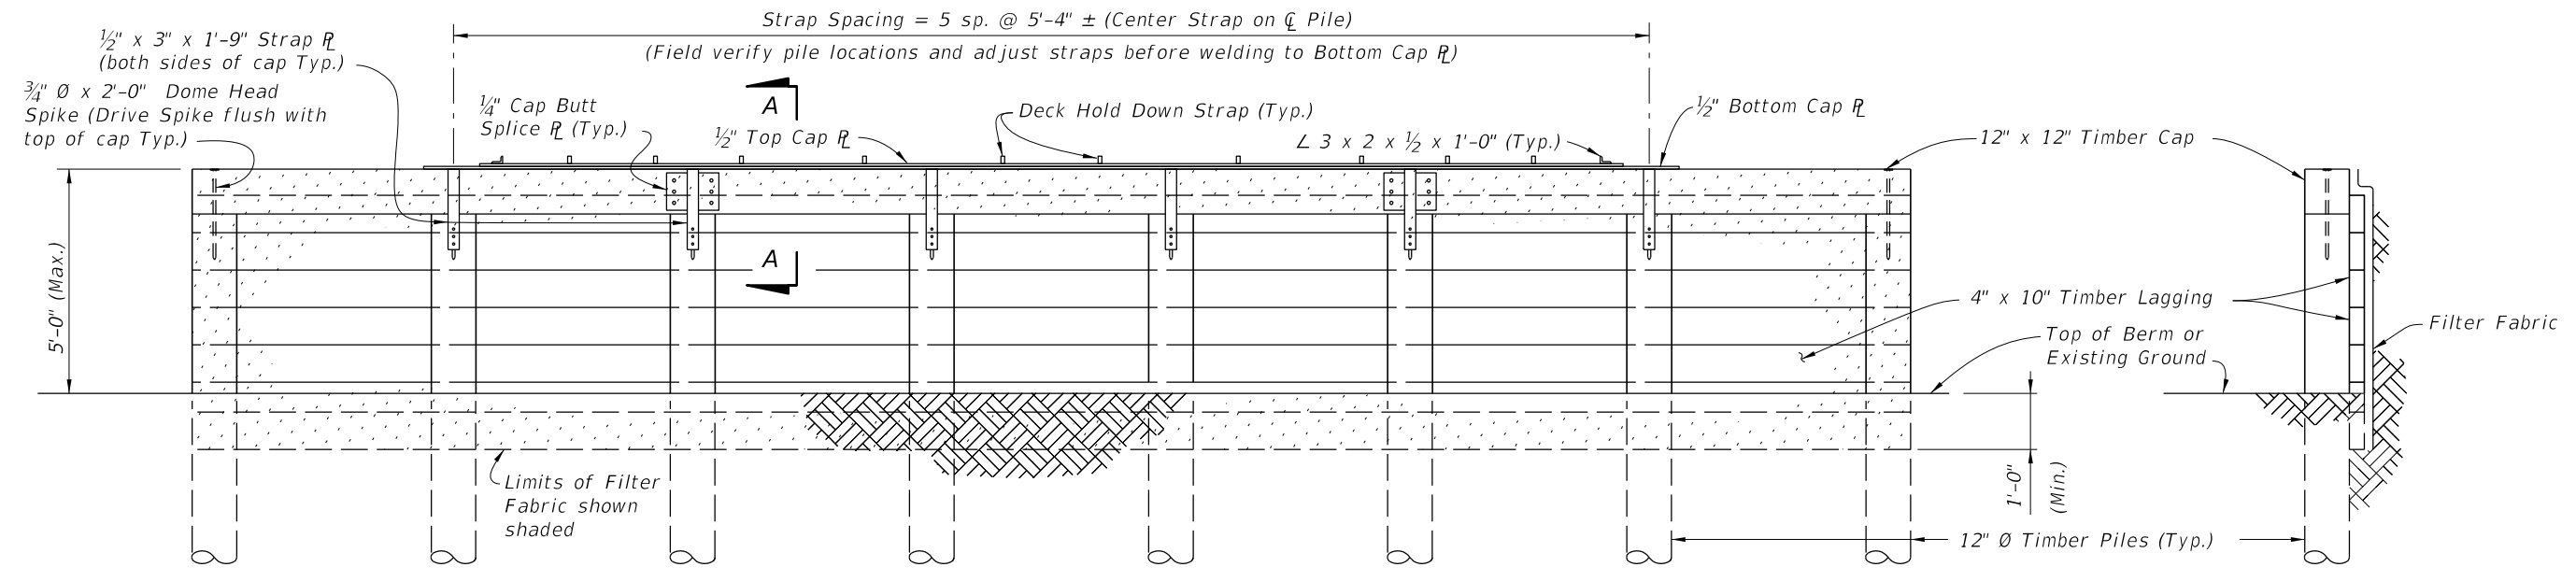
BACKWALL BENT DETAILS

PLAN VIEW

ELEVATION VIEW

END VIEW
