FY 2023-24 STANDARD PLANS

TEMPORARY DETOUR BRIDGE TIMBER PILE FOUNDATIONS

INDEX 102-210

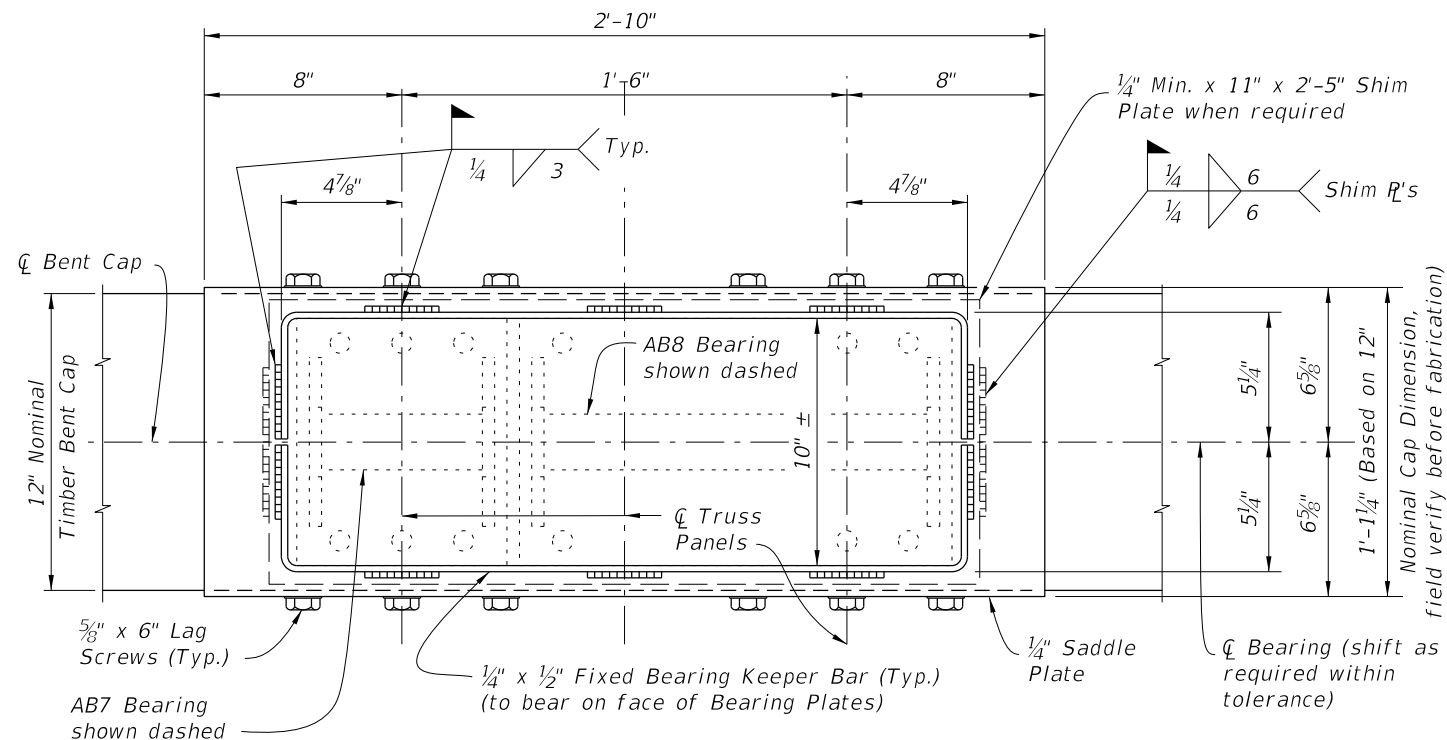
PLAN VIEW

FIXED BEARING DETAILS
