FIXED BEARING DETAILS

EXPANSION BEARING DETAILS

| LAST<br>REVISION<br>11/01/25 | DESCRIPTION: | FDOT<br>FY 2027-28<br>STANDARD PLANS | TEMPORARY DETOUR BRIDGE<br>TIMBER PILE BACKWALL BENT | INDEX<br>102-210 | SHEET<br>1 of 3 |

BACKWALL BENT DETAILS

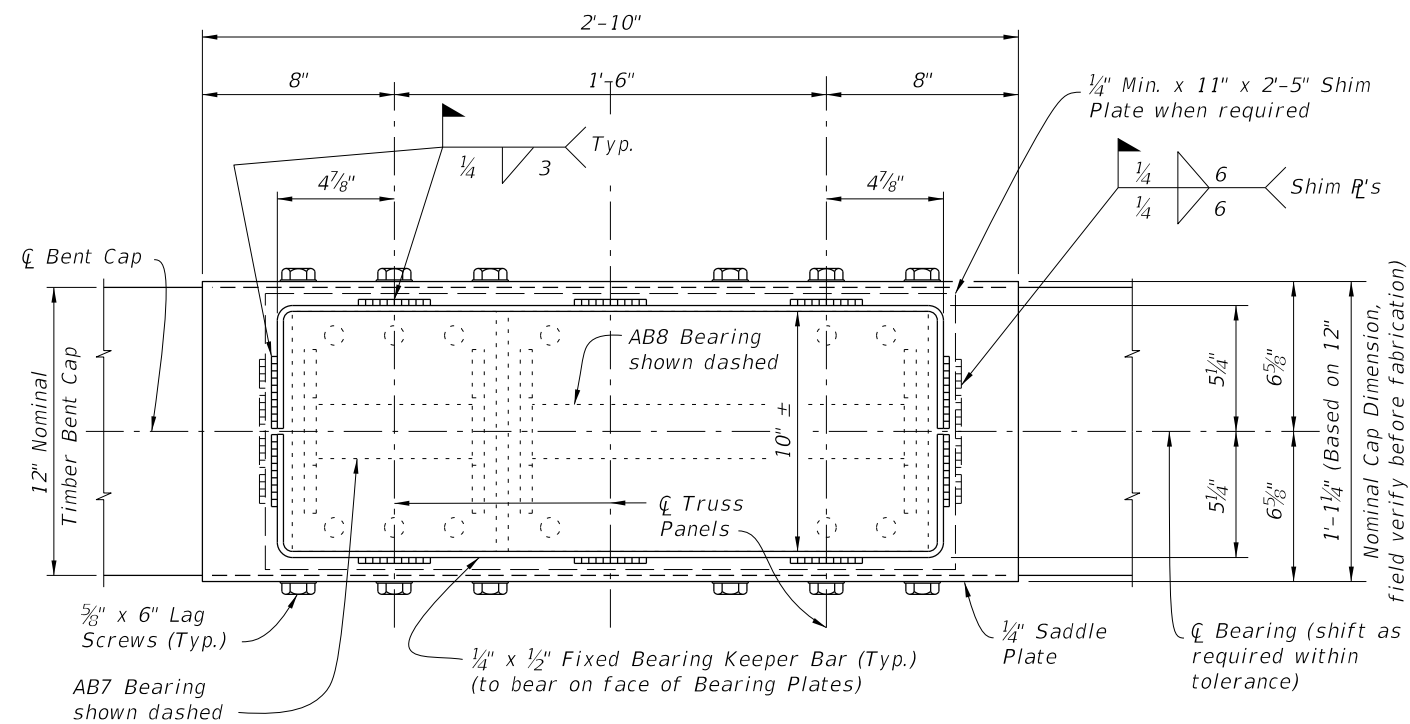
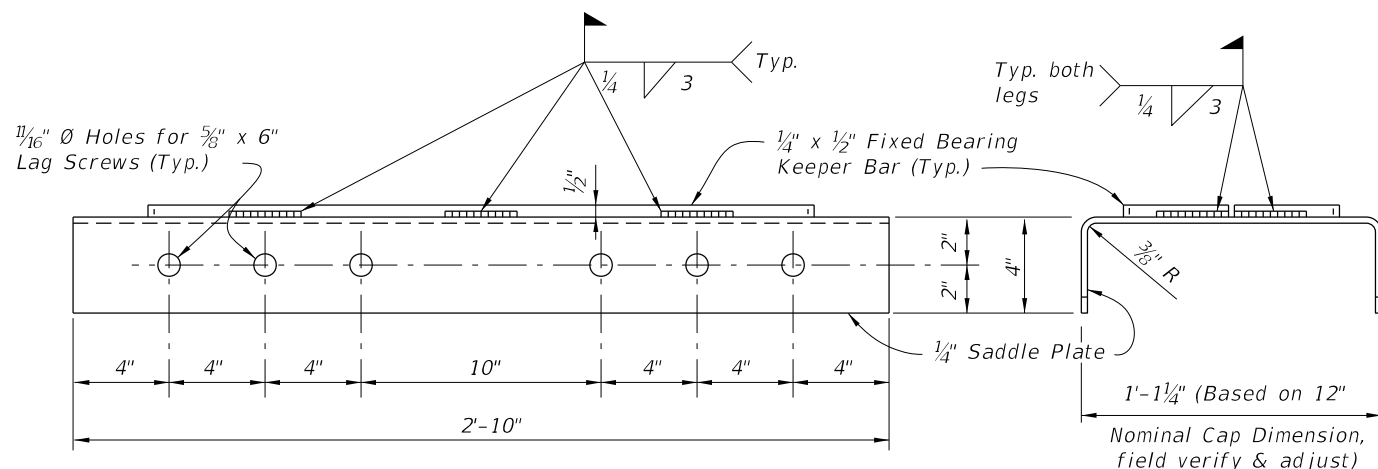
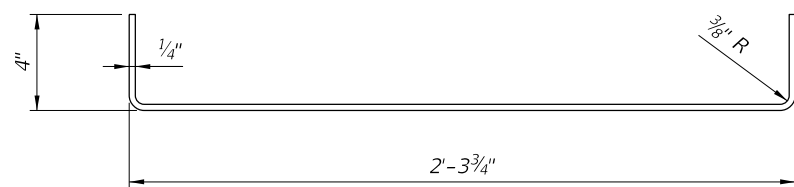
PLAN VIEW

ELEVATION VIEW OF SADDLE PLATE

END VIEW

FIXED BEARING KEEPER BAR DETAIL

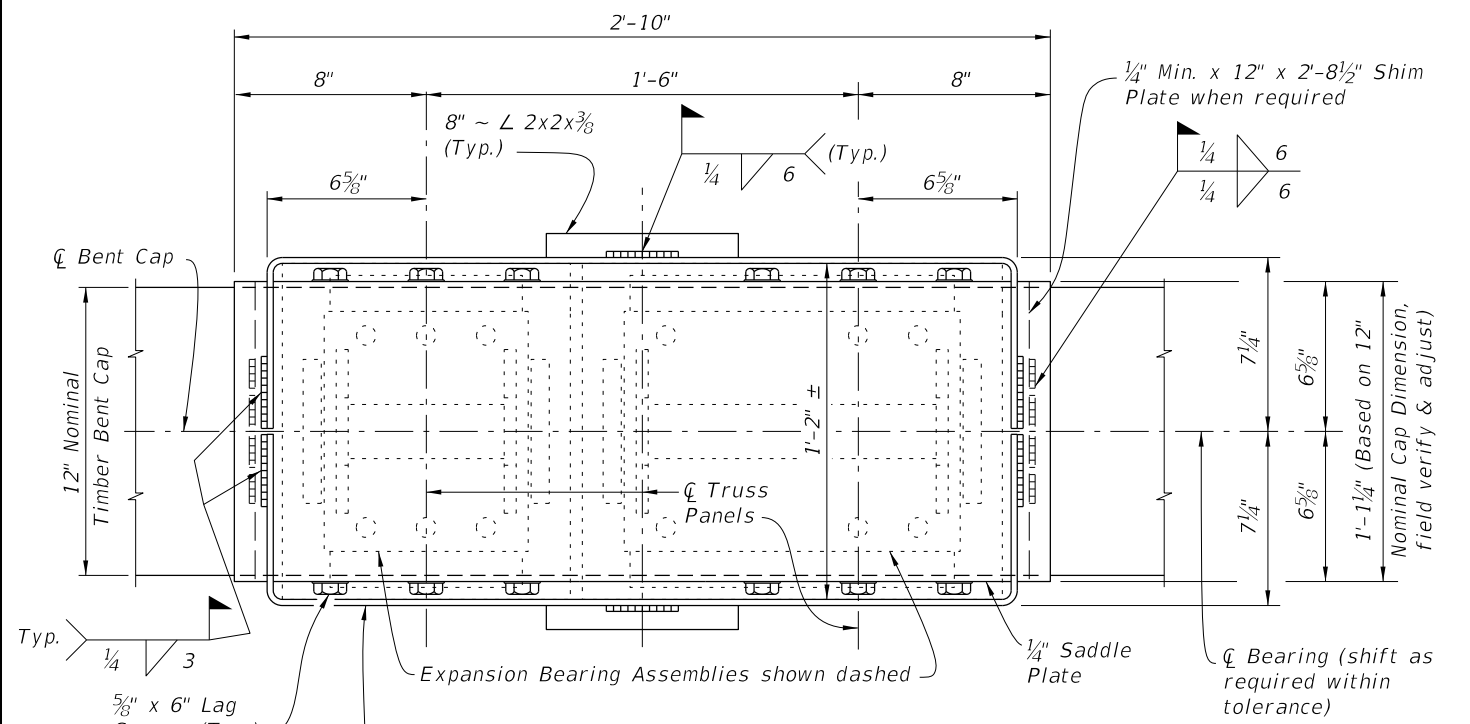
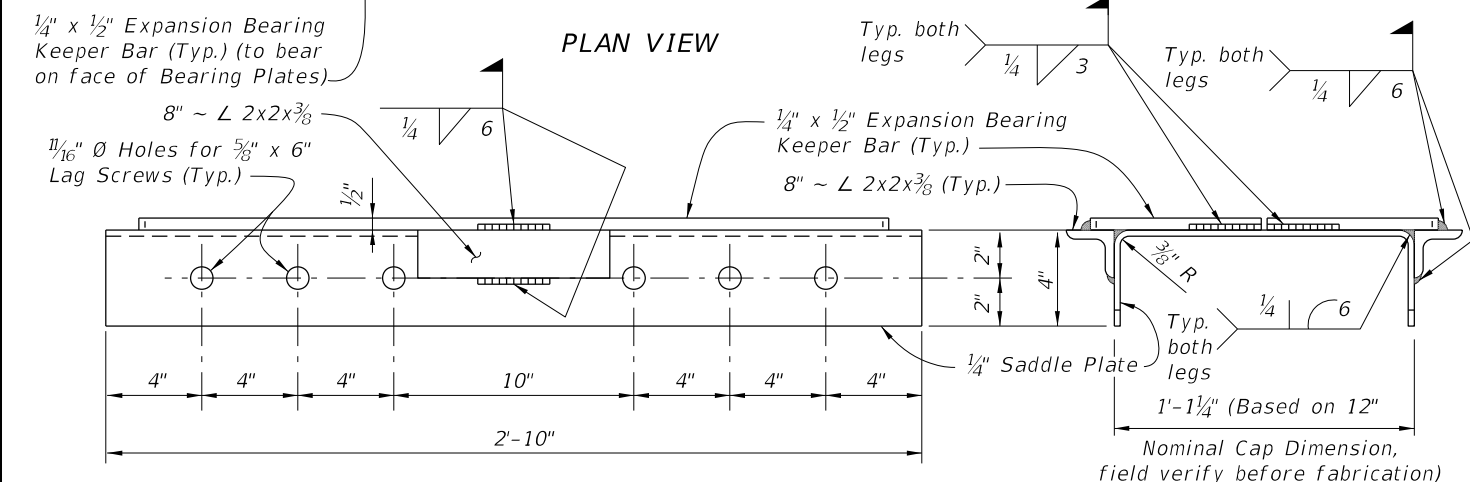
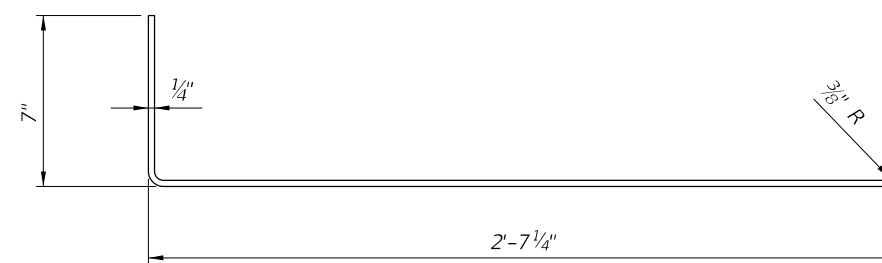
PLAN VIEW

ELEVATION VIEW OF SADDLE PLATE

END VIEW

EXPANSION BEARING KEEPER BAR DETAIL

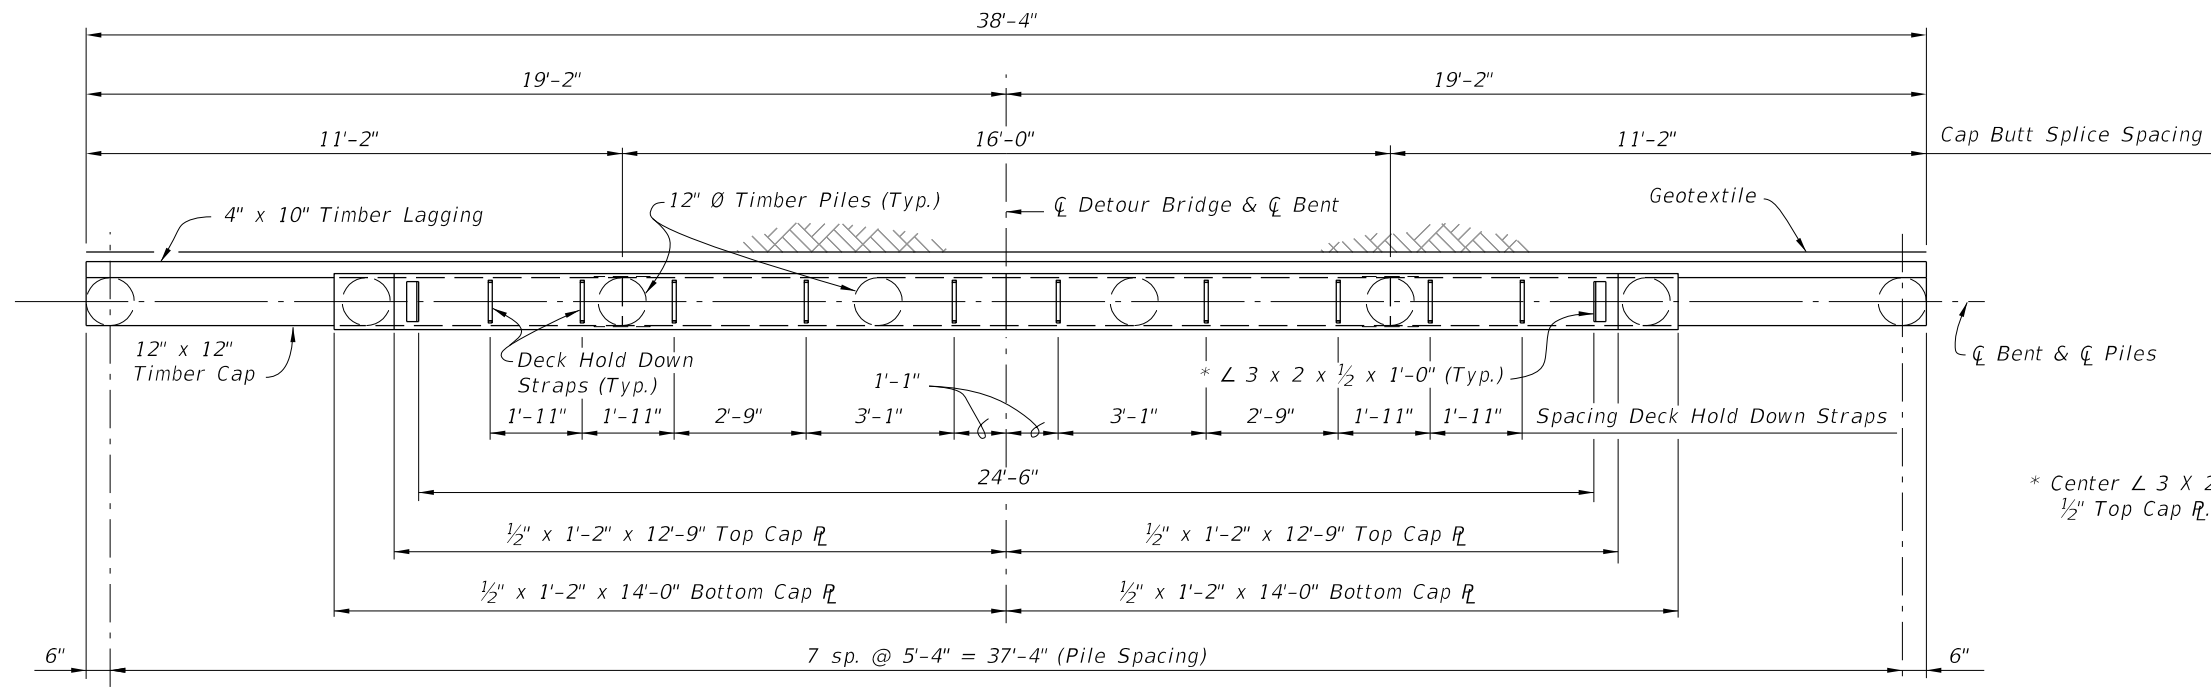
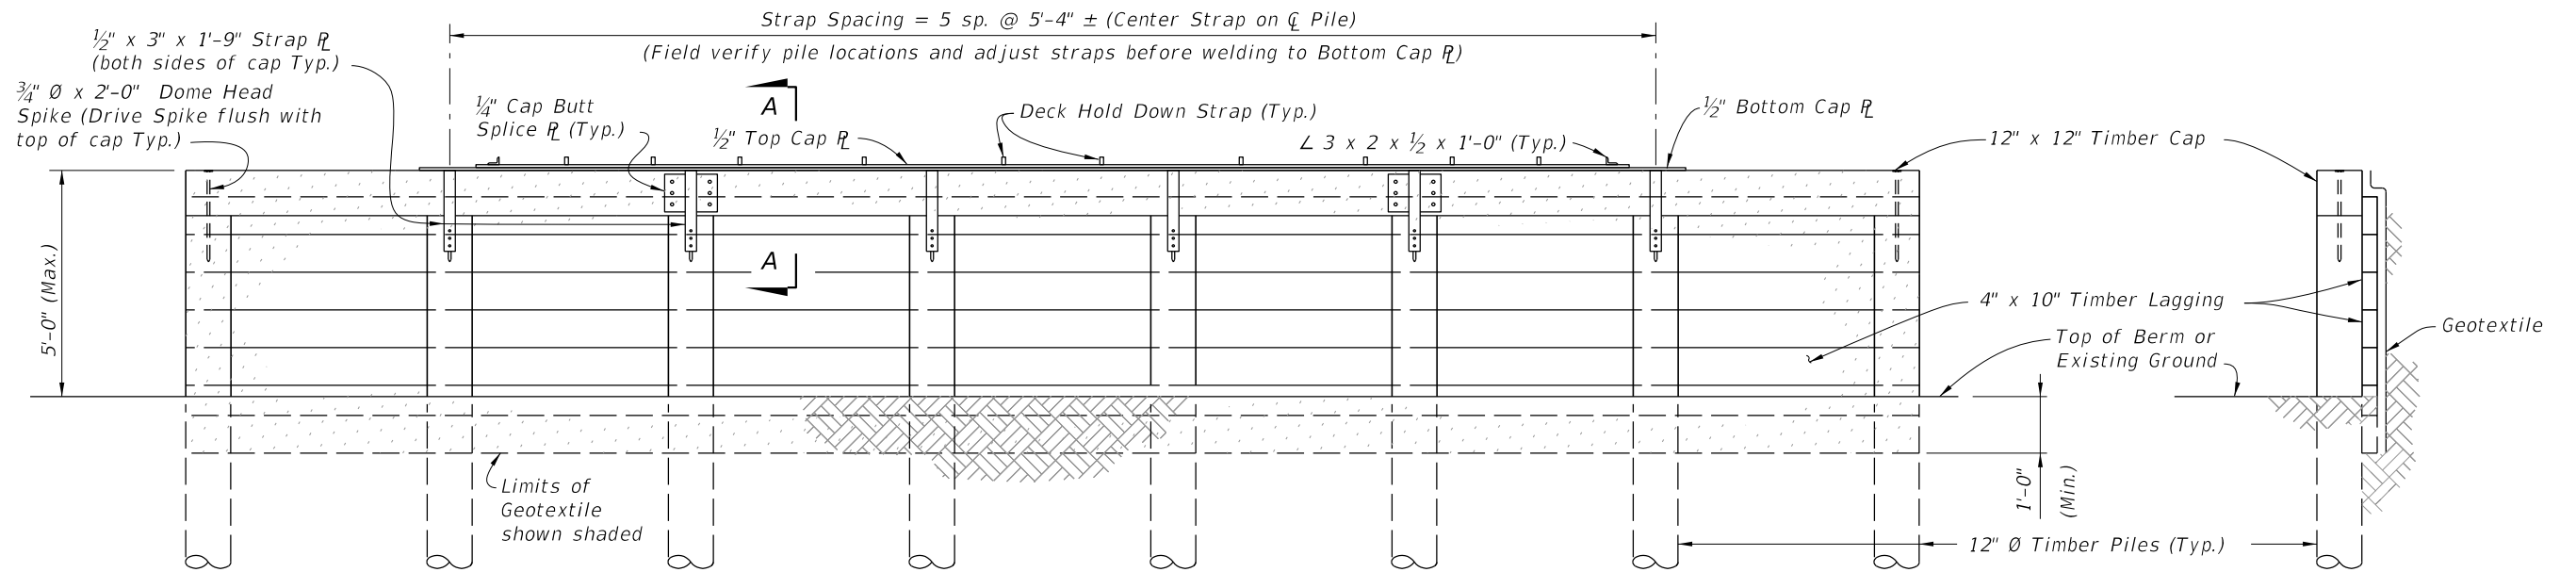
PLAN VIEW

ELEVATION VIEW

END VIEW

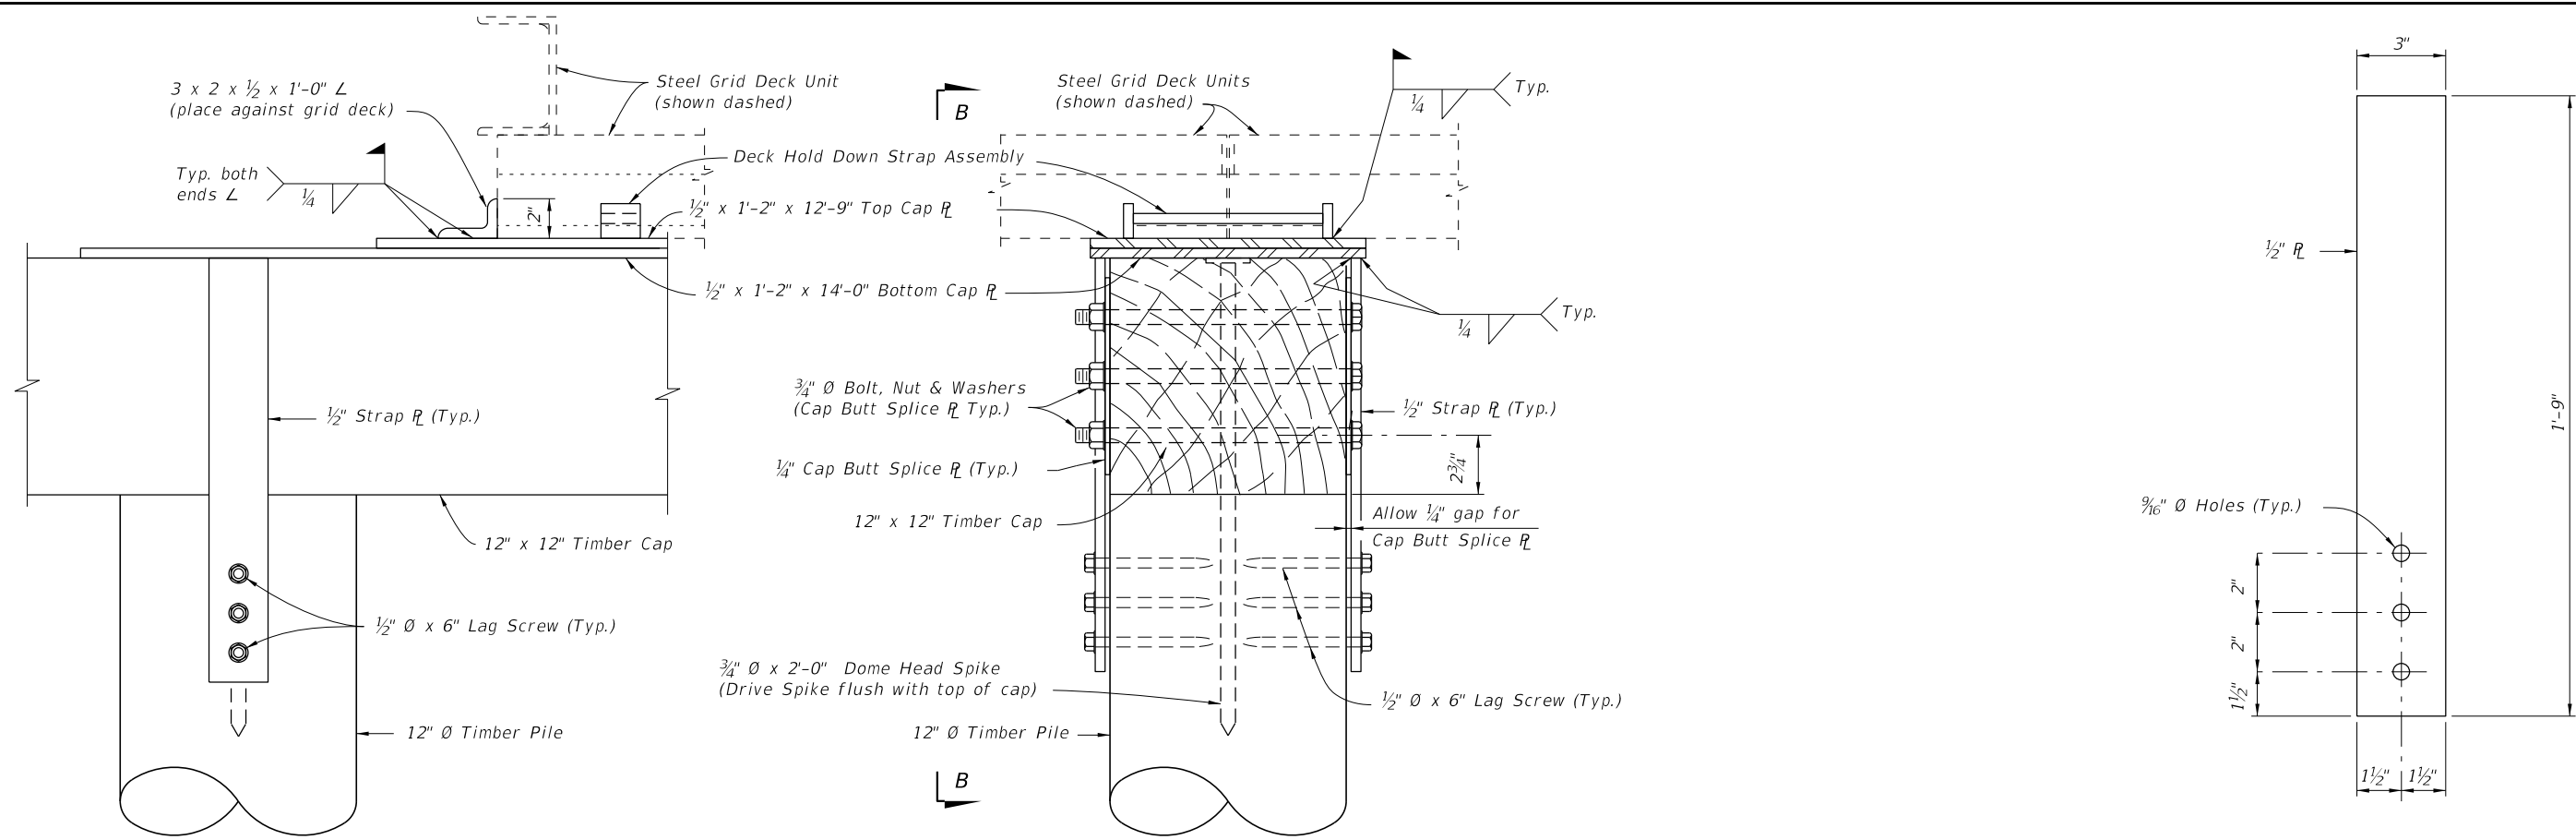
BACKWALL BENT DETAILS

VIEW B-B  
(SHOWING END OF CAP PLATES)

SECTION A-A

STRAP PLATE DETAIL

PLAN VIEW

ELEVATION VIEW

HOLD DOWN STRAP ASSEMBLY DETAIL
