20TRANSPORTATION 24SYMPOSIUM

Evolutions in Safety Engineering

Florida Department of Transportation

'New' Tools for Pedestrian Safety

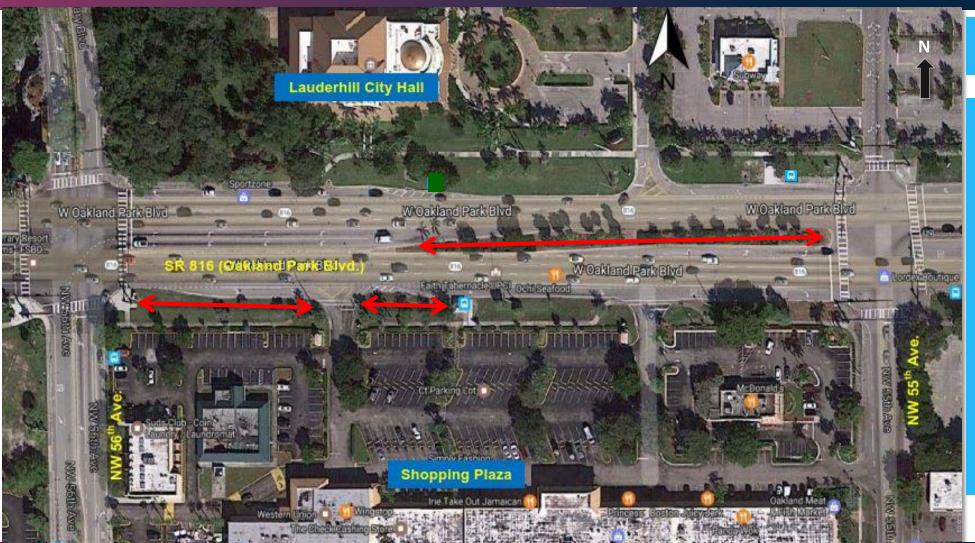
SR 816 (Oakland Park Blvd.) between NW 55th Ave and NW 56th Ave

Installed between February 2017 and July 2017

- Six-lane divided w/ raised median (18 to 20' median; 4 to 5' traffic separator); 45 mph speed limit
- Two signalized intersections (apprx. 900' apart);
- Seven bus stops in the vicinity; (2 along OPB, EB 400' E. of 56th Ave; and WB 100' W. of 55th Ave);
- Surround land uses
 (Shopping Plazas,
 Restaurants, City Hall);
 Residential areas
 north/south of OPB

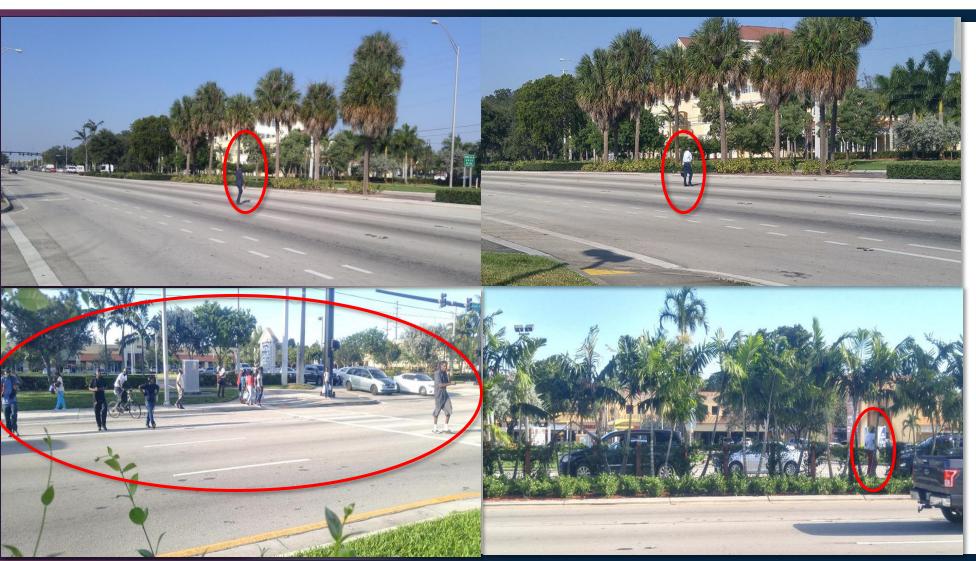
Pedestrian Crossing (May 28, 2024; 5.30-6.30 PM)

Pedestrians
Crossing from WB
Bus Stop in Zones 4
and 5 ("After"
Condition)

Pedestrian
Crossing in the
crosswalk
("After" Condition)

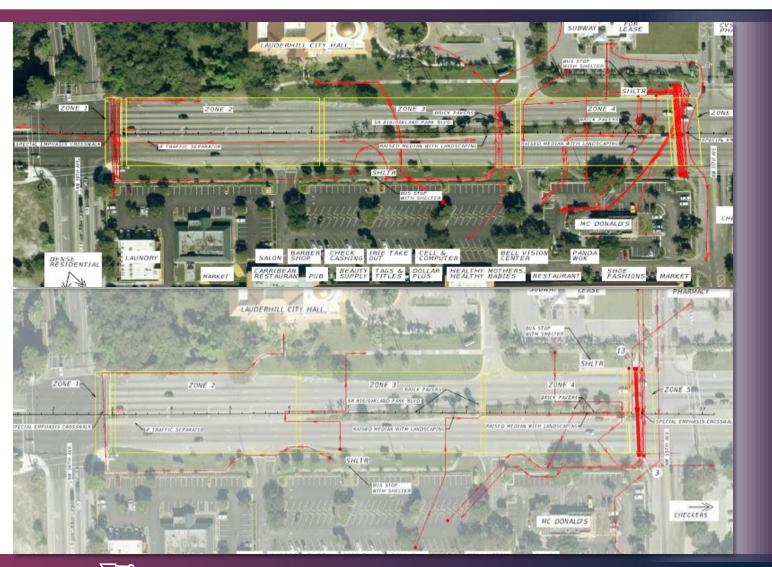
Pedestrian/Bicycle Crossing Paths - AM

Before (50%Crosswalk; 50% Midblock)

After (83%Crosswalk; 17% Midblock)

- Median barrier (in Zones 3 and 4)
 - Pedestrian/bicycle crossings at midblock locations reduced from 32% to 14%
 - Pedestrian/bicycle crossings at adjacent crosswalks increased from 68% to 86%.
 - Results indicate that most pedestrians/bicyclists who were crossing at midblock locations before are now using the crosswalks
 - Separate comparisons of data collected on weekday/weekend indicated similar results
- Roadside barrier (south side of the roadway in Zone 2)
 - Overall, no significant difference between before/after periods (6% vs. 6.87%)
 - Midblock crossings in Zone 2 increased from 5% to 8% based on data collected on Wednesday; Reduced from 7% to 5% based on data collected on Saturday
 - Number of crossings in Zone 2 were relatively low (49 before vs. 61 after)

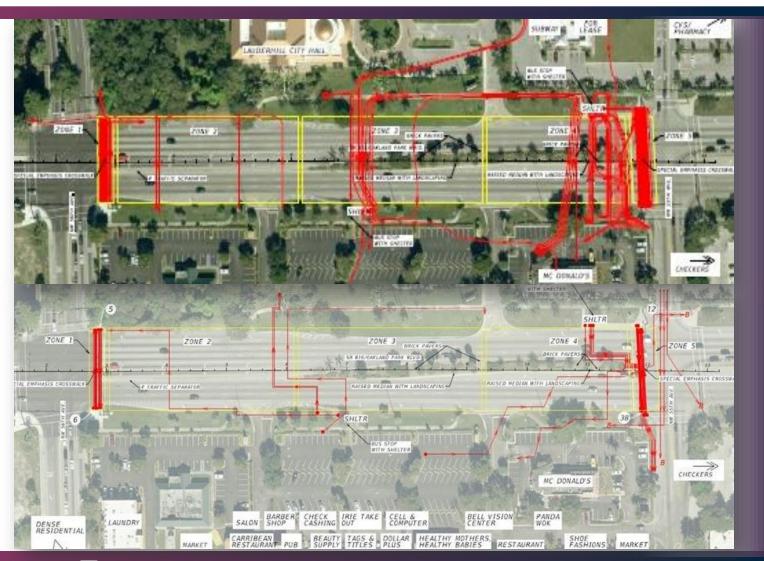
Pedestrian/Bicycle Crossing Paths - PM

Before (61% Crosswalk; 39% Midblock)

After (86%Crosswalk; 14% Midblock)

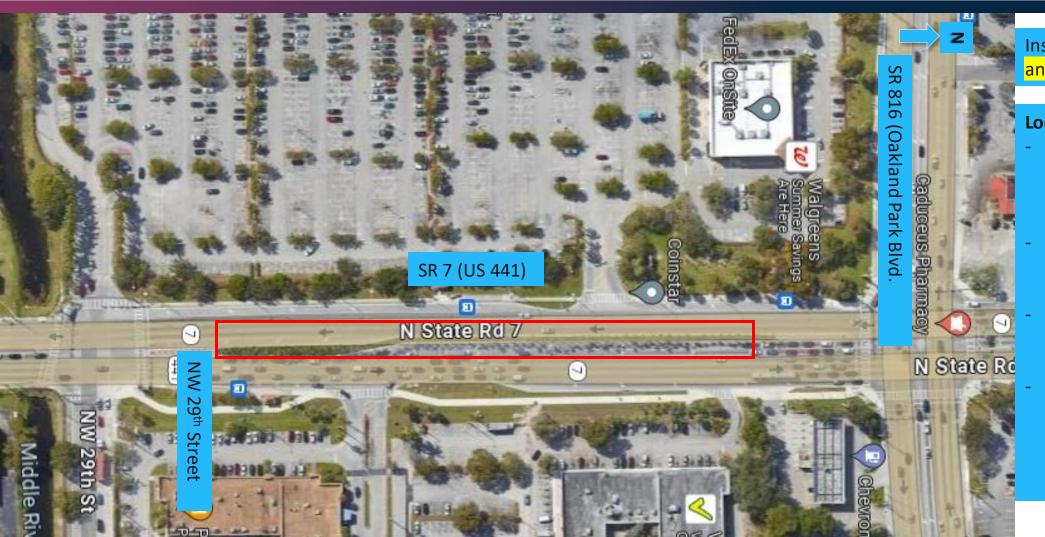
SR 7 (US 441) between Oakland Park Blvd. and NW 29th Street

Installed between July 2019 and May 2020

- Six-lane divided w/ raised median (12 to 16' median;
 9 to 12' traffic separator);
 40 mph speed limit
- Two signalized intersections (apprx. 1,150' apart);
- Three bus stops along OPB (2 SB, 1 NB) within the study area;
- Surround land uses
 (Shopping Plazas,
 Restaurants, Gas Station,
 Pharmacy, Government
 Offices)

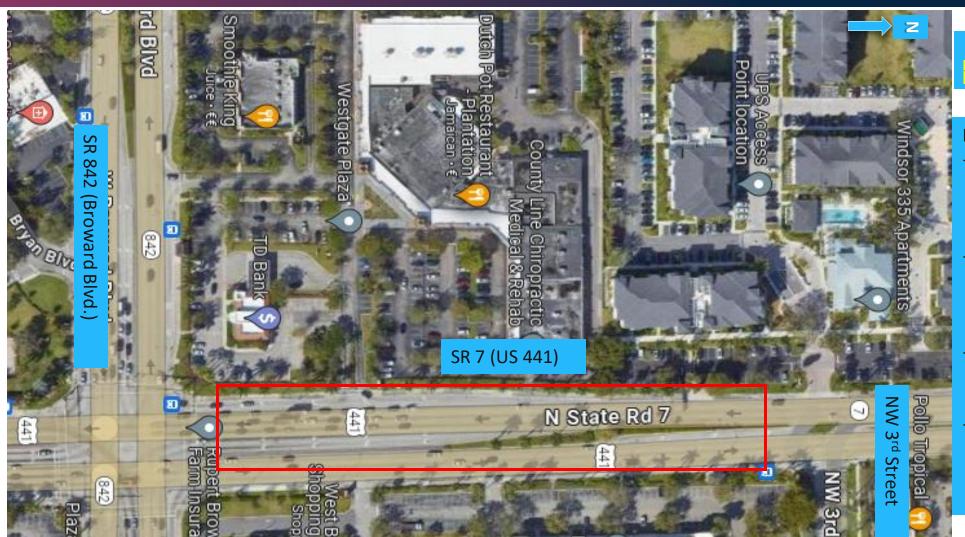
SR 7 (US 441) between Broward Blvd. and NW 3rd Street

Installation from January 2024 to April 2024

- Six-lane divided w/ raised median (10 to 20' median;
 8 to 9' traffic separator);
 40-45 mph speed limit
- One signalized intersection and one directional median opening (apprx.
 950' apart);
- One bus stop along OPB in NB direction within the study area;
- Surround land uses
 (Shopping Plazas,
 Restaurants, Pharmacy,
 Banks)

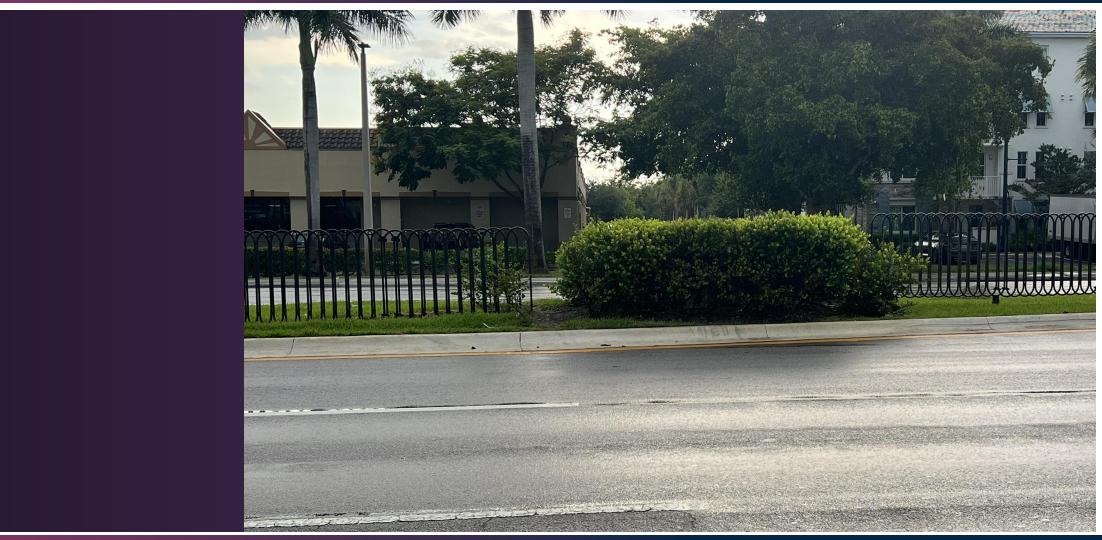
Gaps in Pedestrian Channelization Barrier

- Multiple pedestrians crossing at traffic separator where no median fences (45-50 feet from crosswalks)
- Multiple pedestrians crossing at a gap for landscape in the pedestrian channelization barrier
- One pedestrian crossing in crosswalk then walking diagonally to the bus stop.

- Extend the pedestrian channelization barrier up to the crosswalk. If not feasible, install Do Not Cross and Use Crosswalk signs whenever a gap exists.
- Do not leave any gaps within the pedestrian channelization barrier.
- Relocate bus stops as close to the crosswalks as possible.
- Install landscaping to the entire width of the median to reduce the potential for pedestrians to walk parallel to the median.

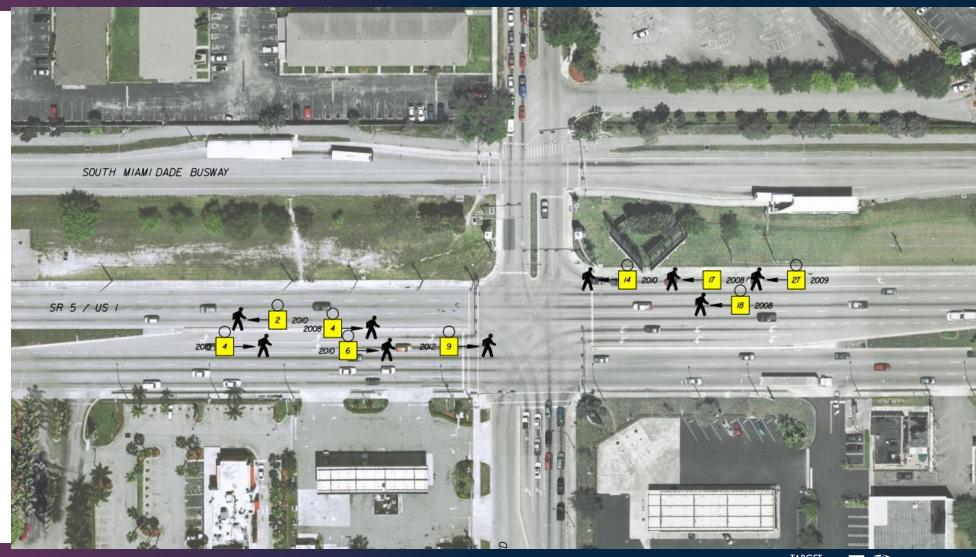
Collision Diagram

Review of the police reports revealed most of the crashes involved pedestrians crossing at undesignated locations

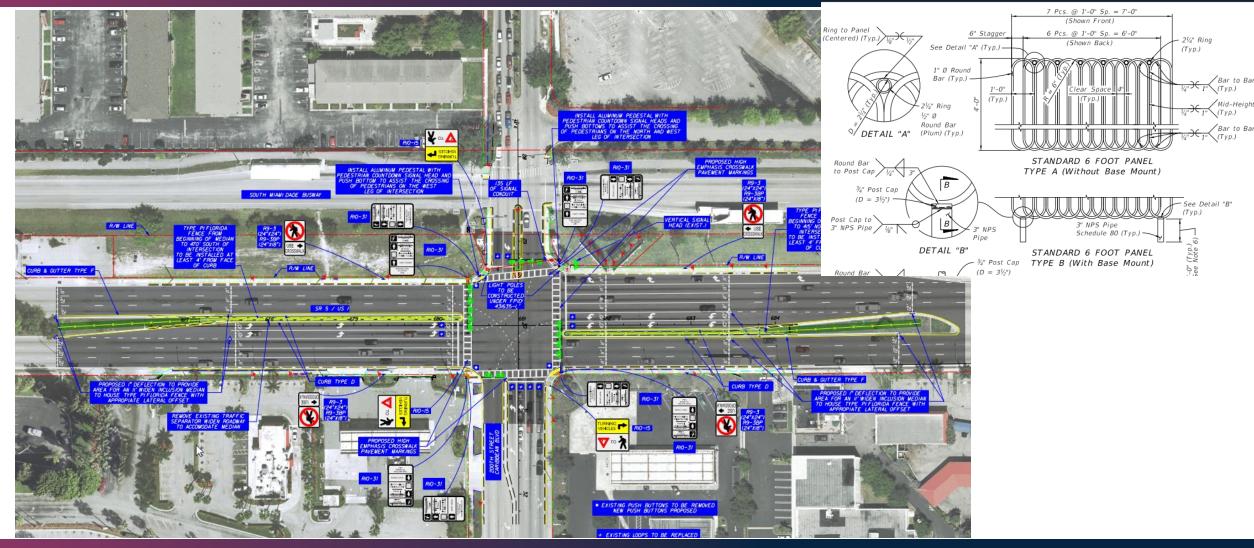
Proposed Improvements

- Provide new crosswalks on the north and west legs
- Install pedestrian push buttons on all legs
- Reduce the lane widths to 11 ft to widen median to accommodate a steel loop fence and landscaping
- Install roadway lighting
- Install signage directing pedestrians to use crosswalks

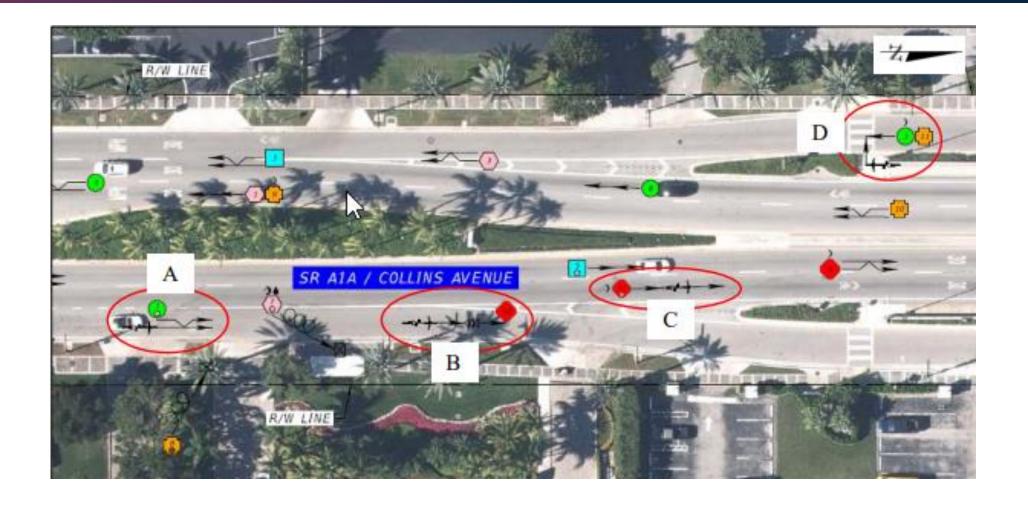
Collision Diagram

- 7 bicycle crashes reported in 5 years
- 3 bicycle crashes occurred on northbound approach
- Bicycle fatality occurred on northbound approach

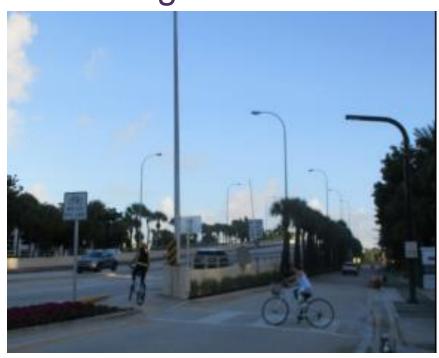
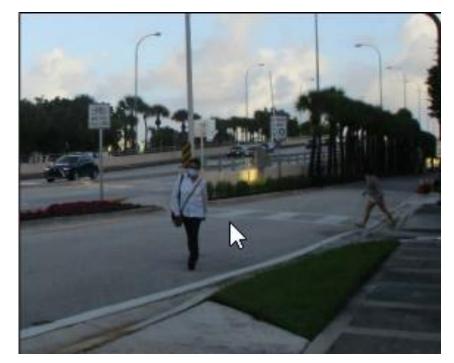
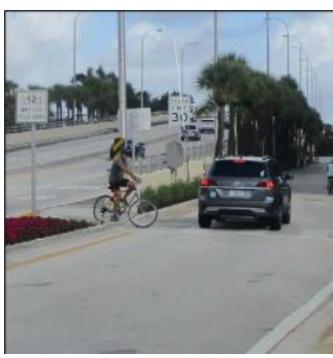
Field Reviews

Motorist did not slow down or stopped for pedestrians at midblock crossings

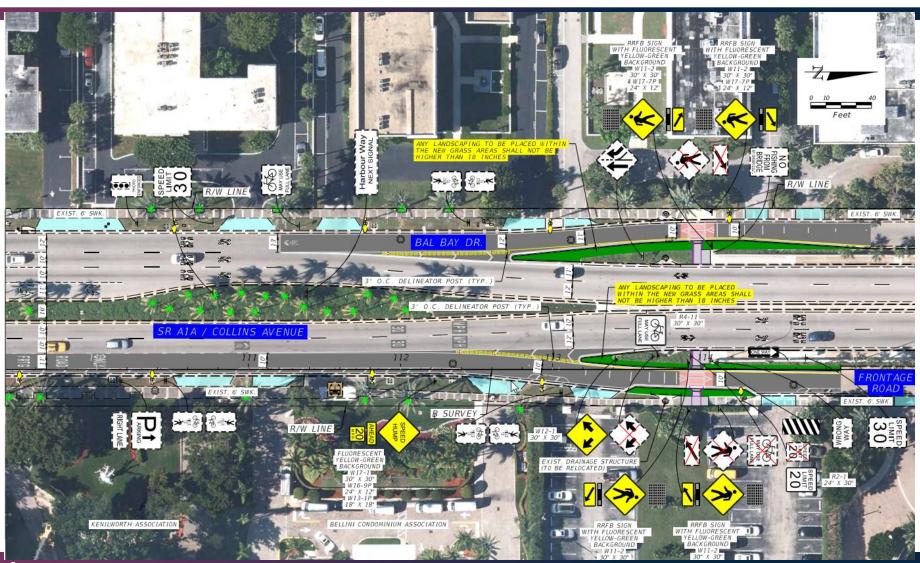
Proposed Improvements

- Reduce the lane widths for northbound and southbound frontage roads
- Extend gore area of the frontage road
- Install additional delineators in the gore area
- Provide a raised crosswalk controlled with a rectangular rapid flashing beacon (RRFB)
- Provide 20 mph and 30 mph pavement markings
- Provide transverse speed lines pavement markings across frontage roads approaching midblock crossings

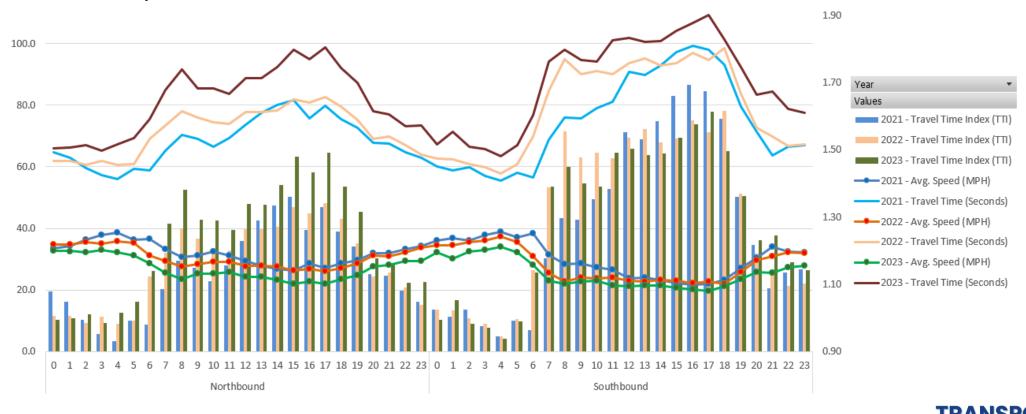
Results of Implementation

- SR 500 / US 441 Orlando
 - Corridor Speed Reductions

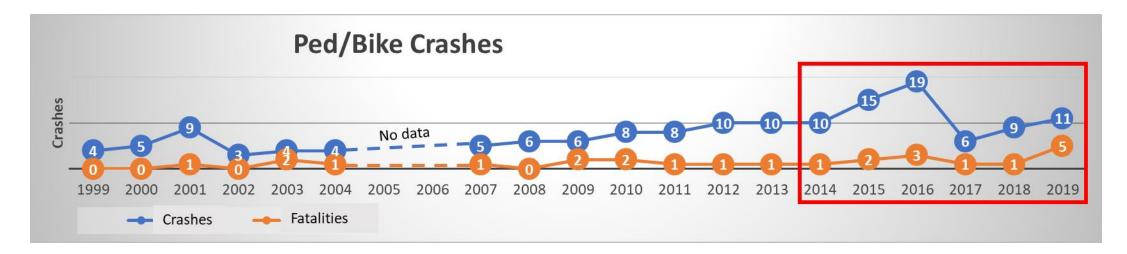
Results of Implementation

- SR 500 / US 441 Orlando
 - Corridor Speed Reductions
 - Post-Construction Crash Data Collection On-Going
