# Transportation Resilience Delivered: District Case Studies

## St. Augustine Seawall Replacement Project

## SR A1A Seawall in Flagler and Volusia Counties

#### **Henry Canal Projects**

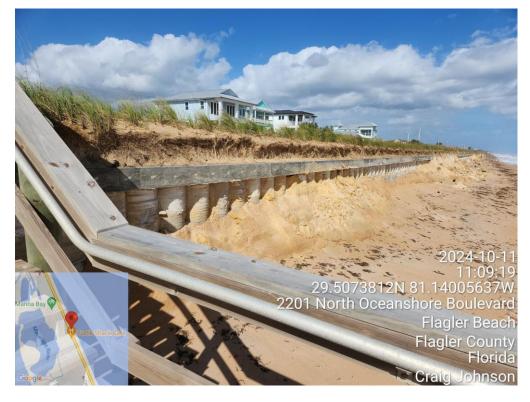
Existing secant wall in Flagler Beach after Hurricane Milton

- Construct two buried secant walls in Volusia and Flagler counties
- Each wall about 1.3 miles long
- Design similar to the buried secant wall in northern Flagler Beach built in 2019

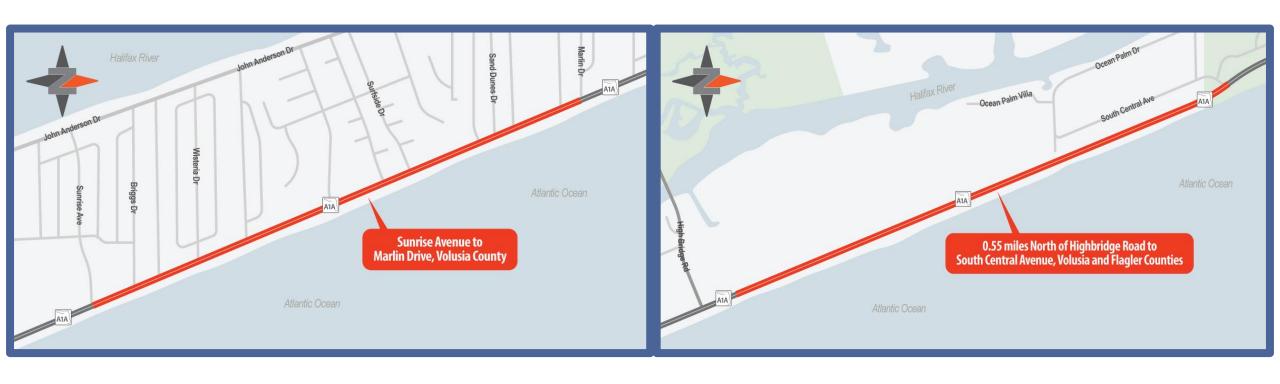
#### **New Seawall Locations**

Locations determined by level of vulnerability and with consideration for the ongoing U.S. Army Corps of Engineers beach renourishment project in Flagler Beach.

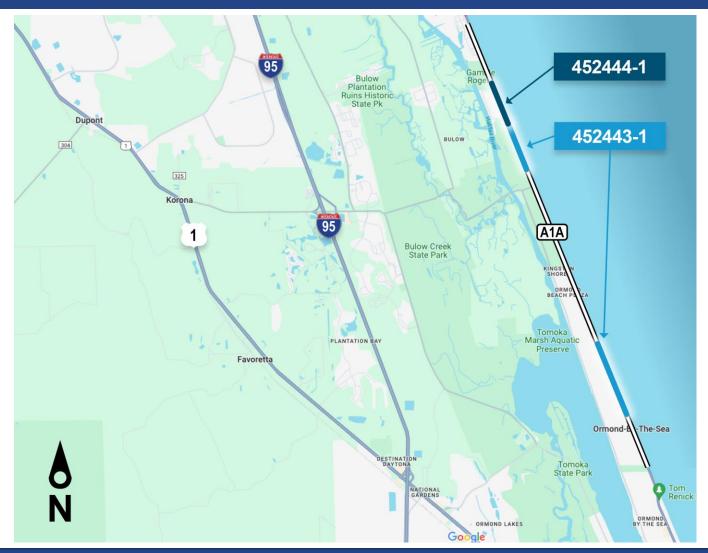
#### New Seawall Locations

Locations determined by level of vulnerability and with consideration for the ongoing U.S. Army Corps of Engineers beach renourishment project in Flagler Beach.

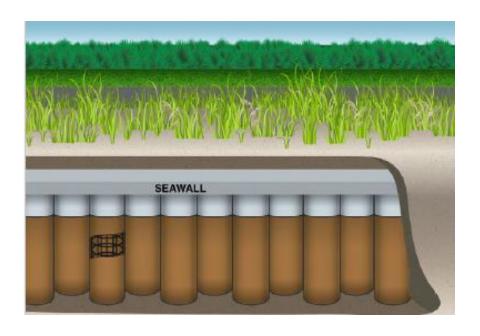
### Why the Secant Wall Design?

- Various armoring techniques were evaluated.
- Secant wall did not require a tie-back, which was not allowed by FDEP.
- Coquina rock was shown to be too fragile.
- Granite required too large a footprint and would have to be sourced from outside Florida.
- Sheet pile could not be driven as deeply as the secant wall piles.

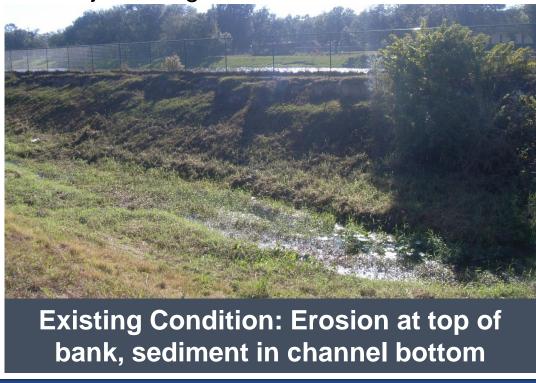
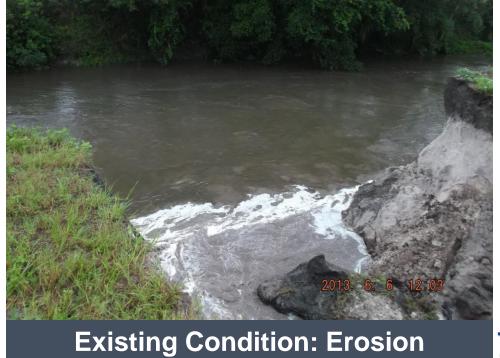
- Project Origin District 7 Maintenance Office
- Project Need Address Erosion, Slope Stability of the channel banks, Scour of the channel bottom, Accessibility for maintenance along Henry Canal
- Project Length 2.5 miles

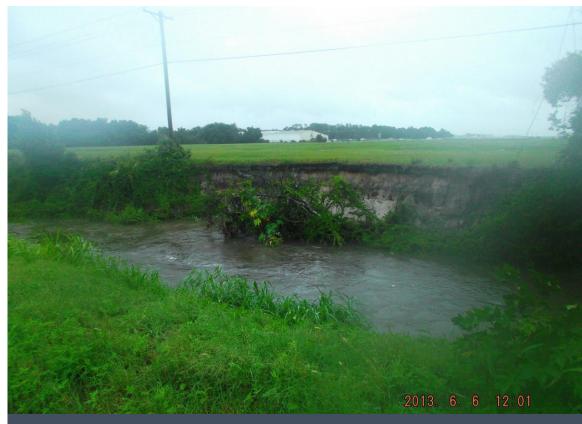
**Existing Condition: Erosion uprooted tree** fell into Henry Canal

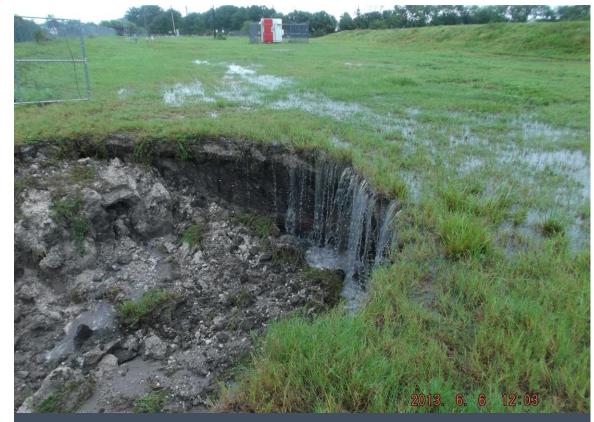
Existing Condition: Erosion caused by sheet flow from rain event

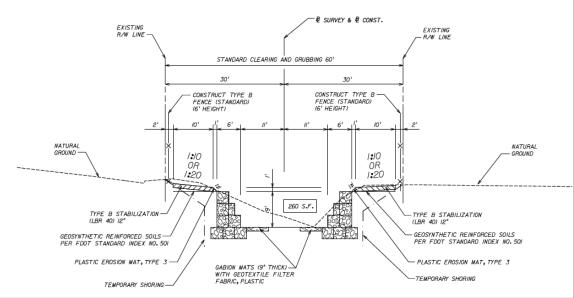
Henry Canal – Typical Section
Gabion Baskets under Geosynthetic
Reinforced Soil Slopes

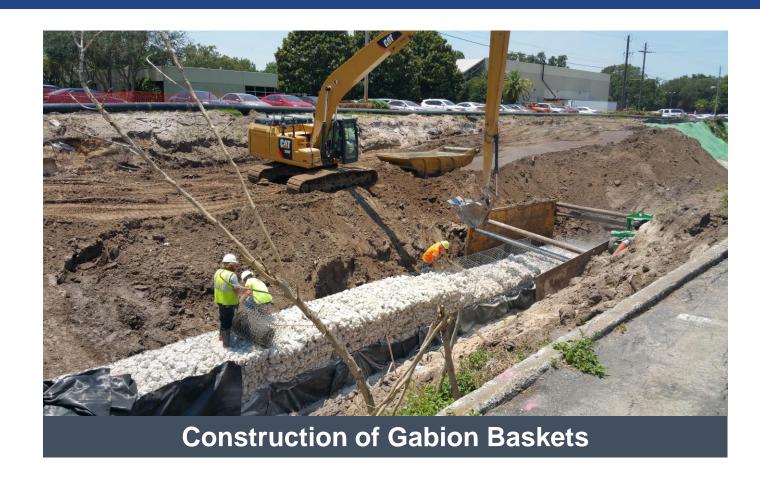
- Temporary Drainage
- Gabion Rock material availability
- Temporary/Permanent
   Easements maintain access
   to canal
- Permitting

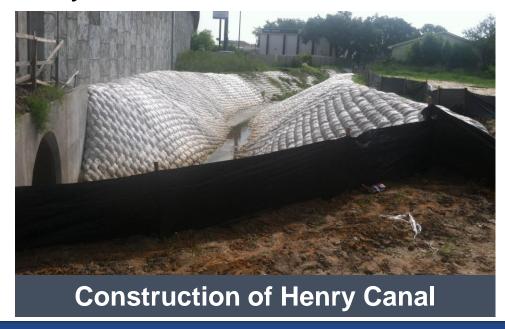
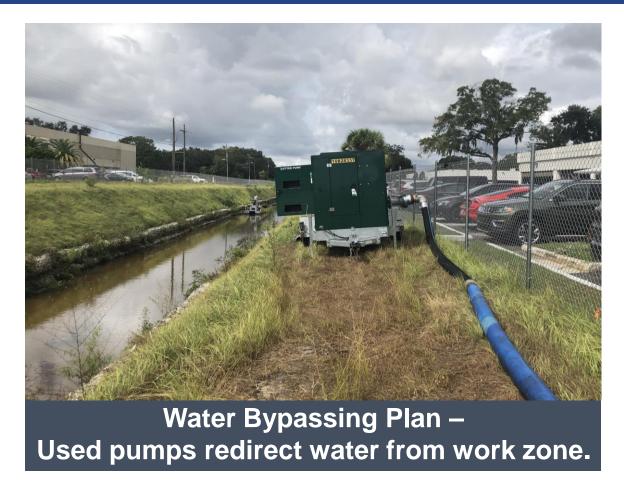
- Construct in sections
- Required contractor to submit a water bypassing plan
- Schedule Letting to construct during nonrainy season

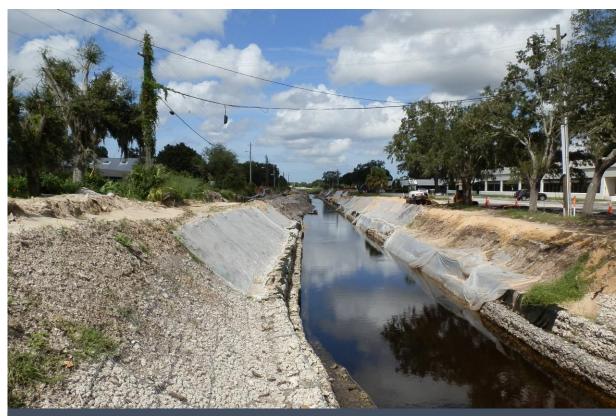
Constructability – Trees in Conflict with Clearing and Grading Work

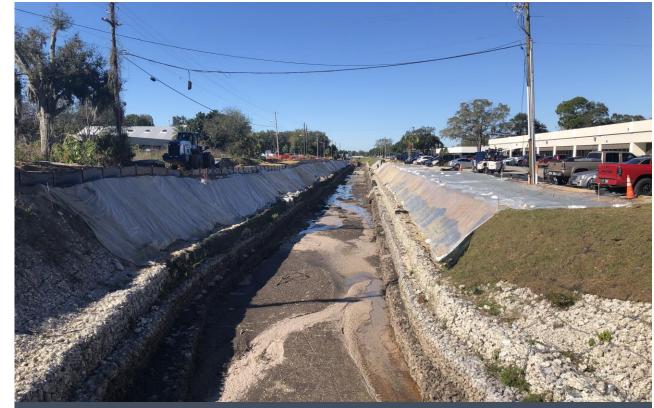
Temporary Construction Easement – Removed Trees to Prevent Property Damage

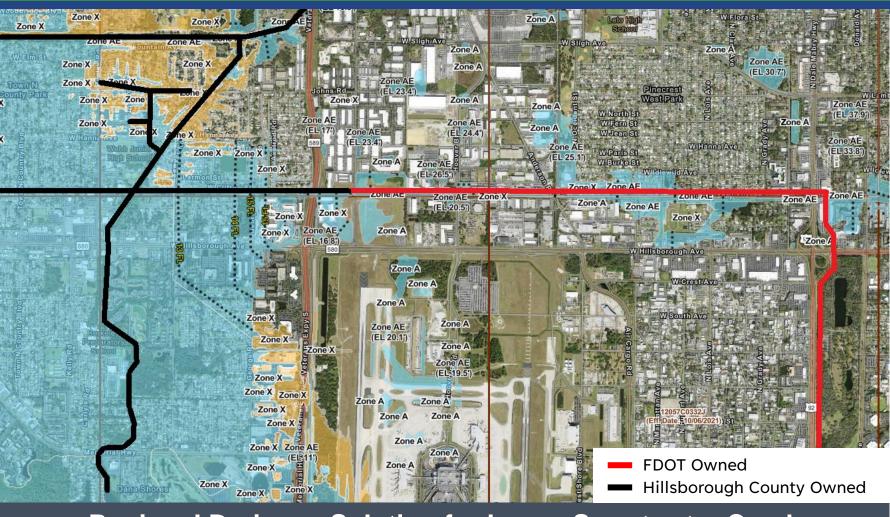
Bypass System to alleviate flooding on SR 580 and surrounding neighborhoods

Regional Drainage Solution for Lower Sweetwater Creek
