# 2024 TRANSPORTATION SYMPOSIUM

## Evolutions in Safety Engineering

Florida Department of Transportation

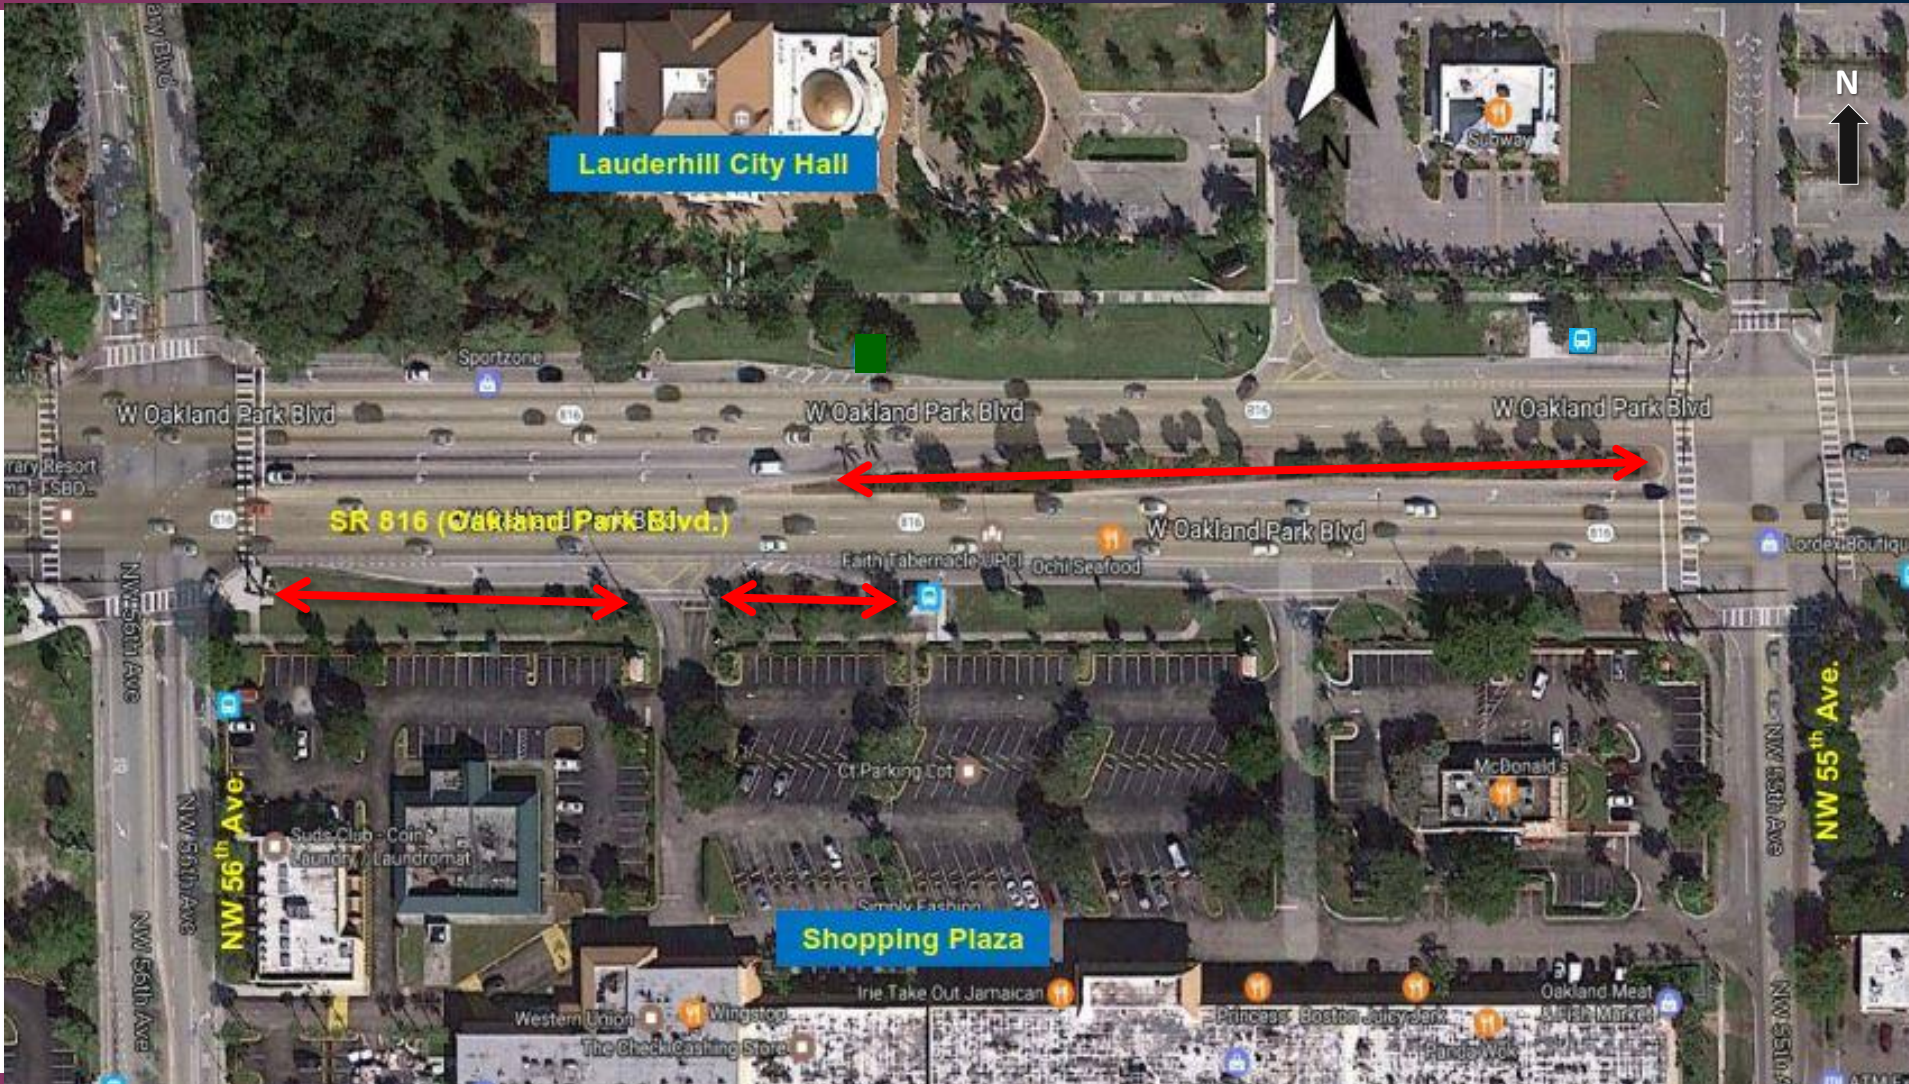
# SR 816 (Oakland Park Blvd.) between NW 55th Ave and NW 56th Ave

Installed between February 2017 and July 2017

- Six-lane divided w/ raised median (18 to 20' median; 4 to 5' traffic separator); 45 mph speed limit
- Two signalized intersections (apprx. 900' apart);
- Seven bus stops in the vicinity; (2 along OPB, EB 400' E. of 56<sup>th</sup> Ave; and WB 100' W. of 55<sup>th</sup> Ave);
- Surround land uses (Shopping Plazas, Restaurants, City Hall); Residential areas north/south of OPB

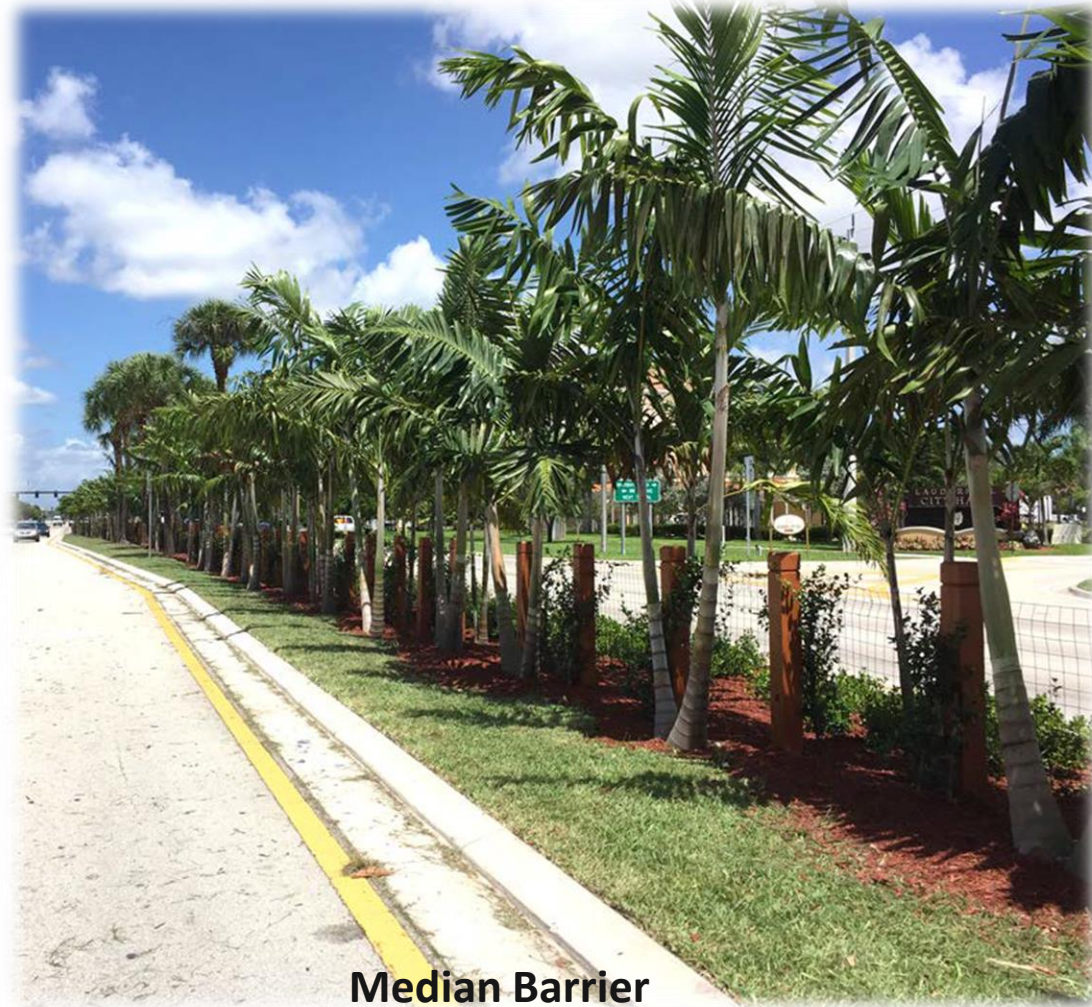
Median Barrier

# Pedestrian Channelization Barrier

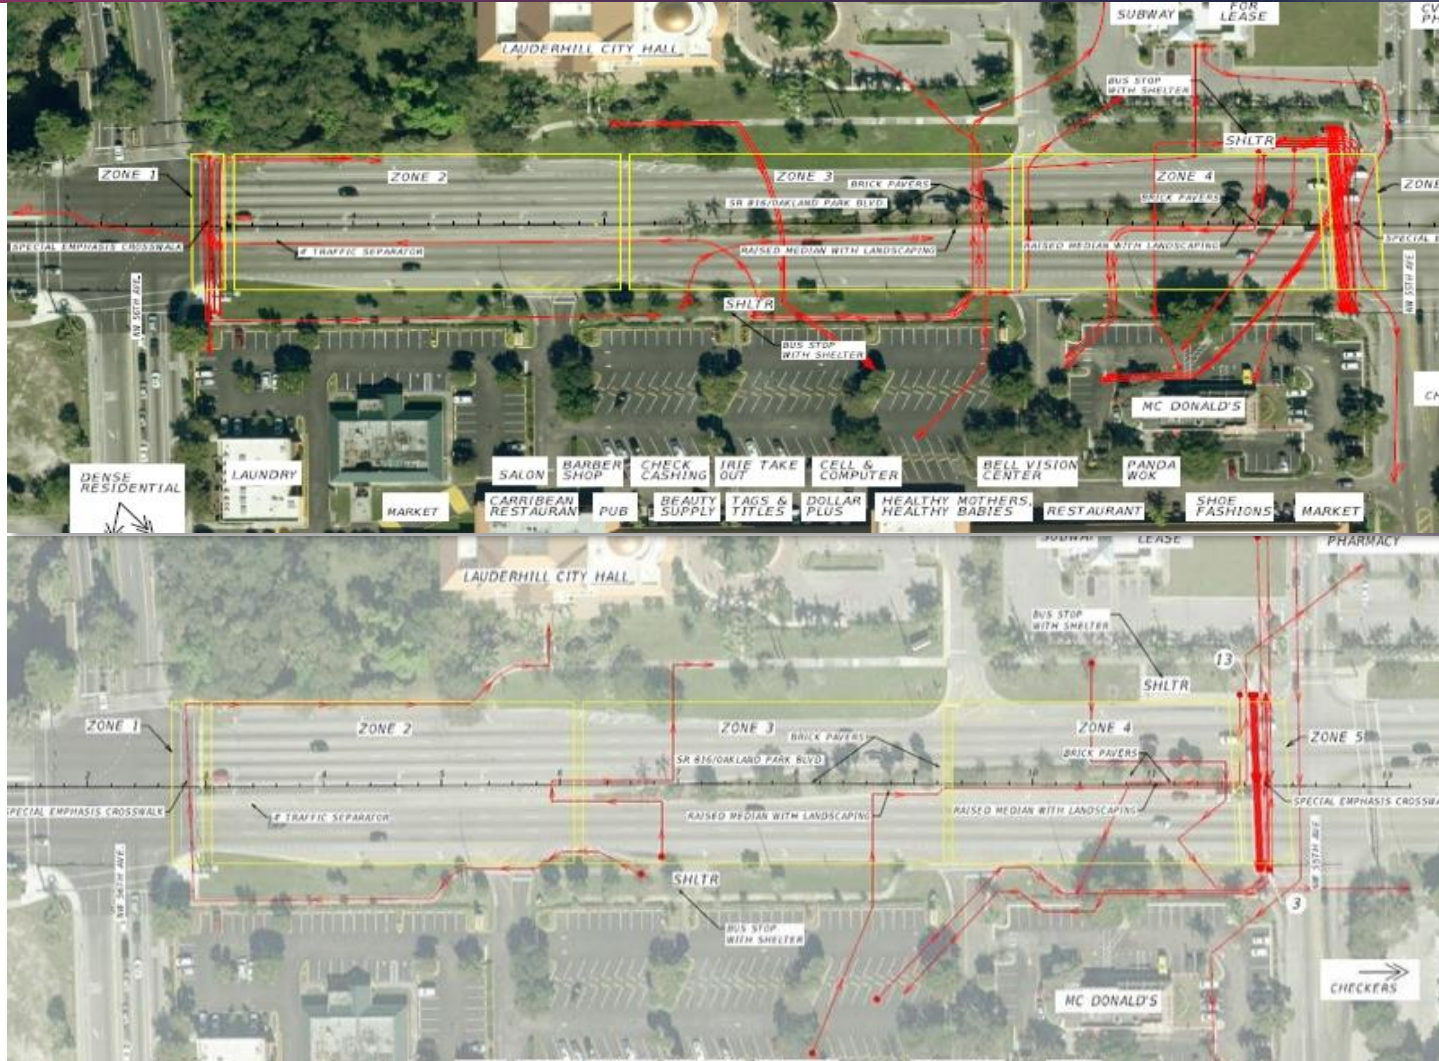
# Pedestrian/Bicycle Crossing Paths - AM

**Before**  
**(50% Crosswalk;**  
**50% Midblock)**

**After**  
**(83% Crosswalk;**  
**17% Midblock)**

- Median barrier (in Zones 3 and 4)
  - Pedestrian/bicycle crossings at midblock locations reduced from 32% to 14%
  - Pedestrian/bicycle crossings at adjacent crosswalks increased from 68% to 86%
  - Results indicate that most pedestrians/bicyclists who were crossing at midblock locations before are now using the crosswalks
  - Separate comparisons of data collected on weekday/weekend indicated similar results
- Roadside barrier (south side of the roadway in Zone 2)
  - Overall, no significant difference between before/after periods (6% vs. 6.87%)
  - Midblock crossings in Zone 2 increased from 5% to 8% based on data collected on Wednesday; Reduced from 7% to 5% based on data collected on Saturday
  - Number of crossings in Zone 2 were relatively low (49 before vs. 61 after)

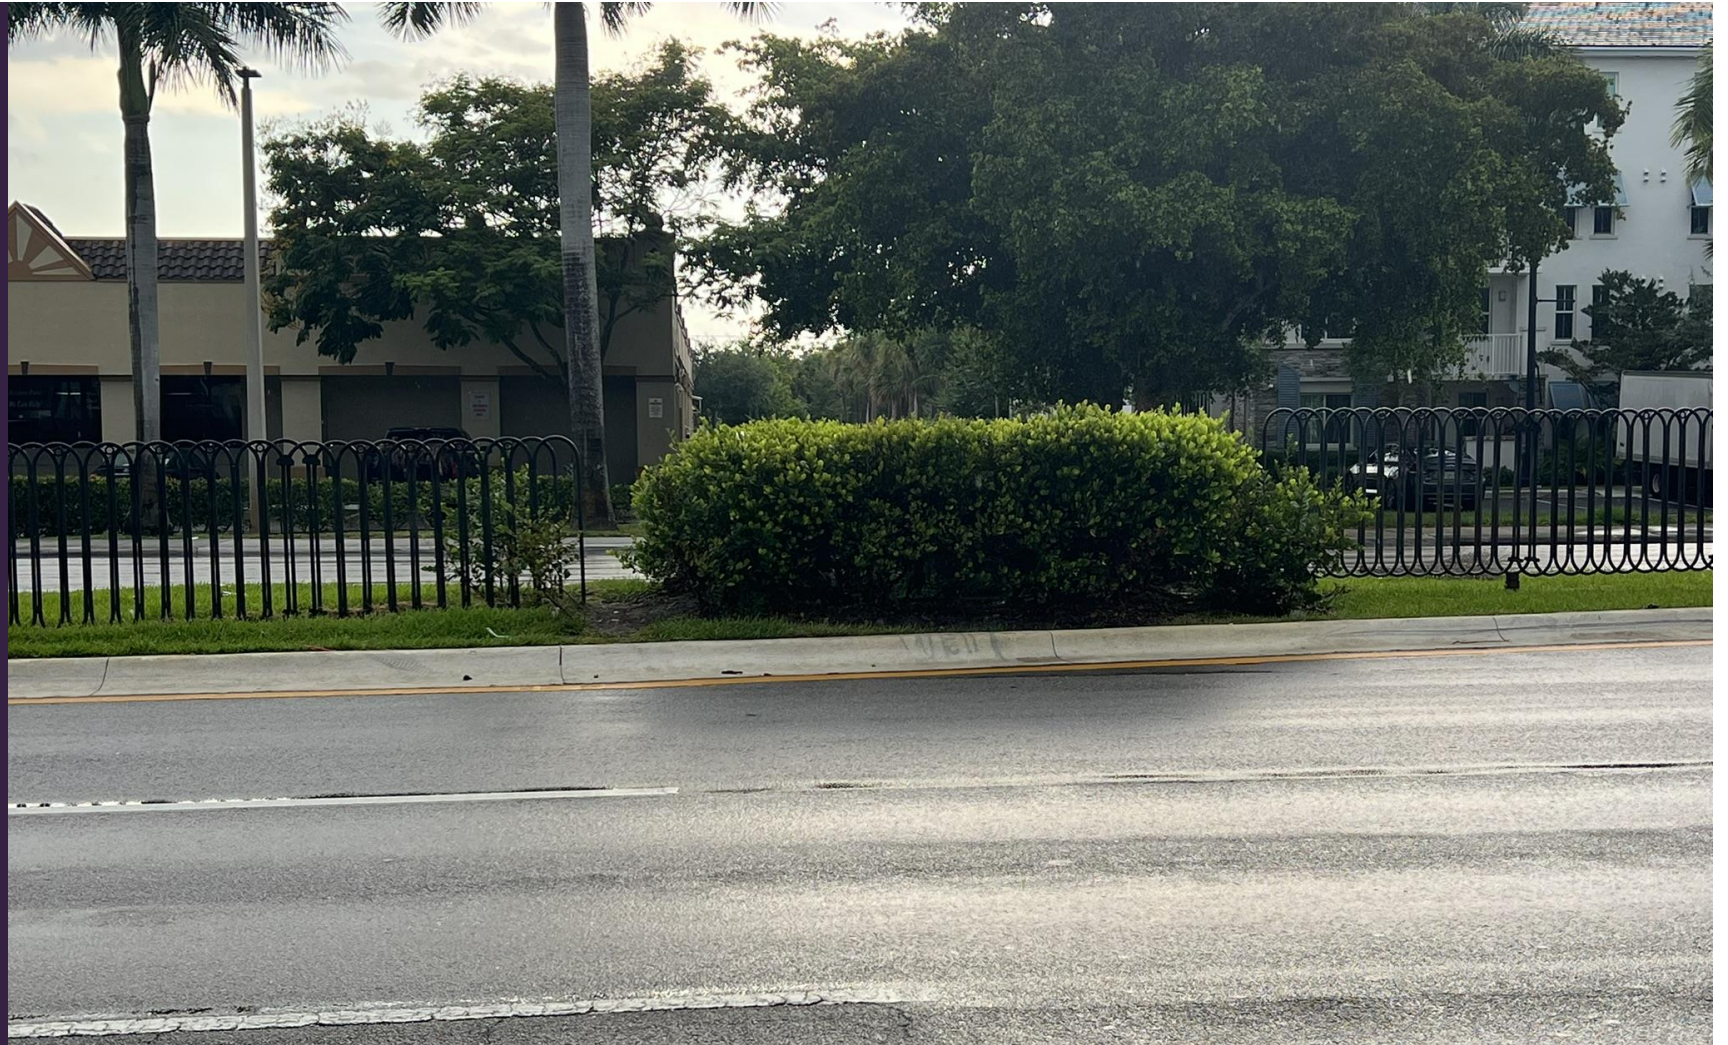
# Gaps in Pedestrian Channelization Barrier

- Multiple pedestrians crossing at traffic separator where no median fences (45-50 feet from crosswalks)
- Multiple pedestrians crossing at a gap for landscape in the pedestrian channelization barrier
- One pedestrian crossing in crosswalk then walking diagonally to the bus stop.

- Extend the pedestrian channelization barrier up to the crosswalk. If not feasible, install Do Not Cross and Use Crosswalk signs whenever a gap exists.
- Do not leave any gaps within the pedestrian channelization barrier.
- Relocate bus stops as close to the crosswalks as possible.
- Install landscaping to the entire width of the median to reduce the potential for pedestrians to walk parallel to the median.

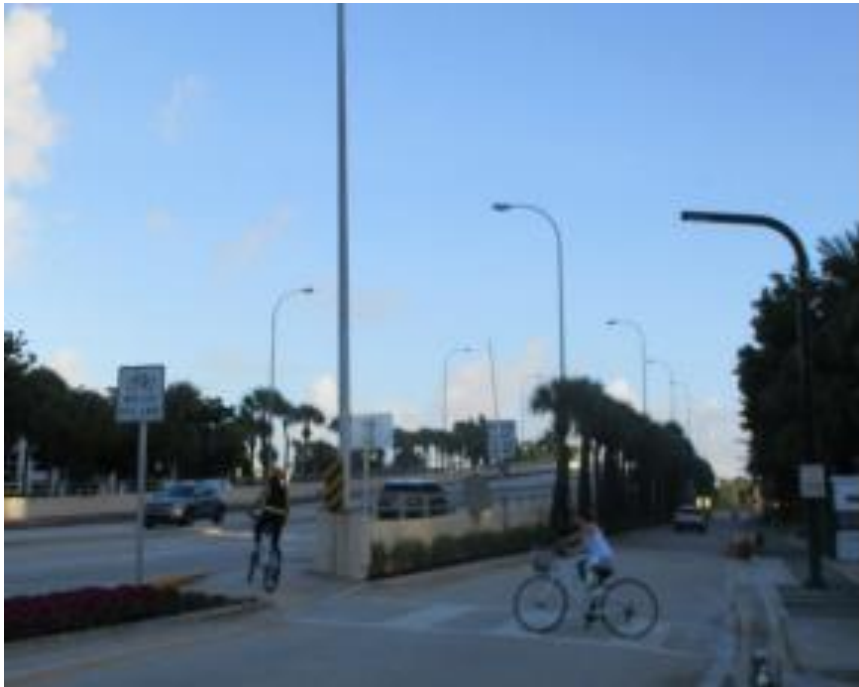
## Field Reviews

- Motorist did not slow down or stopped for pedestrians at midblock crossings

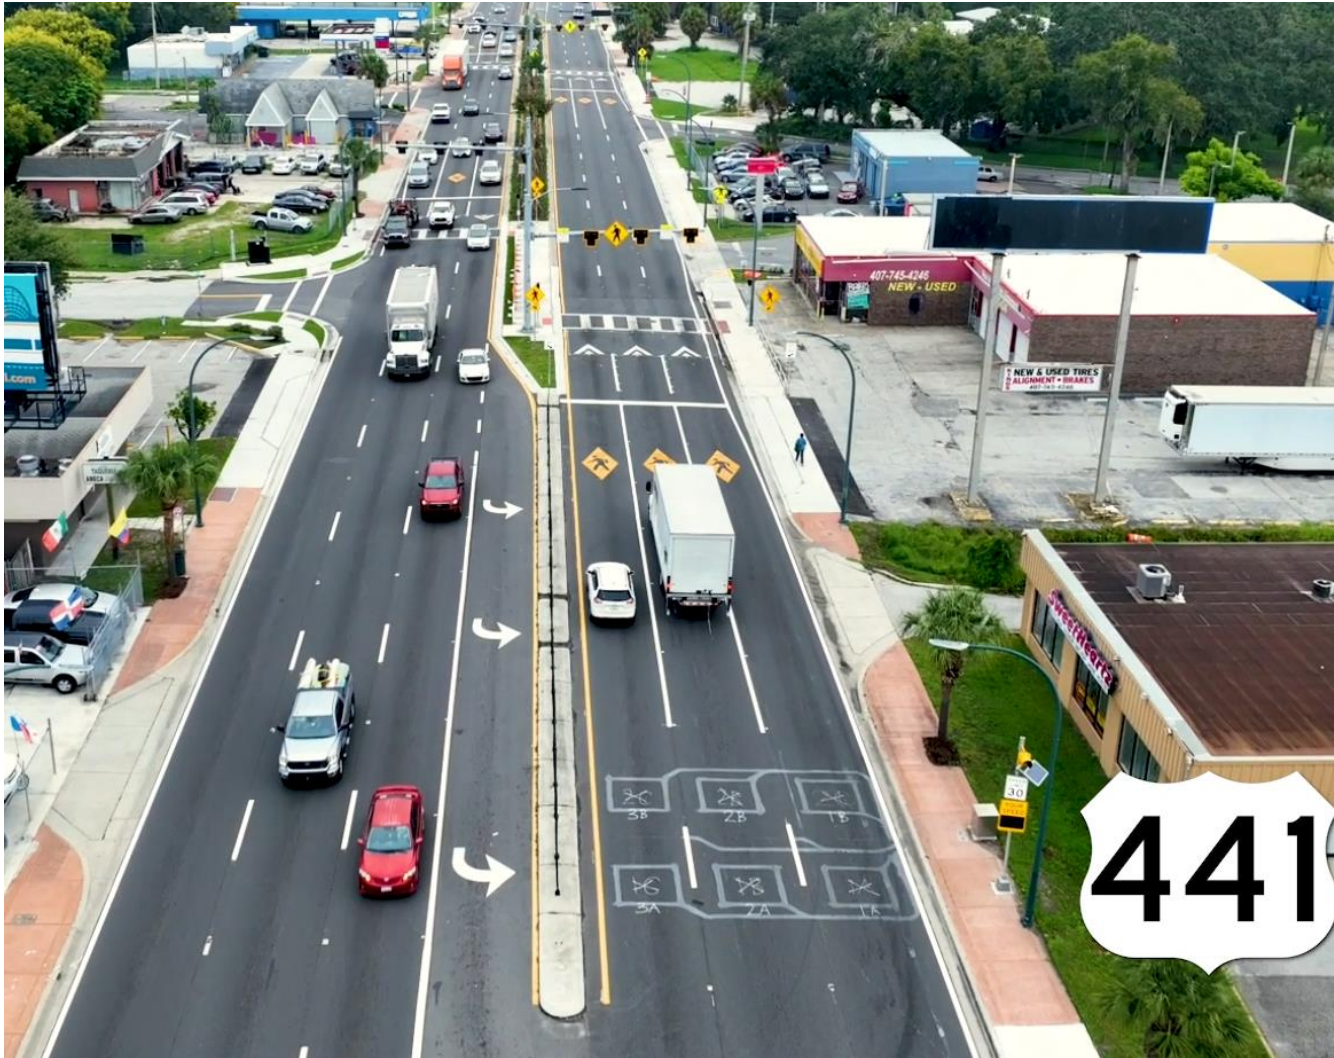
# SR 500 / US 441 – Orlando

Raised Crosswalks

PHBs

Pedestrian Refuge Islands

Lane Narrowing

Speed Feedback Sign

In-Road Lighting

Pedestrian Channelization  
Barrier

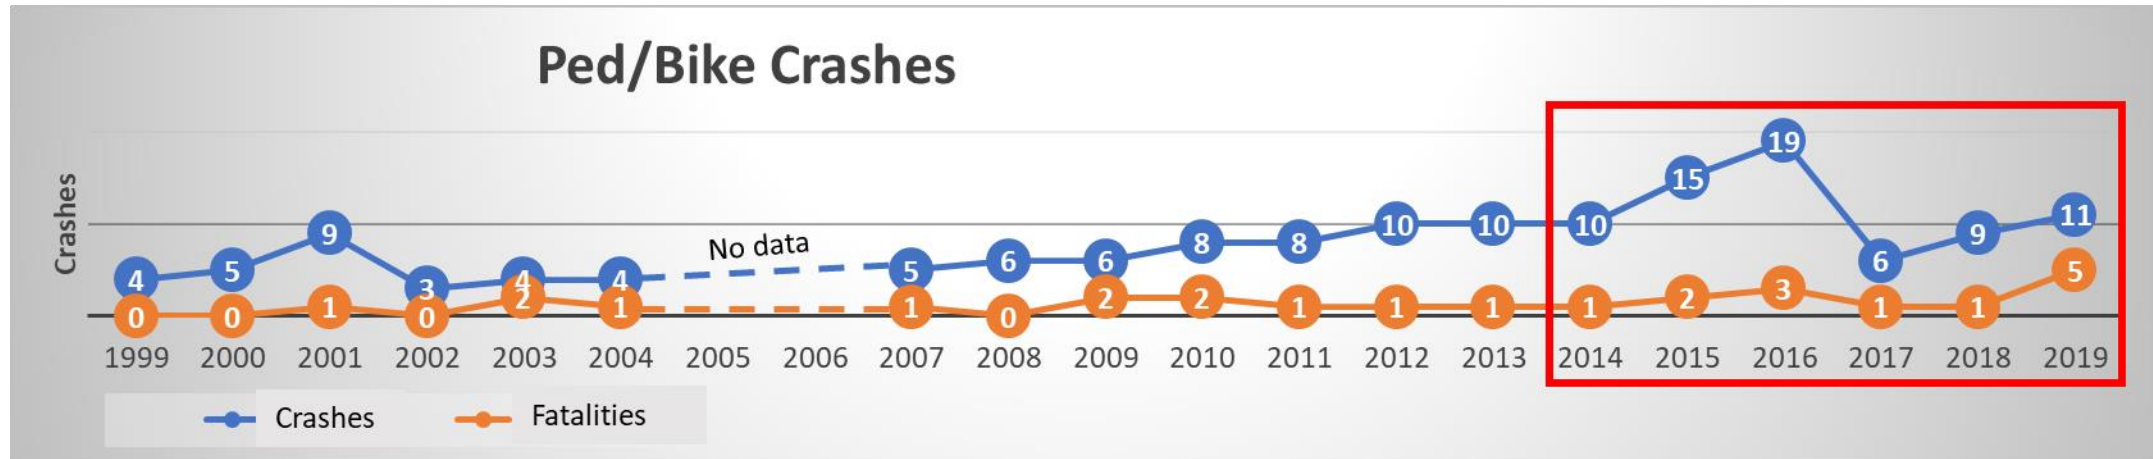
# Results of Implementation

- SR 500 / US 441 – Orlando
  - Corridor Speed Reductions
  - Post-Construction Crash Data Collection On-Going
