2024 TRANSPORTATION SYMPOSIUM

Structures Research Center Update

FDOT Structures Research Center

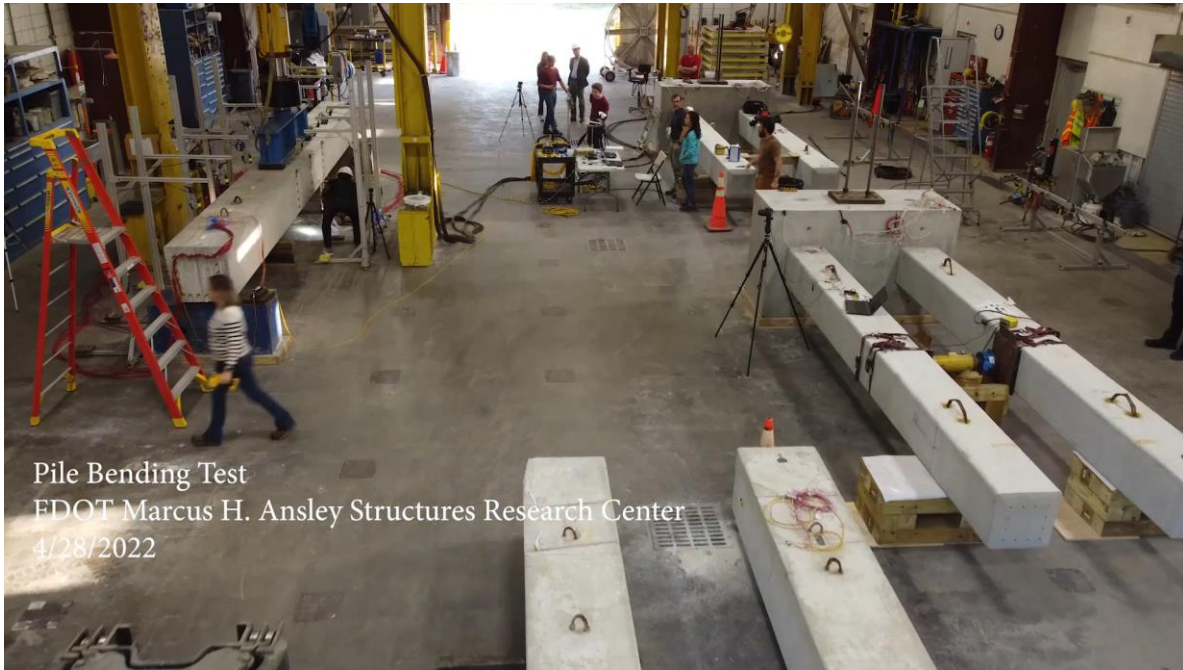
Pile Bending Test
FDOT Marcus H. Ansley Structures Research Center
4/28/2022

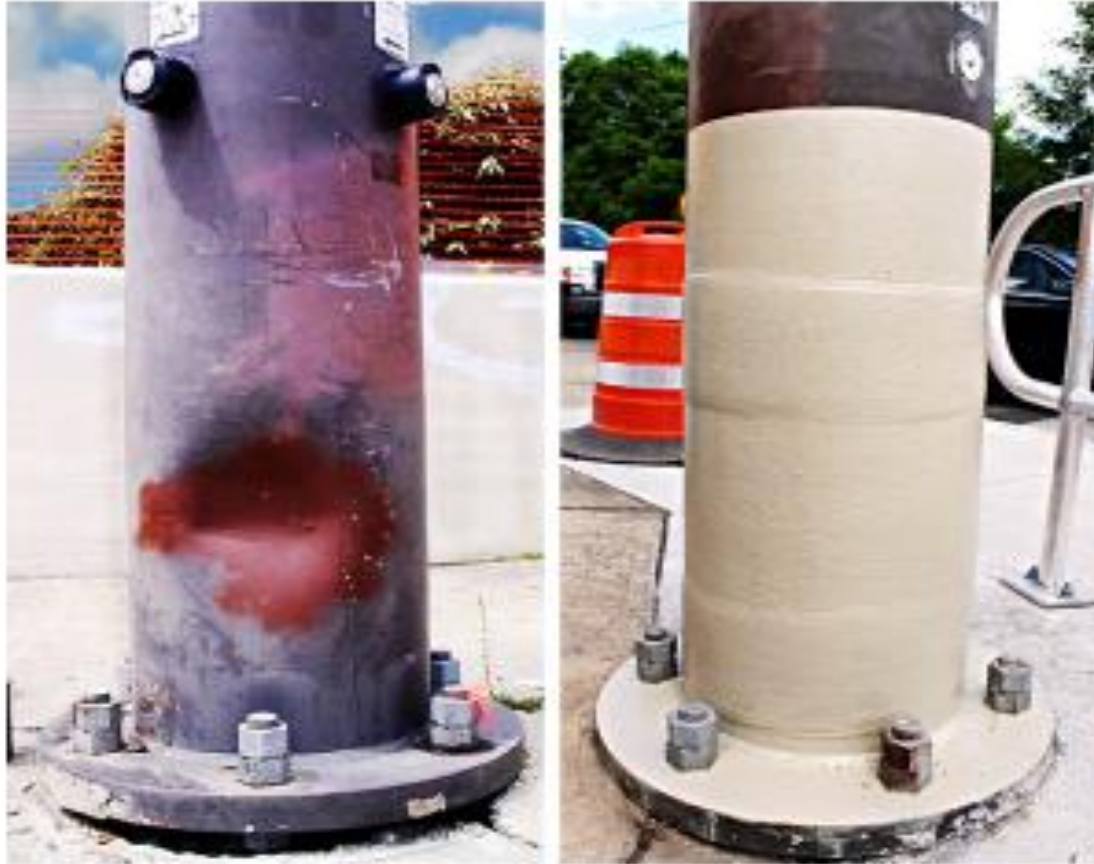
This utility pole (left) was damaged in a collision, but it was successfully repaired (right).

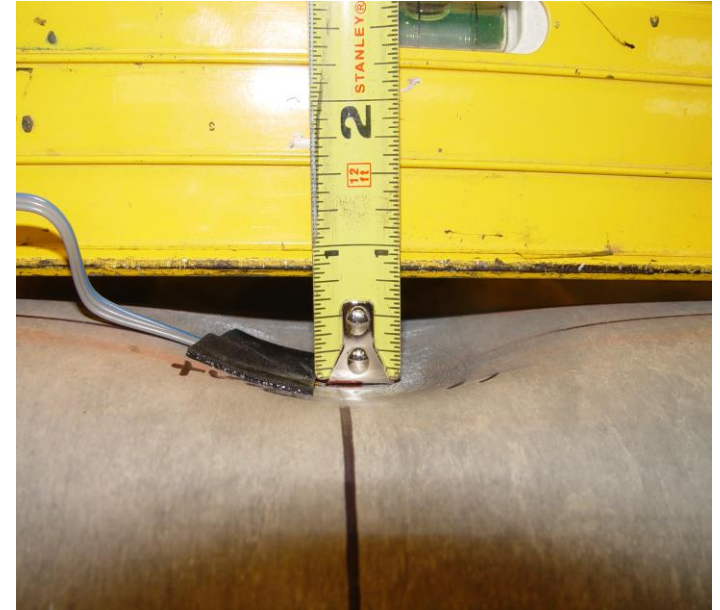
1. Geometry of FRP wrap depends on pole features.
2. Access ports and crosswalk signal buttons in should remain accessible.
3. Repair should extend at least 6 in beyond the edges of the dent and should encompass the circumference of the pole.

| Action | Dent Depth (% of Pole Diameter) | |
| | Aluminum | Steel |
| No Repair | ≤5% | ≤5% |
| Single-Layer Repair | 5% to 25% | 5% to 20% |
| Two-Layer Repair | 25% to 35% | 20% to 35% |
| Replace Pole | ≥35% | ≥35% |

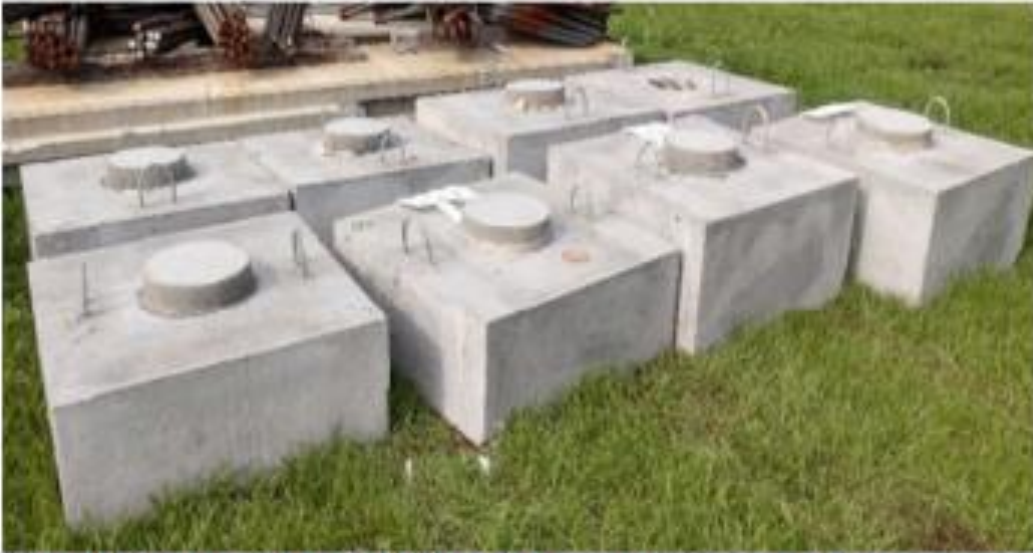
Florida International University researchers used these specimens to test shear friction capacity for precast pile caps and precast piles that do not have steel crossing the interface.

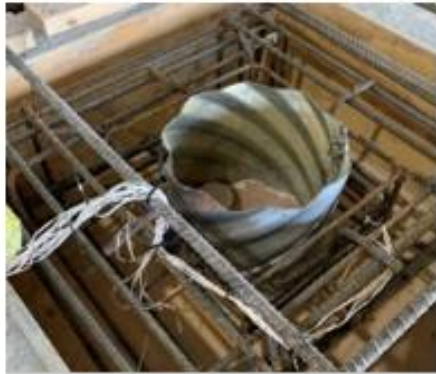
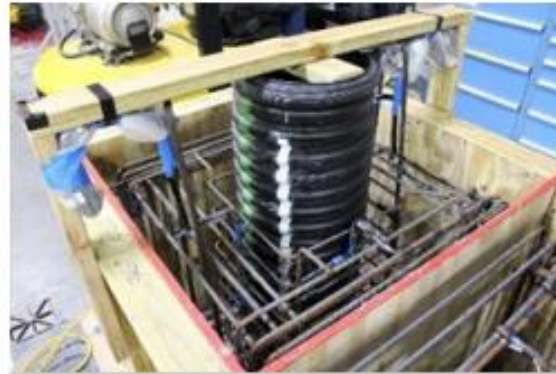
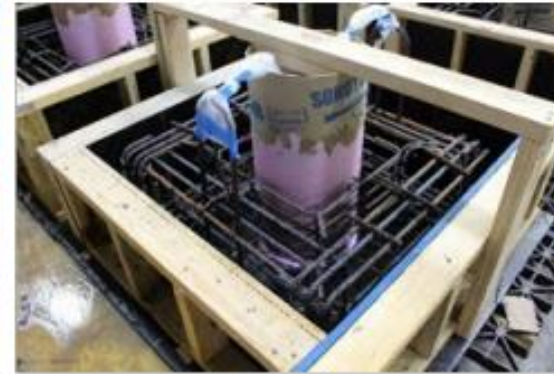
Construction of cap and installation of blockout for void with:

- (a) corrugated metal pipe,
- (b) corrugated plastic pipe,
- (c) Sonotube with paste retarder

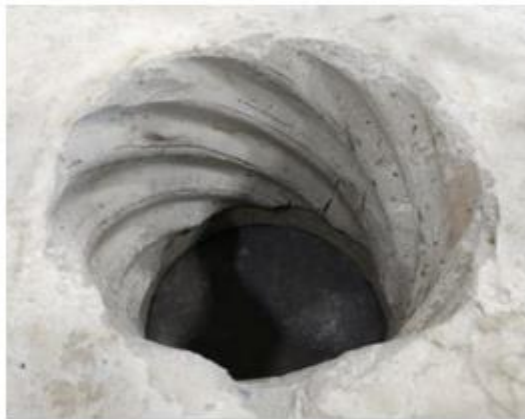
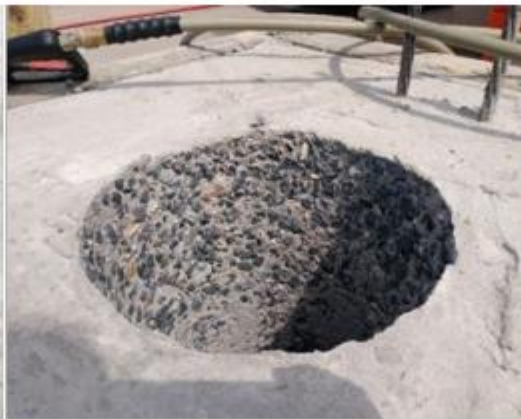
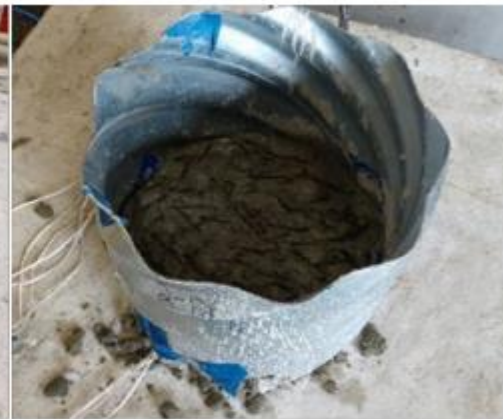
Surface preparation for second series of specimens:

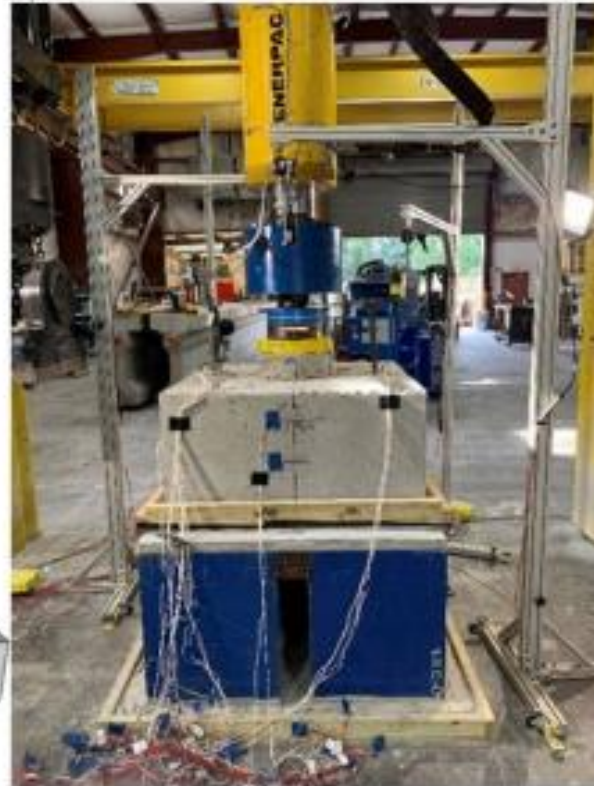
TEST SETUP

- The load was applied to the specimens using a 750-kip hydraulic jack and a 600-kip load cell attached to a load frame
- The specimens were placed on top of four load blocks
- The load was applied at a rate of 0.2 kips per second until a load of 200 kips for all specimens
- The 200-kip load was held on the specimens at this point while the specimens were inspected for cracks
- Load was then applied at the same load rate (0.2 kips per second) until failure of the interface or test capacity was reached.

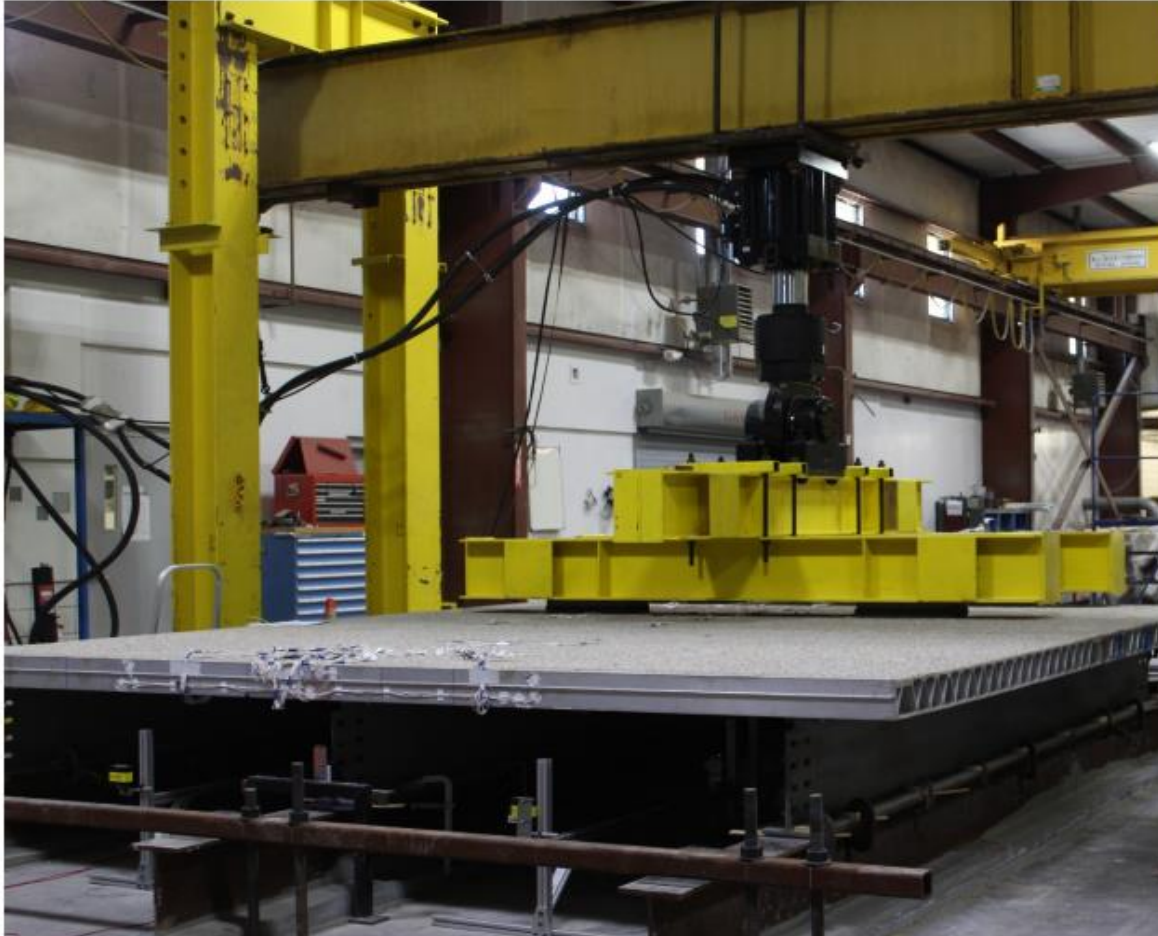
TEST SETUP:

- Nine static tests, one cyclic test, and heavy vehicle simulation
- Varied loading points and support conditions. The support conditions for the steel stringers varied.
- Loads were applied corresponding to the factored Service II, Strength I and Strength II limit states.

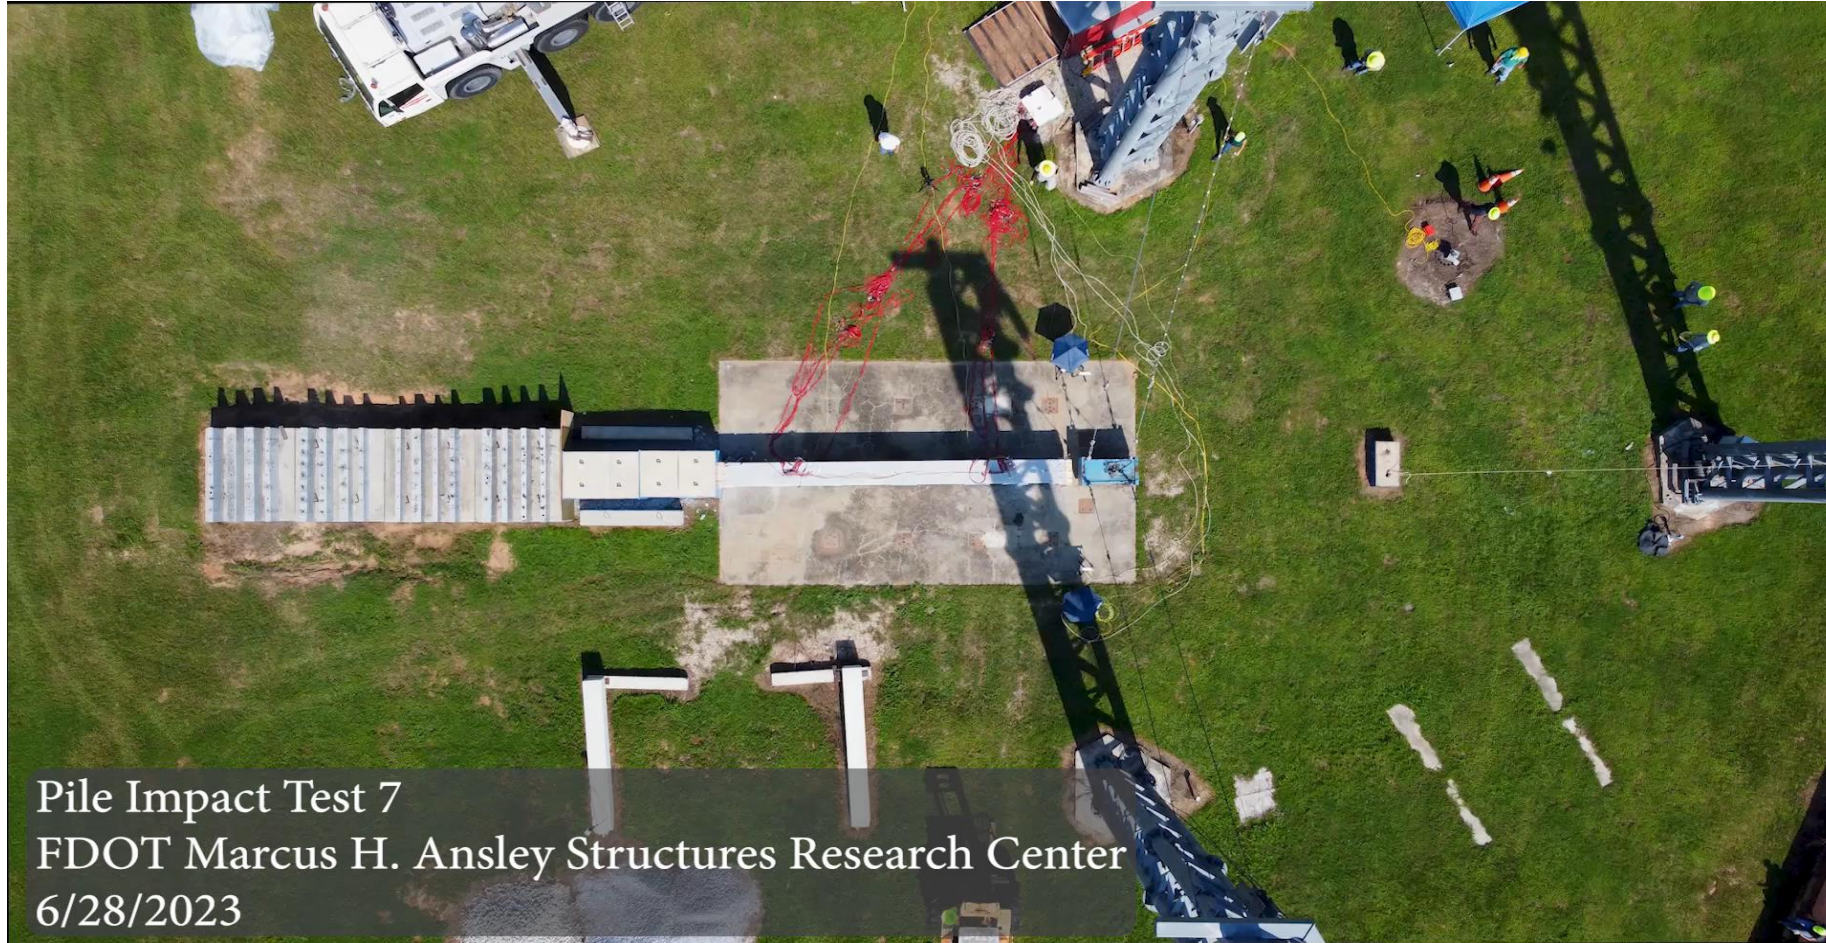
The SRC Pendulum facility was utilized to apply impact loading comparable to pile driving

- Horizontal setup
- 24" x 24" pile
- 5 ksi stress
- Flectionless supports
- Large blocks at the pile toe

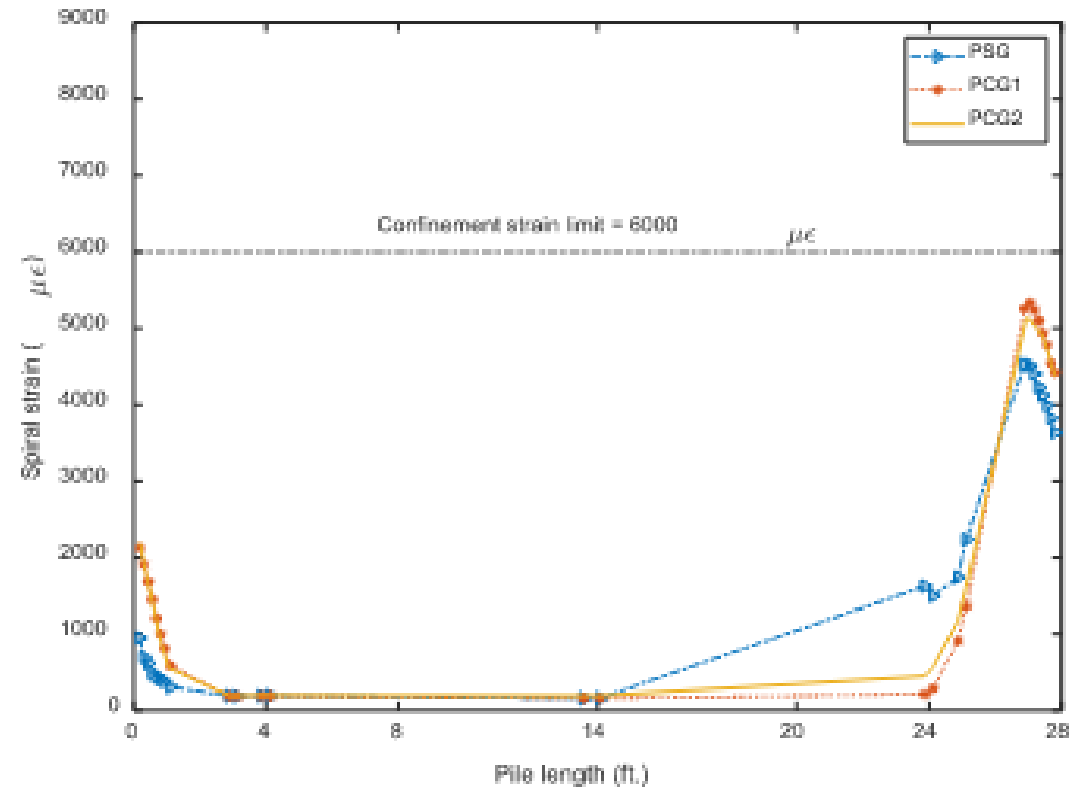
FRP spiral strain comparison for PSG, PCG1 and PCG2 (20 ft. drop height)

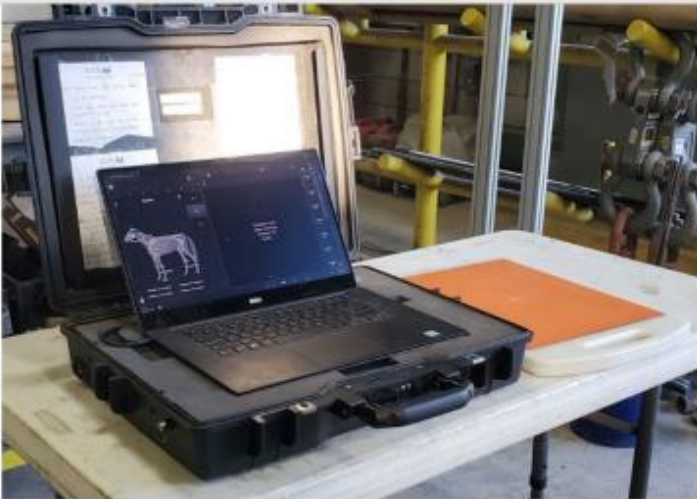
Portable X-Ray System POSKOM PXM-20BT

- Low power 60-80 kV, 1.3-1.6mAs
- Minimum Personal Protective Equipment (PPE)
- Suitable for anchorage cap scanning
- Lightweight 20 pounds
- Commonly utilized by veterinarians

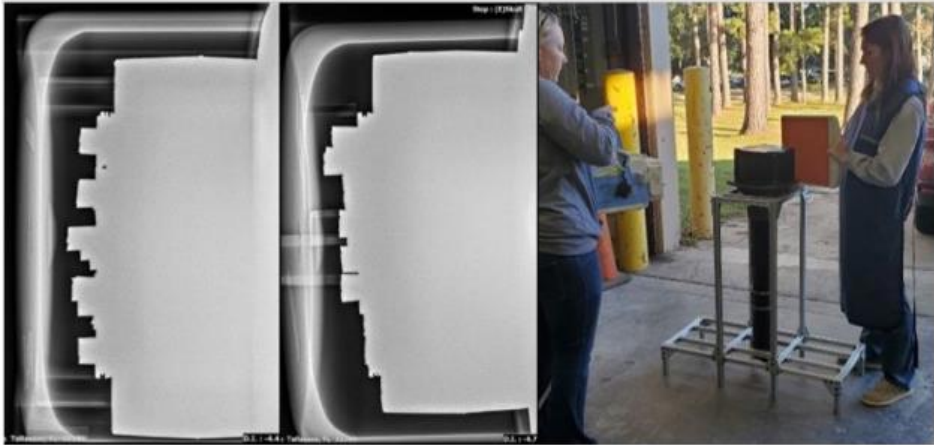
Specimen 1 anchorage cap results

- Identifies the positions of strands and grips, defects within the cap, voids, or corrosion
- Rapid additional assessment to complement existing inspection procedures.
- Flexible filler material (FF) did not interfere with image quality
- Generates 2D image

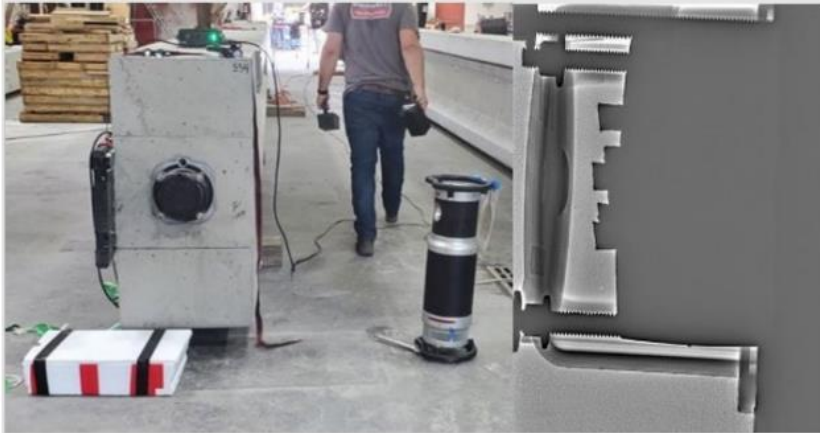
Internal Specimen Results

- The YXLON X-Ray is capable of imaging through 12” of concrete.
- Identifies the mild reinforcement in the member
- Provides a highly detailed image of the individual wires comprising the strands.
- Promises for detecting voids and potentially even corrosion

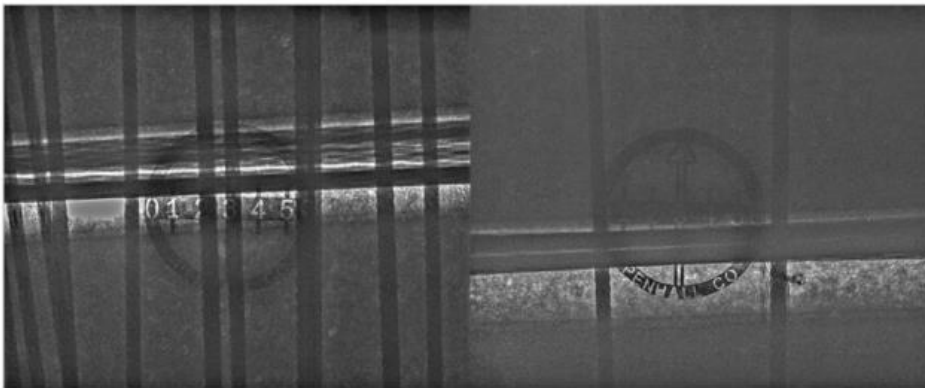
Internal Duct Specimen: duct with strands

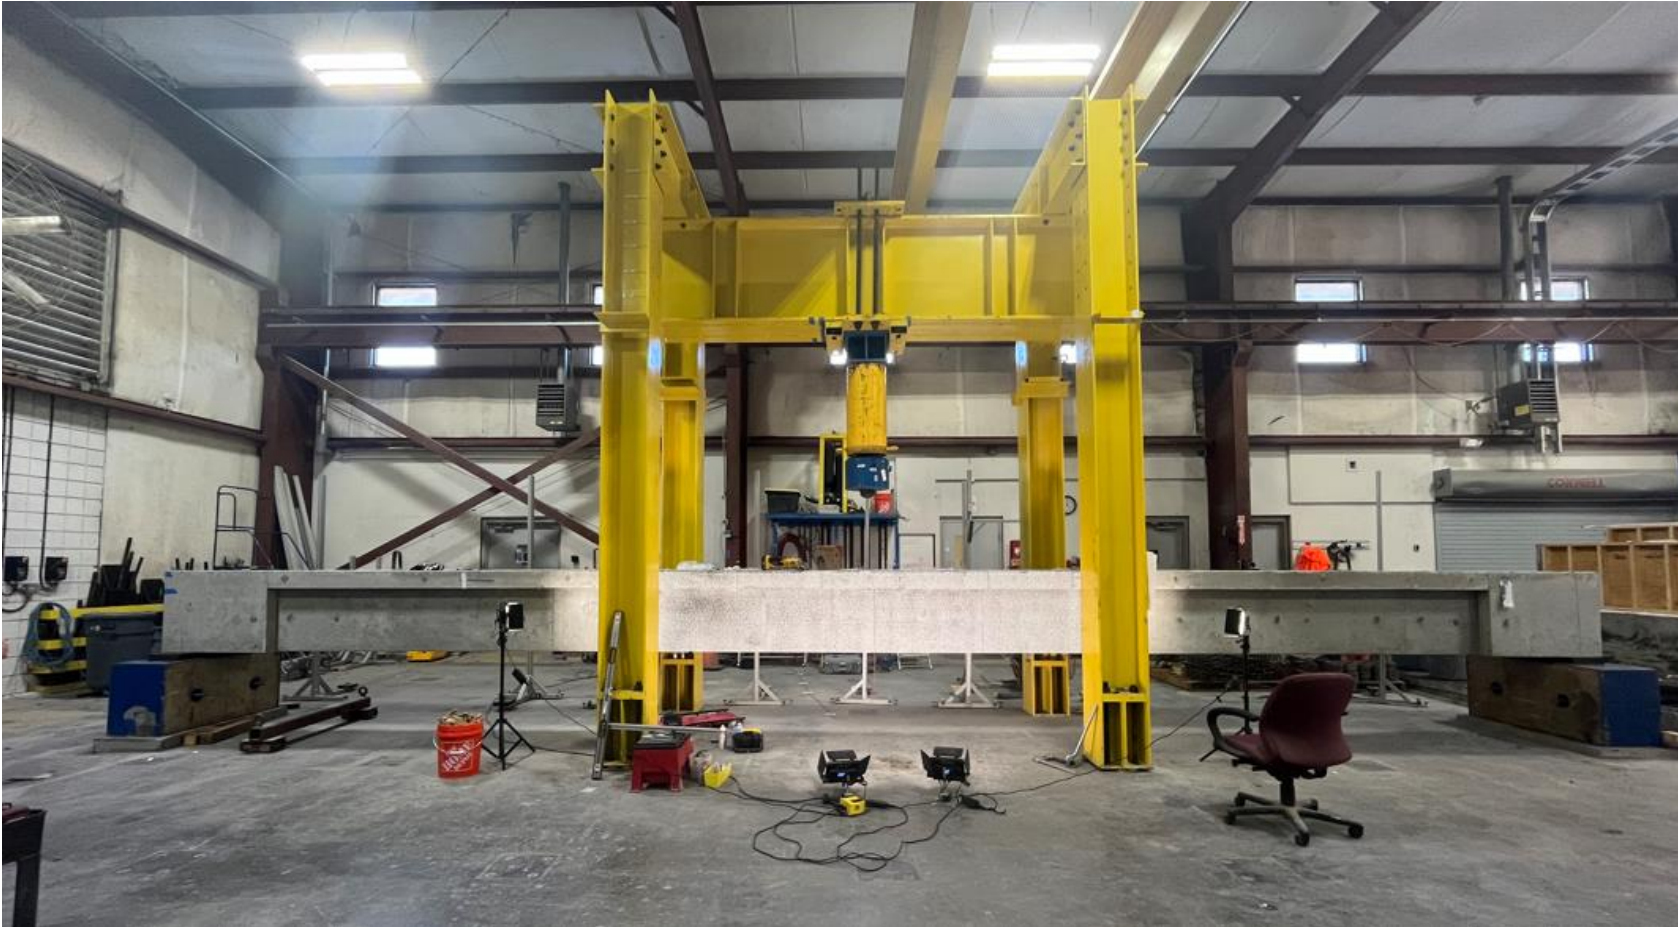
TEST SETUP

- 4-point bending test
- I beam pre-cracked
- Treated/untreated specimen couples
