CONTAMINATION SCREENING EVALUATION REPORT

SR 9/I-95 Project Development and Environment Study
From South of Woolbright Road to North of Woolbright Road
Boynton Beach, Palm Beach County, Florida
(From Mile Post 13.560 to Mile Post 13.995)

FPID: 437279-1-22-02
ETDM #: 14341

DECEMBER 2020

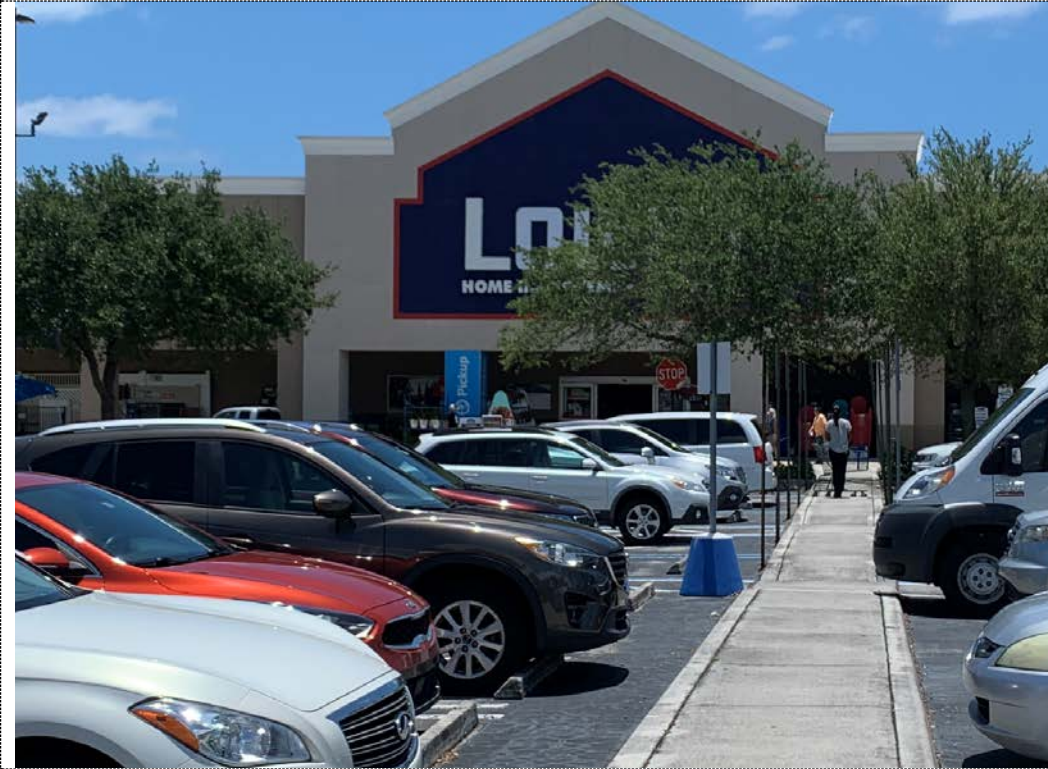
| Site ID | Name | Facility ID | Regulatory Database | Distance to and Direction From Corridor (Feet) | Storage Tanks Present | Contamination of Concern | Site Information | Risk Rating |
|---|---|---|---|--|---|---|---|---|
| 4 | LOWES OF BOYNTON BEACH FL #1111 1500 CORPORATE DR | CHAZ/CESQG ID: FLR000151035 | CHAZ CESQG RCRA | 110 South | 1,500 – Gal Diesel AST | None | This facility was not identified in regulatory databases as being contaminated. This facility stores a 1500-gallon diesel AST associated with an emergency generator. No records of outstanding violations or discharges were identified during our review of regulatory records. This facility is registered as a conditionally exempt small quantity hazardous waste generator. Based on the facility information reviewed, it is not likely that there would be any contamination impacts to the project. | Low |

Photo 1 – View of Lowe's of Boynton Beach, FL #1111, 1500 Corporate Dr., facing east.

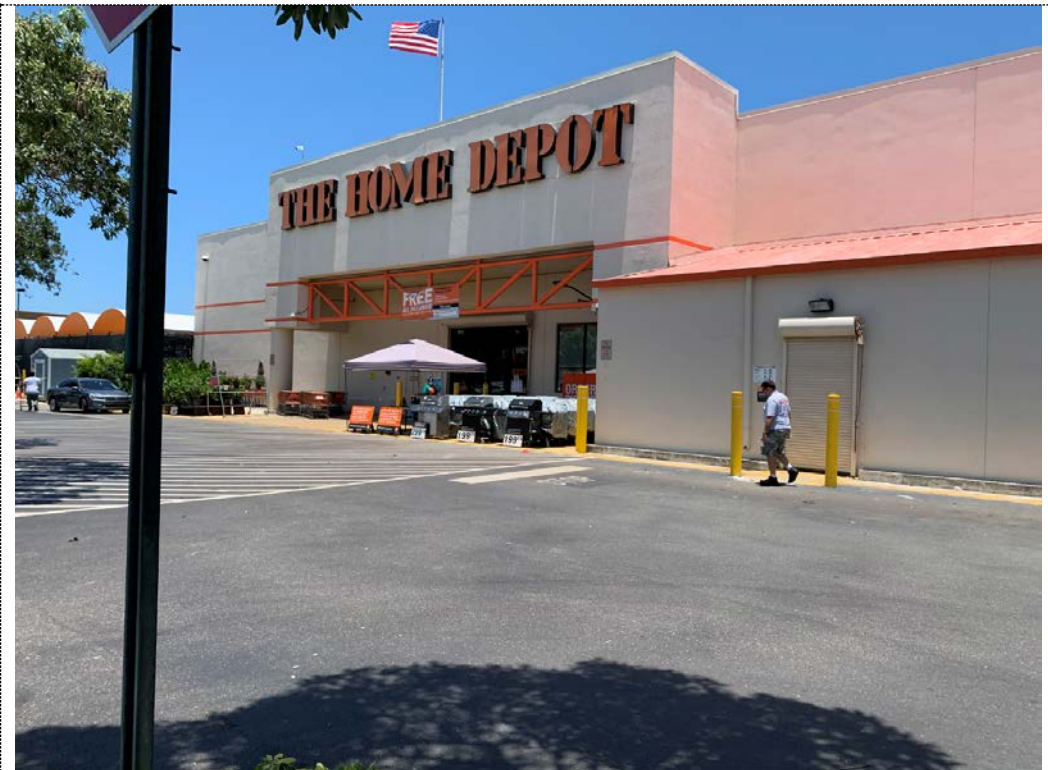
| Site ID | Name | Facility ID | Regulatory Database | Distance to and Direction From Corridor (Feet) | Storage Tanks Present | Contamination of Concern | Site Information | Risk Rating |
|---|---|---|---|--|---|---|---|---|
| 5 | HOME DEPOT #6309 1500-1520 SW 8TH ST | CHAZ ID: FLR000111914 STCM ID: 9810769 | CHAZ STCM RCRA | 165 North | 1,320- Gal Diesel AST | None | This facility was not identified in regulatory databases as being contaminated. This facility stores a 1,320-gallon diesel AST associated with a generator. No records of outstanding violations or discharges were identified during our review of regulatory records. Based on the facility information reviewed, it is not likely that there would be any contamination impacts to the project. | Low |

Photo 2 – View of Home Depot #6309, 1500-1520 SW 8th St., facing northeast.

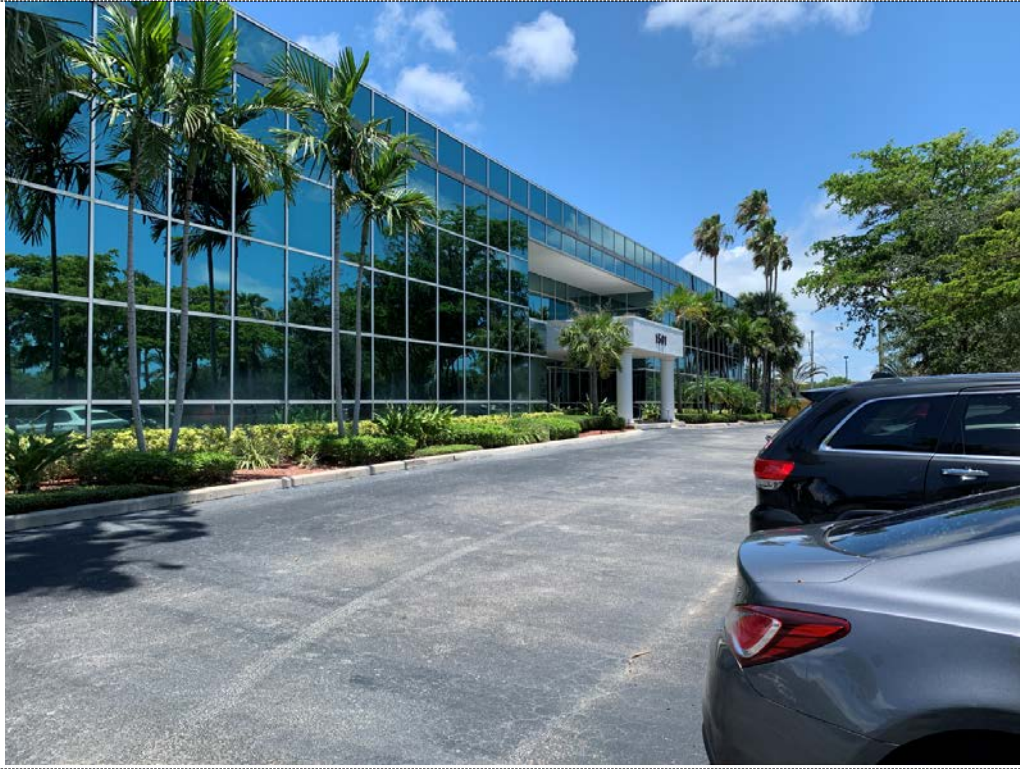
| Site ID | Name | Facility ID | Regulatory Database | Distance to and Direction From Corridor (Feet) | Storage Tanks Present | Contamination of Concern | Site Information | Risk Rating |
|---|---|---|---|--|---|---|---|---|
| 2 | BETTY SEINFELD CENTER 1501 CORPORATE DR | CHAZ ID: FLR000065573 | CHAZ RCRA | 90 South | None | None | This facility was occupied by the Betty Seinfeld Breast Center and was registered as a small quantity generator of silver in 2000. The facility was reportedly closed around 2003. This facility was not identified on regulatory databases as being contaminated. No records of outstanding violations or discharges were identified during our review of regulatory records. Based on the facility information reviewed, contamination impacts are not expected. | No |
| 3 | BOCA RATON ASSOCIATES 1501 CORPORATE DRIVE | SQG ID: 79738 | SQG RCRA | 90 South | None | None | This facility was not identified in regulatory databases as being contaminated. Based on the site location within a medical office, it is expected that the facility is associated with medical services. No records of outstanding violations or discharges were identified during our review of regulatory records. This facility is registered as a small quantity hazardous waste generator. Based on the facility information reviewed, contamination impacts are not expected. | No |

Photo 3 – View of building associated with Betty Seinfeld Center and Boca Raton Associates sites, 1501 Corporate Dr., facing northwest.

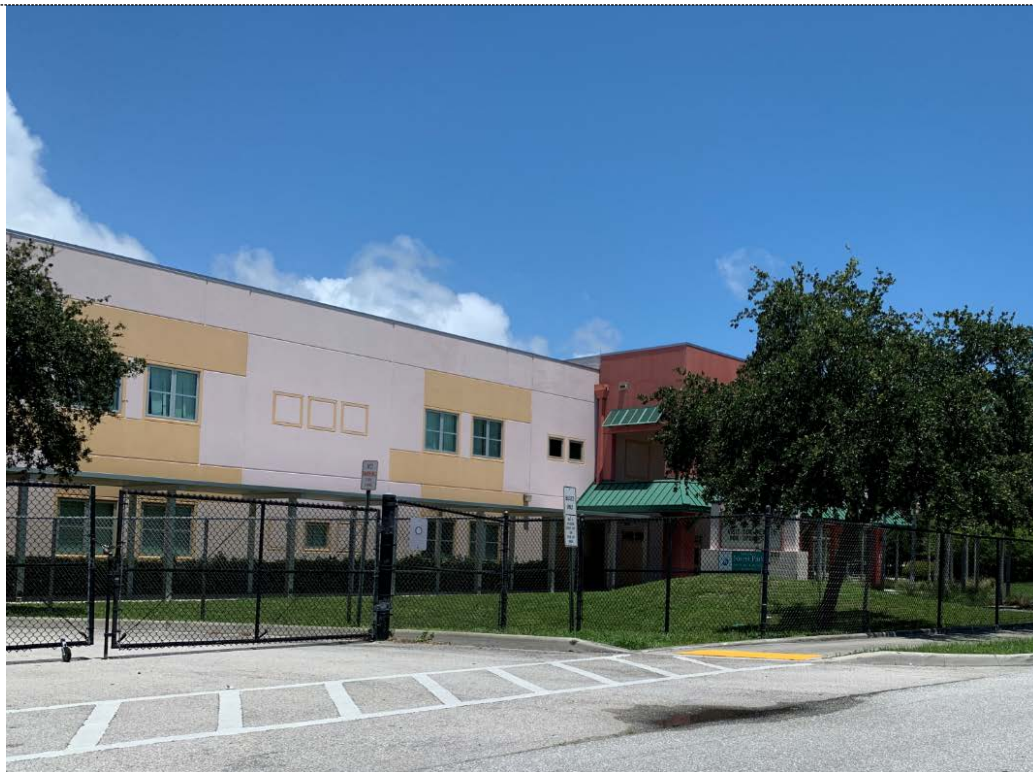
| Site ID | Name | Facility ID | Regulatory Database | Distance to and Direction From Corridor (Feet) | Storage Tanks Present | Contamination of Concern | Site Information | Risk Rating |
|---|---|---|---|--|---|---|---|---|
| 6 | FOREST PARK ELEMENTARY SCHOOL 1201 SW 3RD ST | CHAZ ID: FLD982158115 | CHAZ RCRA | 75 East | AST | None | This facility was not identified in regulatory databases as being contaminated. This facility is registered as a conditionally exempt small quantity hazardous waste generator. Based on the site visit conducted as part of this evaluation, the school houses a generator and associated AST. The specifications of the AST were not available based on review of regulatory records. No records of outstanding violations or discharges were identified during our review of | Low |

Photo 4 – View of Forest Park Elementary School, 1201 SW 3rd St., facing northwest.

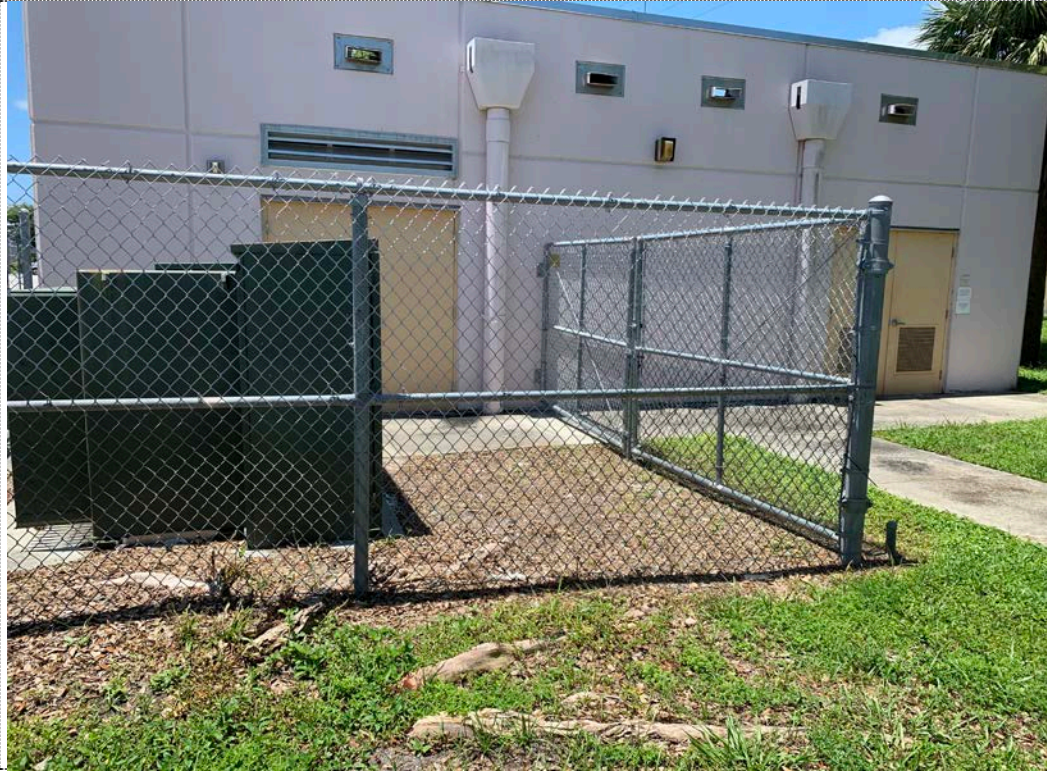
Photo 5 – View of generator and associated tank located in the rear of Forest Park school building.

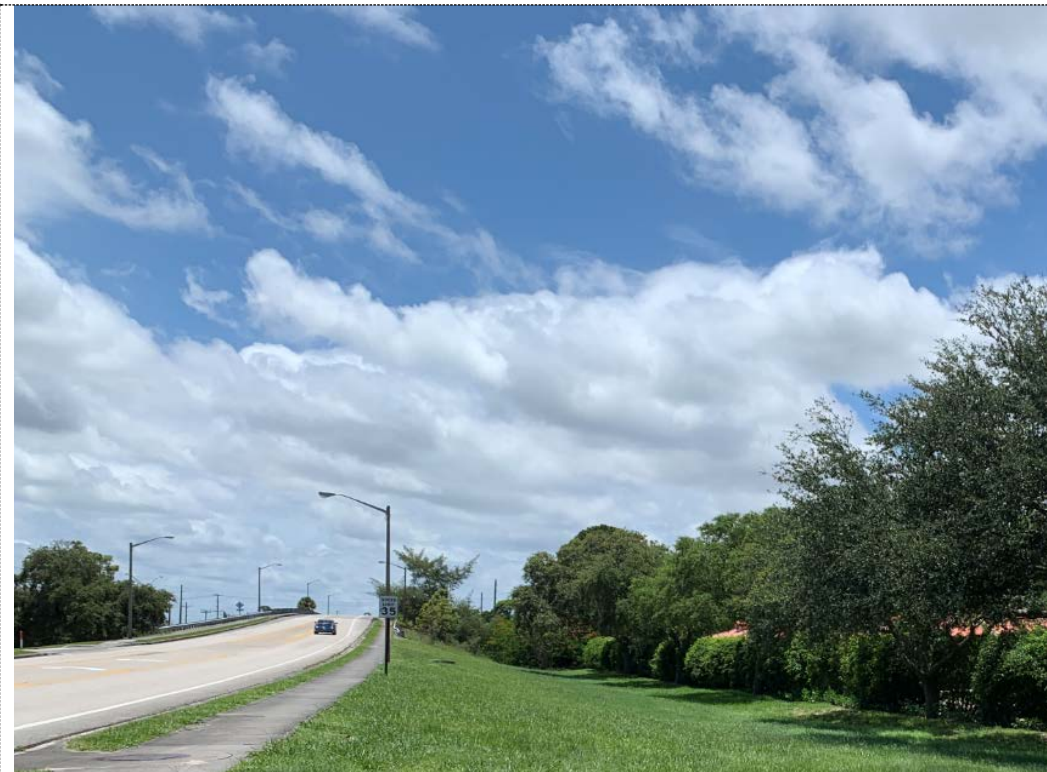
Photo 6 – View of Direct Transport-Delray Spill Atlantic Avenue & Woolbright Rd. site, facing west, showing SW 23rd Street overpass over SR 9/I-95.

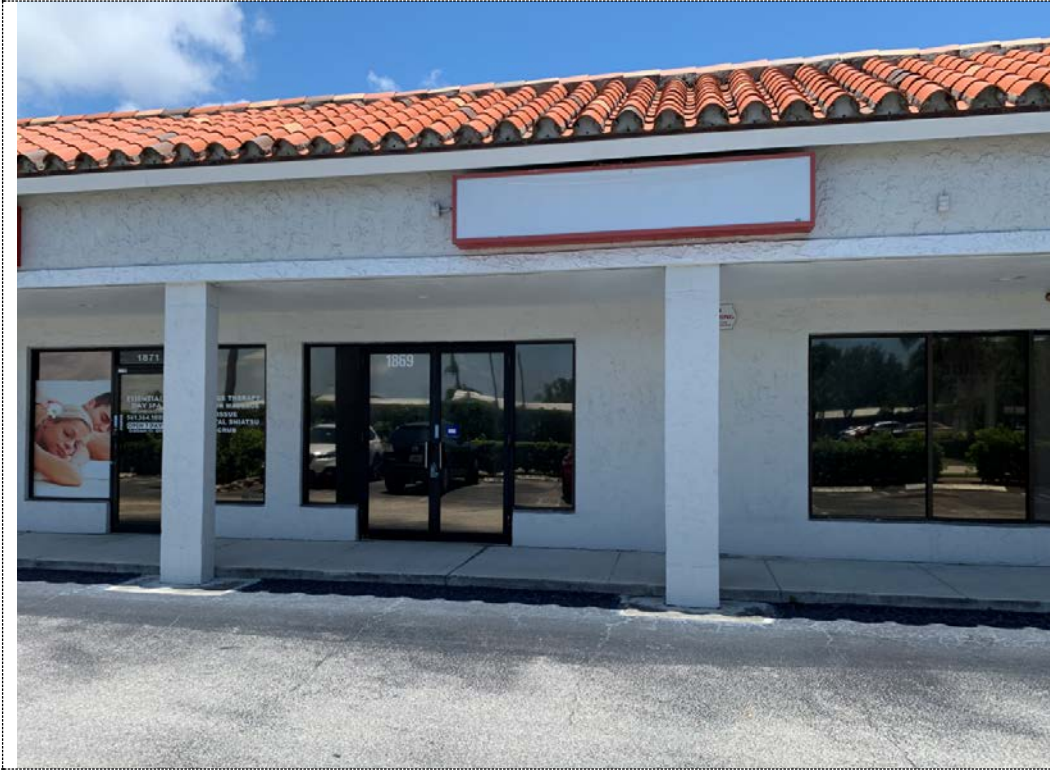
| Site ID | Name | Facility ID | Regulatory Database | Distance to and Direction From Corridor (Feet) | Storage Tanks Present | Contamination of Concern | Site Information | Risk Rating |
|---|---|--|---|--|---|---|--|---|
| 8 | SAVE ON DRY CLEANERS 1859 W WOOLBRIGHT RD | HAZ/SQG ID: FLR000103671 STCM ID: 9809009 | HAZ STCM SQG RCRA | 75 North | None – Historical Tanks Removed | Solvents | This facility operated a drycleaner between 2002 and 2011. This facility was not identified on regulatory databases as being contaminated and was identified as a vacant commercial space during the June 11, 2020 site visit. No records of outstanding violations or discharges were identified during our review of regulatory records. This facility is no longer present at this location. A former AST storing tetrachloroethylene installed circa 2007 has been removed from this facility. Former activities on the property included storage and handling of hazardous materials in some capacity. Based on insufficient regulatory information and lack of assessment data for this site, it is likely that contamination associated with the former activities may have gone undetected. | Medium |
| 9 | BLESSED WOOLBRIGHT CLEANERS RDS OF BOYNTON INC 1869 SW 15TH AVE | HAZ ID: FLR000050401 | HAZ RCRA | 75 North | None | Solvents | This drycleaner facility was registered as a conditionally exempt small quantity hazardous waste generator in 1998. This facility was not identified on regulatory databases as being contaminated and was identified as a vacant commercial space during the June 11, 2020 site visit. No records of outstanding violations or discharges were identified during our review of regulatory records. This facility is registered as a conditionally exempt small hazardous waste quantity generator. Former and current activities on the property included storage and handling of hazardous materials in some capacity. Based on insufficient regulatory information and lack of assessment data for this site, it is likely that contamination associated with the former activities may have gone undetected. | Medium |

Site 8 (Save On Dry Cleaners located at 1859 W Woolbright Rd) and Site 9 (Blessed Woolbright Cleaners located at 1869 SW 15th Avenue) have been assigned a medium risk rating based on the former operation of drycleaner facilities at each of these locations. However, no records of discharges or outstanding violations were identified for these facilities. The proposed work in the vicinity of Site 8 and Site 9 is limited to lane widening. Therefore, based on the absence of contamination records associated with these sites, no additional assessment (Level II or Level III) is deemed necessary. If invasive work that requires dewatering is proposed, then groundwater assessment would be recommended. If groundwater testing is conducted, laboratory analysis should include volatile organic hydrocarbons (VOHs) using EPA Test Method 8260 (or equivalent).

Photo 7 – View of former location of Save On Dry Cleaners (1859 W. Woolbright Rd.) and Blessed Woolbright Cleaners/RDS of Boynton, Inc. (1869 SW 15th Ave.), facing north, showing vacant commercial space (on left) and My Choice Rx pharmacy (on right) within the Leisureville Shopping Center.

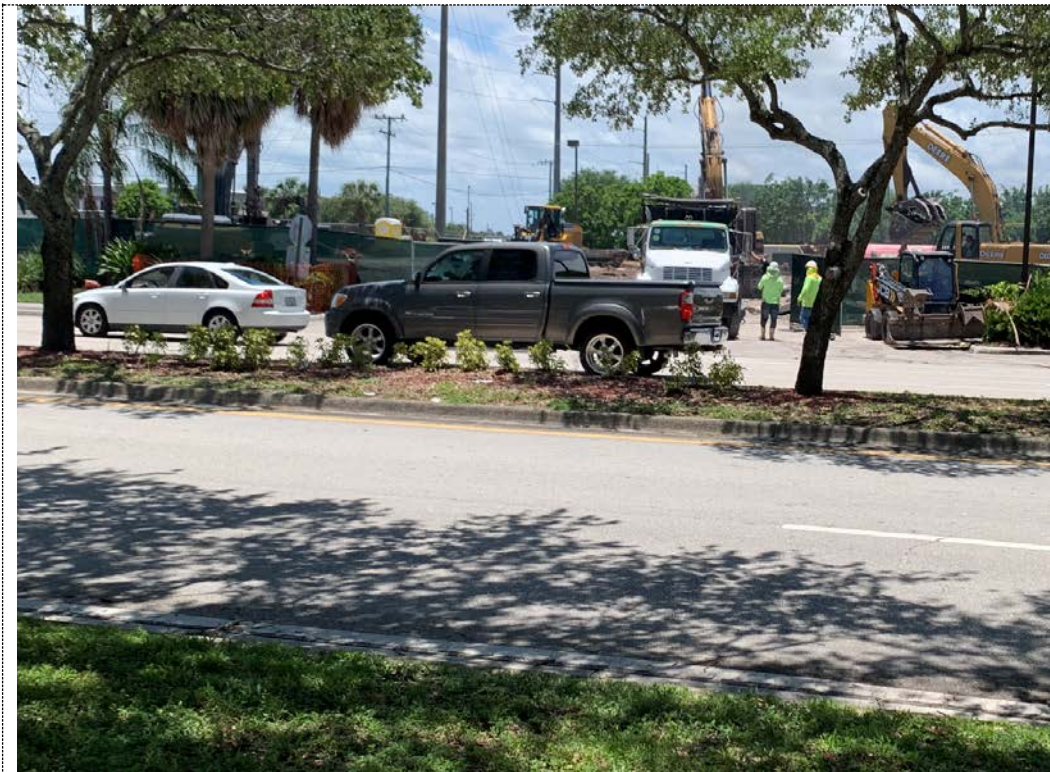
| Site ID | Name | Facility ID | Regulatory Database | Distance to and Direction From Corridor (Feet) | Storage Tanks Present | Contamination of Concern | Site Information | Risk Rating |
|---|---|--|---|--|---|---|--|---|
| 10 | RACETRAC #459 905 W WOOLBRIGHT RD | STCM ID: 9600708 | SCTM | 35 West | 12,000-Gal Unleaded Gas UST 12,000-Gal Diesel UST 12,000-Unleaded Gas UST | Petroleum | This facility is an active gas station housing three USTs installed in 1995. No records of outstanding violations or discharges were identified during our review of regulatory records. This facility has been assigned a Medium risk rating based on the current operation of the gasoline station. This site is was observed to be under construction during the site visit conducted on June 11, 2020. | Medium |

Site 10 (Racetrack Station located at 905 W Woolbright Rd.) has been assigned a medium risk rating based on the current operation of a gasoline station housing three USTs. However, no records of discharges or outstanding violations were identified for this facility. Therefore, based on the absence of contamination records associated with this facility, no additional assessment (Level II or Level III) is deemed necessary. The proposed work in the vicinity of Site 10 is limited to lane widening and the facility is at a lower elevation than the adjacent project corridor. The elevation gradient would be expected to promote groundwater flow away from the corridor; additionally, the presence of the C-4 canal may influence the groundwater to flow to the east. Due to the fact that actual contamination has not been documented at this site, the distance between the USTs and the ROW, the elevation difference and the minimally invasive work anticipated for this portion of the project, additional assessment is not recommended. If invasive work that requires dewatering is proposed, then groundwater assessment would be recommended. If groundwater testing is conducted, laboratory analysis should include petroleum contaminants including polynuclear aromatic hydrocarbons using EPA Test Method 8270 (or equivalent), volatile organic aromatics using EPA Test Method 8260 (or equivalent) and total recoverable petroleum hydrocarbons using the Florida Residual Petroleum Organics Method.

Photo 8 – View of Racetrac #459 site, 905 W. Woolbright Rd., facing north, showing ongoing construction activities.

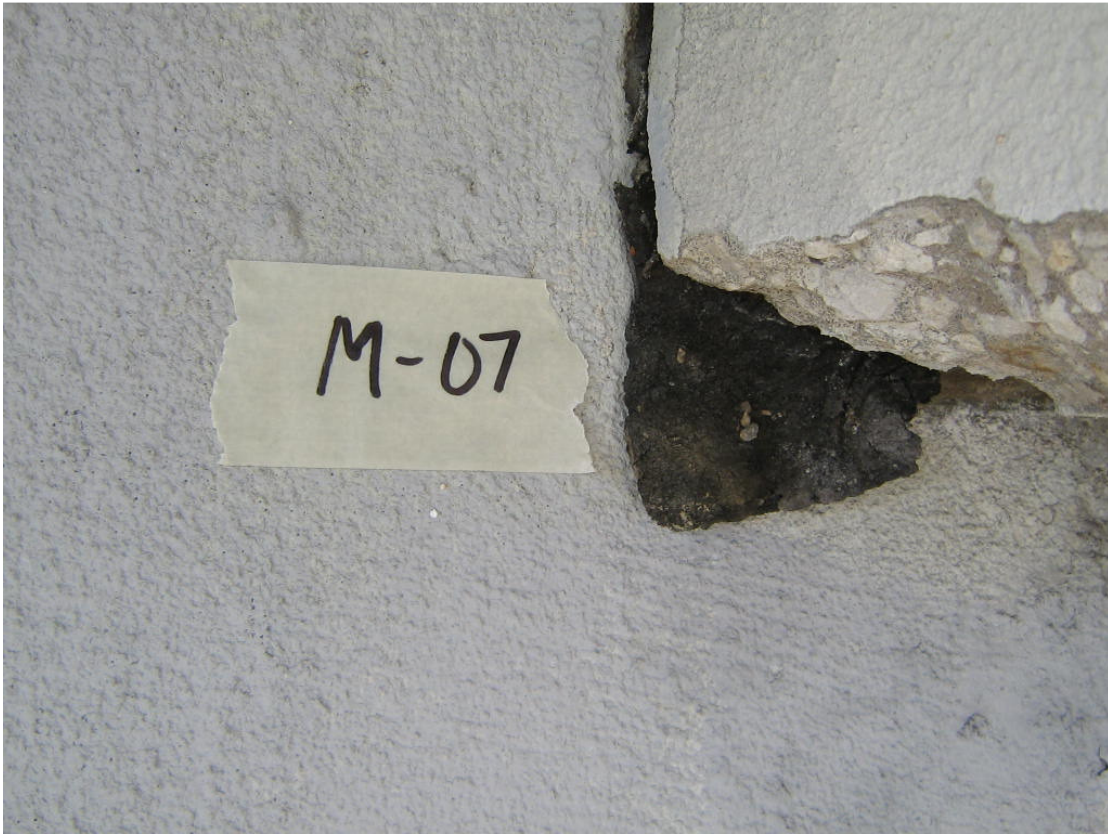
D-5

Upper Photo:
Black Particle Board - Backwall

Lower Photo:
Tan Reflector Adhesive - Guardrail

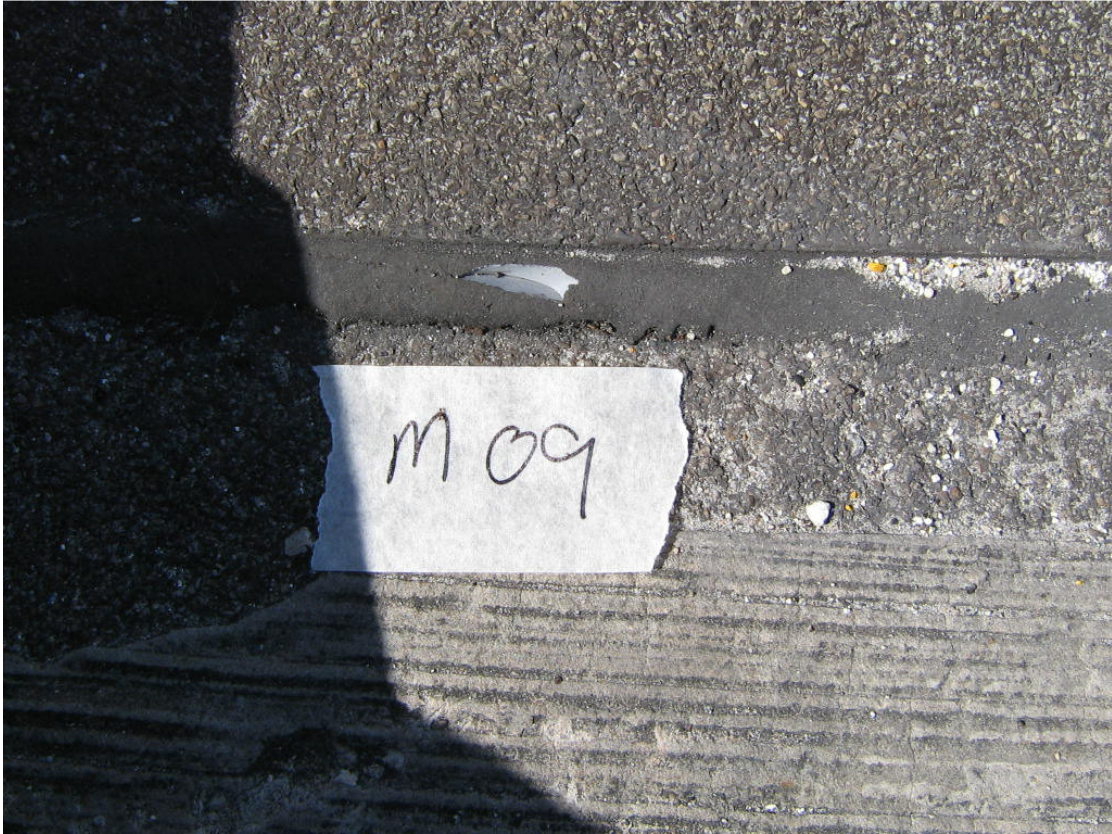
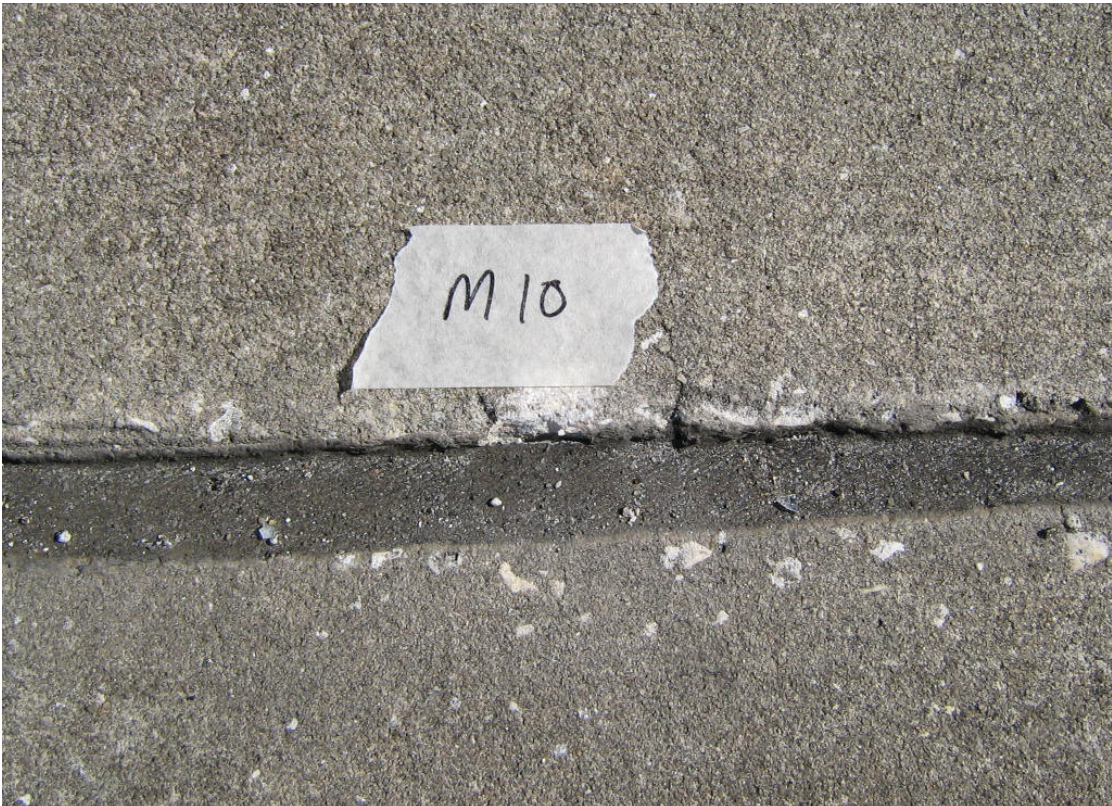
| Date 2/11/2011 | D-6 |

Upper Photo:
 Grey Expansion Joint Sealant - Deck and Sidewalk

Lower Photo:
 Concrete - Deck

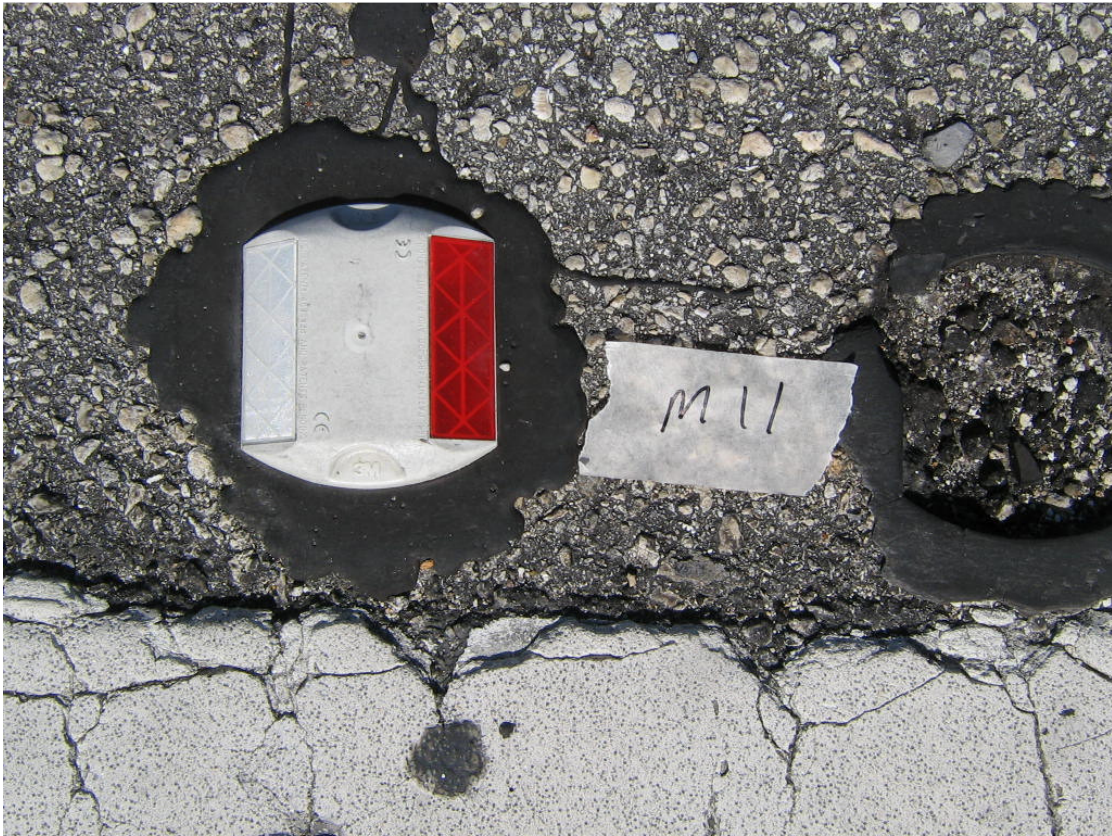
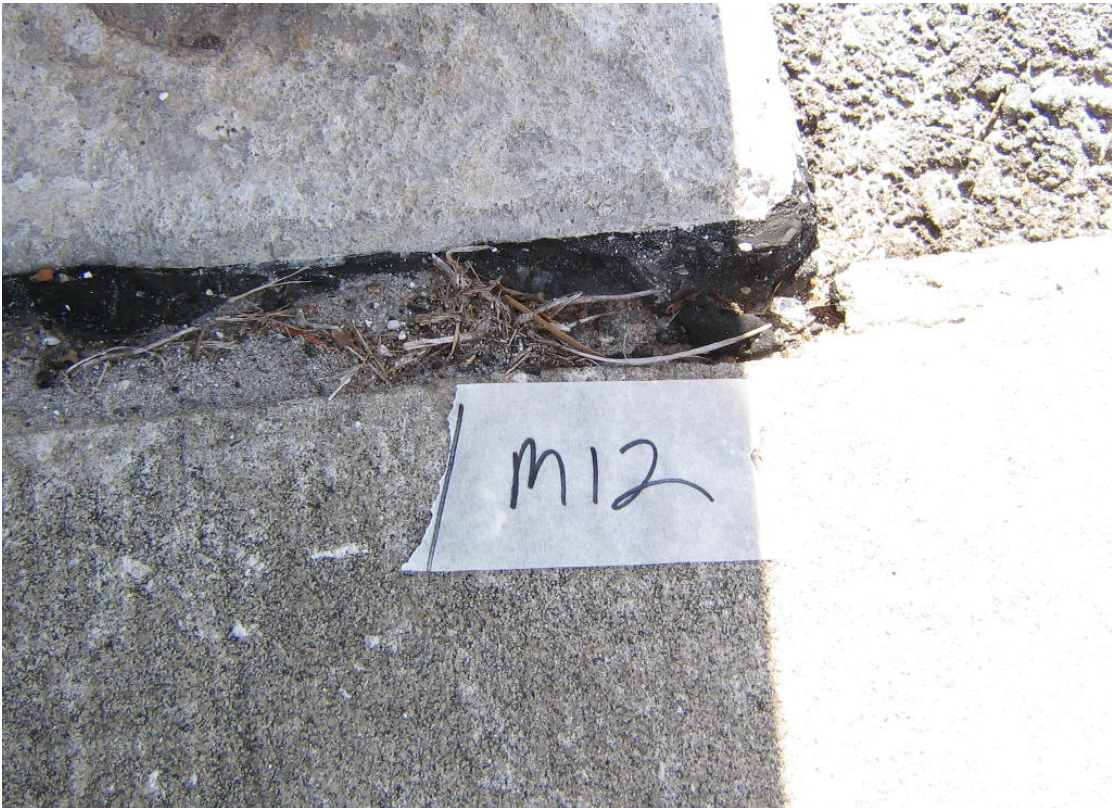
D-7

Upper Photo:
Black Bitumen Reflector Adhesive - Deck

Lower Photo:
Black Bitumen Sealant - Sidewalk at Parapet Wall

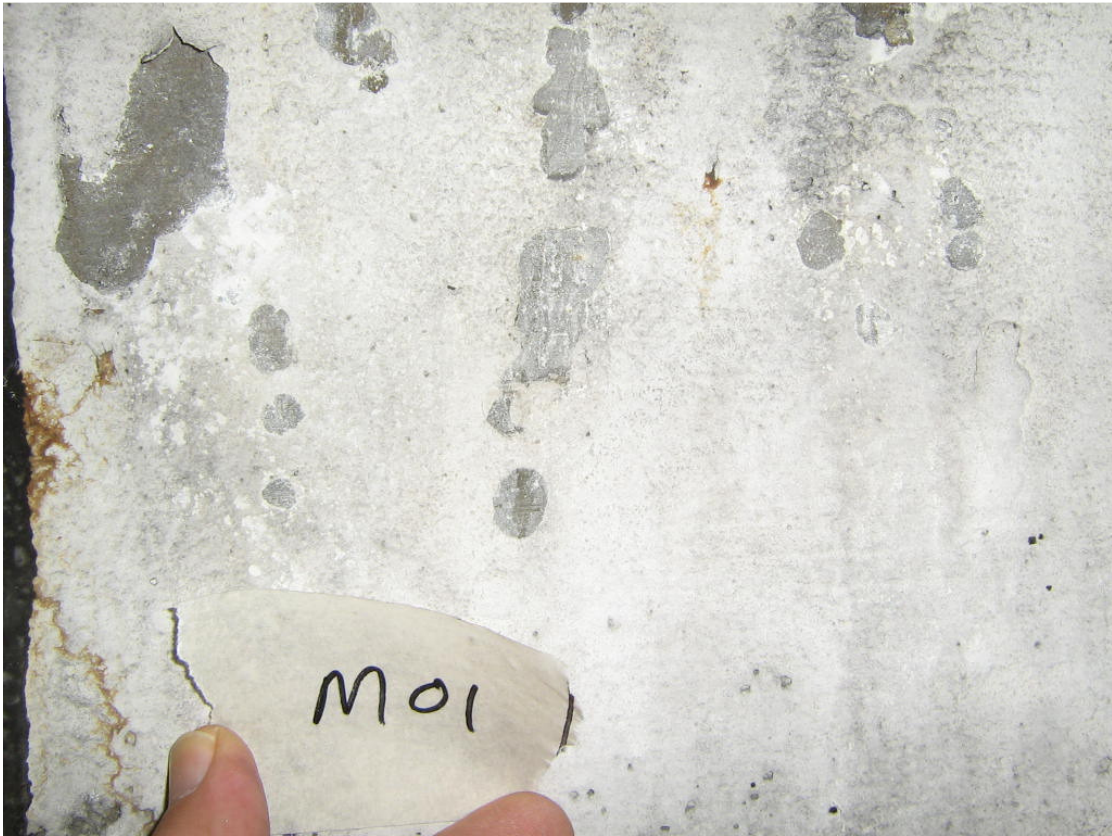
| Date 2/1/2011 | D-2 |

Upper Photo:
Class 5 Finish - End Bent Backwall

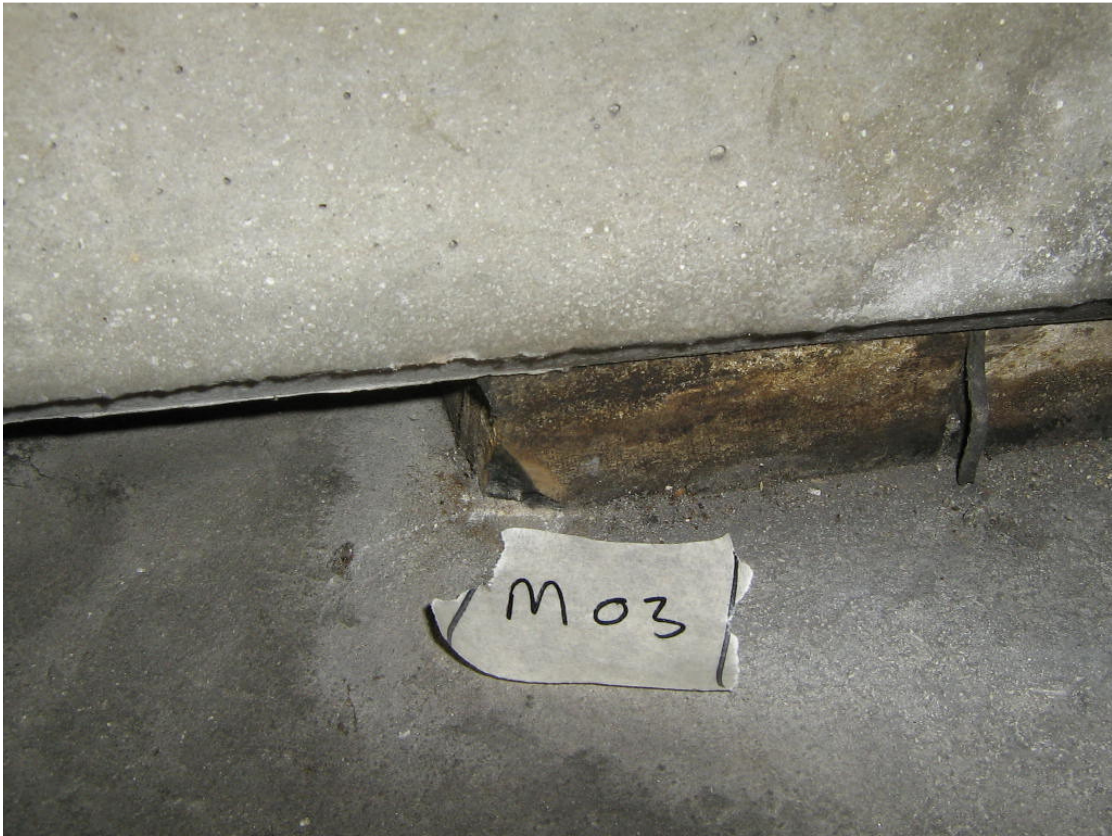
| Date 2/1/2011 | D-3 |

Upper Photo:
Black Neoprene Bearing Pad - End Bent Backwall

Lower Photo:
Class 5 Finish - Column

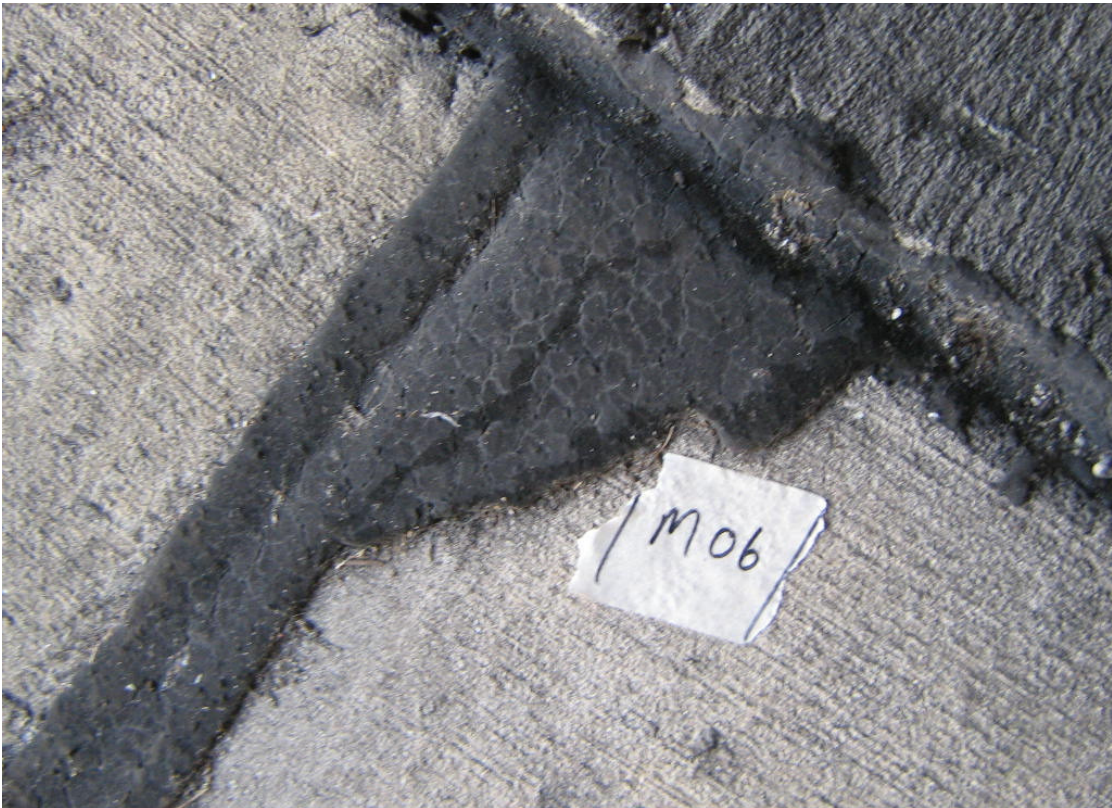
| Date 2/1/2011 | D-4 |

Upper Photo:
Black Particle Board - End Bent Backwall

Lower Photo:
Black Bitumen Sealant - Slope

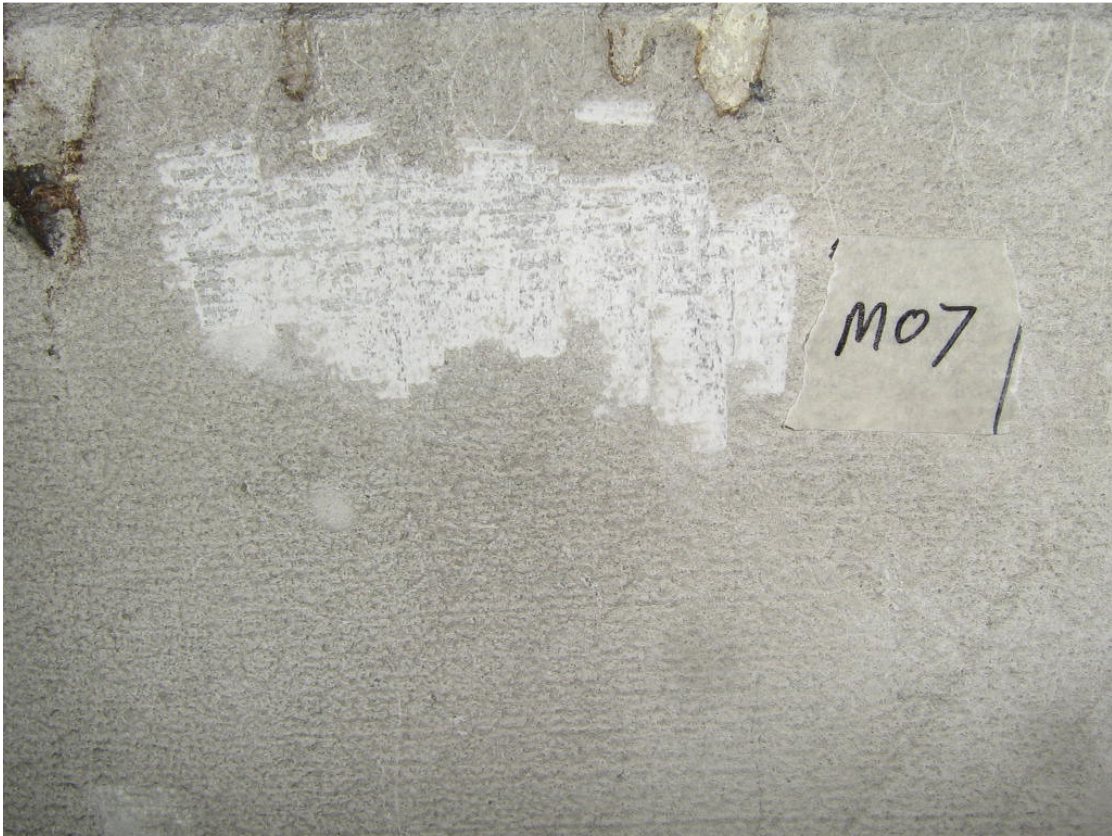
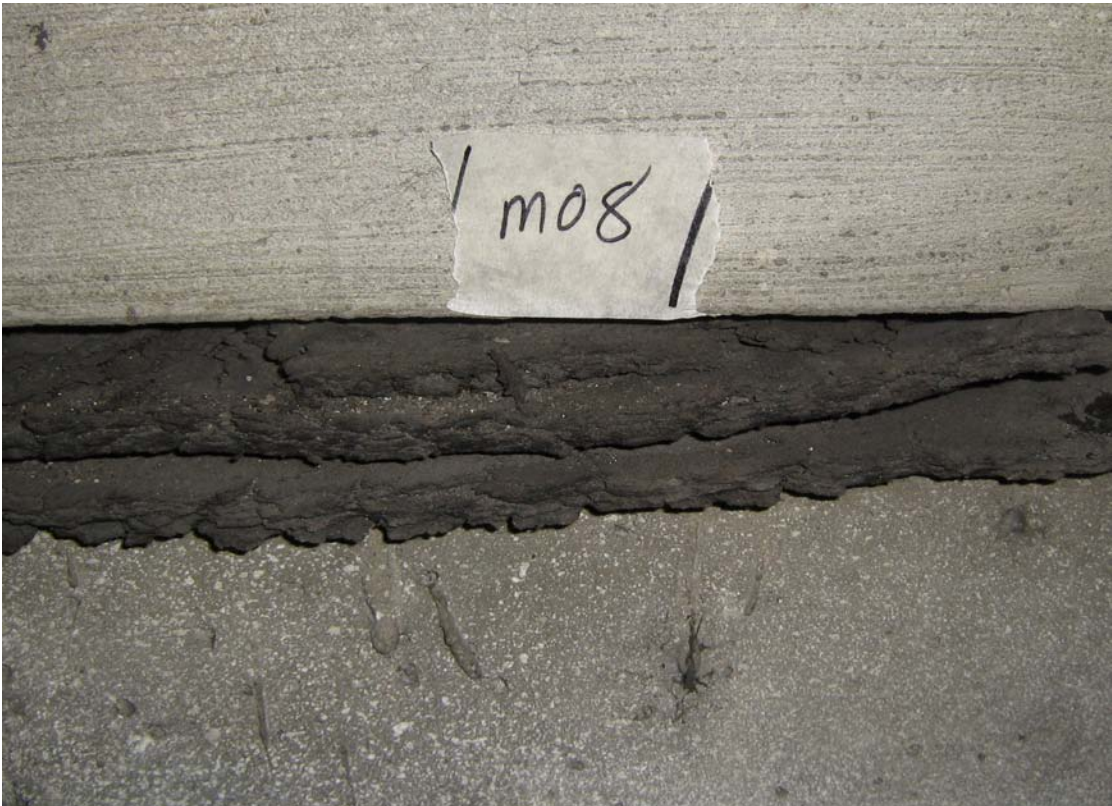
| Date 2/1/2011 | D-5 |

Upper Photo:
Class 5 Finish- Intermediate Cap

Lower Photo:
Black Particle Board- Intermediate Cap

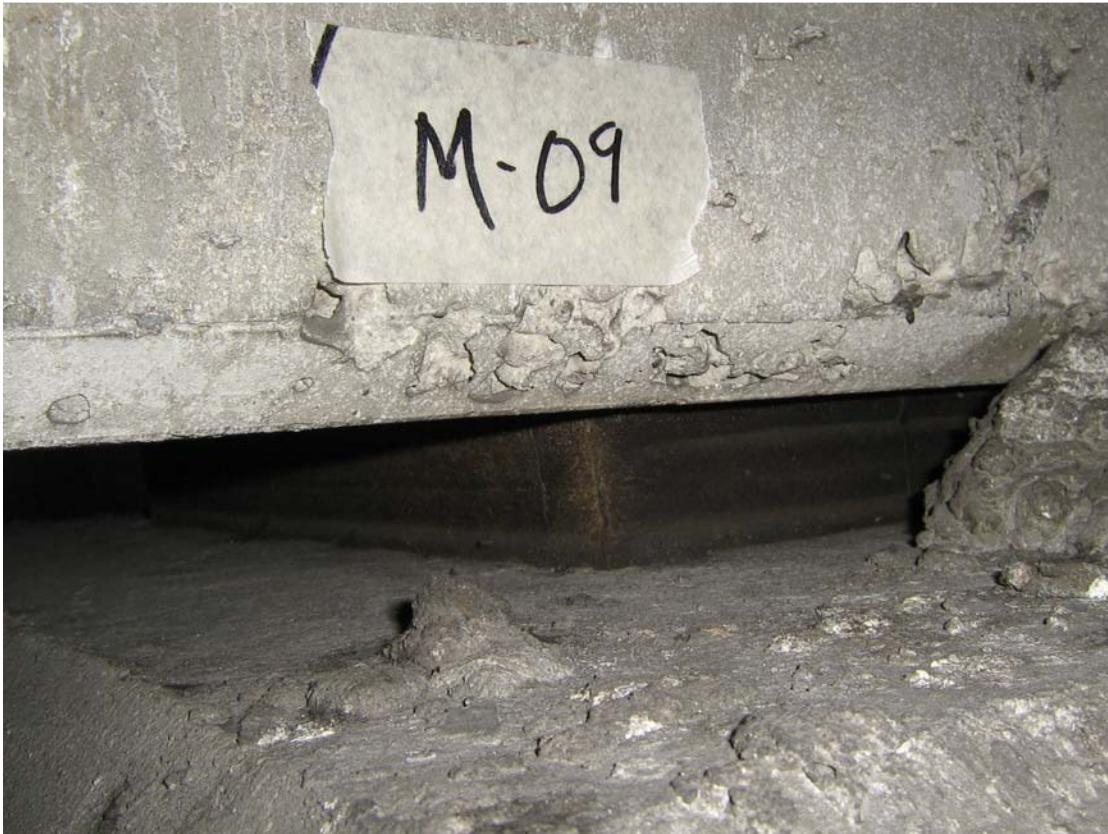
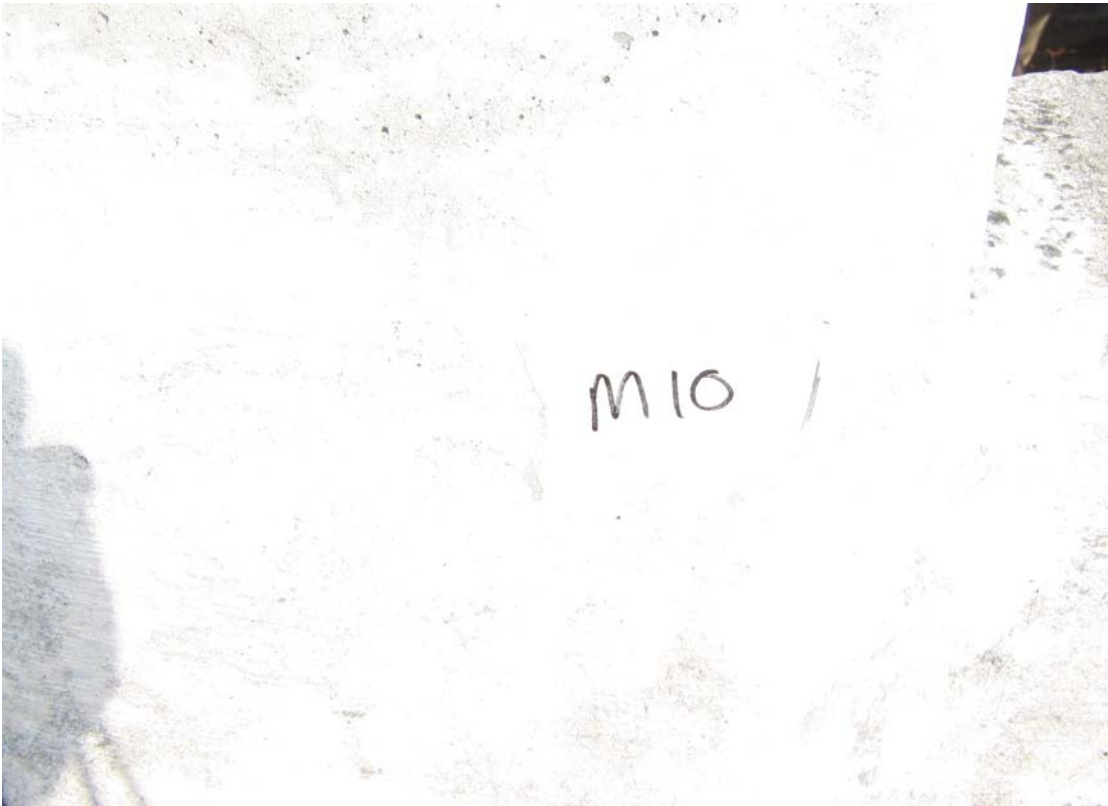
| Date 2/1/2011 | D-6 |

Upper Photo:
Black Neoprene Bearing Pad - Intermediate Cap

Lower Photo:
Class 5 Finish - Parapet Wall

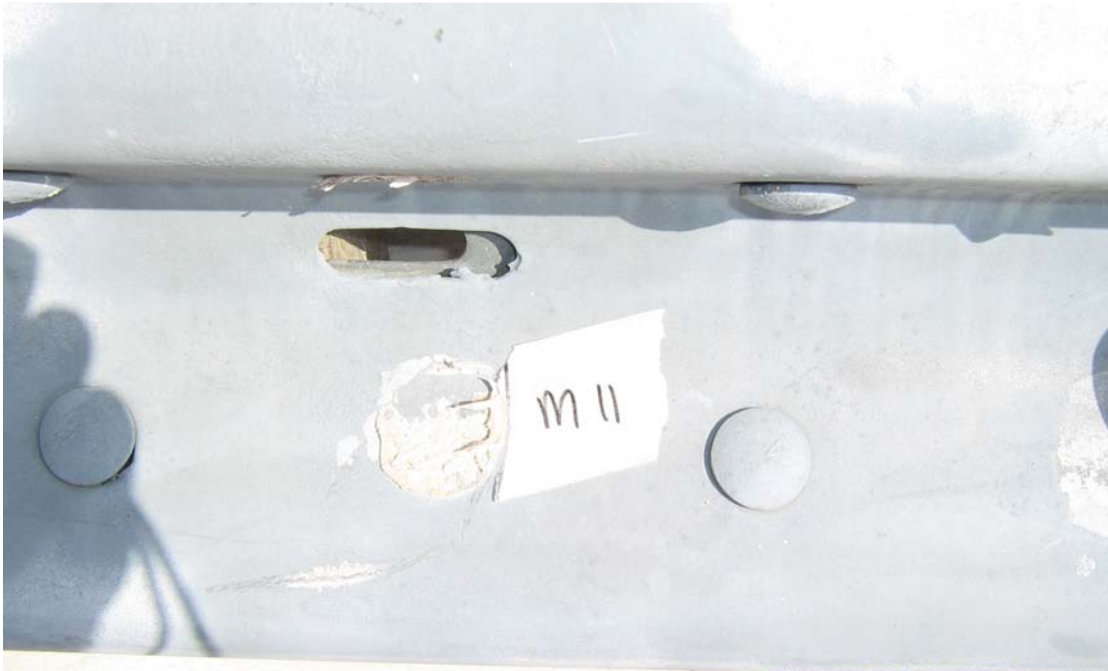
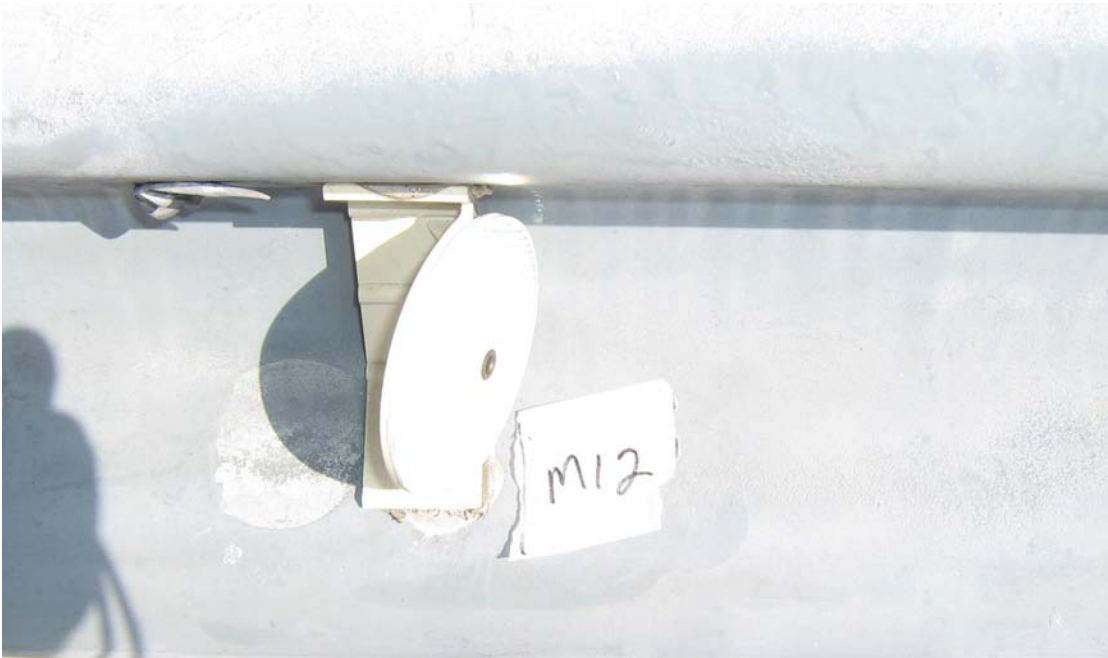
D-7

Upper Photo:
Beige Reflector Adhesive - Metal Guardrail

Lower Photo:
Grey Reflector Adhesive - Metal Guardrail
