CONTAMINATION SCREENING EVALUATION REPORT

SR 9/I-95 Project Development and Environment Study
From South of Woolbright Road to North of Woolbright Road
Boynton Beach, Palm Beach County, Florida
(From Mile Post 13.560 to Mile Post 13.995)

FPID: 437279-1-22-02
ETDM #: 14341

DECEMBER 2020

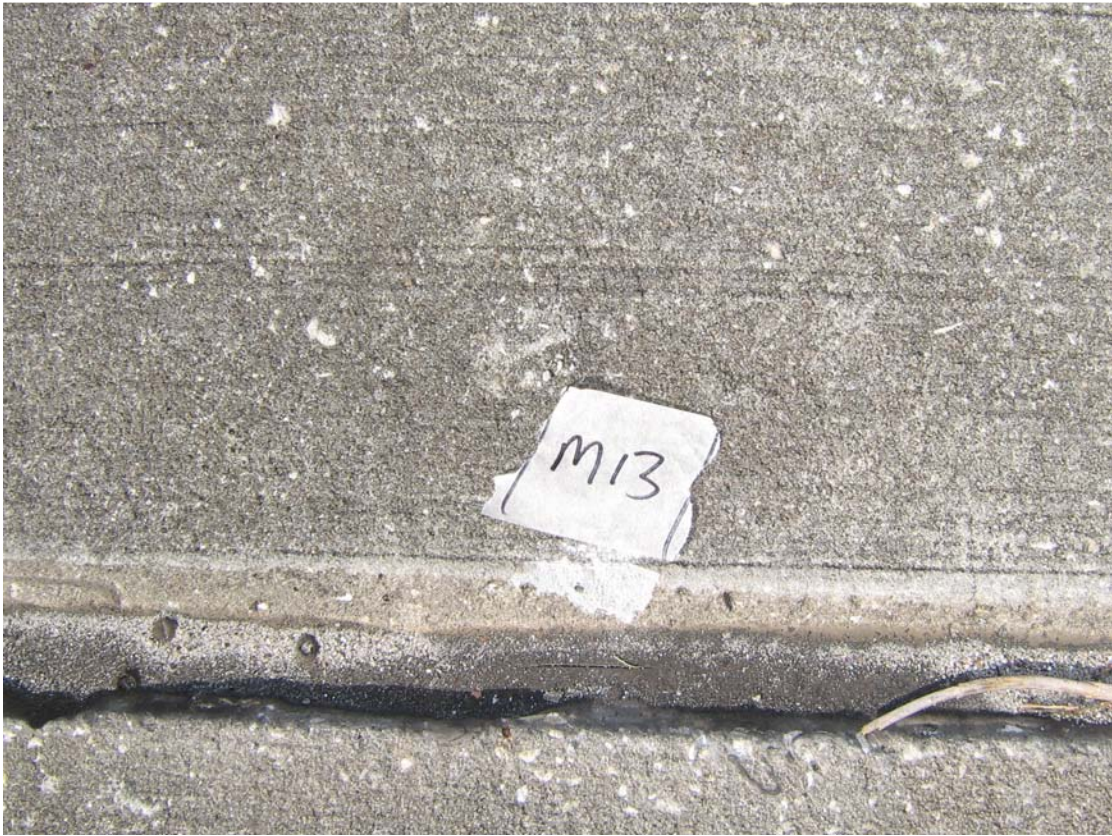
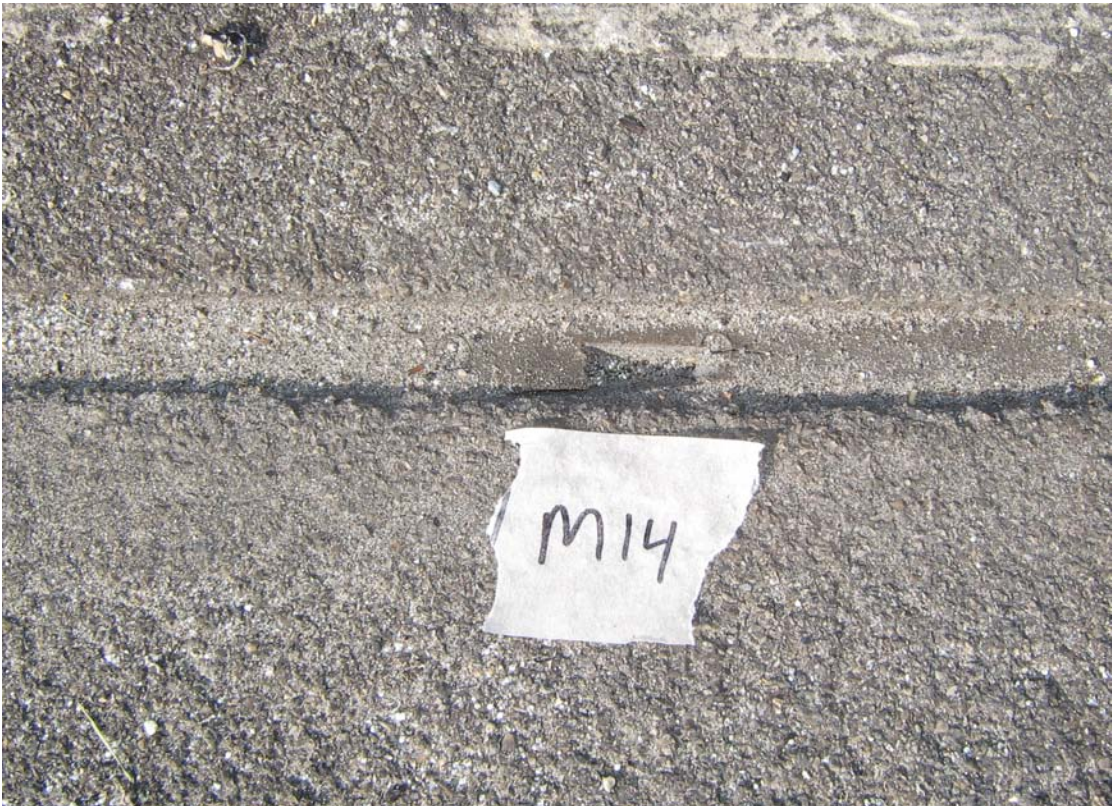
| Date 2/1/2011 | D-8 |

Upper Photo:
Concrete - Deck

Lower Photo:
Gray Expansion Joint Seal - Deck

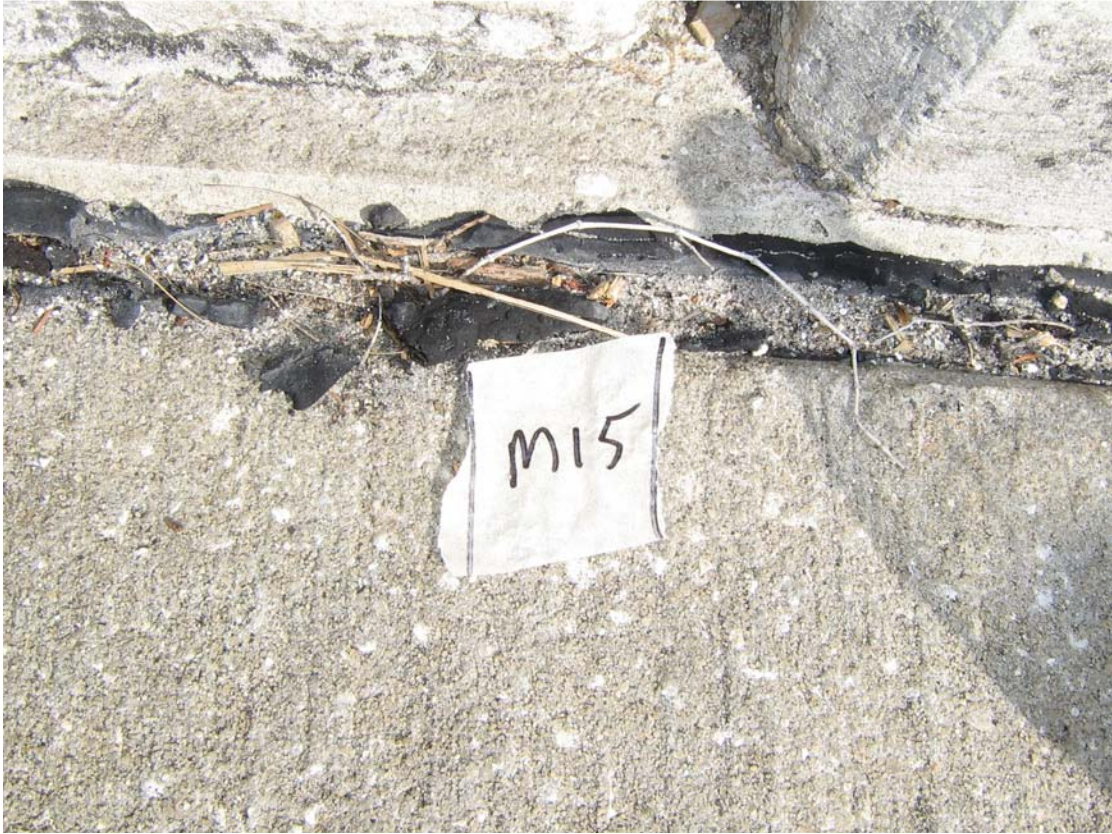
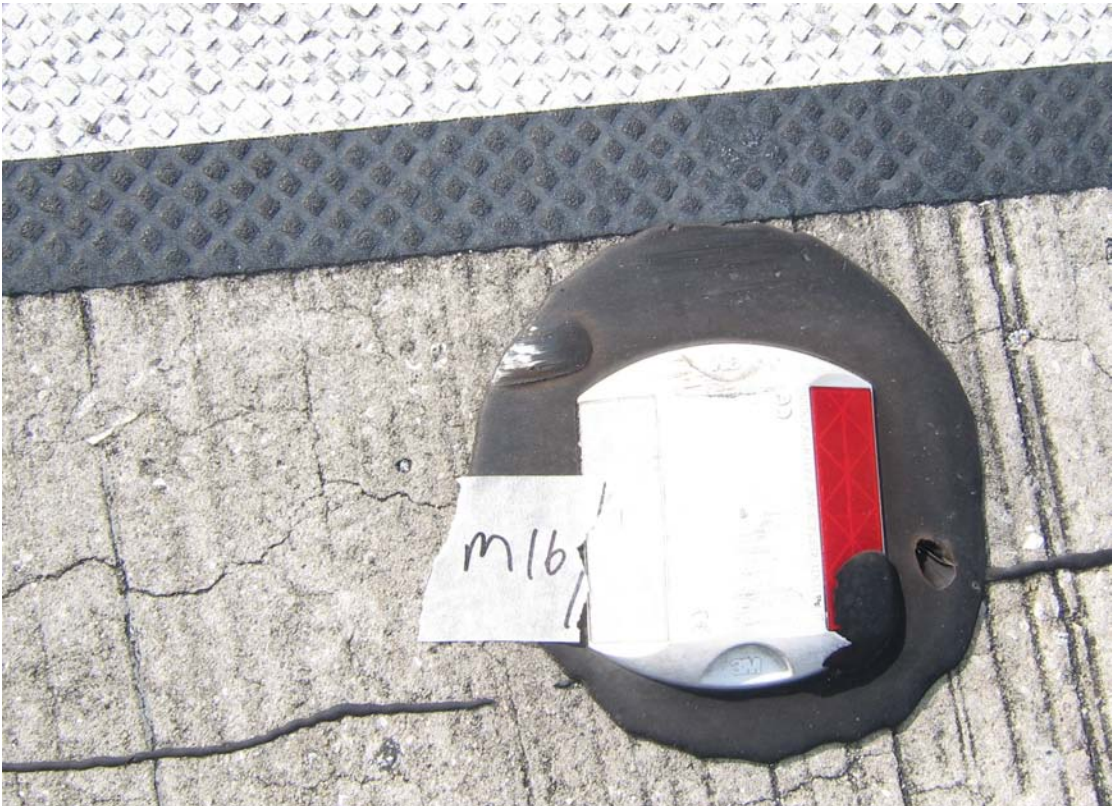
D-9

Upper Photo:
Black Bitumen Sealant - Deck

Lower Photo:
Black Bitumen Reflector Adhesive - Deck

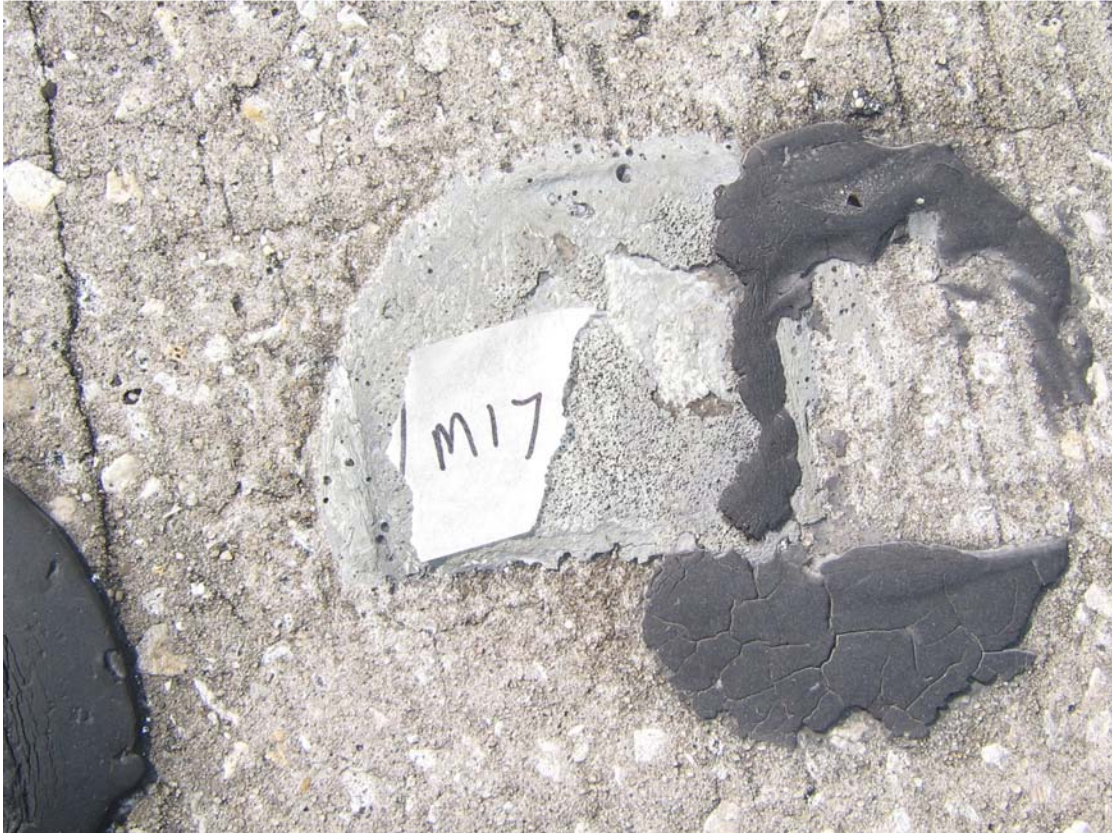
| Date 2/1/2011 | D-10 |

Upper Photo:
Gray Reflector Adhesive - Deck
