Table of Contents – Appendix B

| B.1 Example Inspection Report | B-1 |
| B.3 Comparison of Non-Destructive (NDT) Methods Table | B-21 |
| B.4 Summary OF NDT Methods | B-23 |

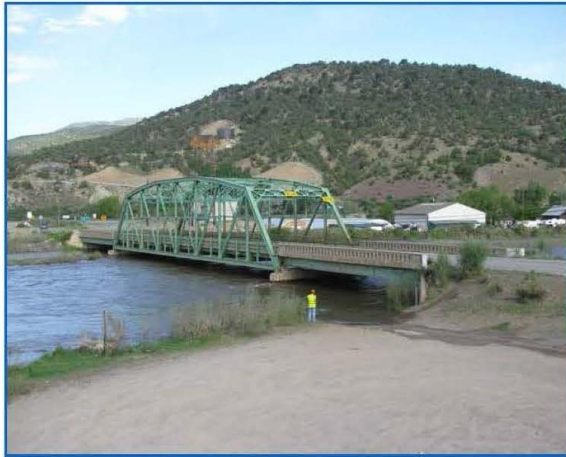
F08F-b NW.jpg

Typically orientation of photo given

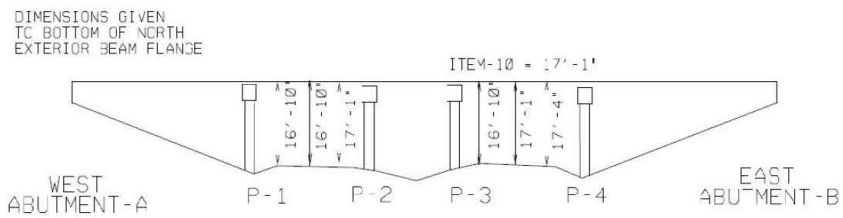
Bridge Inspection Field Sketches

Simple sketches help to clarify locations of defects, define elements, or help with measurements such as clearances

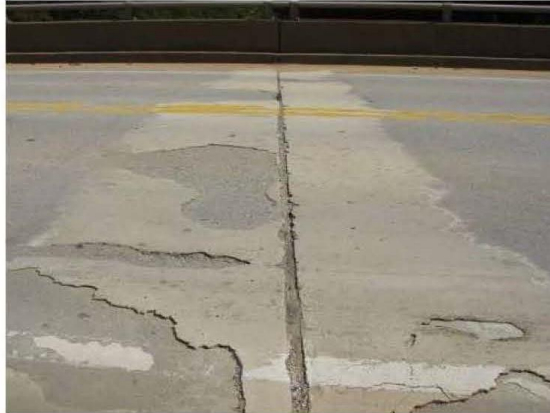
Photo-1
Shows delamination of the epoxy overlay/repair typical at Pier-3 and 4.

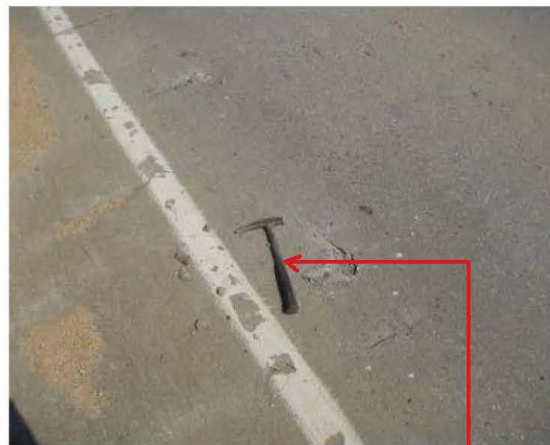
Photo-2
Shows delamination and shallow spalling to the deck in Span-2.

Showing a tool, or other item of known size, provides a reference to the scale shown in the photo.

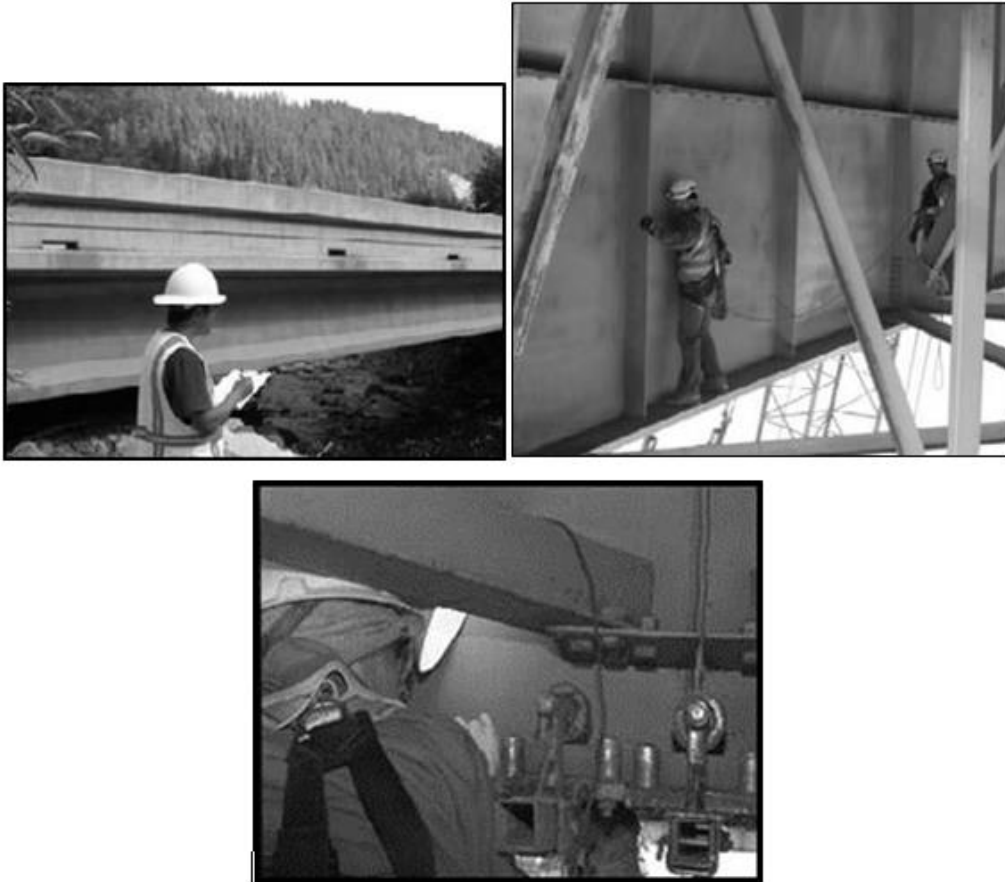
Figure B.1 Visual Inspection Examples

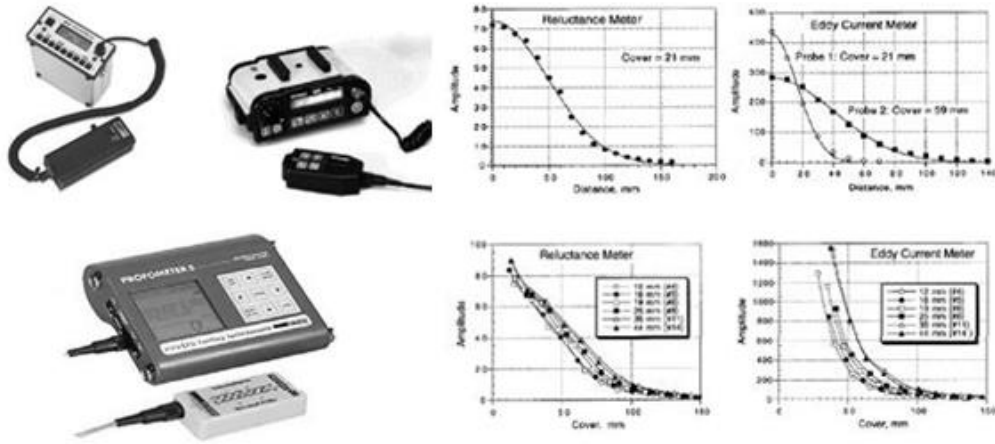
Figure B.2 Examples of Cover Meter Equipment (left) and Cover Meter Output (right)

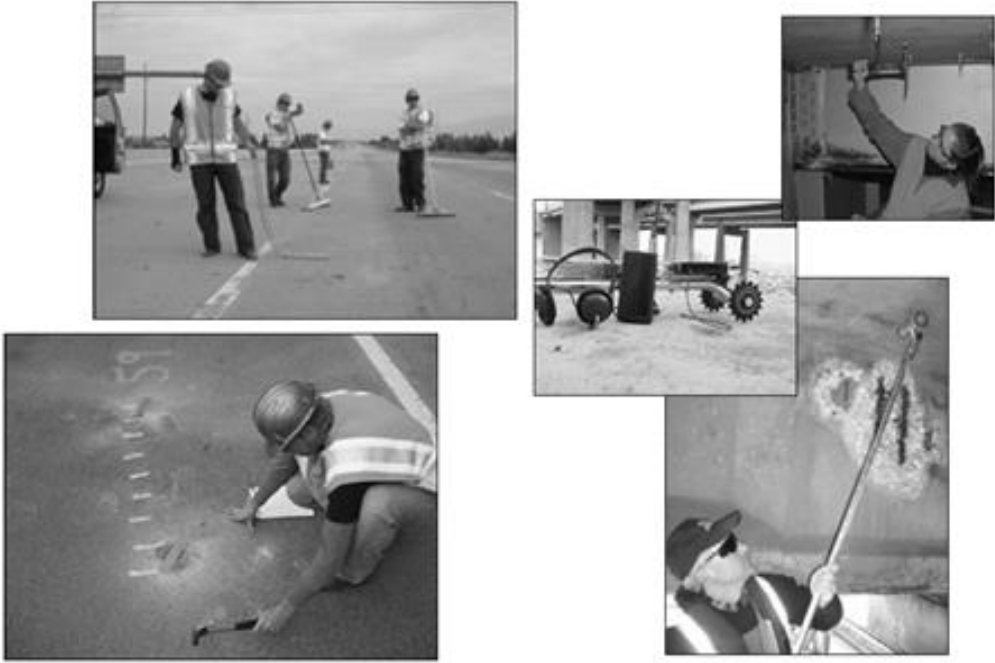
Figure B.3 Sounding Examples

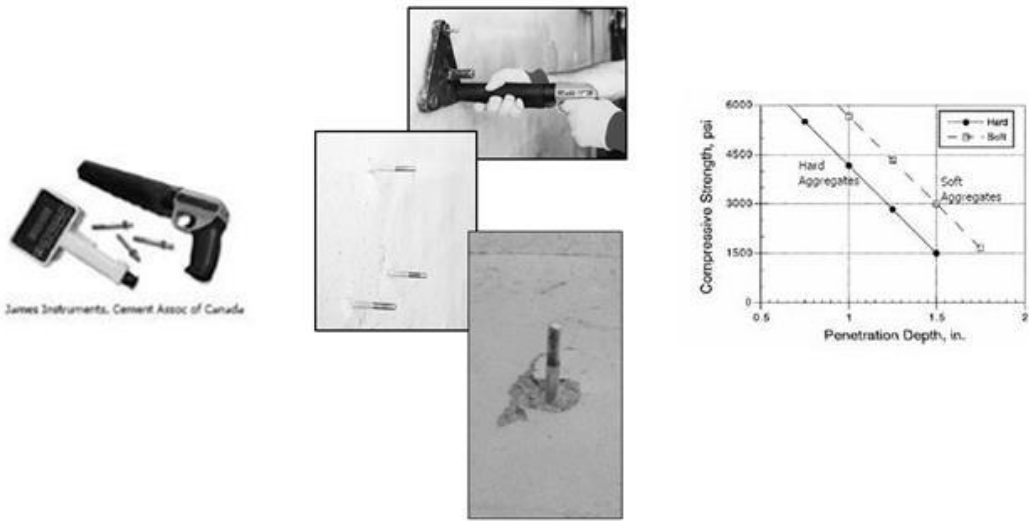
Figure B.4 Examples of Windsor Probes and Resulting Data

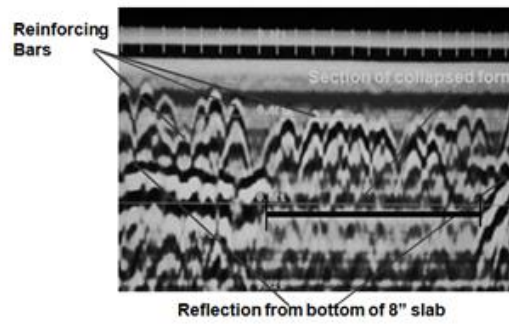
Figure B.7 GPR Equipment, Grid, and Output

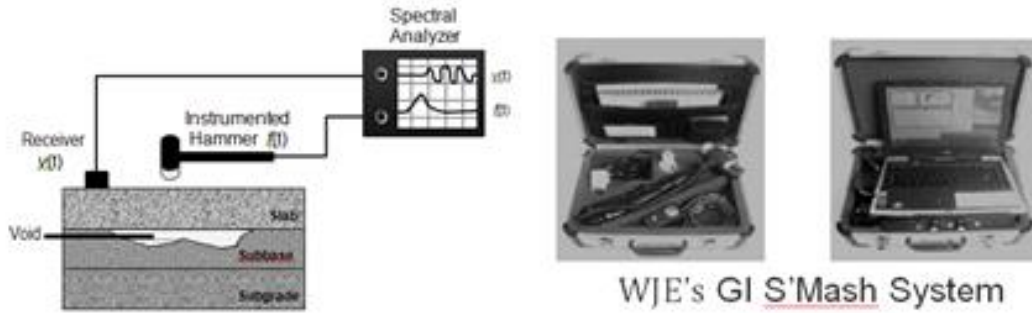
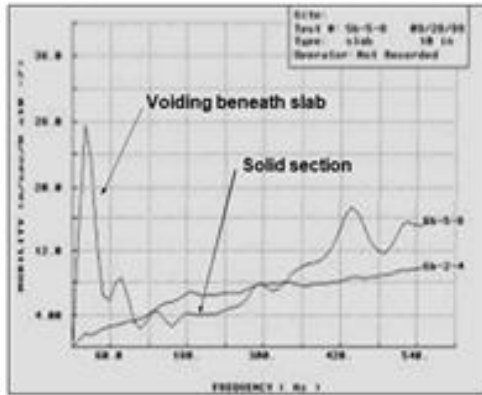
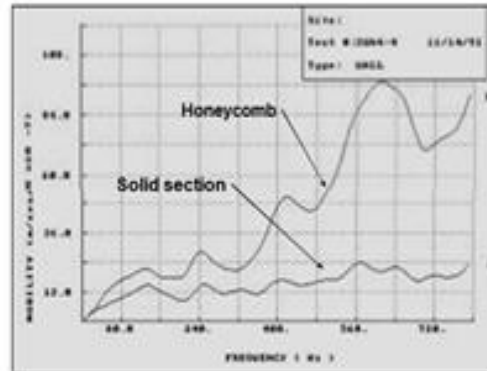
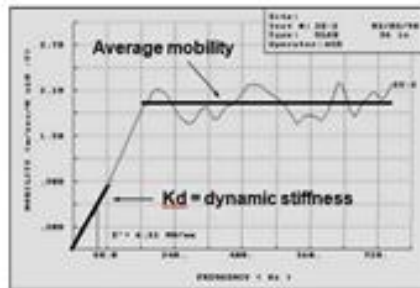
Figure B.11 Impulse Response Systems (top) and Data (bottom)

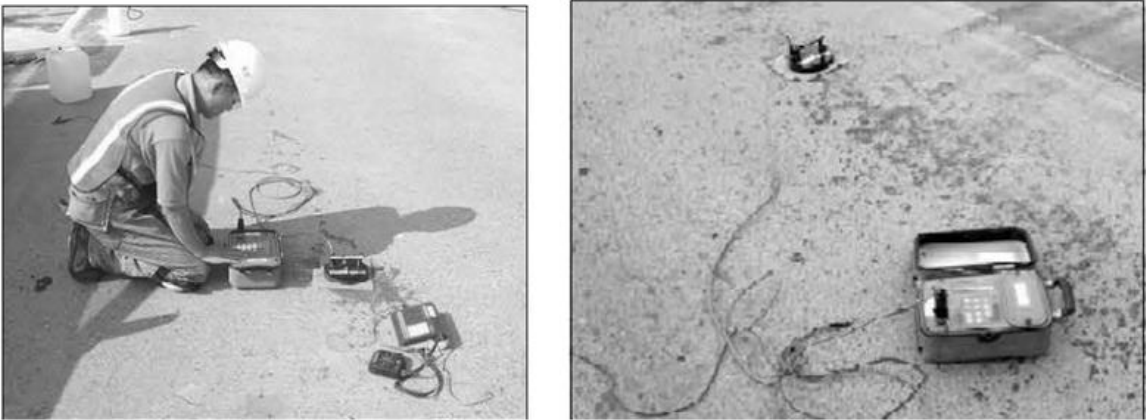
Figure B.13 Examples of Linear Polarization Equipment

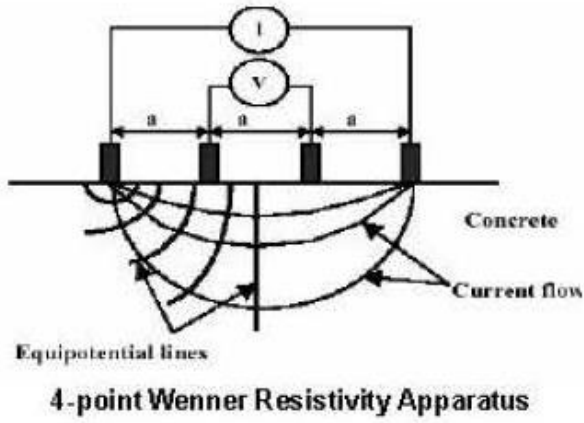
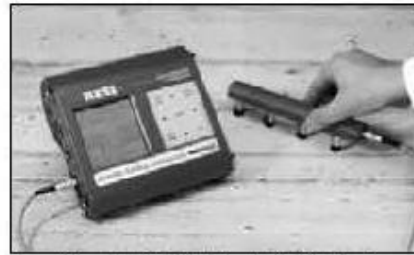
Corvib RESI Resistivity Meter

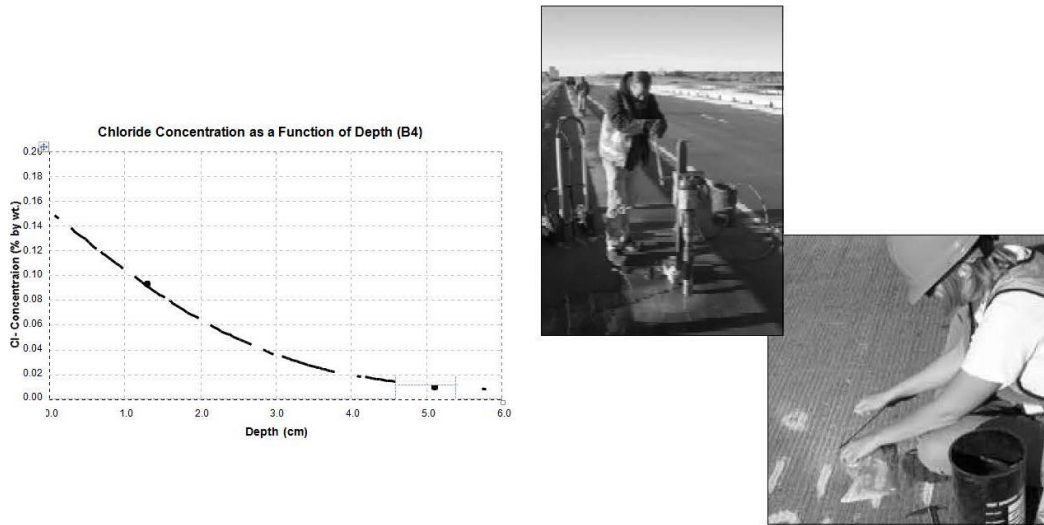
Figure B.15 Chloride Measurement and Example Data

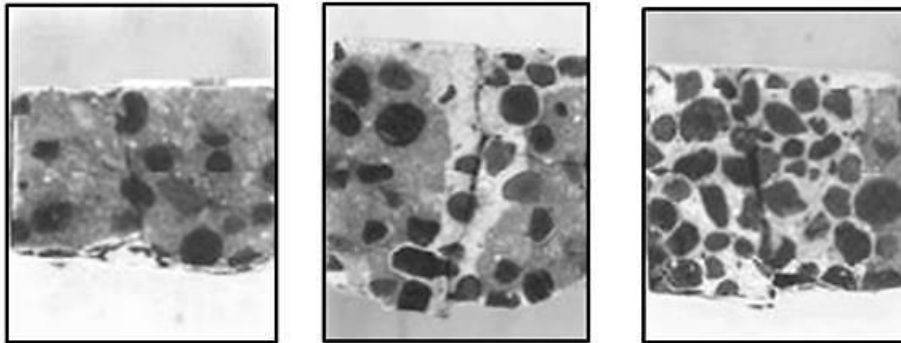
Figure B.17 Pink (darker) areas have pH > 10. Neutral areas are carbonated. Note carbonation along cracks, which provide some indication of crack age.

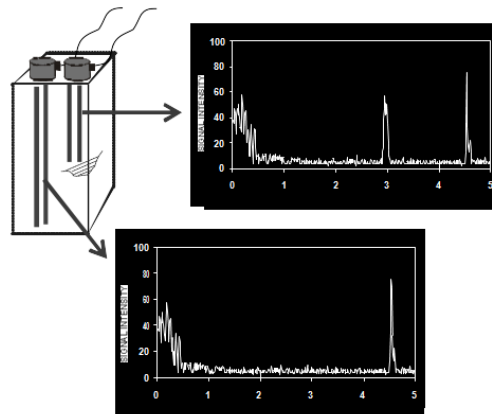
Figure B.18 Schematic of UT and Example Output Data

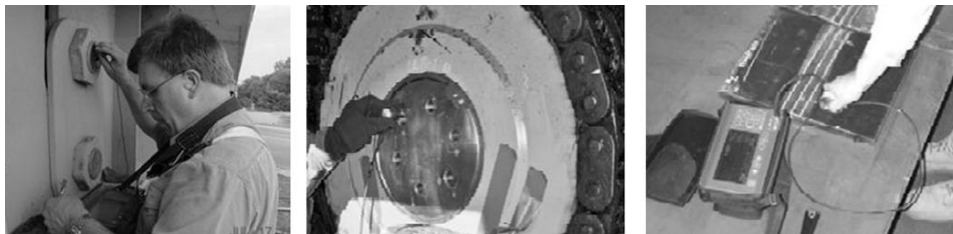
Figure B.19 UT Inspection of Bridge Hanger Pins (left), Bogie Shaft (middle), Sample CJP Weld (right)

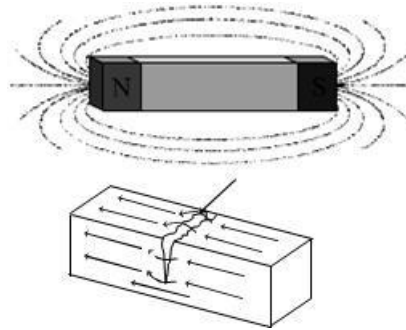
Figure B.20 Examples of Magnetic Fields

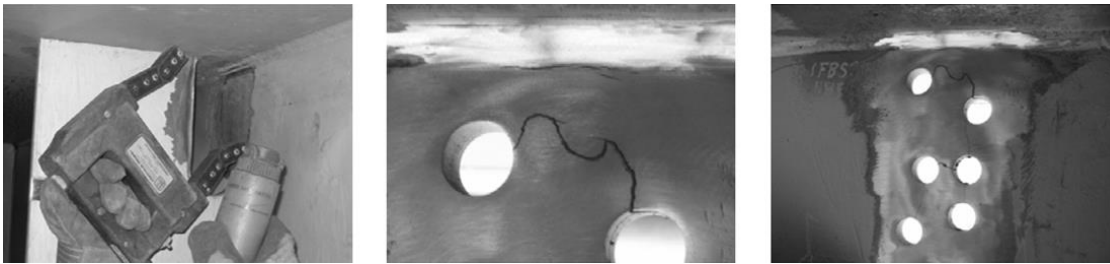
Figure B.21 Magnetic Particle Testing Showing: Magnetic particle yoke and particles in use after primer and paint removal (left); Crack after magnetic particle application (middle); Numerous cracks at a transverse floor beam (right)
