Chapter 6 – Table of Contents

Chapter 6 - Approach Slabs and Approach Roadway

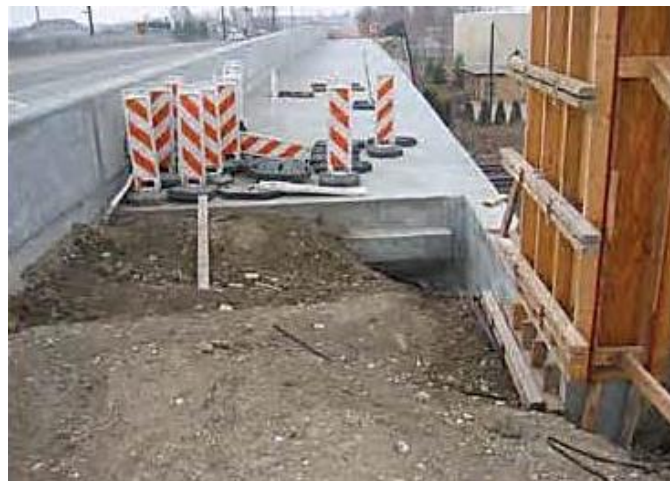
Figure 6.3 Non-Compacted Granular Backfill Behind a Bridge Abutment (Courtesy of Iowa DOT)

- Granular backfills compacting further over time, most often a result of poor compaction during construction (see Figure 6.3)
 - Creates voids
 - Creates faulting of the slab

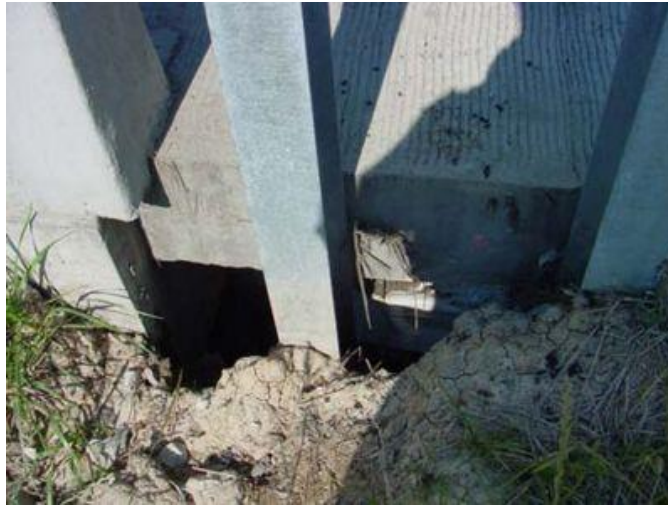
Figure 6.5 Void under Approach Slab (Courtesy of Missouri DOT)

- Poorly compacted fill material adjacent to the abutment that continues to consolidate over time.
- Voids behind the abutment resulting from scour caused by the waterway or erosion from surface drainage (see Figure 6.5). Spill through or column abutments are particularly prone to this problem. A small rock drill or ground-penetrating radar can be used to locate and determine the size of voids under the pavement (see Figure 6.6).
- A slight tilting of the abutment from uneven settlement or from scour caused by the waterway that creates a small void near the pavement seat. The pressure of the pavement pushing against the abutment, producing additional movement can further aggravate this situation.

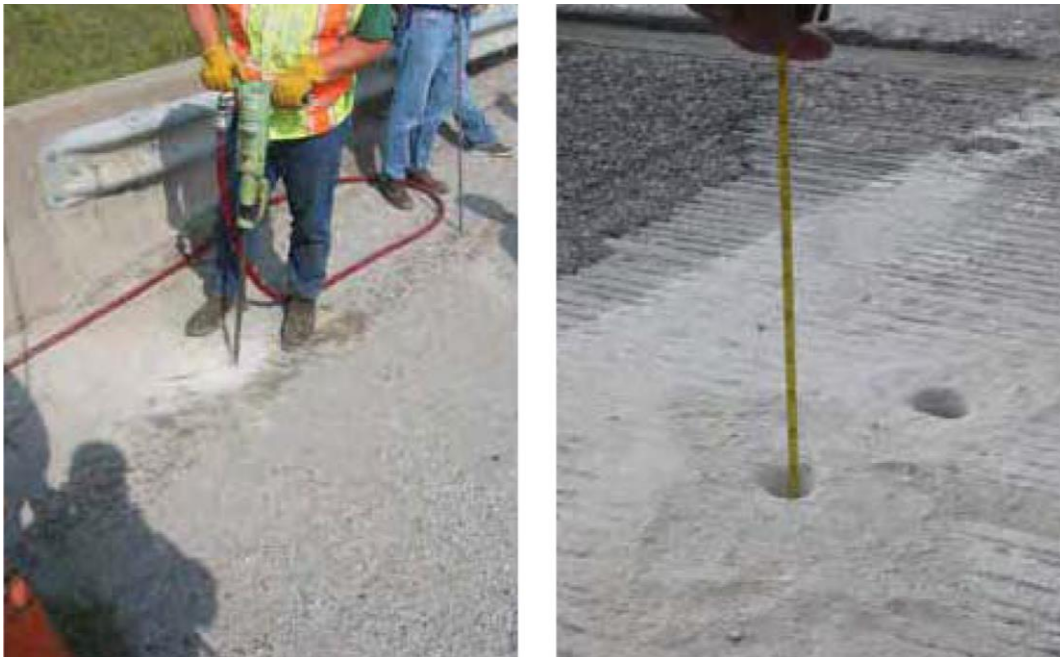
Figure 6.6 Drilling through the Approach Slab (left). Measuring the Depth of the Void (right). (Courtesy of Iowa DOT)

If settlement is occurring, it is very important that the cause of the problem be determined. If scour is creating a void, the condition could become unsafe. Additional layers of blacktop will only temporarily hide the problem and contribute to the unsafe condition because of the increased dead load over the void.

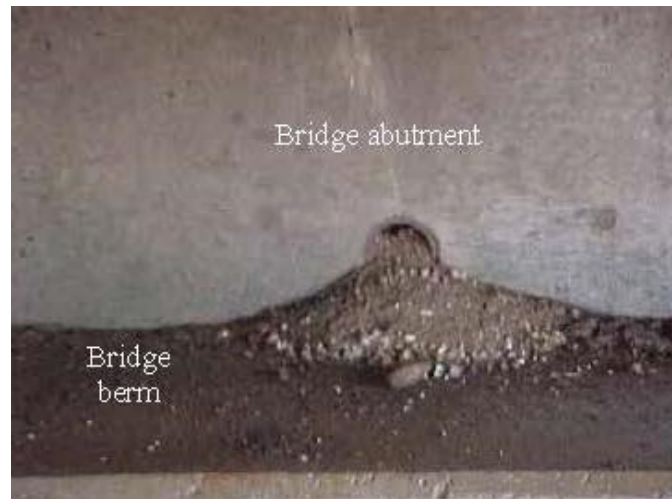
Figure 6.7 Weepholes Filled with Backfill Material (Courtesy of Iowa DOT)

Inadequate drainage of abutment backfill is a common problem. Abutment subdrains and weep holes often do not function as intended, or have failed completely, due to being blocked by soil deposits or debris; an example of this is provided in Figure 6.7. Subdrain failure is often a result of non-porous backfill being placed around them. Abutment subdrain failure can lead to erosion of slopes and collapses of armoring.

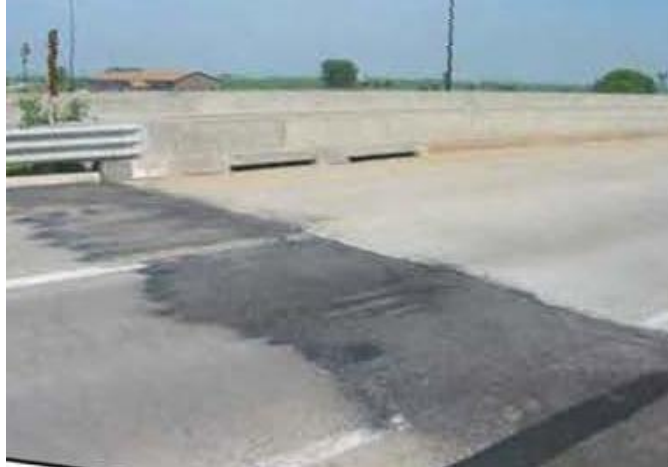
Figure 6.8 Asphalt Ramp Placed at the Approach Slab

- Patching of spalls (potholes) in the approach slab with asphalt, typically performed on an annual basis
- Placing a temporary asphalt ramp at the end of the bridge when an approach made of poor soils heaves or settles, resulting in a rise or drop of the approach slab in relation to the bridge deck elevation (see Figure 6.8)

There are various methods that can be used to address slab settlement. Installing an asphalt pavement ramp on the approach pavement to compensate for the settlement is a common temporary repair that was mentioned in Section 6.3.1. Alternatively, approach slab overlays, such as those discussed earlier in this chapter, can be applied with varying thicknesses to compensate for the settlement.

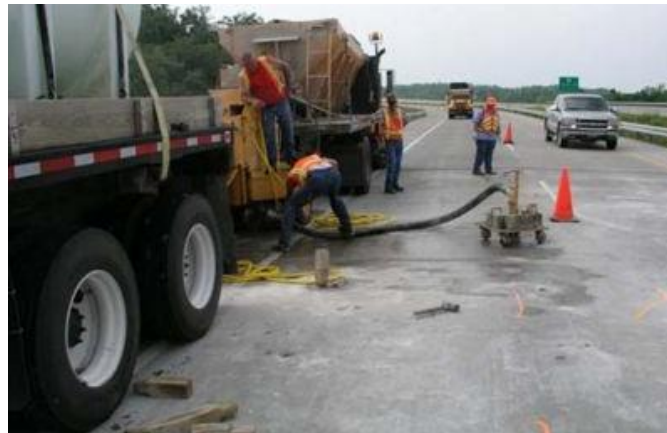
Figure 6.10 Mudjacking Slurry Pumped Under Approach Slab (Courtesy of Missouri DOT)

4. Pump the slurry into one of the two open holes, awaiting the slurry to appear at the other hole, as shown in Figure 6.10.
5. Cover one of the current open holes and remove the seal from a different hole.

An example of mudjacking slurry being pumped under an approach slab is shown in Figure 6.10.

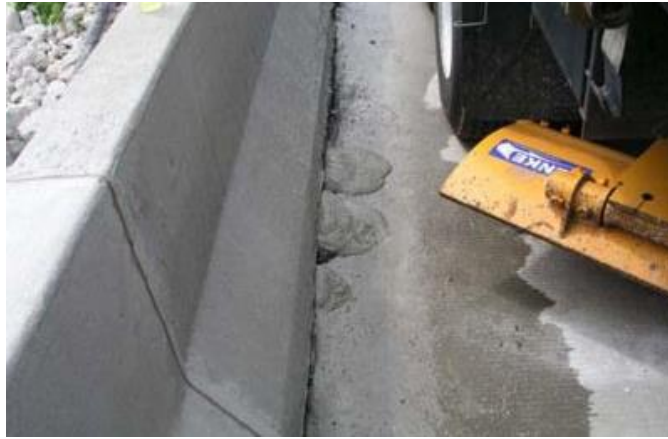
Figure 6.11 Mudjacking Slurry Blowing Out at Barrier (Courtesy of Missouri DOT)

If slurry appears through the shoulder, as shown in Figure 6.11, an old grader blade can be wedged along and below the pavement edge. Shoulder material can then be added and compacted to seal off the blowout. A wide plank, with the dual wheels of the mudjacking equipment placed upon it, is also effective in keeping the shoulder material from blowing out.

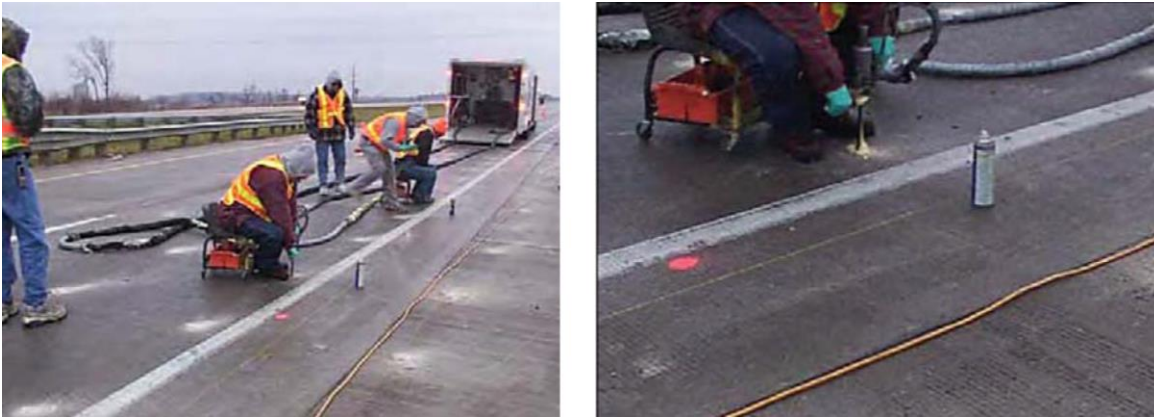
Figure 6.12 Injecting Expansive Polyurethane under Approach Slab (Courtesy of Iowa DOT)

A contractor has developed a method that involves injecting expansive polyurethane under the approach slab to lift the pavement back to its original profile; this method is depicted in Figure 6.12. Grout holes are drilled through the existing approach slab, and then injected by a pumping truck with expansive polyurethane foam that, as it expands, will lift the approach slab and provide an underseal to the slab. Within 15 minutes, 90 percent of its maximum compressive strength is reached. The holes are then filled with non-expansion grout to prevent water and debris from infiltrating the slab. Tests in Oklahoma, Michigan, and Texas found this method to be effective for at least 10 years when properly conducted.

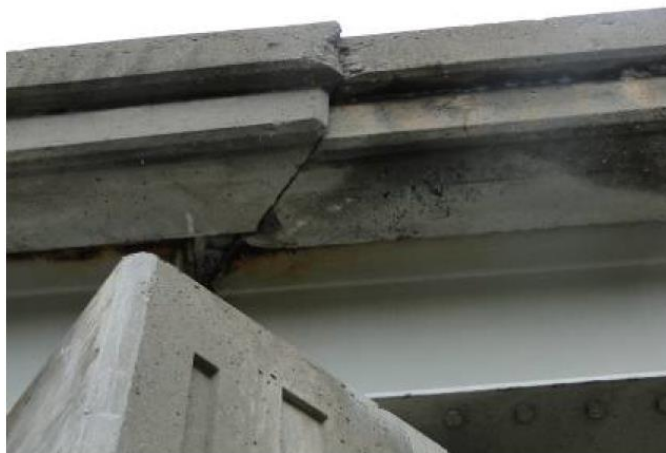
Figure 6.14 Expansion Joint Permanently Closed due to Approach Pavement Growth (Courtesy of MDOT)

- Closed expansion joints (see Figure 6.14)
- Damaged or crushed concrete barriers (see Figure 6.15)
- Railing tube separation at joints between two sections of steel or aluminum railing (see Figure 6.16)
- Diagonal deck cracking at ends of bridge (see Figure 6.17)
- Closed pin and hangers, especially if during cold weather
- Severely tilted rocker bearings, especially if during cold weather
- Beam end contact with backwall, or a backwall that is not vertically plumb

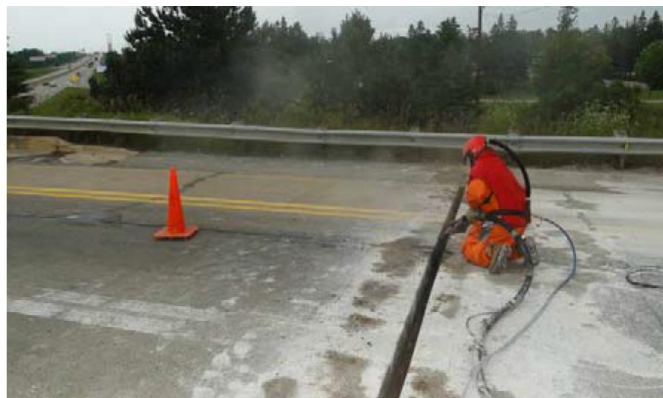
Figure 6.21 Sandblasting the Vertical Surfaces of the Joint Opening (Courtesy of MDOT)

3. After concrete removal, dry the vertical surfaces with air and sandblast the vertical surfaces to aid the bonding ability of the lubricant adhesive (see Figure 6.21).
