Performance Evaluation of Limerock, Cemented Coquina, and Shell Rock as a Base Material

FDOT Office
State Materials Office

Experimental Project Location
County Section 94030-3506
State Road 70
St. Lucie County

Date of Publication
March 2011

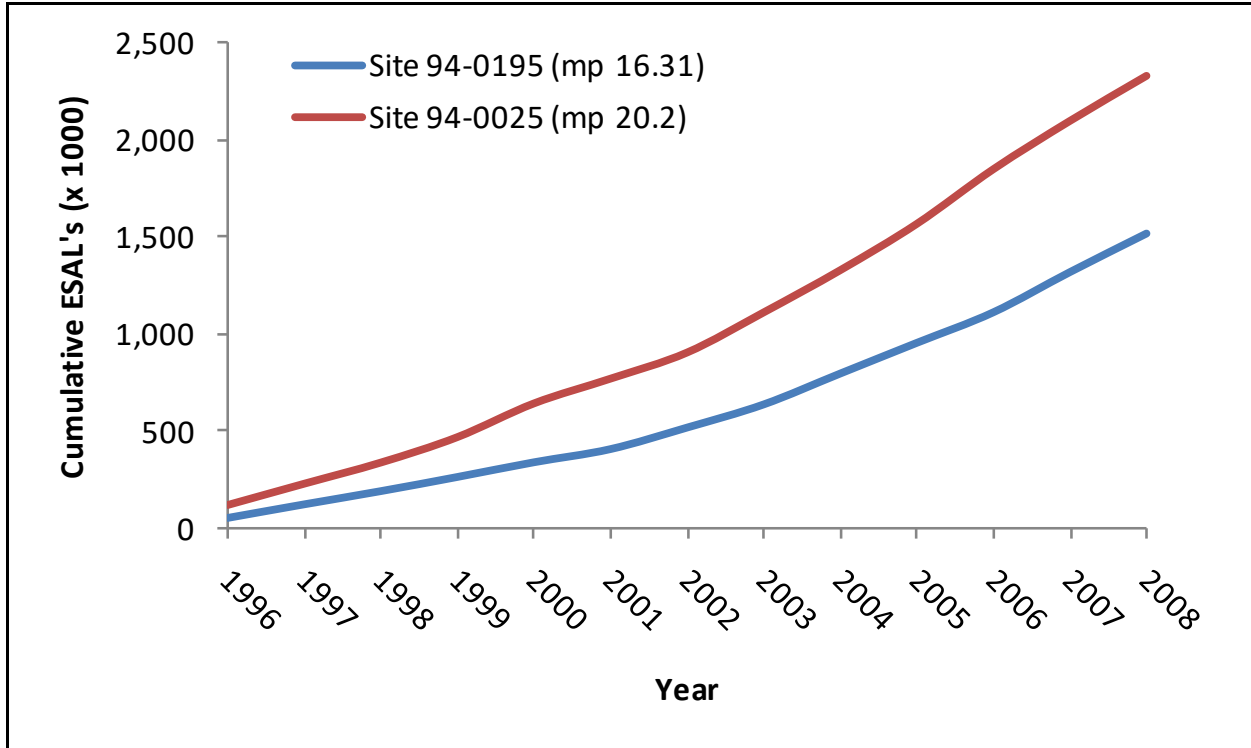
FIGURE 1 SR Traffic summary.

The experimental project is in the westbound travel lane of SR 70 just a few miles west of the Turnpike and I-75 in St. Lucie County. The roadway in this area consists of four 12-foot lanes divided by a grassy median. The three 1,500-foot-long test sections were constructed as a segment of County Section 94030-3506. The experimental sections consisted of 4 inches of hot-mix asphalt (HMA), 10 inches of base, and 12 inches of subgrade. The locations of each section are described in TABLE 2. The experimental sections were initially constructed in 1996 and resurfaced in 2008. Traffic monitoring sites are located at MP 16.310 and MP 20.200. The site located at MP 20.200 is less than 0.5 miles from the Turnpike access ramp and has recorded increased traffic levels. FIGURE 1 summarizes the ESALs for the project. Prior to resurfacing in 2008, 1.5 million ESALs were recorded at MP 16.310 and 2.3 million ESALs were recorded at MP 20.200. Rainfall data from 1999 to 2008 is presented in FIGURE 2.

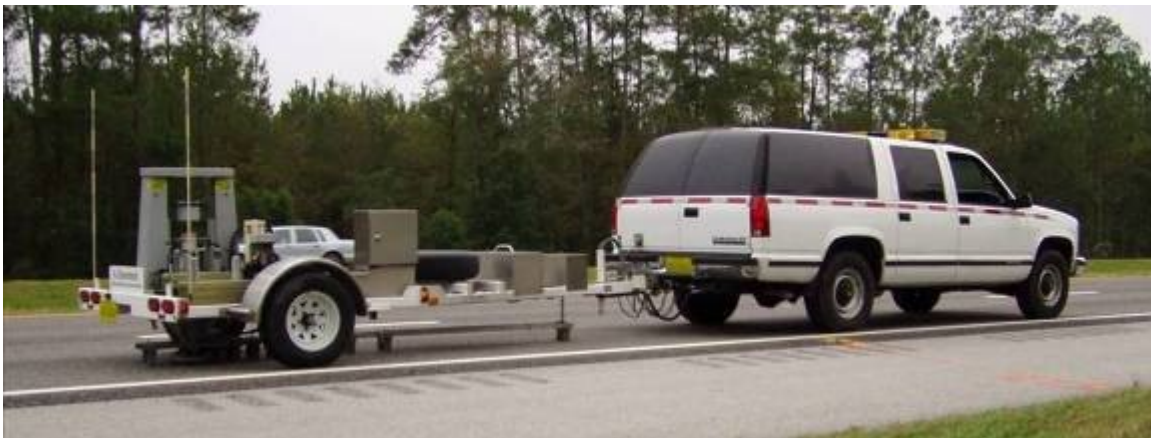
Annual deflection measurements are made in the outside wheel path of each lane. A photograph of a FWD is shown in FIGURE 3. A typical testing configuration includes the following:

- A 12-inch load plate
- A 9-kip load
- Deflection sensors placed at 0, 8, 12, 18, 24, 36, and 60 inches from the load plate

FIGURE 3 Falling Weight Deflectometer.

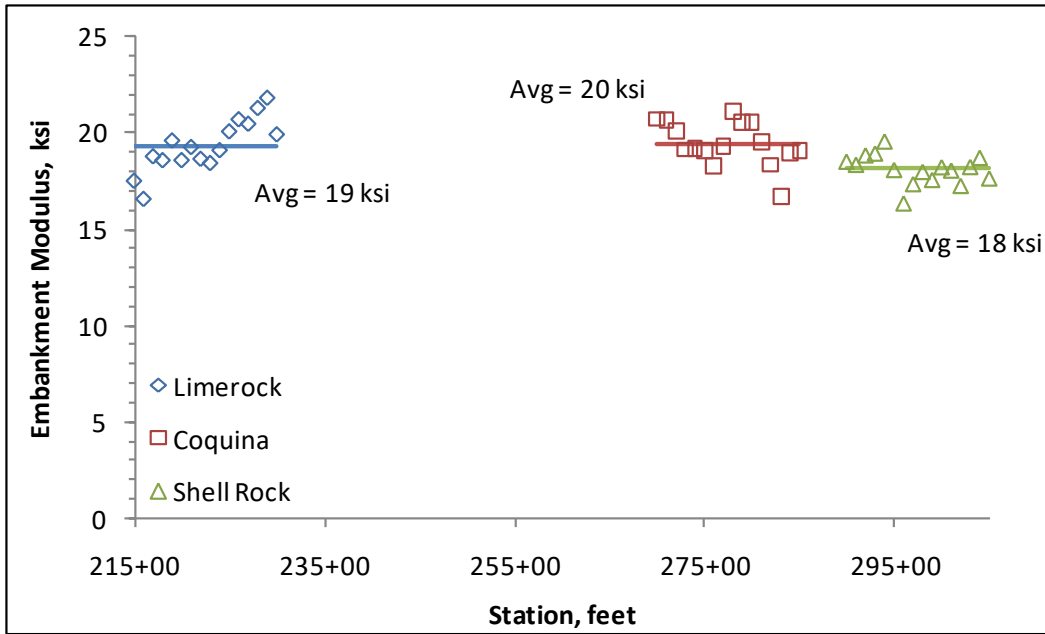
FIGURE 4 Embankment modulus measured during first survey year (1996).

The stiffness of a pavement system may be inferred through the analysis of deflection basins or by estimation of layer moduli through backcalculation or forward calculation. Backcalculation is a process used to estimate pavement layer moduli by matching estimated deflection basins with measured basins through an iterative process. The backcalculated embankment modulus during the first year of the experimental project is shown in FIGURE 4. The embankment modulus for each section is similar, ranging between 18 and 20 ksi, and should not influence the results of the study. The initial deflection basins measured in 1996 and 2007 are shown in FIGURE 5. The basins show that the initial stiffness of the three sections is similar. In 2007, the section with the limerock base is slightly stiffer than the Coquina section and the section constructed with a Shell Rock base was slightly weaker than the other sections. A complete FWD survey was not possible in 2008 due to the resurfacing effort. FIGURE 6 shows the variability of the backcalculated base modulus measured since 1996. Overall, the limerock base was found to be slightly stiffer than the other two sections.

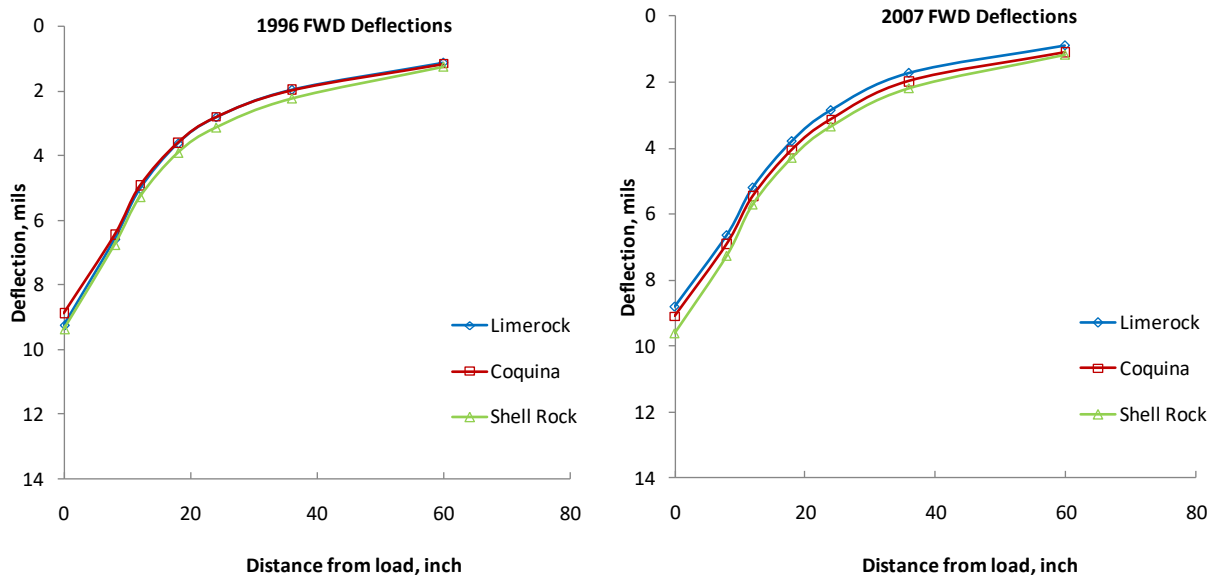
FIGURE 5 Deflection basins.

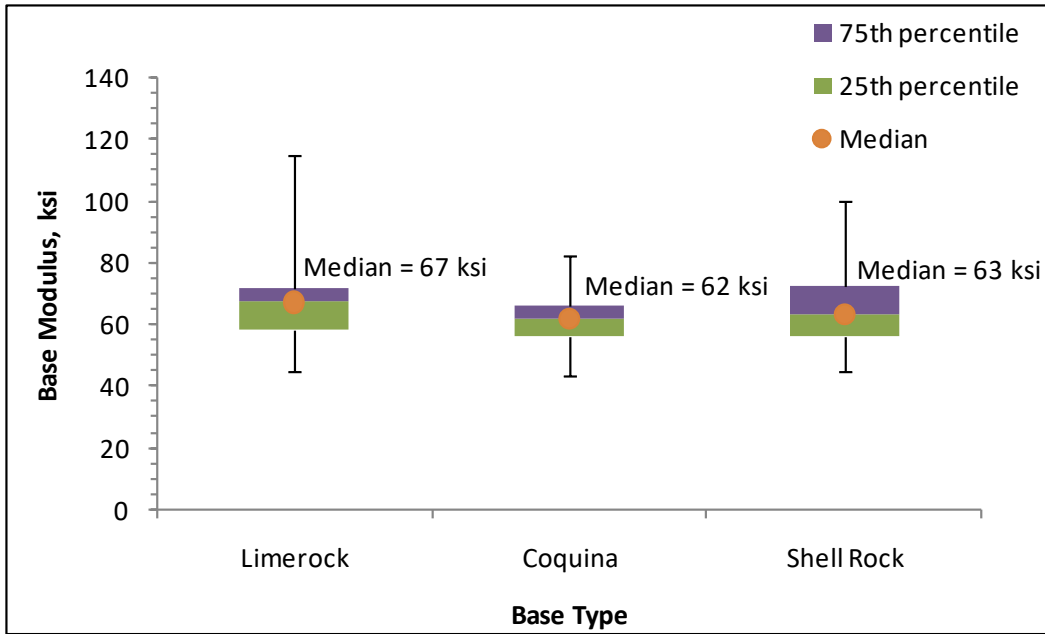
FIGURE 6 Variability of SR 70 base modulus since 1996.

Plate bearing tests and laboratory measurements made during construction showed that the limerock base was the stiffest material and the shell rock base the least stiff. Plate bearing tests performed just after construction through trenches showed that the limerock base was more than 2.2 times stiffer than the shell rock base and 1.5 times stiffer than the coquina. However, FWD data collected during the life of the project showed that the limerock base was just slightly stiffer than either other base type (median limerock base modulus of 67 ksi compared to 62 to 63 ksi for coquina and shell rock, respectively).

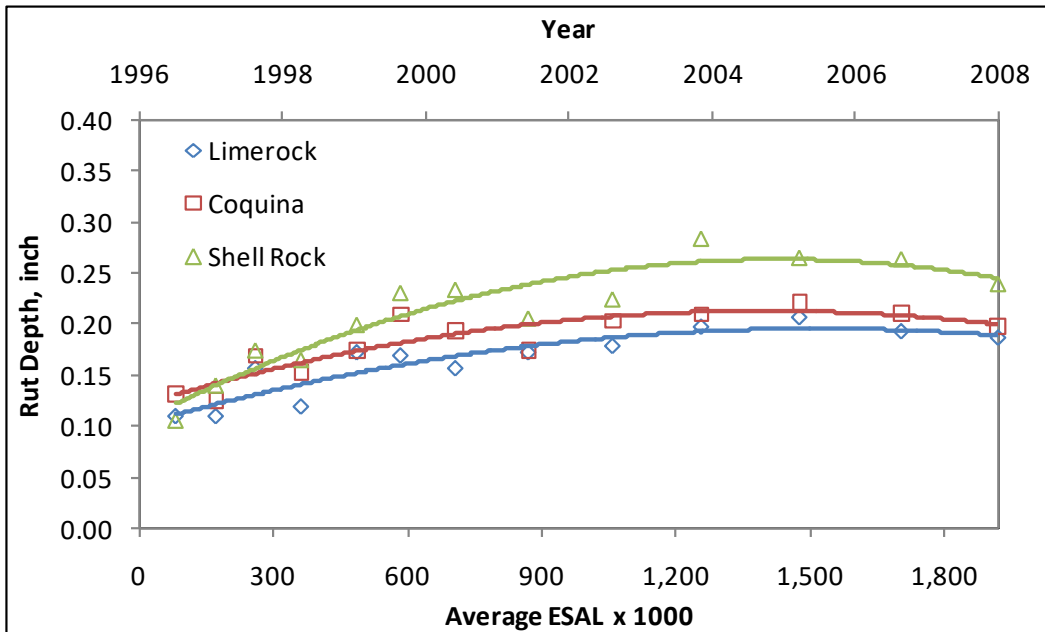
Permanent deformation, or rut depth, is measured manually. The rut depths measured during 2008 for the sections with the limerock, coquina, and shell rock bases were 0.19 inches, 0.20 inches, and 0.24 inches, respectively. While the shell rock base has a slightly greater rut depth on average, as indicated in FIGURE 7, the overall rut depths of the sections are acceptable.

FIGURE 7 Rut depth measurements.

The section with the shell rock base rutted the greatest but the overall rut depths of all three sections were still satisfactory prior to resurfacing. Cracking was the most predominant distress of all three sections. The first cracks observed were in the shell rock section five years after construction and included primarily longitudinal cracks in the wheel paths. Cracks were first observed in the other sections two years later. Load and non-load associated crack types were observed. The shell rock section had nearly twice as much cracking as the other two sections in 2008. Since only the extent of total cracking was measured, it is not clear how much load associated cracks were present in each section. As indicated previously, the shell rock base was found to be somewhat weaker than the other sections. Relatively speaking, pavements with weaker support systems result in greater damage than those with stronger systems.

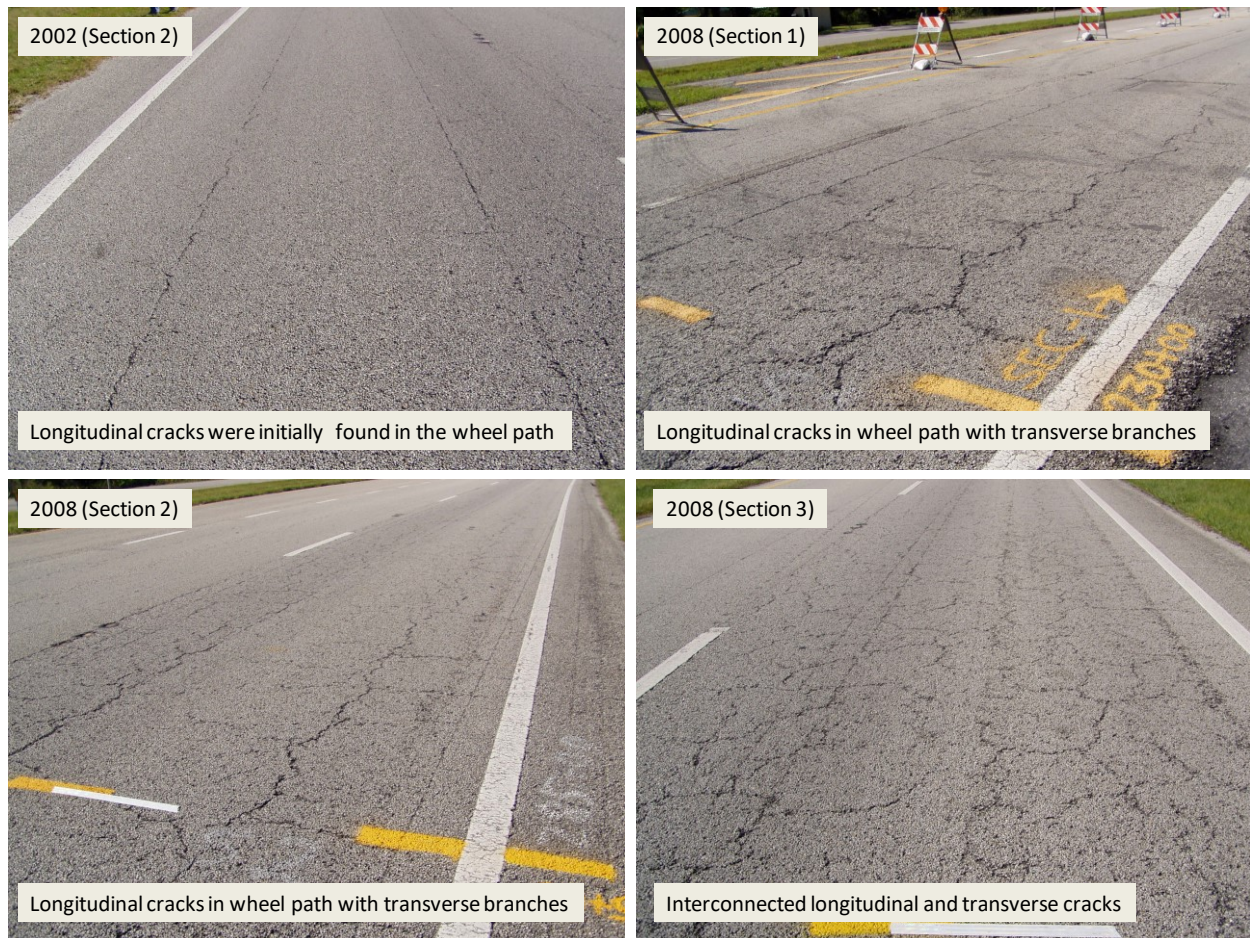
FIGURE 8 Pavement cracking trends: longitudinal crack in the wheel path initially.

The first cracks were observed in the Shell rock section five years after construction. Cracks were first observed in the other sections two years later. The primary crack type initially observed included longitudinal cracks located in the wheel paths. Later, transverse cracks were observed extending beyond the wheel paths. Block cracking was also evident between the wheel paths. Transverse cracks near the wheel path may be associated with fatigue due to traffic. Block cracking is usually caused by shrinkage of the asphalt due to daily temperature cycling. The presence of block cracking is an indication the asphalt has hardened significantly. Photographs of the crack patterns are shown in FIGURE 8. The shell rock section had nearly twice as much cracking as the other two sections in 2008. FIGURE 9 summarizes the crack measurements prior to resurfacing in 2008.

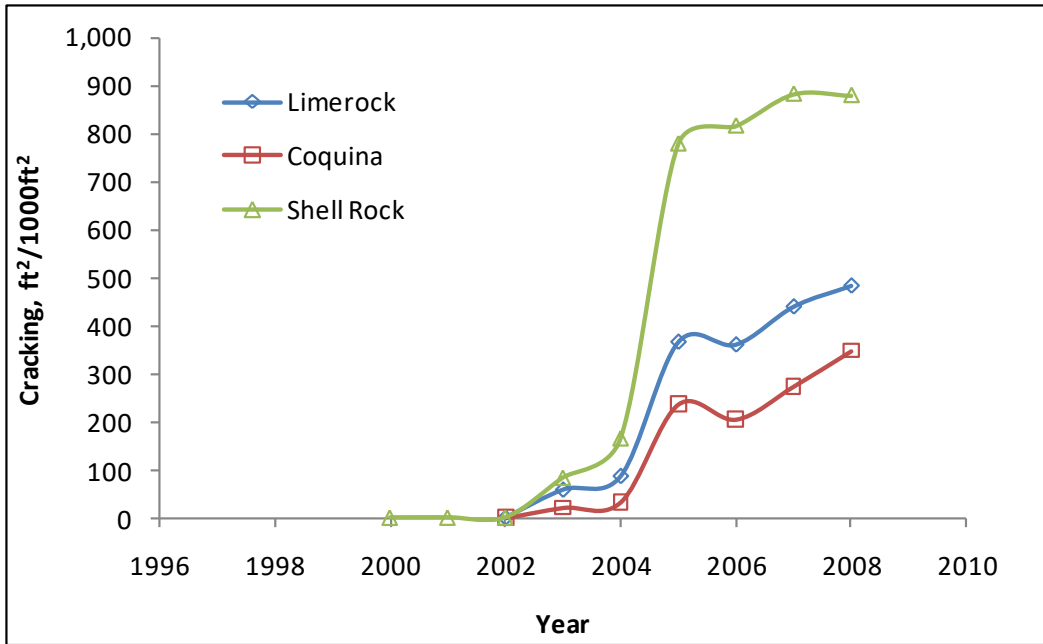
Section	Years Until First Crack	2008 Crack Extent, ft ² /1000ft ²
Limerock	7	484
Coquina	7	349
Shell Rock	5	878

FIGURE 9 Summary of cracking on the SR 70 experimental project.

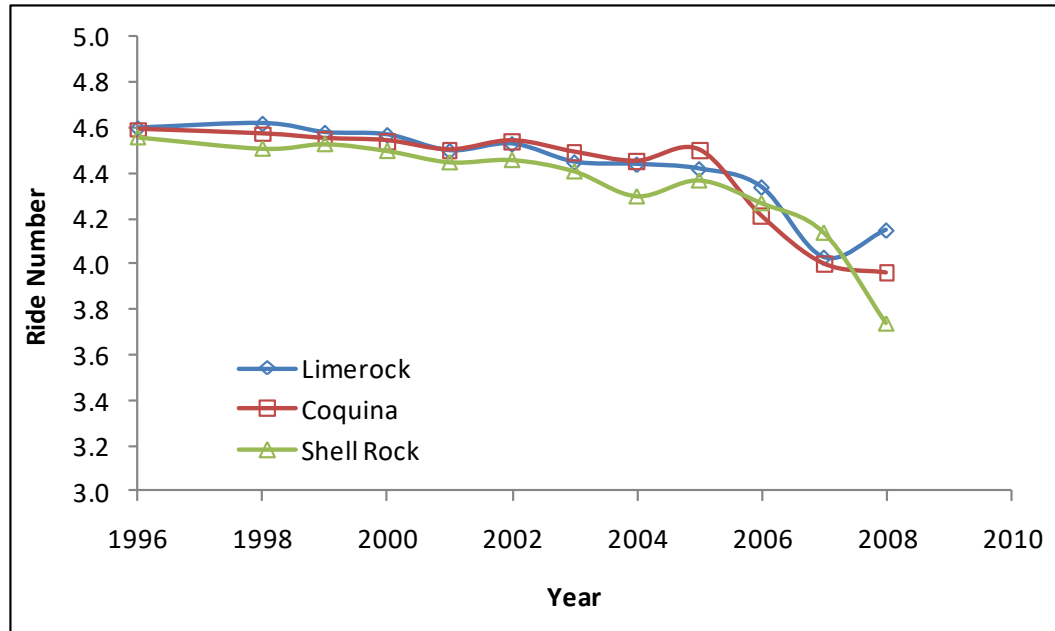
The Ride Number (RN) (ASTM E 1489) is a profile index that rates the ride quality of a road using a scale that corresponds to a user’s perception of pavement roughness. A RN of 5.0 represents a perfect ride quality while an RN of 0 corresponds to a virtually impassable surface. Prior to rehabilitation in 2008, the RN of each section remained above 4.0, for most of the pavement life representing a good ride quality. During the year prior to resurfacing, the RN for the Coquina and Shell Rock dropped below 4.0. FIGURE 10 shows the gradual decline in RN for each survey year.

FIGURE 10 SR 70 Ride Numbers.
