Impact of the Interlayer Scabbing on Pavement Performance

DOT Office

State Materials Office

March 2022

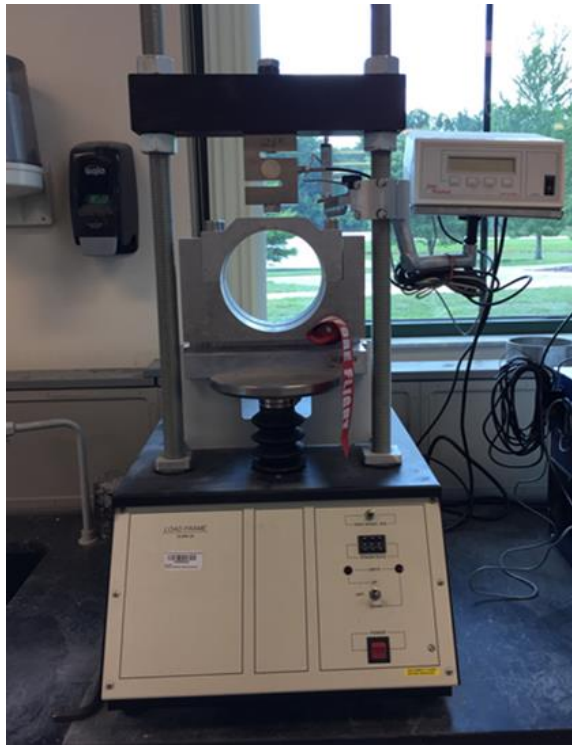
- Interlayer bonding strength: Multiple previous studies identified that the lack of interlayer bonding strength between asphalt layers causes premature pavement distresses, including cracking, rutting, and slippage (1, 2, 3). A total of 36 core specimens were obtained from the areas with different levels of interlayer scabbing, including no-scabbing, moderate scabbing, and severe scabbing. The Florida shear test (FM 5-599) was performed on the core specimens to identify and compare the interlayer bonding strength. Figure 1 shows the testing apparatus developed in the FDOT state materials office.

Figure 1. Florida Shear Strength Testing Apparatus

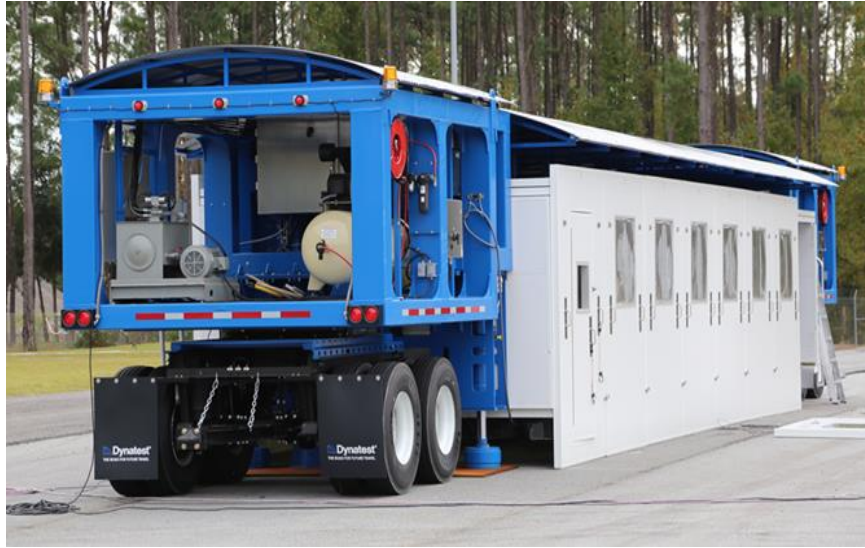
- Accelerated Pavement Testing: Accelerated loading was performed using FDOT's heavy vehicle simulator (HVS Mk VI) to evaluate the rutting and cracking performance of the testing areas. Two test locations were selected and included a section with moderate scabbing and another section with no scabbing. All localized areas of severe scabbing were dedicated to preparing core specimens for the interlayer bonding strength test. After overlay, the chosen locations were trafficked using unidirectional passes of an aircraft tire with 4-inches of wheel wander at ambient temperature. Average ambient temperatures during the APT testing were 78.5°F and 78.0°F for the moderate scabbing and no scabbing sections, respectively. A total of 300,000 passes, including consecutive 100,000 HVS passes of 20-kip, 24-kip, and 28-kip wheel loads were applied to each location. According to the Generalized Fourth Power Law, the HVS wheel loads were equivalent to 14.7 million ESALs. The rut depth was measured intermittently during testing using an onboard laser profiler. Cracking performance was assessed through a visual inspection. In addition, six cores for each testing location were prepared to identify the bonding strength loss caused by the HVS loading. Figure 2 shows the HVS Mk VI utilized for the APT.

Figure 2. FDOT’s HVS Mk VI

Accelerated loading was performed using FDOT’s heavy vehicle simulator (HVS Mk. 6) to evaluate the rutting and cracking performance of the testing areas under closely simulated traffic loading. Based on the visual inspection of the milled surface, one testing area for each of the non-scabbing and minor scabbing conditions was selected. Both test areas were in Section C and had comparable structural design and materials. Figures 8 (a) and (b) show the milled surfaces of the selected testing areas. After overlay, those areas were trafficked using unidirectional passes of an aircraft tire with 4-inches of wheel wander. A total of 300,000300,000 passes, including consecutive 100,000 HVS passes of 20-kip, 24-kip, and 28-kip wheel loads were with up to a 28-kip wheel load was applied to each location

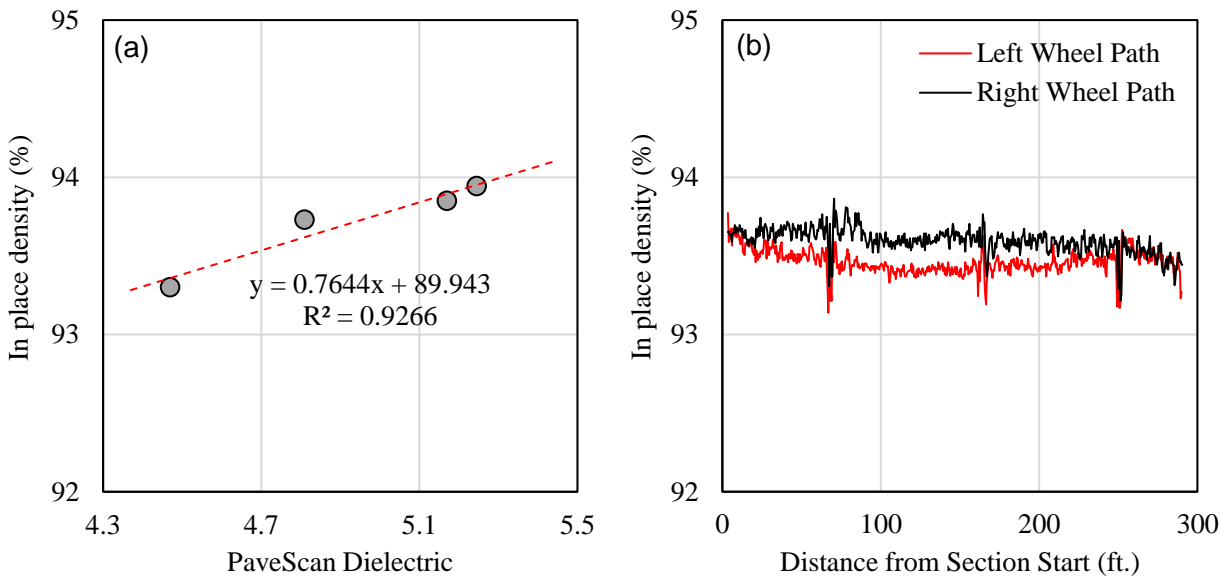
A 1.5-inch-thick asphalt layer was placed on the milled surface using a 12.5 nominal maximum aggregate size Superpave mixture (SP-12.5) with granite aggregate and PG 76-22 Elvaloy modified asphalt binder. The mixture contained 20% recycled asphalt pavement (RAP). After the overlay was placed, it was compacted using a steel drum roller (SAKAI SW850-II). The overlay temperature was recorded behind the paver every 20 ft. using a handheld thermal camera. All temperature readings were within a range of 280 to 300°F. After compaction, the overlay density and uniformity were checked using the PaveScan rolling density meter (RDM). Figure 3 shows (a) the relationship between core densities and PaveScan dielectrics and (b) estimated overlay densities along the right and left wheel path of the test track lane. As presented, all calculated densities of the test track lane ranged from 93% to 94% of maximum theoretical density (Gmm). The density variations observed at the section start/end were due to the vibration of the PaveScan instrument when it was moving over the drop/raise of the surface elevation.

Figure 3. (a) Relationship between core densities and PaveScan dielectrics and (b) Estimated overlay densities

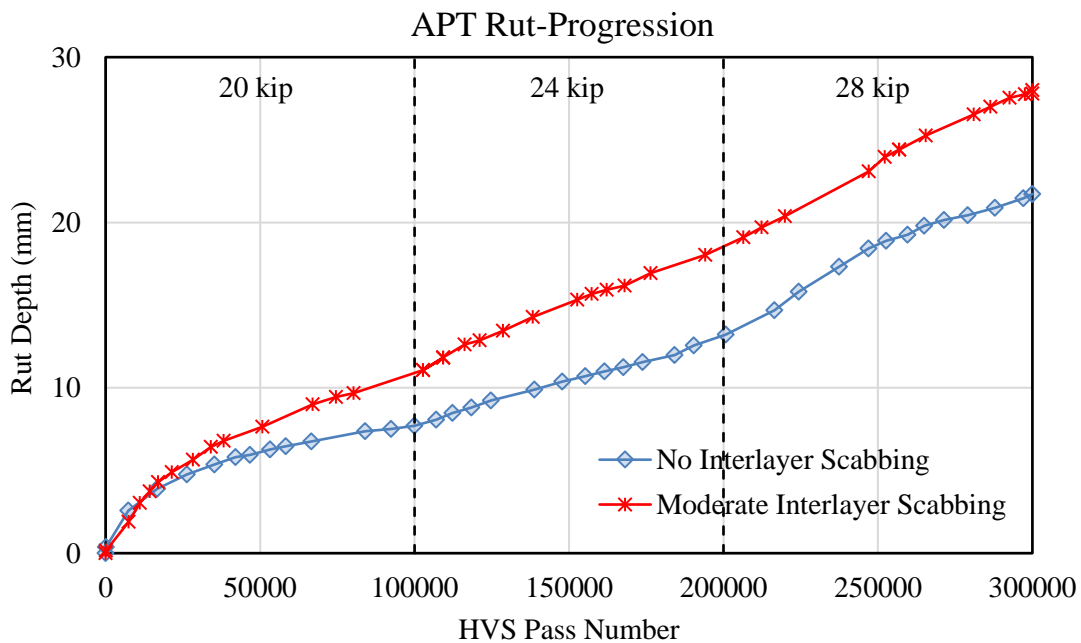
Rut depths were measured using the laser profiler installed underneath the HVS wheel carriage. As presented in Figure 9, the scabbling section experienced approximately 30% deeper rutting throughout the accelerated loading. Under the heavy traffic load, the lack of interlayer bonding strength of the scabbling section may contribute to the deeper pavement deformation since both loading areas have an identical structural design.

Figure 9. Comparison of rut-depth progression

- Rut depths were measured during the accelerated loading using the laser profiler installed underneath the HVS wheel carriage. The rutting of the scabbing area was approximately 30% greater than the rutting of the no scabbing area throughout the accelerated loading area. In addition, the testing areas were visually inspected to compare cracking performance. Some longitudinal cracks were observed along the edge of the HVS wheel path of the scabbing section, while no visible cracks were detected on the area without scabbing.

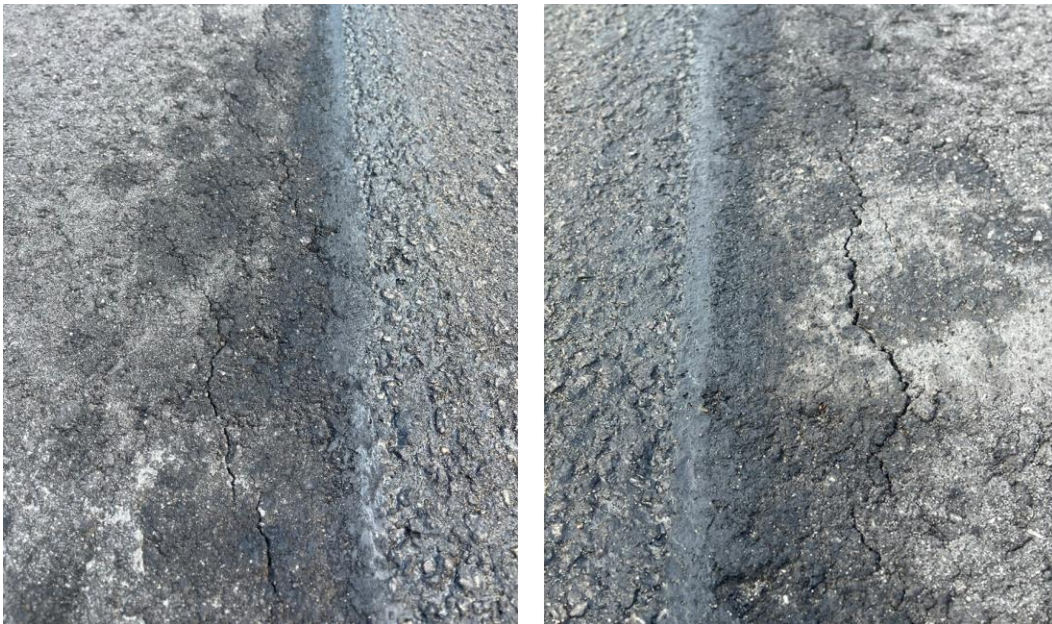
In addition, the loaded areas were visually inspected to compare their cracking performance. Some longitudinal cracks were observed along the edge of the HVS wheel path of the scabbing section, while no visible cracks were detected on the HVS wheel path without interlayer scabbing. These top-down longitudinal cracks are mainly caused by the excessive lateral strain resulting from the permanent deformation caused by the heavy HVS wheel loads, which is magnified in the scabbed section, whereas the non-scabbed section successfully resisted the permanent deformation and lateral strain and did not crack. Figure 10 shows the longitudinal cracks observed on the loaded area with scabbing.

Figure 10. Longitudinal cracks along the edge of HVS wheel-path on scabbing section
