Asphalt Pavement Interlayer Bonding Study

DOT Office

State Materials Office

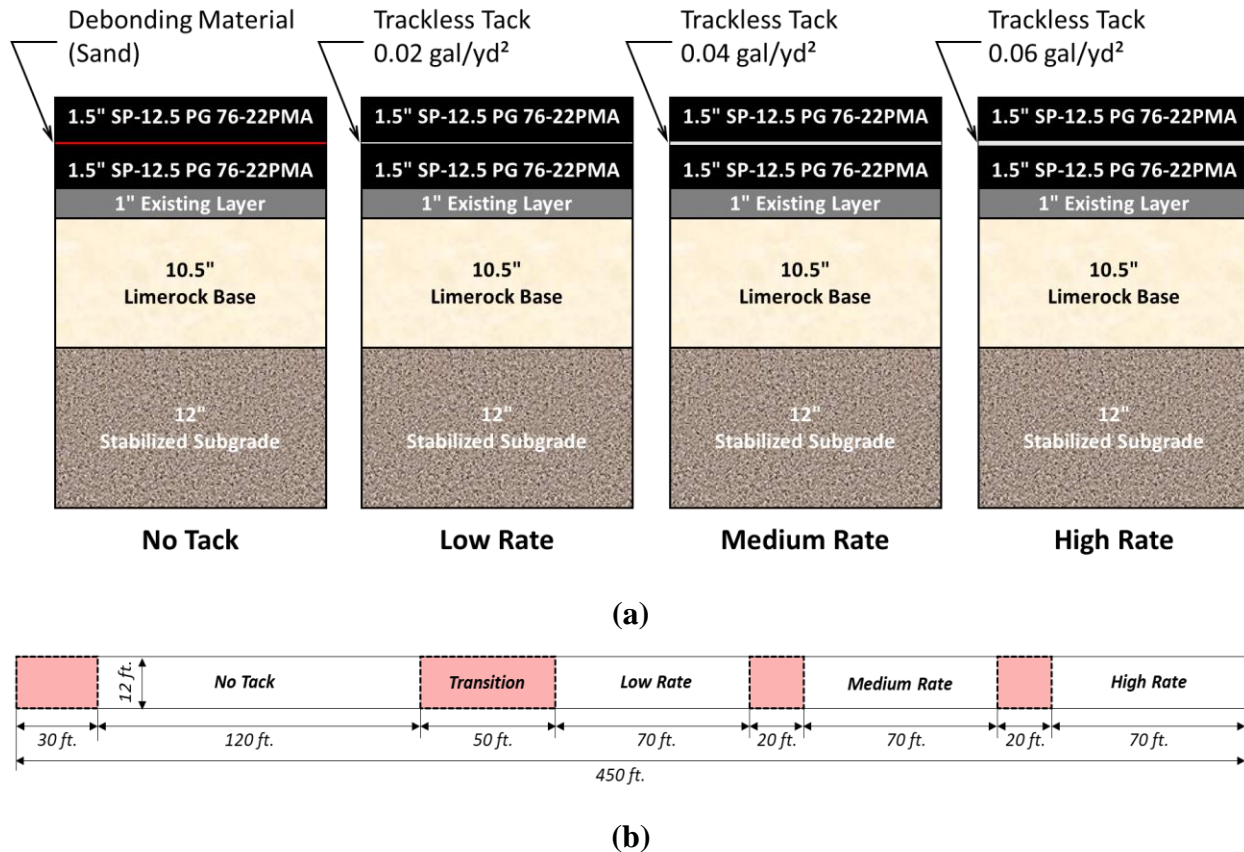
different settings of the distributor to achieve the target residual rates, including no tack, 0.02, 0.04, and 0.06 gal/sy². After 30-minute curing, another 1.5-inch lift of dense-graded mixture was placed on the tacked surface. Figures 1 (a) and (b) show the structural design and layout of the four test sections.

Figure 1. Test section (a) structural design and (b) layout

A 12-foot wide and 450-foot-long test track lane was milled and resurfaced at FDOT's APT facility located at the State Materials Office. Existing HMA was milled to a depth where approximately 1-inch of existing material remained. Tackless tack was applied, followed by a 1.5-inch lift of dense-graded HMA mixture. Next, the trackless tack with a 0.45 dilution rate was sprayed at

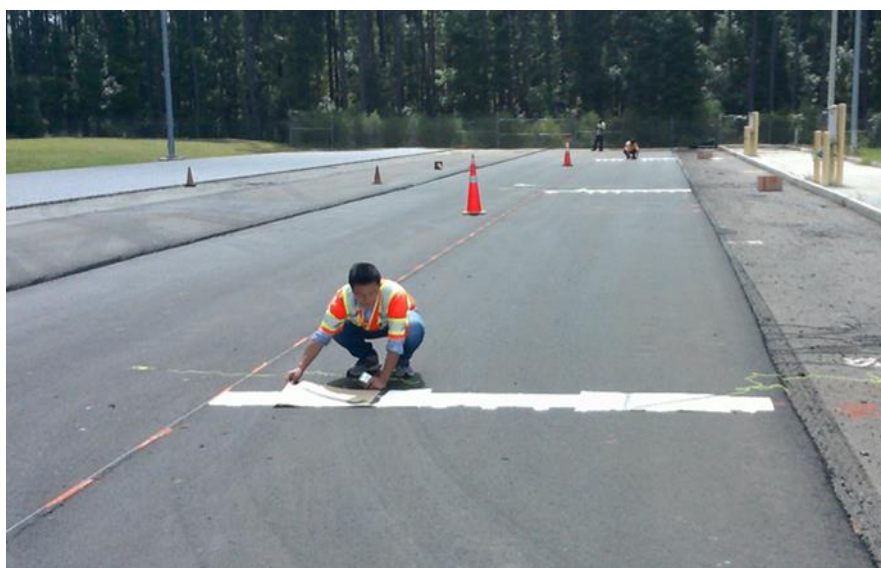
Prior to spraying the tack coat, a total of 12 absorption pads were placed across the width of each test section to verify the actual residual rate applied. Figure 2 shows the absorption pads placed on the test sections. The tack coat rate was controlled by pre-determined flow rates of the sprayer with a constant truck speed of 7 mph. It is noted that the center nozzle of the sprayer was clogged and resulted in a lean application of the center area. This area was excluded from further sampling and testing.

Figure 2. Preparation for measuring tack coat residual rate

After applying the tack coat, the residual rate of each pad was calculated in accordance with the ASTM D2995 method, and the calculated values were averaged for each section. Corresponding application rates were also estimated using the water-to-bitumen ratio of the tack coat emulsion. Of note, the minimum application rate required for the newly paved surface is 0.05 gal/yd² in Florida. Table 1 summarizes the target and measured tack coat rates.

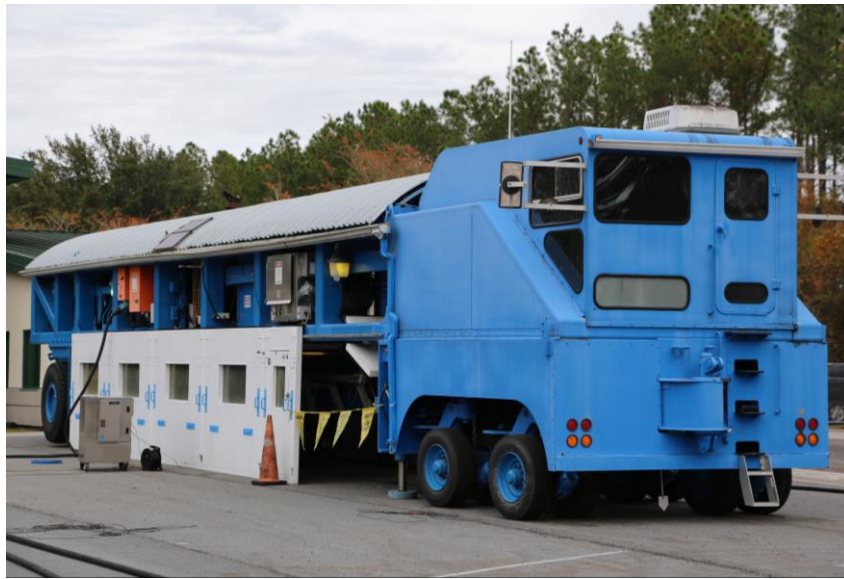
Accelerated loading was performed using FDOT's Heavy Vehicle Simulator (HVS Mk.4), shown in Figure 4. Each loading area was trafficked with unidirectional passes of a super single tire (Goodyear G286 A SS, 425/65R22.5) and 4 inches of wheel wander. A total of 200,000 passes of the 11,500-pound wheel load was applied to evaluate the fatigue performance of each test section. This load is equivalent to 0.6 million equivalent single axle loads (ESALs). HVS loading was performed during the winter season under ambient temperature.

Figure 4. FDOT’s HVS Mark 4 utilized in fatigue performance evaluation

A total of 200,000 HVS passes using a super single tire loaded to 11,500 pounds, equivalent to a half-million ESALs, were applied to a testing area assigned to each test section. An additional 100,000 HVS passes using an aircraft tire loaded to 20,000 pounds were applied to the loading areas in the low and high tack rate sections. The additional HVS passes were equivalent to approximately 2.9 million ESALs. A total of 3.5 million ESALs were applied to each of those loading areas. None of the loaded areas showed signs of fatigue. However, the area in the debonded section exhibited crescent-shaped slippage cracks. Hairline cracks were first observed near the edge of the loading area at 60,000 HVS passes. The cracks then propagated rapidly in a diagonal direction and finally resulted in the shape of slippage cracks. Figure 7 shows the loading area in the debonded section after applying 200,000 HVS passes.

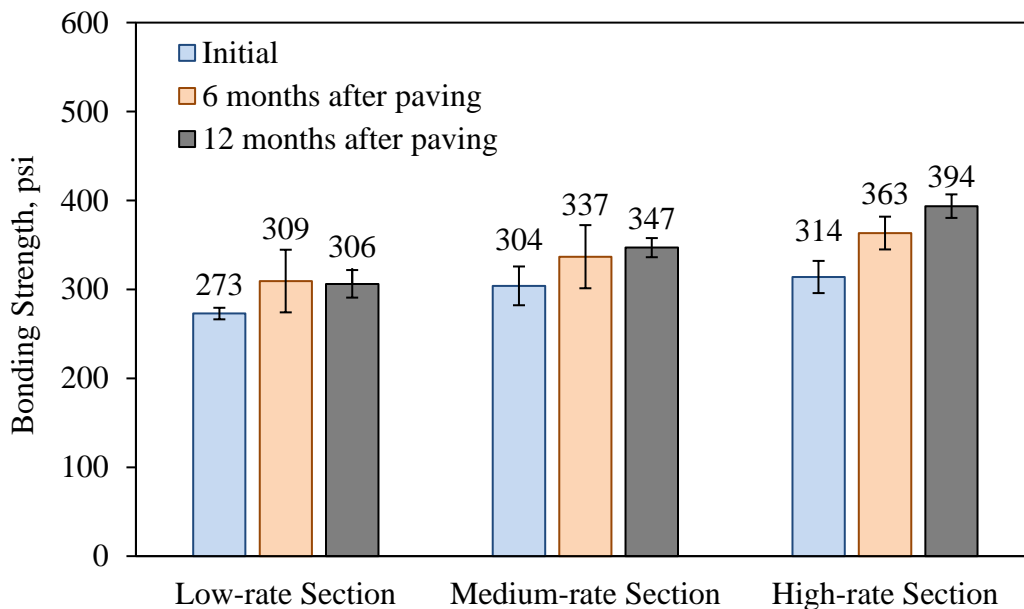
The interlayer bonding test was first performed approximately two months after construction. The second and third sets of tests were performed at subsequent six-month intervals. As presented in Figure 5, all tacked sections showed average shear strength of 270 psi or higher in the first test. A minimum of 300 psi were observed for the second and third tests. West et al. (2005) suggested that an interlayer bonding strength of 100 psi or higher is required to ensure good pavement performance (3). With consideration of the suggested bonding strength requirement, it can be postulated that all tacked sections may exhibit minimal chances of poor performance due to interlayer deficiencies. Figure 6 shows the interlayer condition after the shear strength tests. The interface texture of the low and medium rate section appeared smoother than the high-rate sections, possibly due to the relatively lower bonding strength. Of note, the shear strength test was not conducted on the no-tack section since the top and bottom layers of the core specimens separated during the coring operation.

Figure 5. Comparison of interlayer bonding strength for various tack application rates

- All tacked test sections exhibited average interlayer bonding strengths of 270 psi or higher. With consideration of the suggested interlayer bonding strength identified in a previous study (100 psi), all tacked sections were expected to exhibit good interlayer performance. Compared to the low tack rate section, double and triple amounts of tack coat rates resulted in approximately 10 % to 20 % increases in interlayer bonding strength.

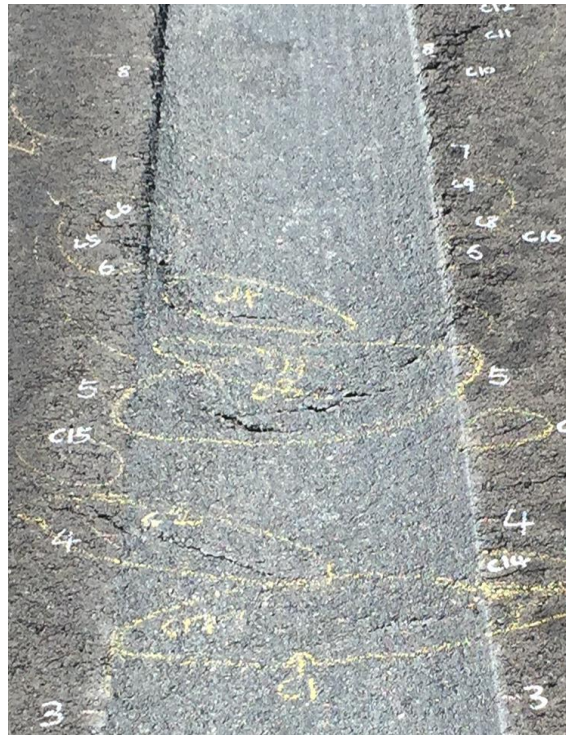
Figure 7. The unbonded section after the application of 0.6 million ESALs

- Despite the significant amount of accelerated loading, 3.5 million ESALs, no cracks were observed on both low and high tack rate sections, whereas the deboned section showed crescent-shaped slippage cracks with less than 0.5 million ESALs equivalent load applied.
