# Quantifying Pile Rebound with Detection Systems Best Suited for Florida Soils

*Task Work Order BDV28 Two 977-07*

Florida Institute of Technology  
Melbourne FL 32901-6975  
321-674-7555 Direct

# Today's Presentation

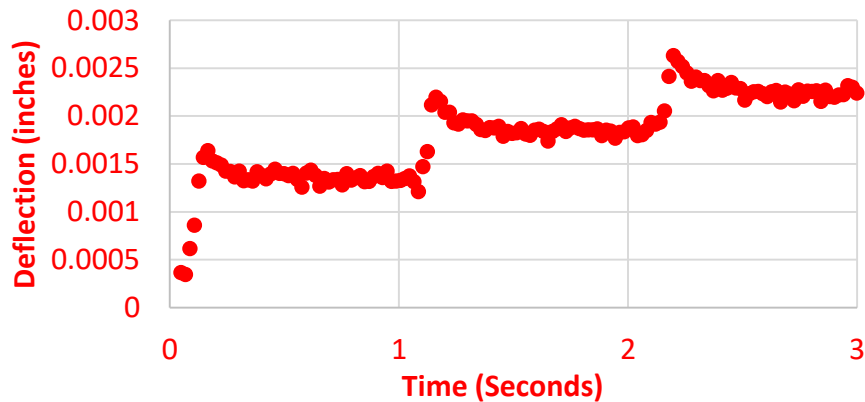
# Cyclic Results show HPR Soils are Viscoelastic

Three deflection versus time cycles @ Ramsey Branch - 63' Site 12    Three deflection versus time cycles @ Heritage Parkway -57' Site 10

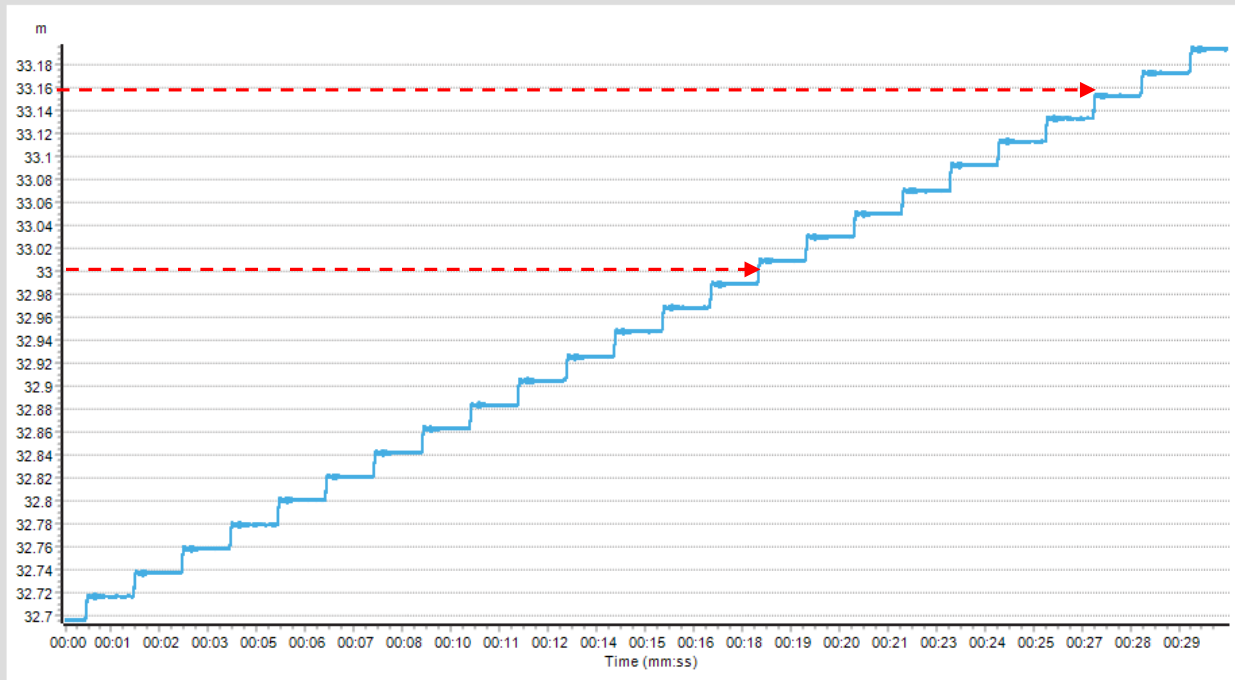
# Reedy Creek PDM Data Near 90'

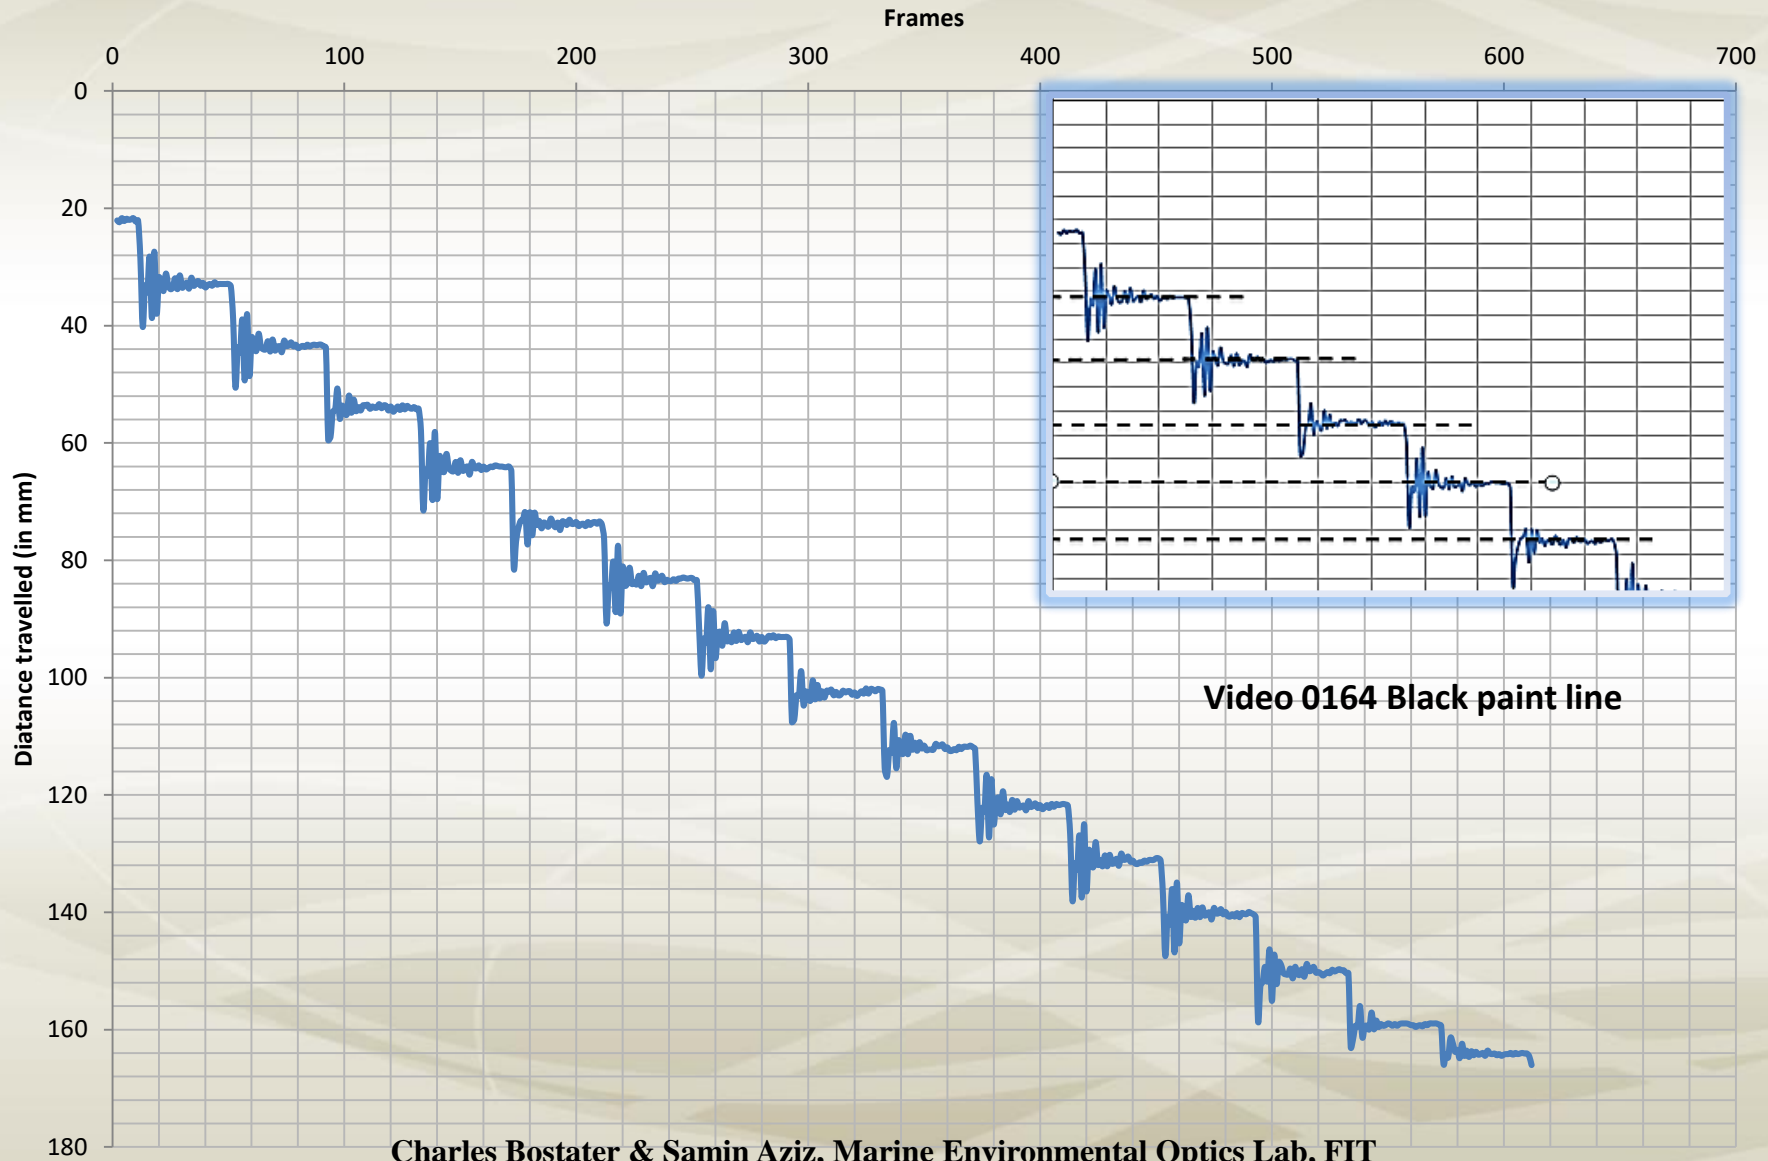
Video 0164 Black paint line

# (mm) vs 60 HZ Frames for Baldwin Bypass Jacksonville Pile: black spray paint line

# Max Displacement, Set and Rebound of Baldwin Bypass video: 0164

Hits	Max displacement (pixels)	Rebound (pixels)
1	88	37
2	82	33
3	93	40
4	93	43
5	87	42
6	87	37
7	79	29
8	75	30
9	85	35
10	88	38
11	85	40
12	100	45
<b>Mean</b>	<b>86.83333333</b>	<b>37.41666667</b>
<b>standard deviation</b>	<b>21.96403837</b>	<b>16.57581139</b>
<b>Standard error</b>	<b>6.340471732</b>	<b>4.785024583</b>
Hits	Max displacement (mm)	Rebound (mm)
1	17.336	7.289
2	16.154	6.501
3	18.321	7.88
4	18.321	8.471
5	17.139	8.274
6	17.139	7.289
7	15.563	5.713
8	14.775	5.91
9	16.745	6.895
10	17.336	7.486
11	16.745	7.88
12	19.7	8.865
<b>Mean</b>	<b>17.10616667</b>	<b>7.371083333</b>
<b>standard deviation</b>	<b>4.326915559</b>	<b>3.265434843</b>
<b>Standard error</b>	<b>1.249072931</b>	<b>0.942649843</b>

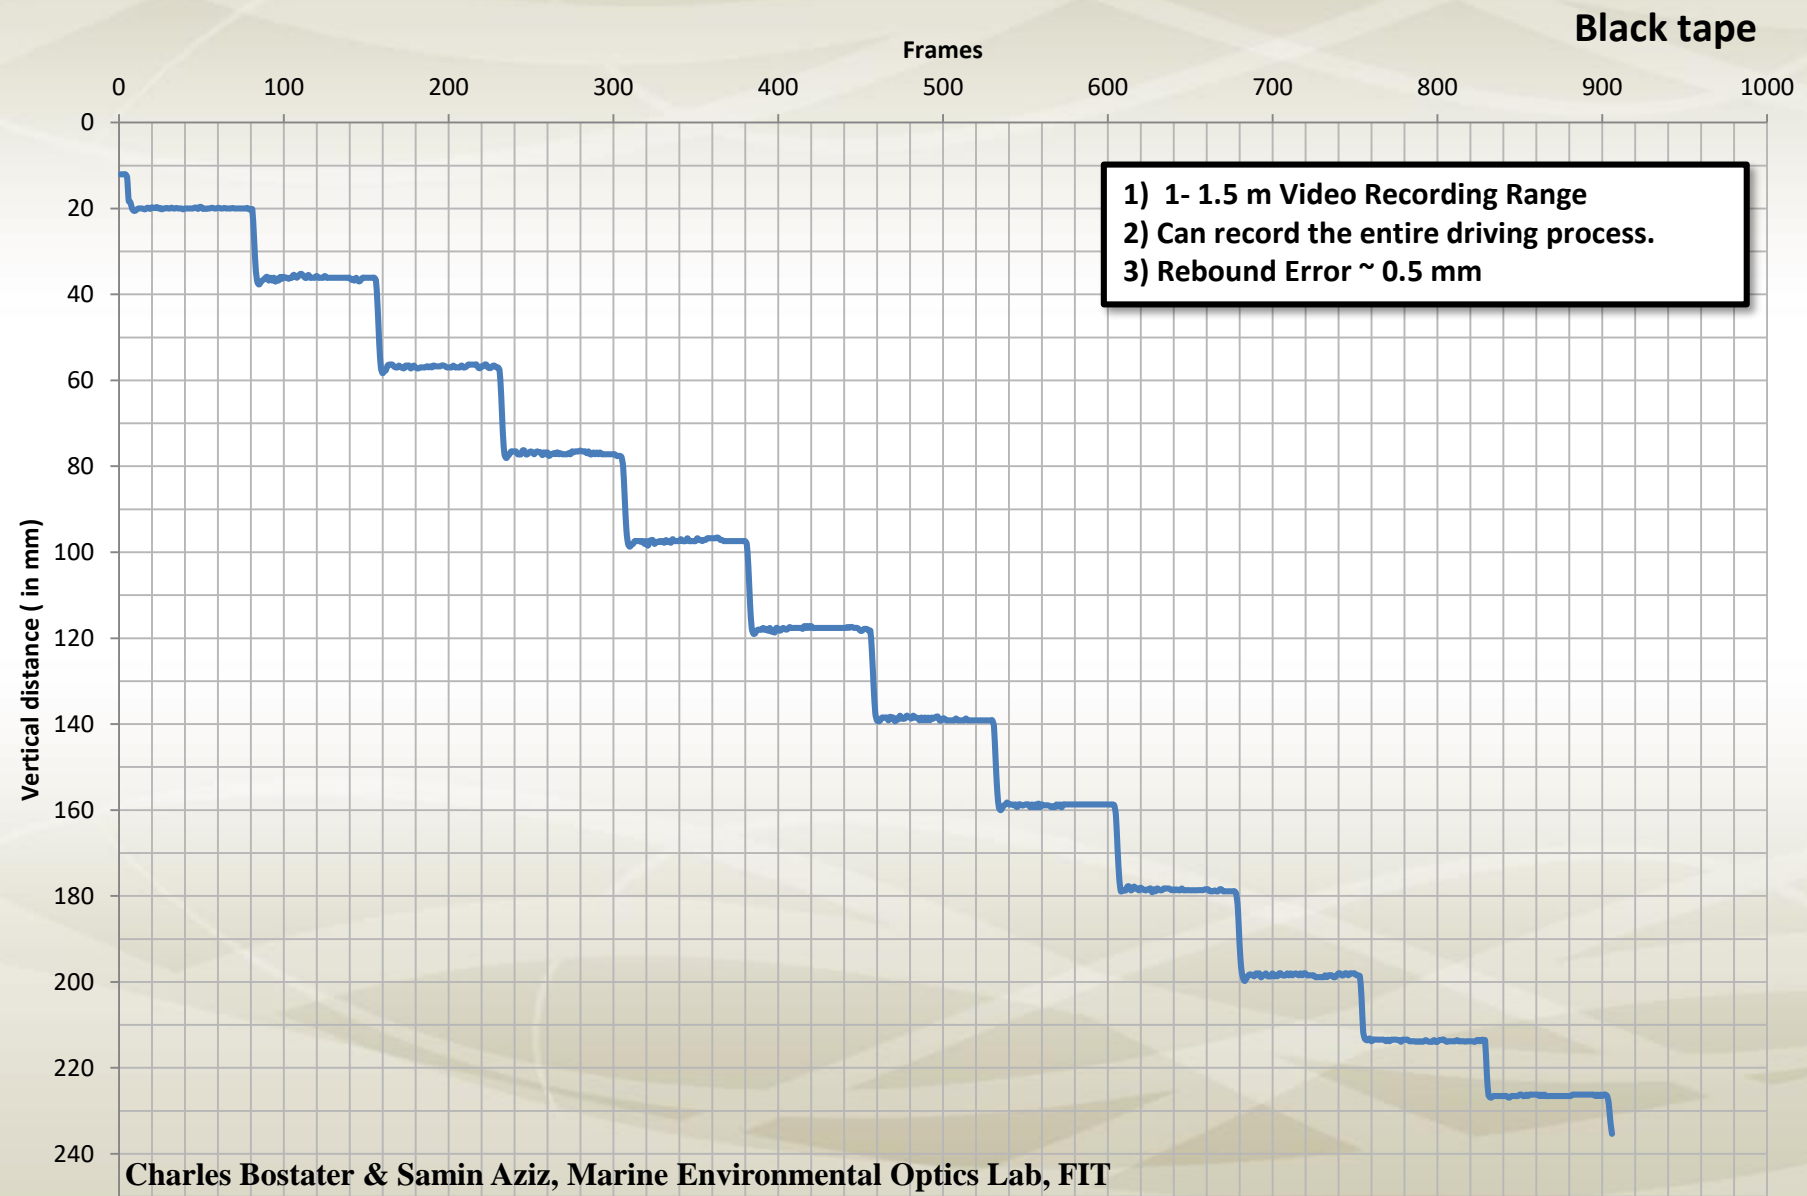
# Vertical distance travelled (mm) vs 60 HZ frame graph

## Orlando Reedy Creek Site - 90<sup>th</sup> ft mark on pile - little rebound detected

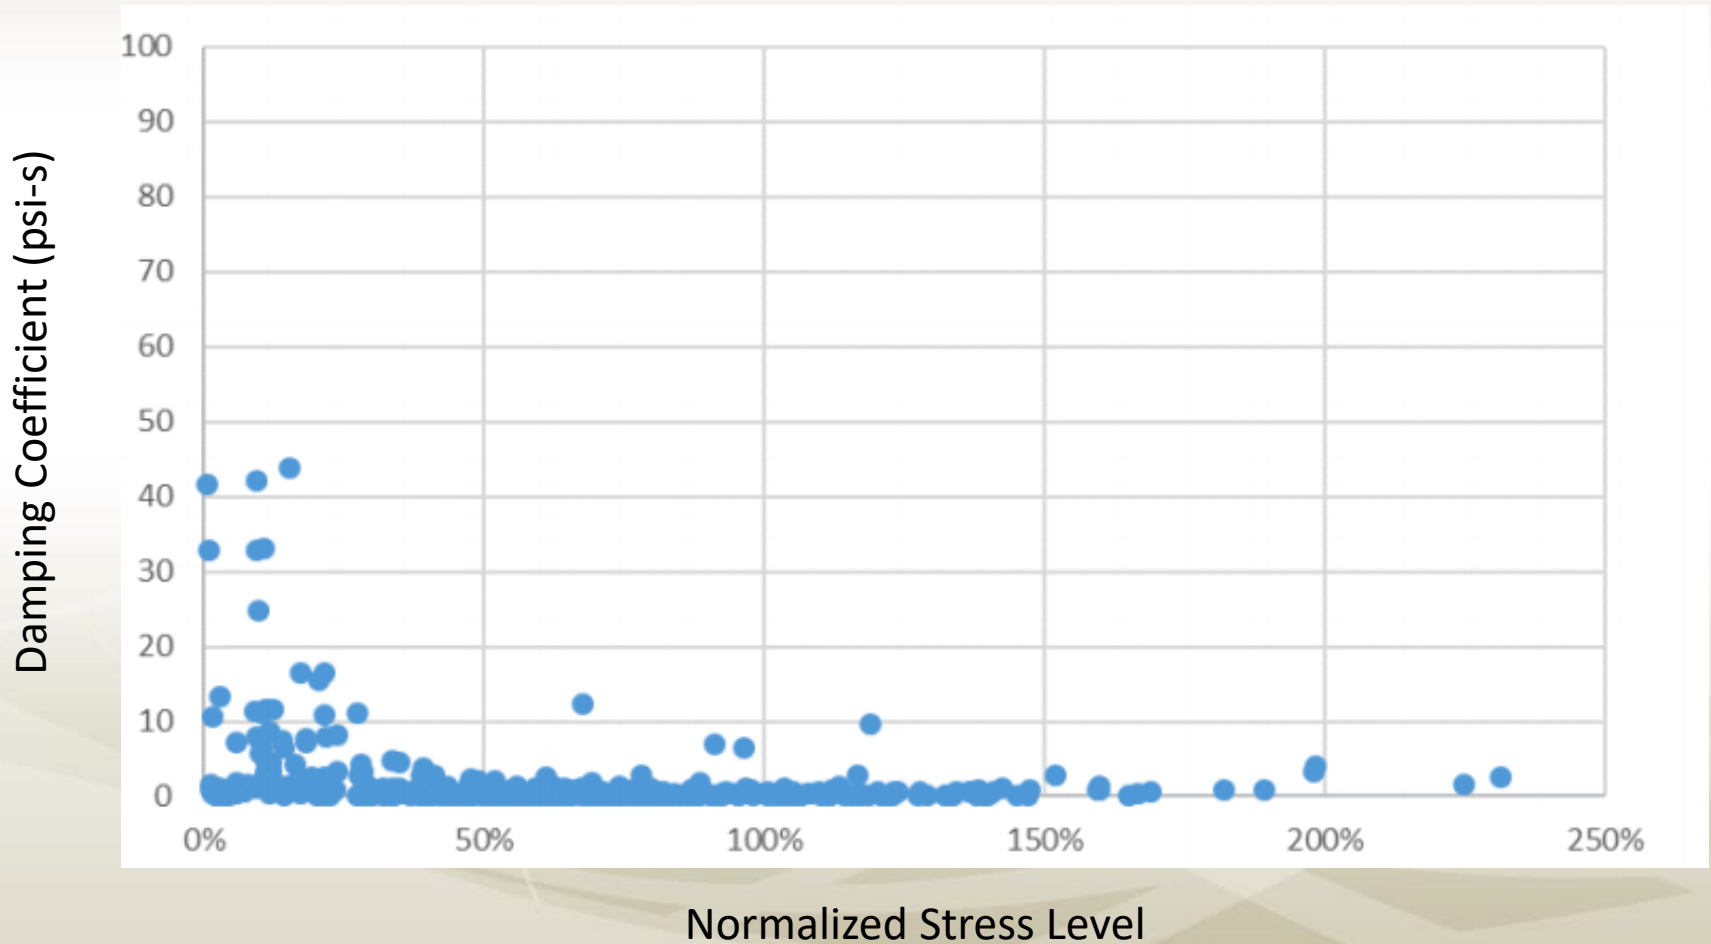
## Damping Coefficient Plot – All Sites

Range	Data Points	% Total	% Cumulative
0 - 0.01	5	1.1%	1.1%
0.01 - 0.1	<b>106</b>	<b>23.6%</b>	<b>24.7%</b>
0.1 - 1	<b>214</b>	<b>47.6%</b>	<b>72.2%</b>
1 - 10	<b>84</b>	<b>18.7%</b>	<b>90.9%</b>
10 - 100	19	4.2%	95.1%
100 - 1,000	13	2.9%	98.0%
1,000 - 10,000	3	0.7%	98.7%
10,000 - 100,000	4	0.9%	99.6%
100,000 - 1,000,000	1	0.2%	99.8%
1,000,000 - 10,000,000	0	0.0%	99.8%
10,000,000 - 100,000,000	1	0.2%	100.0%
<b>Total</b>	<b>450</b>	<b>100%</b>
