Evaluation Of SCC and Class IV Concrete Flow In Drilled Shafts – Part 1

BDV25 TWO977-25

*Closeout Meeting
Presented by
Gray Mullins, Ph.D., P.E.*

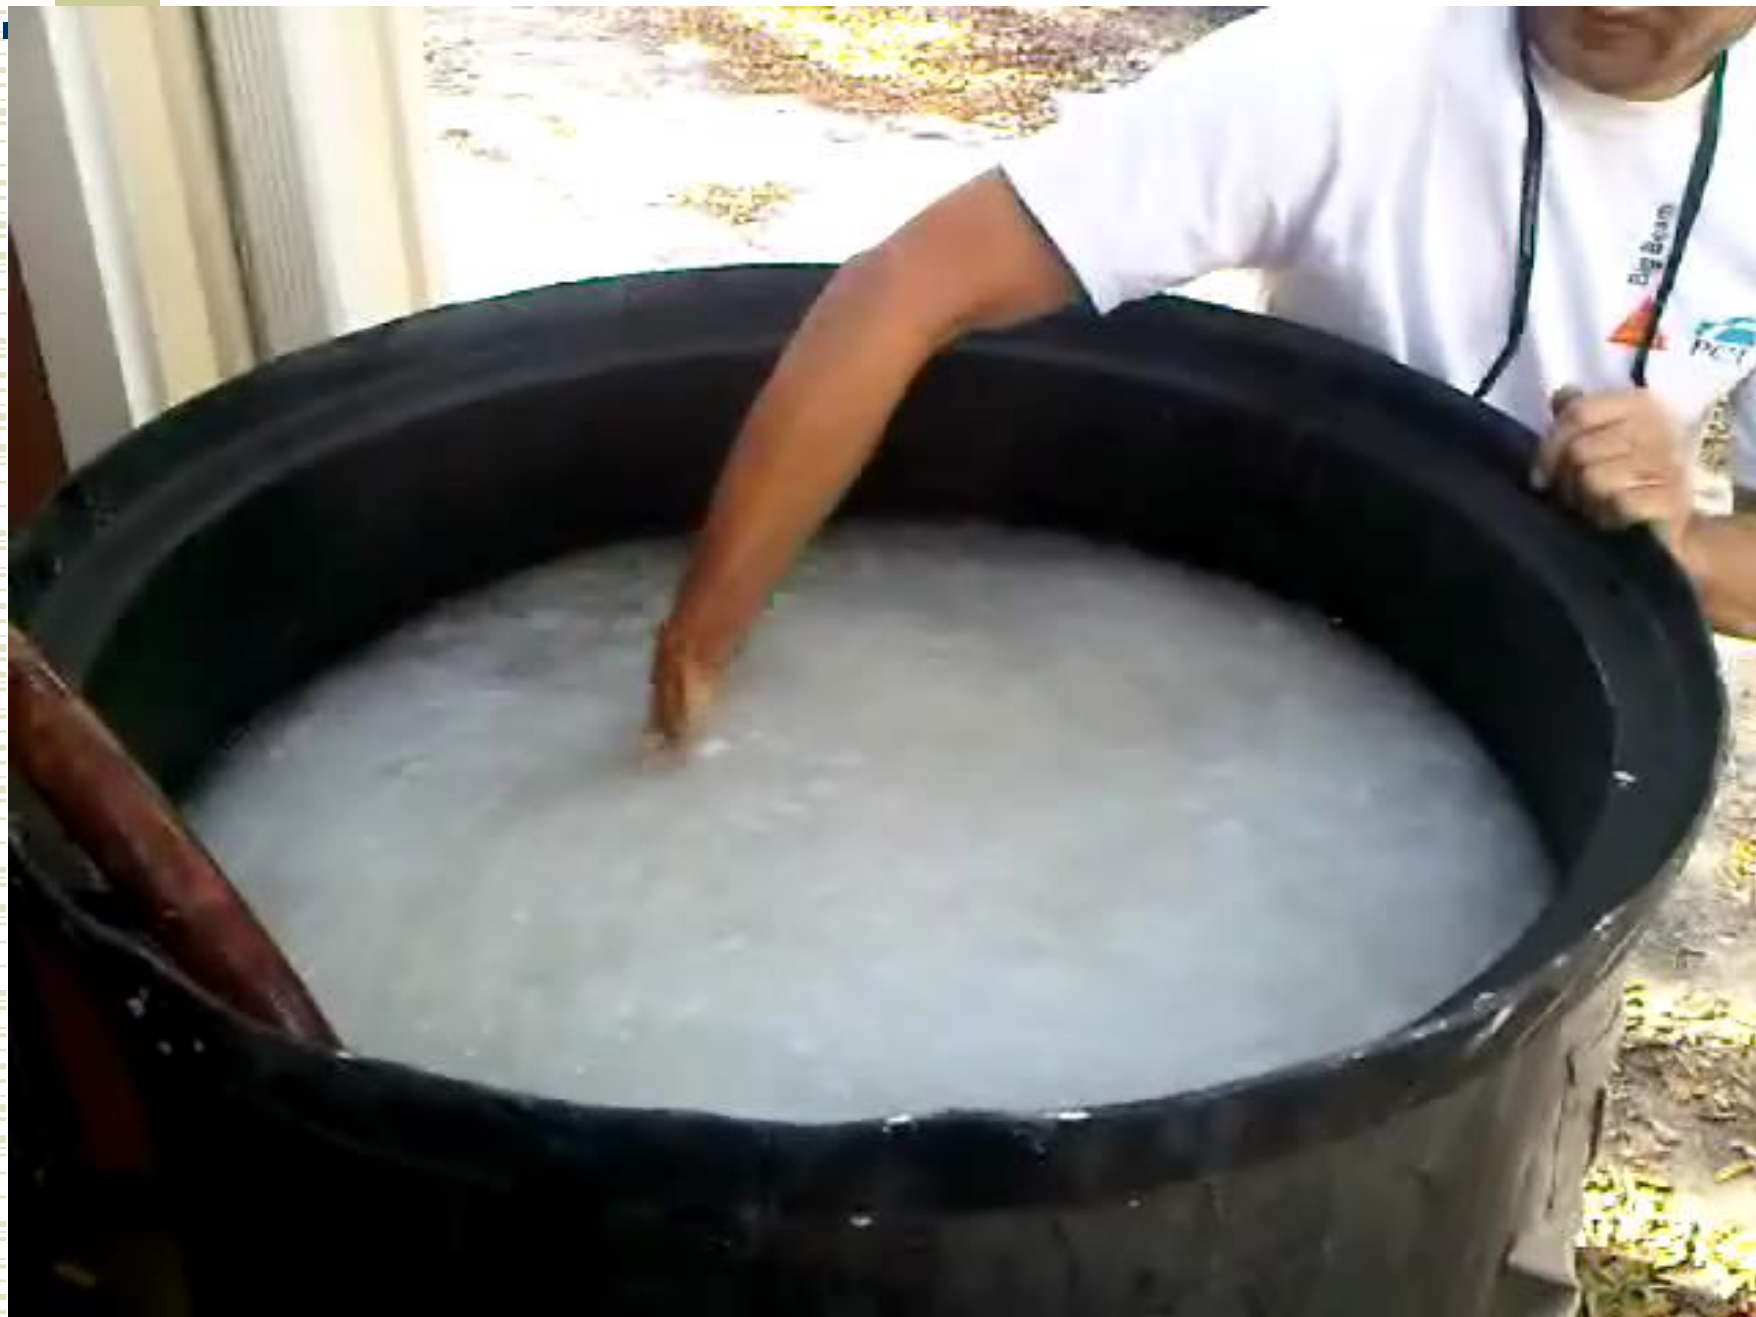
Slurry Preparation

Mix with venturi eductor

Recirculate

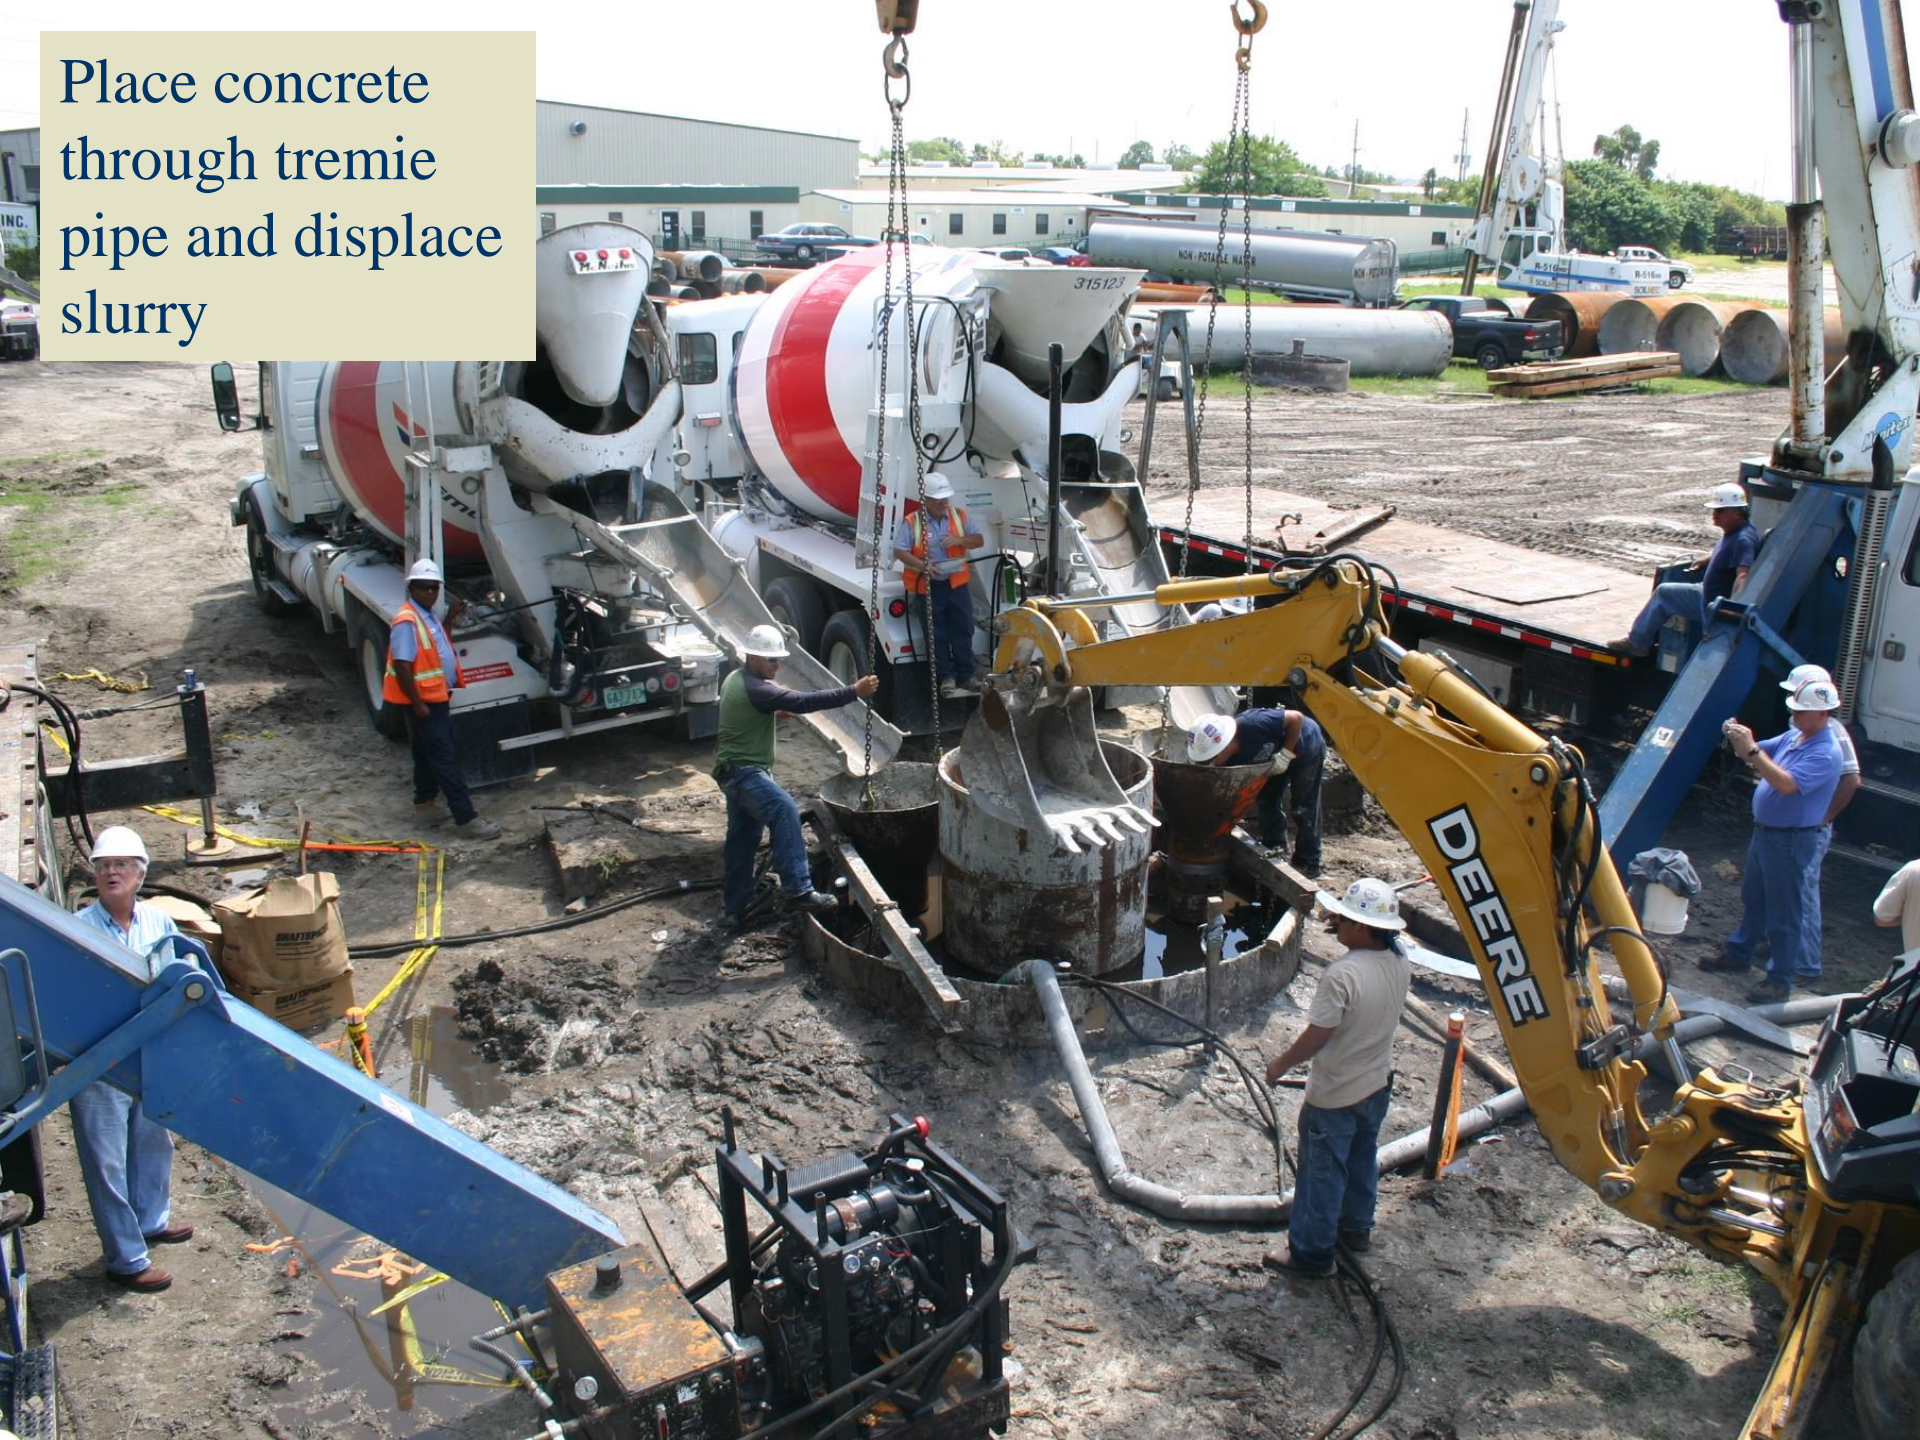
Place concrete through tremie pipe and displace slurry

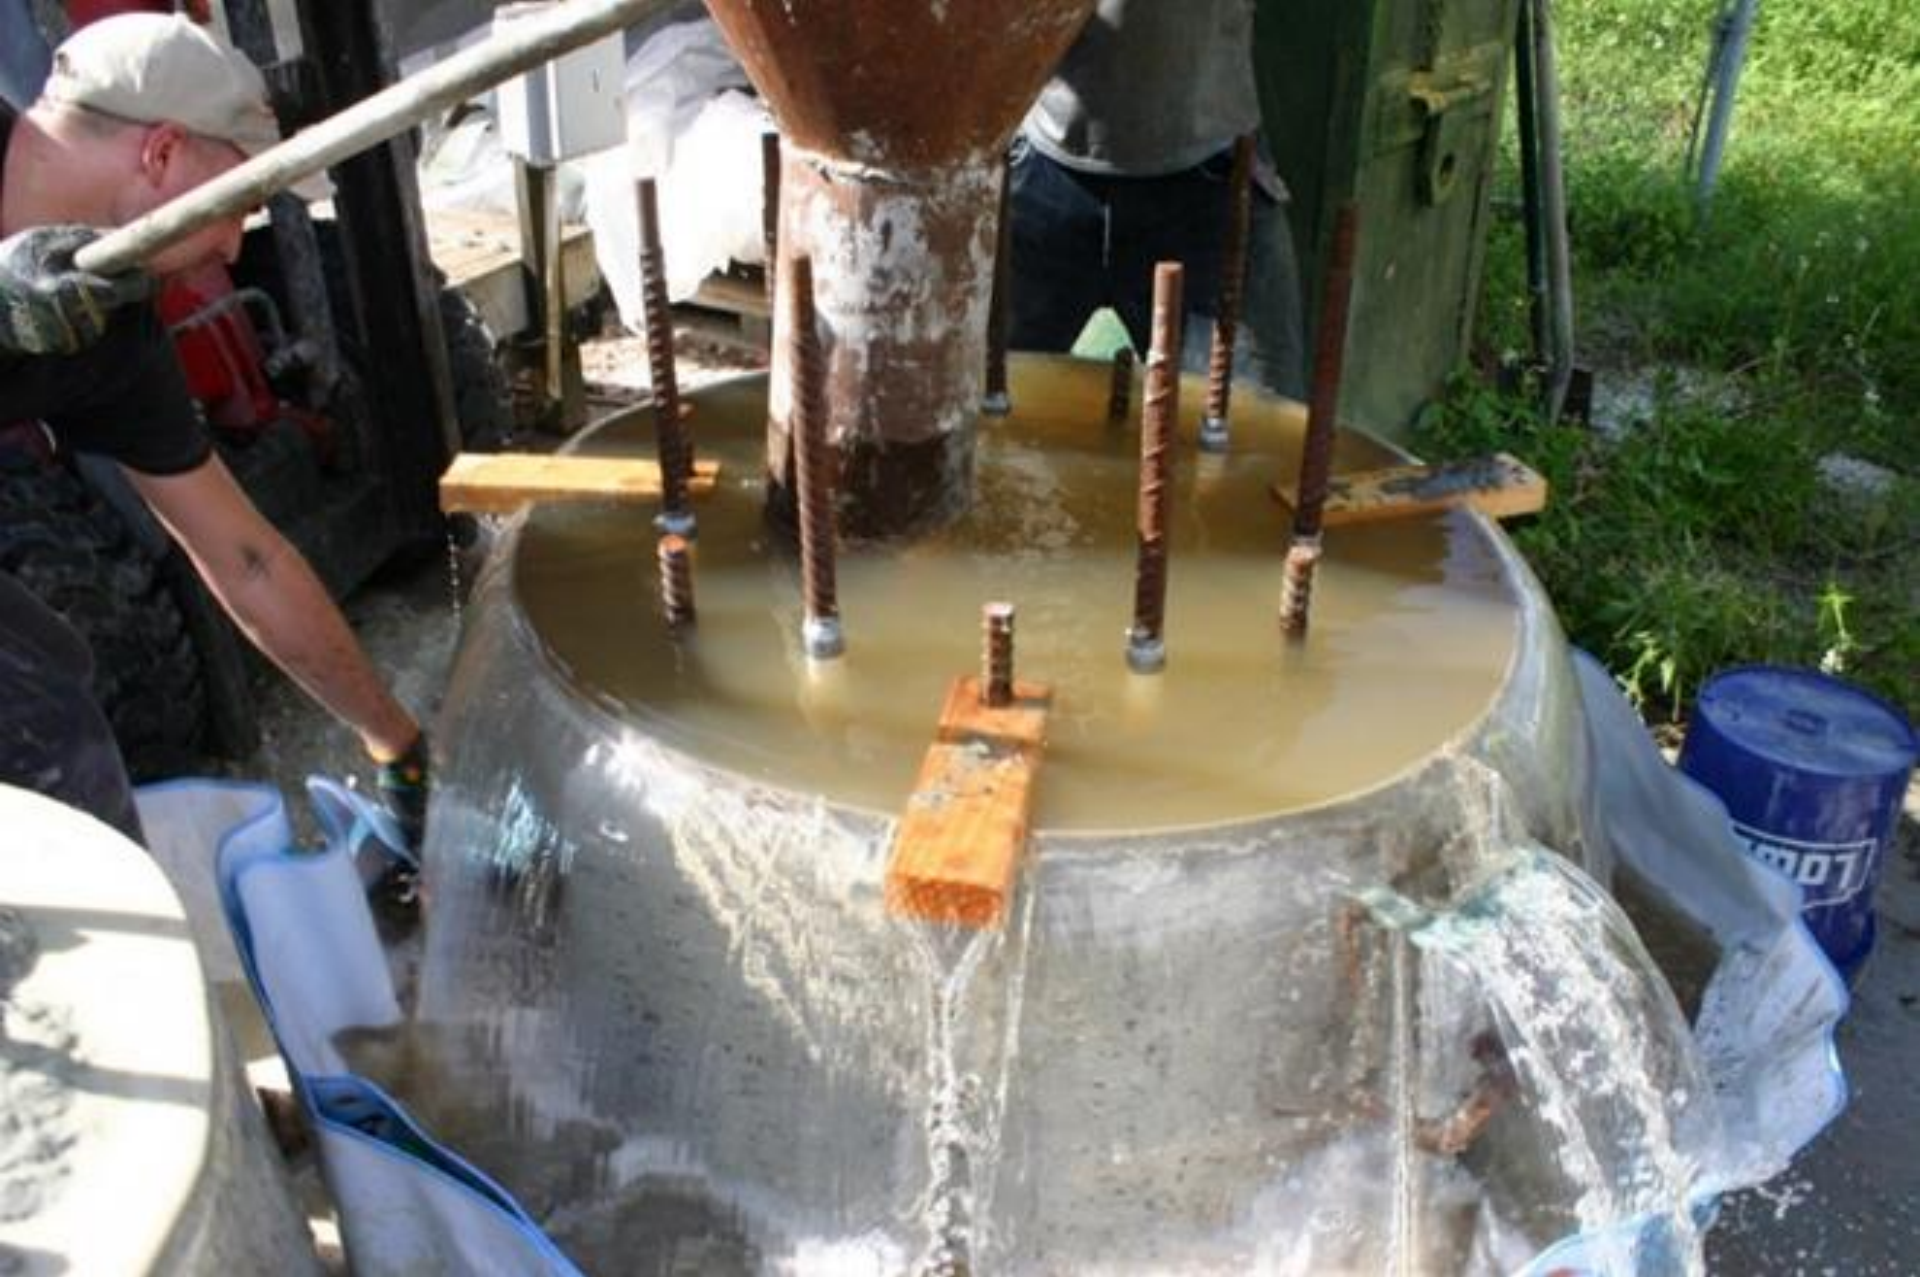
Drilling Fluid: Water

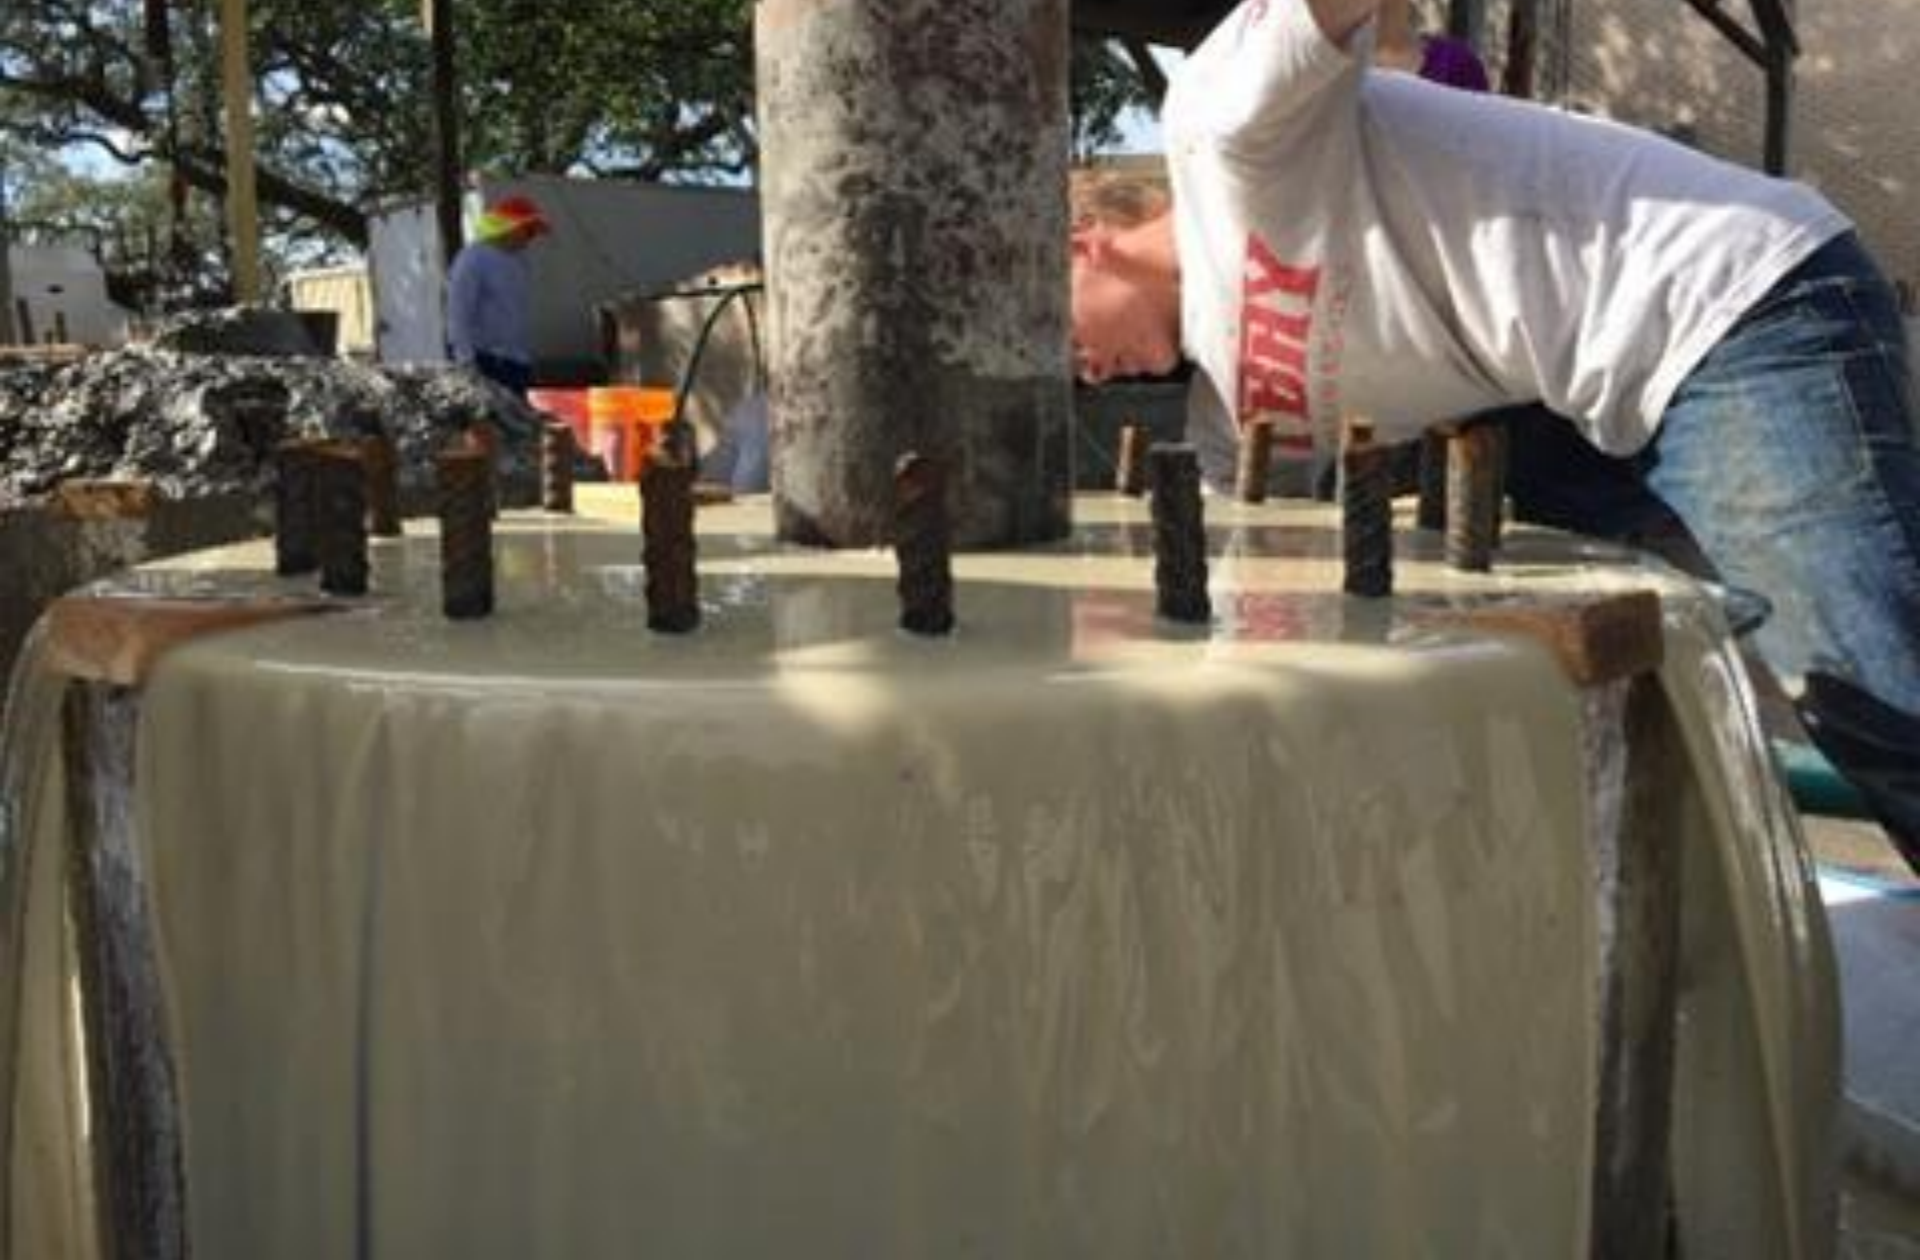
Drilling Fluid: Bentonite

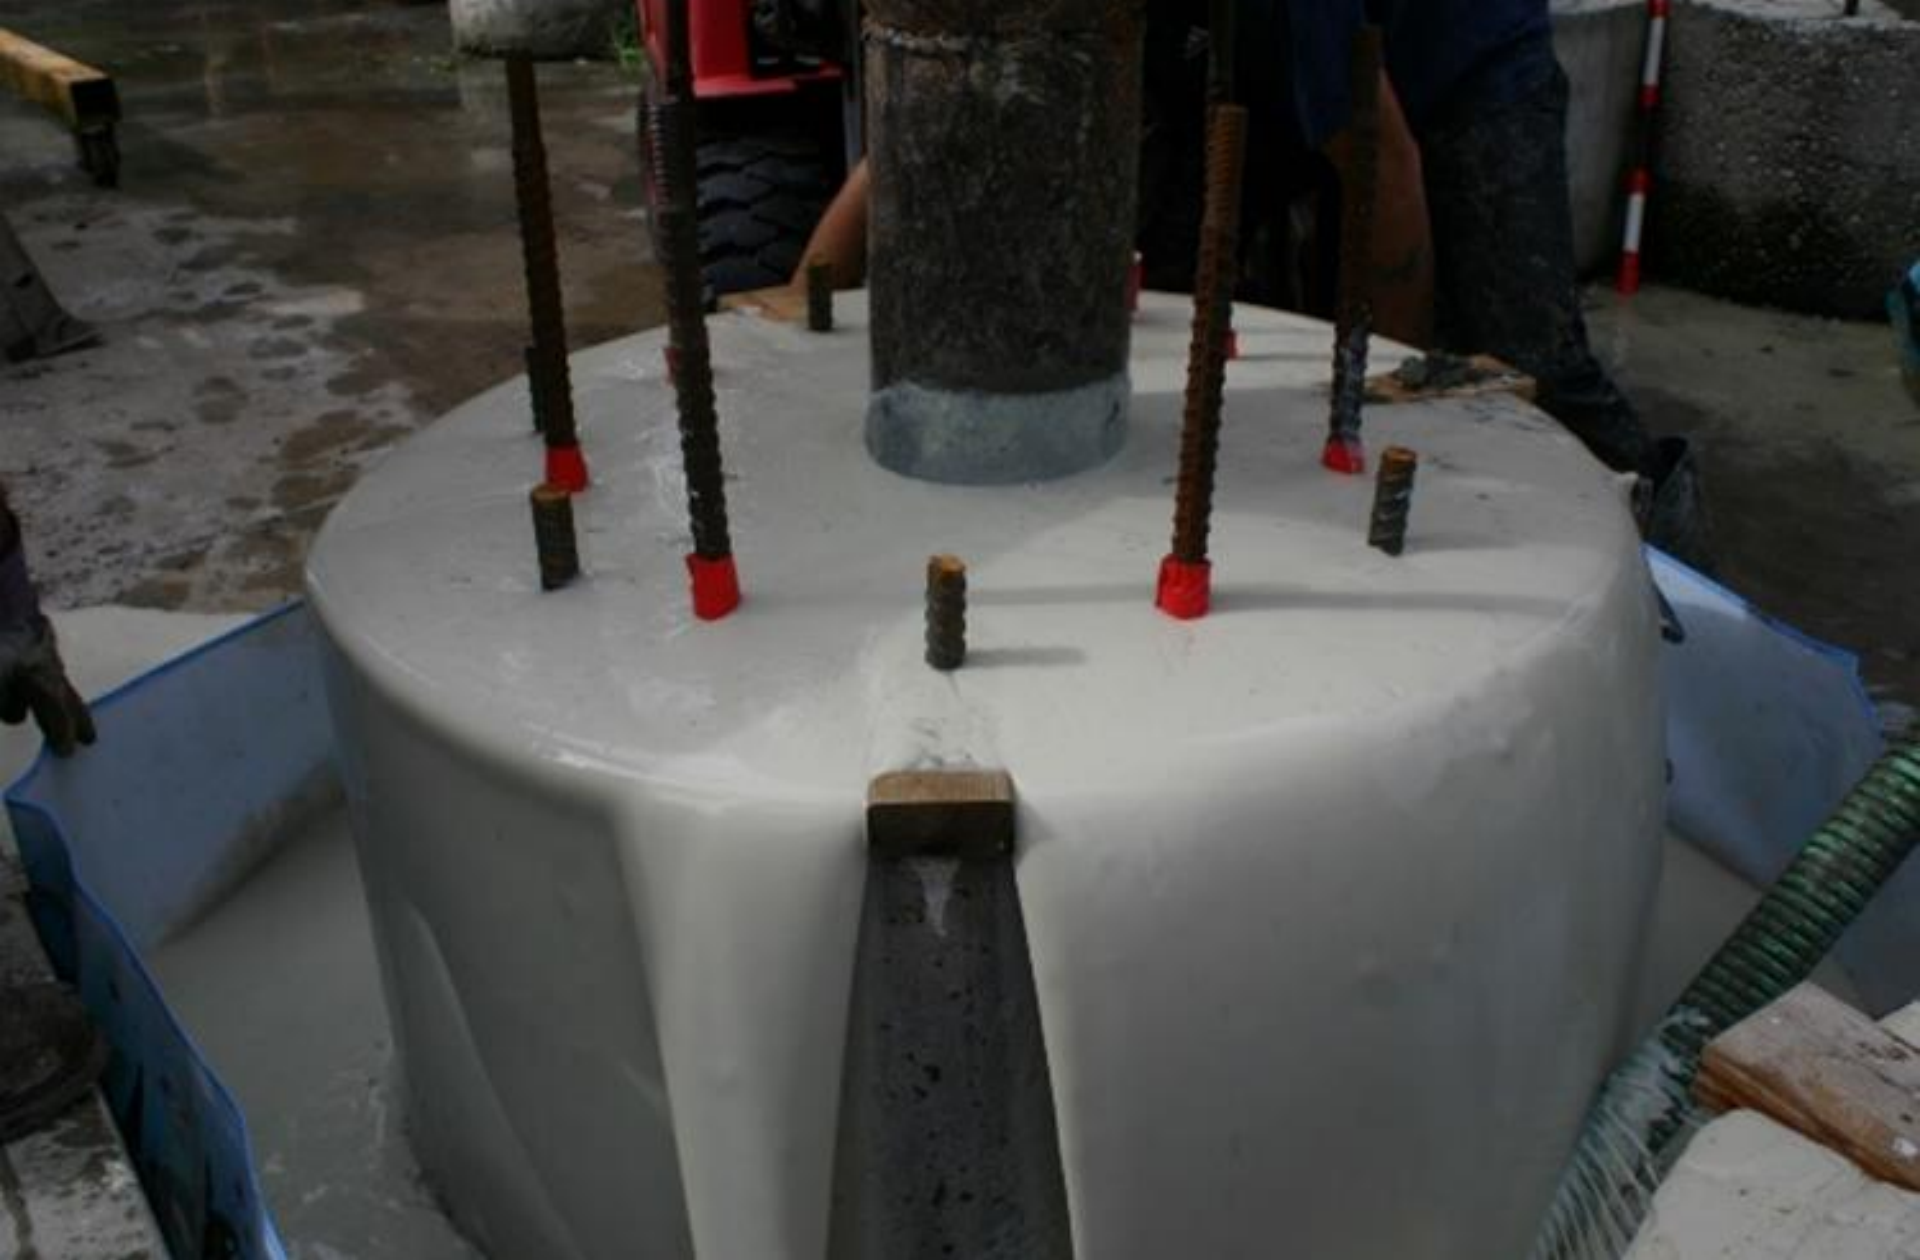
Drilling Fluid: Attapulgite

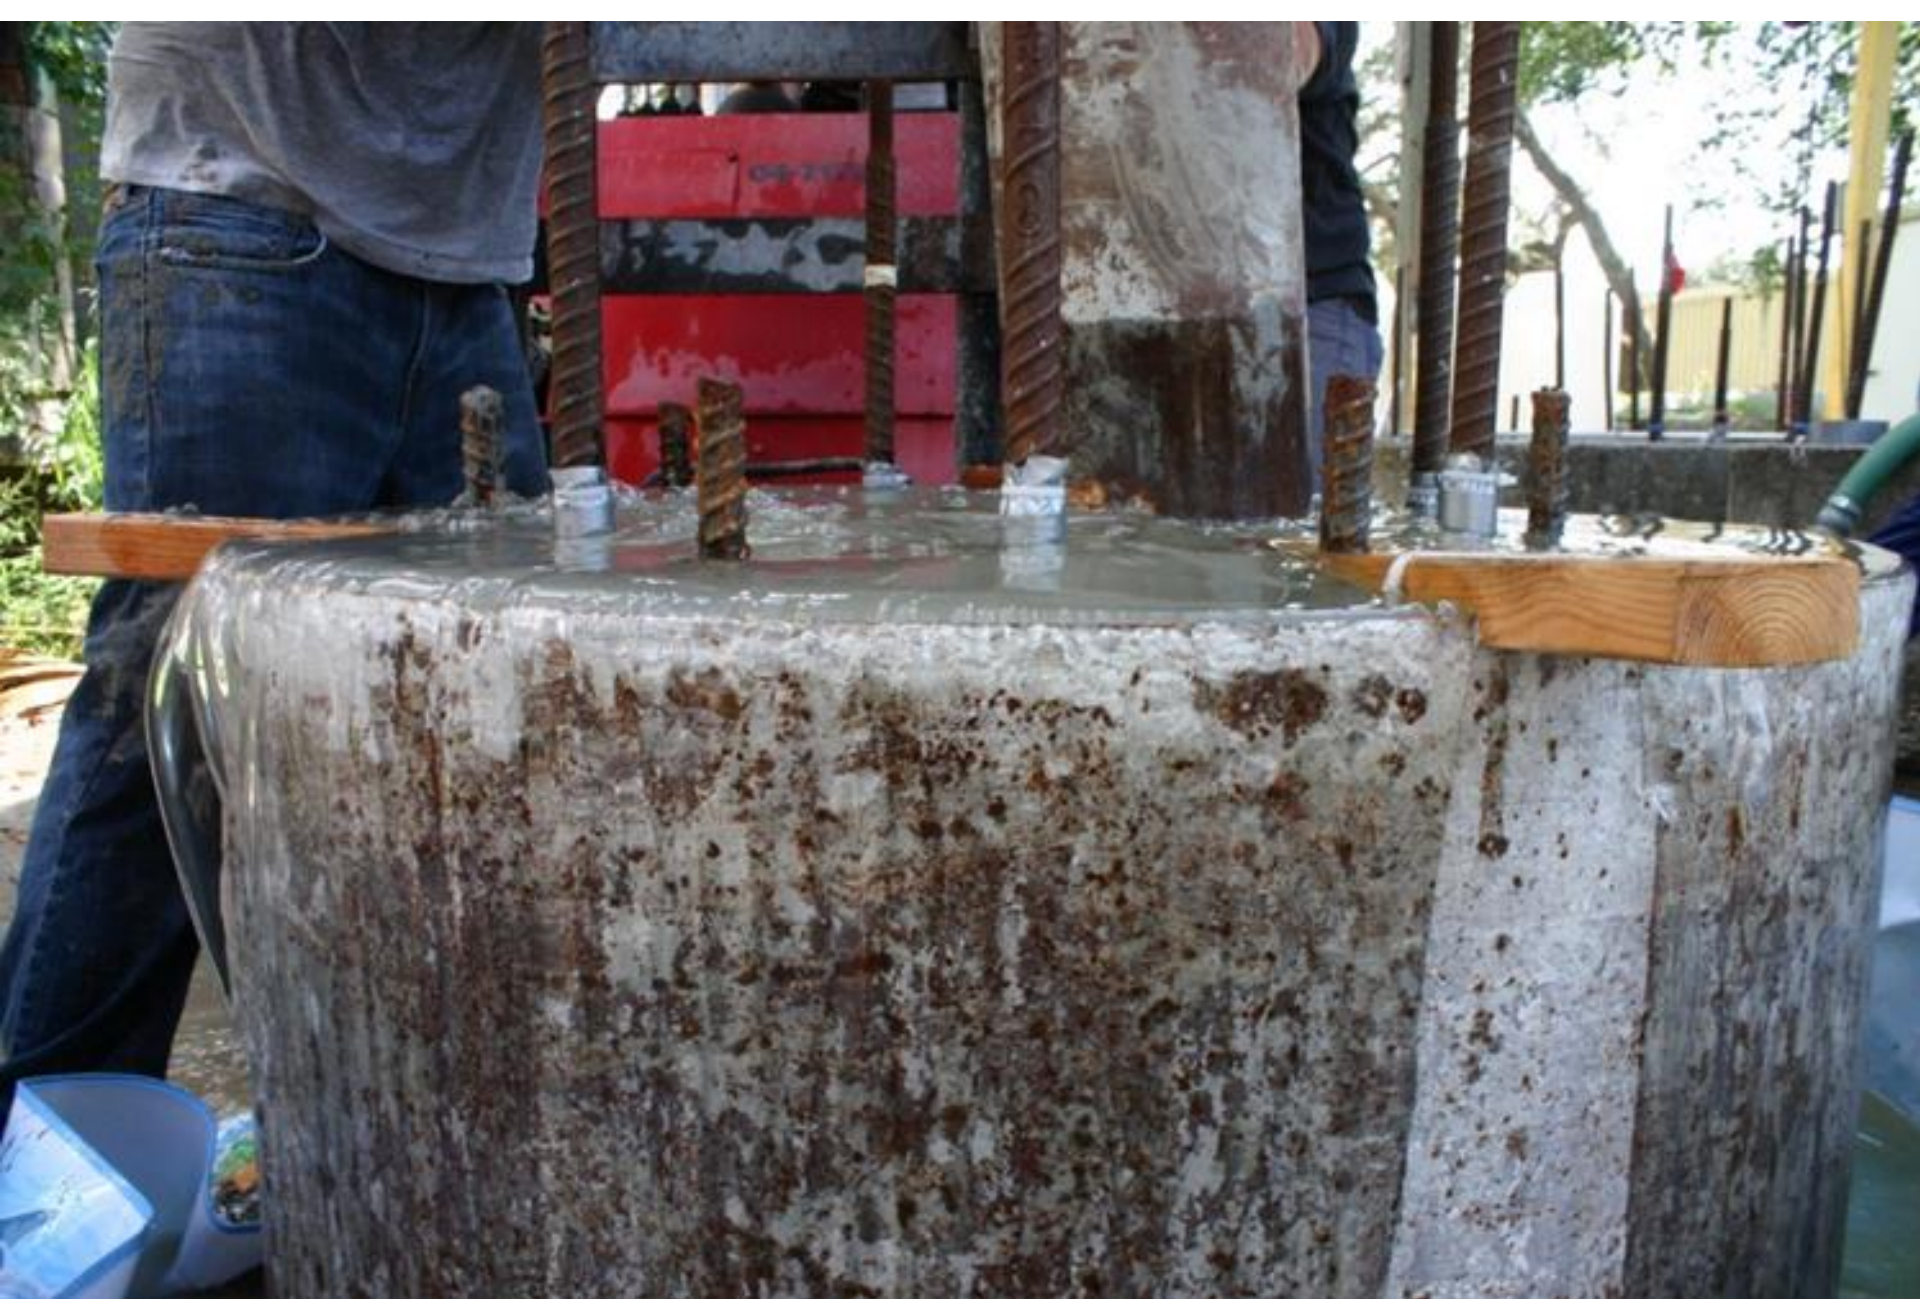
Drilling Fluid: Polymer

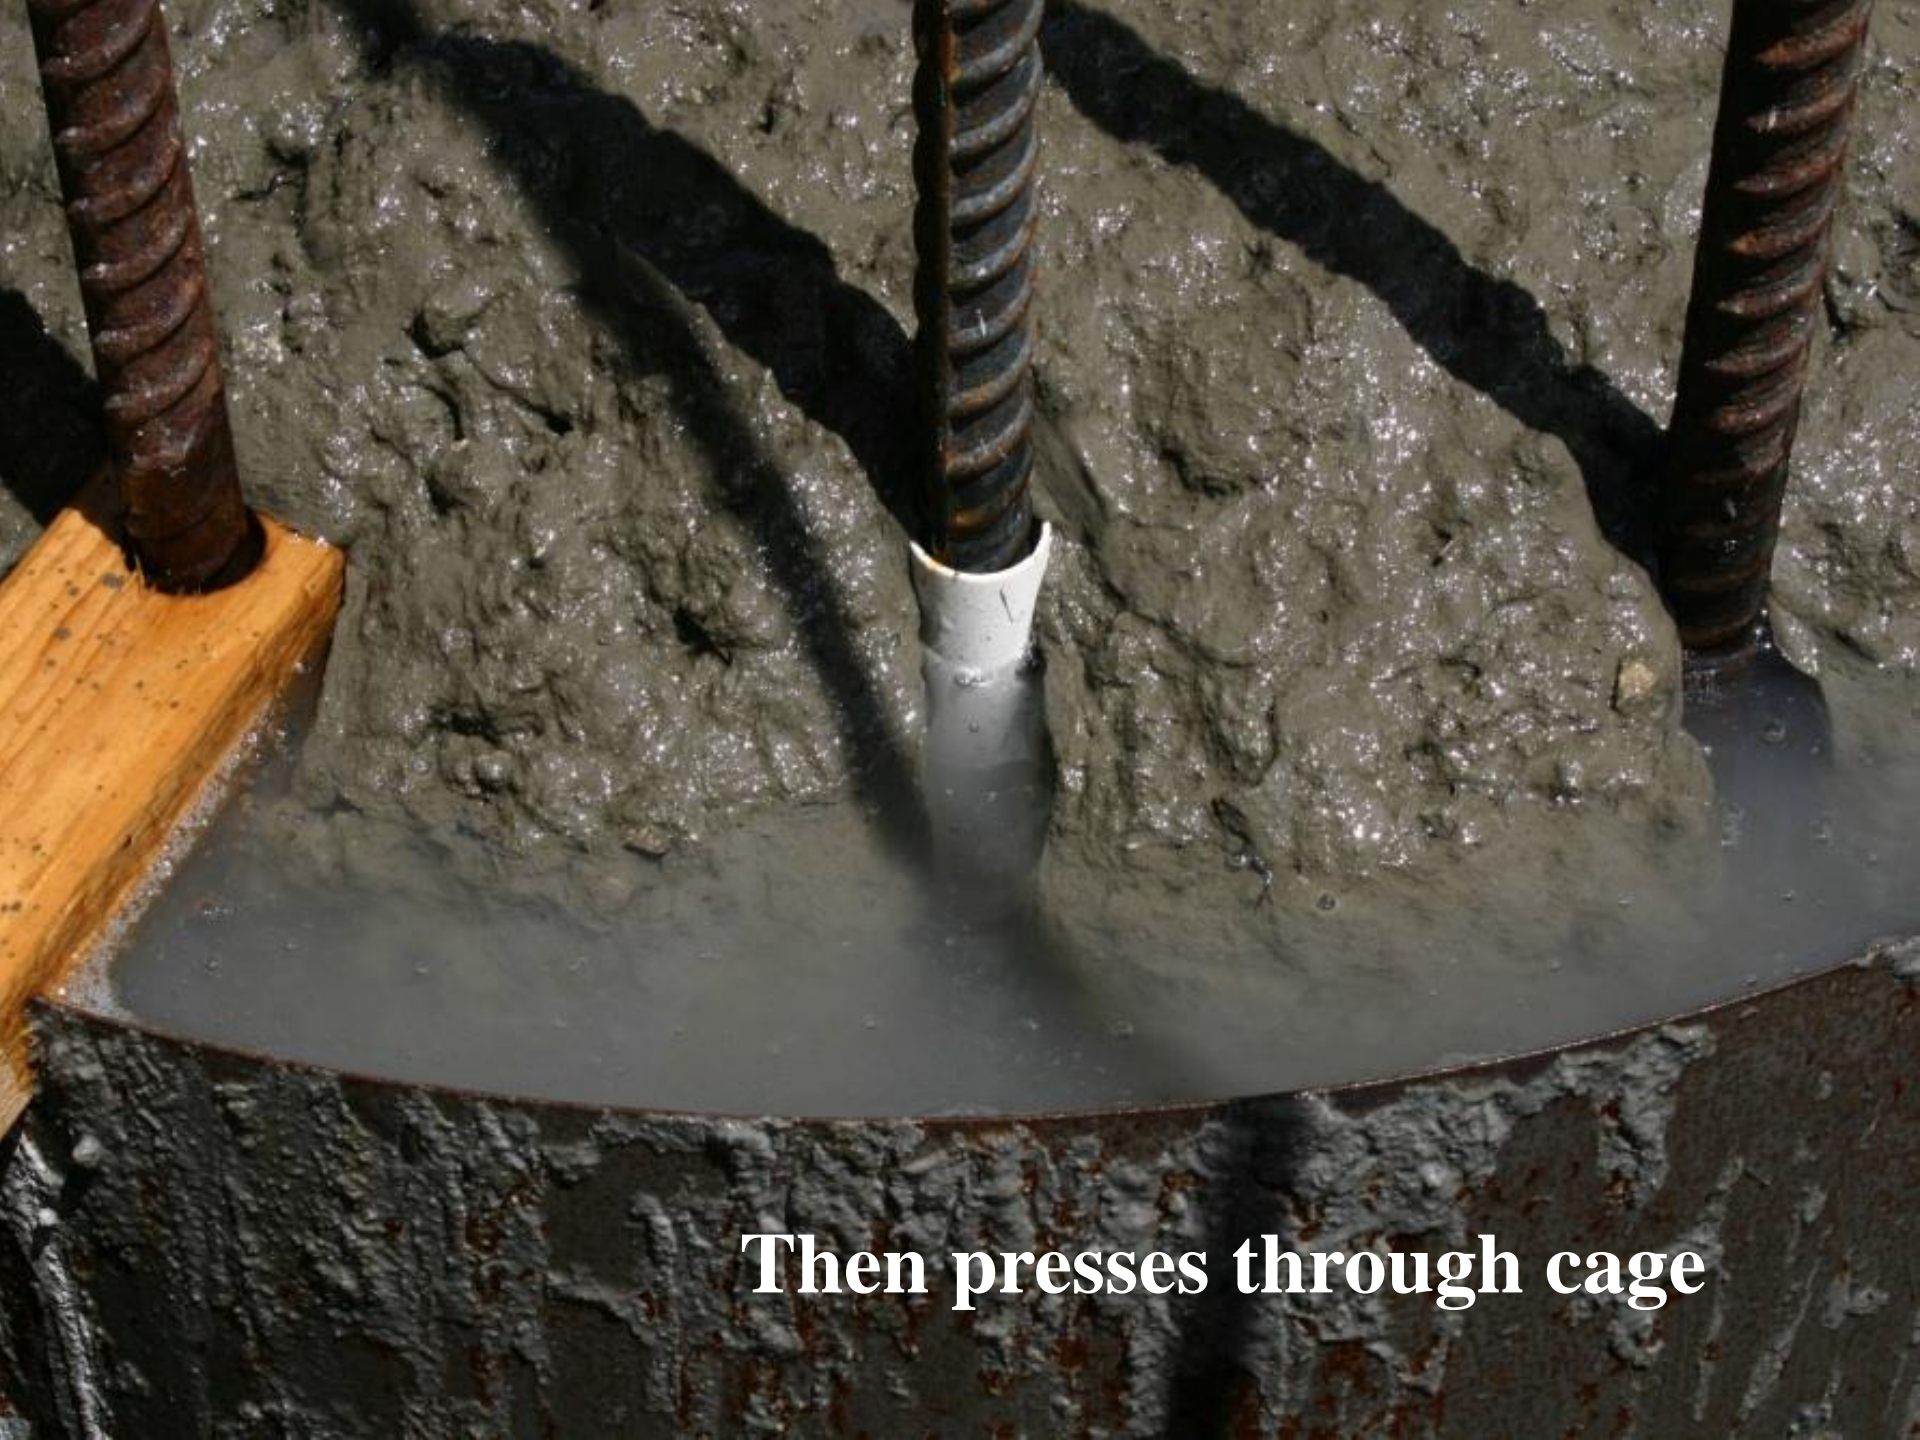
Then presses through cage

**Creases form that
may not fully close**

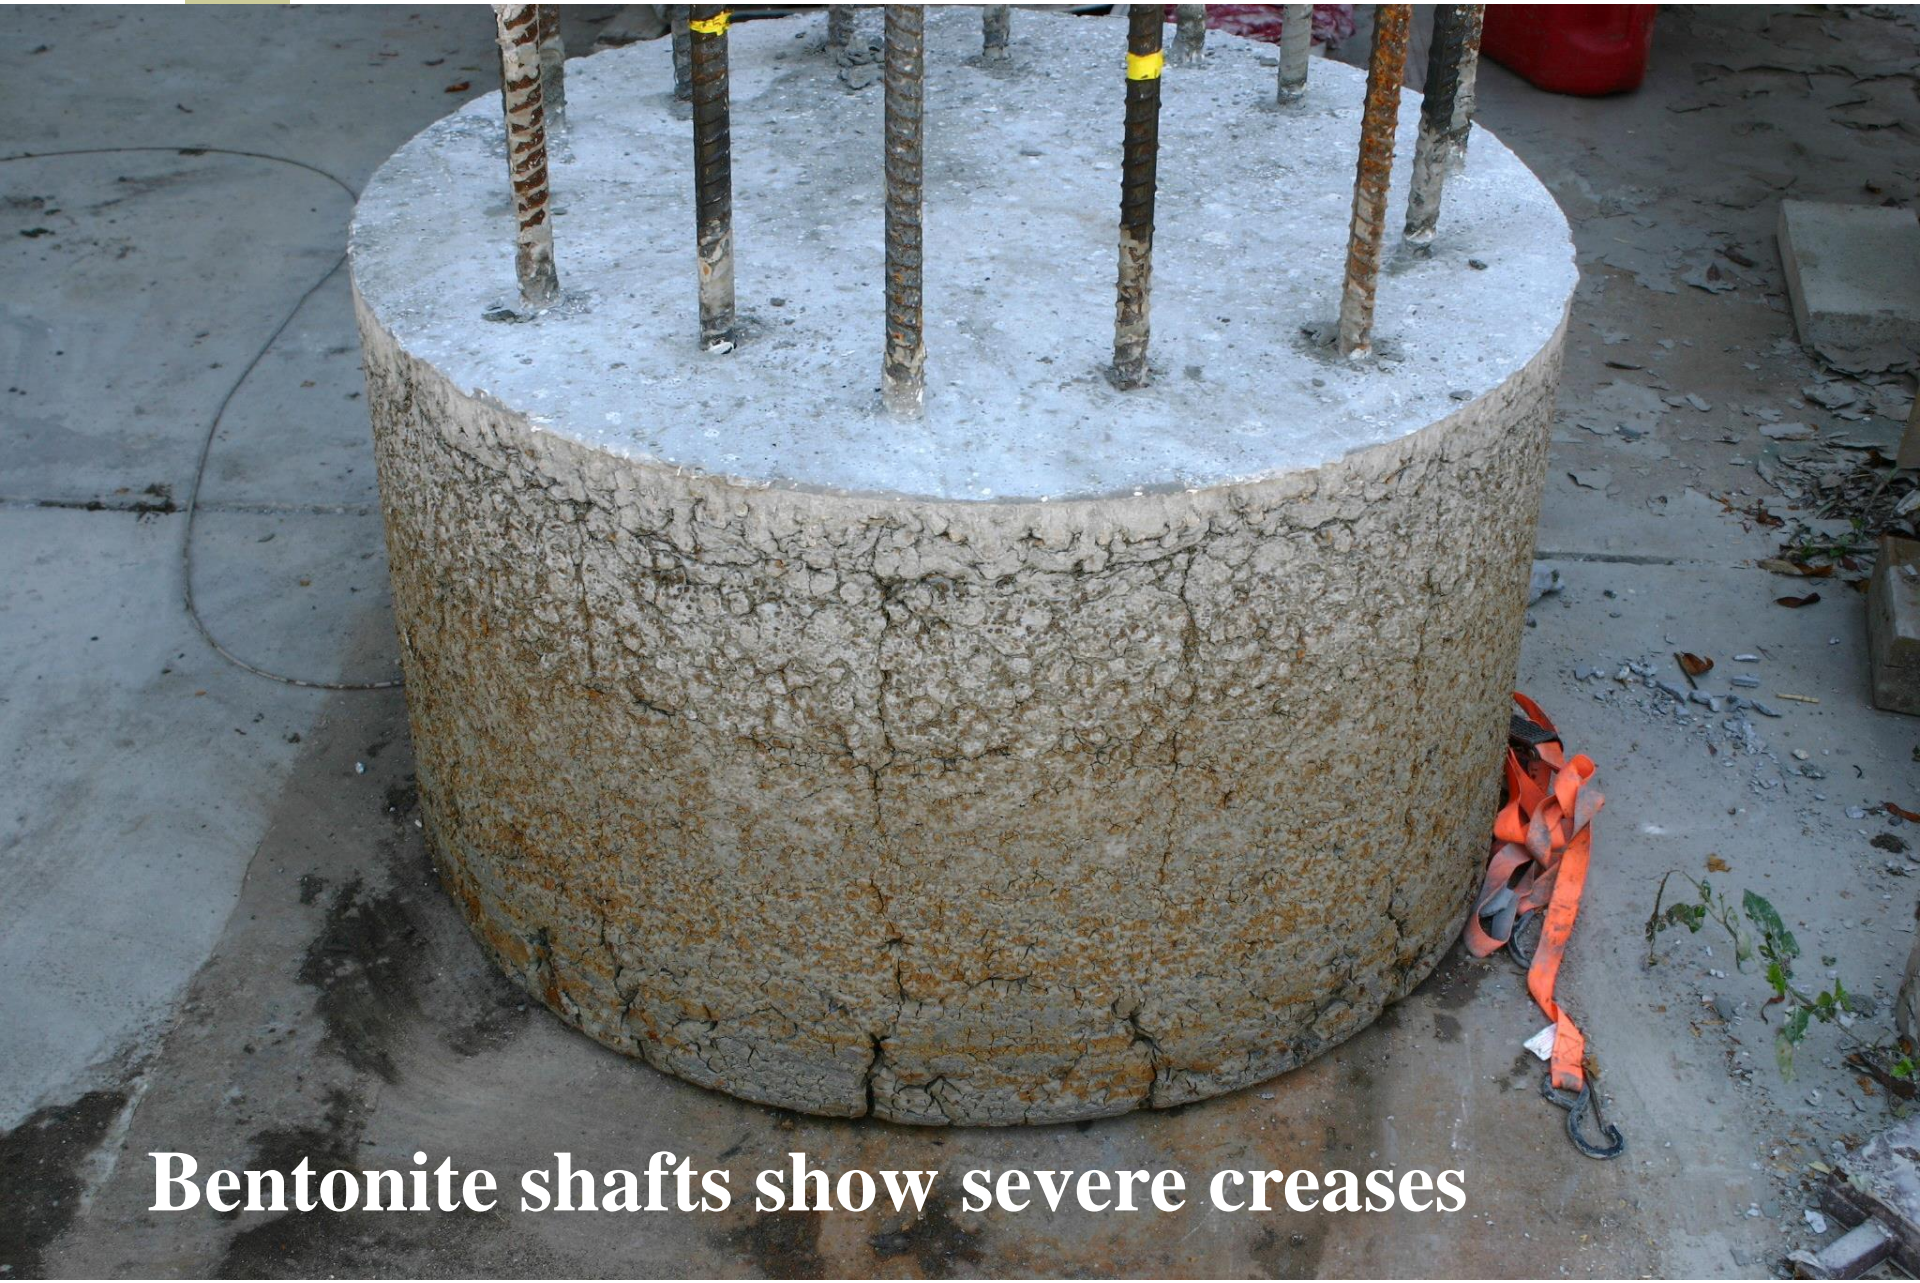
Bentonite shafts show severe creases

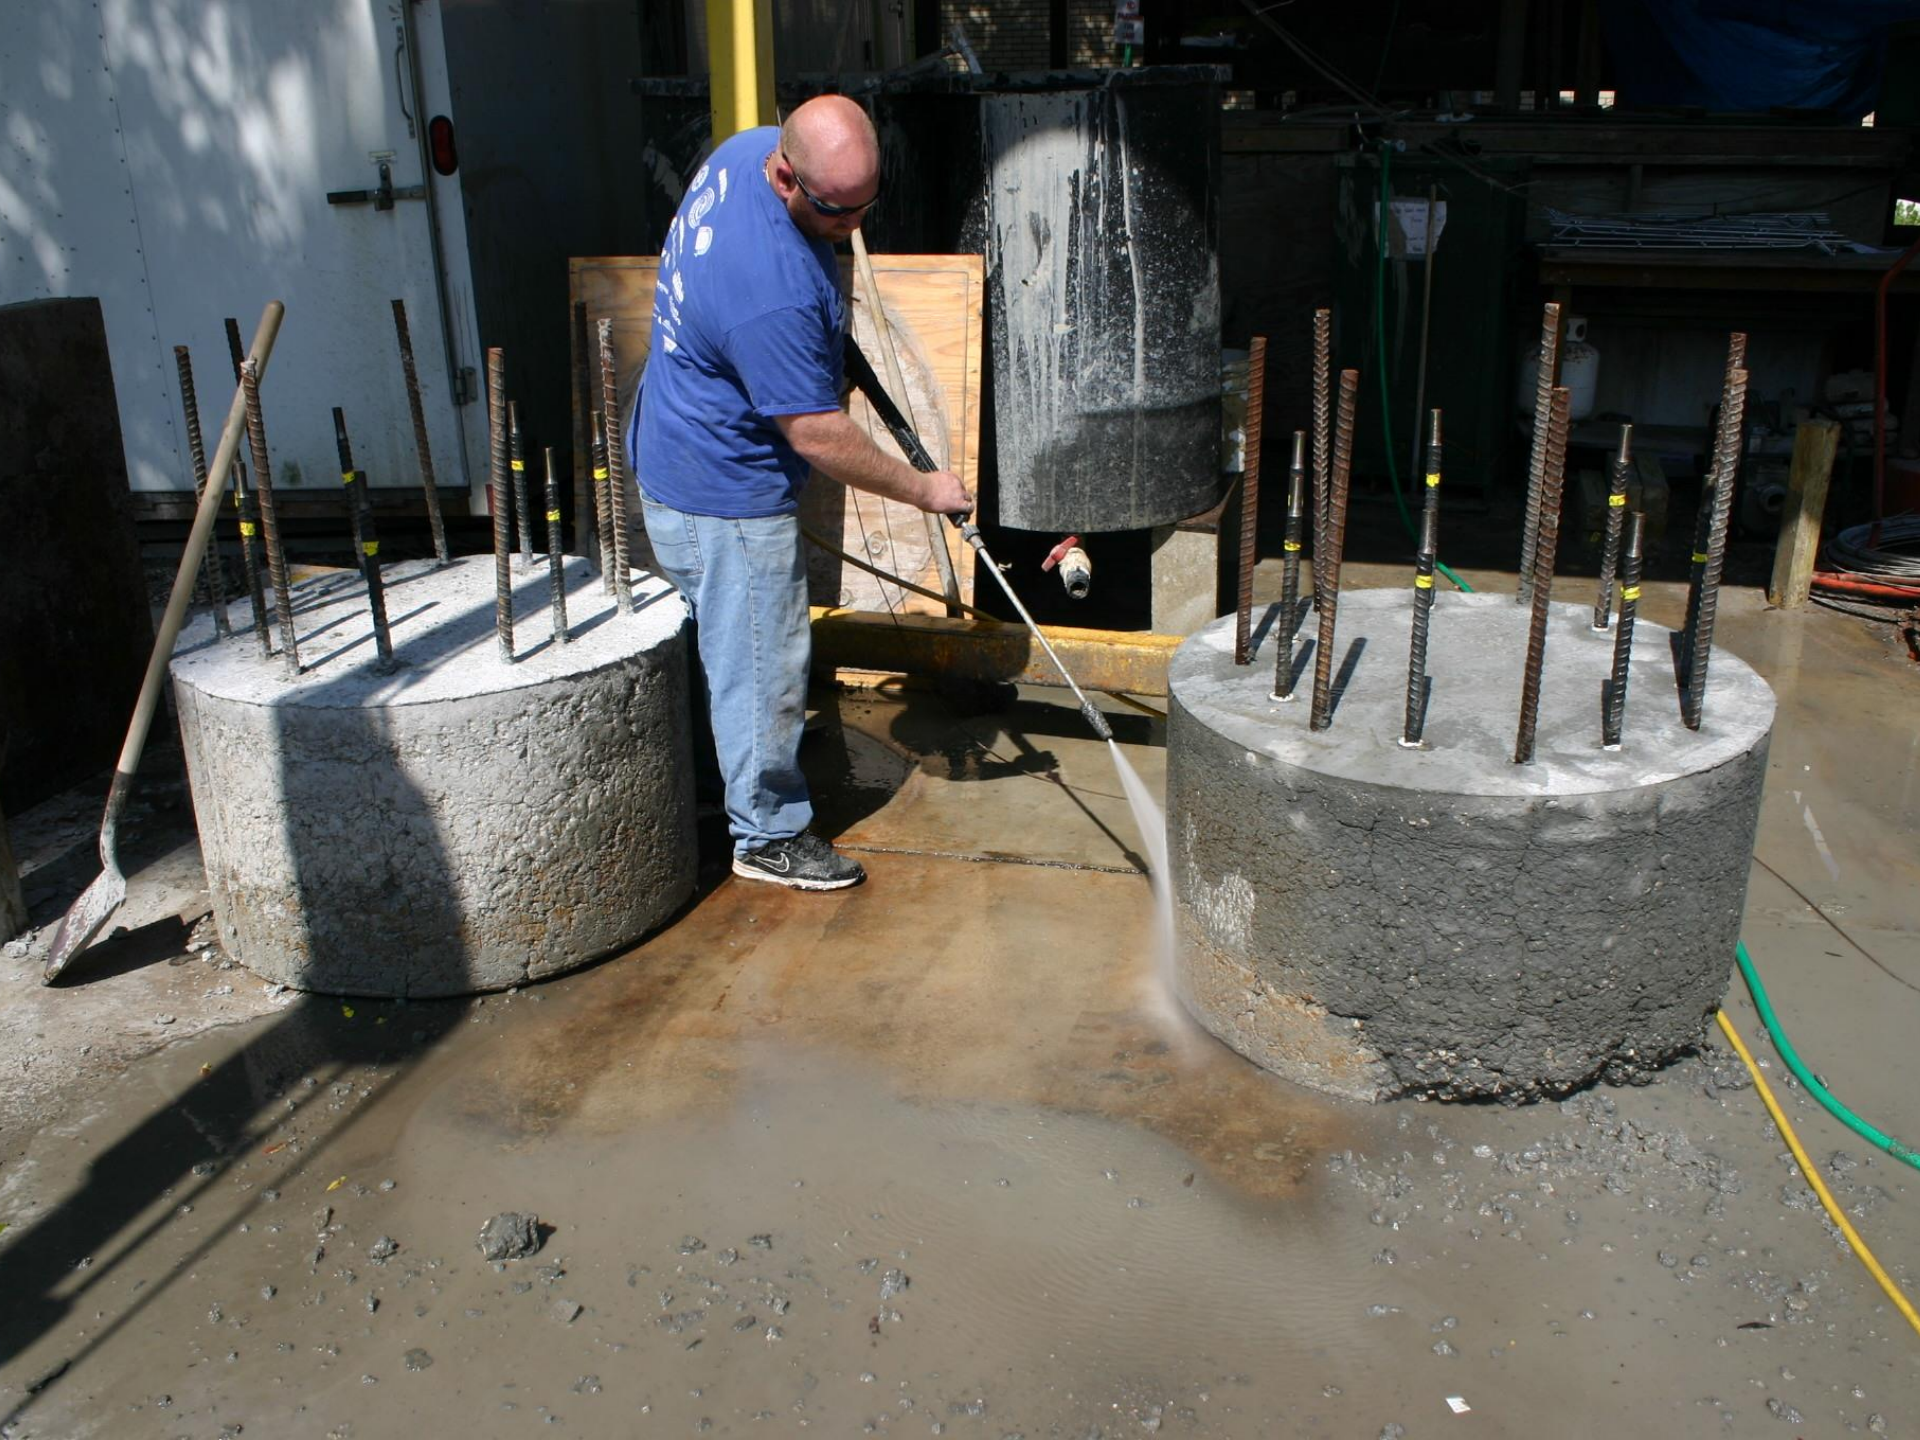
Volume of voided surface
was trapped bentonite clay

Layer of clay reduces side shear

Water or polymer slurry not trapped

No soil interface interruption
