Evaluation Of SCC and Class IV Concrete Flow In Drilled Shafts – Part 1

BDV25 TWO977-25

*Closeout Meeting
Presented by
Gray Mullins, Ph.D., P.E.*

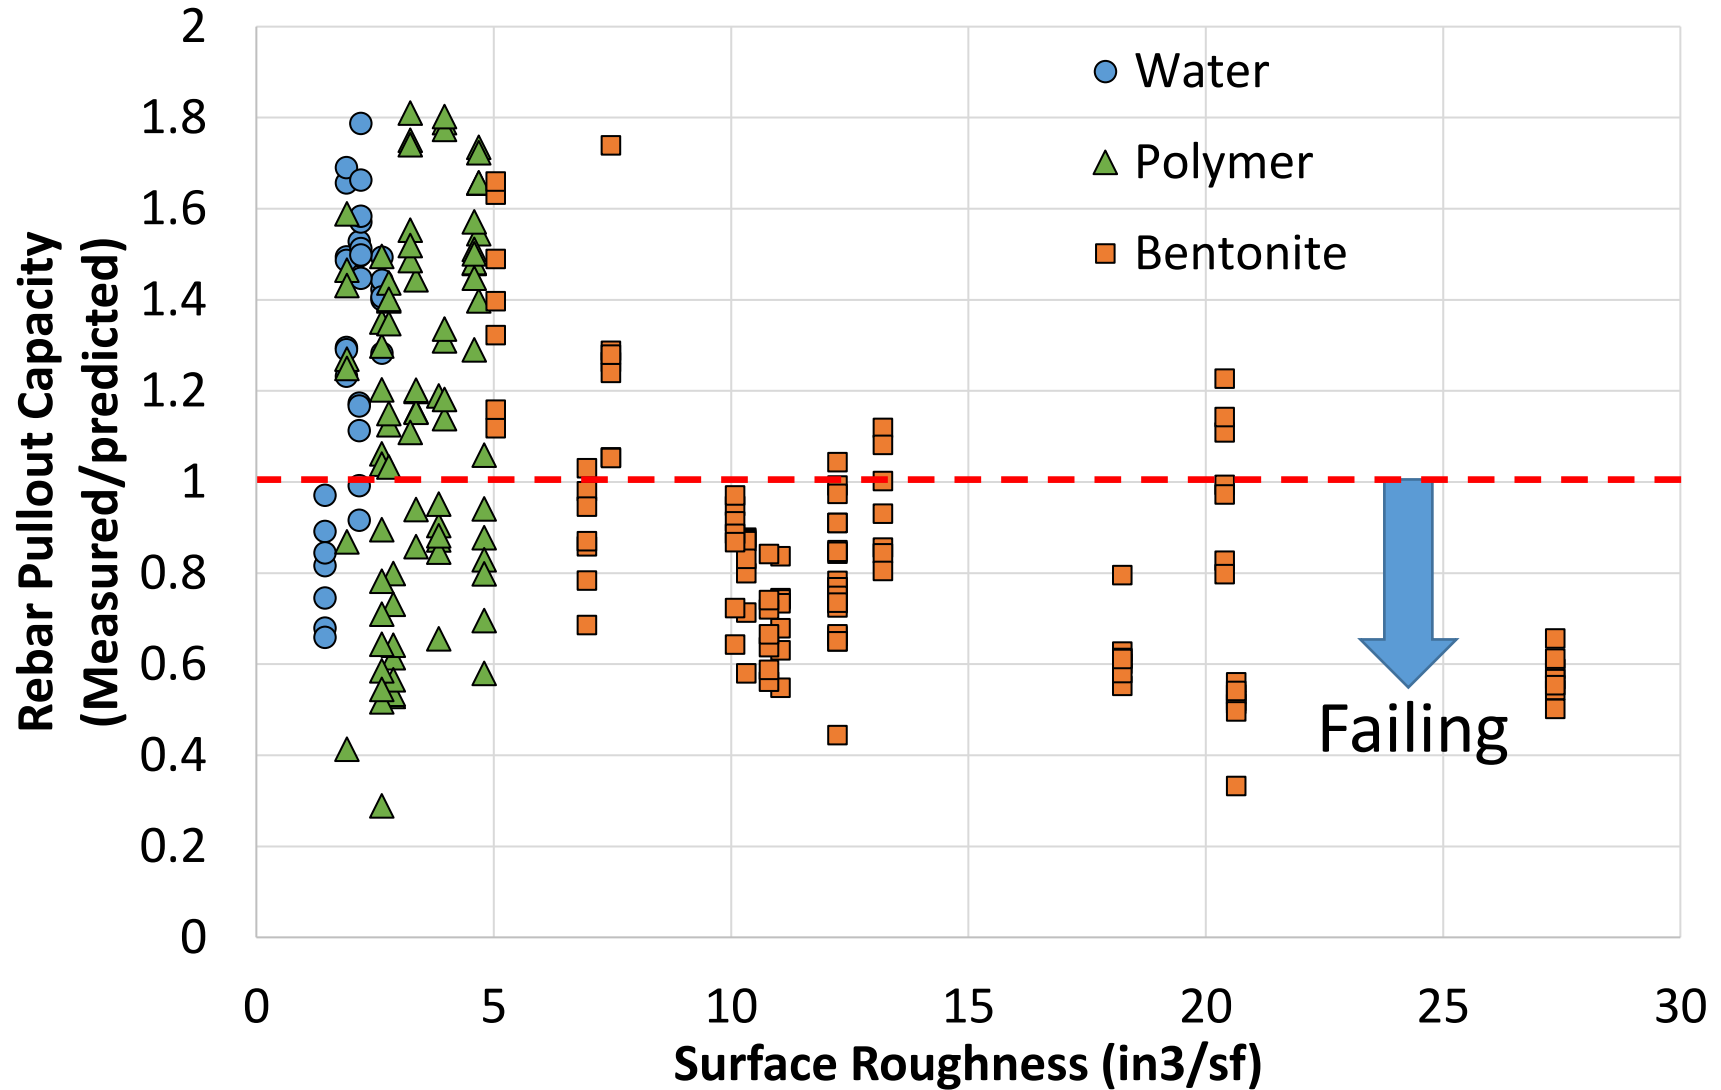
Surface Roughness vs Rebar Pullout

(Costello, 2018)

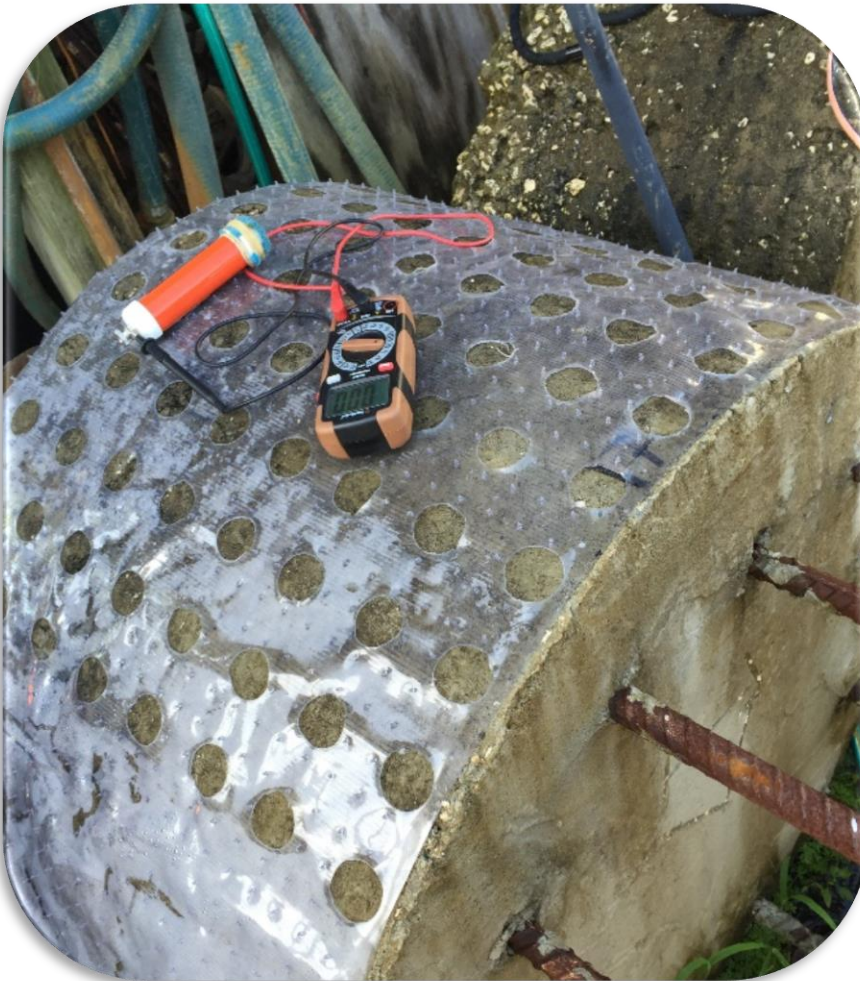
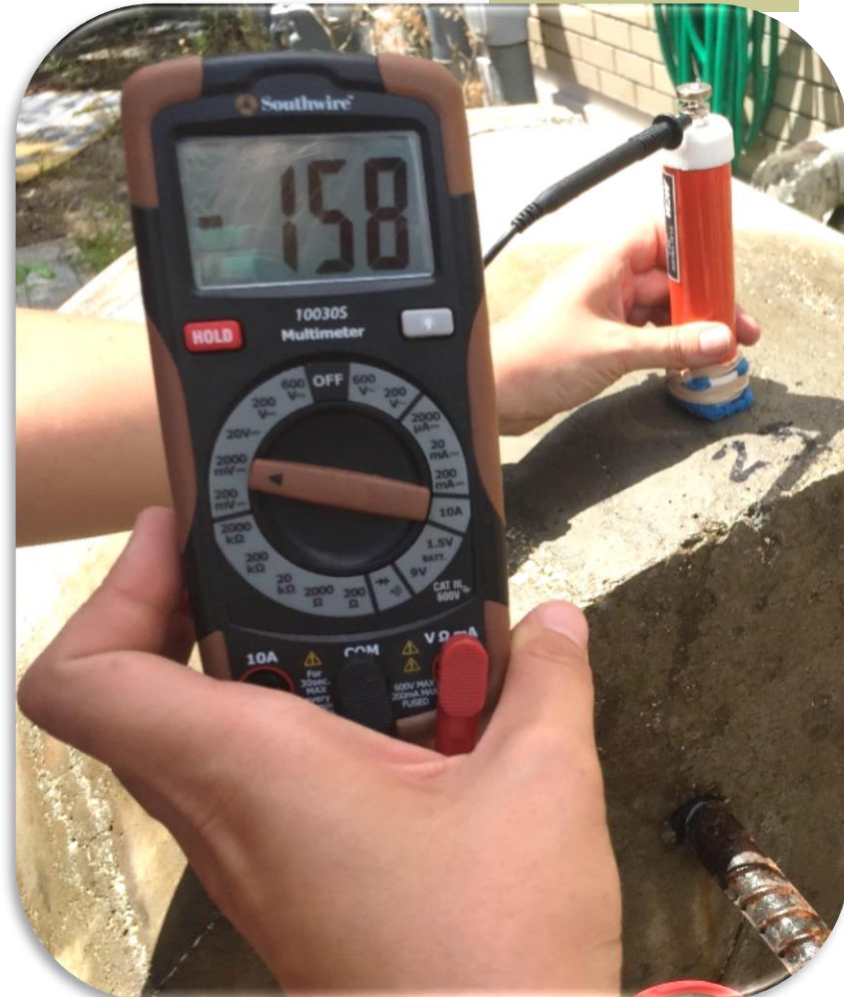
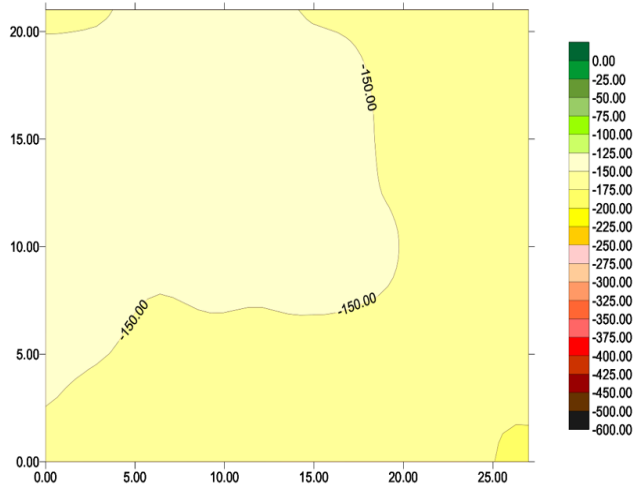
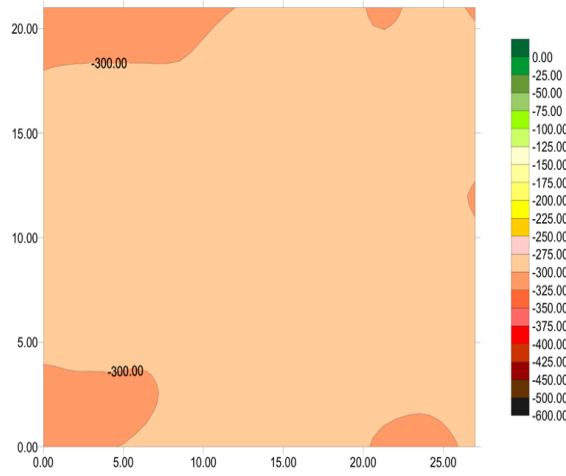
Effects of Slurry on Corrosion Resistance (surface potential mapping)

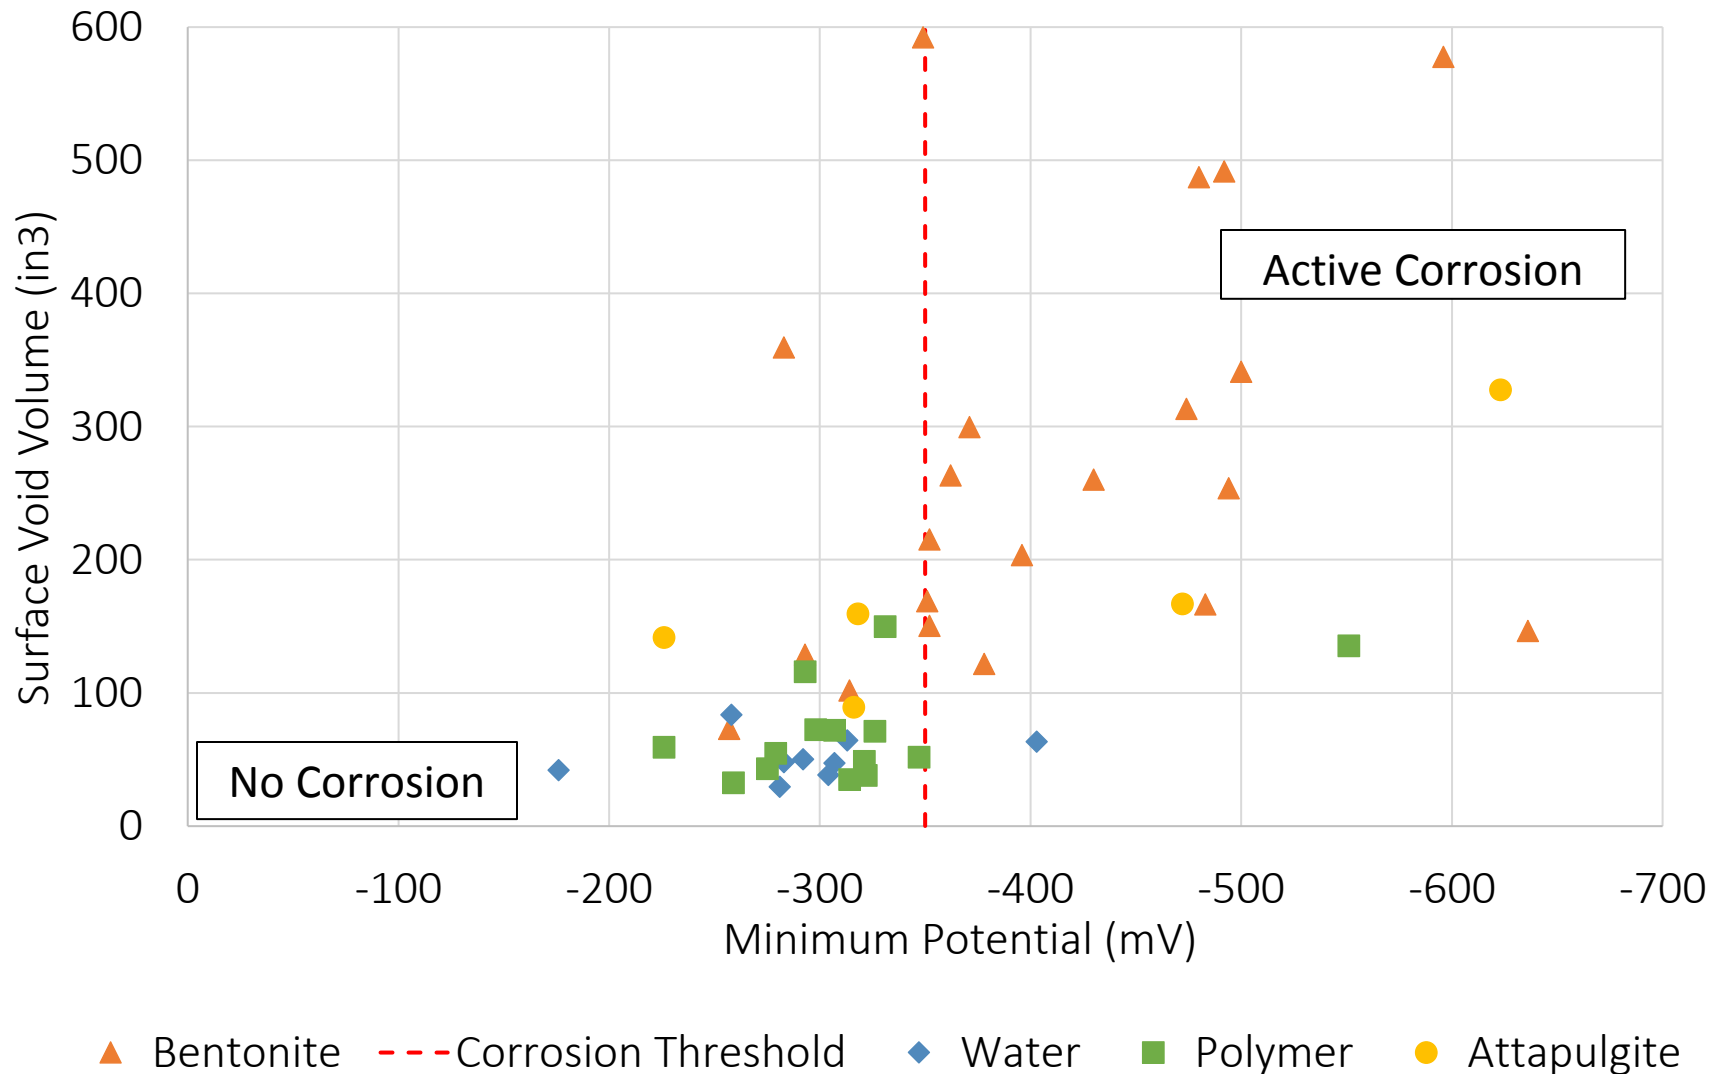
Surface Roughness

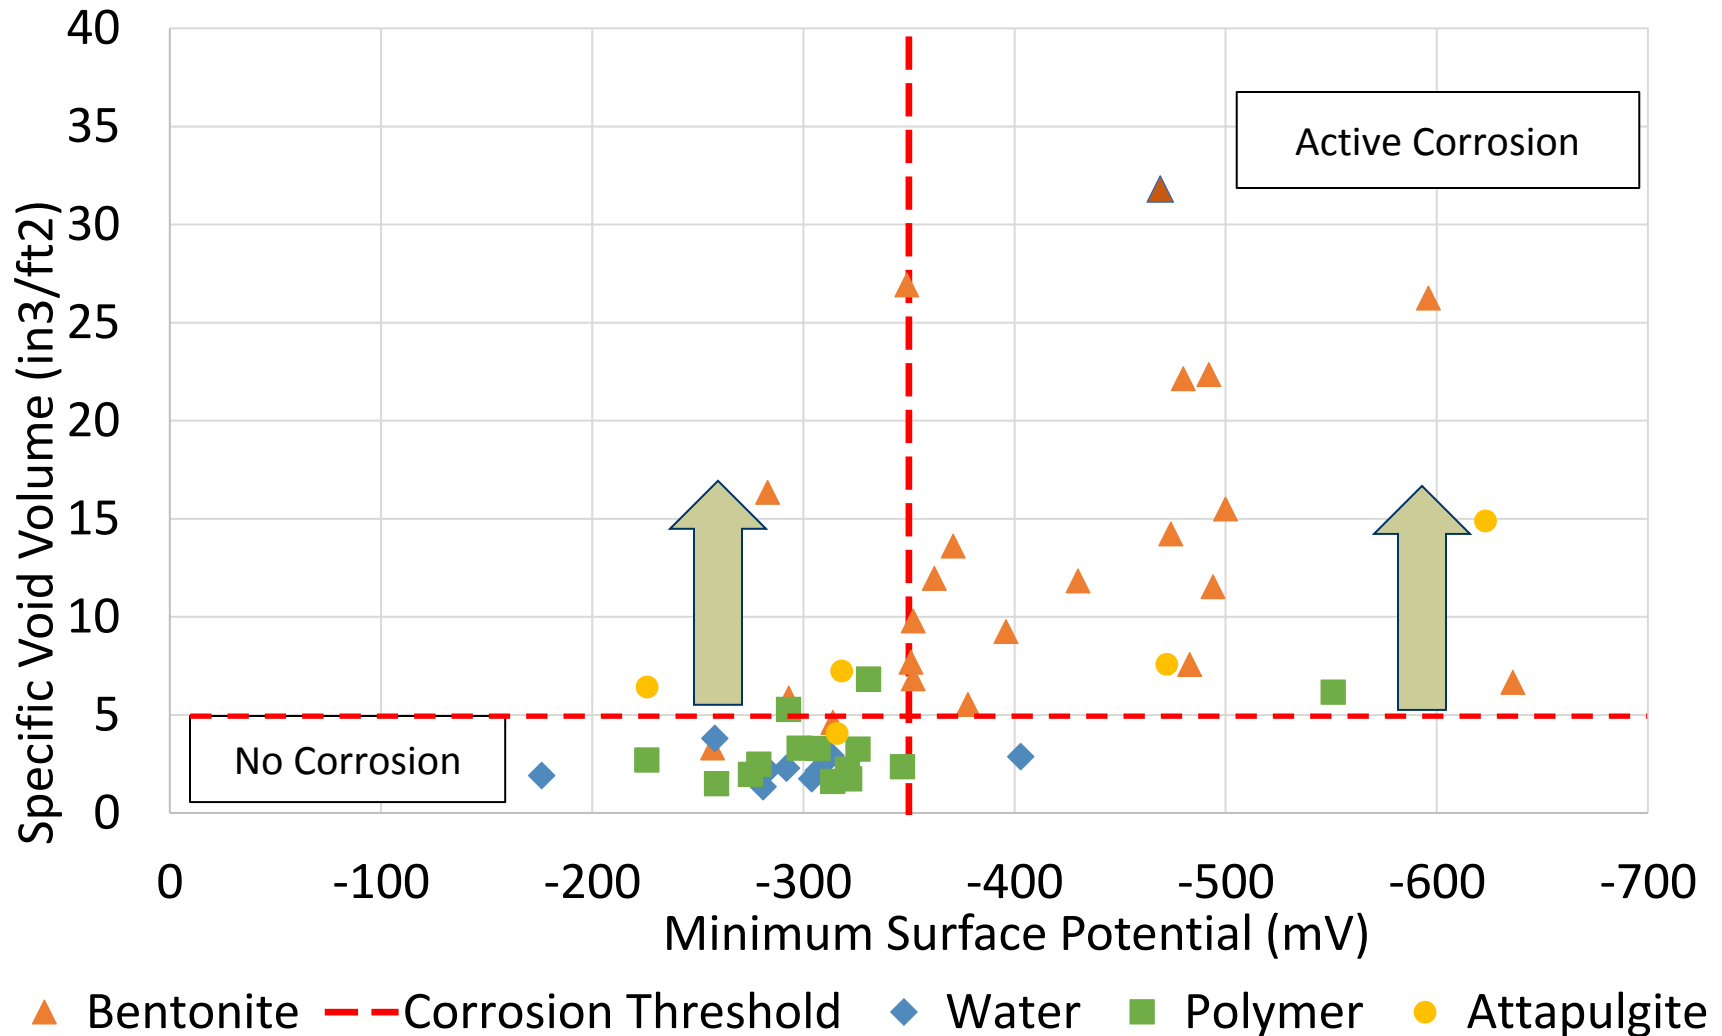
Specific Surface Roughness (Need to quantify)

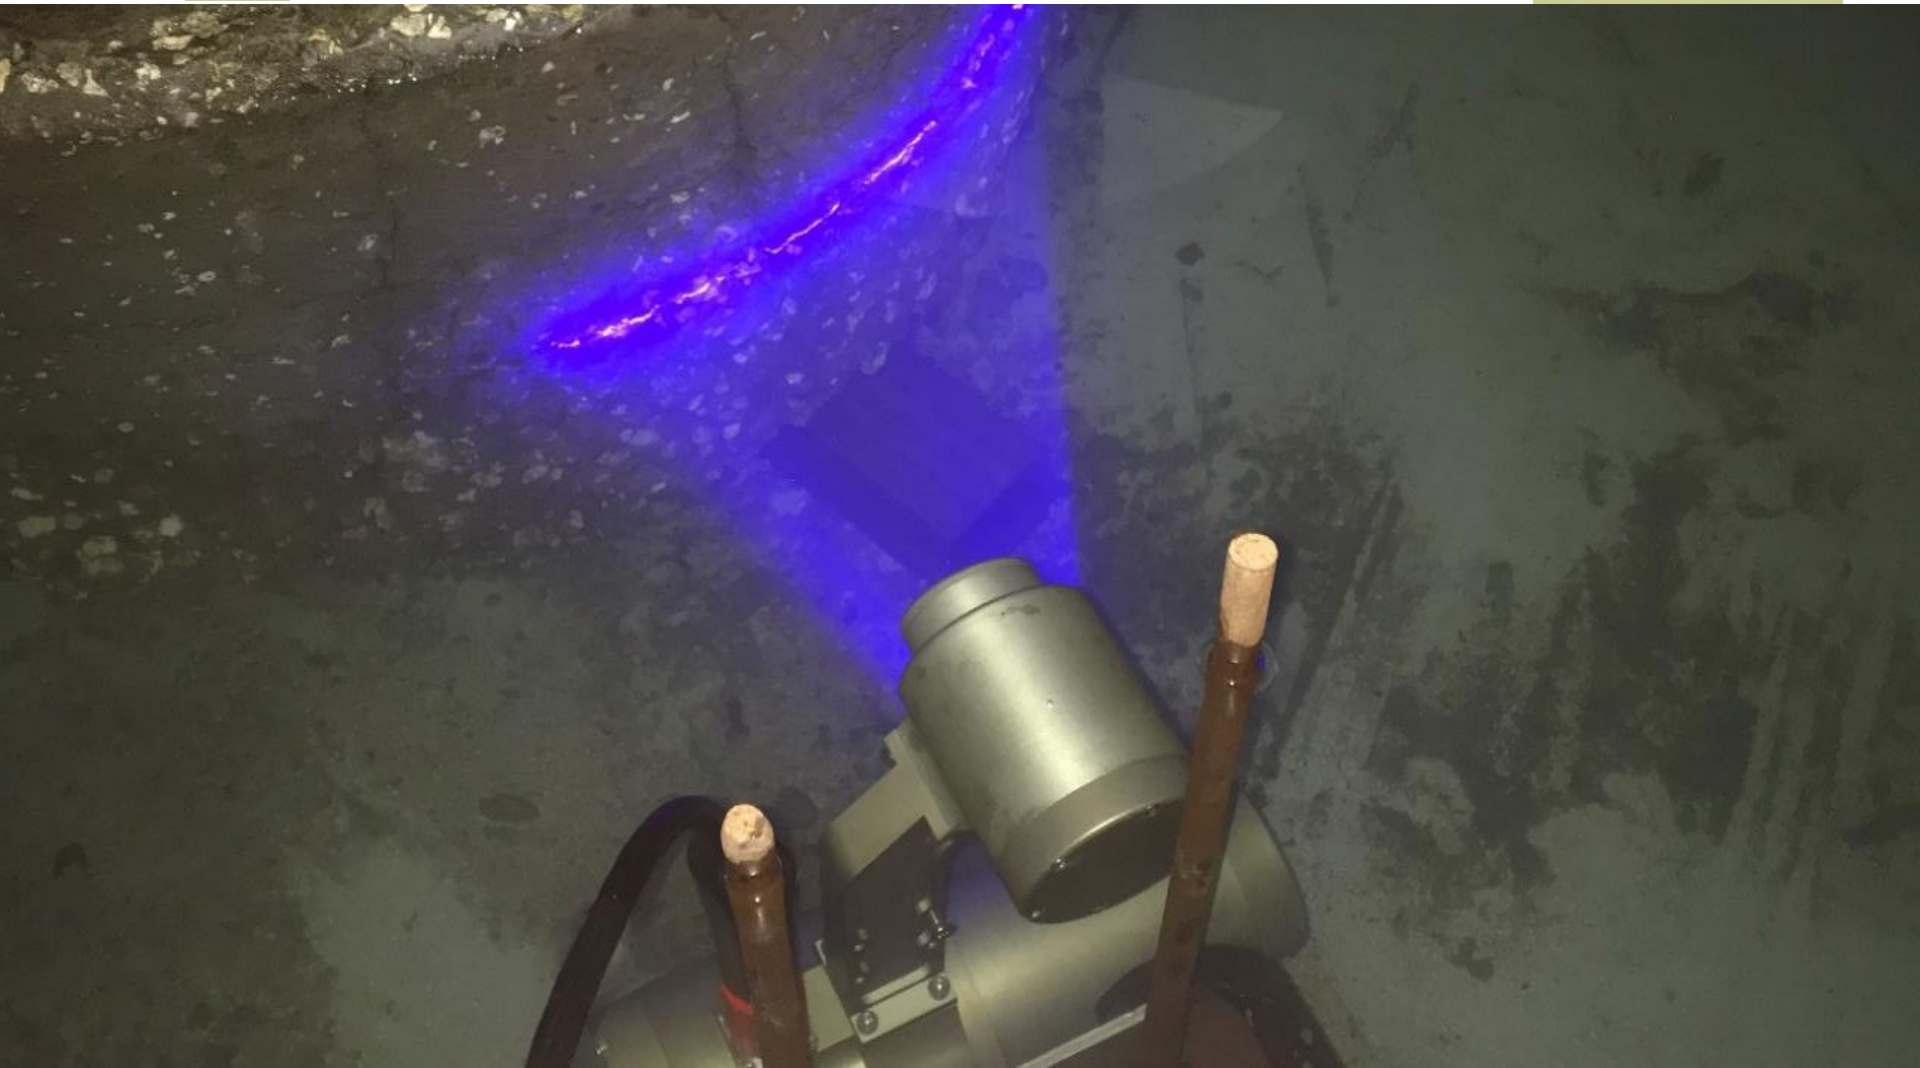
Underwater Laser Scanning

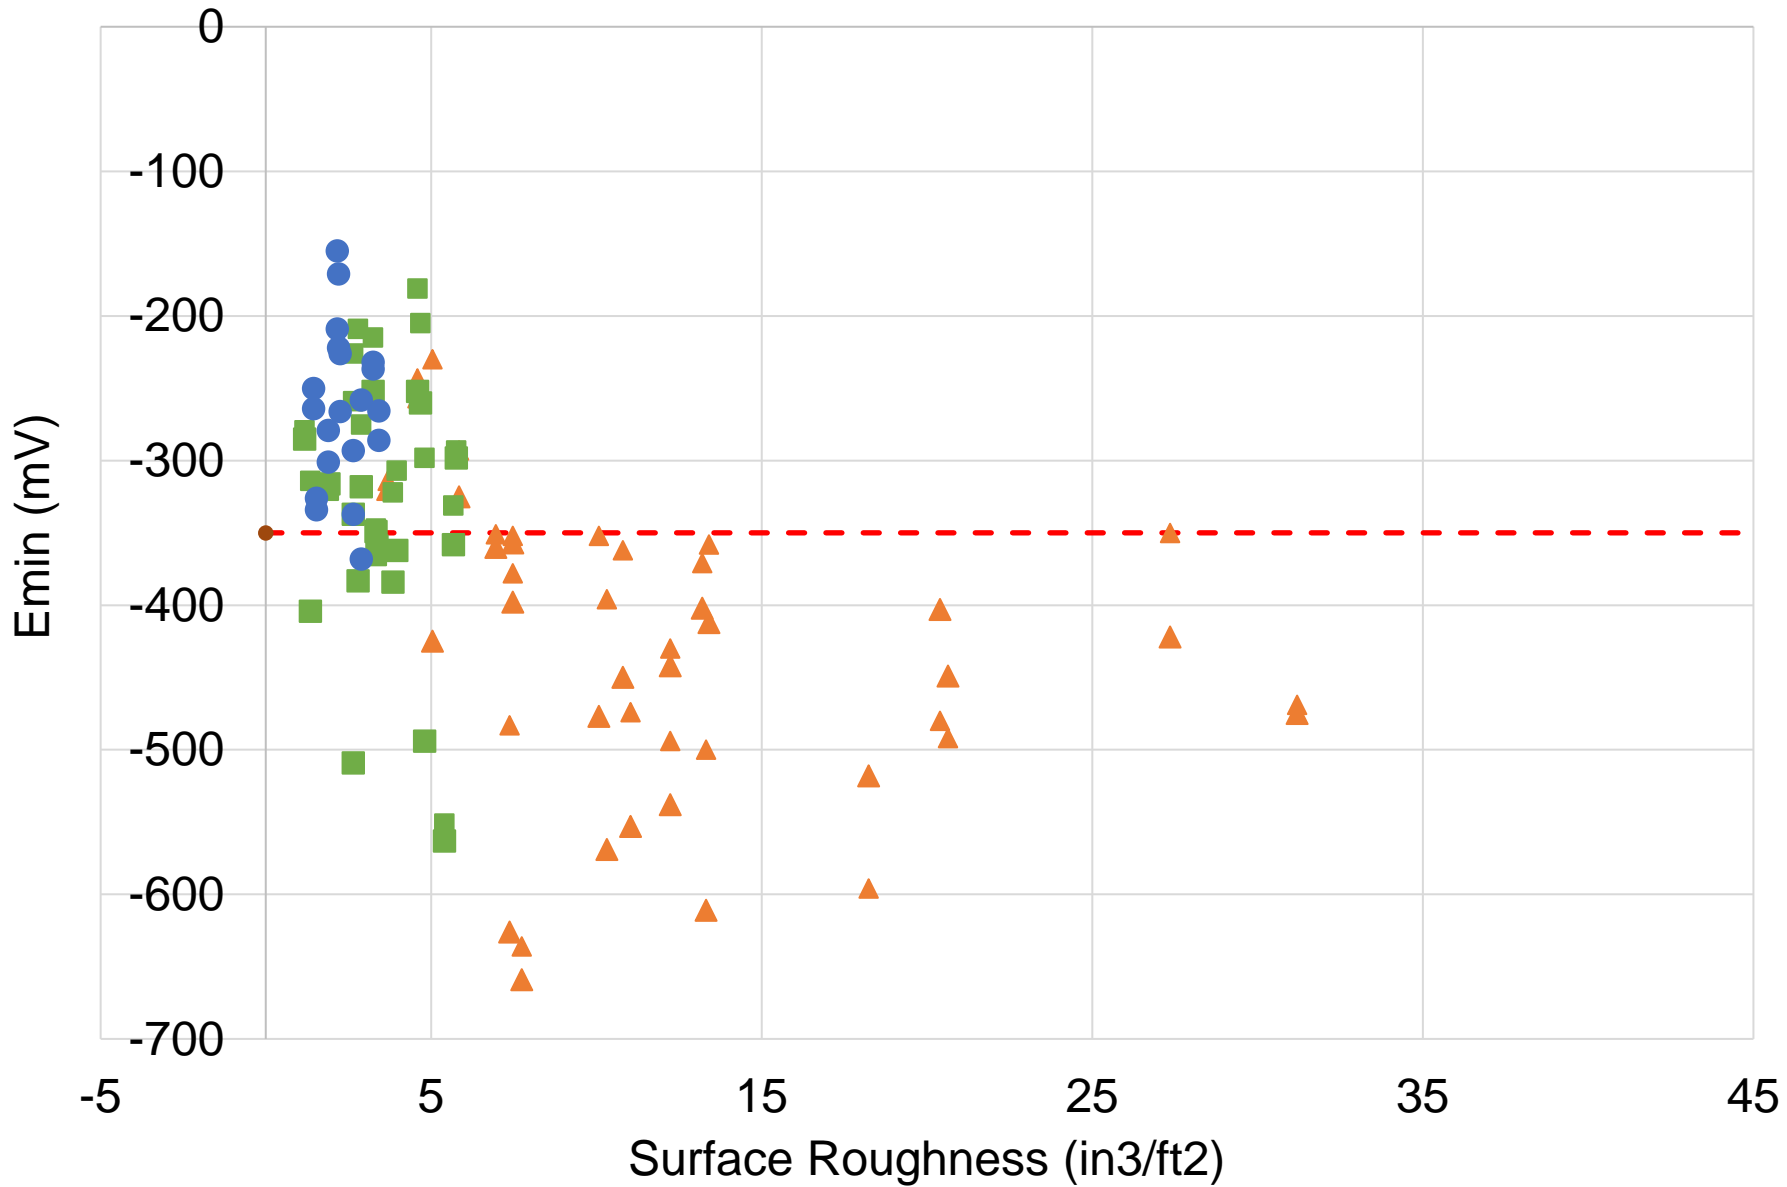
Digital Surface Roughness

Shaft ID	Surface Void Volume	Slurry Type
Pier 13 North	13.81	Bentonite
Pier 13 South	8.39	Bentonite
Pier 14 North	7.52	Bentonite
Pier 14 South	12.57	Bentonite
Pier 59 North	12.49	Bentonite
Pier 59 South	40.44	Bentonite
Pier 94 Southwest	1.89	Water
Lab verification	45.42	Bentonite
