Field Investigation of Downdrag on Concrete Piles in Sandy Soil

BDV25 TWO977-67

GRIP 2021

Malaak Araujo, E.I. and Gray Mullins, Ph.D., P.E.

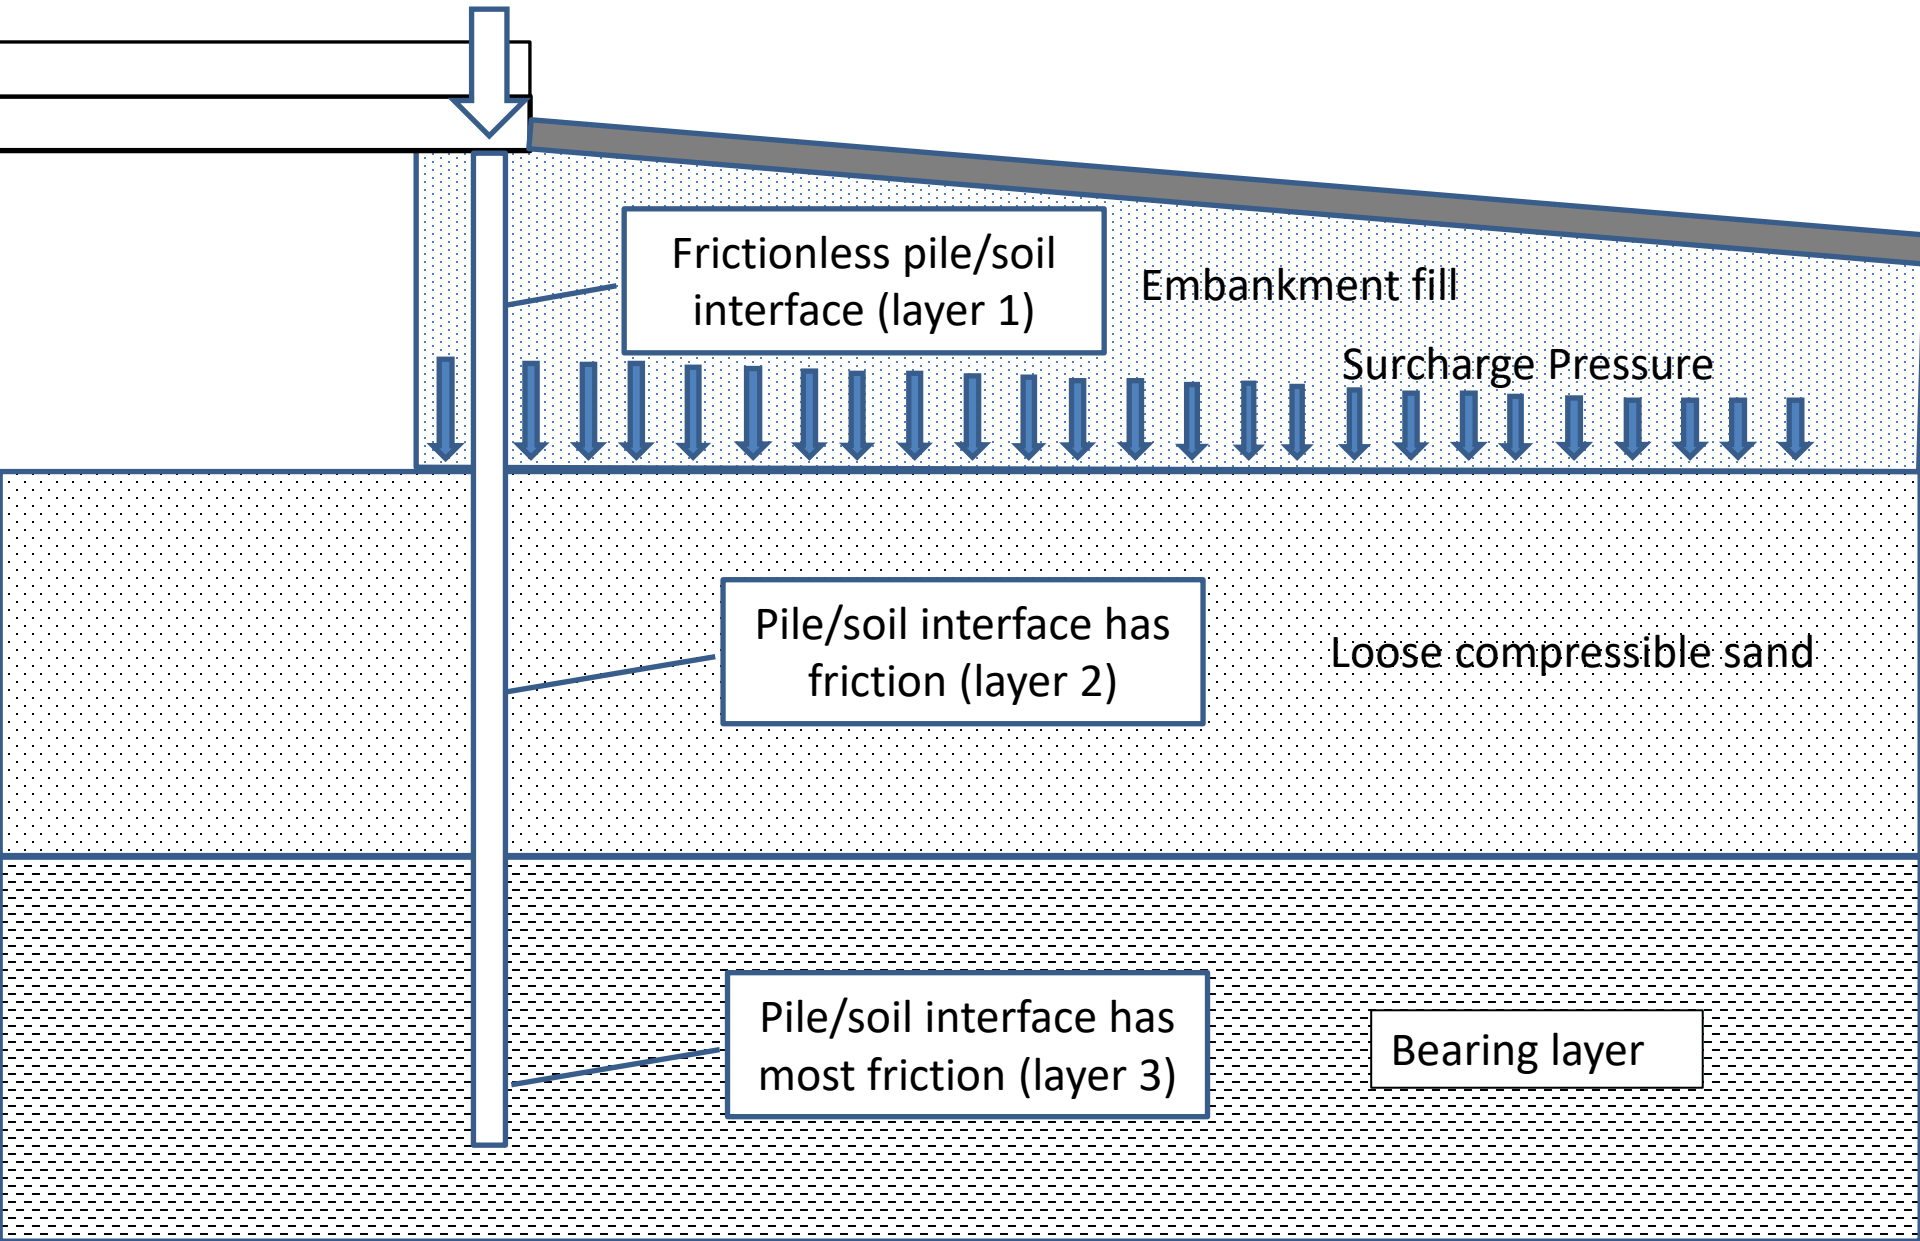
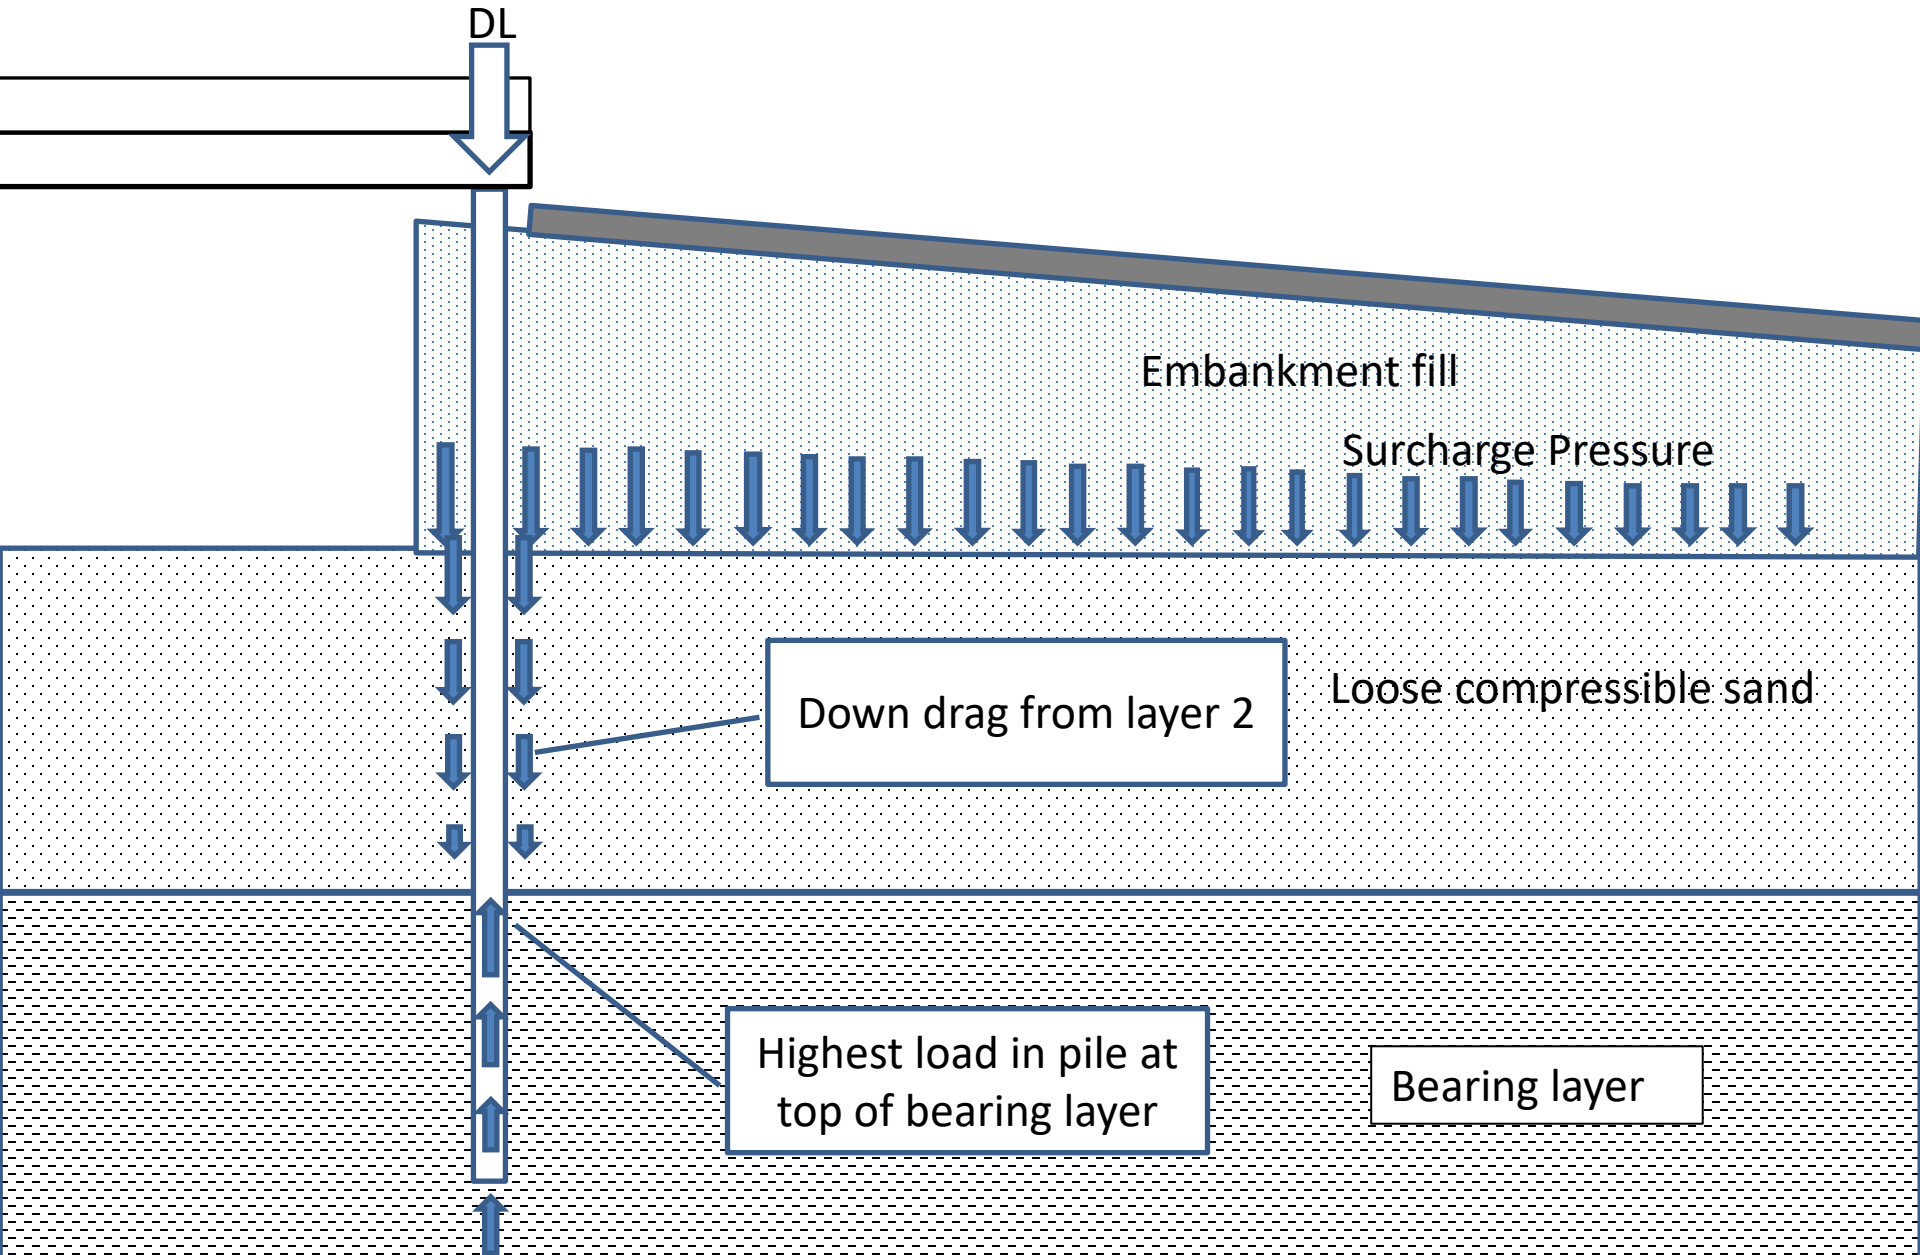
Simple Embankment Model

DL

Embankment fill

Surcharge Pressure

Down drag from layer 2

Loose compressible sand

Highest load in pile at top of bearing layer

Bearing layer

- Piles in end bents are often subjected to settlement induced surcharge loads in addition to structural bridge loads.
- Depending on the site-specific conditions it is conceivable that the additional loads may exceed the structural and/or geotechnical pile capacity.
- This study will investigate these conditions.
- Misconception: sandy soils settle immediately so there is no downdrag

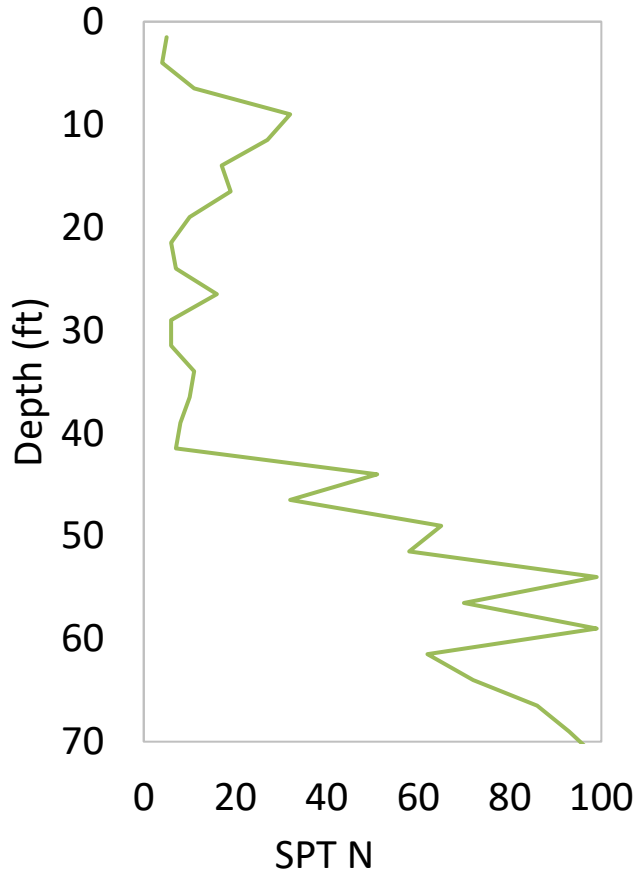
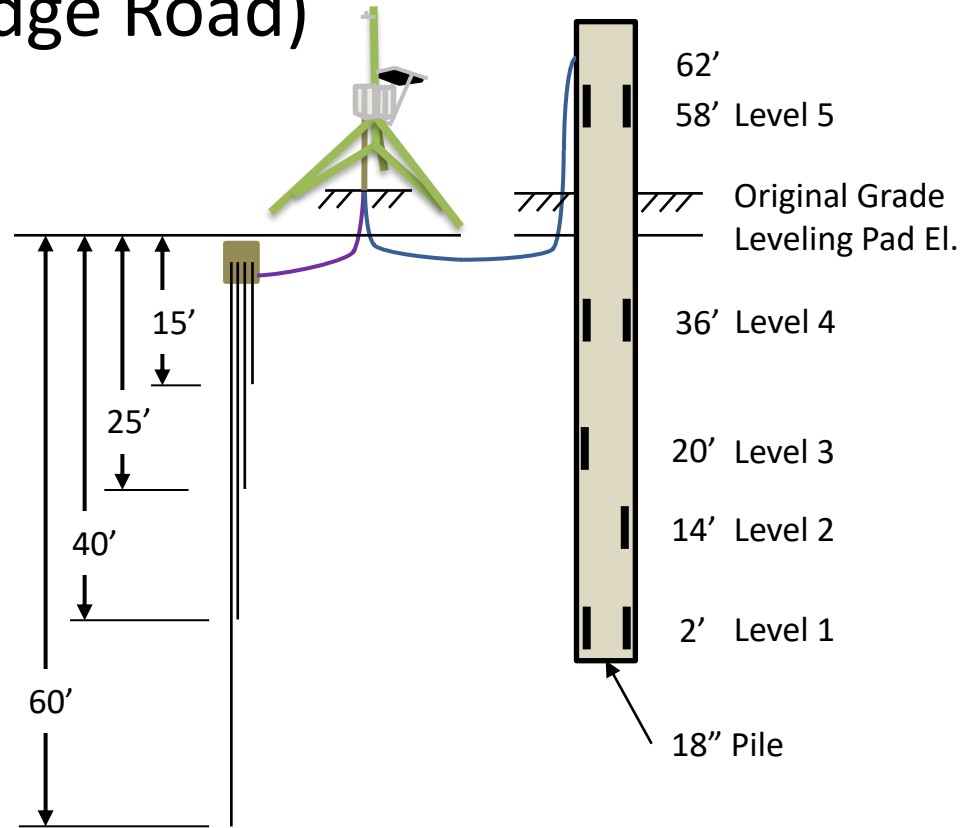
Site Evaluations (Sandridge Road)

SR 23 Northbound over CR-739B Sandridge Road

- Clay County, District 2
- Bridge No. 710113
- (6) 18-inch square prestressed concrete piles
- End Bent 1, Pile 4
- Pile instrumented: 3/29/21
- Site instrumented: 5/4 – 5/5

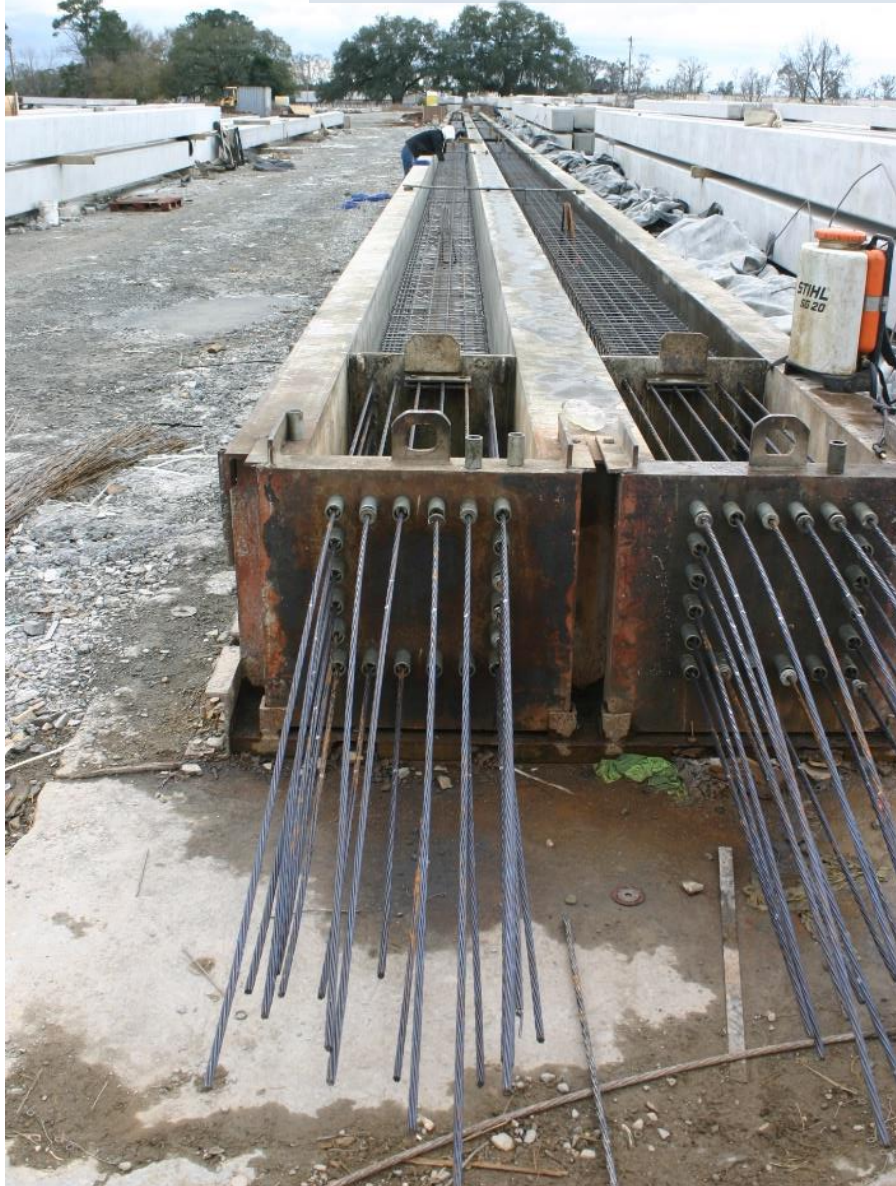
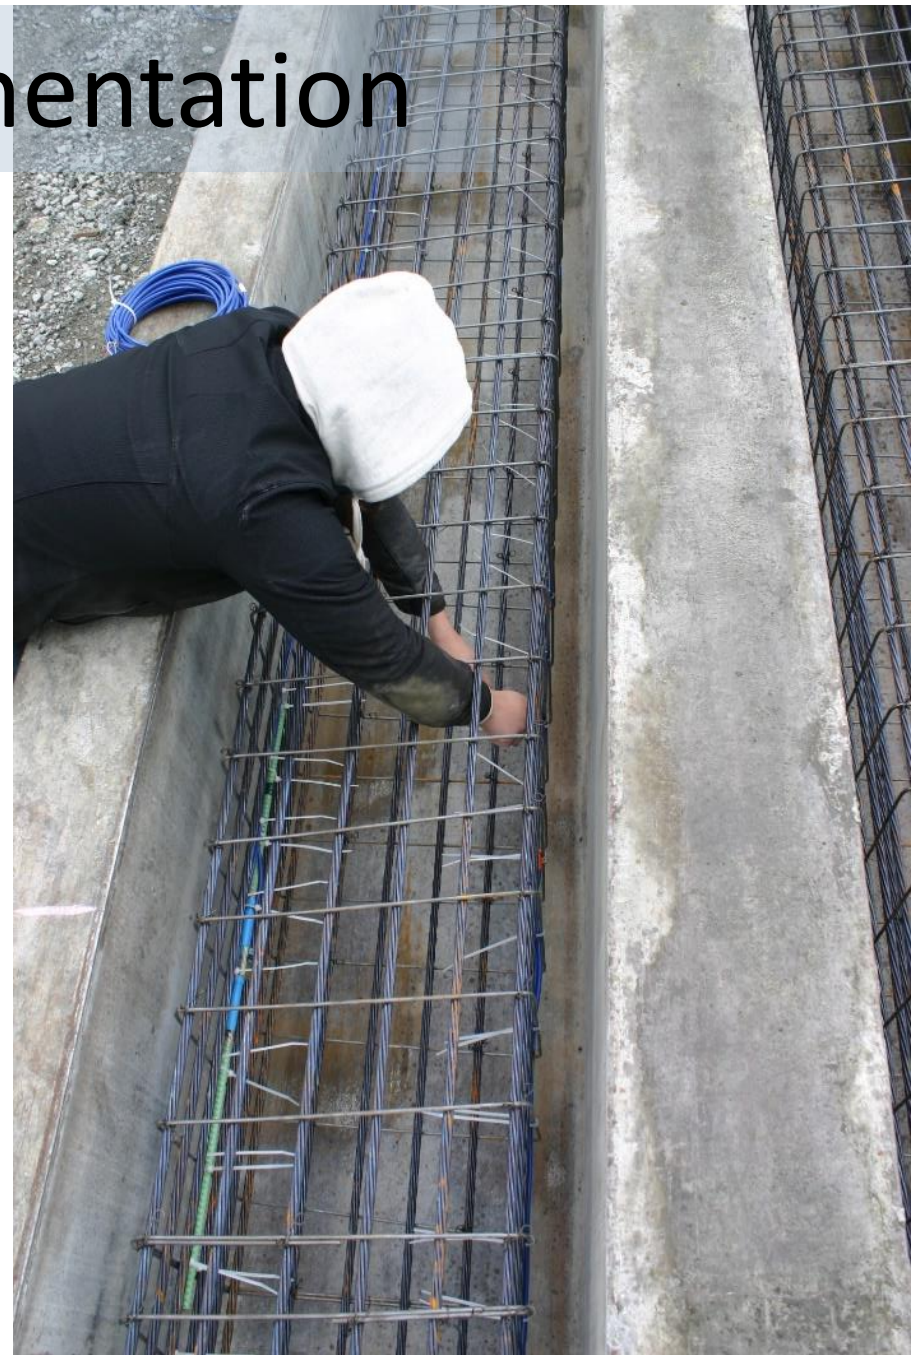
Pile Instrumentation

- Select sites with compressible soils beneath embankment
- Evaluate for potential downdrag
- Instrument piles for internal loads
- Instrument existing soils with settlement sensors.

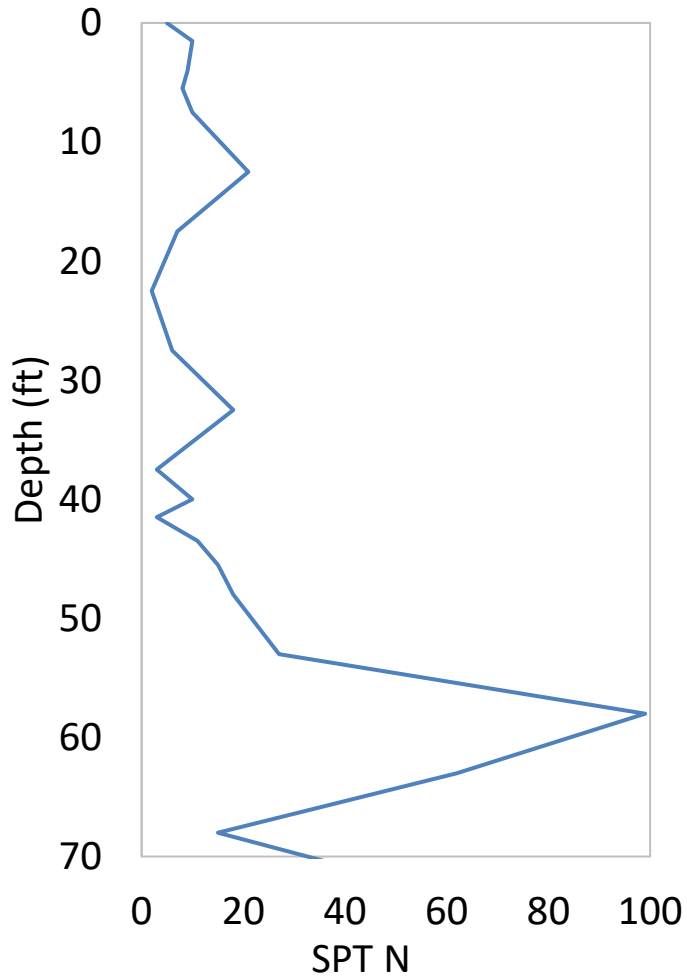
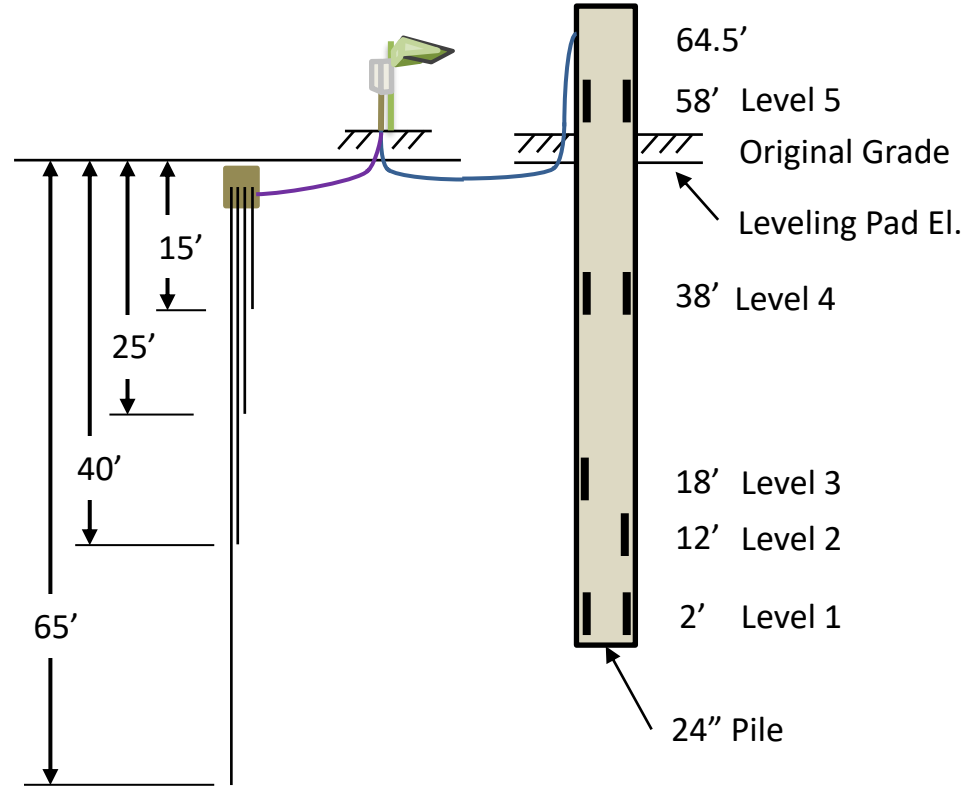
Paseo Al Mar Blvd

Paseo al Mar Boulevard I-75 Flyover

- Hillsborough County, District 7
- Bridge No. 104495
- (16) 24-inch square prestressed concrete piles
- End Bent 3, Pile 12
- Pile instrumented: 4/15/21
- Site instrumented: 5/1, 5/3
