Field Implementation of the Vertical In situ Permeameter (VIP)

BDV31-977-88

FDOT GRIP Meeting

July 22, 2021

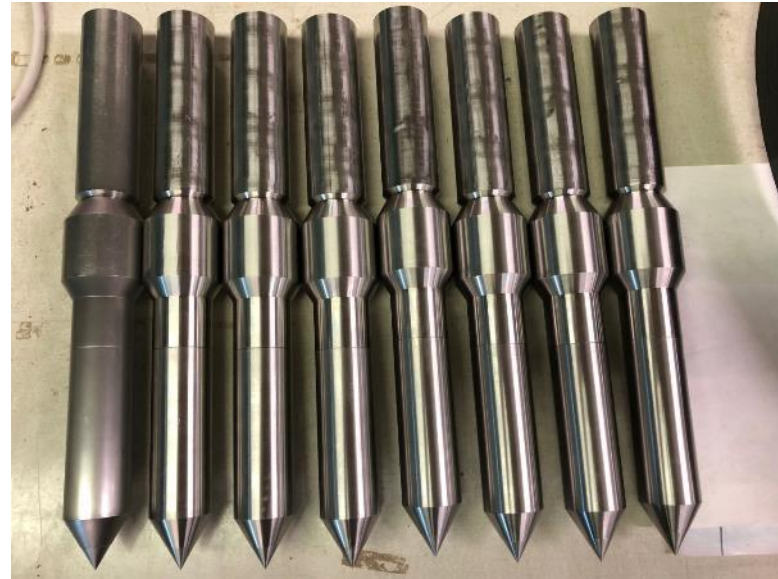
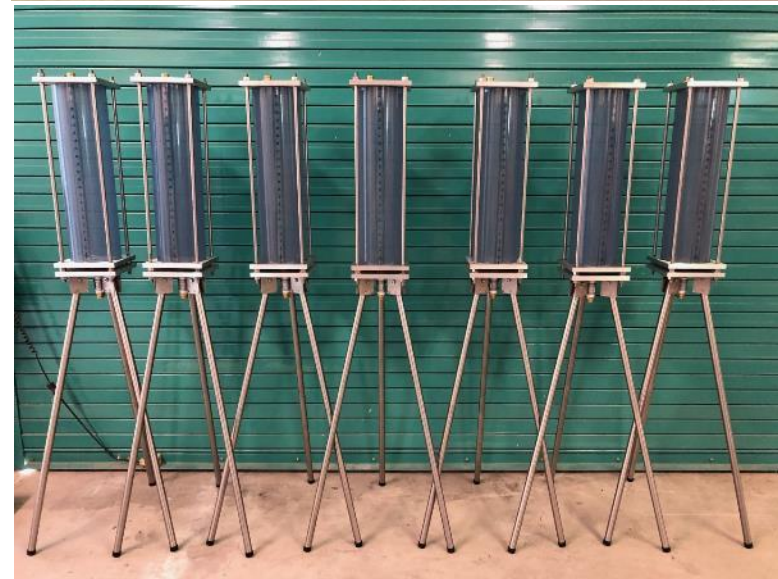
VIP Testing Equipment

- Each district received:
 - VIP Probe
 - Falling Head Vessel
 - AWJ attachment
- On-site training was provided within each FDOT district
 - D4 and D6 were combined
- YouTube VIP instructional video now available online

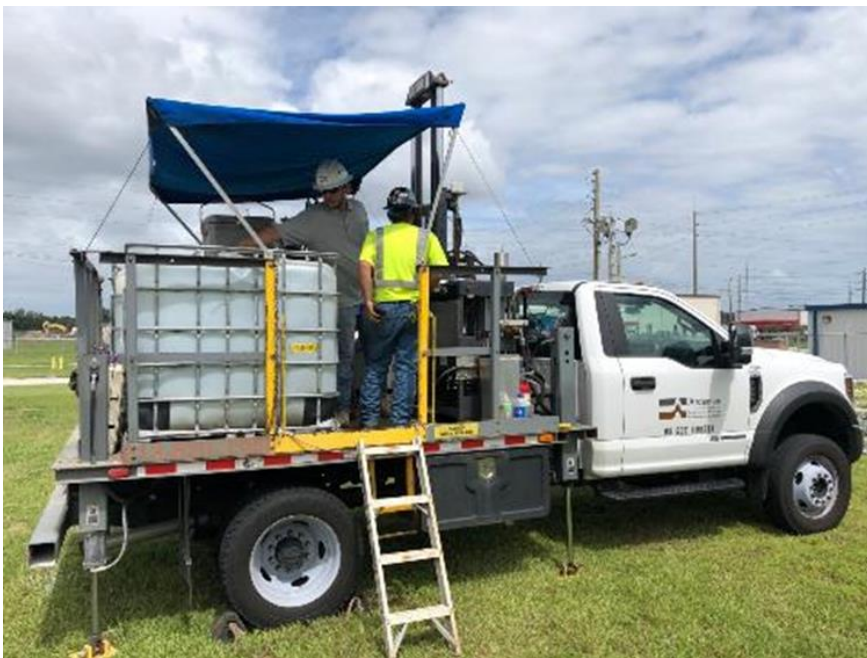
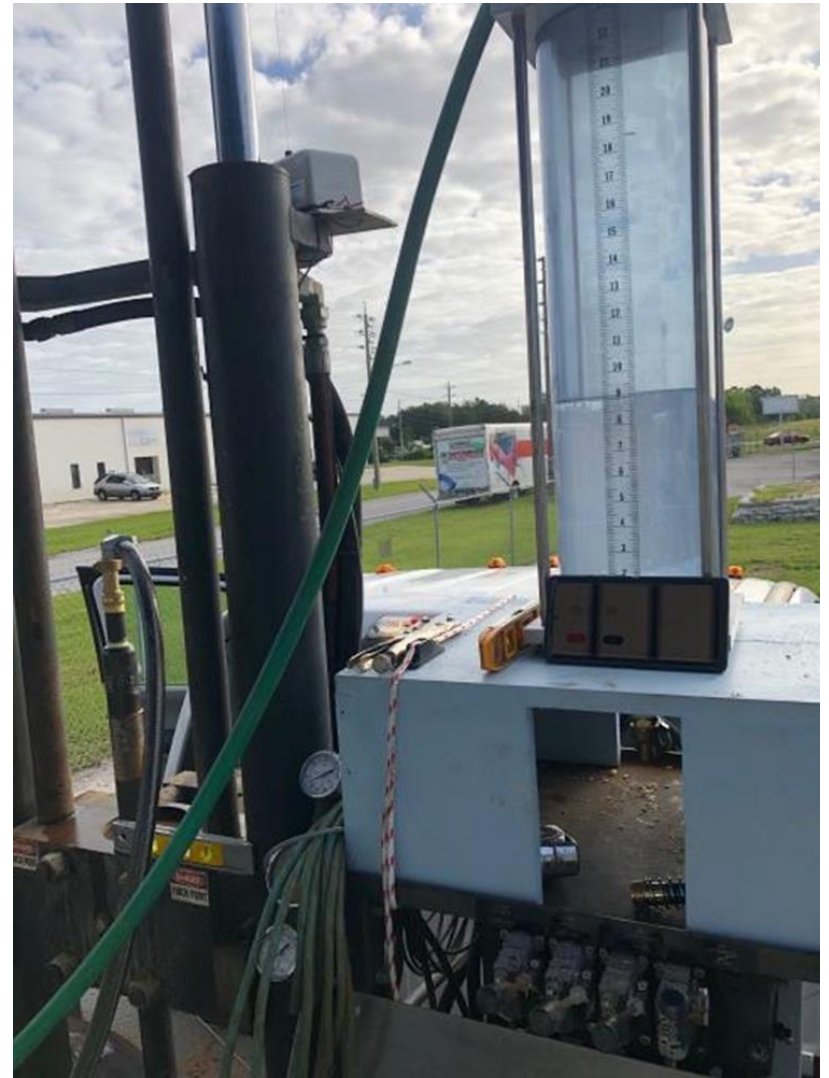
D1 – Bartow

- CPT style truck was used for VIP tests
- Custom VIP tank platform was installed
- Very precise control for opening and closing the probe
- Water supply and rig controls all within close proximity to VIP tank
 - Convenient to perform VIP tests

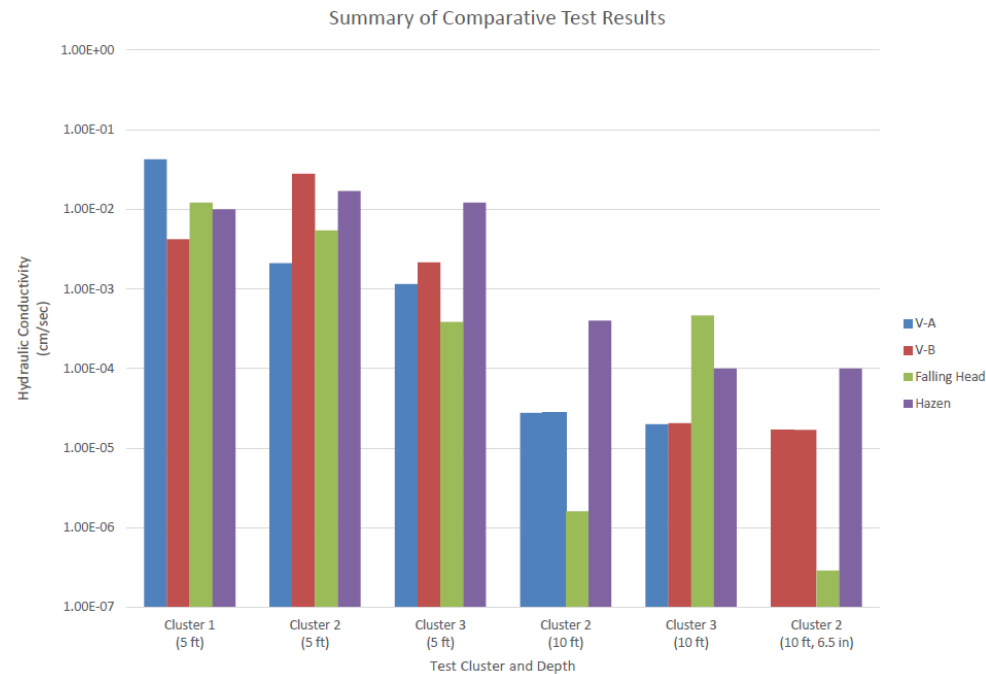
D1 – VIP vs. Laboratory Testing

- VIP and Lab Data agreed in coarse grained soils near surface
- Results were not conclusive at greater depths with lower permeable soils
 - Hazen not intended for fine-grained soils
 - Channeling observed in lab tests
 - Recommended longer FH lab test times due to clayey soils encountered
- Stated that VIP identified lower permeability soils

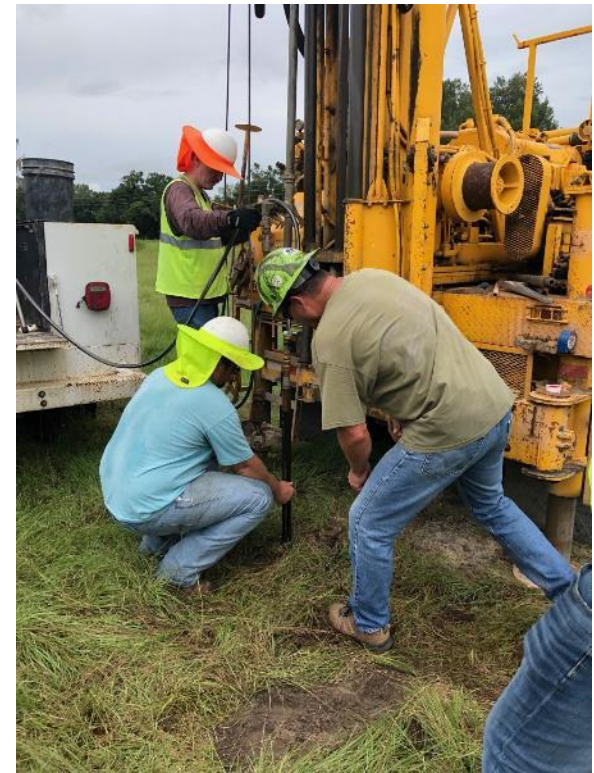
D2 – Newberry

- Investigated a potential retention pond site
 - Provided training to FDOT D2 field specialists
- Tested the hydraulic conductivity at the same elevation across the site
- Similar hydraulic conductivity across the site @ same elevation
 - Slight increase in K_m moving east to west

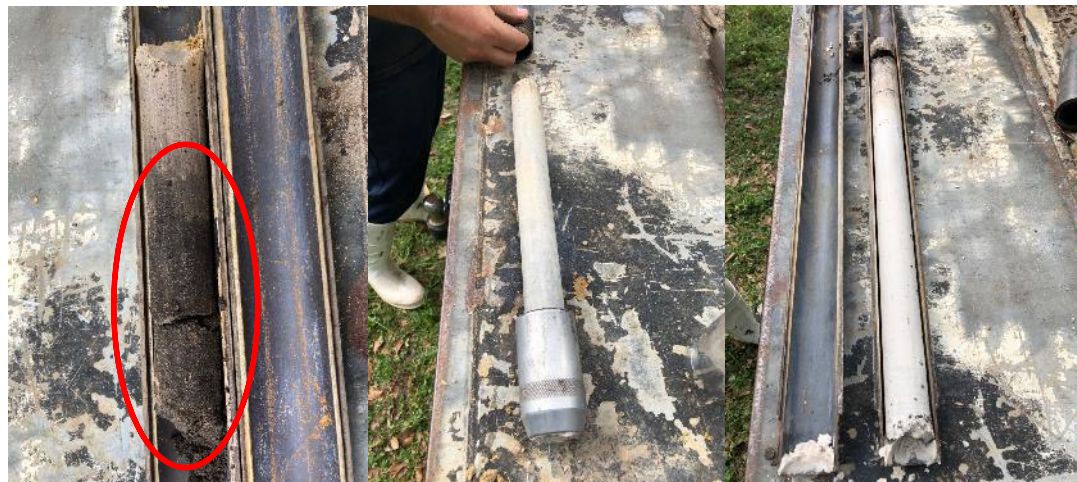
D2 – CR 349

- Provided VIP training to D2 consultants
- Observed large change in k_m moving from 5' to 10'
 - Increase in SPT blow counts
- Recorded very low k_m at 15'
 - A-7-6 / CH
 - $K_m = 3.45 \times 10^{-6} \text{ cm/s}$

5 ft
SPT N = 6

10 ft
SPT N = 27

15 ft
SPT N = 25

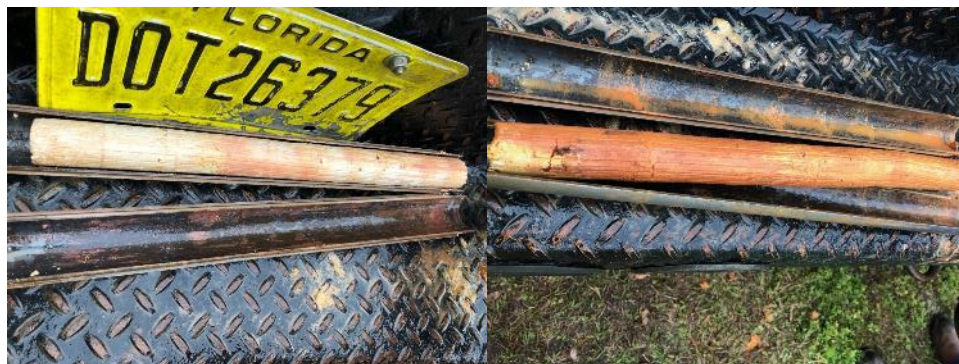
D3 – Marianna

- Provided training to FDOT D3 Field Specialists
- Tested 2 locations at the site
 - 3 test depths per location
- Low k_m at all locations
- No clear trend of increasing k_m with depth
 - SPT N decreased with depth

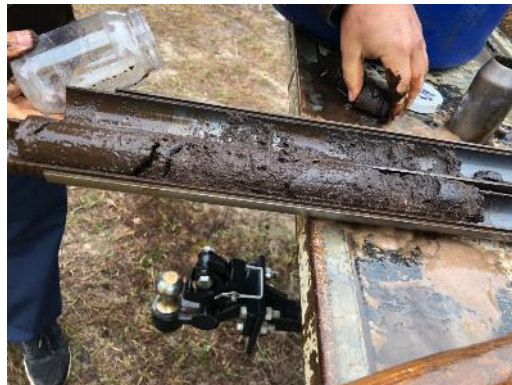
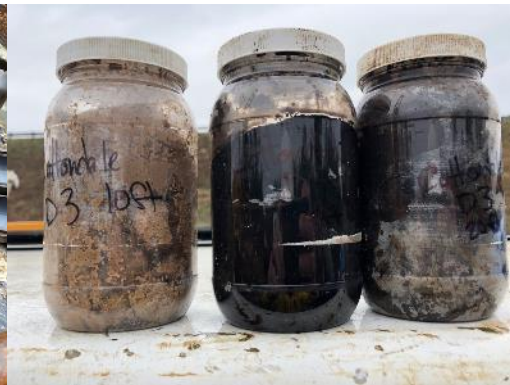
D3 – SR 231 - Cottondale

- Tested 3 locations at the site
 - 3 test depths per location
- Lower k_m at all 3 locations
- Only Location 3 indicated decreasing k_m with depth
 - SPT N variable with depth
- Often encountered dark black soil at site

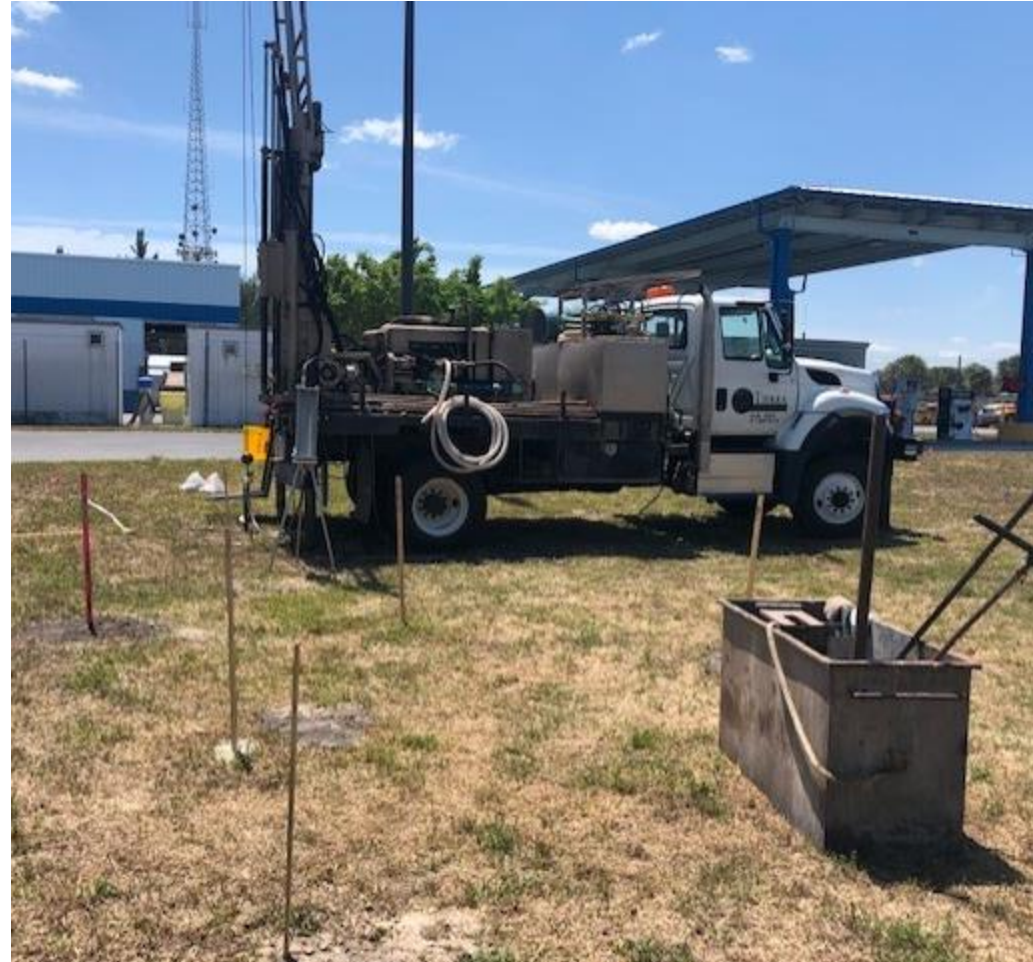
D4/6 – D4 Operations Center

- Completed 22 VIP tests
- Depths ranged from 5 to 20 feet
- All soil was classified as A-3
- Large range of SPT blow counts
- Excellent opportunity to investigate influence of density on soil permeability

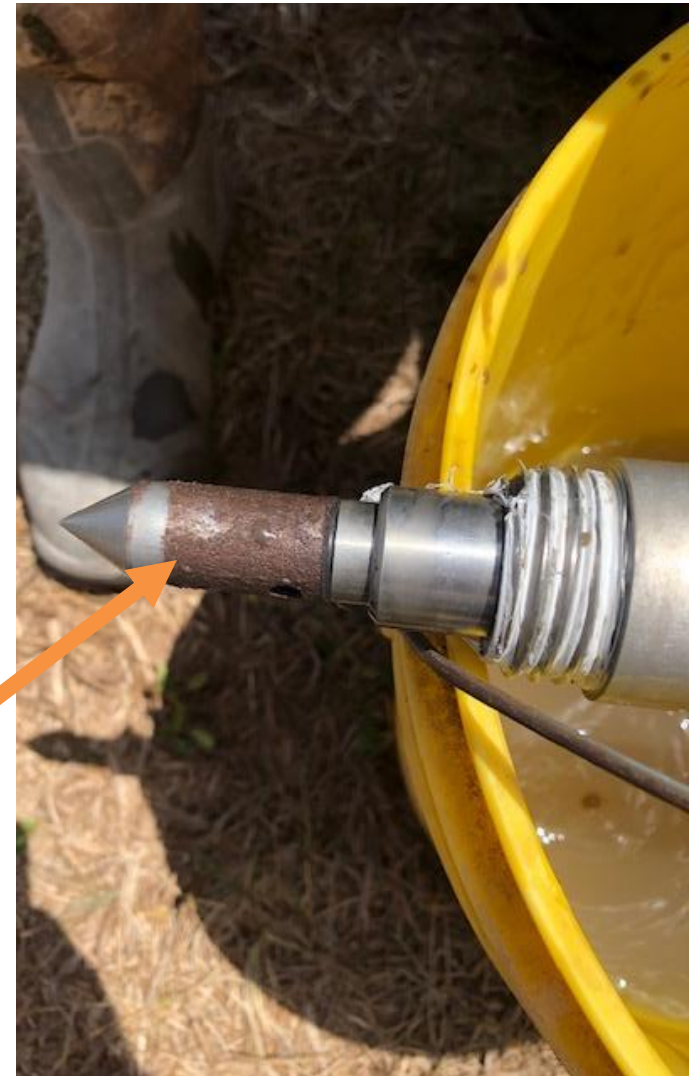
False Reading

- Too much grease was added to AWJ threads
- Transmitted through the drill string and out of the probe tip
- Grease likely permeated into soil and caused a false reading

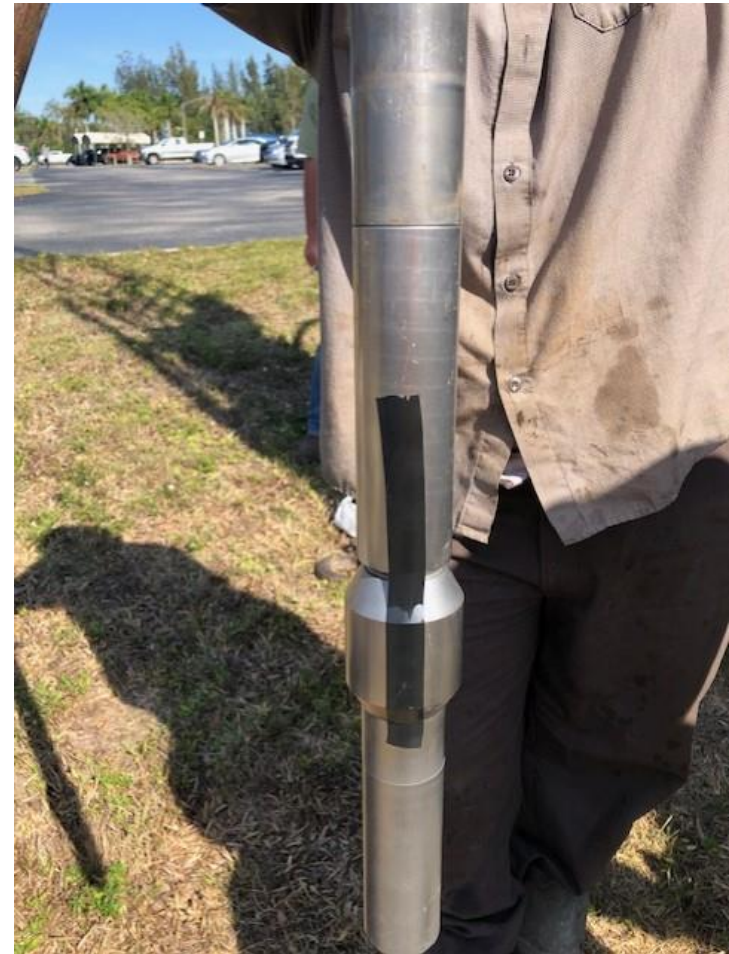
Placing the Probe Down an Open Hole

- South Florida site had shell and limestone fragments near surface
- Hand augered first 3-4 feet to pass through limestone fragments
- Placed VIP probe down the open hole
- Used electric tape to ensure probe stayed closed until the test was initiated

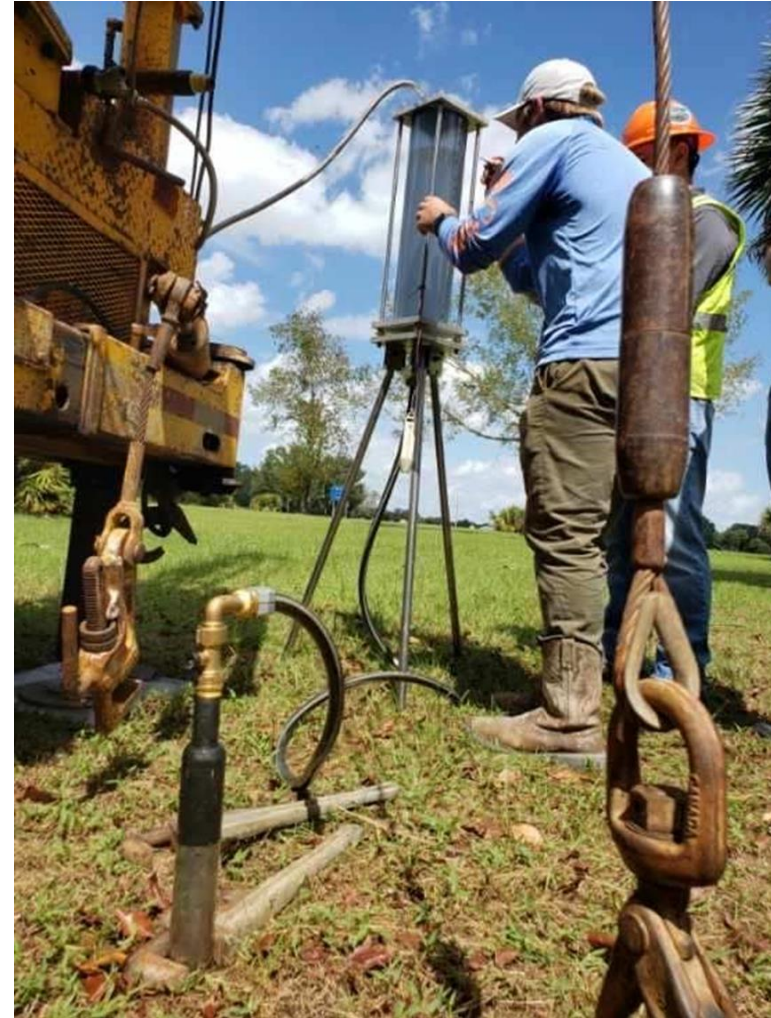
D5 – I75 Rest Area

- Provided training for D5 FDOT engineers and consultants
- 21 VIP tests completed
 - 10 comparative CCH tests performed
- Investigated VIP as infiltrometer tests
 - Shows promise as a new quick infiltrometer method
- Very large range of hydraulic conductivity
 - $K_{m-max} = 4.15 \times 10^{-2} \text{ cm/s}$
 - $K_{m-min} = 8.65 \times 10^{-7} \text{ cm/s}$

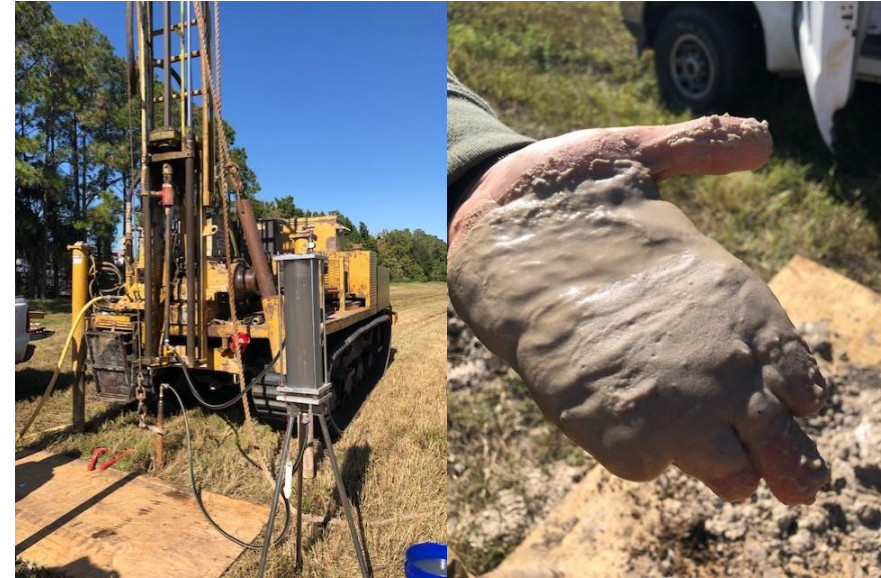
D7/Turnpike – Veterans Expressway

- 5 VIP tests were completed
 - 5 to 15 feet
 - High water table (2.6 ft) slowed testing down
- 1 VIP infiltrometer tests was completed
 - Do not to use drill rig for VIP infiltrometer tests
- Historical data indicated km range of 7.37×10^{-3} cm/s to 2.43×10^{-4} cm/s
- VIP measurements were in excellent agreement
 - Fine grained soil collected by hand auger also indicates lower permeability
