Field Investigation of DOWNDrag on Concrete Piles in Sandy Soil

BDV25 TWO977-67

GRIP 2022

Malaak Araujo, E.I. and Gray Mullins, Ph.D., P.E.
Project Manager: Larry Jones, P.E.

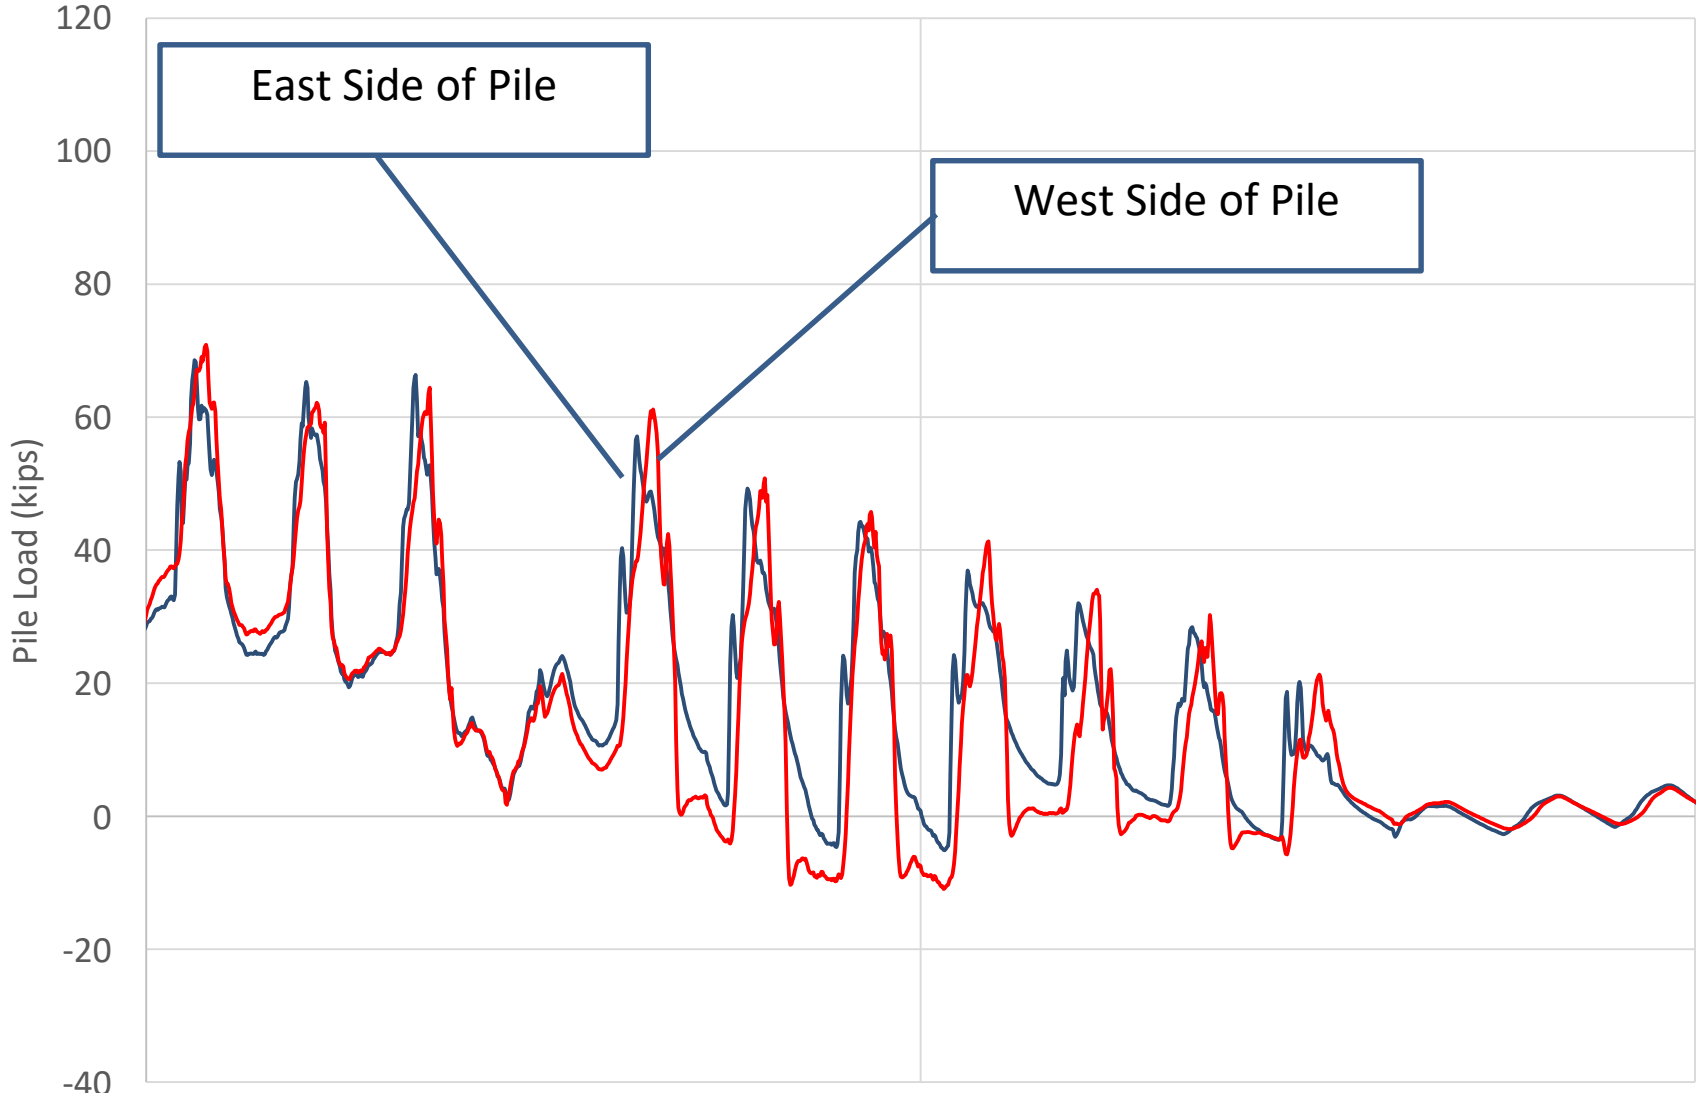
Apparent Pile Load from Sun Effects

East Side of Pile

West Side of Pile

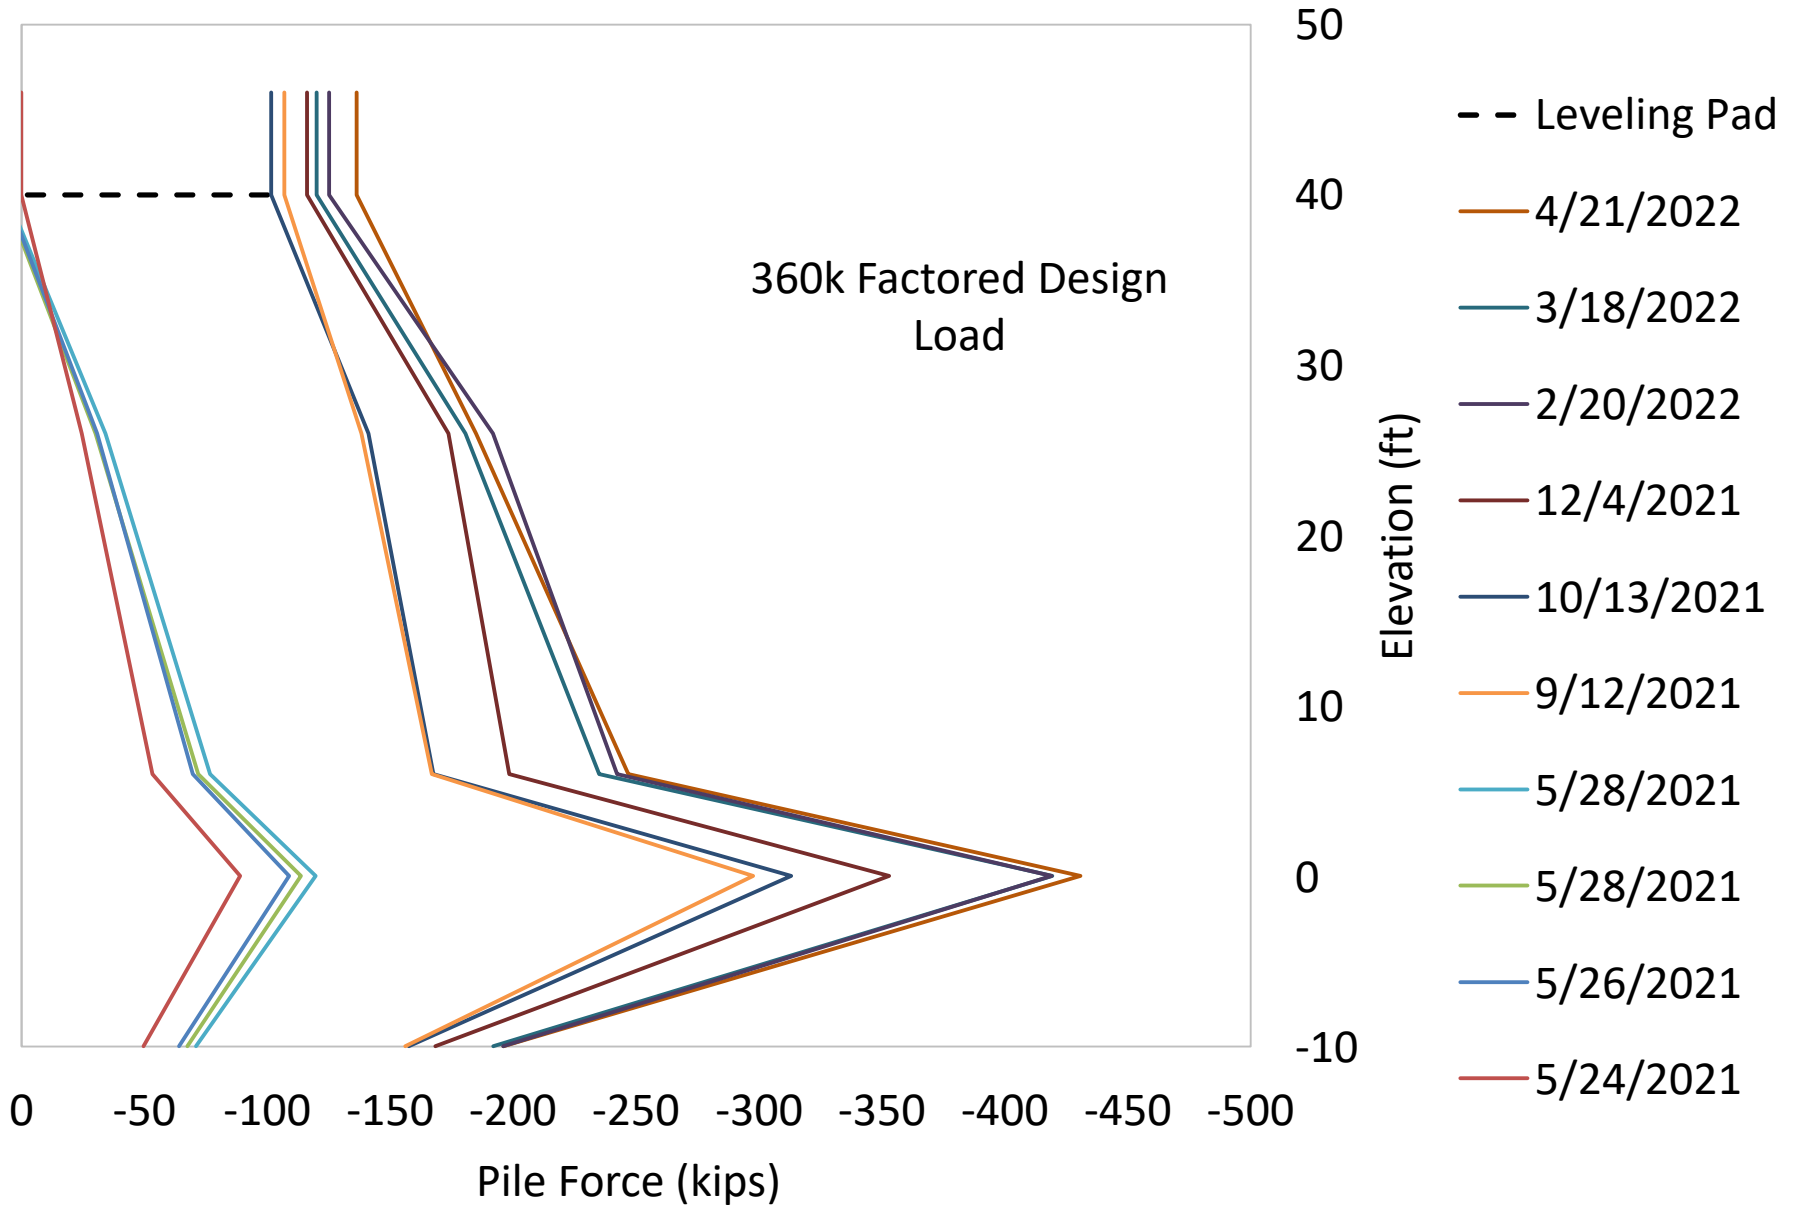
Force Evolution

253-261kip Service Load (DL/LL = 2 or 3, respectively)
