# GRIP 2022

## Project: Validation and Update of the Sinkhole Index (BDV24 TWO 977-41)

August 12<sup>th</sup>, 2022

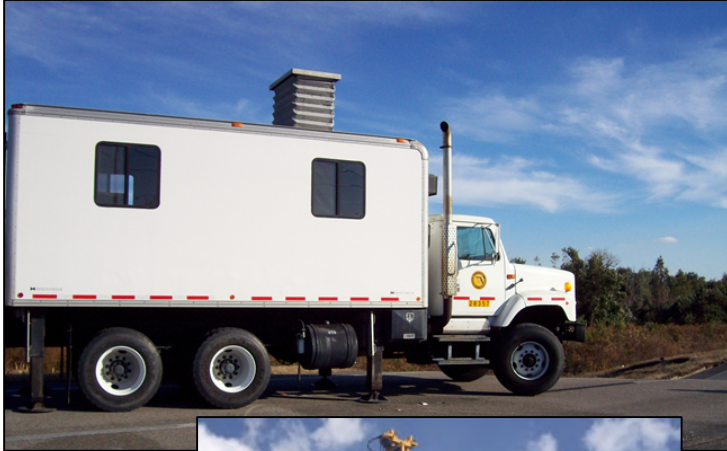
# CPT and SPT

Cone penetration test (CPT): **0.16 ft** [60ft ~ > 1 hr]  
 Standard penetration test (SPT): **2.5 ft** [60ft ~ half day]  
Important for ground verification

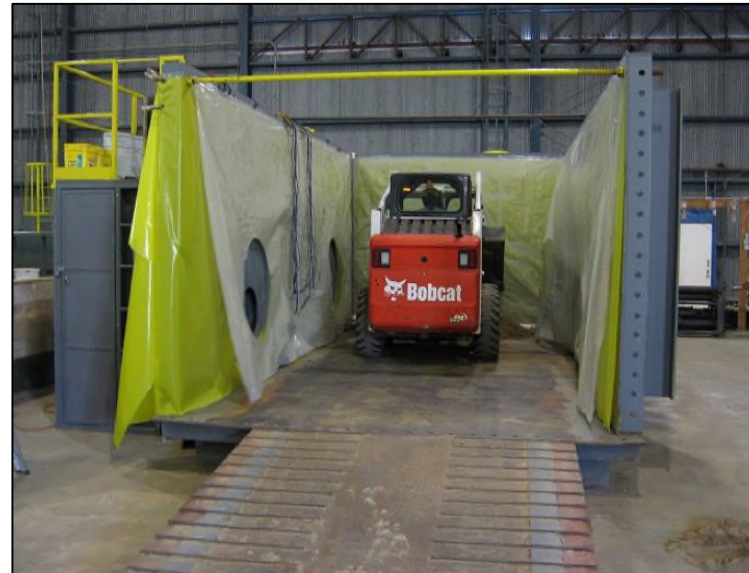
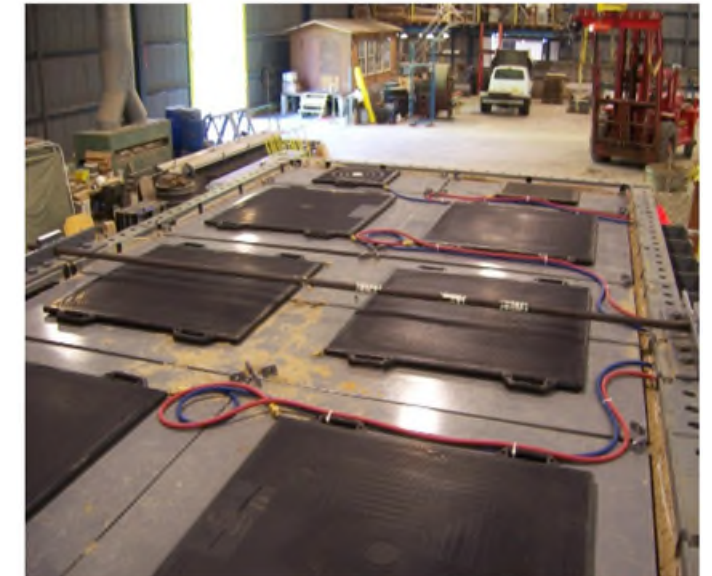
# Task 3: Setup of the Large-Scale Soil Box (LSSB)

Deconstruction (UF), transportation, and re-construction at campus of UNF

- Concrete slab, gated/locked area, tarped and covered with parking canopy
- LSSB preparation for sinkhole testing.

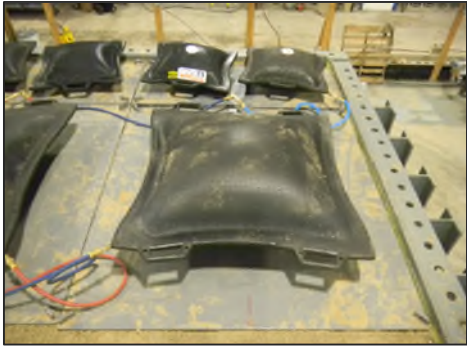
Inflated airbag to simulate overburden pressure (ABOVE)

Entry port for “void” installation and sediment transport (BELOW)

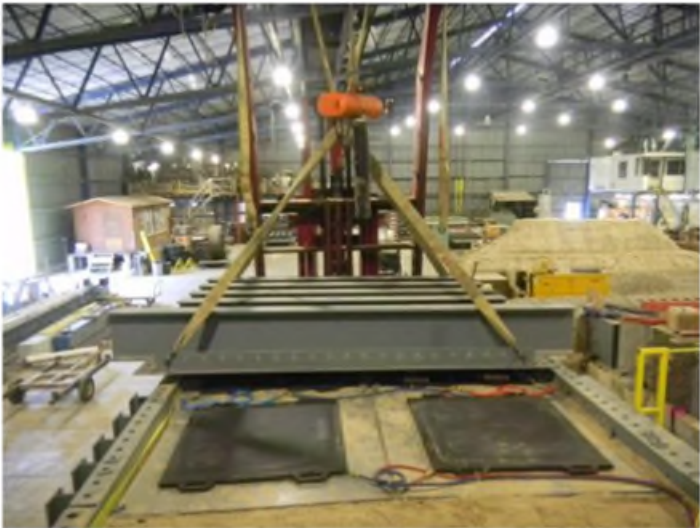
(LEFT) Installation of I-Beam roof for reaction force of airbags and overburden simulation

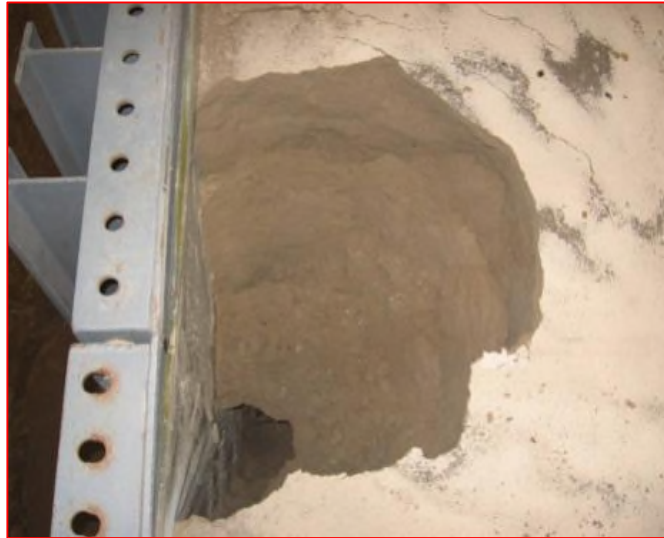
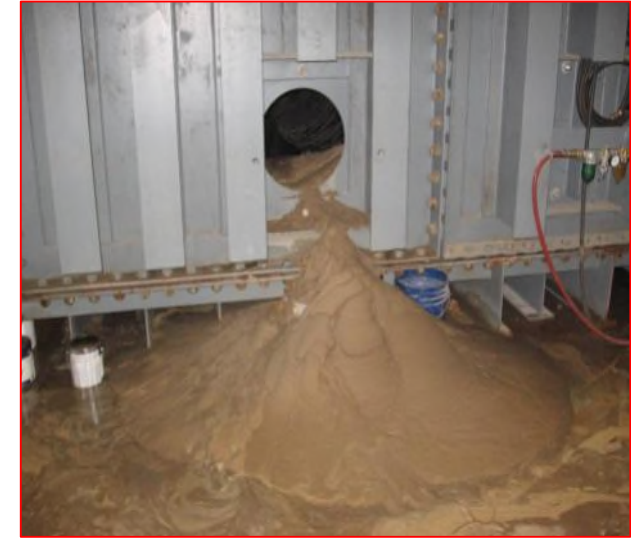
Previous accidental sinkhole formation:

*UF Thesis, Faraone 2012*
