# GRIP 2022

## Project: Validation and Update of the Sinkhole Index (BDV24 TWO 977-41)

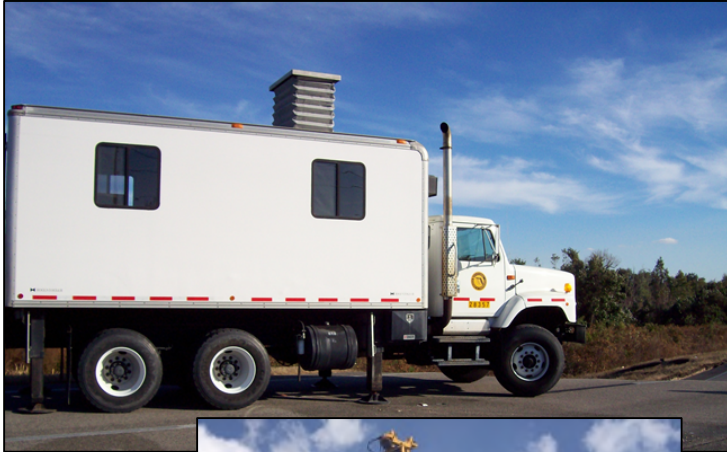
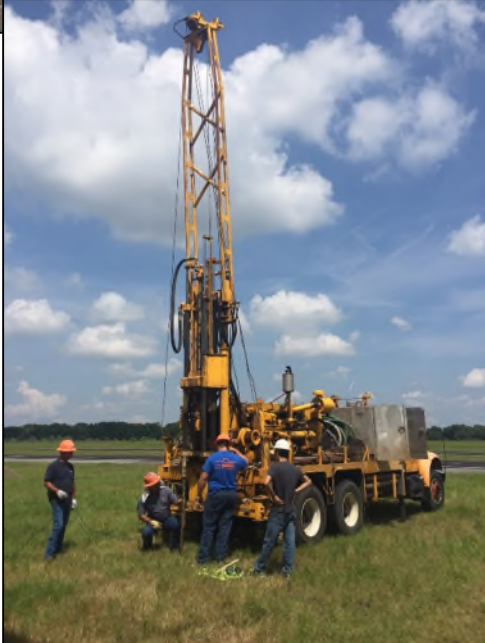
SPT performed ~3m NE of sinkhole

CPT performed ~0.5m from Boring B-1

Cone penetration test (CPT): **0.16 ft** [60ft ~ > 1 hr]  
 Standard penetration test (SPT): **2.5 ft** [60ft ~ half day]  
Important for ground verification

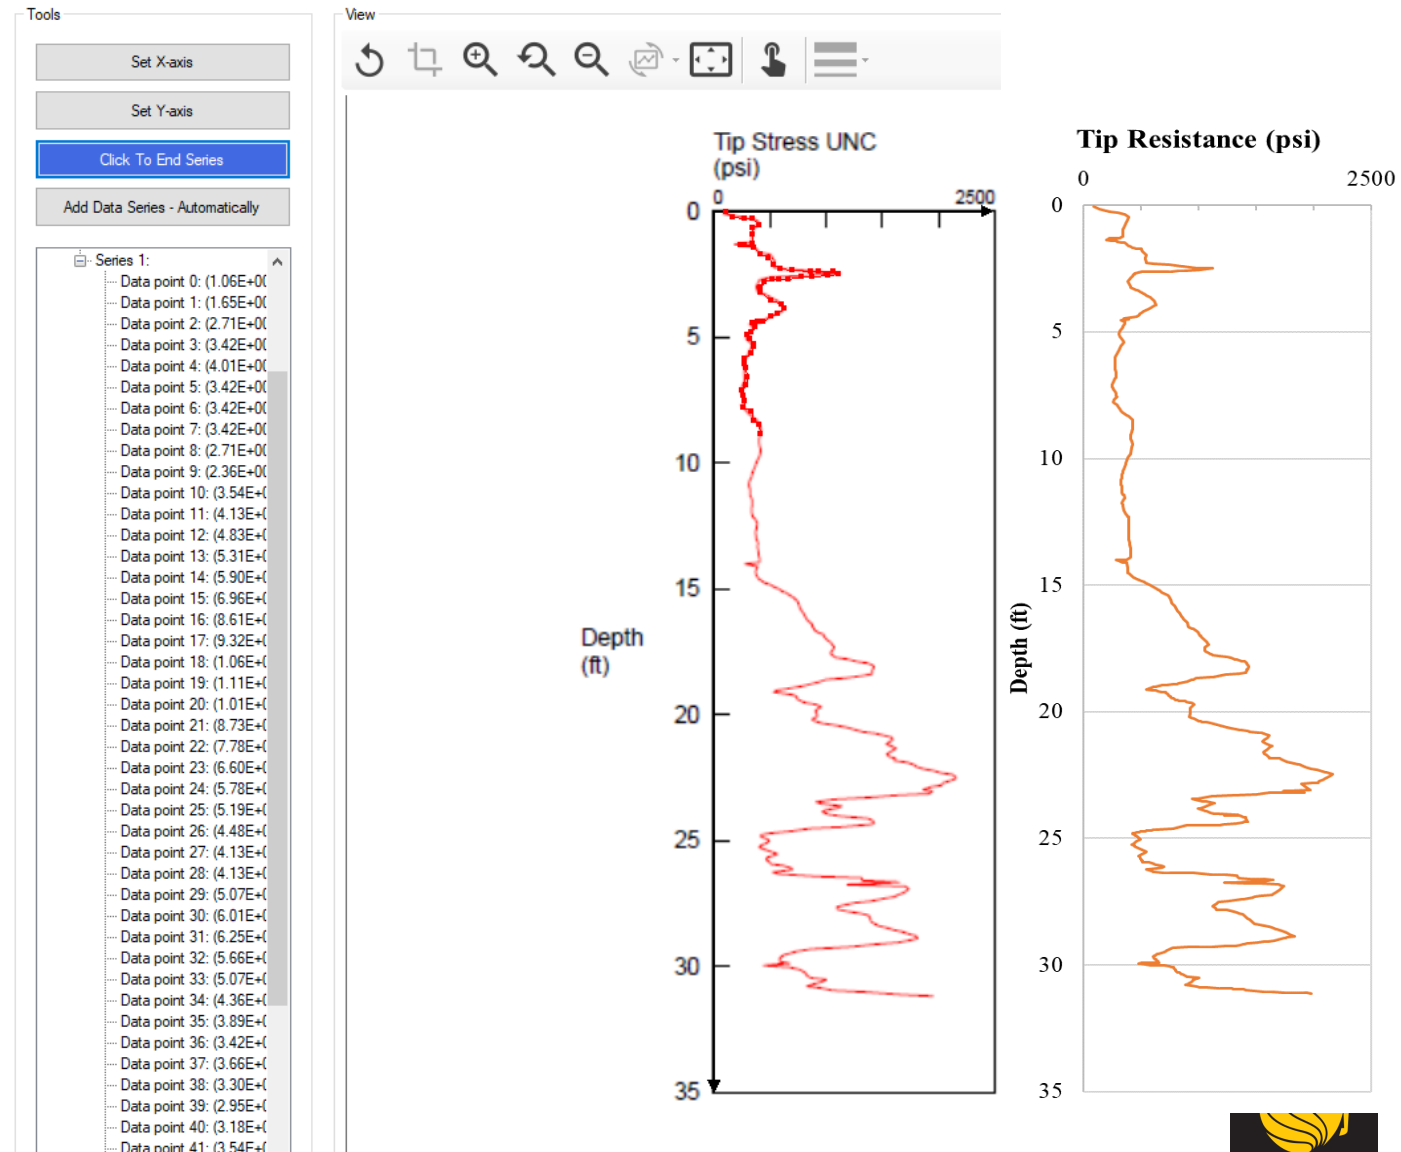
- In cases where the data was not digitized (either a picture or PDF of graphic information), the data was digitized.
- *Graph Grabber* program was used to digitize all CPT data including tip resistance ( $q_c$ ), sleeve friction ( $f_s$ ) and pore waster pressure when available.
  - CPT profile was imported into the software and the cursor was moved along the line and manually clicked to obtain data points.
- To aligning the tip resistance, sleeve friction and pore pressure values with depth an interpolation program was written to allow for consistent readings of each parameter per depth for each CPT data set.
- The digitized data was then compared with the PDF graphic to determine accuracy.

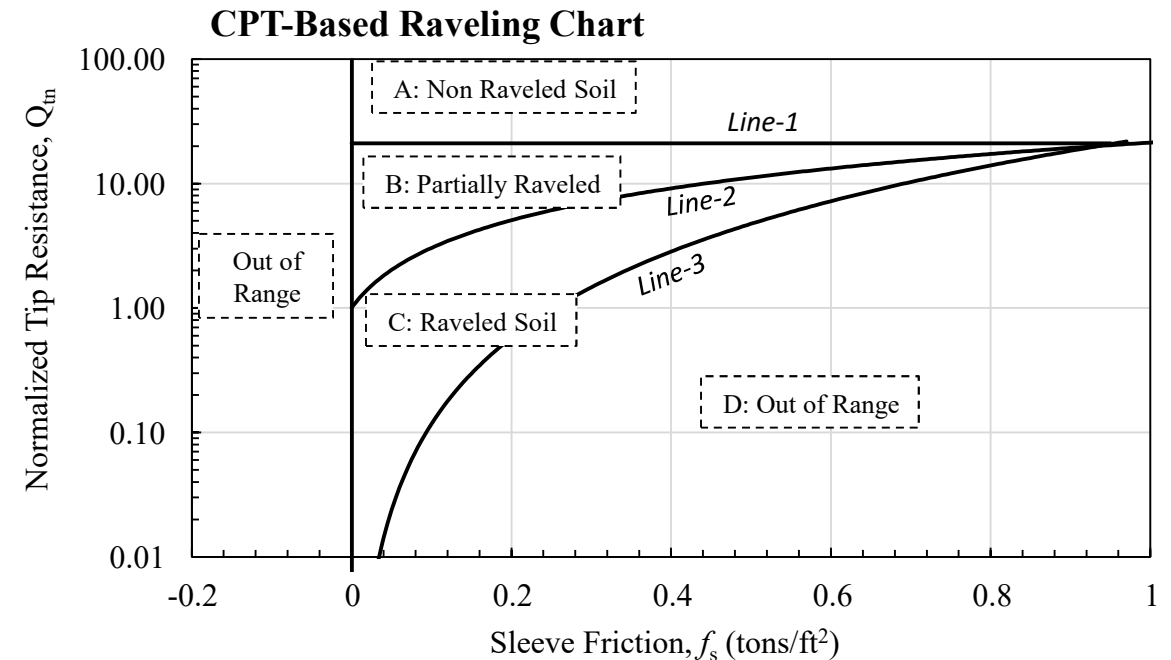
# Raveling Chart

- A helpful tool to identify potentially raveled soil from the  $Q_{tn}$  and  $f_s$  values obtained from the CPT.
- Practitioners can quickly plot the CPT parameters along this chart to estimate the likelihood of sinkhole forming raveling soils, during the site investigation.
- The zones making up the CPT-raveling chart are labeled A through D, with zones B and C pertaining to the raveled soils, A associated with non-raveled soil, and D being the lower range of data, demarcating the raveled soil.
- Previous Limitations:
  - Validation of chart with varying subsurface geology and anticipated sinkhole type
  - Normalized tip resistance ( $Q_{tn}$ ) as part of input value for chart

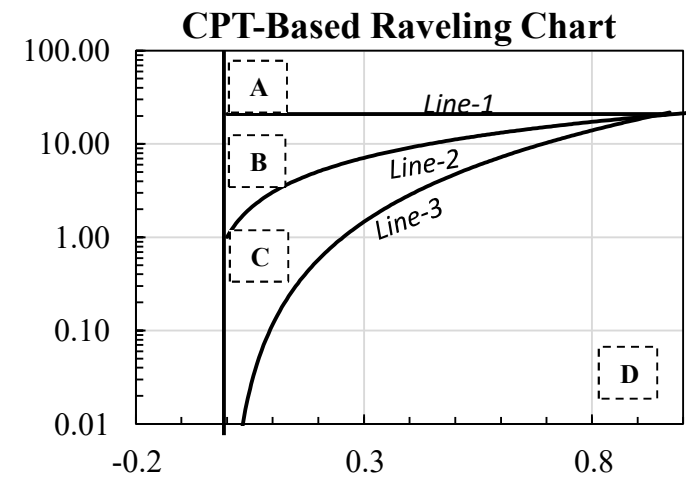
# CPT Location

- Used sub-set of 118 CPTs (Inside – 23 CPTs, Edge – 36 CPTs, Outside – 33 CPTs, & Unknown – 26 CPTs)
- Calculated SRR for each CPT
- The CPTs were then evaluated on a point by point basis along the depth in reference to the raveling chart:

- CPTs located inside and edge of sinkhole have more easily definable raveled zones. Those outside tend to not follow the trends seen inside.
  - Inside CPTs had the highest percentage of points, 43%, within the raveling zone, as expected.

- Additionally, inside CPTs also had the highest percentage located within the more severely raveled zone C.
  - Edge CPTs have a slight larger overall percentage of raveled points than those outside and a higher percentage within the more severely raveled zone C.

- Overall, the CPT designations align with our expectations, largest percentage of points within the raveled zone for the inside designation and smallest for the outside.

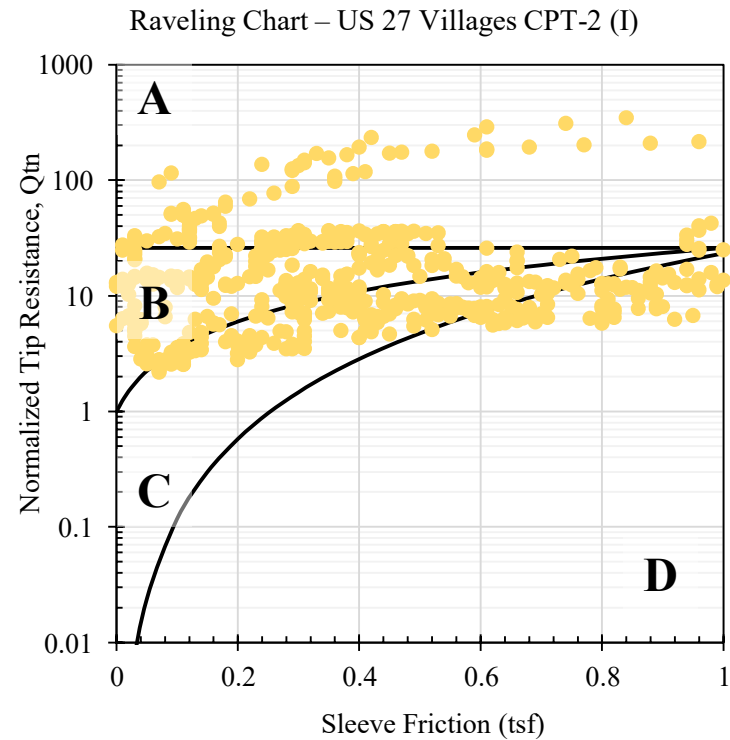
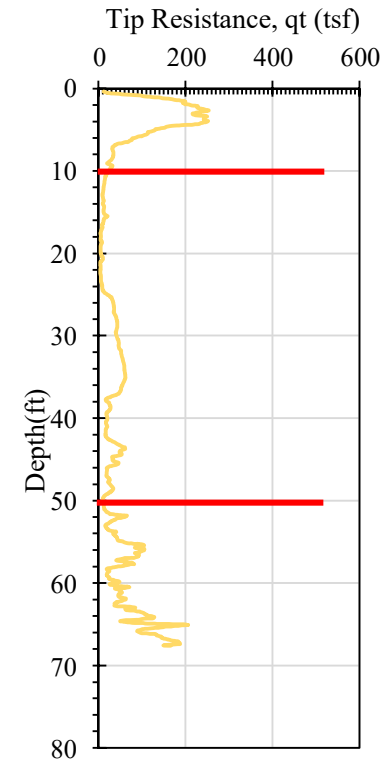
# Type 1 – US 27 Villages Sinkhole CPT-2

Name (CPT Location)	Ravel Start (ft)	Ravel End (ft)	Positive	False Positive	Negative	False Negative
US 27 Villages CPT-2 (I)	10	50	67.00%	33.00%	85.30%	14.70%

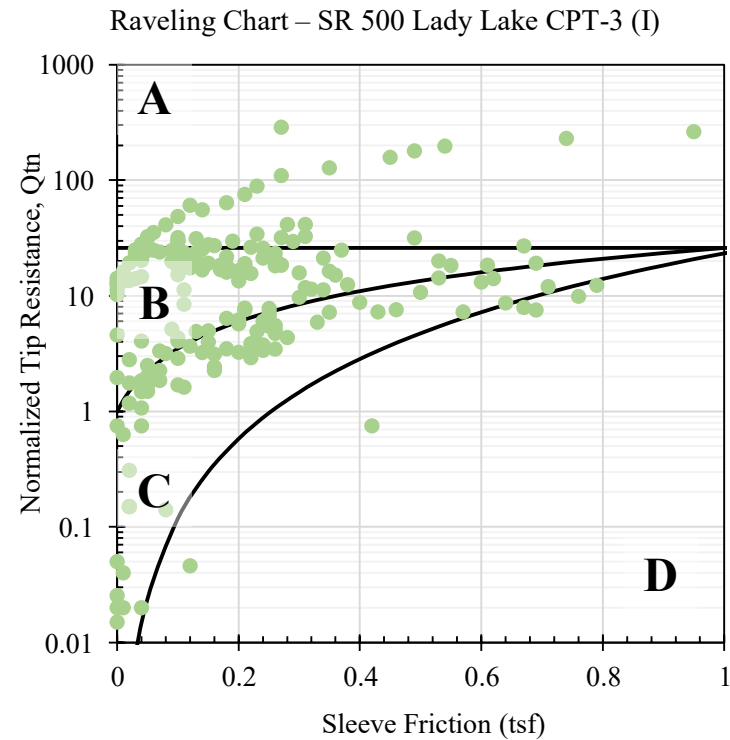
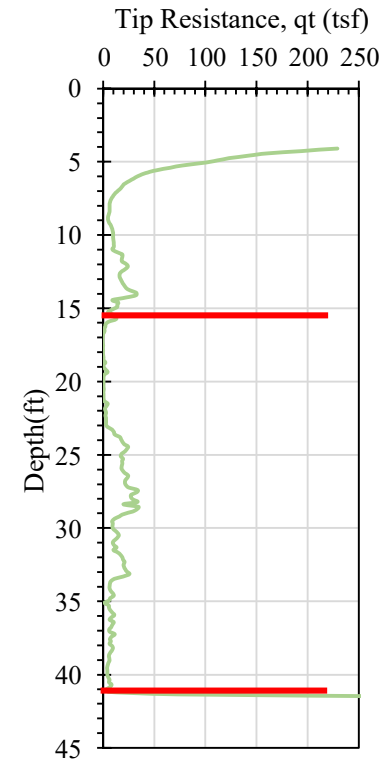
# Type 2 – SR 500 Lady Lake Irma 2017 CPT-3

Name (CPT Location)	Ravel Start (ft)	Ravel End (ft)	Positive	False Positive	Negative	False Negative
SR 500 Lady Lake Irma 2017 CPT-3 (I)	15.3	41.2	81.10%	18.90%	42.10%	57.90%

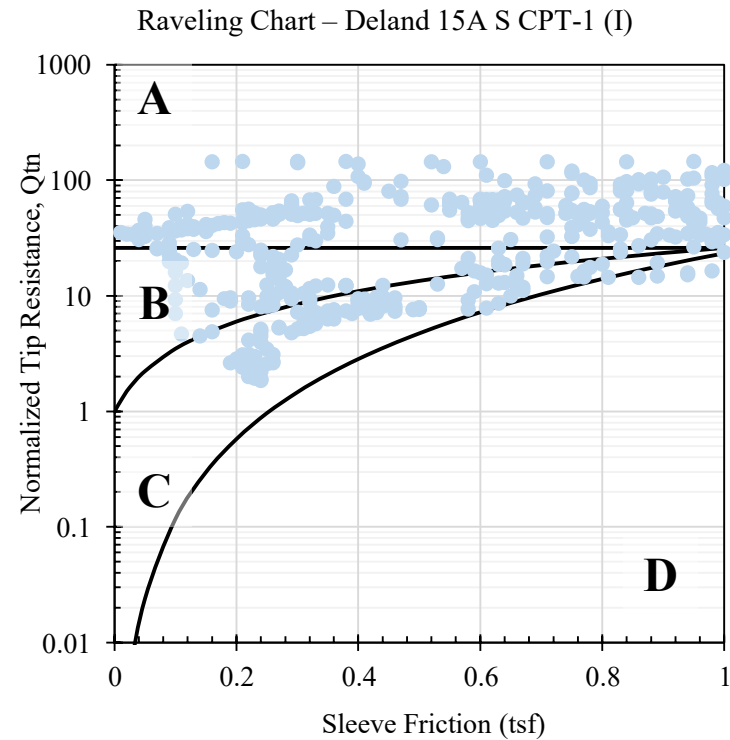
# Type 3 – Deland 15A South 2016 CPT-1

Name (CPT Location)	Ravel Start (ft)	Ravel End (ft)	Positive	False Positive	Negative	False Negative
Deland 15A South 2016 CPT-1 (I)	19	26	97.50%	2.50%	88.40%	11.60%

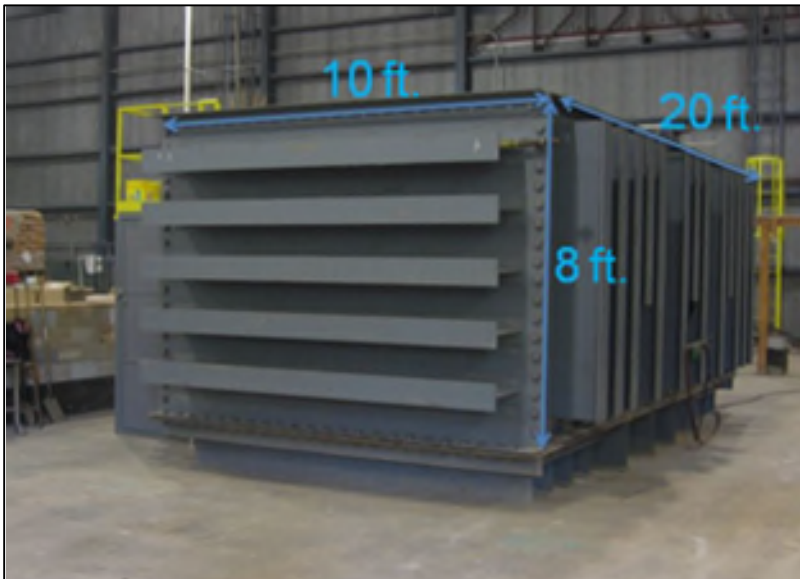
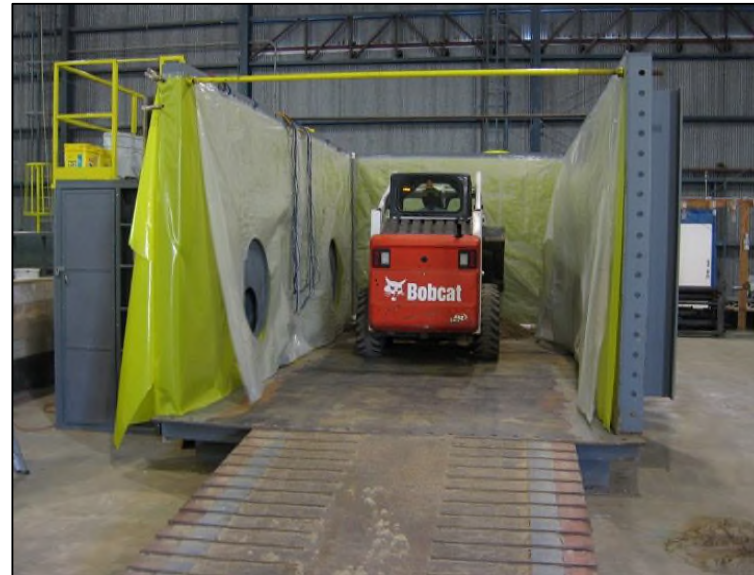
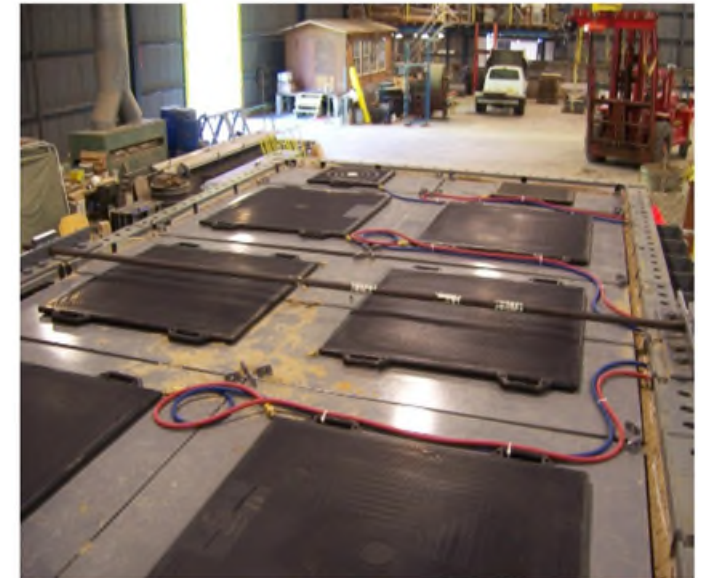
Deconstruction (UF), transportation, and re-construction at campus of UNF

- Concrete slab, gated/locked area, tarped and covered with parking canopy
- LSSB preparation for sinkhole testing.

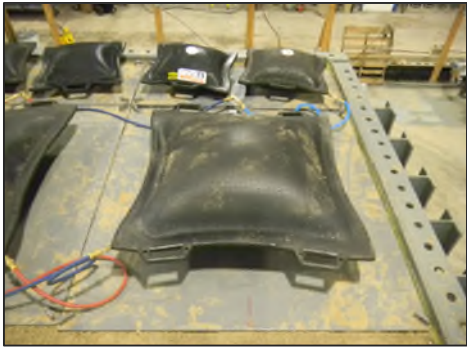
Inflated airbag to simulate overburden pressure (ABOVE)

Entry port for “void” installation and sediment transport (BELOW)

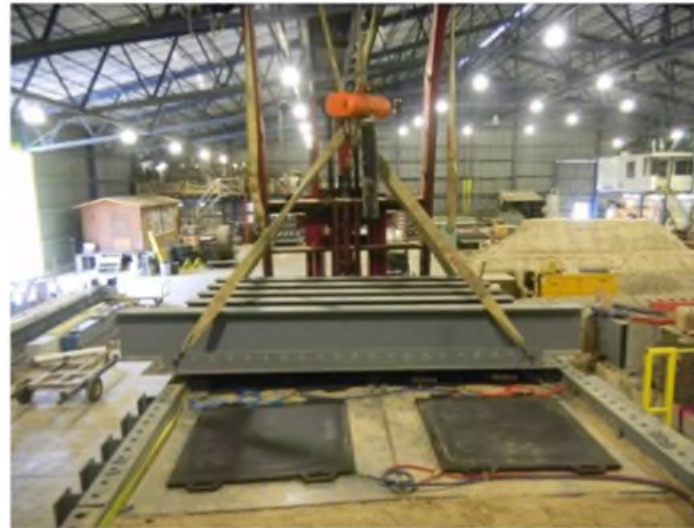
(LEFT) Installation of I-Beam roof for reaction force of airbags and overburden simulation

- Pressure cell installation
- Piezometer installation
- Boundary conditions (plastic liner and waterproof)
- Roof plate removal/rearrange
- Catchment basin for effluent eroded slurry

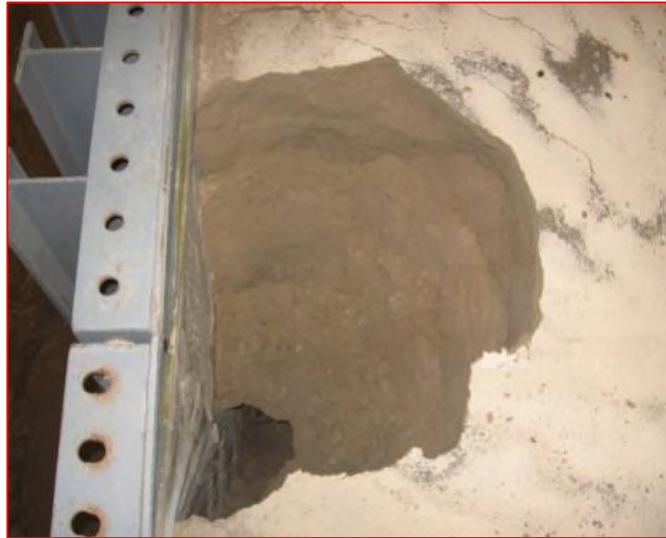
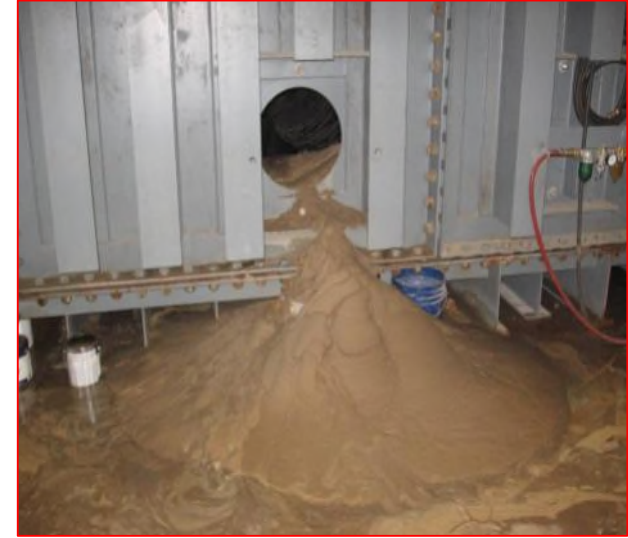
Previous accidental sinkhole formation:  
*UF Thesis, Faraone 2012*

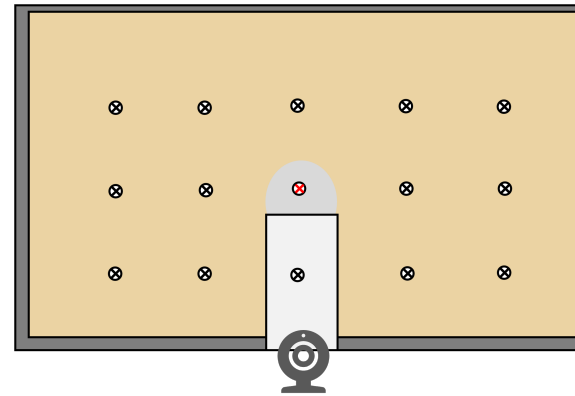
## Profile view:

## Top view:

1. Subsurface void: installation of in situ (controllable) volume and drainage port
2. Soil fill and overburden simulation (airbag inflation)
3. reference  $q_c$  profiling (hCPT)
4. Recharge simulation, erosion monitoring, post-collapse forensics → Sinkhole Indexing
