Relaxation of Driven Piles in Florida Soils

BED25-977-05

GRIP 2025

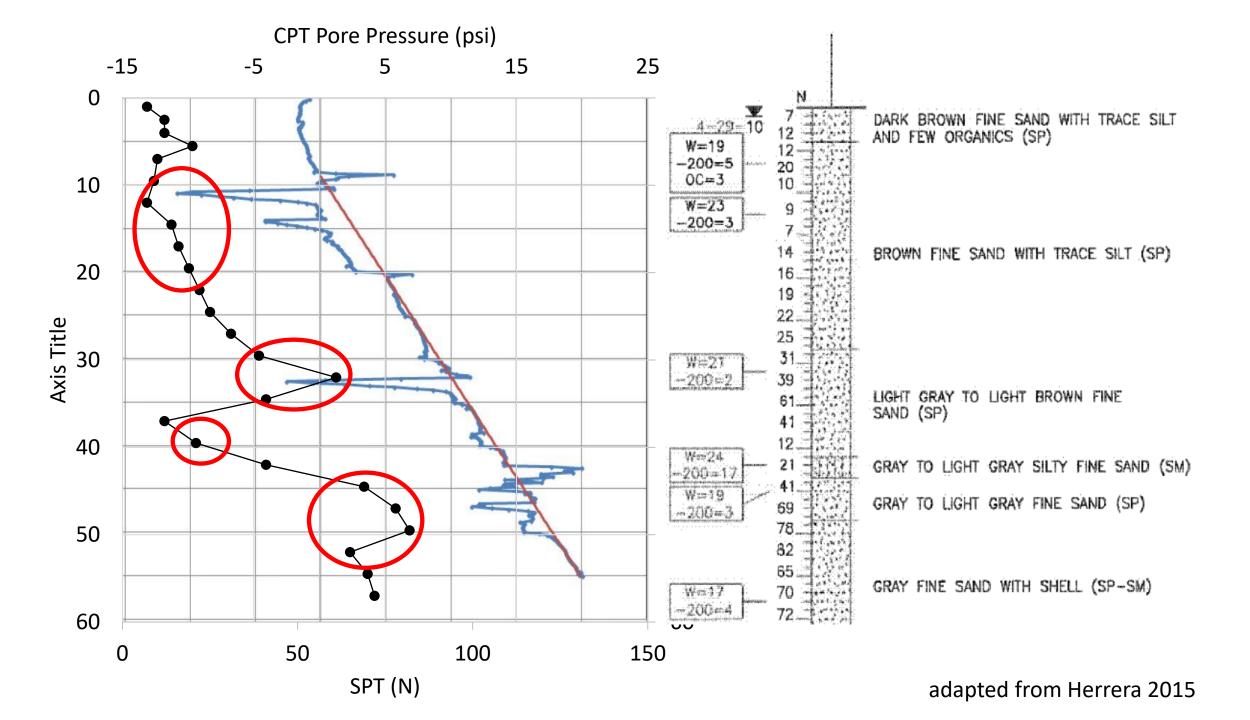
Granular Materials										
Relative Density	Safety Hammer SPT N-Value (Blow/Foot)	Automatic Hammer SPT N-Value (Blow/Foot)								
Very Loose	Less than 4	Less than 3								
Loose	4 - 10	3 – 8								
Medium Dense	10 - 30	8 – 24								
Dense	30 - 50	24 - 40								
Very Dense	Greater than 50	Greater than 40

May dilate during pile driving

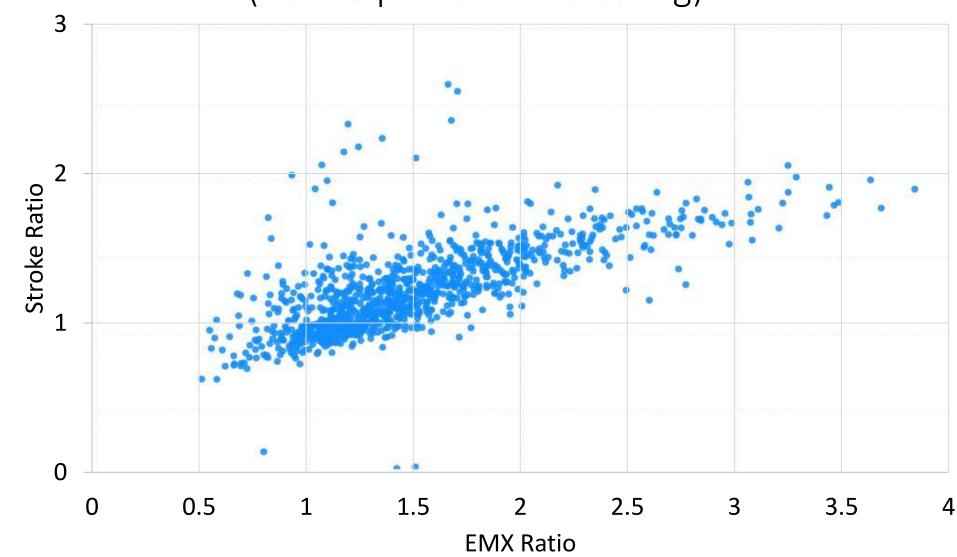
Stroke vs EMX

(not helpful but interesting)

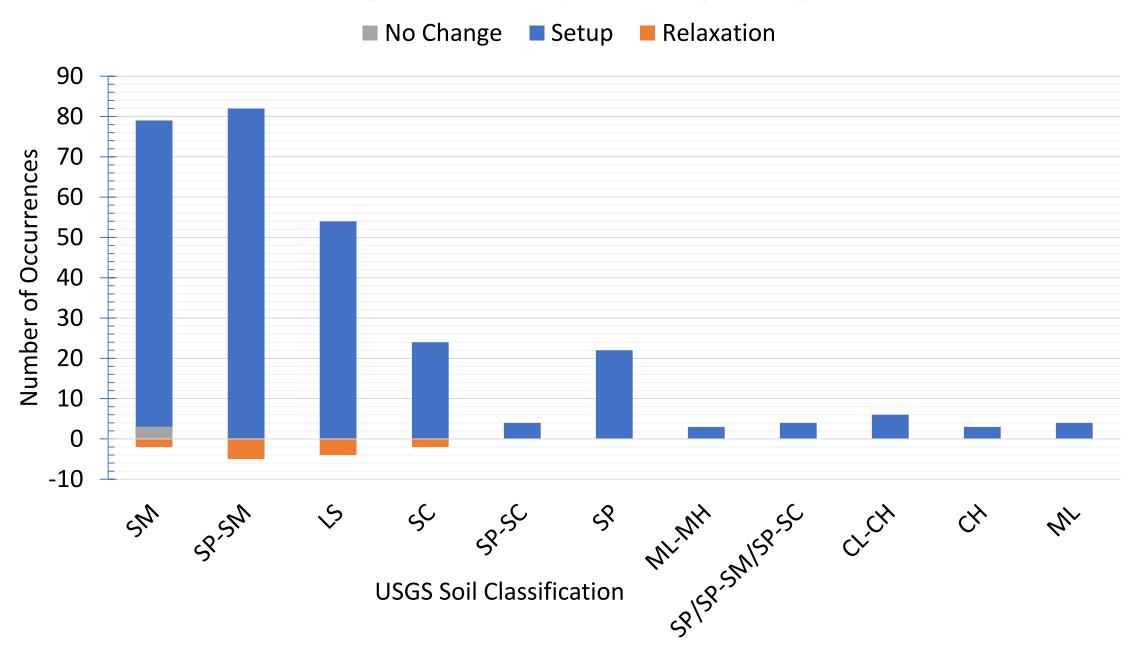
Strength Gain / Loss per Bearing Soil Type

- Most relaxation cases occurred in medium dense, dense and very dense sand.
- Dilation theory is likely the best explanation
- Creep effects not found
- Pile length not specifically the cause of relaxation
- Sufficient embedment depth into competent bearing layer appears to be the strongest deterrent to relaxation
- D/B embedment > 10 showed no relaxation

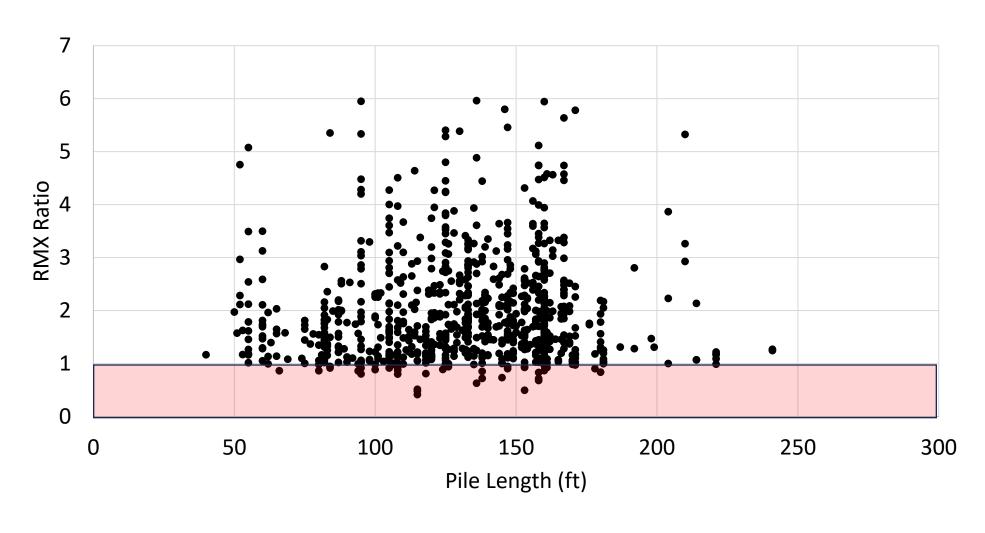
Capacity Ratio vs Pile Length

(short piles ≠ relaxation)

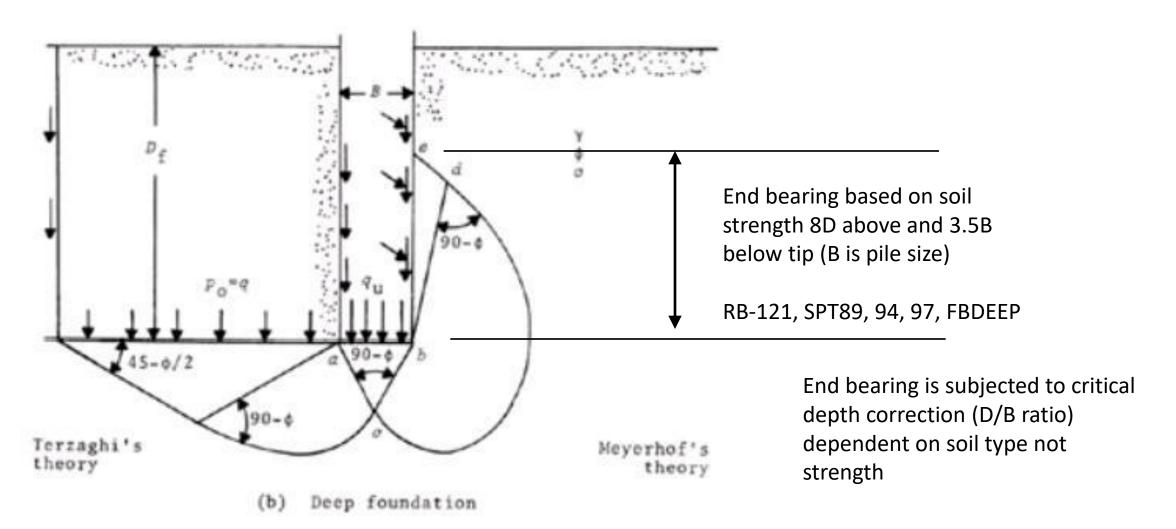
Embedment Depth

(based on soil strength?)
