**State of Florida Department of Transportation
PAVEMENT EVALUATION AND CONDITION DATA SHEET**

Project No.: 242484-7		Cored By: Elipsis Engineering and Consulting				Date: 2/22/16 to 2/24/16				Page No.: 1 of 7										
County: Orange		Highway Sect. No.: 75280				From: West of SR 528/Beachline				To: West of SR 436/Kirman Rd										
Road No.: SR 400 (I-4) BTU		Begin MP: 5.650				End MP: 9.249				Length: 3.599										
Core No.	MP	Distance from left edge of lane (ft)	Lane	Wheel Path	Pavement Layer (in.)						Base		Crack				Pavt Cond.	Rut Depth (in)	Cross Slope (%)	Comments
					Type SP-12.5	Type SP-9.5	FC-4	Type SP	Type S	Core Length (in)	Type	Thick-ness (in)	Depth (in)	Type	Class	Extent

Turkey Lake Road from 1000' south of Central FL Parkway to 2000' north of Central FL Parkway

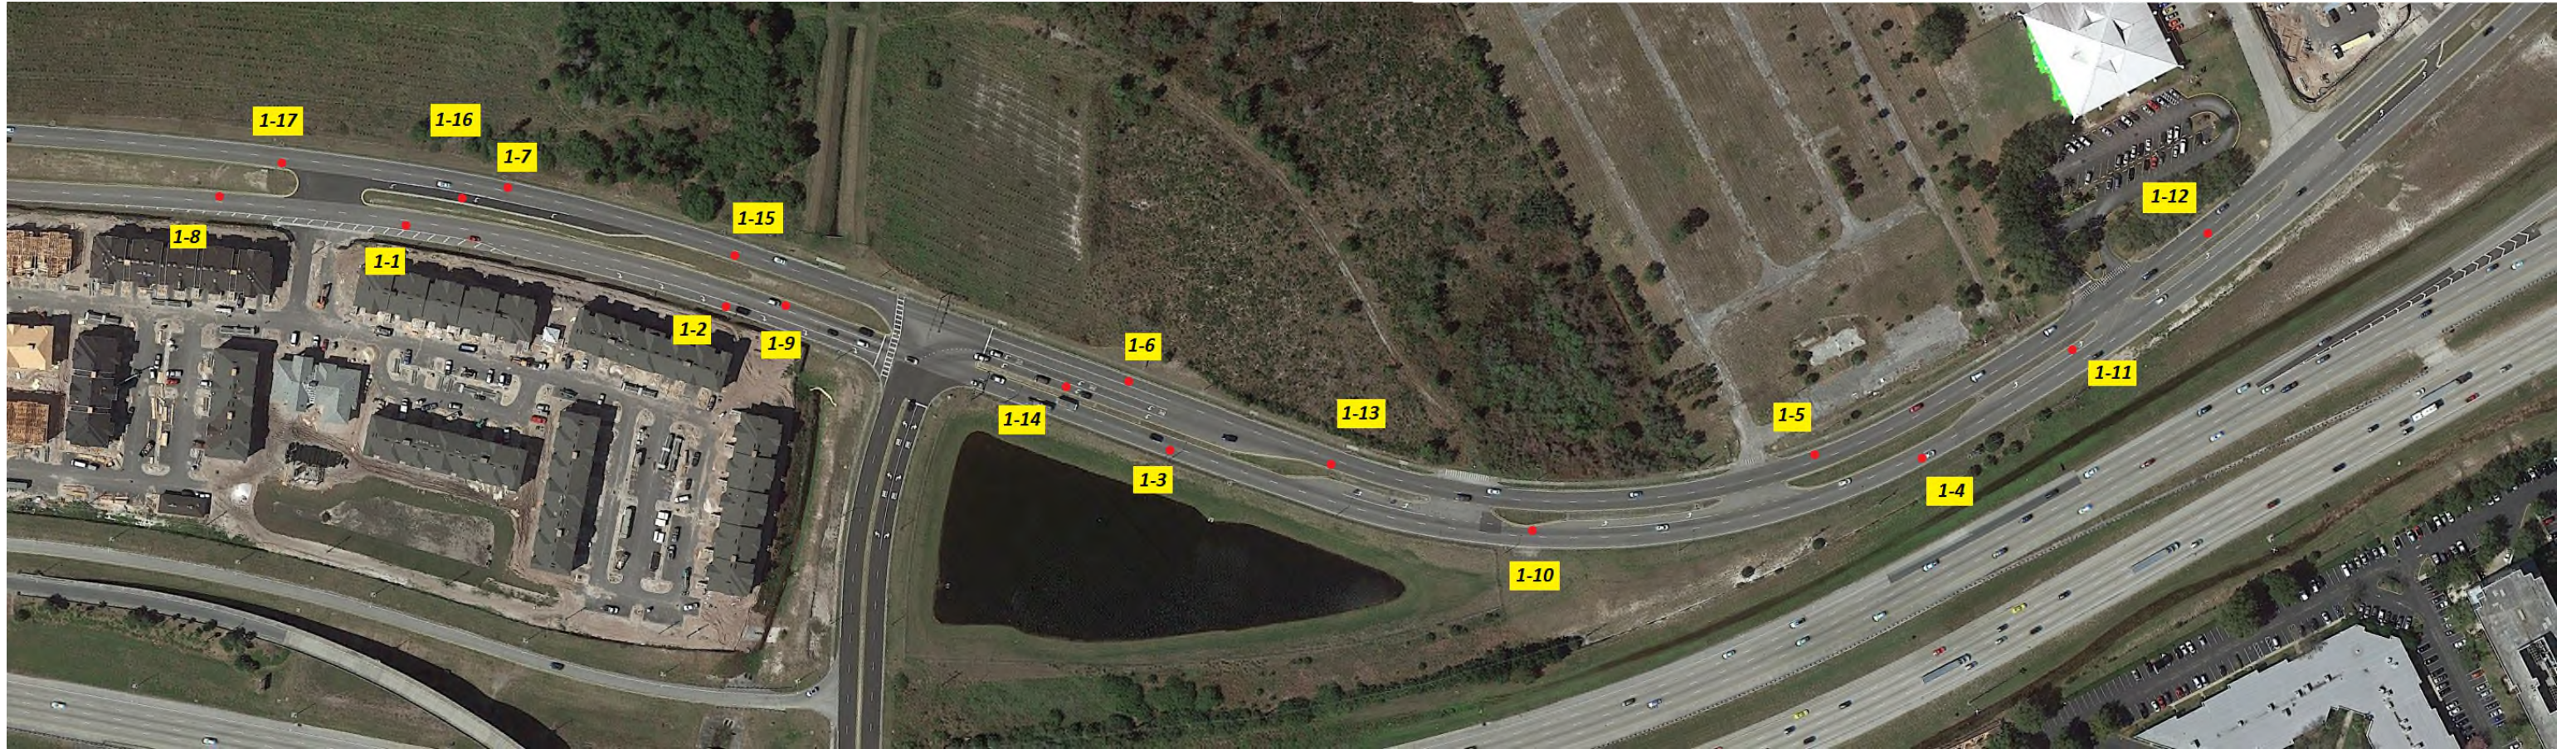
Turkey Lake Road - - Near Central Florida Parkway (17 cores - 1 series)

1-1	*	9.0	R2	X	2.0			3.9		5.9	SC	9.6	-	-	-	-	F	0.2	3.1	
1-2	*	2.5	RRTL	X	2.3			3.3		5.6	SC	-	-	-	-	-	F	0.1	4.0	To EB Central Florida Parkway
1-3	*	3.0	R2	X	1.3			4.2		5.5	SC	11.5	-	-	-	-	F	0.2	3.7	
1-4	*	10.0	R2	X	1.2			3.2		4.4	SC	-	-	-	-	-	F	0.1	-2.8	
1-5	*	10.0	L2	X	1.7			3.6		5.3	SC	9.7	-	-	-	-	F	0.2	3.9	
1-6	*	3.0	L2	X	1.6			4.6		6.2	SC	-	-	-	-	-	F	0.0	3.2	Core fractured during extraction
1-7	*	2.5	L2	X	1.2			4.0		5.2	SC	10.8	B	ST	I	M	F	0.2	4.8	
1-8	*	2.5	R1	X	1.5			3.5		5.0	SC	-	-	-	-	-	F	0.2	0.9	
1-9	*	9.0	R1	X	0.8			4.2		5.0	SC	12.0	-	-	-	-	F	0.2	1.2	
1-10	*	2.5	R1	X	1.0			4.1		5.1	SC	-	-	-	-	-	F	0.3	-2.8	
1-11	*	8.5	RLTL	X	1.7			4.3		6.0	SC	11.0	-	-	-	-	F	0.0	-3.4	To Post Office
1-12	*	3.0	L1	X	1.4			5.4		6.8	SC	-	-	-	-	-	F	0.2	1.2	
1-13	*	9.0	L1	X	1.2			4.6		5.8	SC	11.5	-	-	-	-	F	0.2	2.9	
1-14	*	2.0	LLTL-1	X	1.1			4.6		5.7	SC	-	-	-	-	-	F	0.3	1.1	To EB Central Florida Parkway
1-15	*	9.0	L1	X	1.5			3.5		5.0	SC	13.0	B	ST	II	M	F	0.1	0.5

1-16	*	2.0	LLTL	X	1.9			4.9		6.8	SC	-	-	-	-	-	G	0.0	0.8	To Sand Lake Altis Apartments
1-17	*	9.0	L1	X	1.1			4.1		5.2	SC	10.6	-	-	-	-	F	0.1	1.2

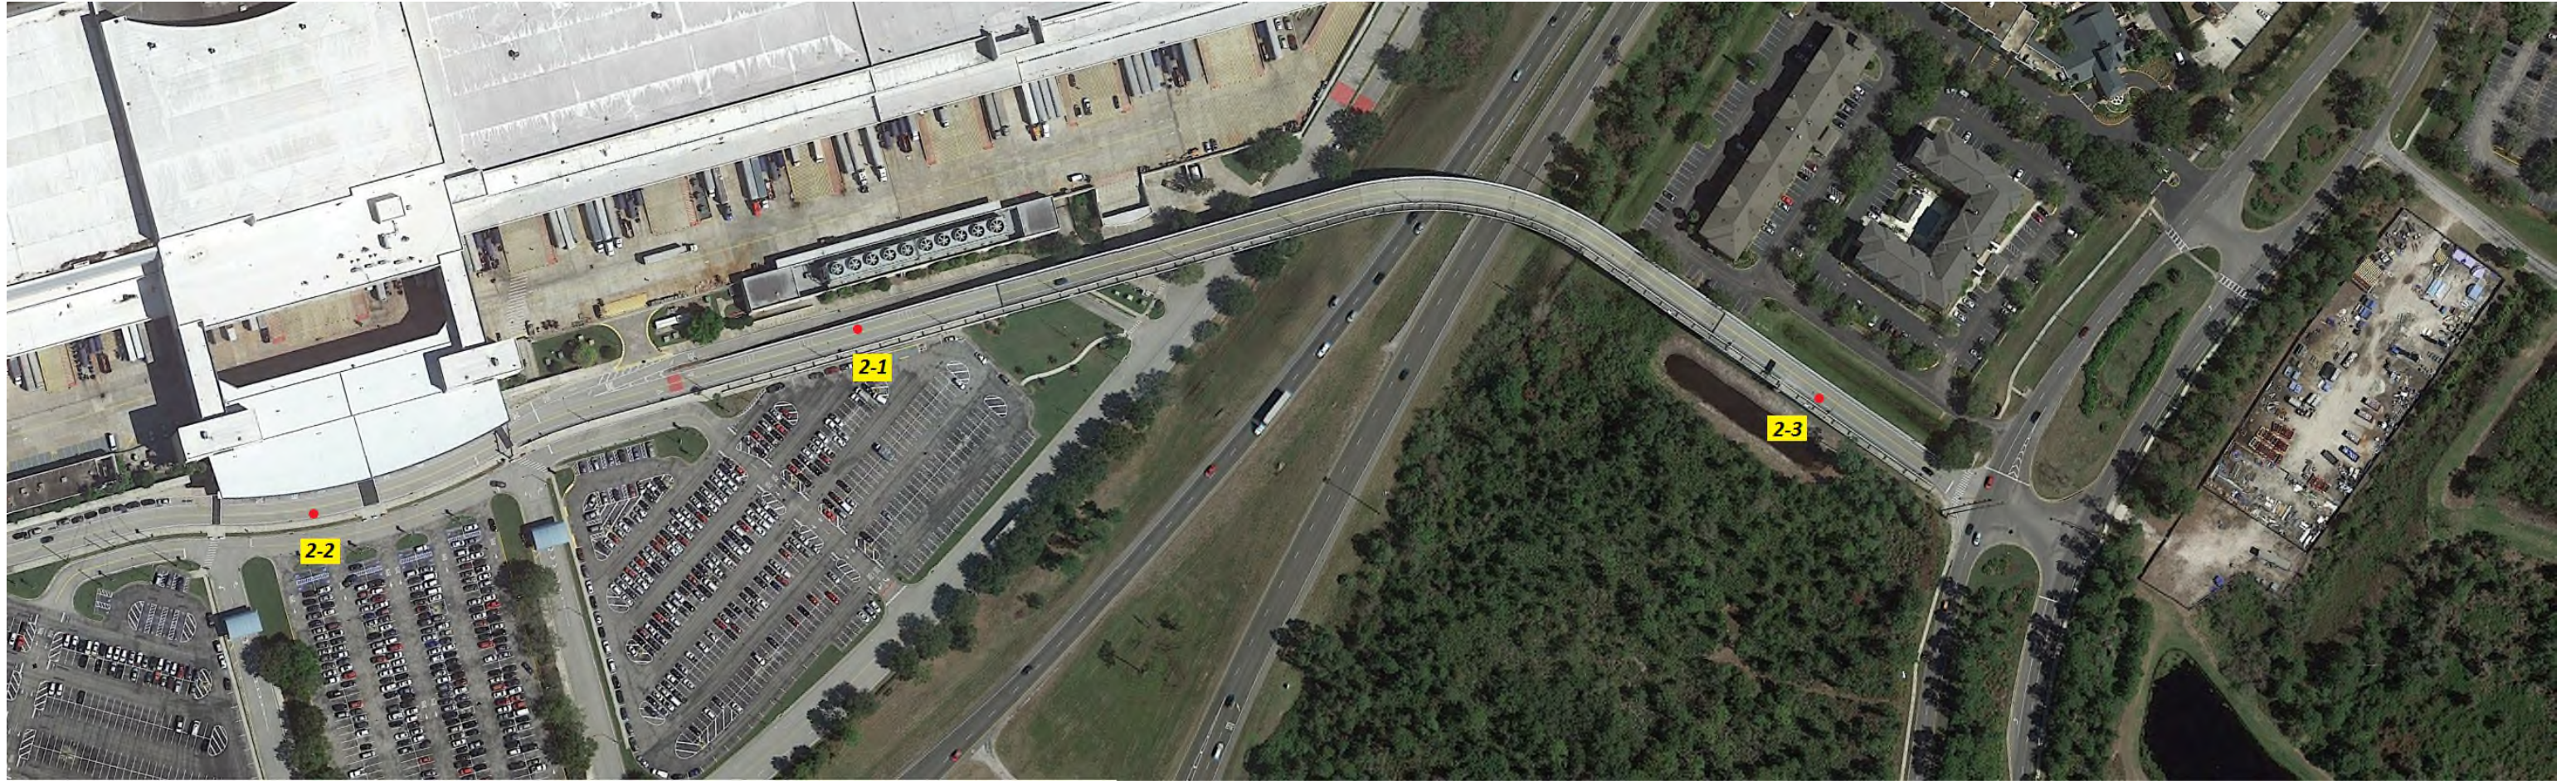
West Entrance Road - - From Westwood Blvd. to 1500' +/- North of SR 528 (3 cores - 2 series)

2-1	*	7.5	R1				0.7			1.9		2.6	SC	—	B	SL	III	S	F	0.1	1.5	
2-2	*	8.0	L1				1.3			1.7		3.0	LR	13.8	—	—	—	—	F	0.0	1.8	
2-3	*	4.0	L1				1.6			1.9		3.5	SC	—	B	SL	III	S	P	0.3	1.3

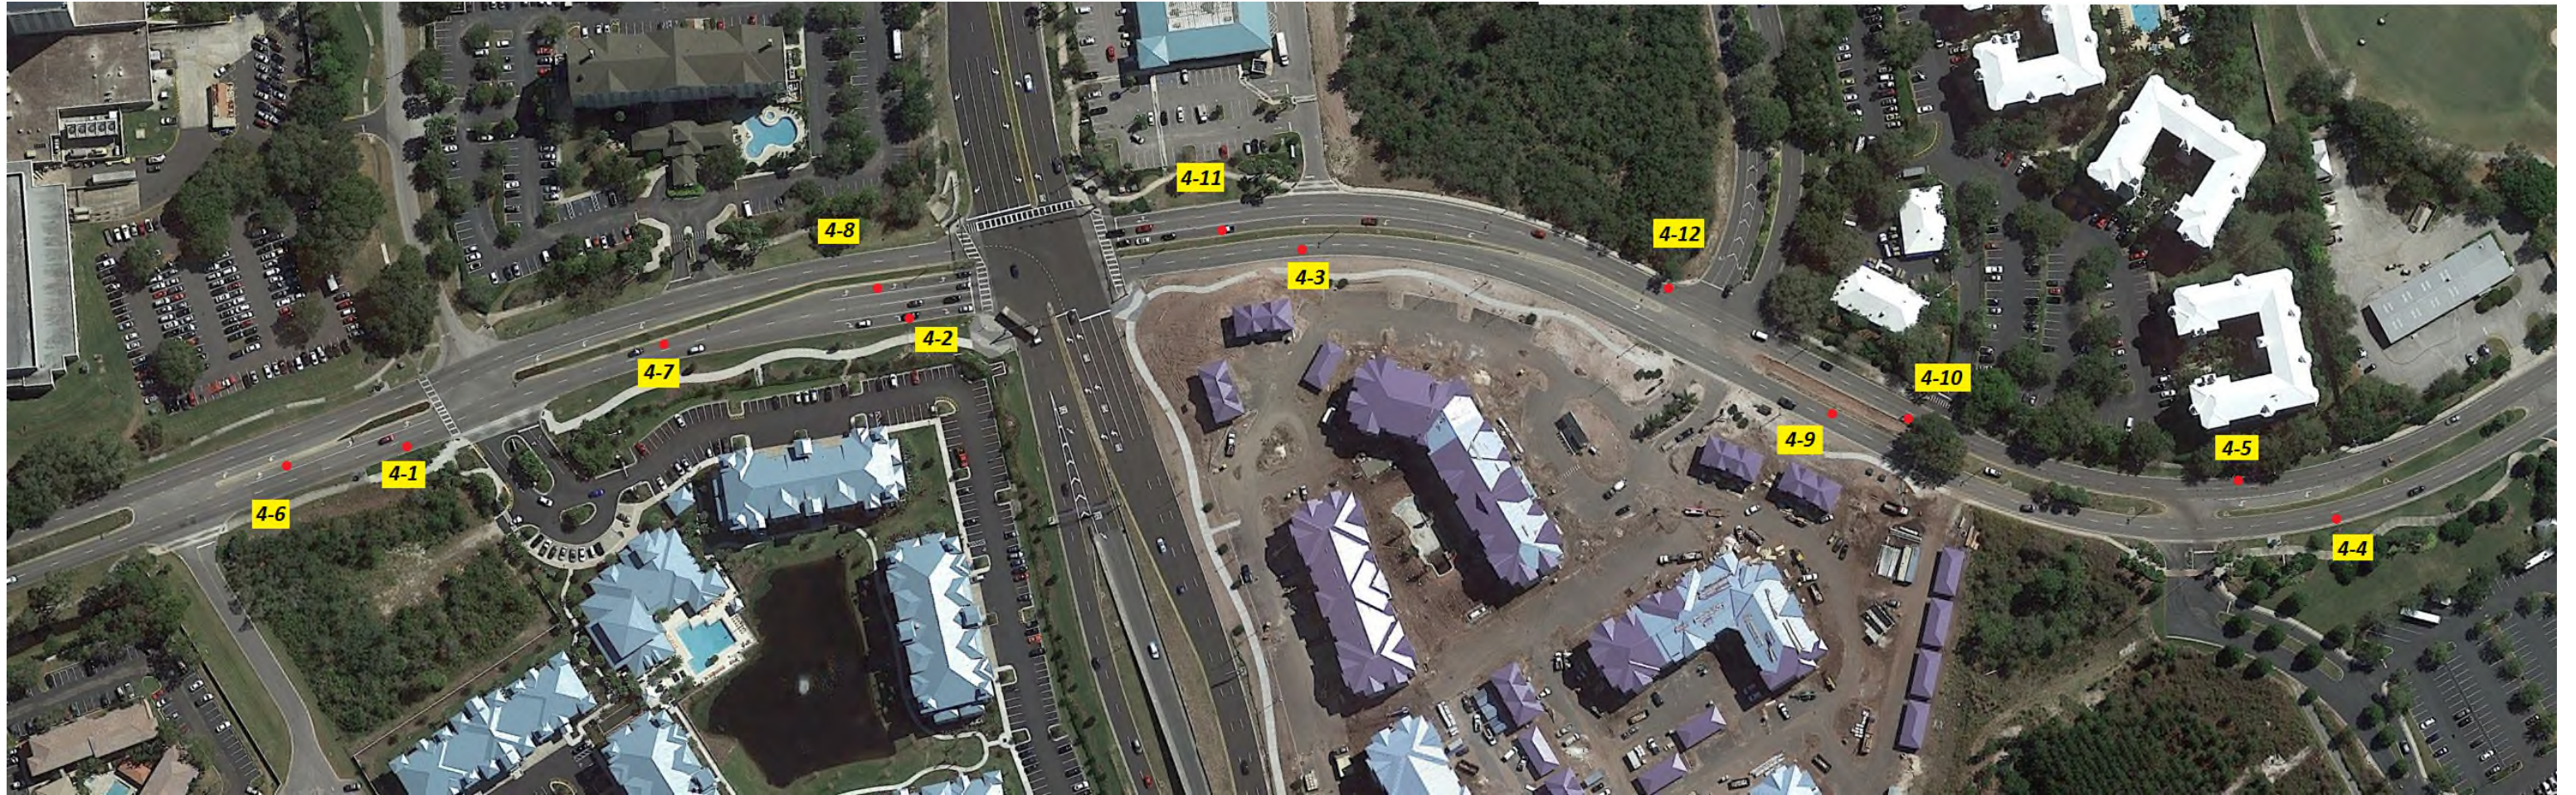
Westwood Boulevard - - Near Central Florida Parkway (12 cores - 4 series)

4-1	*	7.0	L2		1.1				1.0		2.1	SC	11.7	B	Al	II	S	P	0.7	2.4		
4-2	*	9.0	LRTL	X	1.1				1.7		2.8	SC	—	B	ST	II	L	F	0.4	0.4	To WB Central Florida Parkway	
4-3	*	3.0	L2	X	1.8						1.8	SC	8.7	B	Br	III	S	P	1.6	3.5	Area in OWP has severe Al Cracking. Did not core here because the core would be in several pieces.	
4-4	*	8.5	L2	X	2.0						2.0	SC	—	B	SL	II	L	F	0.3	0.8		
4-5	*	2.5	R2	X	1.7				0.5		2.2	SC	6.8	B	Al	II	S	P	0.8	3.6	Severe IWP Cracking	
4-6	*	7.0	LLTL	X	1.4				0.7		2.1	SC	—	—	—	—	—	F	0.2	0.4	To Academic Dr	
4-7	*	4.0	L1		1.6				0.6		2.2	SC	7.9	B	ST	II	M	F	0.3	1.6		
4-8	*	2.5	LLTL	X	1.8				1.0		2.8	SC	—	B	SL	I	L	F	0.2	1.5	To EB Central Florida Parkway	
4-9	*	8.0	L1		1.5				1.0		2.5	SC	7.5	B	ST	I	L	F	0.0	-0.9		
4-10	*	4.0	R1		1.7						1.7	SC	—	B	ST	II	S	P	0.0	0.8		
4-11	*	4.0	RLTL		1.3				0.6		1.9	SC	7.4	B	Br	II	S	P	0.4	-0.7	Severe IWP Cracking To WB Central Florida Parkway	
4-12	*	2.5	R2	X	1.5				0.4		1.9	SC	—	—	—	—	—	F	0.0	1.9

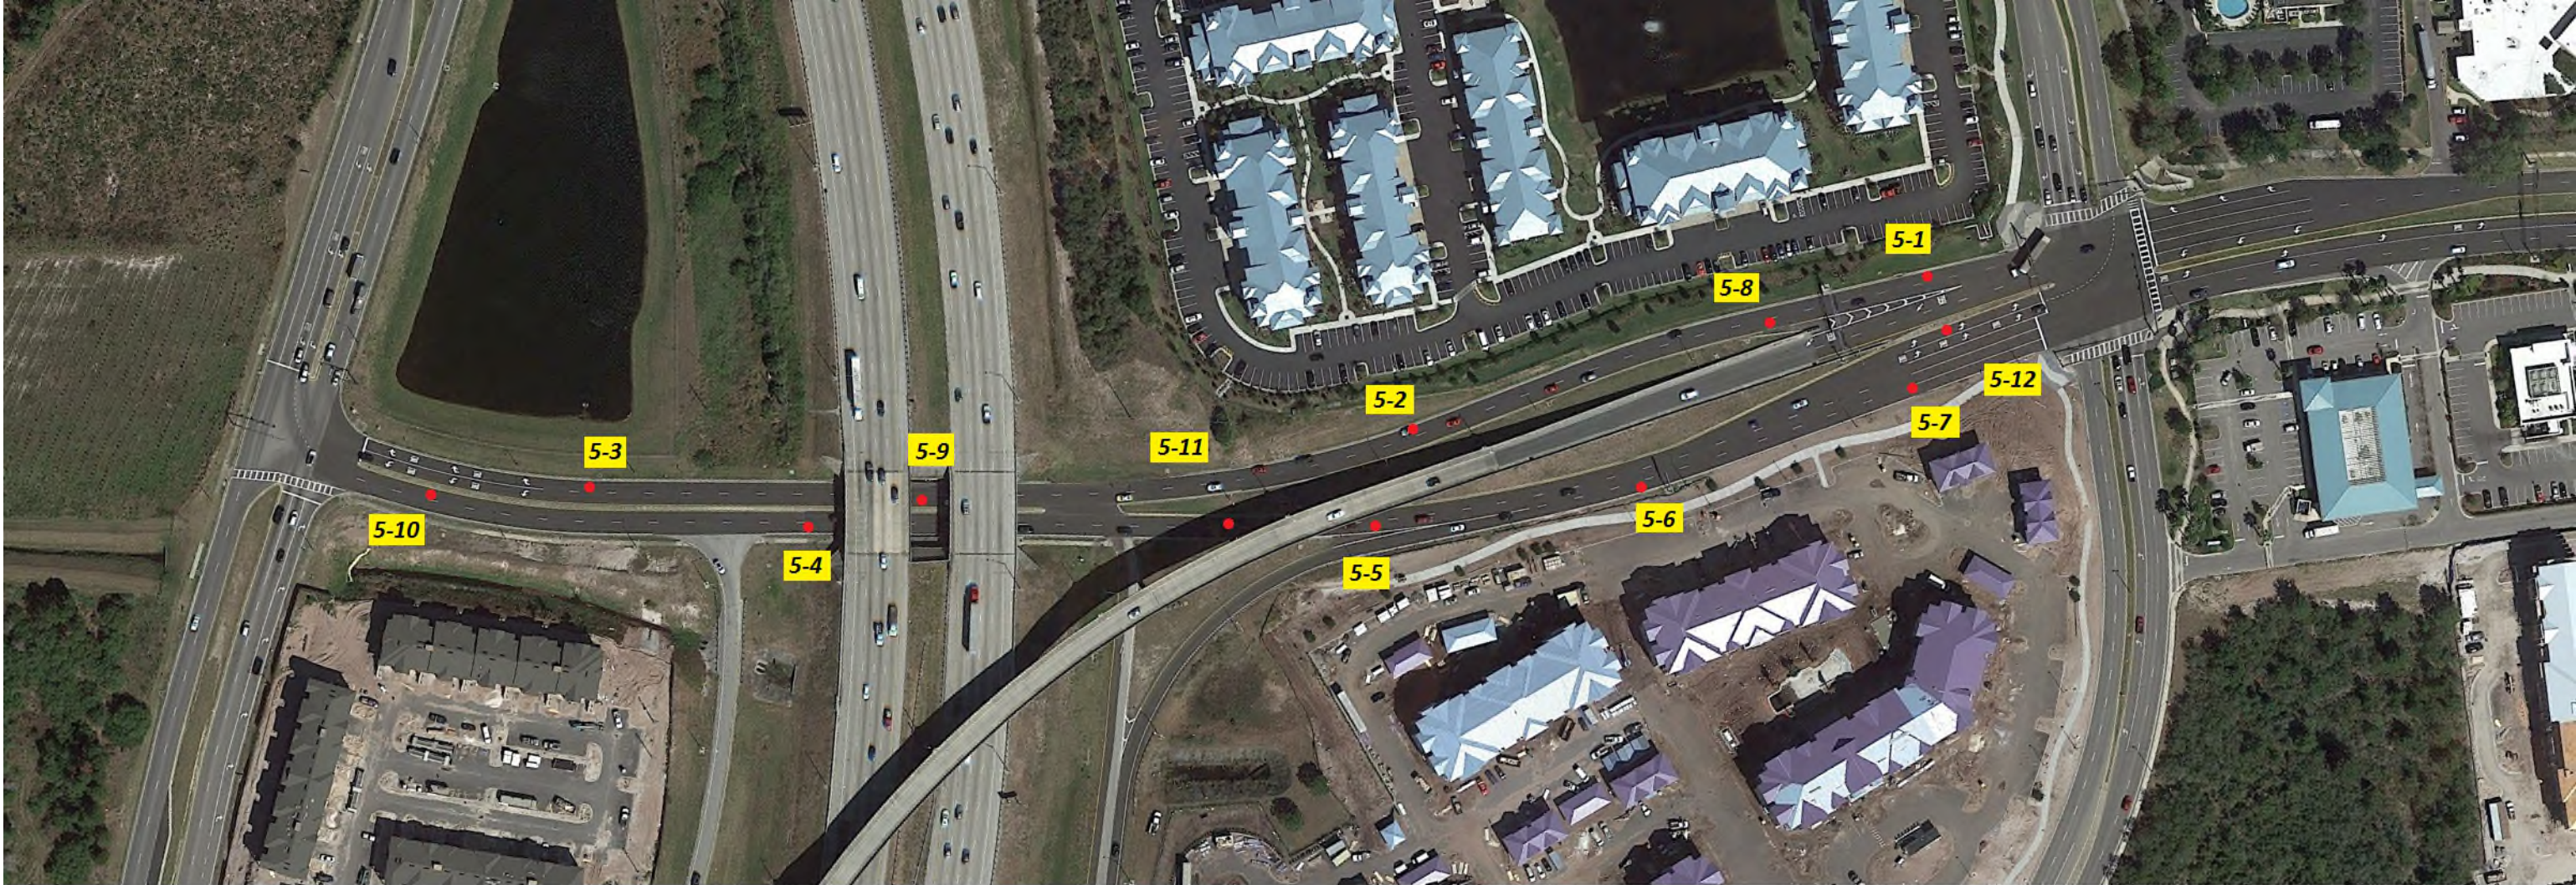
Central Florida Parkway - - From Turkey Lake Road to Westwood Boulevard (12 cores - 5 series)

5-1	*	8.5	L2	X		1.2			1.8		3.0	SC	—	0.4	SL	I	L	F	0.1	3.2		
5-2	*	8.0	L2			1.0			1.5		2.5	SC	9.5	—	—	—	—	F	0.0	3.6		
5-3	*	4.0	L2			1.2		2.1	1.5		4.8	SC	—	—	—	—	—	F	0.3	3.0	1.5" Crack starting from the bottom	
5-4	*	2.5	R2	X		0.7		1.6	2.2		4.5	SC	12.4	2.4	ST	I	L	F	0.2	2.7		
5-5	*	5.0	R2			1.0		1.8	0.8		3.6	SC	—	—	—	—	—	F	0.0	-3.0		
5-6	*	7.0	R3			1.0		1.5			2.5	SC	10.5	—	—	—	—	F	0.0	-2.5		
5-7	*	3.0	R3	X		1.2		1.3			2.5	SC	—	—	—	—	—	F	0.3	3.1		
5-8	*	2.5	L1	X		1.2		2.2			3.4	SC	10.4	0.2	SL	I	L	F	0.1	2.2		
5-9	*	3.0	L1	X		1.2		1.7	0.9		3.8	SC	—	0.2	SL	I	L	F	0.0	2.4		
5-10	*	9.5	R1	X	1.4			1.4	2.0		4.8	SC	10.0	—	—	—	—	F	0.0	1.4		
5-11	*	4.0	R1			1.7		1.4			3.1	SC	—	2.0	SL	I	L	F	0.2	-1.2		
5-12	*	8.0	RLTL-1			1.1		1.5			2.6	SC	10.9	—	—	—	—	F	0.3	-4.1	To NB Westwood Blvd

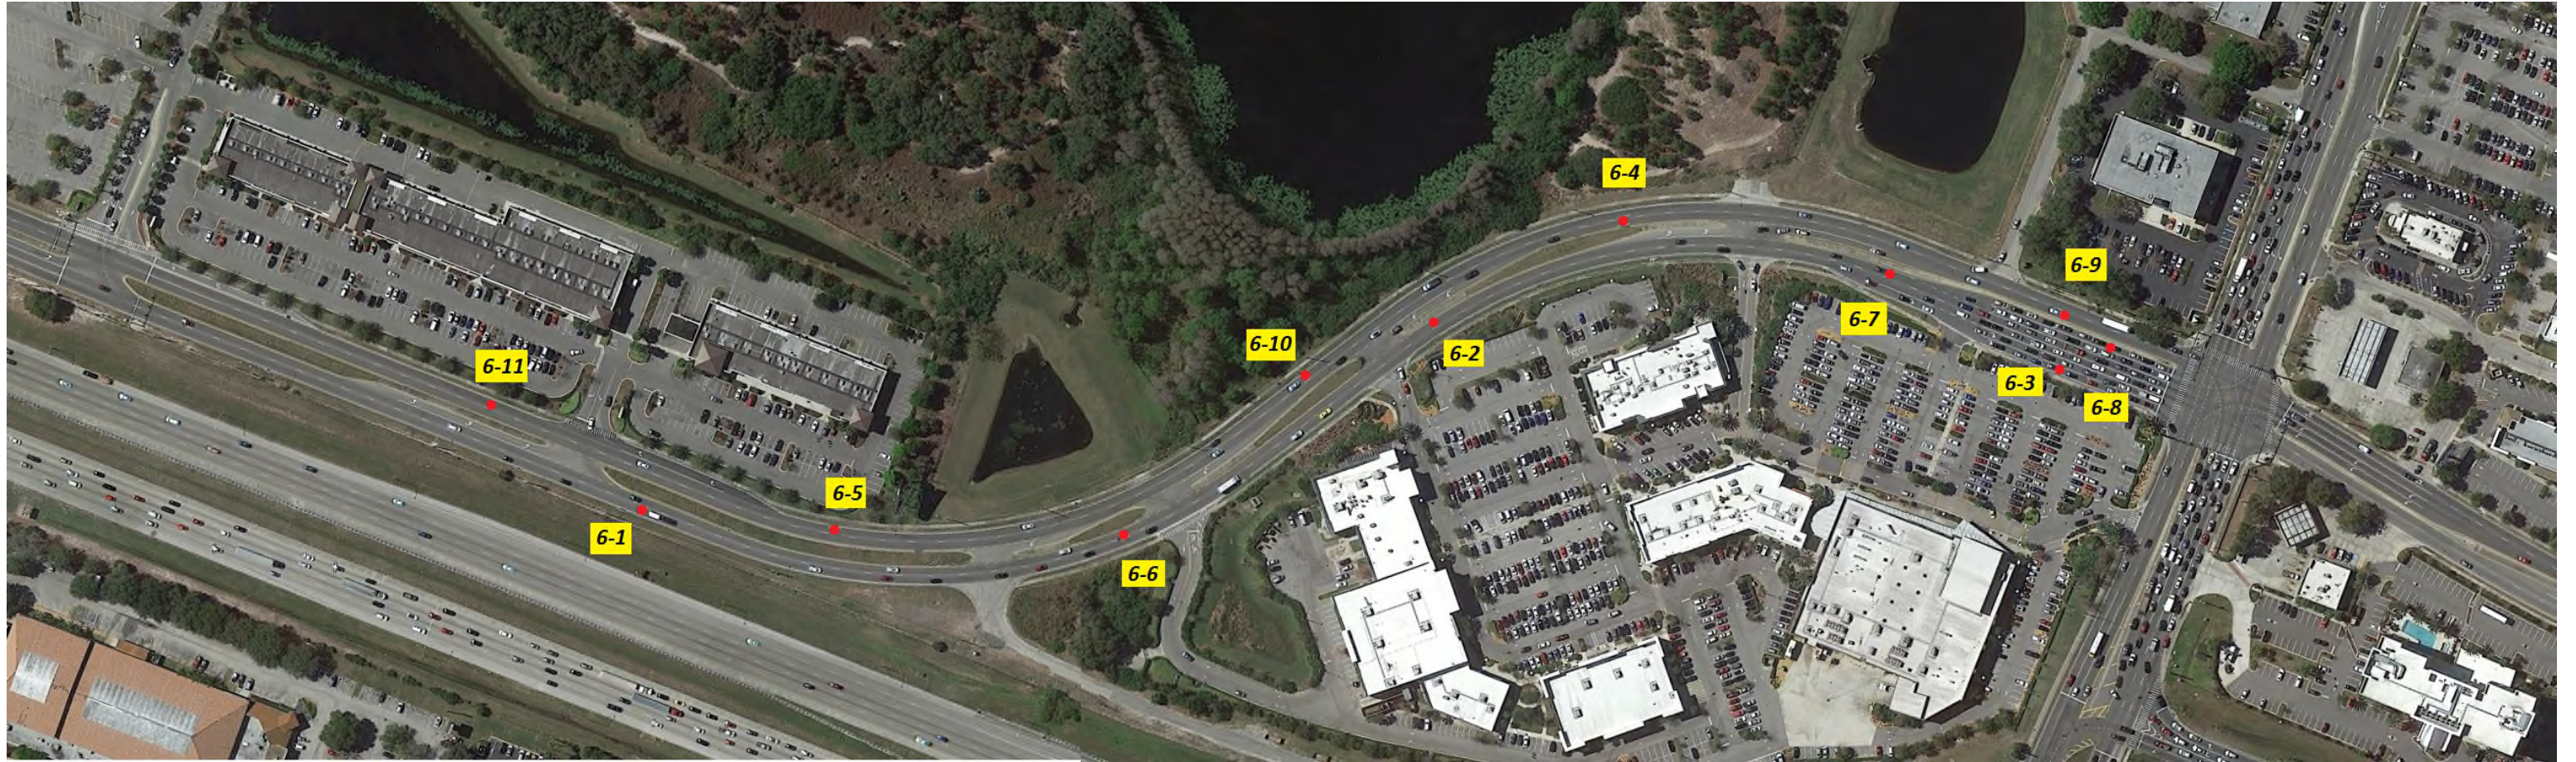
Turkey Lake Road - - South of Sand Lake Road (11 cores - 6 series)

6-1	*	10.0	R2	X	1.1				3.0		4.1	SC	—	B	ST	II	L	F	0.1	2.7	
6-2	*	2.5	R2	X	2.2				3.0		5.2	SC	7.3	—	—	—	—	F	0.2	6.5	RH Curve
6-3	*	5.0	RRTL-2		1.2			2.9		13.5	ABC	9.4	—	—	—	—	F	0.3	3.2	Cored in the middle of the lane to avoid possible underground utilities; To EB Sandlake Rd	
6-4	*	2.5	L2	X	2.3				3.3		5.6	SC	9.4	B	SL	I	L	F	0.2	-1.5	LH Curve
6-5	*	2.5	L2	X	1.9				3.9		5.8	SC	—	B	ST	II	M	F	0.1	6.7	
6-6	*	4.0	R1		1.0				3.2		4.2	SC	8.3	1.0	SL	II	L	F	0.2	-6.7	LH Curve
6-7	*	9.0	R1	X	2.0				2.6		4.6	SC	—	—	—	—	F	0.0	2.4		
6-8	*	2.5	RLTL-1	X	0.9			3.9		4.8	SC	16.7	—	—	—	—	F	0.1	1.7	To WB Sand Lake Rd	
6-9	*	2.5	L1	X	2.1				2.0		4.1	SC	—	—	—	—	F	0.2	-0.7		
6-10	*	9.0	L1	X	0.8			1.1	2.5		4.4	SC	9.9	—	—	—	F	0.0	-1.2	RH Curve	
6-11	*	2.5	L1	X	1.7				3.9		5.6	SC	—	—	—	—	F	0.1	0.7

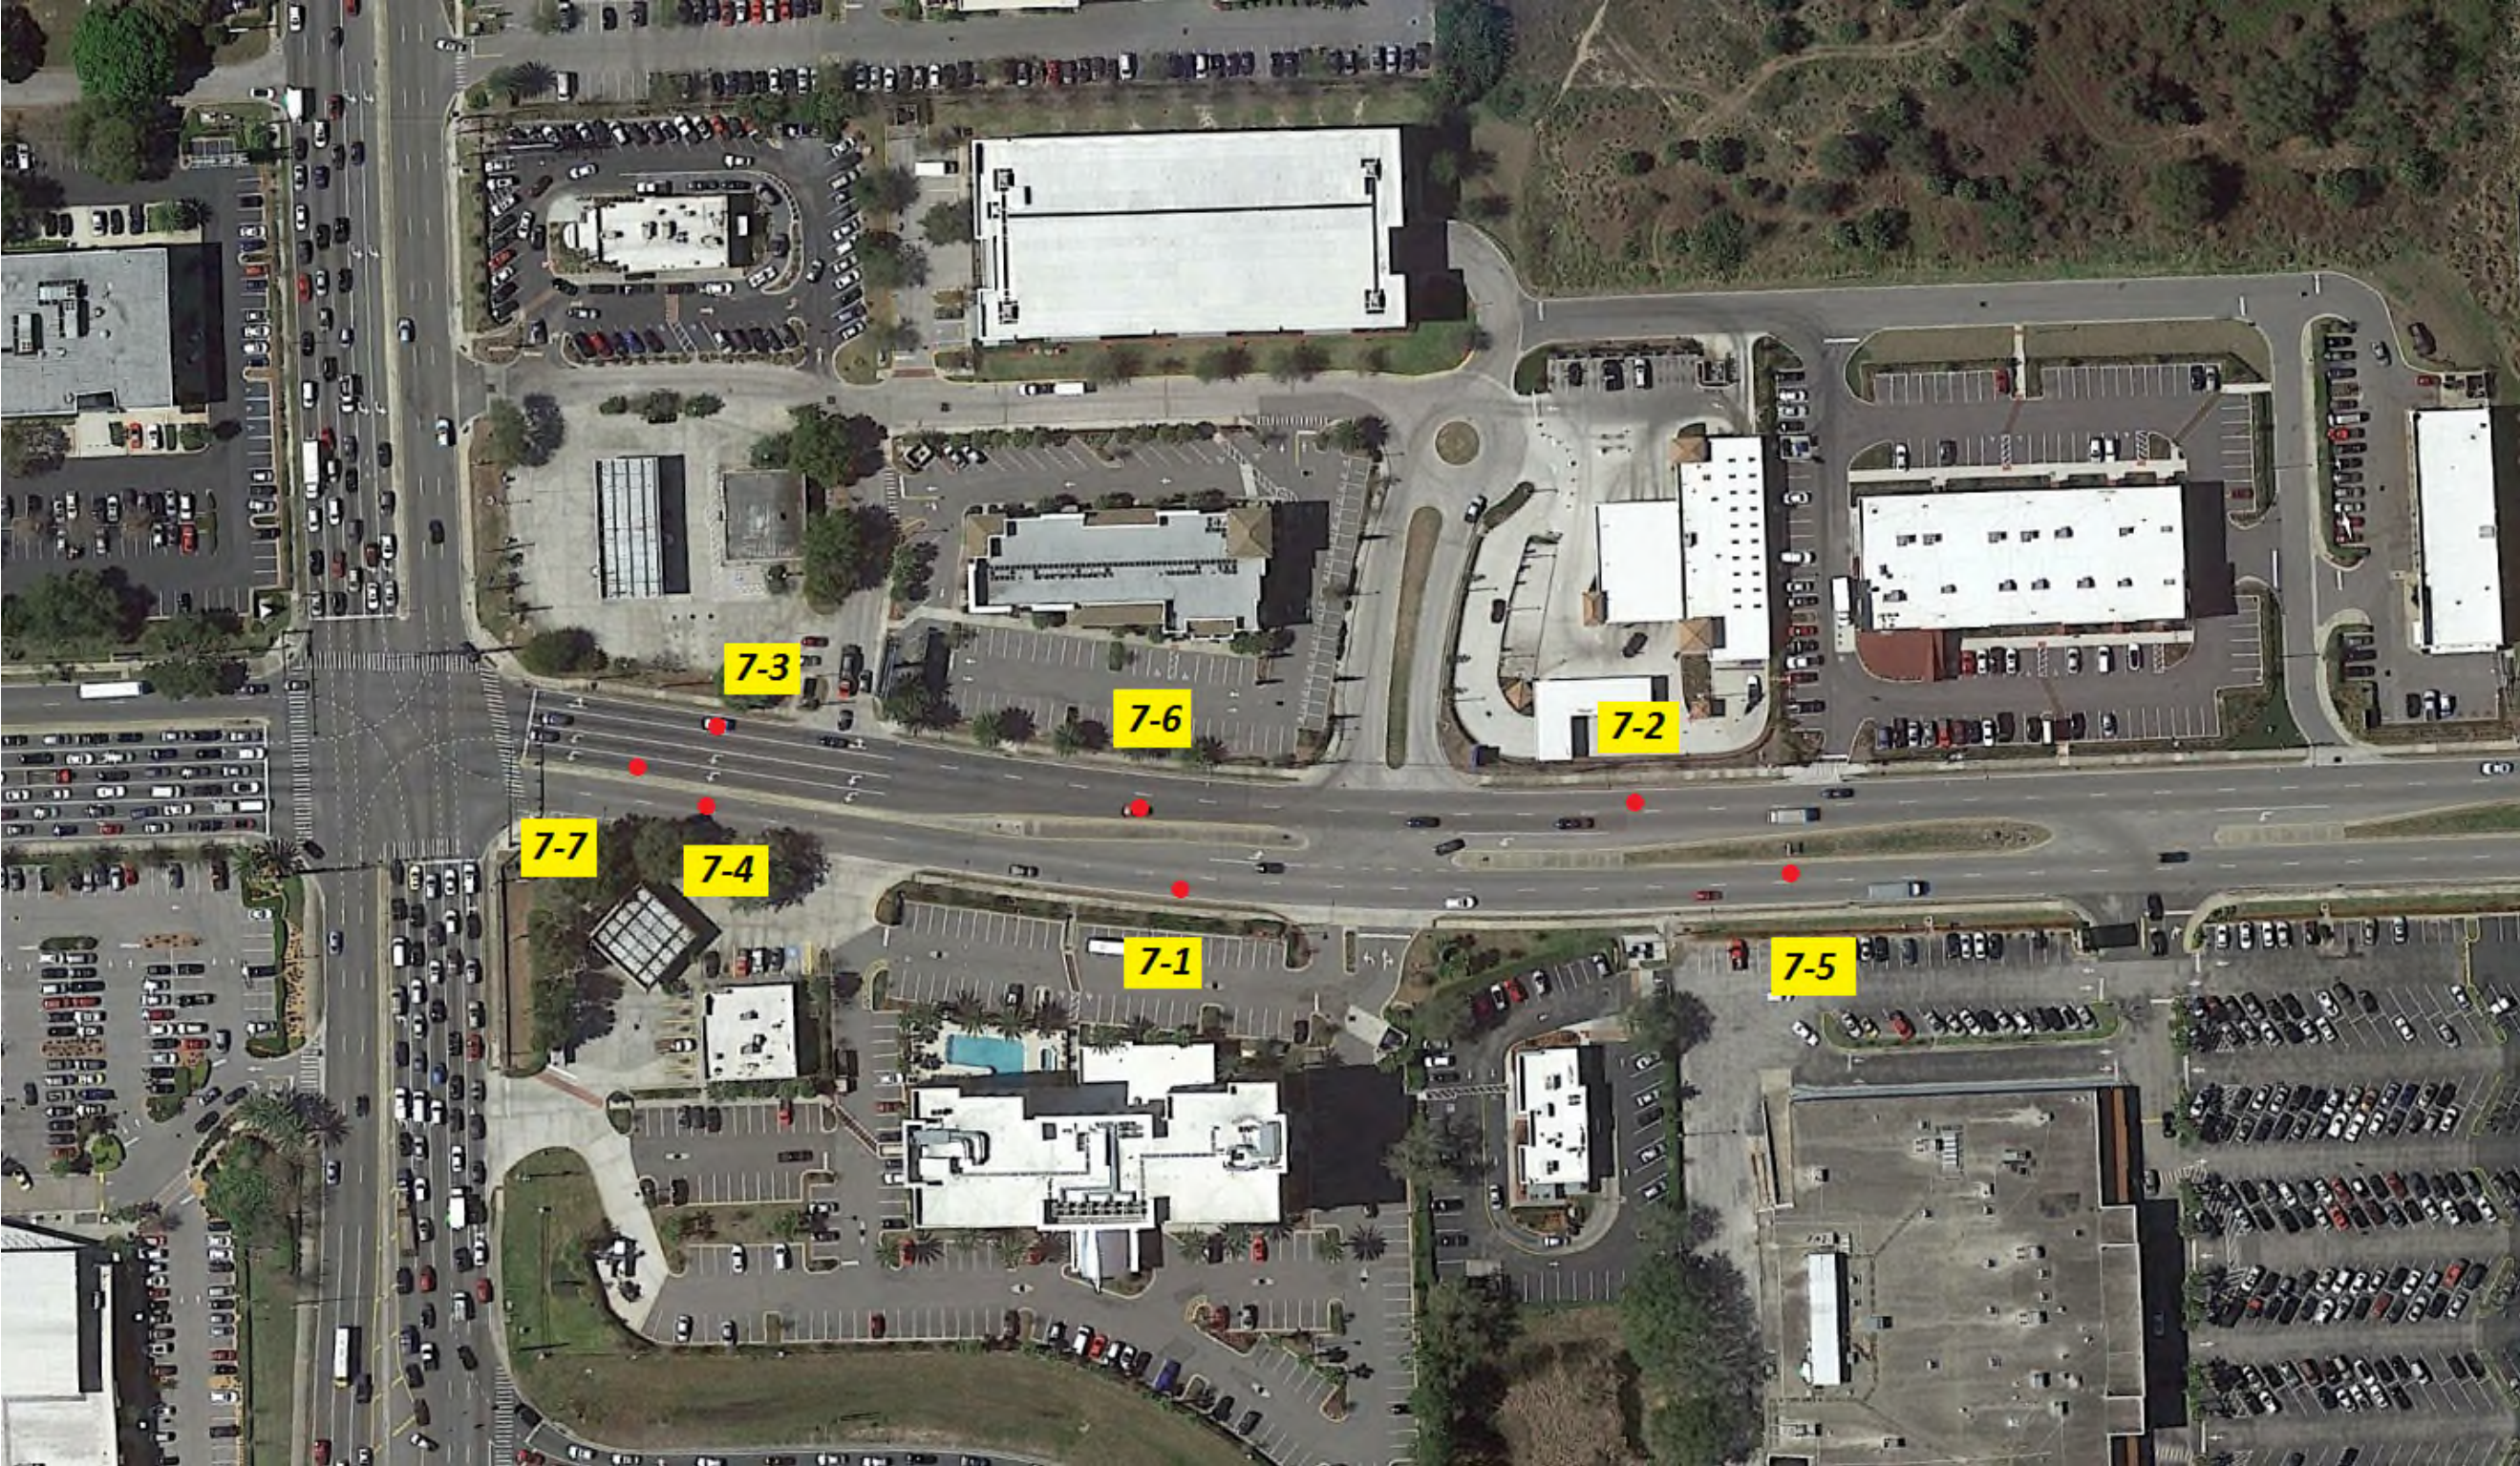
Turkey Lake Road - - North of Sand Lake Road (7 cores - 7 series)

7-1	*	3.0	R2	X		1.6	0.8		3.0		5.4	LR	—	—	—	—	F	0.0	3.4	
7-2	*	10.5	L2			0.9	1.0		3.1		5.0	LR	11.0	—	—	—	F	0.1	3.1	
7-3	*	2.5	L2/LRTL	X		0.9	0.9		2.9		4.7	LR	—	—	—	—	F	0.2	2.0	To WB Sand Lake Rd

7-4	*	8.5	R1	X		0.4	0.8		2.6		3.8	LR	10.7	-	-	-	-	F	0.3	2.1	
7-5	*	8.0	R1			1.5	0.9		2.7		5.1	LR	-	B	SL	II	S	F	0.0	-0.5	
7-6	*	9.0	L1	X		1.0	0.5		3.0		4.5	LR	10.4	-	-	-	-	F	0.0	3.2	
7-7	*	2.5	LLTL-1	X	0.9	2.1					15.4	ABC	12.4	-	-	-	-	F	0.3	-0.7	To EB Sand Lake Rd; LR noted below ABC

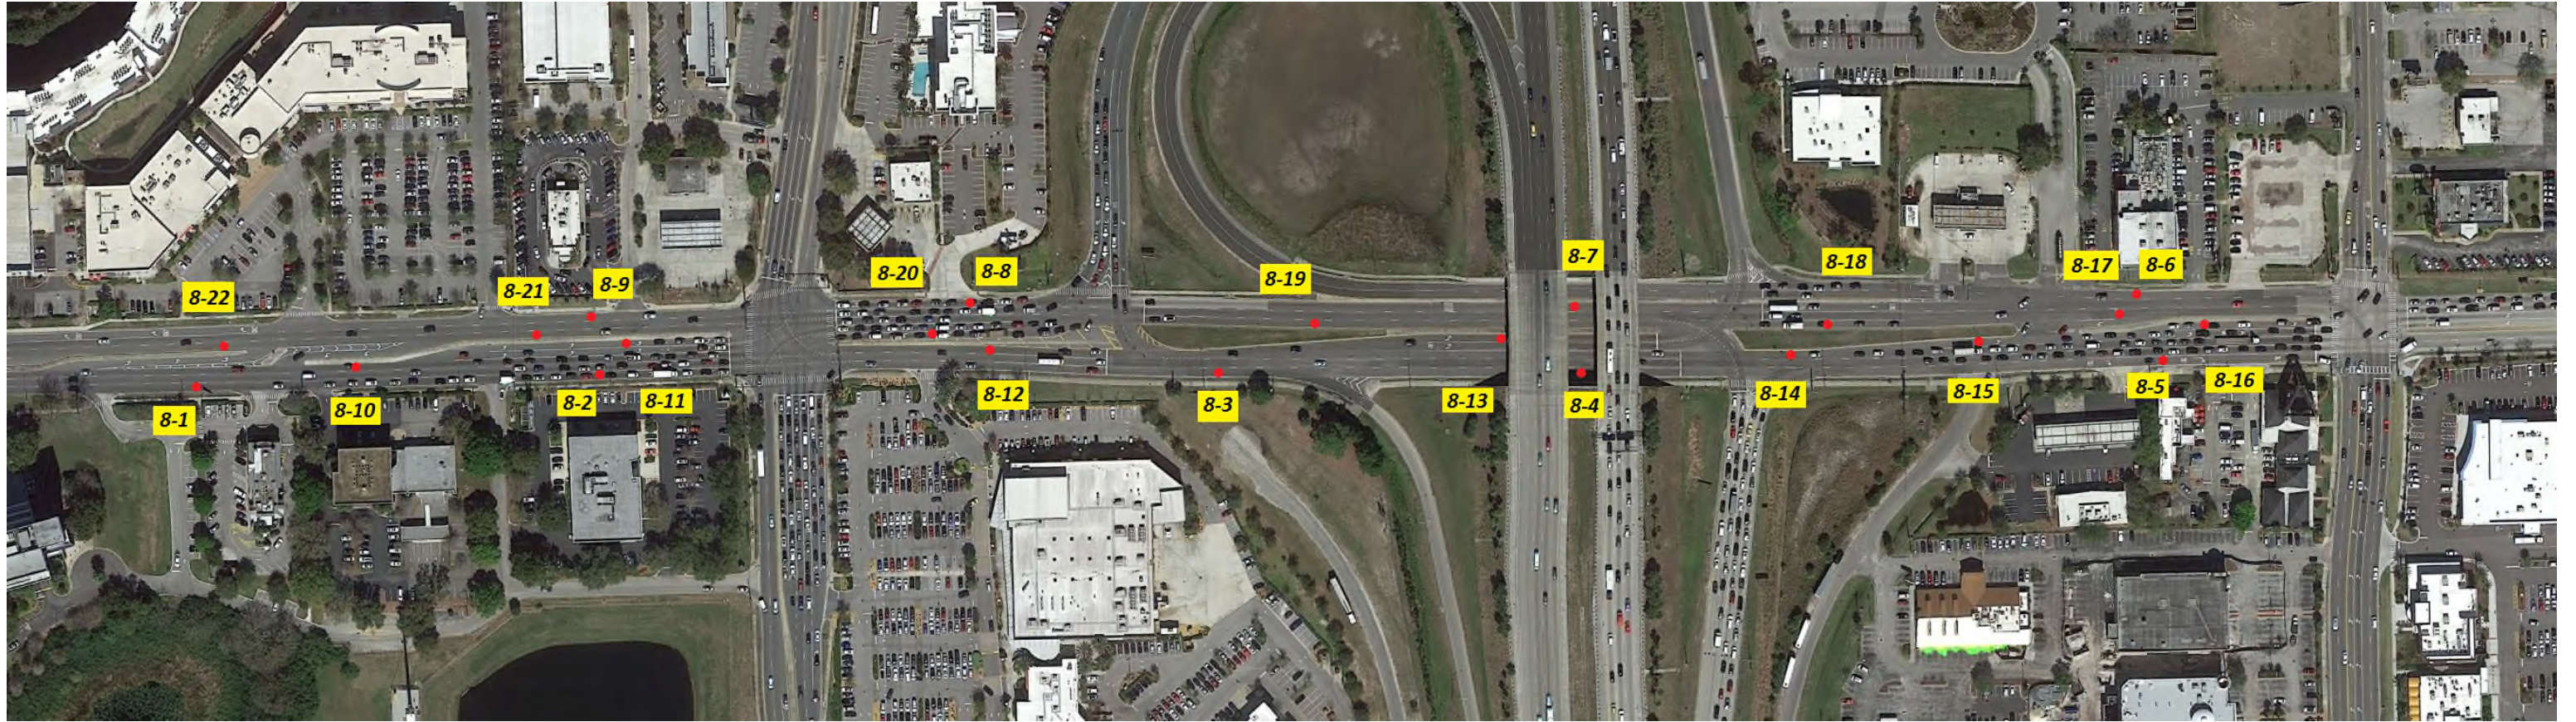
Sand Lake Road - - West of Turkey Lake Road to West of I-Drive (22 cores - 8 series)

8-1	*	9.0	R3	X		1.1			2.0		3.1	LR	12.9	B	SL	II	S	P	0.2	2.1	
8-2	*	9.0	R3	X		0.8		2.5			3.3	LR	-	B	Br	II	S	P	0.3	2.5	
8-3	*	7.0	R3		1.2				3.6		4.8	LR	12.2	B	Br	II	S	P	0.4	1.7	Severe IWP Rutting
8-4	*	3.0	R3	X		0.6			3.3		3.9	LR	-	-	-	-	-	P	0.3	3.0	
8-5	*	2.5	RRTL	X		0.5			3.5		4.0	LR	13.0	-	-	-	-	P	0.4	2.1	To SB International Dr
8-6	*	2.5	L3	X		0.6			3.0		3.6	LR	-	-	-	-	-	P	0.4	3.9	
8-7	*	11.0	L3			0.6			3.1		3.7	LR	12.3	-	-	-	-	P	0.3	2.6	
8-8	*	2.0	L3	X		0.8		0.7	1.5		3.0	LR	-	-	-	-	-	F	0.3	1.9	Core broke during extraction
8-9	*	8.0	L3		1.4			2.4			17.4	ABC	13.6	-	-	-	-	F	0.3	2.4	
8-10	*	2.5	R1	X		0.8			3.0		3.8	LR	-	-	-	-	-	F	0.2	2.6

8-11	*	8.0	RLTL-1		1.0		0.9			15.9	LR	14.0	-	-	-	-	F	0.2	0.7	To NB Turkey Lake Rd; 5.1' of LR noted below ABC	
8-12	*	8.5	R1	X	0.9			3.1		4.0	LR	-	B	SL	II	M	F	0.3	2.1		
8-13	*	9.0	RLTL-1	X			0.6		3.3	3.9	LR	12.1	3.1	ST	II	L	P	0.5	1.7	To EB I-4	
8-14	*	2.0	R1	X			0.4		2.8	3.2	LR	-	B	ST	II	L	P	0.3	2.6		
8-15	*	9.0	RLTL	X			0.6		2.9	3.5	LR	15.5	-	-	-	-	P	0.2	2.0	To Quality Inn	
8-16	*	2.0	RLTL-1	X			0.7		3.3	4.0	LR	-	-	-	-	-	P	0.2	1.0	To NB International Dr	
8-17	*	11.0	L1				0.7		3.3	4.0	LR	13.5	B	SL	III	S	P	0.4	2.2		
8-18	*	2.5	L1	X			0.7		2.4	3.1	LR	-	-	-	-	-	P	0.2	1.3		
8-19	*	8.5	L1	X			0.6		3.2	3.8	LR	12.7	-	-	-	-	P	0.3	2.9		
8-20A	*	5.5	LLTL-1		0.6			3.7		4.3	LR	-	B	SL	I	M	F	0.3	-0.2	Core is near the LLTL-2 Side; To SB Turkey Lake Rd	
8-20B	*	3.0	LLTL-1	X	0.5			2.1		15.0	ABC	12.4	-	-	-	-	F	0.3	-0.2	Core is near the Inside Median Side; To SB Turkey Lake Rd	
8-21	*	7.0	L1			0.8		2.7		3.5	LR	8.7	-	-	-	-	F	0.2	1.3

8-22	*	2.5	L1	X		1.3		3.0		4.3	LR	-	-	-	-	-	F	0.3	2.2
