**State of Florida Department of Transportation
PAVEMENT EVALUATION AND CONDITION DATA SHEET**

Project No.: 418021-1		Cored By: Elipsis Engineering and Consulting					Date: May 6, 2013					Page No.: 1 of 2								
County: Volusia		Highway Sect. No: 79060					From: N/A					To: N/A								
Road No.: SR 600 (US 92) & Williamson Blvd.		Begin MP: 16.700					End MP: 16.800					Length: 0.100 mile								
Core No.	MP	Distance from left edge of lane (ft)	Lane	Wheel Path	Pavement Layer (in.)						Base		Crack				Pavt Cond.	Rut Depth (in)	Cross Slope (%)	Comments
					FC-9.5	Type SP	Type S	PCC		Core Length (in)	Type	Thick-ness (in)	Depth (in)	Type	Class	Extent				
1	N/A*	3.5	LRTL		1.1	1.2	1.0			3.3	LR	17.0	—	—	—	—	F		TL Radi from US 92 WB to Williamson Blvd. NB Unknown thickness of asphalt was encountered after augering through the LR.	
2	N/A*	8.5	NE ISLAND					4.6		4.6	LR	4.0	—	—	—	—	—		8.4" earth soil layer exists directly below PCC and 4" of LR exists below the earth soil layer.	
3	N/A*	7.5	LRTL		1.1	0.9	1.3			3.3	LR	15.0	—	—	—	—	F		TL Radi from Williamson Blvd. SB to US 92 WB Unknown thickness of asphalt was encountered after augering through the LR.

State of Florida Department of Transp

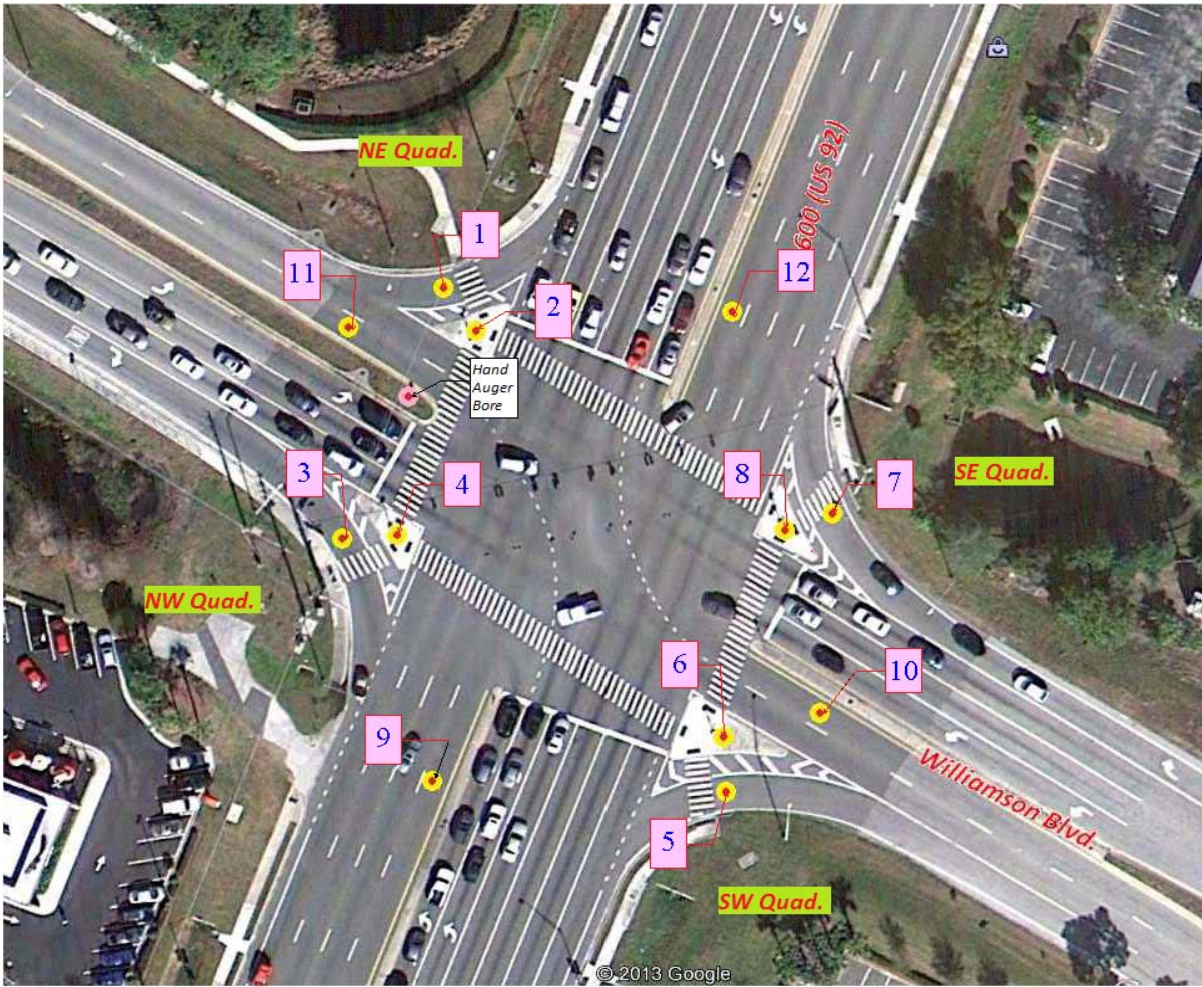
* Refer to Marked Up Aerial Sheet for Approximate Core Locations																				
NOTE: In the narrow grassed median traffic separator on Williamson Blvd ; near the bullnose area - - the hand augering of this area revealed 14" of earth soil layer with 21" of limerock material beneath it.																				
Remarks: Crack Depth of "B" indicates full depth crack to the base. Cross Slope has two (2) measurements: 1 st value represents 0-6' of lane (left half) and 2 nd value represents 6-12' (right half). <u>Crack Extent:</u> L= Light; M= Moderate; S= Severe <u>Pavement Condition:</u> G= Good; F= Fair; P= Poor <u>Crack Types:</u> A= Alligator; Bl= Block; Br= Branch <u>SL=</u> Single Longitudinal; <u>ST=</u> Single Transverse; <u>R=</u> Reflective; <u>J=</u> Joint; <u>OGFC=</u> Open-Graded FC Stress Crack <u>Base Types:</u> LR= Limerock; COQ= Coquina; SC= Soil Cement; ABC= Asphalt Base; SAHM= Sand Asphalt Hot Mix; NB= No Base
