Project: Project Development & Environment Study
SR A1A Over Sebastian Inlet – Bridge 880005
Bridge Replacement
Indian River County and Brevard County

FPID No.: 445618-1-22-02

SUBJECT: BENTHIC SURVEY TECHNICAL MEMORANDM

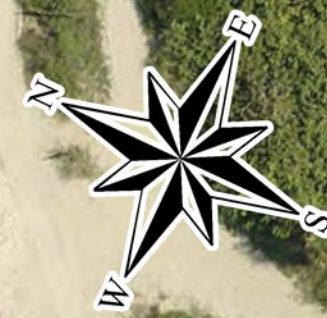
Benthic Survey Methodology Map

Note: Each transect was 100-ft in length.

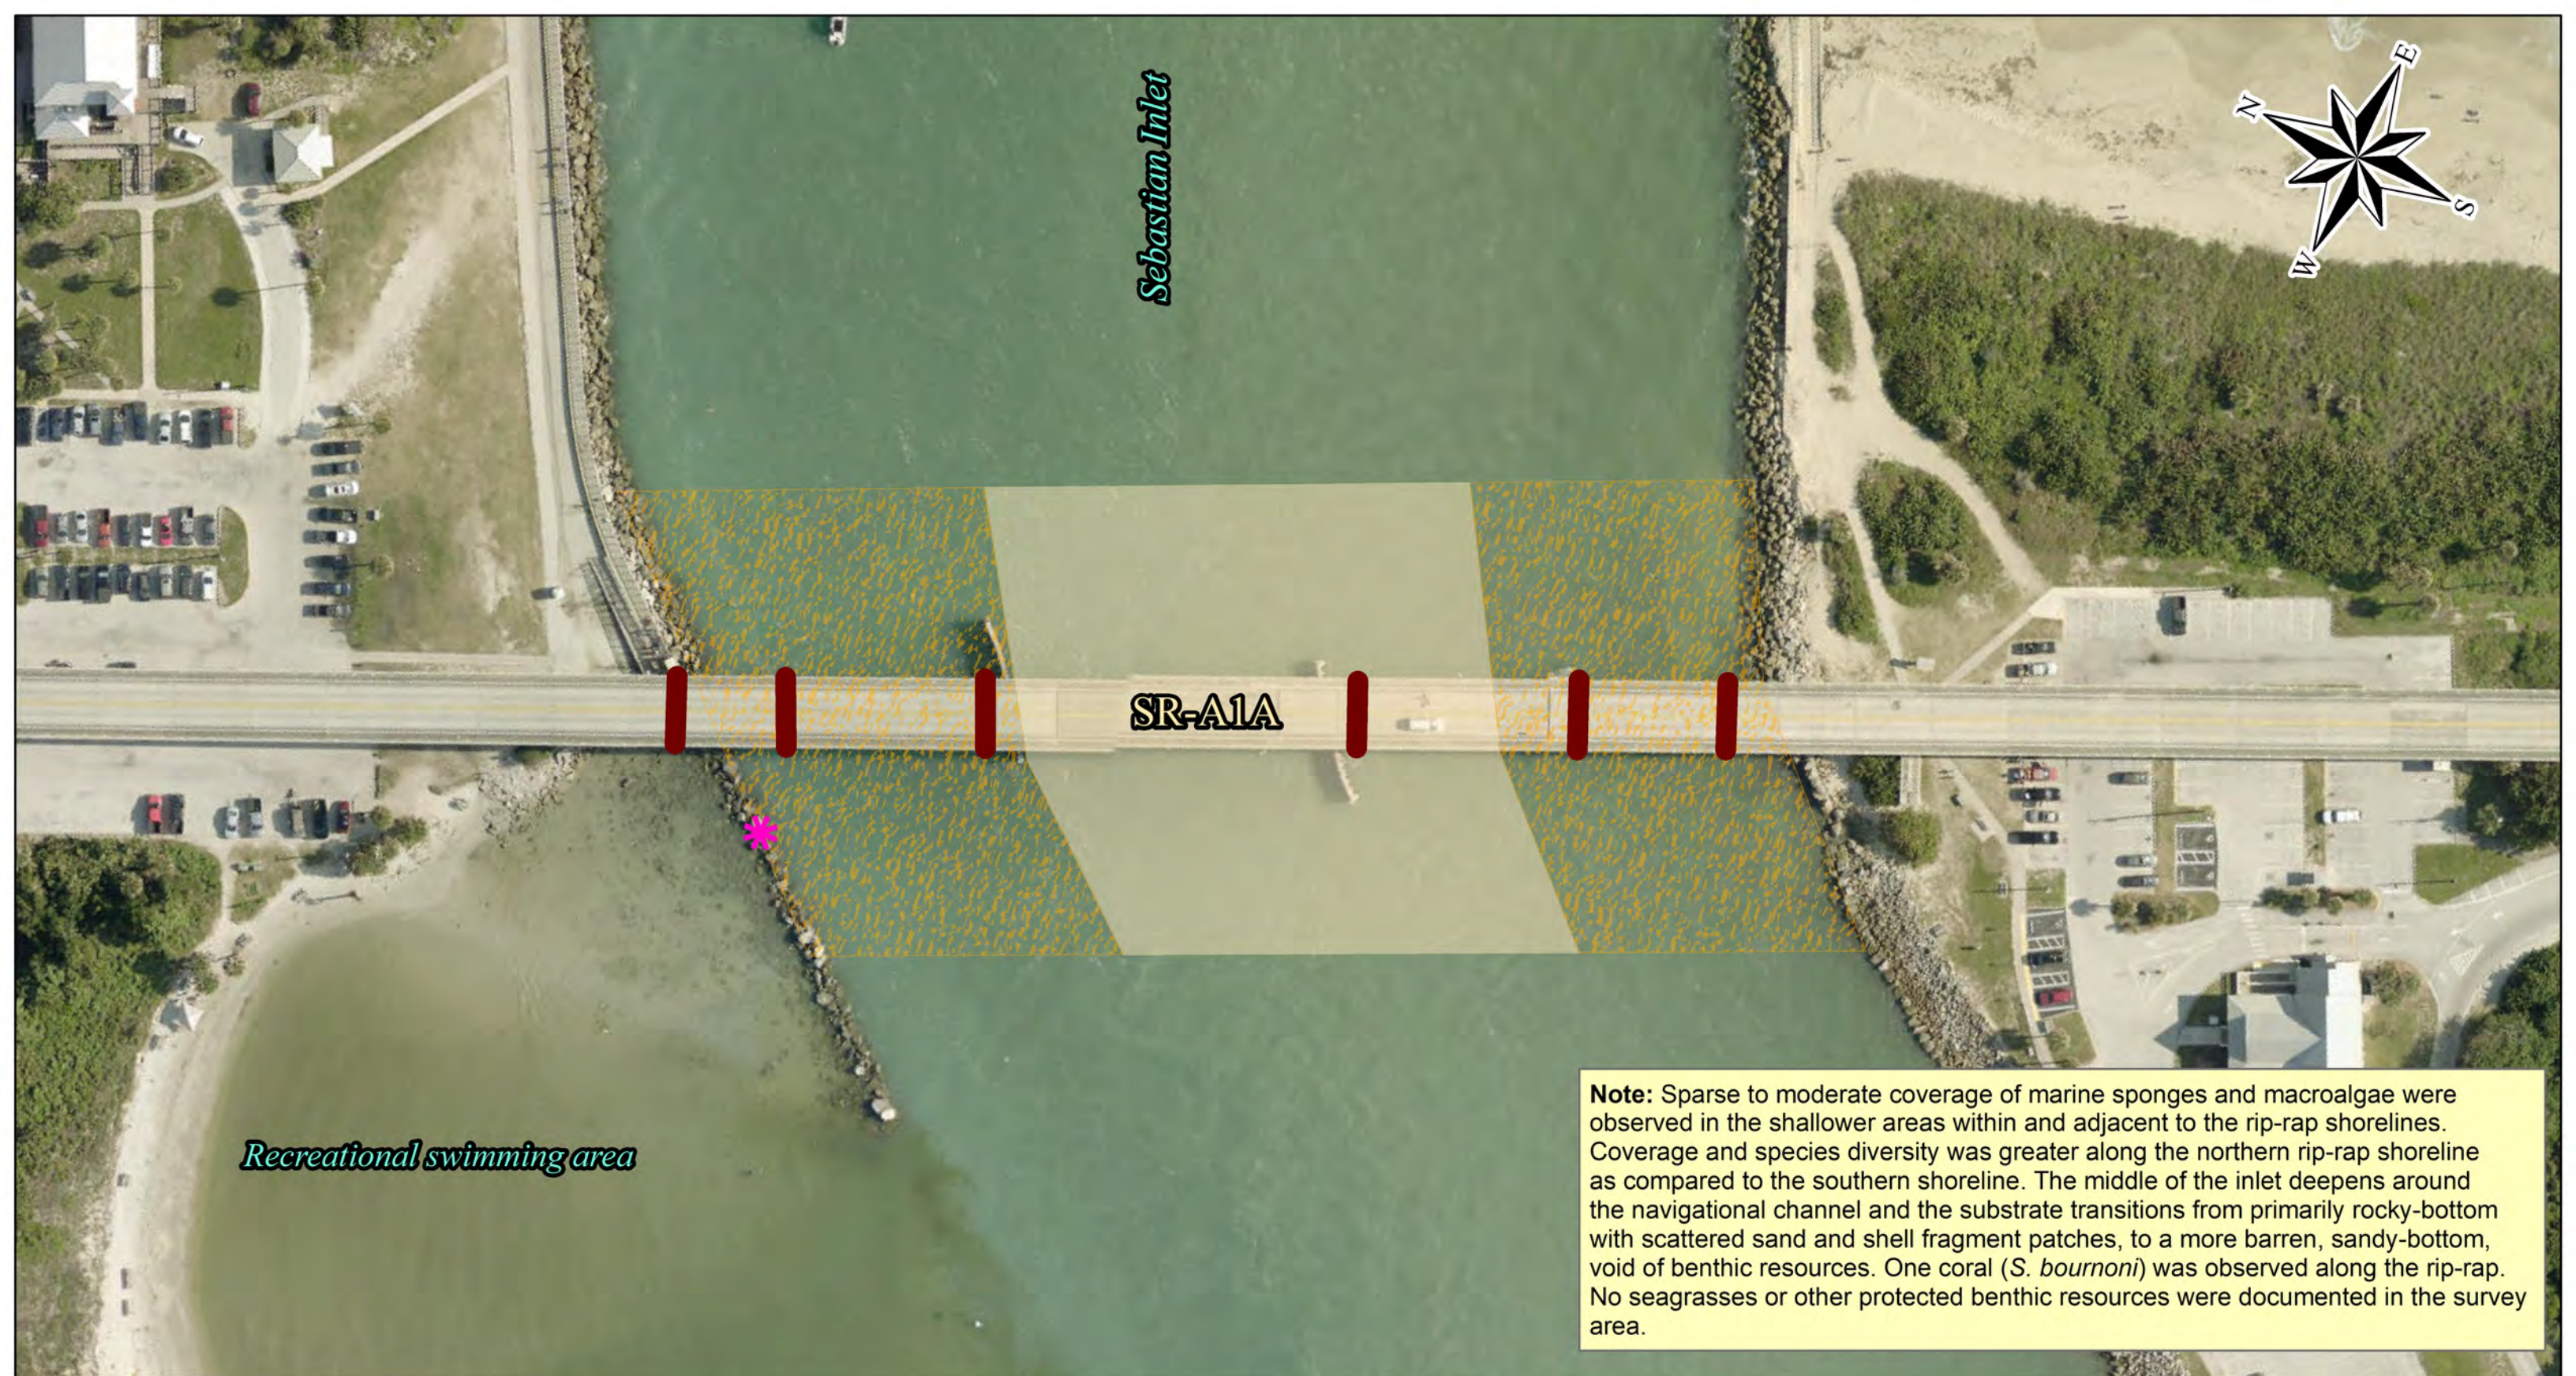
Benthic Survey Results Map

The benthic survey of the project area was completed within the scientific seagrass survey window on June 4, 2021 during incoming and outgoing tidal cycles. The Sebastian Inlet experiences extremely high velocity currents which can get up to 9-ft/sec; therefore, slack tides were utilized to the greatest extent to complete this survey. The benthic substrate within the survey area is primarily rocky hard-bottom with scattered patches of sand with shell fragments. No seagrasses or corals were documented on the bottom substrate or any of the bridge pilings. Sparse to moderate coverage of sponges and algae were found along the rip-rap shorelines, rocky benthic substrate, and the in-water bridge pilings. This survey found a greater assortment of sponge and algal diversity on the northern rip-rap shoreline than the southern rip-rap shoreline. One individual smooth star coral (*Solenastrea bournoni*) was identified on the rip-rap shoreline.

to the northwest of the existing bridge (See **Attachment 3**). A complete list of all marine species documented during this survey is included in **Table 1**.

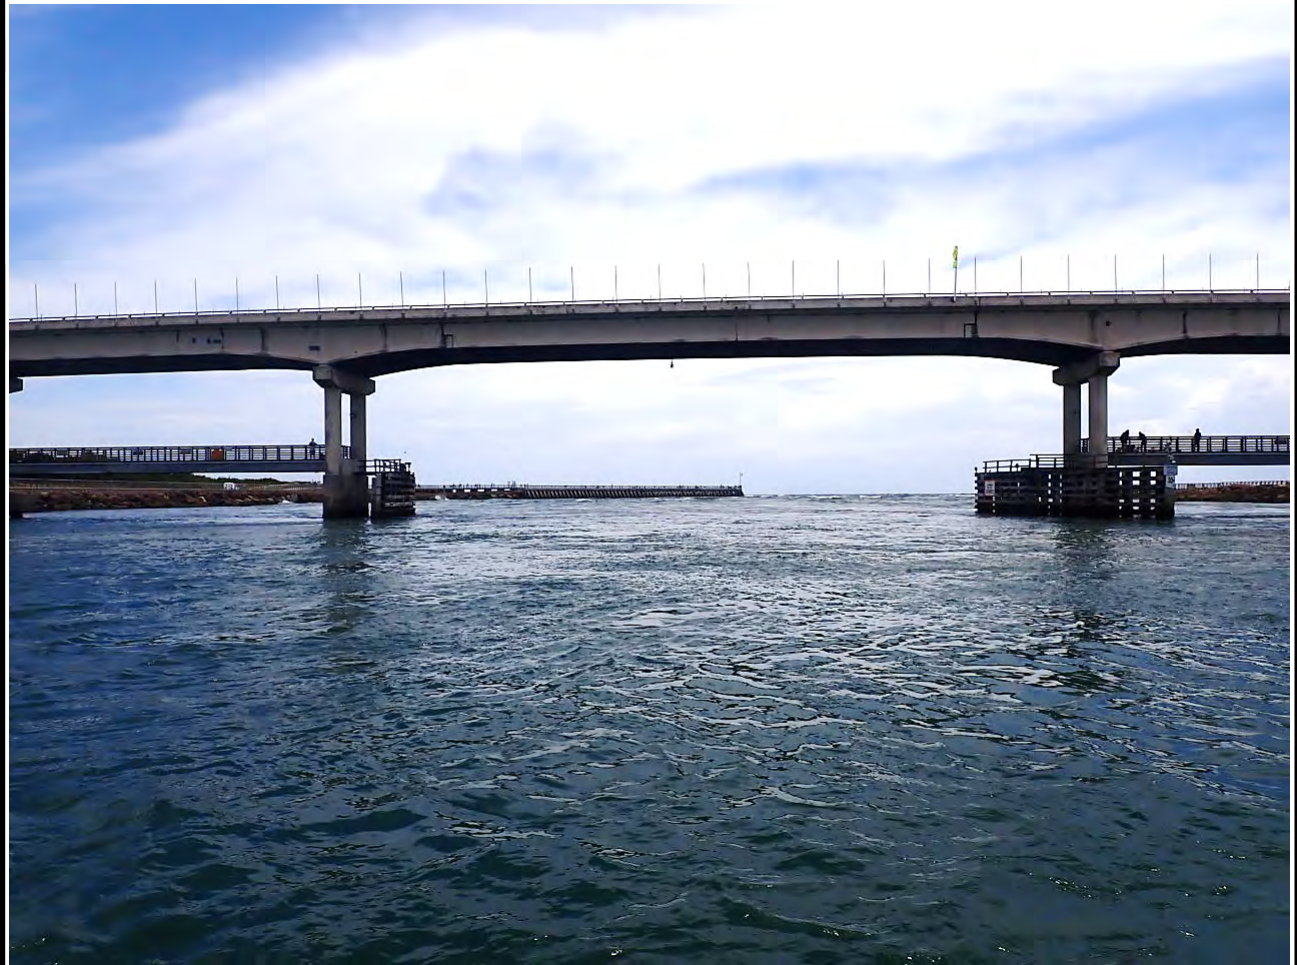
Photograph No.: 1

Notes: The photograph shows the project bridge looking east towards the Atlantic Ocean. This inlet experiences extremely high velocity current during tidal interchanges making it unlikely to support seagrasses or corals in the areas adjacent to the bridge.

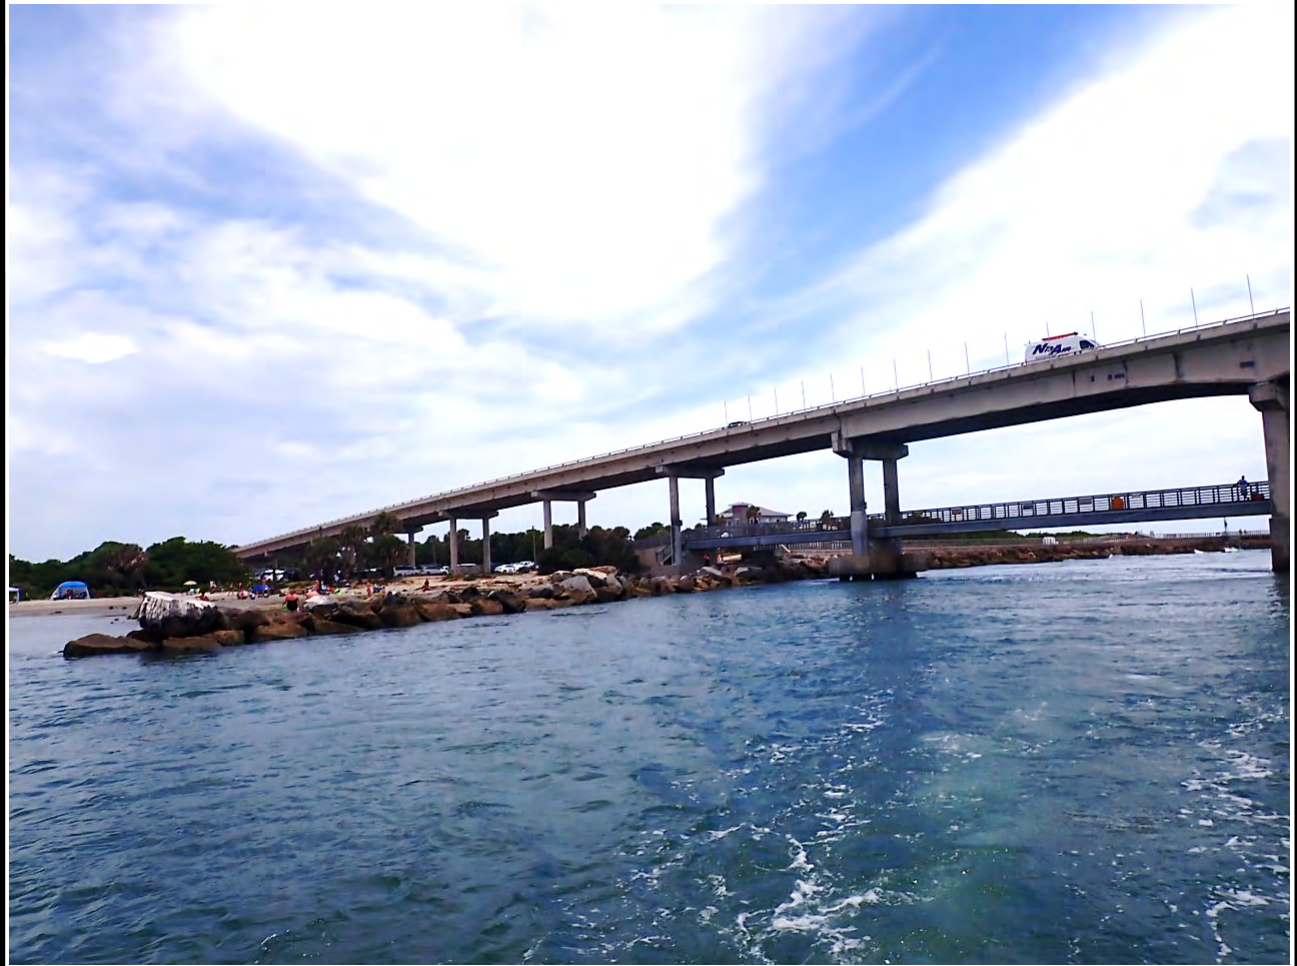
Photograph No.: 2

Notes: The photograph shows the northern rip-rap shoreline underneath the project bridge over the Sebastian Inlet.

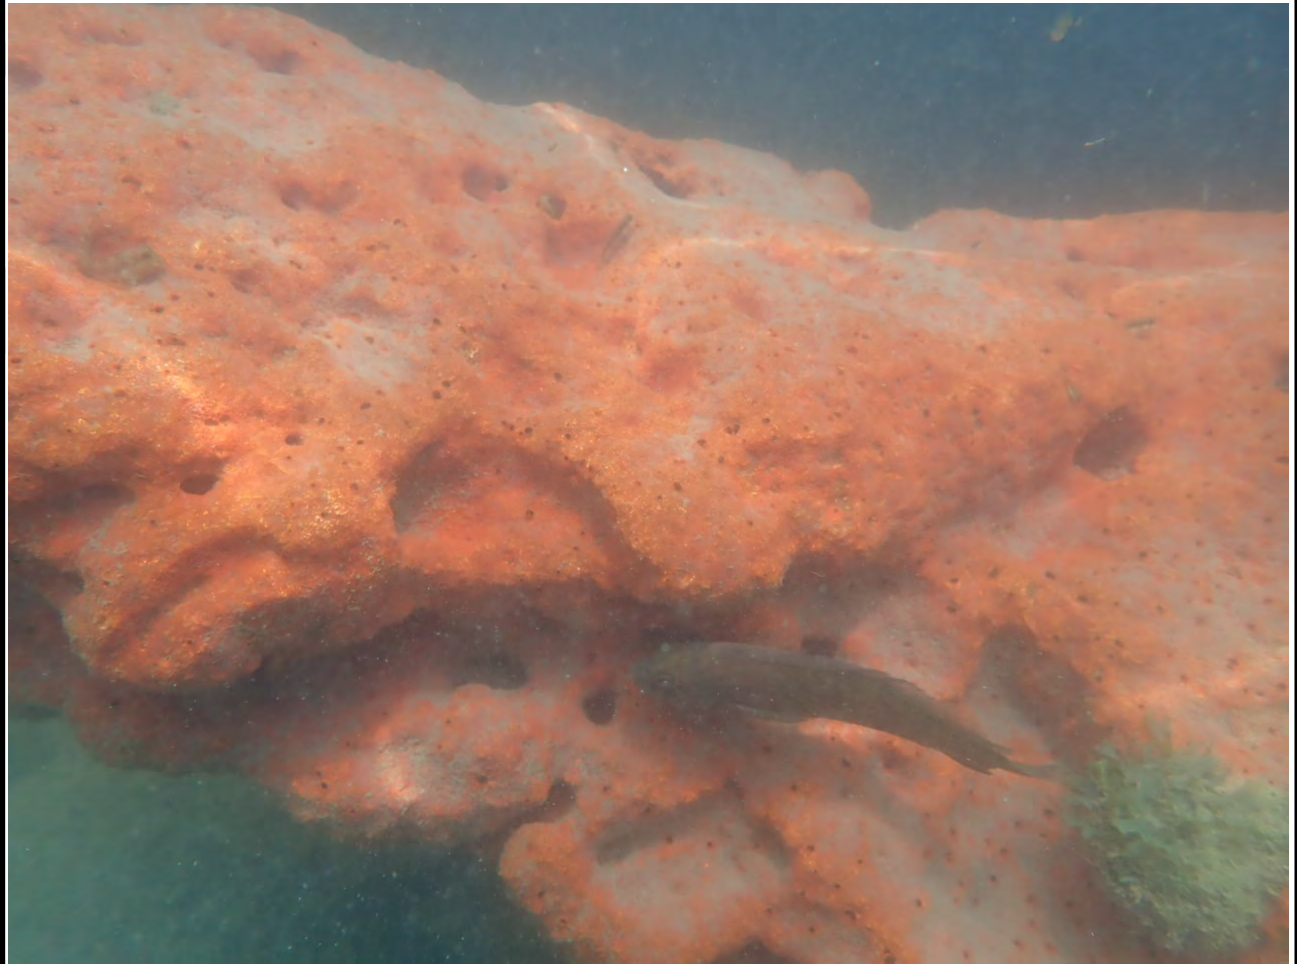
Photograph No.: 3

Notes: The photograph shows a large red ball sponge/red boring sponge, *Drumacidon sp.*, that was observed throughout much of the survey area. These ranged in size from smaller than a fist and larger as shown here within the rip-rap shoreline on the northern shore.

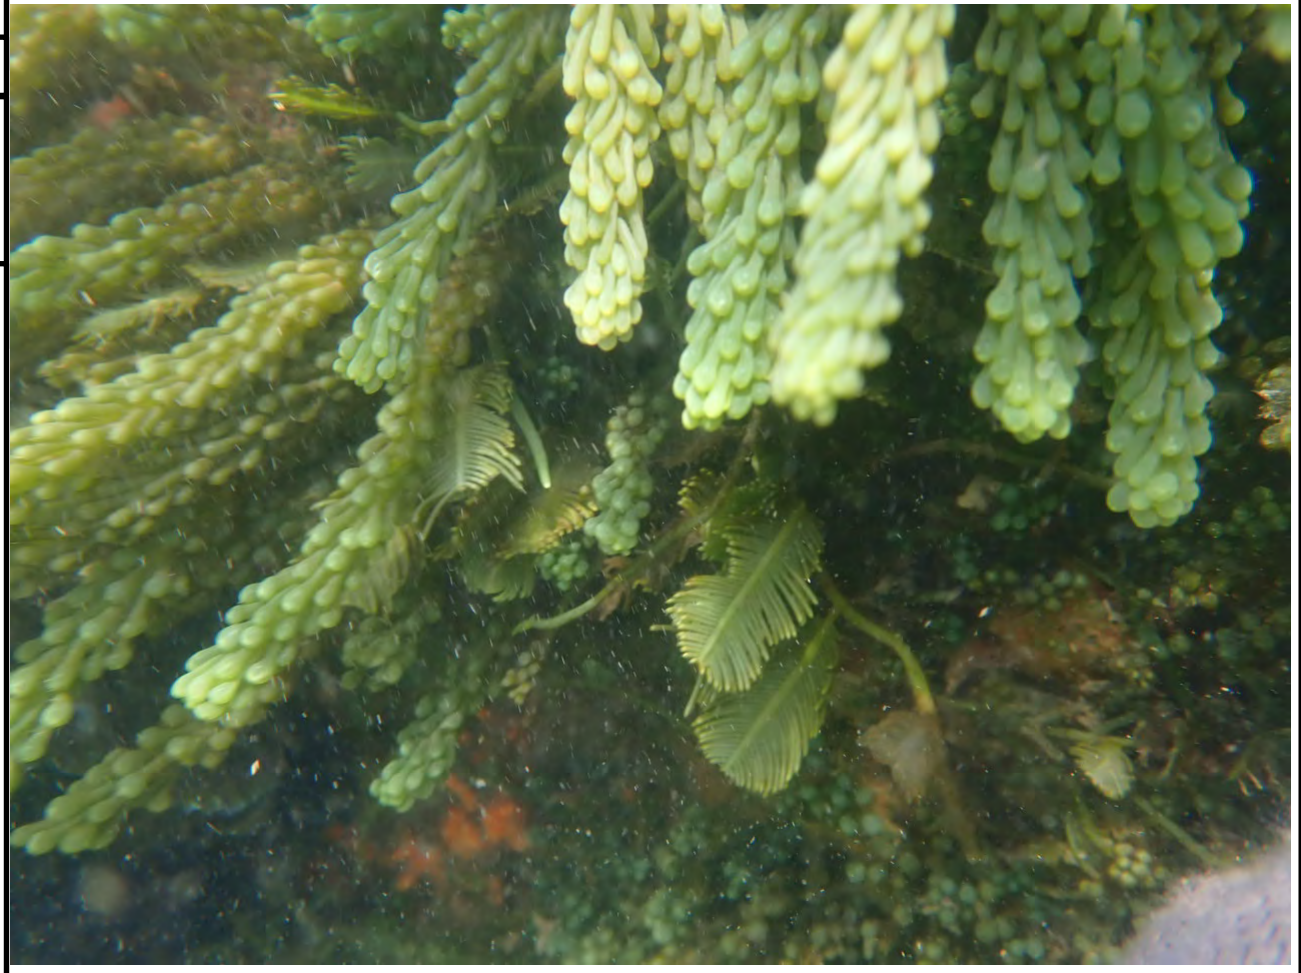
Photograph No.: 4

Notes: The photograph shows some green feather alga, *Caulerpa sertularioides* along with some sea grape *Caulerpa racemosa* observed within the rip rap shoreline habitat.

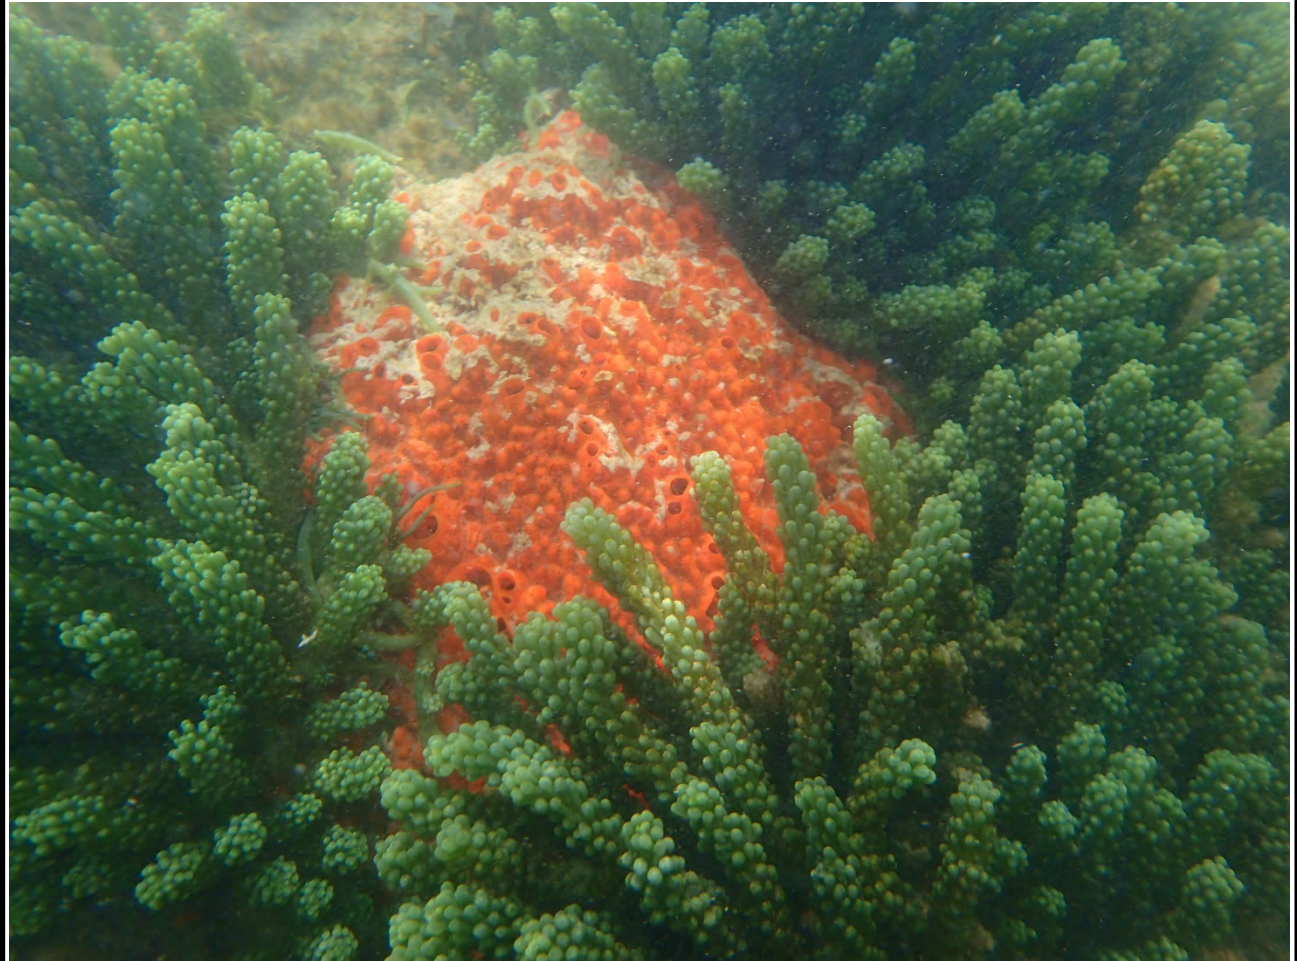
Photograph No.: 8

Notes: The photograph
shows some sea grape
green algae, *Caulerpa
racemosa*, that was
observed within the
northern rip-rap shoreline.

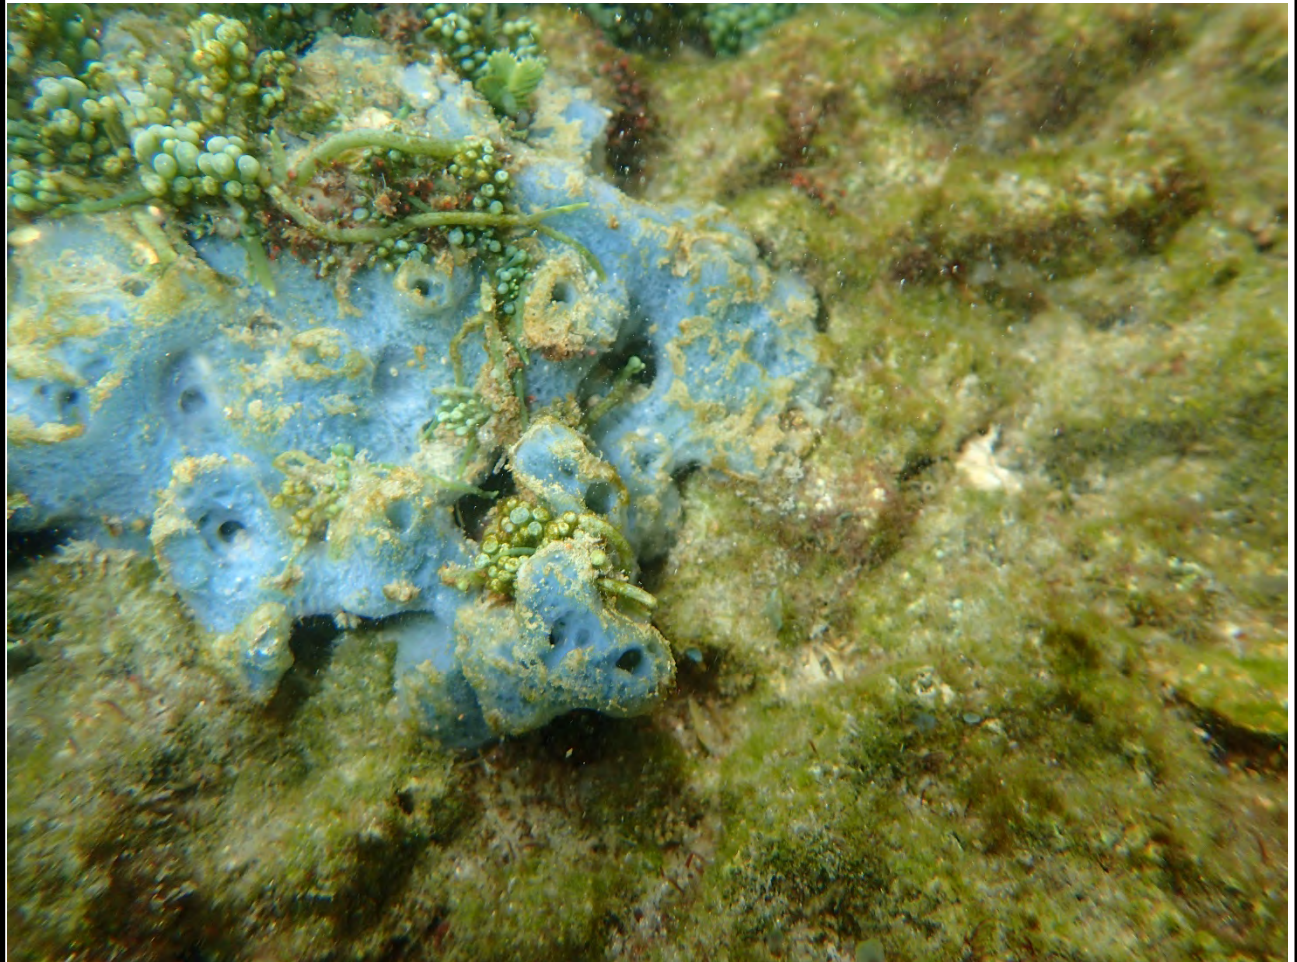
Photograph No.: 9

Notes: The photograph
shows a blue tube sponge,
Haliclona caerulea, that
was observed throughout
much of the survey area.

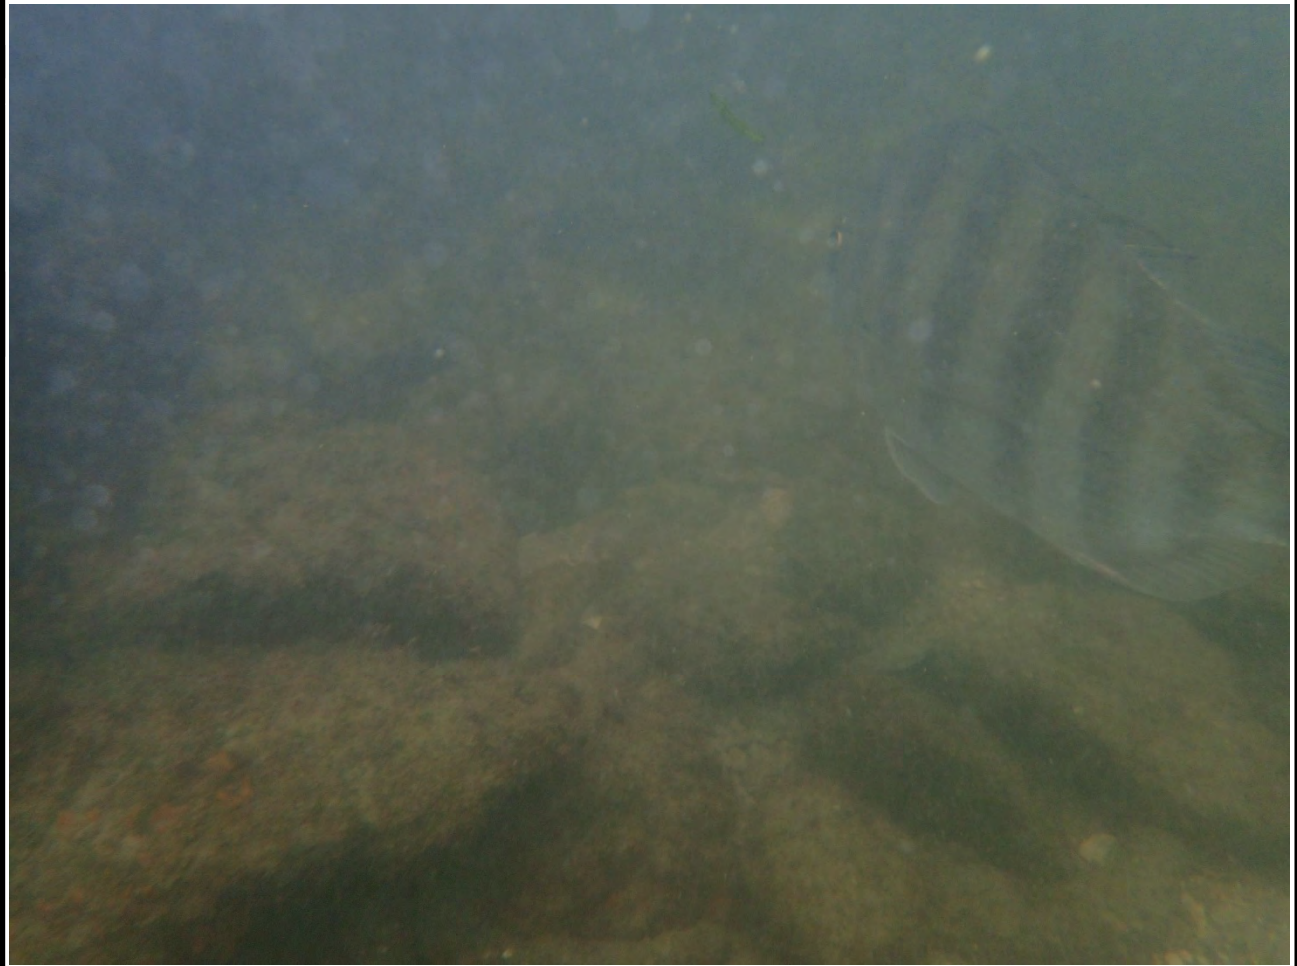
Photograph No.: 10

Notes: The photograph
shows a sheepshead
(*Archosargus
probatocephalus*) utilizing
the rip-rap shoreline
habitat.

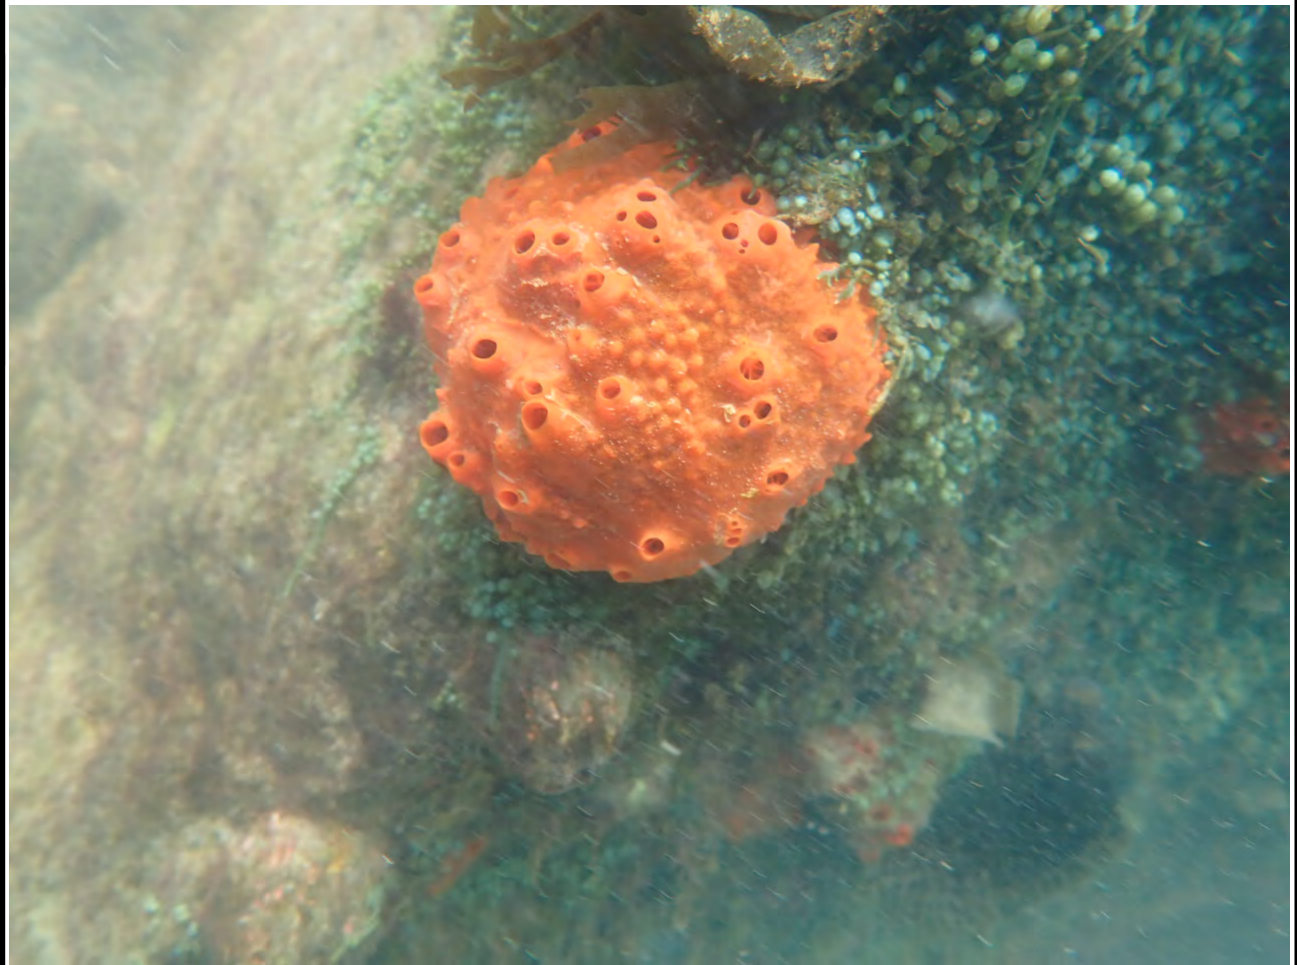
Photograph No.: 11

Notes: The photograph
shows a sponge,
Lissodendoryx sigmata,
observed utilizing the rip-
rap shoreline habitat.

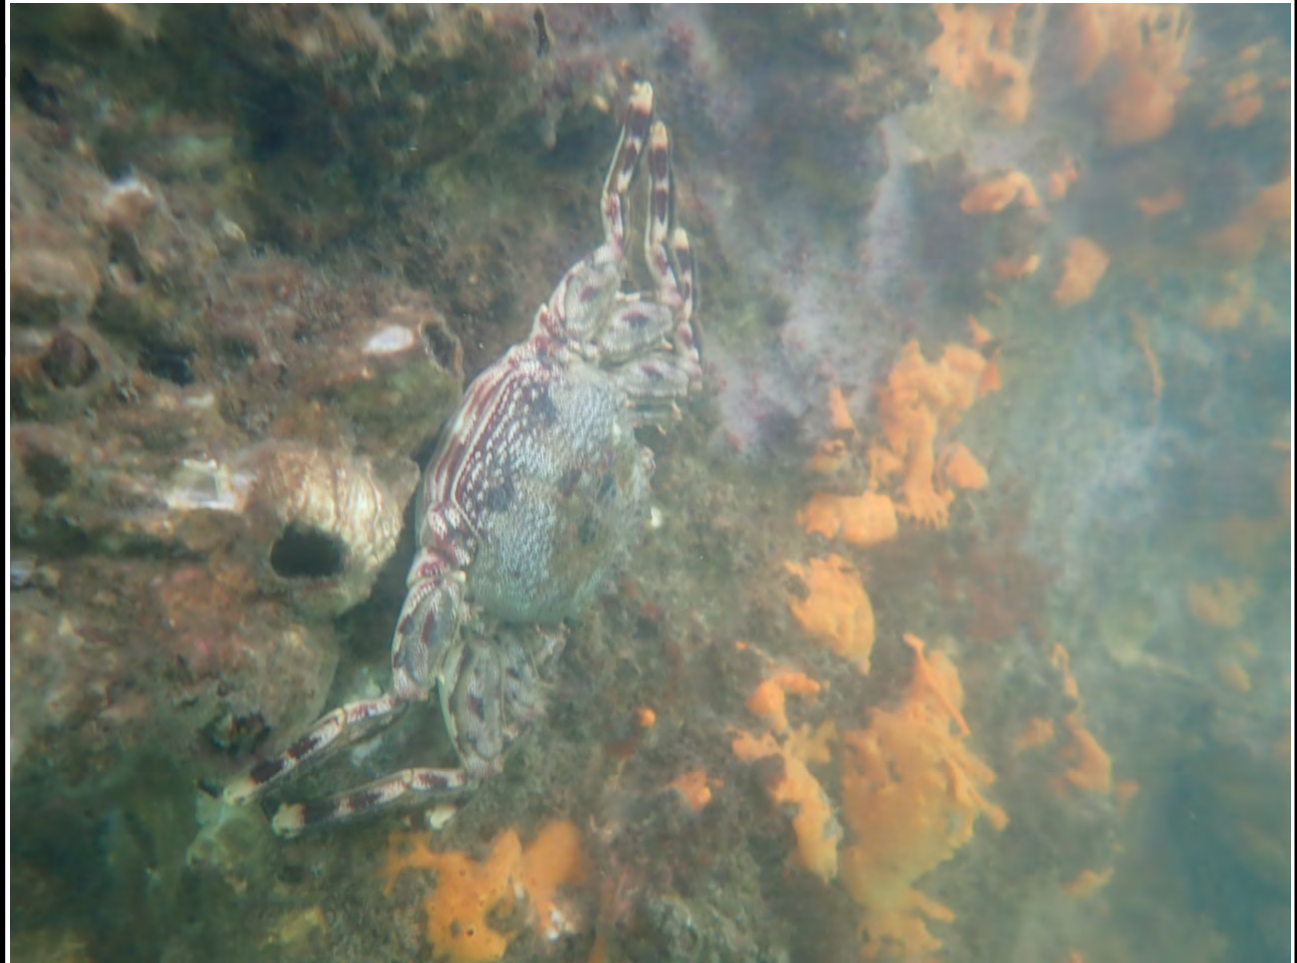
Photograph No.: 12

Notes: The photograph
shows a tidal spray crab,
Plagusia depressa, utilizing
the rip-rap shoreline
habitat within the survey
area.

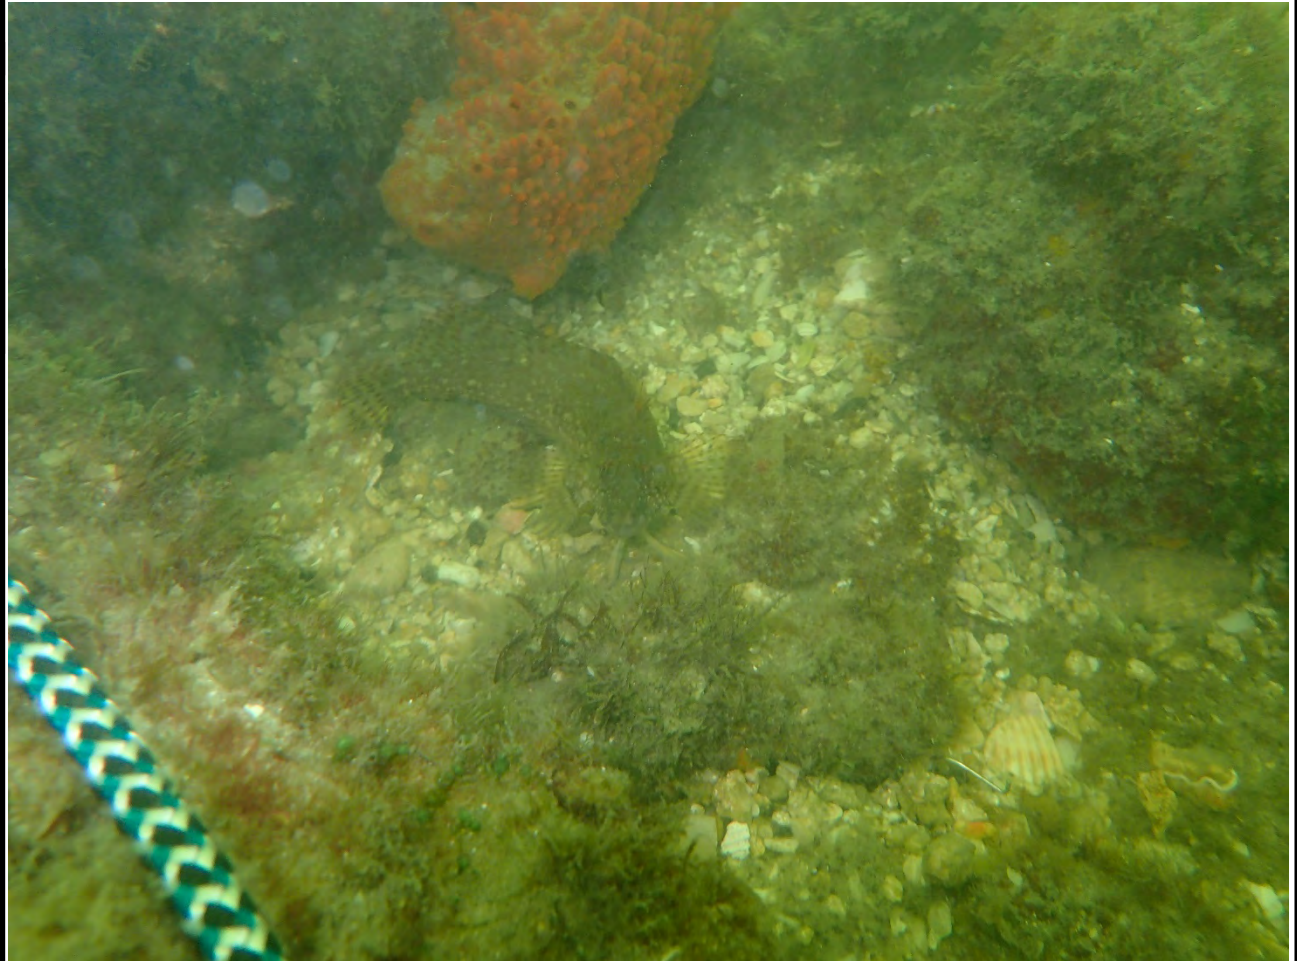
Photograph No.: 14

Notes: The photograph shows a hairy blenny, *Labrisomus nuchipinnis*, that was observed along a transect within the survey area.

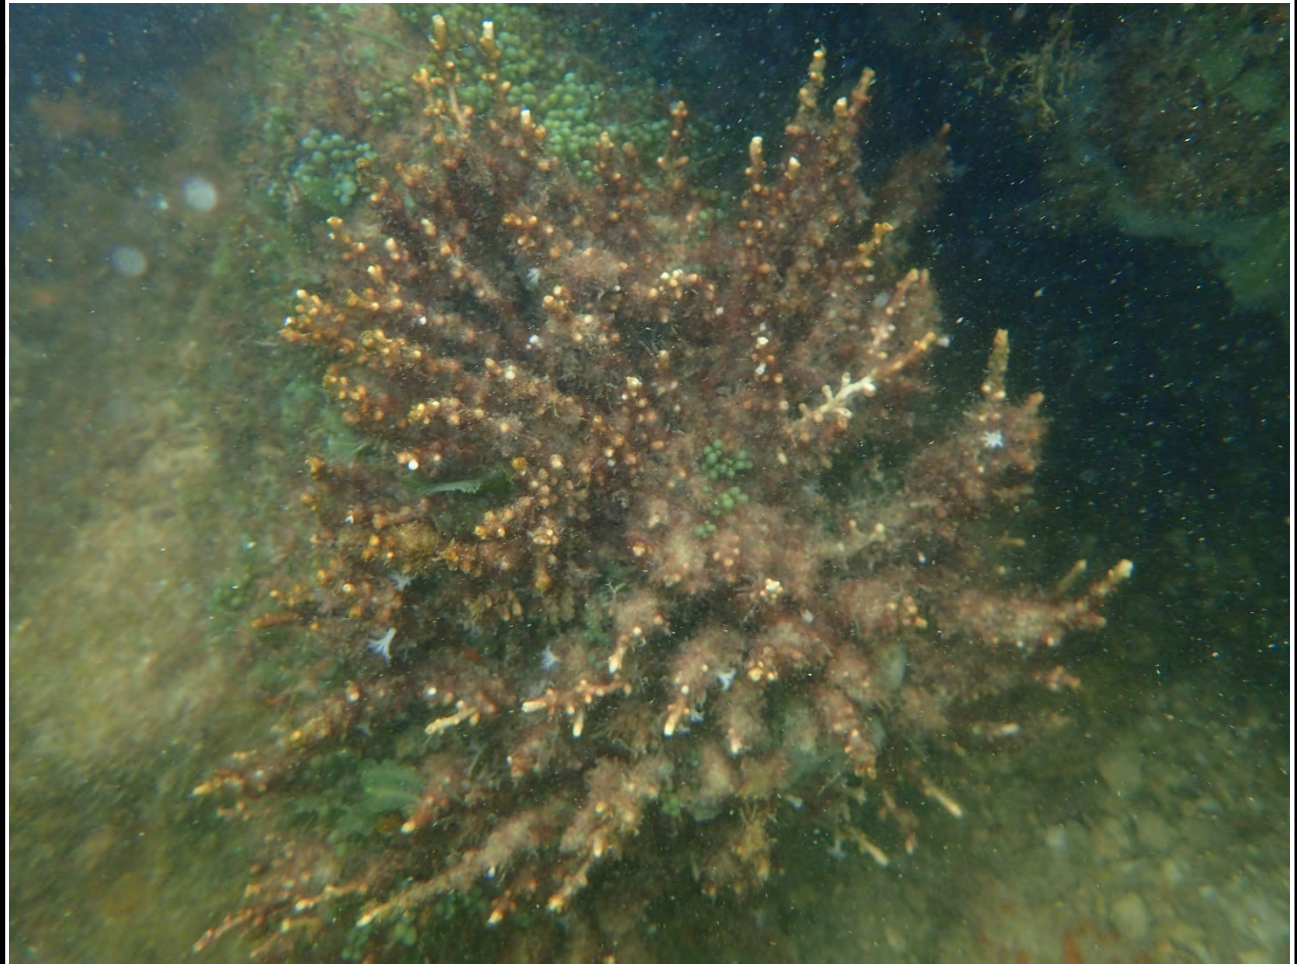
Photograph No.: 16

Notes: The photograph
shows some fire coral,
Millepora alcicornis,
colonizing the rip-rap
shoreline.

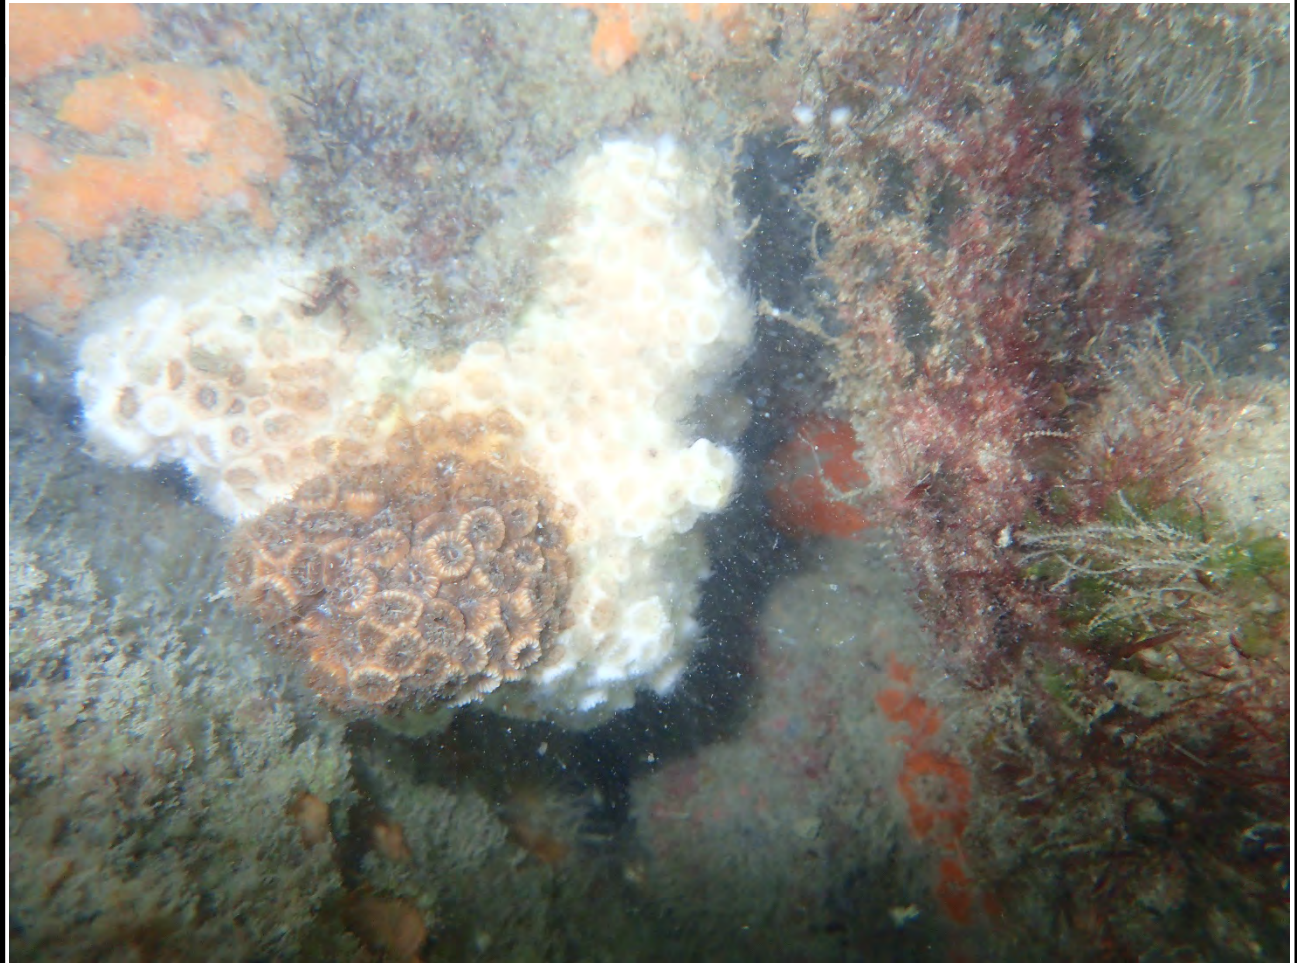
Photograph No.: 17

Notes: The photograph shows a smooth star coral, *Solenastrea bournoni*, colonizing the rip-rap shoreline. This coral appears to be bleaching as the majority of this individual has turned white.

No HAPCs were identified within the project area; therefore, no HAPCs are anticipated to be impacted by the proposed project. No mangroves are present within the Sebastian Inlet adjacent to the existing bridge, no seagrasses were documented within the project area, and only one (1) individual stony coral was observed. The rip-rap, rocky-hardbottom, and bare sand substrates documented in the survey area provide EFH for species within several FMPs, including spiny lobster, snapper and grouper, migratory pelagics, red drum, and penaeid shrimp. Minor impacts/disturbance to these EFHs may occur from the proposed bridge replacement project; however as discussed, these habitats would be expected to naturally recover post construction. Therefore, it is anticipated that this project will result in *minimal* impacts to EFH.
