# Multimodal Access Management Applications Guide

June 2024

STATE OF FLORIDA DEPARTMENT OF TRANSPORTATION  
SYSTEMS IMPLEMENTATION OFFICE

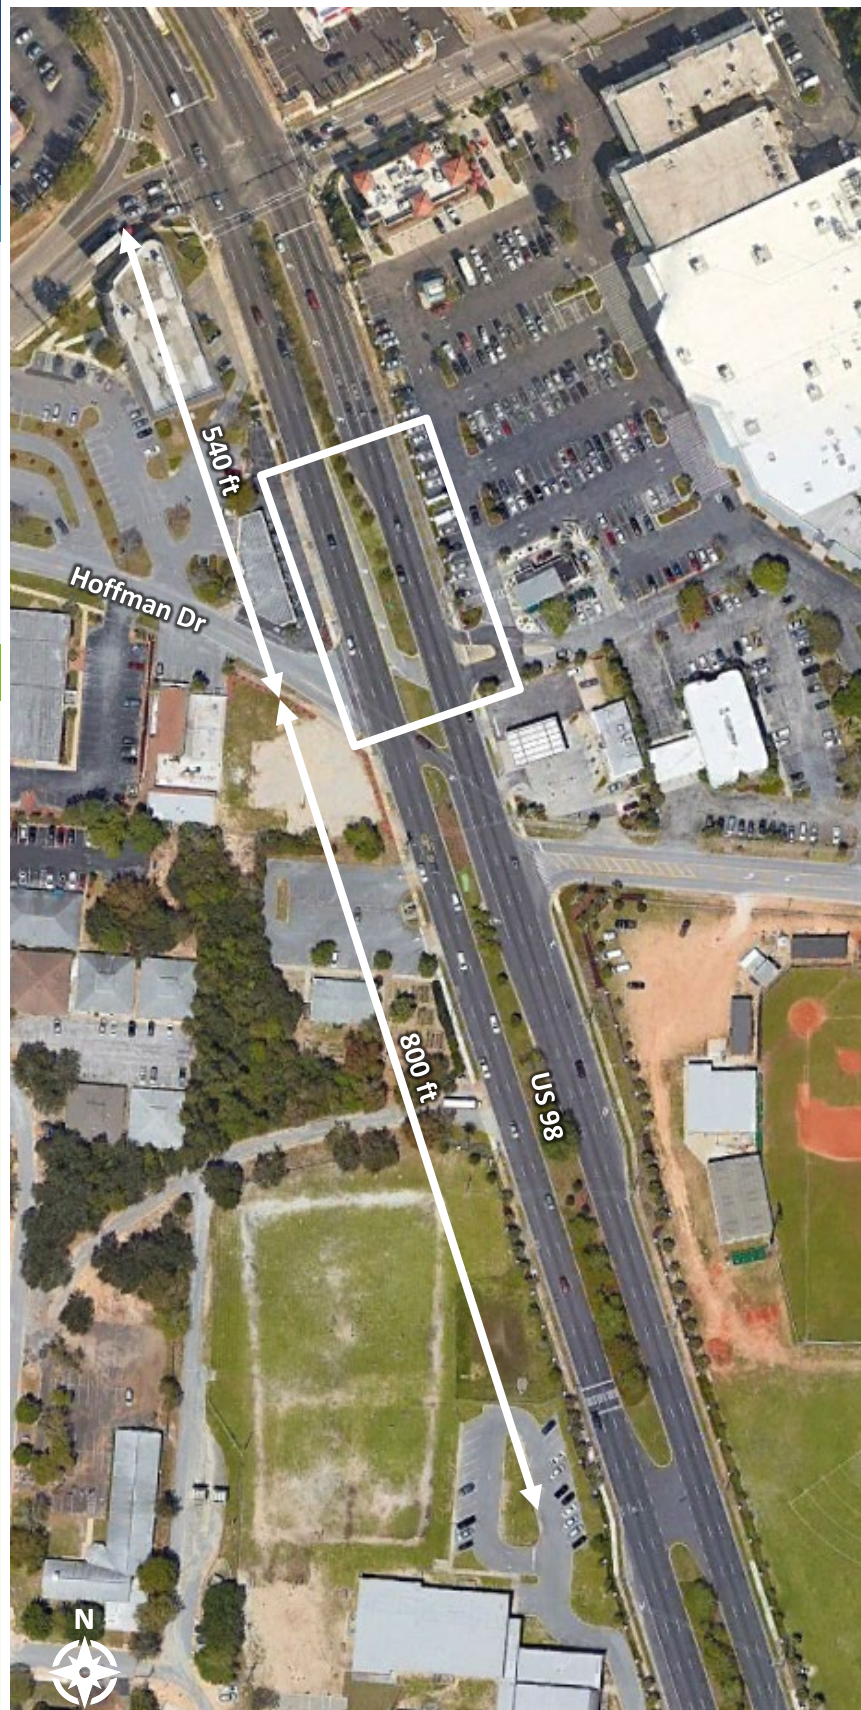
### Before

- There was a significant crash history at the directional median opening for southbound left turns at Hoffman Drive into the Gulf Breeze Shopping Center.
- Northbound vehicles routinely queued from the signal upstream past the directional median opening, creating a blocked condition with stacked vehicles and sight distance issues for vehicles attempting to turn left through the queue.
- The directional median opening did not meet spacing standards.

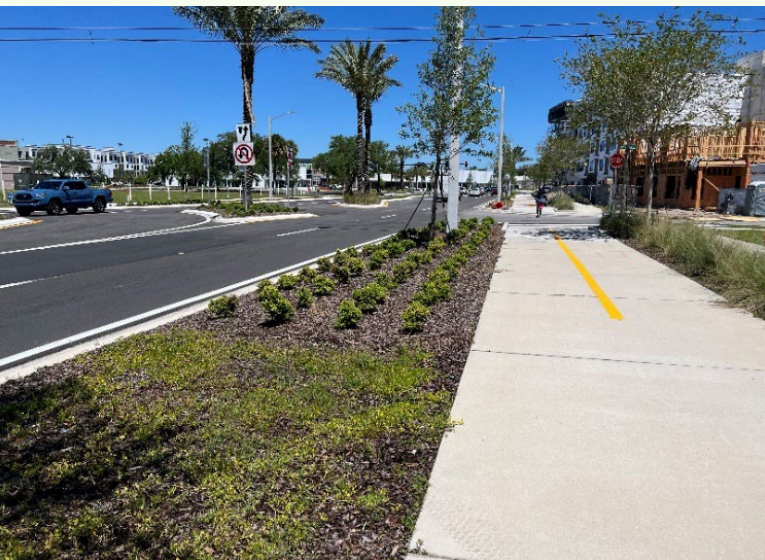
Princeton Street at directional median opening at Diversified Way.

- Two previously full median openings (Stanhope Way, Diversified Way) were reconfigured as directional median openings, and sections of continuous two-way center turn lane were replaced with median. On Princeton Street, U-turns are now prohibited at the two directional medians, but can be made downstream in either direction.

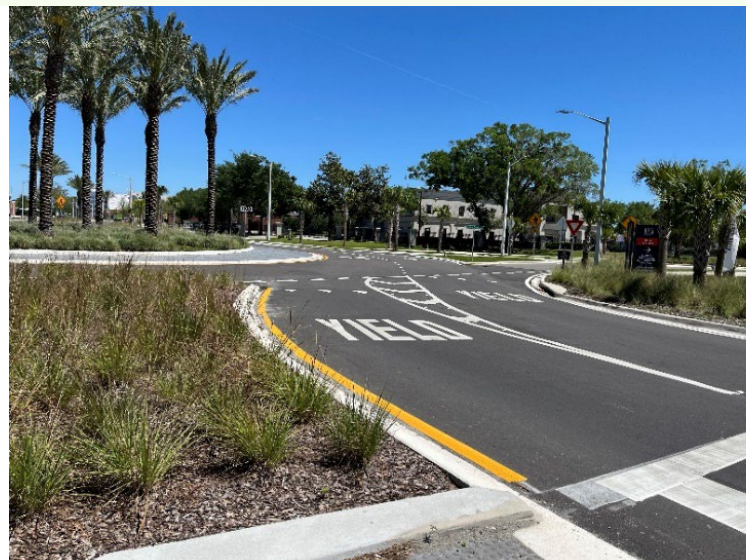
Princeton Street at Texas Avenue roundabout.

- The narrower street section, Complete Street features, roundabout, on-street parking, and additional landscaping along Princeton Street embody the speed management principles of engagement, enclosure, and deflection and support the use of lower posted speeds, which were lowered for the majority of the corridor from 40 mph to 25 and 30 mph. Posted speeds between John Young Parkway and the roundabout at Texas Avenue were lowered from 45 mph to 35 mph.

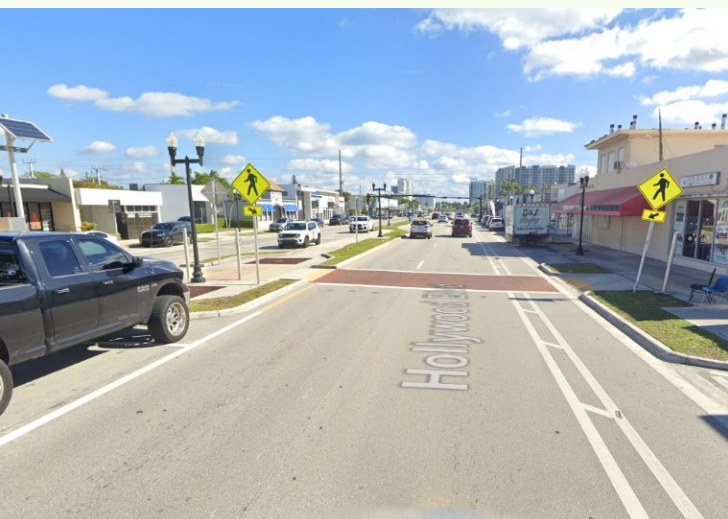
Hollywood Boulevard at 24<sup>th</sup> Avenue with new median, bike lane, pedestrian crossing, and enhanced lighting.

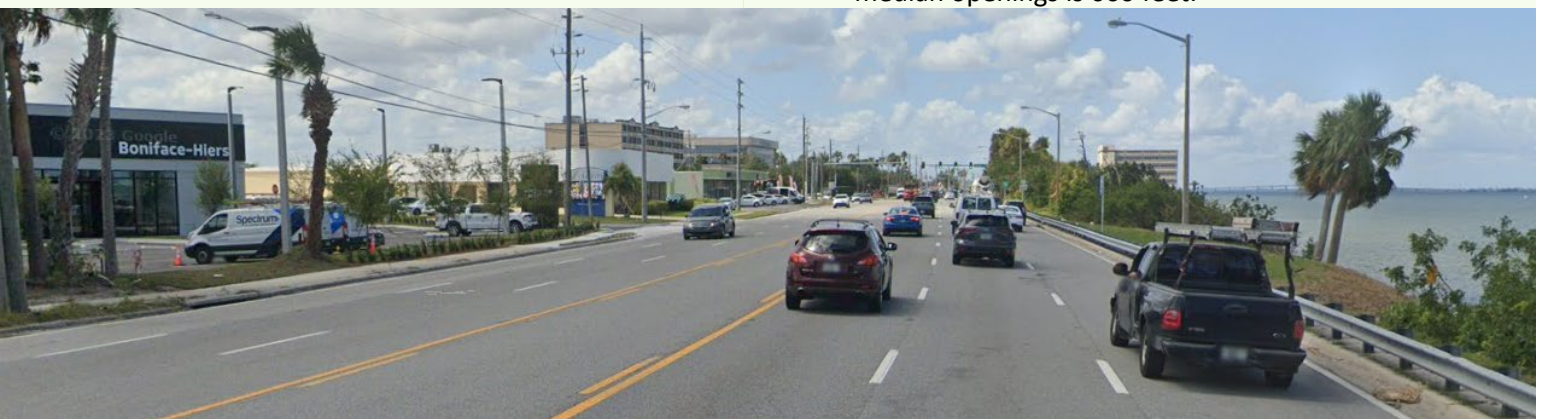
Current US 1 Cross-section in central portion of the corridor.

- The proposed typical section shows the conversion of the existing 11-foot two-way left-turn lane to a 16.8-foot maximum-width median with 10-foot auxiliary left-turn lanes, and the narrowing of the existing inside two lanes to 10 feet wide, with the outside lanes varying from 10 feet to 11 feet wide depending on the existing roadway width.
