**ANALYSIS OF FLOODING PROBLEM FOR  
S.R. 29 WEST OF CHAPARRAL SLOUGH**

**Financial Project ID 198356-1-32-04  
Work Program Item No. 1119960  
S.R. 29 between S.R. 78 and Chaparral Slough**

**The Florida Department of Transportation  
District One  
801 North Broadway  
Bartow, FL 33831-12349**

**October 1999**

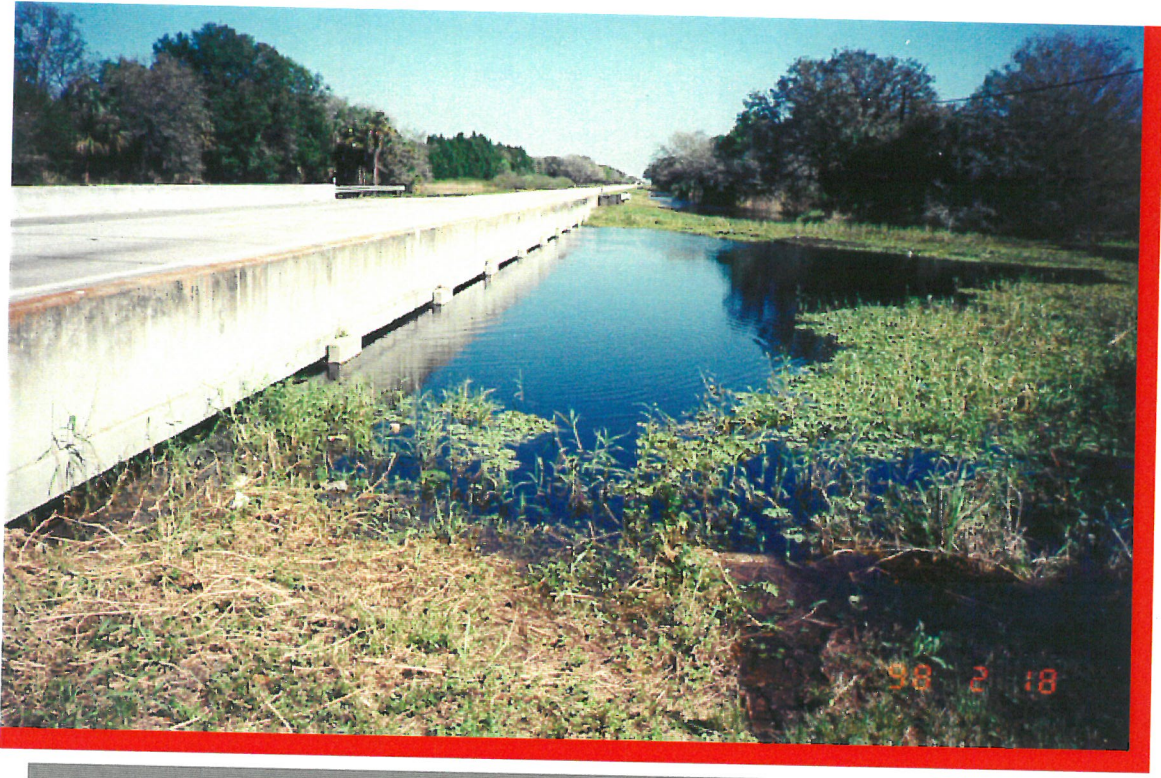
- The flow capacity of Chaparral Slough Bridge could be significantly reduced by partial blockage resulting from accumulation of Water Hyacinths. This could cause diversion of flow to the southwest and overload the pipes and Lone Pine Creek bridge. *A review of the photograph taken at Chaparral Slough bridge during flooding conditions on February 18, 1998 shows low velocities through the bridge, thus significant head losses would not be possible.*

**LOOKING NORTHEAST ALONG S.R. 29 AT CHAPARRAL SLOUGH BRIDGE**

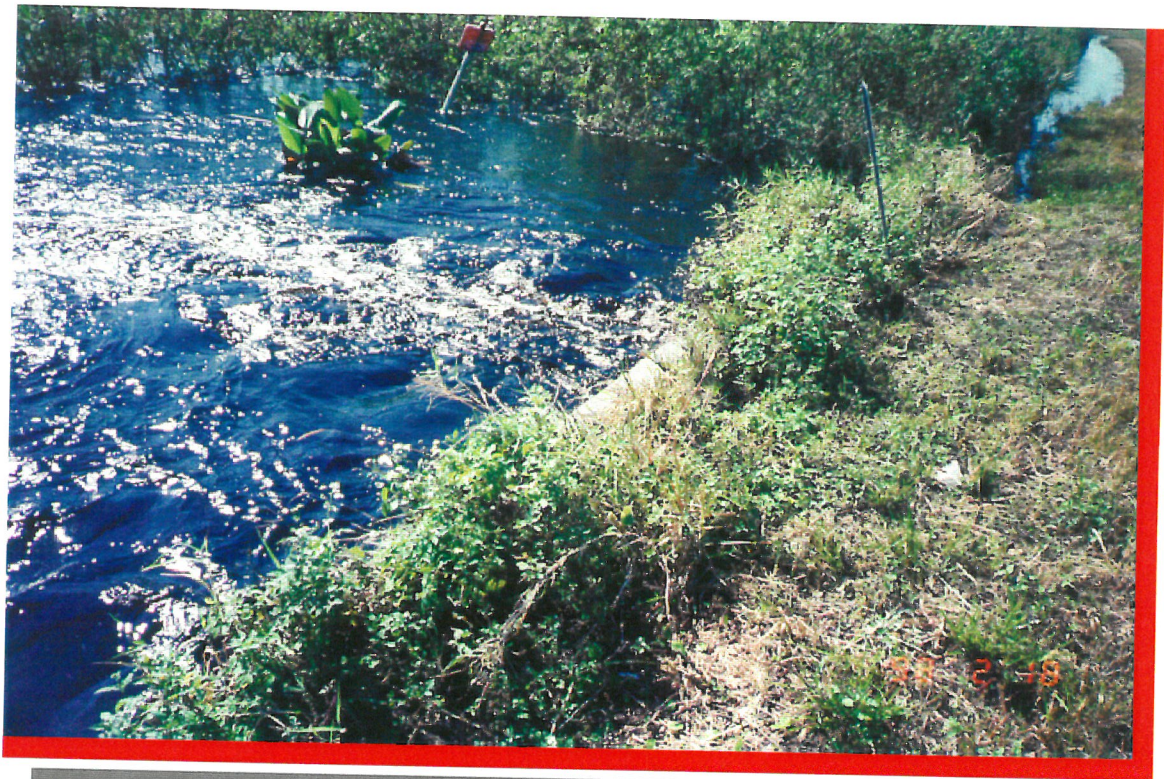
- The location of the (3)-30" pipes offers a more efficient path for removal of flood waters than either Lone Pine Creek or Chaparral Slough. This is apparent from the photographs of flooding. It is obvious that the tailwater stages at this site are 2' to 3' below upstream stages. Low velocities at the bridge, observed during flood events, indicate losses through the bridges are low. If the headwaters are near 35.5, as shown in the photograph, then the tailwaters at the bridges are much closer to the 35.5 than at the pipes. An examination of the USGS Quadrangle map adds further support to the hypothesis that tailwater stages are lower at the pipes than at the two bridges. Based on these facts, the original design may not have been the most hydraulically effective. *Clearly, the most certain remedy for the flood condition is a significant enlargement of the (3)-30" pipes, however such alteration can have far reaching impacts. The increased discharge rate downstream would require concurrence of property owners and the Water Management District.*

**LOOKING SOUTH ALONG S.R. 29 AT (3) 30" RCP APPROXIMATELY STA. 354+00**

- Step two is to be implemented if the side drain enlargement does not reduce flooding to an acceptable level. It requires replacement of the (3)-30" cross drain pipes with a box culvert. This modification will involve design, permitting, and possible acquisition of flood rights from downstream property owners.

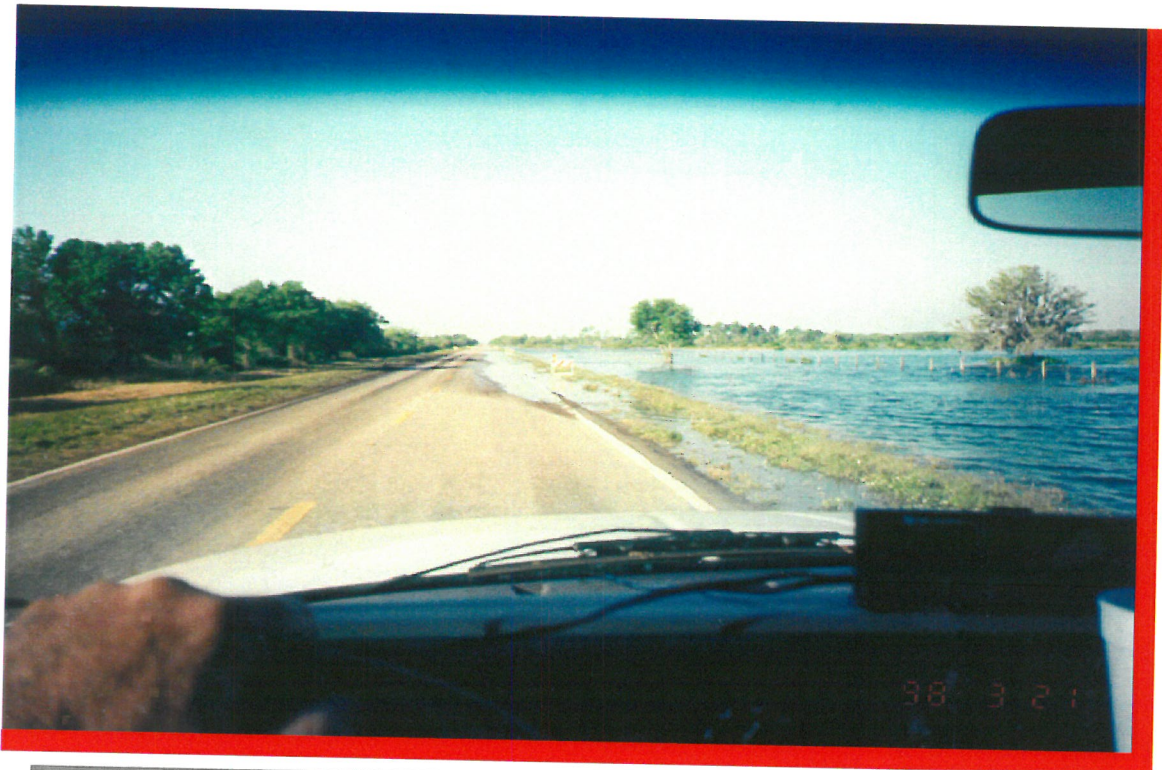
**LOOKING SOUTHWEST ALONG S.R. 29 BETWEEN LONE PINE CREEK AND  
CHAPARRAL SLOUGH**

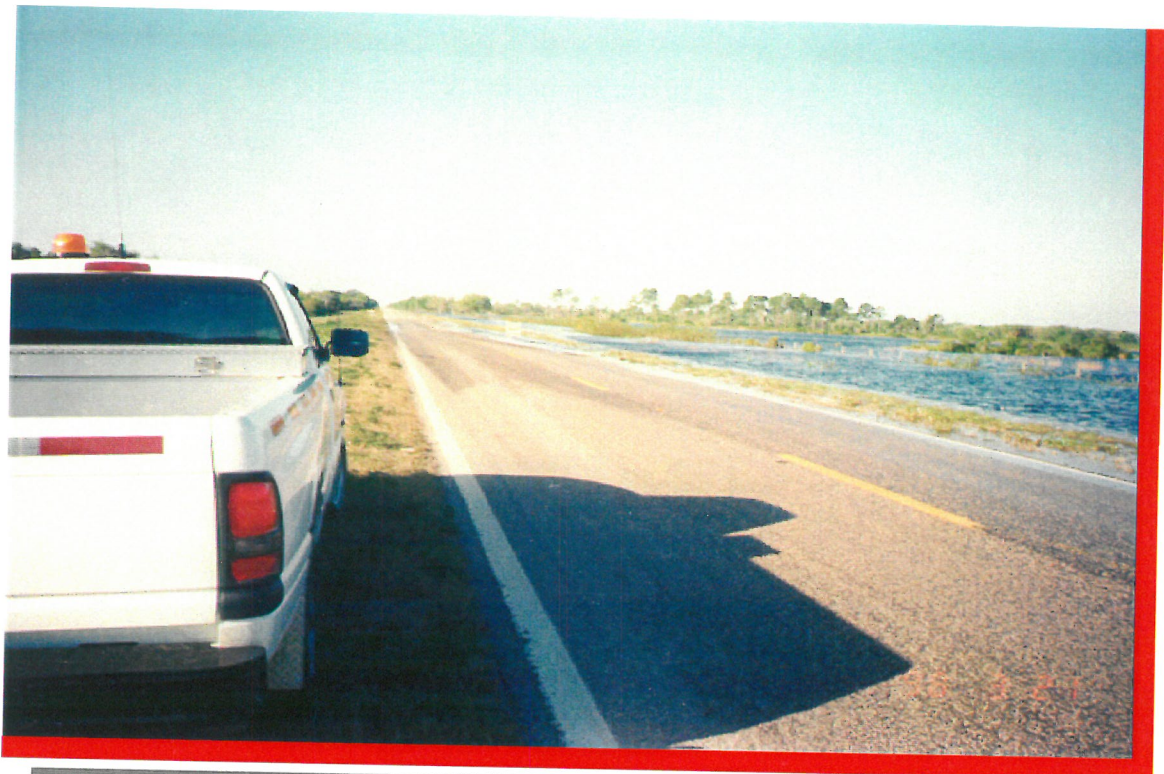
**LOOKING SOUTHWEST ALONG S.R. 29 BETWEEN LONE PINE CREEK AND  
CHAPARRAL SLOUGH**

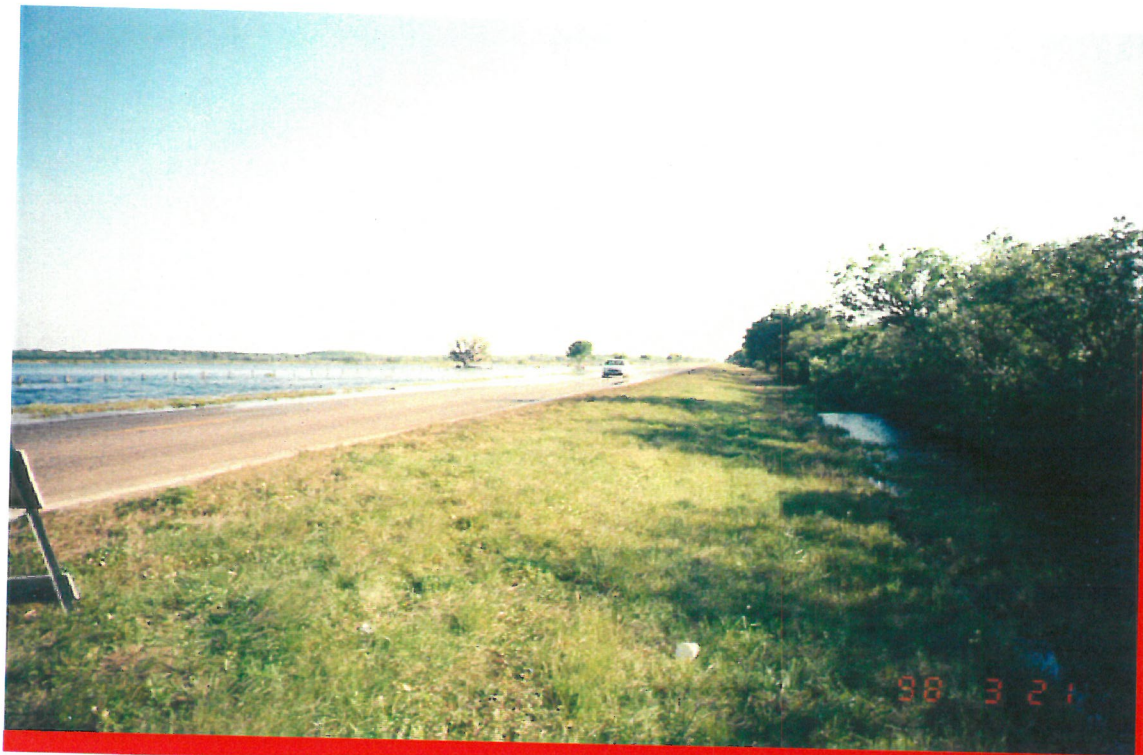
**LOOKING NORTHEAST ALONG S.R. 29 BETWEEN LONE PINE CREEK AND  
CHAPARRAL SLOUGH**

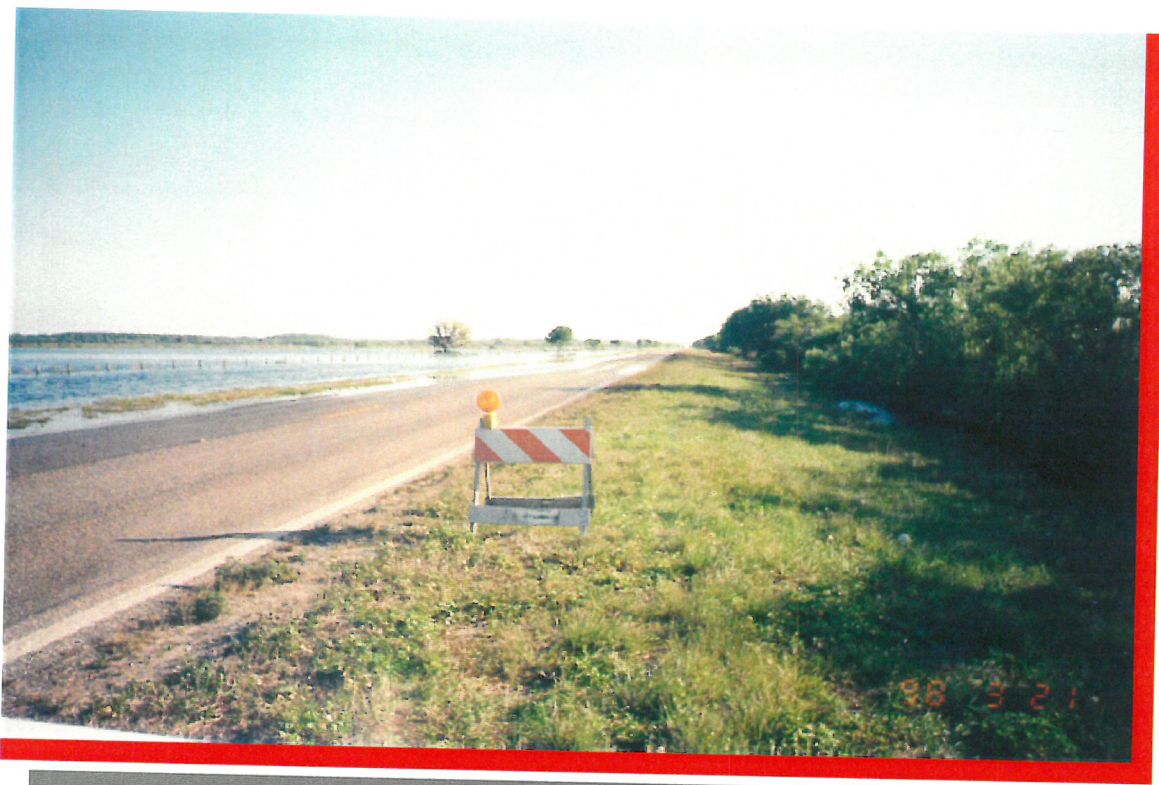
**LOOKING NORTHEAST ALONG S.R. 29 BETWEEN LONE PINE CREEK AND  
CHAPARRAL SLOUGH**
