# SR 29 ENGINEERING REPORT

**SR 29 FROM SR 78 TO US 27**

**GLADES COUNTY**  
**ROADWAY ID: 05090000**  
**MILEPOINT: 1.850 – 12.393**

April 6, 2022

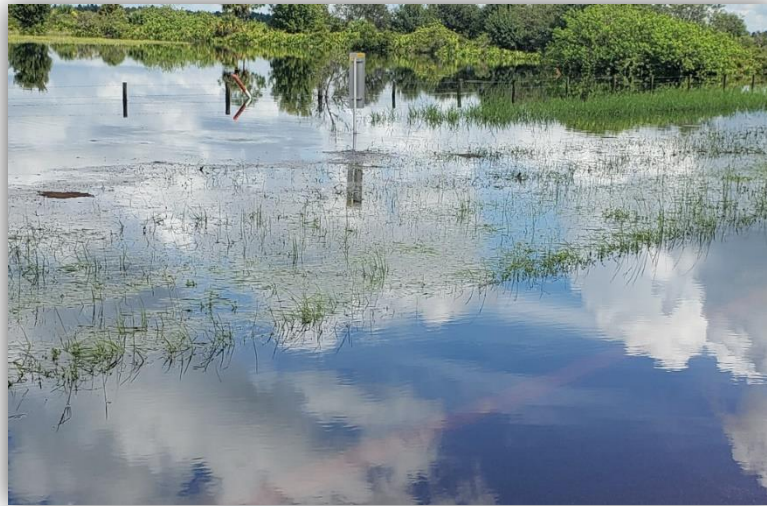
Figure 14: West side of Cross Drain at MP 5.528

Based on historical accounts and flood records provided by the Operations staff, SR 29 floods every few years, requiring the road to be closed. FDOT completed a project (FPID 431394-1-52-01) in 2013 to help minimize the flooding by widening the ditches on both sides of SR 29 to provide more capacity. While this helped to reduce the frequency of SR 29 flooding and road closures, there have been several closures since the project was completed. From witness accounts, it was noted that the triple 30” cross drain located at MP 5.528 tends to be the first drainage structure to overflow. On September 22, 2021 during a field review the limits of the roadway overtopping were observed to take place between MP 4.850 and MP 6.380. Water was seen to be backing up at both cross drains (MP 5.528 and MP 6.267) and neither structure was visible. As can be seen in **Figure 13**, there was a large amount of sheet flow coming from the west side of SR 29 and much of the adjacent land was inundated by water.

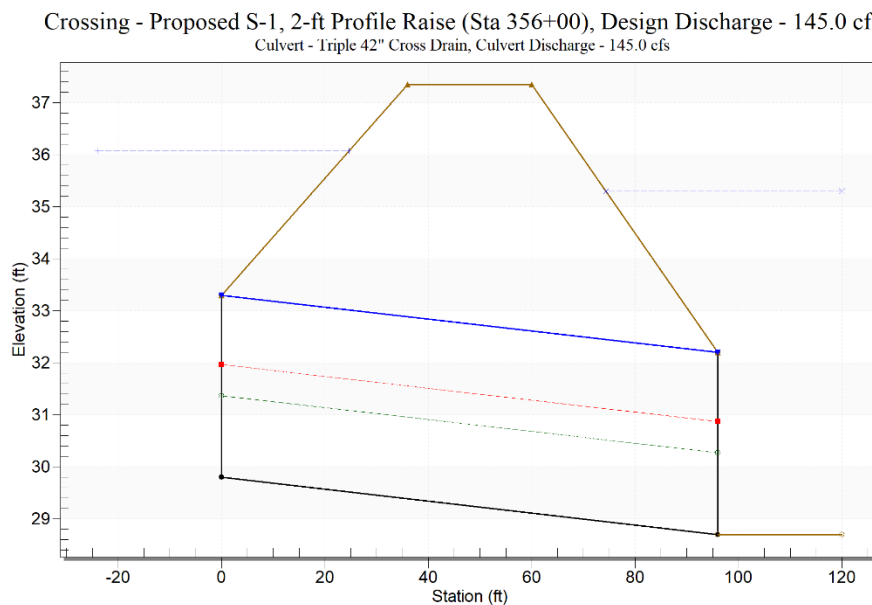
**Figure 18: Proposed 42" Pipe and Roadway Profile Raise Cross Drain Model**

With this information, a second proposed model was then generated in which the roadway profile was raised 2-ft. Raising the profile in conjunction with keeping the pipes at a 42" diameter resulted in a less significant reduction in the headwater elevation; however, it also put the water surface elevation roughly 0.75-ft below the edge of shoulder, demonstrating no anticipated overtopping for the 50-year event. See **Figure 18** for a graphical representation of the proposed triple 42" cross drain with 2-ft profile raise.

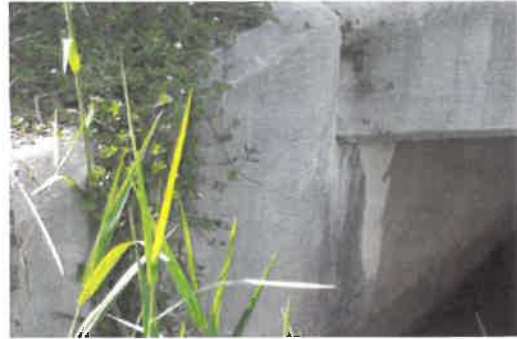
Water stains on west side of bridge.

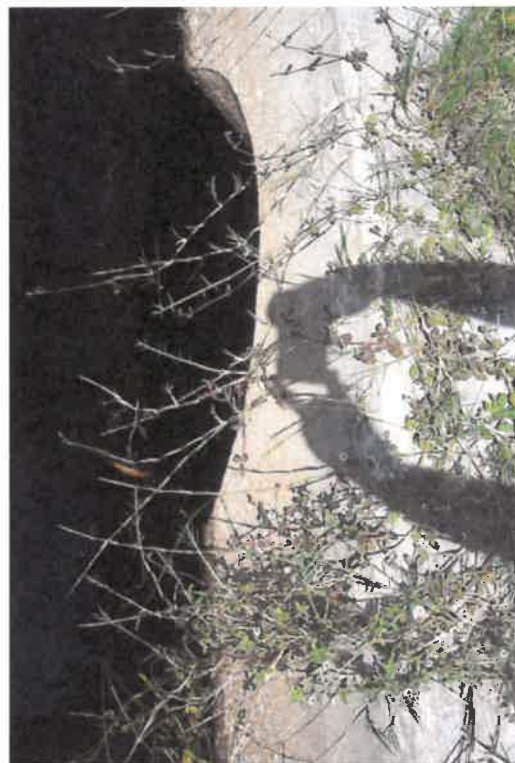
Staining on headwall on east side of cross drain.

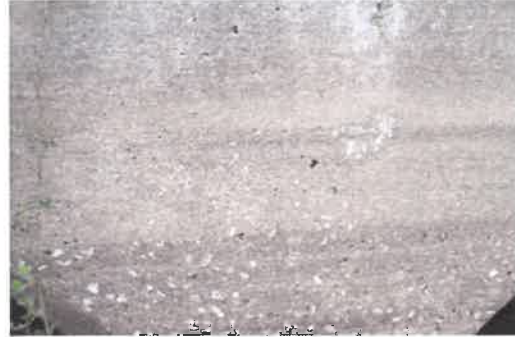
Water stains on headwall on west side of cross drain.

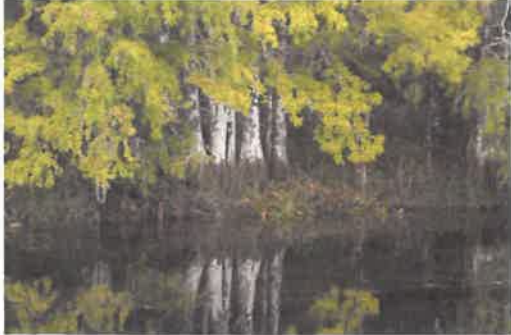
Facing southwest from west side of bridge. Trees appear to have water stains pretty high.
