RRR Scoping Report

FM# 447827-1

SR5/US-1/Biscayne Boulevard
From SR 915/NE 6th Avenue to NE 105th Street
(87030000 | 16.686 – 18.057)
Miami-Dade County, Florida

Project: RRR Scoping Report for SR 5/US-1/Biscayne Boulevard
From SR 915/NE 6th Avenue to NE 105th Street
FM# 447827-1-52-01 | Roadway ID: 87030000 | MP 16.686 – 18.057

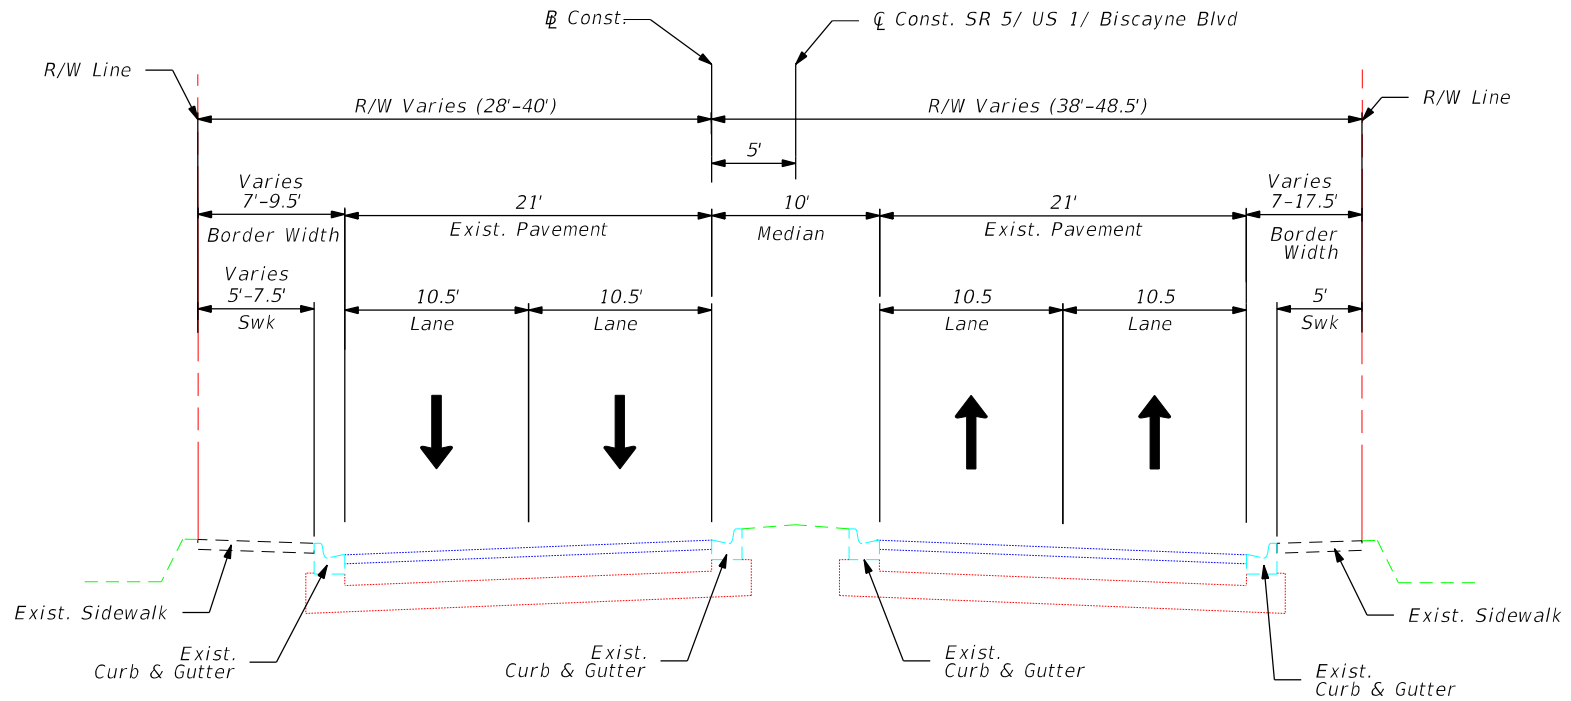
Figure 2-1 Existing Typical Section from NE 88th Street to NE 90th Street

There are three existing roadway typical sections along the project corridor as shown in **Figure 2-1** to **Figure 2-3**. The first typical section extends from NE 88th Street to NE 90th Street and consists of a four-lane divided roadway with two 10.5-foot travel lanes in each direction, and sidewalk along both sides of the roadway adjacent to the curb and gutter. The second typical section extends from NE 90th Street to NE 93rd Street and consists of a four-lane divided roadway with two 11-foot travel lanes in each direction, and an 8-foot sidewalk along both sides of the roadway separated by a 12.5-foot sod area. The typical section for the final segment extends from NE 93rd Street to NE 105th Street and consists of a four-lane divided roadway with two 11-foot travel lanes in each direction with an 8-foot sidewalk along both sides of the roadway separated by an 8-foot sod area.

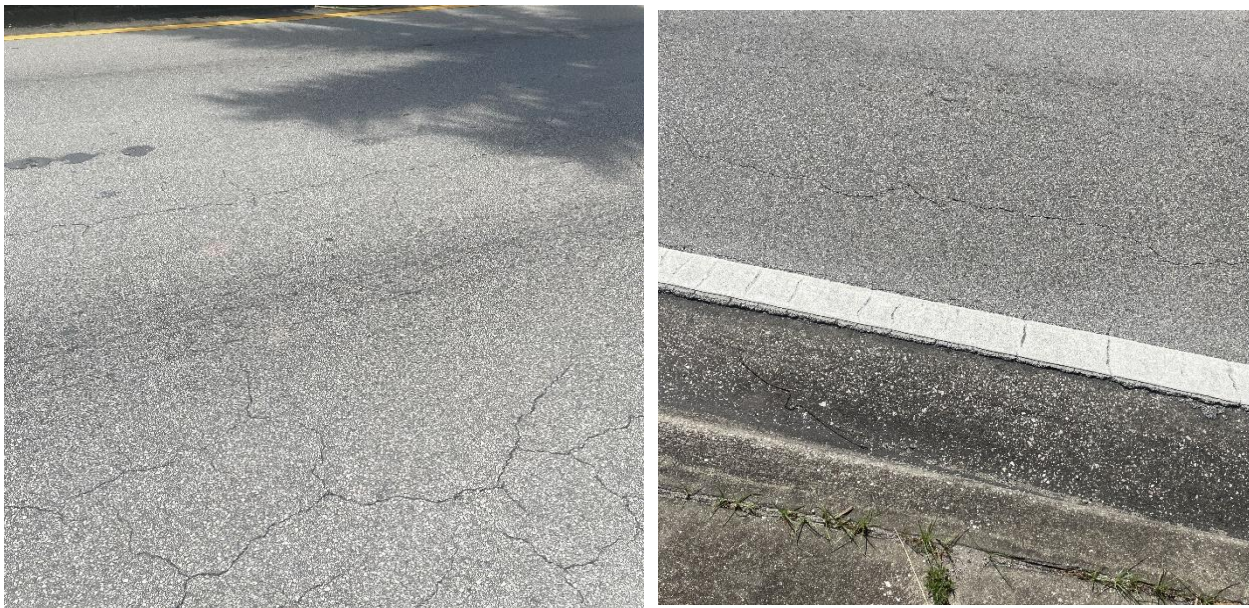
Figure 2-4 Existing Pavement Conditions

Based on a visual inspection of the pavement during our field reviews, the existing pavement condition appears to be fair with minor cracking and rutting observed at several locations within the limits of the project. Isolated pavement deficiencies such as cracking at intersections, poor utility patches were also observed as shown in **Figure 2-4**.

- Correct the deficient pavement conditions by milling and resurfacing.

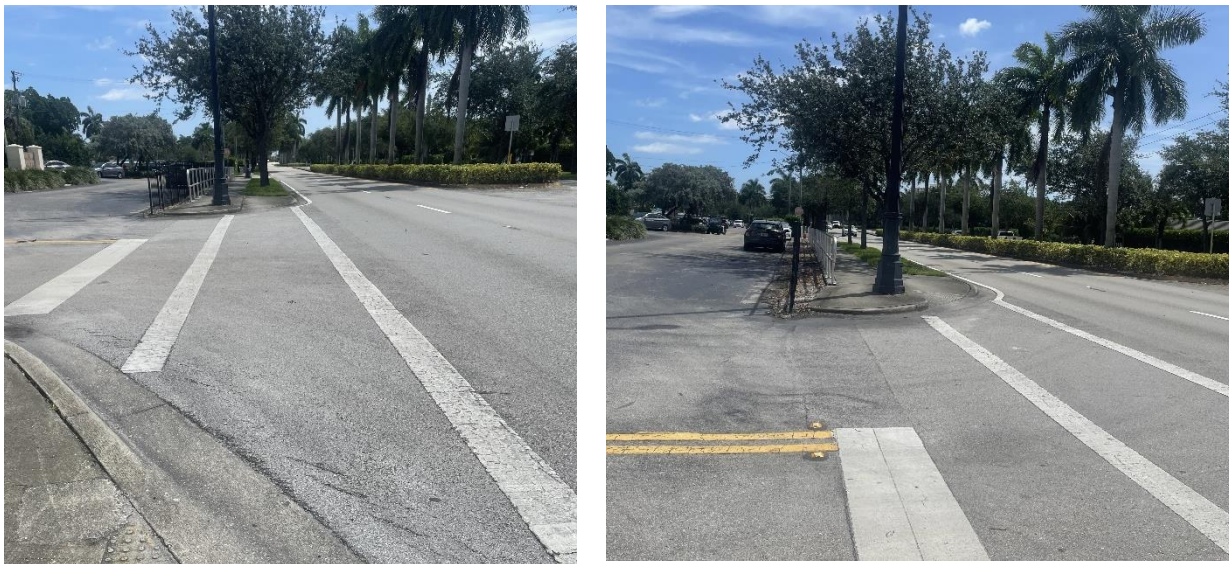
Figure 2-5 Clear Sight obstructions at intersections

Clear sight triangles were evaluated at the intersections and driveways within the project limits. Based on field observations and an office review, obstructions to intersection sight distance were identified at several locations within the project limits as shown on the Roadway Plans. **Figure 2-5** shows examples of existing intersection sight distance issues within the project limits.

Based on field observations and an office review, sight triangle obstructions consist of trees, light poles, signposts, fences and privacy walls. At the time of this Scoping Report submittal, the District Traffic Operations Office has not documented any specific intersections where a significant crash history is directly related to the existing sight triangle obstructions. Where

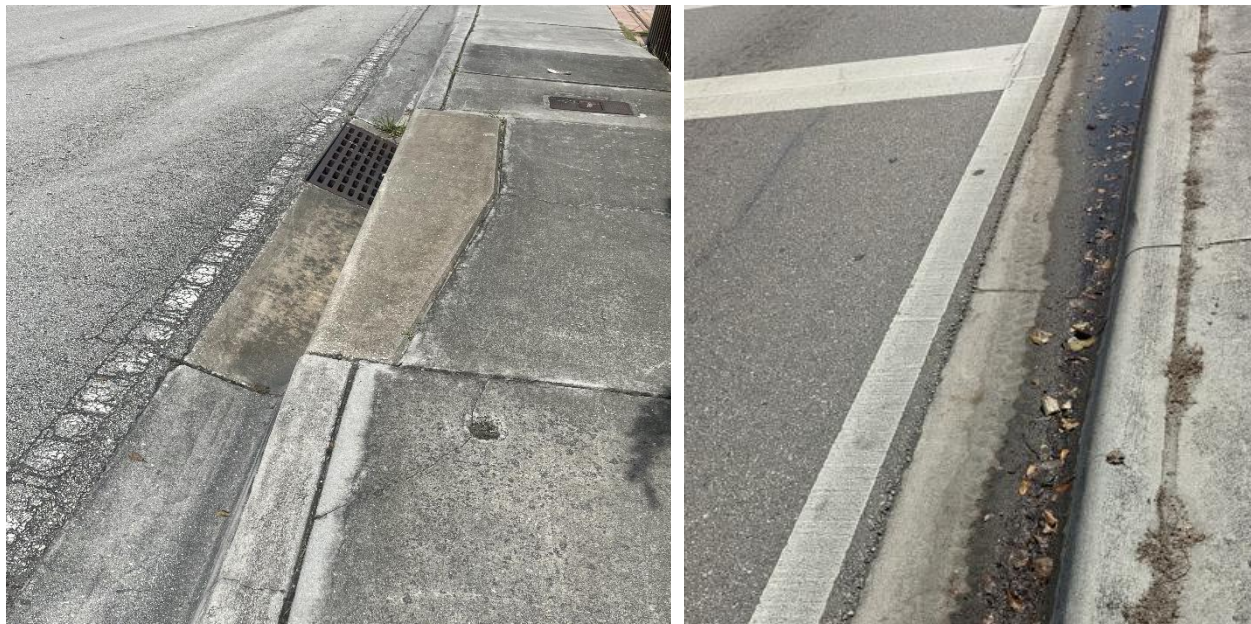
Figure 2-6 Existing Drainage Issues

The existing drainage system was reviewed based on the plans from the previous projects. The existing conditions throughout the project limits typically consist of closed drainage system with curb inlets and ditch-bottom/curb inlets at side-street intersections. **Figure 2-6** shows some drainage inlets and ponding locations encountered during the field review.

This Scoping Report does not include an evaluation of the hydraulic, safety and physical adequacies of the existing drainage system. Since this is a RRR project, no changes in the existing drainage system are anticipated. However, the designer should regrade curb return locations with identified ponding as shown in the project exhibits.

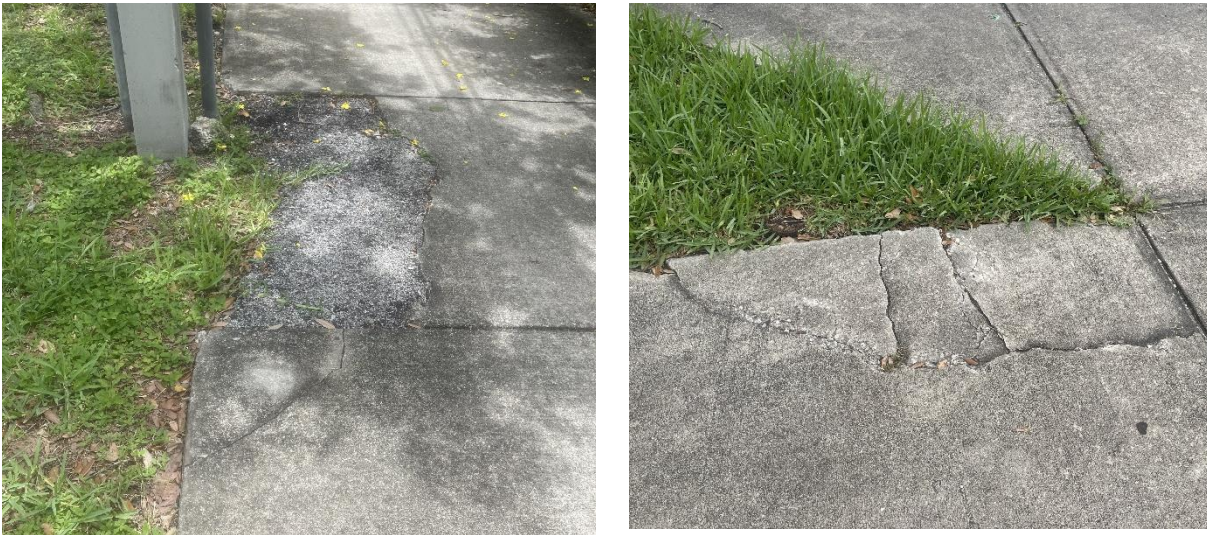
Figure 2-7 **Damaged or Uneven Sidewalks**

Existing sidewalks are located along both sides of the roadway throughout the project limits. The sidewalk widths vary from 5 feet to 8 feet as indicated in the existing typical sections. Locations of uneven and damaged sidewalks were identified at some locations within the project limits. **Figure 2-7** shows some of deficiencies encountered during the filed review.

For RRR projects, the FDM recommends that unaltered sidewalk with width 4 feet or greater may be retained within any context classification. As such, the existing sidewalk widths are recommended to remain. However, the following are substandard conditions identified.

- Upgrade deficient pedestrian curb ramps and related components such as detectable warning surfaces, pavement markings, pedestrian crossing signs and plaques.
- Reconstruct damaged or missing sidewalk segments (lifted, sunken or broken sidewalk) and address the cause of said damage.
- Provide new high emphasis crosswalk with pedestrian signals on the north leg of NE 91st Street intersection.
- Upgrade the crosswalk on the west leg of NE 105th Street to high emphasis crosswalk.

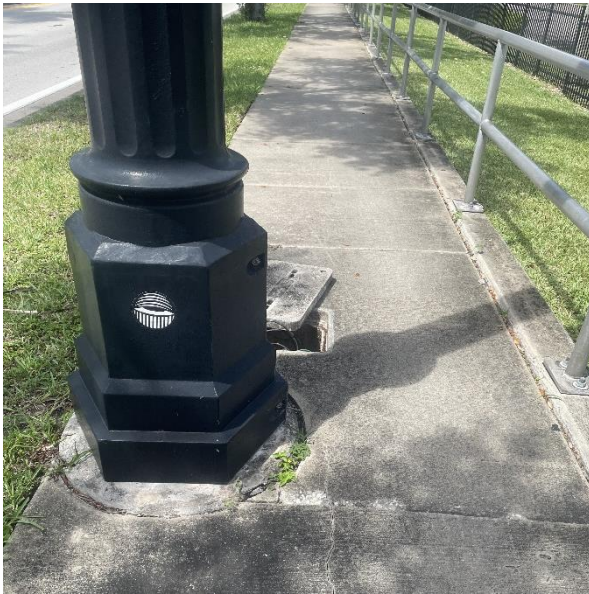
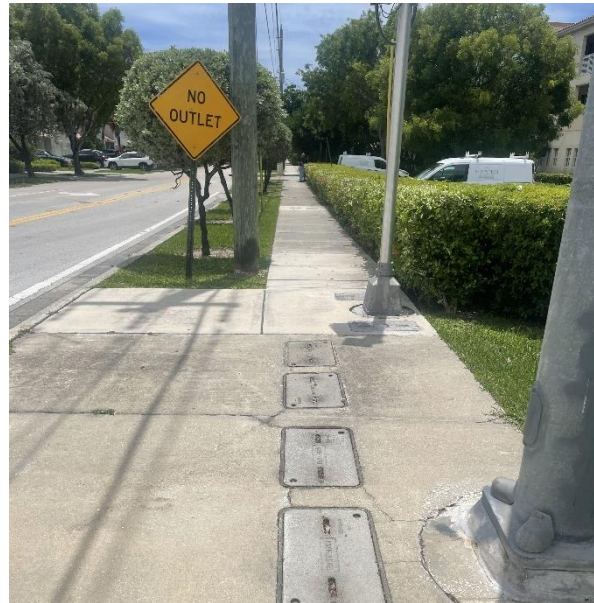
Figure 2-8 Sidewalk Obstructions

Clear sidewalk width less than 48 inches was identified at some locations as illustrated in the roadway concept plans. Where there is landscape buffer, it is recommended to provide additional sidewalk area to meet the 48 inches clear sidewalk width requirement. Where it is not feasible due to right of way constraints, a **design variation for unobstructed sidewalk width** is required when relocation of obstructions is not feasible and additional sidewalk width cannot be provided.

Some of the existing shade trees along the corridor do not provide the 8.5 ft minimum vertical clearance required for vegetation over the sidewalk. These low hanging tree branches should be trimmed.

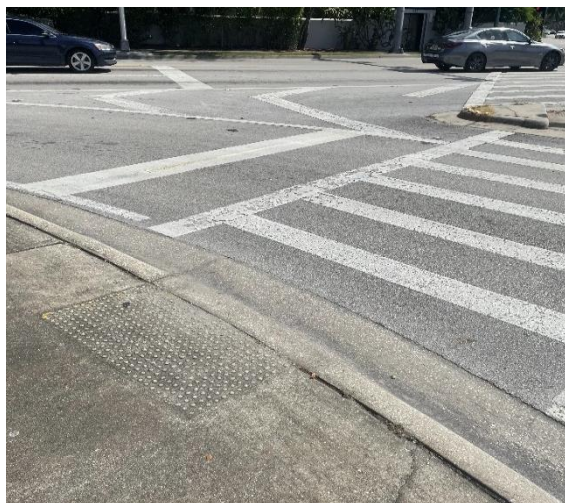
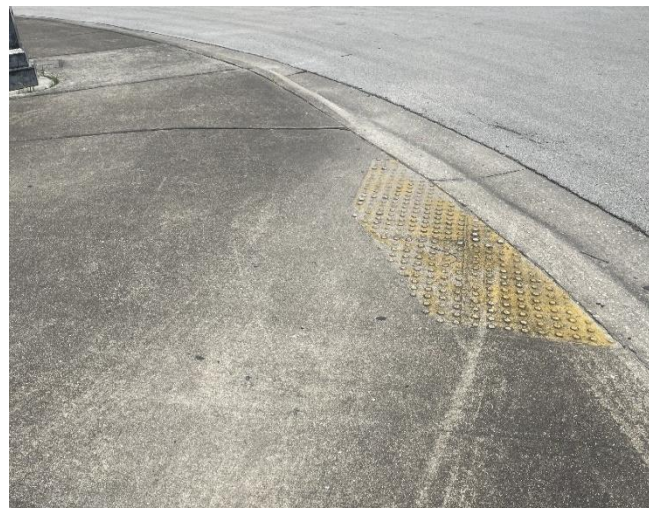
Figure 2-9 Existing Curb Ramps

Existing pedestrian curb ramps are located at all the intersections within the project limits. The existing pedestrian ramps were evaluated for compliance with the FDOT Design Standards and ADA Standards. Based on our field review, several curb ramp deficiencies were identified including missing/worn out detectable warnings, detectable warnings and curb ramps not aligned with the crosswalk, substandard ramp slopes and substandard transition slopes. **Figure 2-9** shows examples of the deficiencies encountered within the project limits. It is recommended to upgrade all the deficient curb ramps within the project limits.

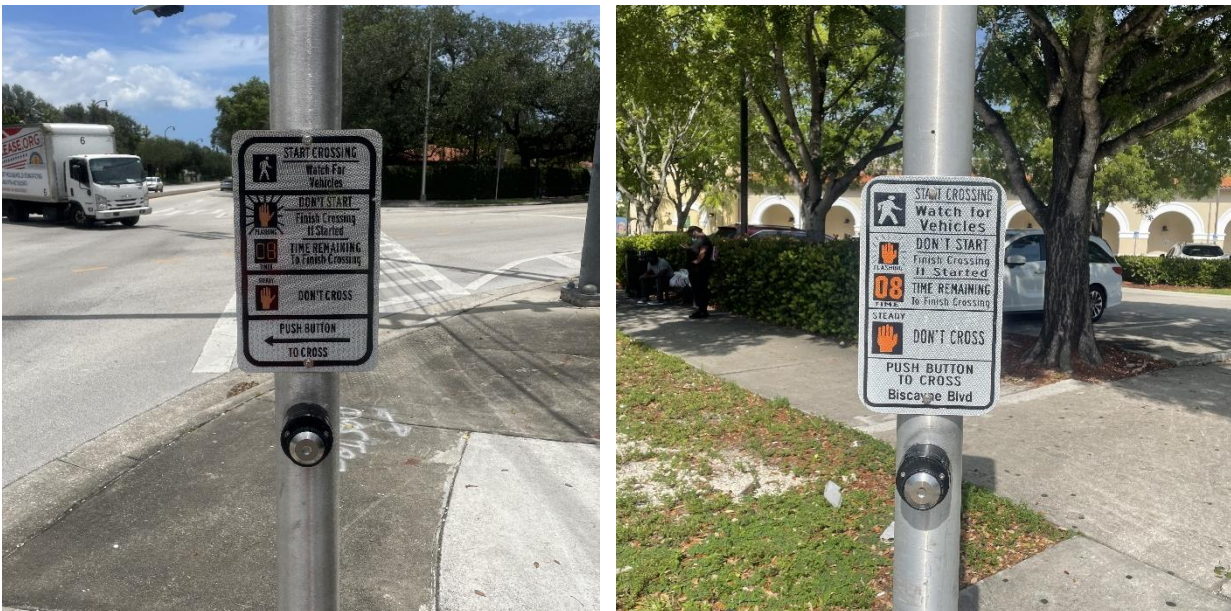
Figure 2-10 Existing Pedestrian Signalization Features

Four signalized intersections are located within the project limits. Existing pedestrian signal heads are provided at most of the signalized crosswalks. However, several deficiencies were identified including no countdown pedestrian signals, obsolete or missing pedestrian push buttons and detectors signs. In addition, the location of some of the push buttons exceed the 10” maximum reach. **Figure 2-10** shows the existing pedestrian signalization features.

Miami-Dade County’s preference is to provide push buttons with actuation for all the crosswalks including the minor streets.

- Provide new countdown pedestrian signals and/or install ADA-compliant pedestrian pushbuttons and detector signs at all signalized intersections.
- Replace pull boxes (traffic signal and lighting) impacted by the reconstruction of sidewalk and/or pedestrian curb ramps.
- Provide flexible retroreflective backplates to all signals at signalized intersections. If the retro reflective backplates cannot be installed without replacing the signal heads, then the recommendation can be omitted.
- Provide video detection for the existing signalized intersections and upgrade the existing cabinets and electrical service disconnect.

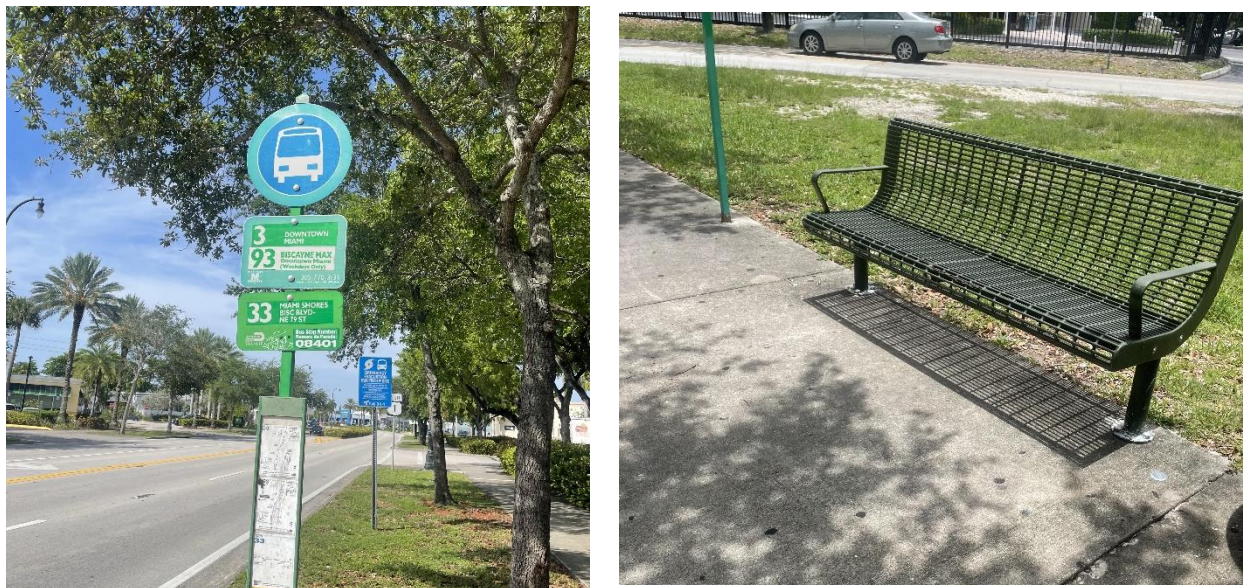
Figure 2-11 Existing Transit Facilities

Miami-Dade Transit (MDT) Bus Route 3, 33, 93, and Miami Shores East Shuttle have operations along the project limits. There are 10 bus stops along the project corridor; however, only three of the bus stops provide benches and trash cans. Most of the bus stops provide the required boarding and alighting areas however, these do not meet the minimum 5 feet width and 8 feet length requirement and are recommended to be widened. **Figure 2-11** shows examples of existing transit features within the project limits.

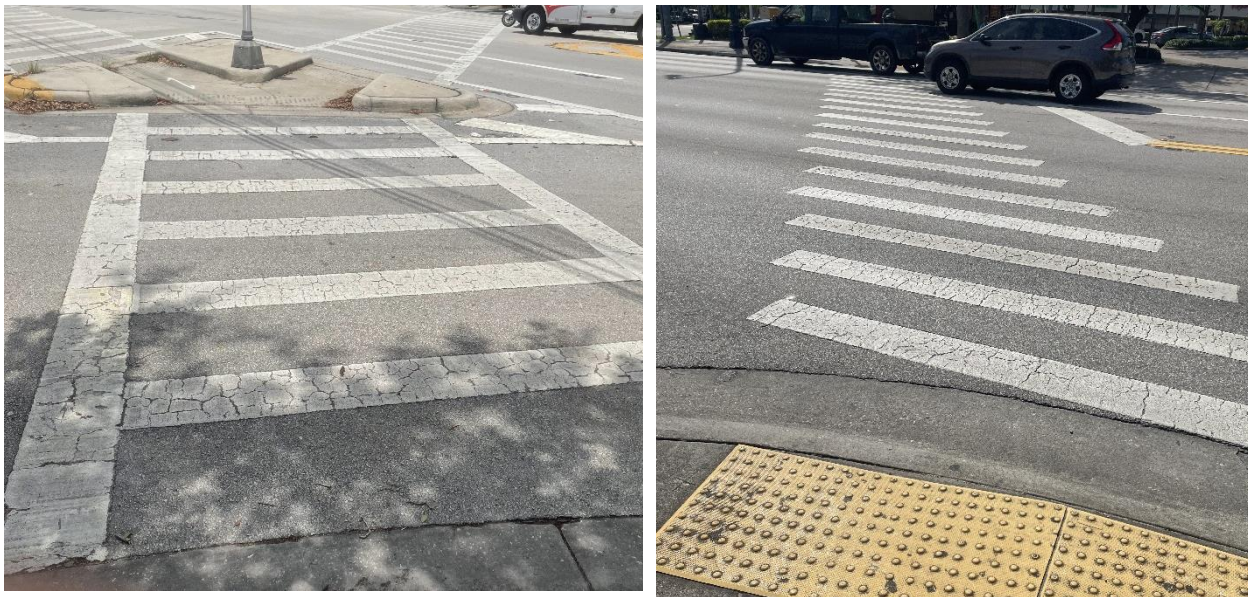
Figure 2-12 Existing Signs and Pavement Markings

Existing signing includes ground-mounted signs within the sidewalk, and median along the project corridor. There are also signs mounted on overhead mast-arms at signalized intersections. Faded, broken or substandard signs were observed within the project limits.

Based on field observations, the existing pavement markings are generally in fair condition, with faded striping as well as raised reflective pavement markers that are missing or with low reflectivity. **Figure 2-12** illustrates examples of substandard signing and pavement markings within the project limits.

An existing sign inventory is not included in this Scoping Report. A review of all existing signage with the Manual on Uniform Traffic Control Devices (MUTCD) and the FDOT Traffic Engineering Manual (TEM) criteria should be conducted at the Design Phase. Based on field observations, there are some existing signs within the project limits that are defaced/damaged, and therefore do not comply with the latest standards. Most of the existing single-post signs along the roadside comply with the standard placement per Index 700-101. It is also recommended to provide wrong way countermeasure signs and pavement markings at the unsignalized intersections.

- Upgrade all broken and substandard ground-mounted signs to comply with the applicable editions of the FDOT Standard Plans, the FDOT Traffic Engineering Manual (TEM), and the Manual on Uniform Traffic Control Devices (MUTCD).
- Provide wrong way countermeasure signs and pavement markings at the unsignalized intersections.
- Replace and upgrade all pavement markings to meet the latest FDOT Standard Plans for Road Construction.

- Replace all missing, damaged and/or non-ADA compliant signs within the project limits.
- Replace the existing pavement markings along the bridge over C-8 Canal with permanent tape per FDM 230.3.1.4
