# RRR Scoping Report

FM# 449738-1

## SR 5 / US 1 / Overseas Highway

From West of Venetian Boulevard to North of Executive Bay Club

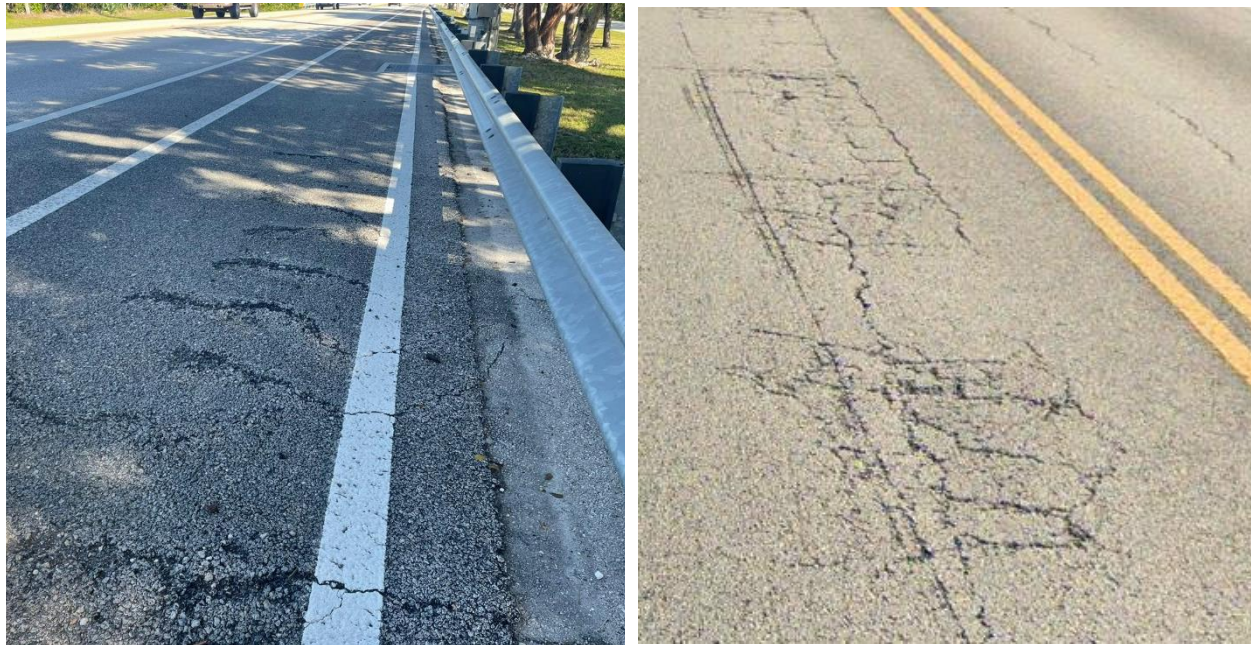
**Figure 2-5 Existing Pavement Conditions**

Based on a visual inspection of the pavement during our field reviews, the existing pavement condition appears to be fair/poor with extensive cracking and rutting observed at several locations within the limits of the project as shown in **Figure 2-5**.

Based on the 2021 Pavement Condition Survey (PCS) conducted in 2021, the existing pavement, as indicated by the crack rating, is considered fair/poor for the 45-mph posted speed limit on both sides of the roadway. The PCS rating from 2021 are listed in **Table 2-2**.

- Objective
  - Correct the deficient pavement conditions by milling and resurfacing.
- Justification
  - The project originated from the 2021 Pavement Condition Survey (PCS) Ratings, which identified the pavement within the project limits to be deficient (Ride and Crack).
  - The pavement age was the key primary factor for the origination of this project. The existing pavement within the project limits was resurfaced in 2008 and will be 18 years old by 2026 when this resurfacing project is funded for construction.
  - Field reviews confirmed that overall, the existing pavement is in poor condition with multiple locations presenting deterioration. These included cracking, patching, and raveling.

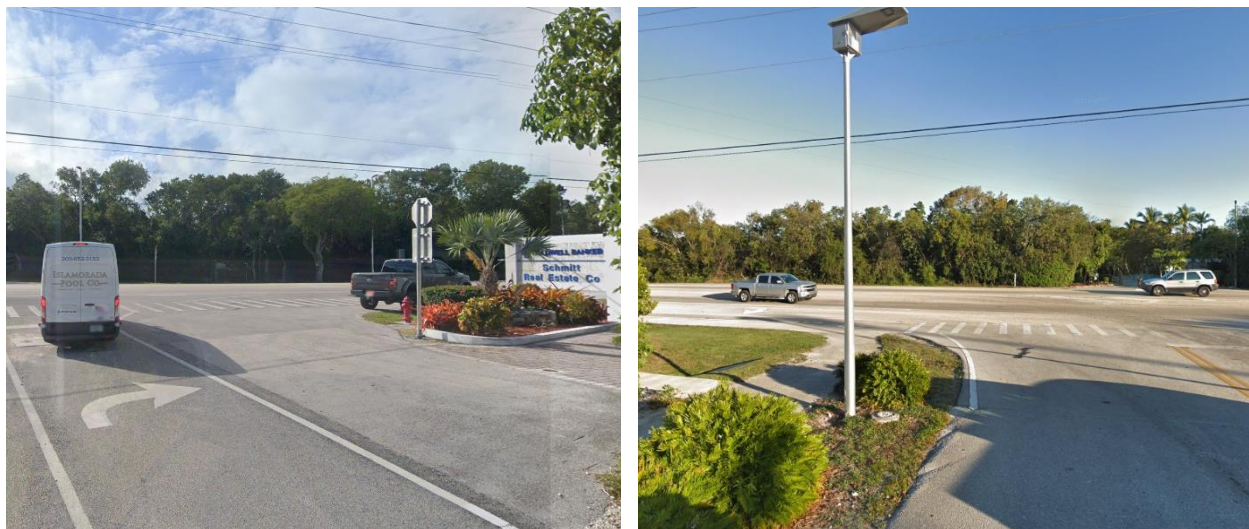
**Figure 2-6** Clear Sight obstructions at intersections

Clear sight triangles were evaluated at the intersections and driveways within the project limits. Based on field observations and an office review, obstructions to intersection sight distance were identified at a majority of intersections and driveways within the project limits as shown on the Roadway Plans. **Figure 2-6** shows examples of existing intersection sight distance issues.

Based on field observations and an office review, sight triangle obstructions consist of trees and vegetation, utility poles and above ground utilities, signposts, fences, and parked vehicles in adjacent parking lots. At the time of this Scoping Report submittal, the District Traffic Operations Office has not documented any specific intersections where a significant crash history is directly related to the existing sight triangle obstructions. Where intersection sight distance obstructions are located within the right of way and are easily movable, the Designer should consider relocation of the obstruction. Any proposed tree relocation/removal should be coordinated with the District Landscape Architect. If relocation/removal of any obstructions is deemed unfeasible, a design variation for clear sight distance is required.

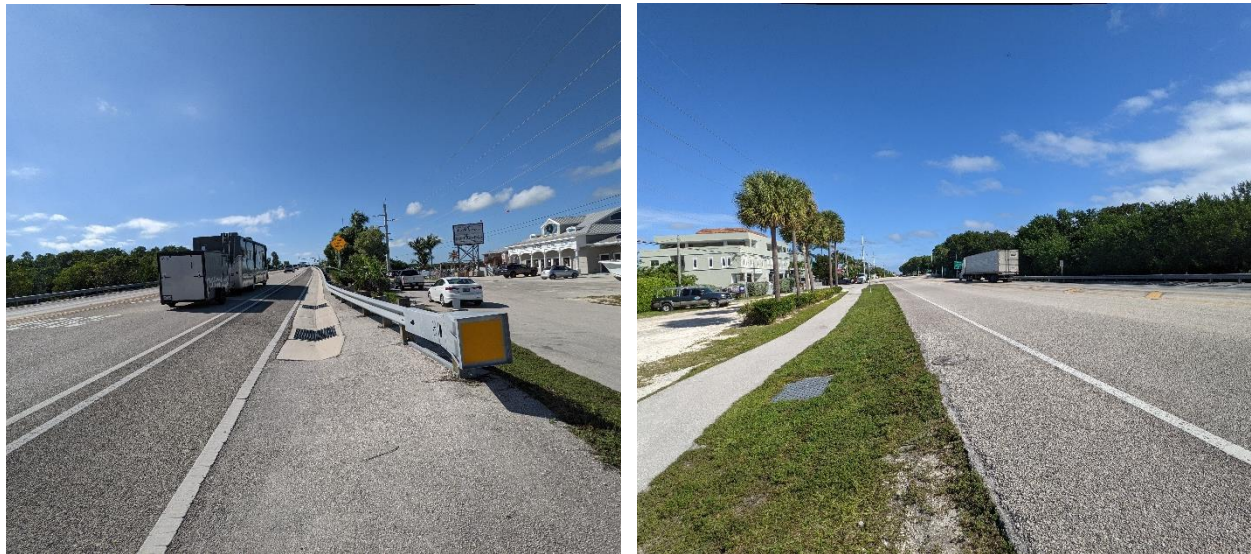
**Figure 2-7** Existing Drainage System

The existing drainage system and its condition were reviewed in the field. Throughout the project limits, the existing drainage typically consisted of an open drainage system with roadside swales. **Figure 2-7** shows some pictures of this condition. Due to the recommended shared use path construction, regrading of the existing swales and/or additional drainage infrastructure may be required to account for the additional impervious area and swale storage loss.

- Repair/replace any damaged drainage inlet tops.

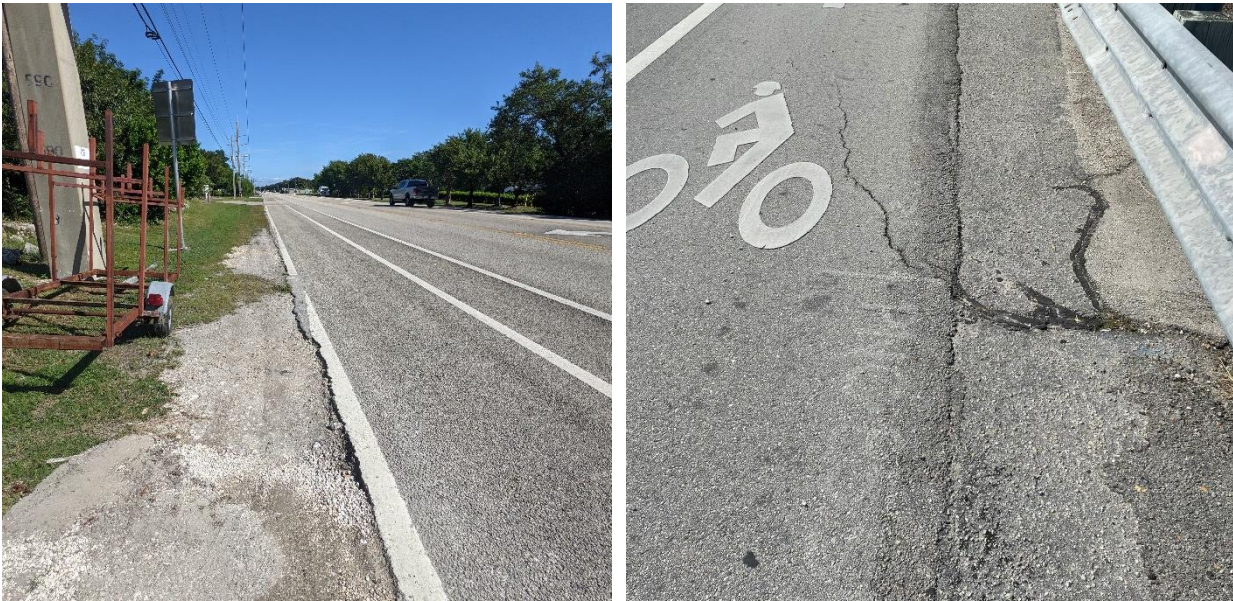
**Figure 2-8** Damaged or Uneven Bike Path

There is an existing bike path – the Florida Keys Overseas Heritage Trail (FKOHT) – located on the west side of the roadway within the project limits. The path width is 6 feet as indicated in the existing typical section. Locations of uneven and damaged asphalt were identified at some locations within the project limits. **Figure 2-8** shows some of the deficiencies encountered during the field review. Several pedestrians and bicyclists were observed using the existing trail.

The FDOT District 6 Planning Office completed a feasibility study to evaluate the FKOHT and recommended reconstruction of the existing trail to provide an 8-10 feet shared use path for the adjacent roadway segment which is also applicable to this roadway segment. This will require a design variation and approval from the Chief Planner approval for a trail width of less than twelve (12) feet since the FKOHT is a SUN Trail network per the FDM. The conceptual design plans for the reconstruction of the FKOHT from East Ridge Road to Executive Bay Club are shown in **Figure 3-5**.

Based on the evaluation, there are locations along the shoulders where transmission poles cannot be avoided. The proposed design will meander the path around the transmission poles at these locations. A Design Variation for shared use path horizontal clearance will be required as well as the incorporation of additional striping and object markers to delineate the obstruction.

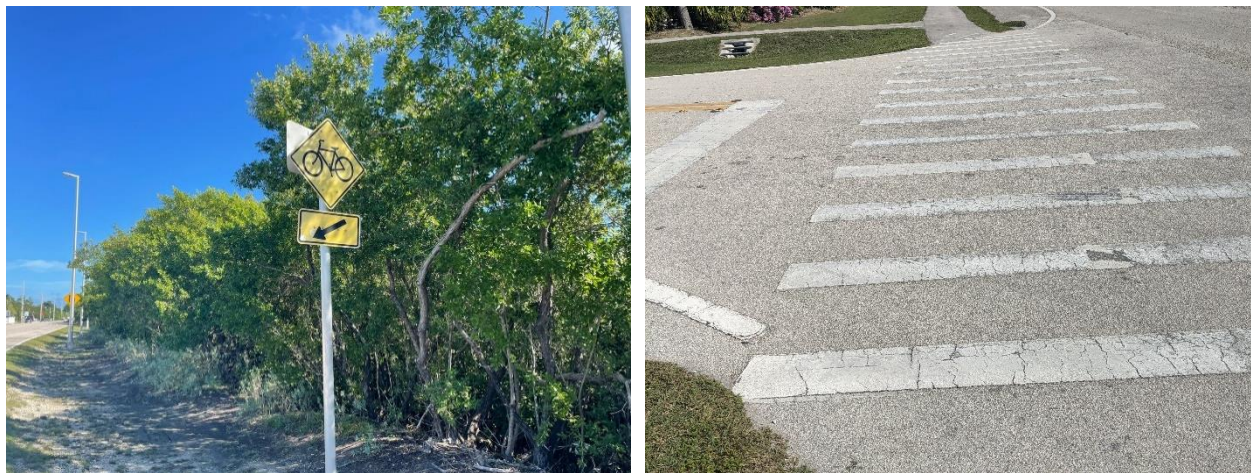
**Figure 2-9** Existing Signs and Pavement Markings

Existing signing includes ground-mounted signs within the swale along the project corridor. Faded, broken or substandard signs were observed within the project limits.

Based on field observations, the existing pavement markings are generally in fair/poor condition, with faded striping as well as raised reflective pavement markers and delineators that are missing or with low reflectivity. **Figure 2-9** illustrates examples of substandard signing and pavement markings within the project limits.

- Upgrade all broken and substandard ground-mounted signs to comply with the latest editions of the FDOT Standard Plans, the FDOT Traffic Engineering Manual (TEM), and the Manual on Uniform Traffic Control Devices (MUTCD).
- Replace and upgrade all pavement markings to meet the latest FDOT Standard Plans for Road Construction.
- Provide 7 feet buffered bicycle lane keyholes at the exclusive right turn locations in the northbound direction.
- Replace all missing, faded and/or damaged signs within the project limits.
- Relocate existing signs outside of shared use path horizontal clear zone or provide at least 2 feet from the edge of the shared use path where right of way is constrained.
- Replace existing tubular delineators.

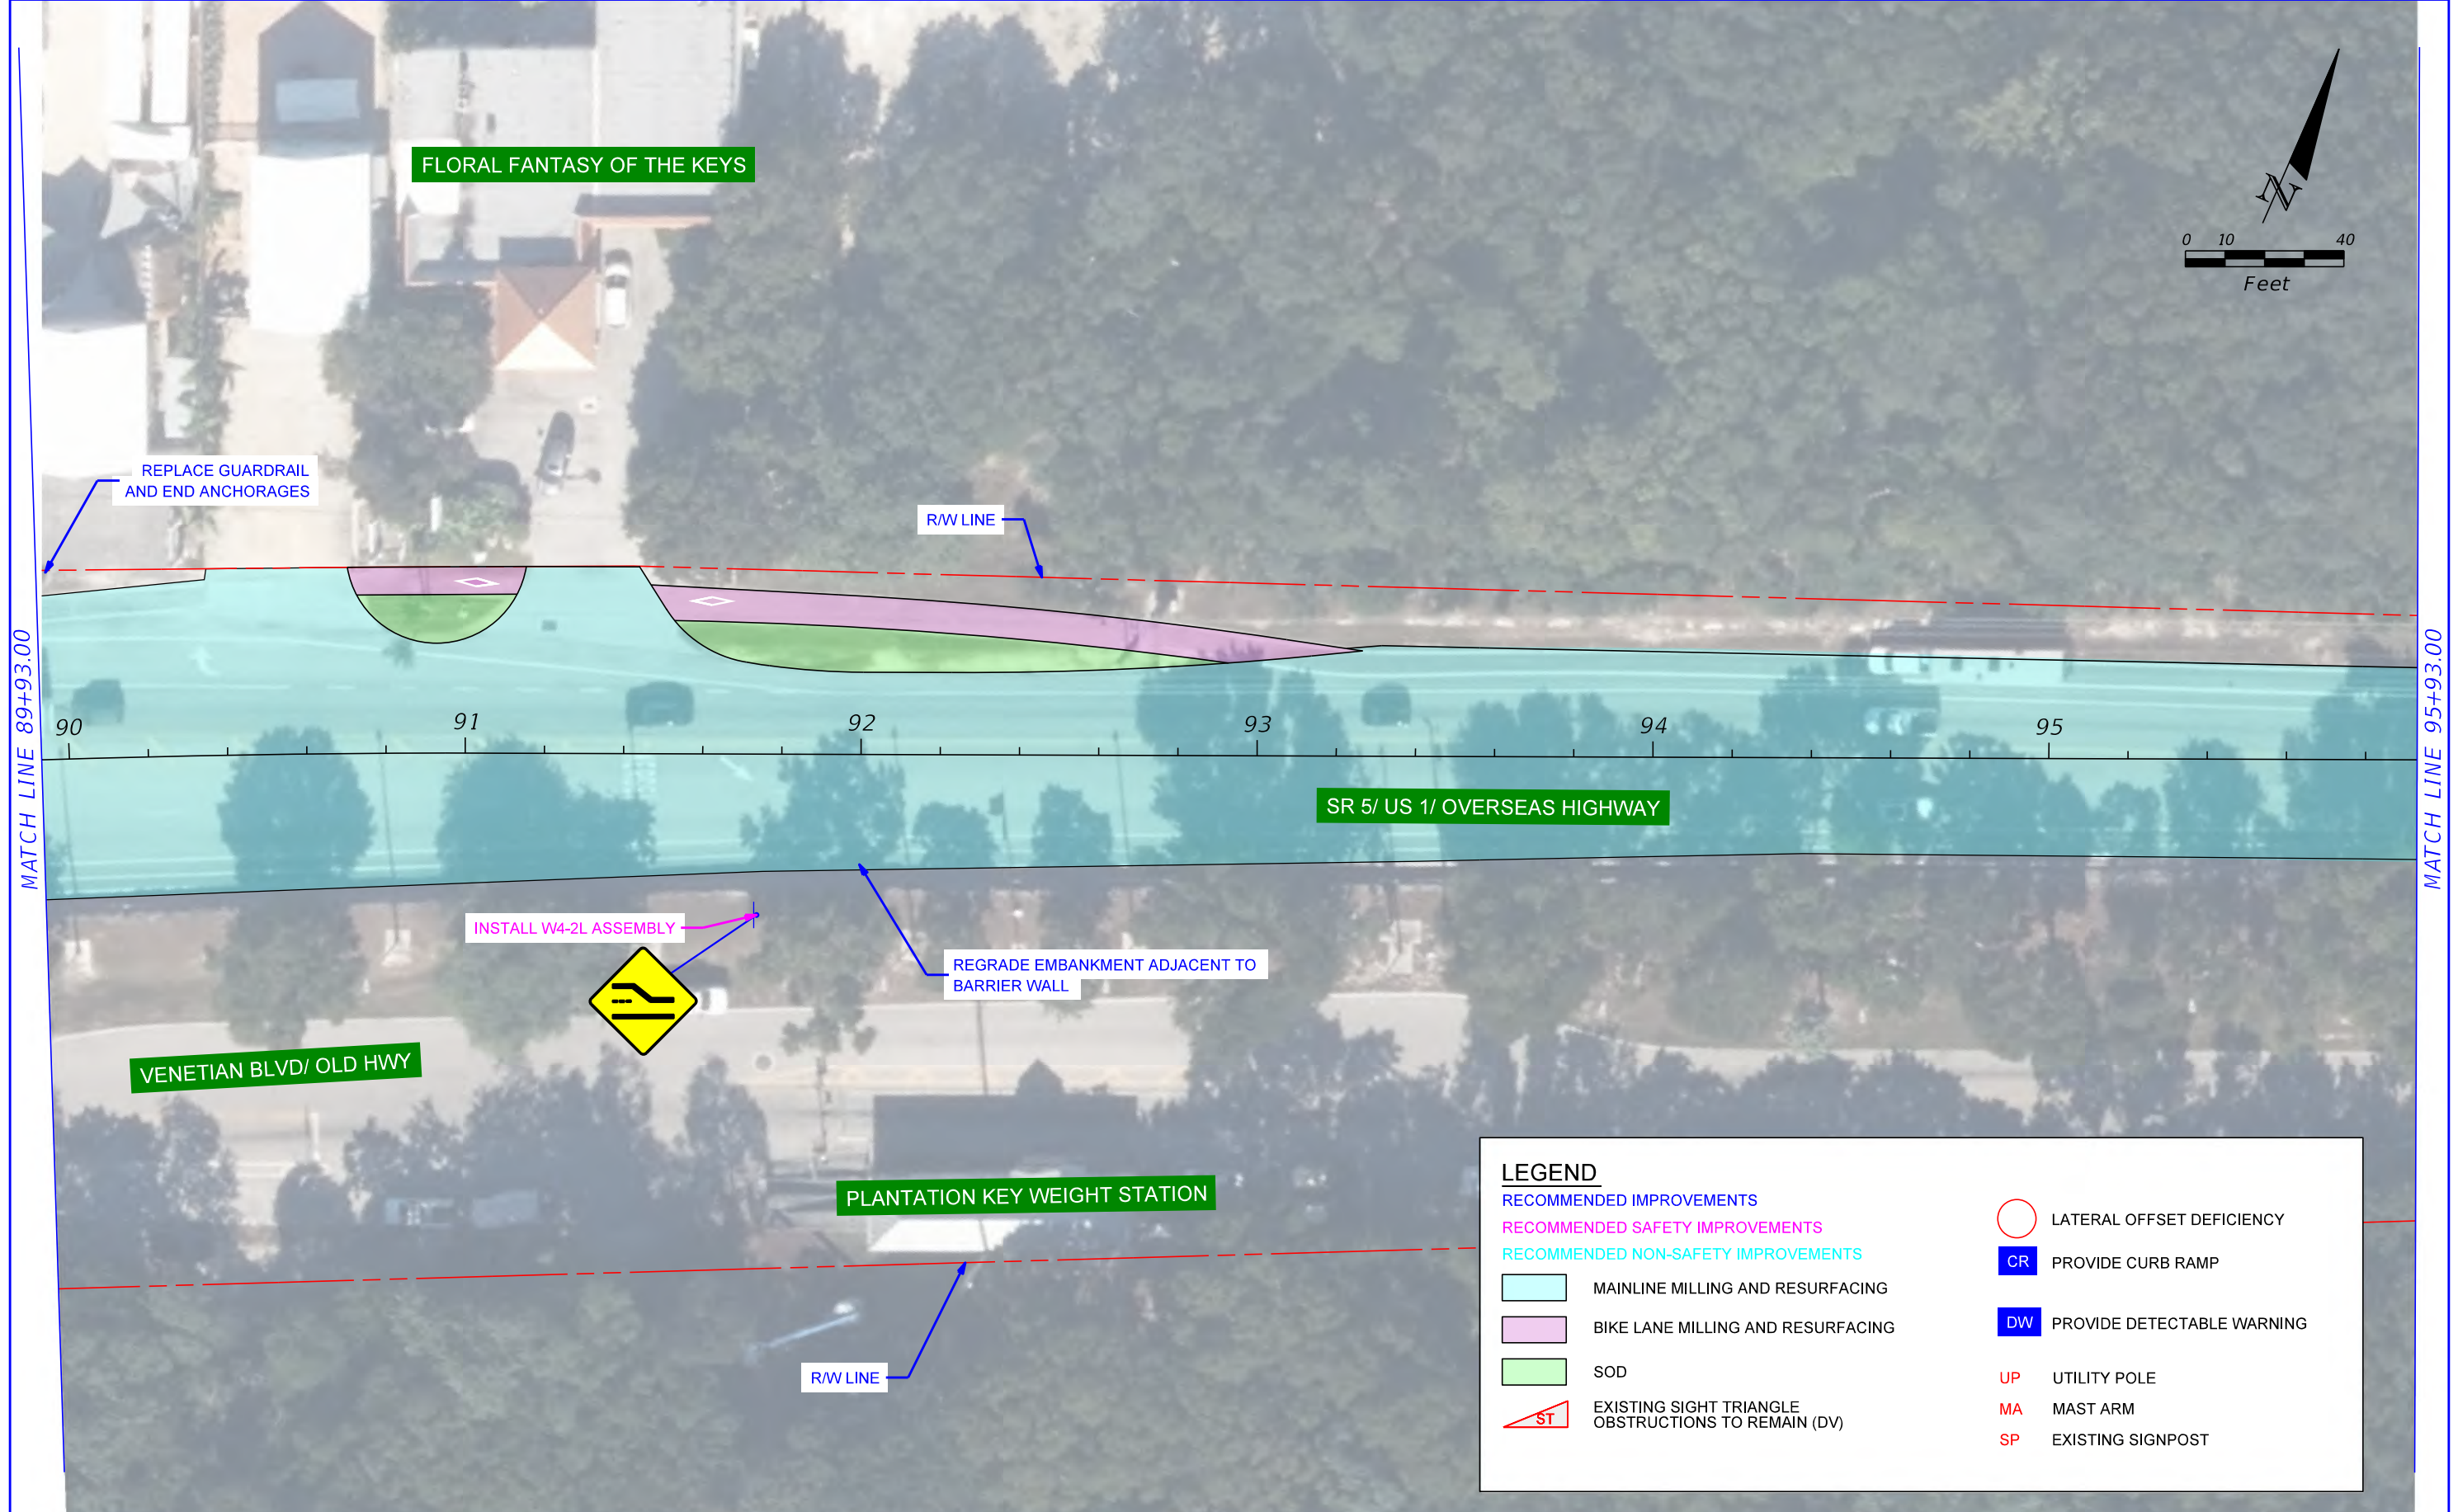
**FIGURE 3-5**  
**DEFICIENCIES AND RECOMMENDATIONS**

Concept plans summarizing the existing deficiencies and recommended improvements are shown in **Figure 3-5**.
