# FINAL SCOPING REPORT

SR 823/NW 57TH AVENUE/RED RD FROM S. OF NW 186TH STREET TO S. OF HEFT

(87002000 MP 7.752 – 9.399)

FM 452567-1-32-01

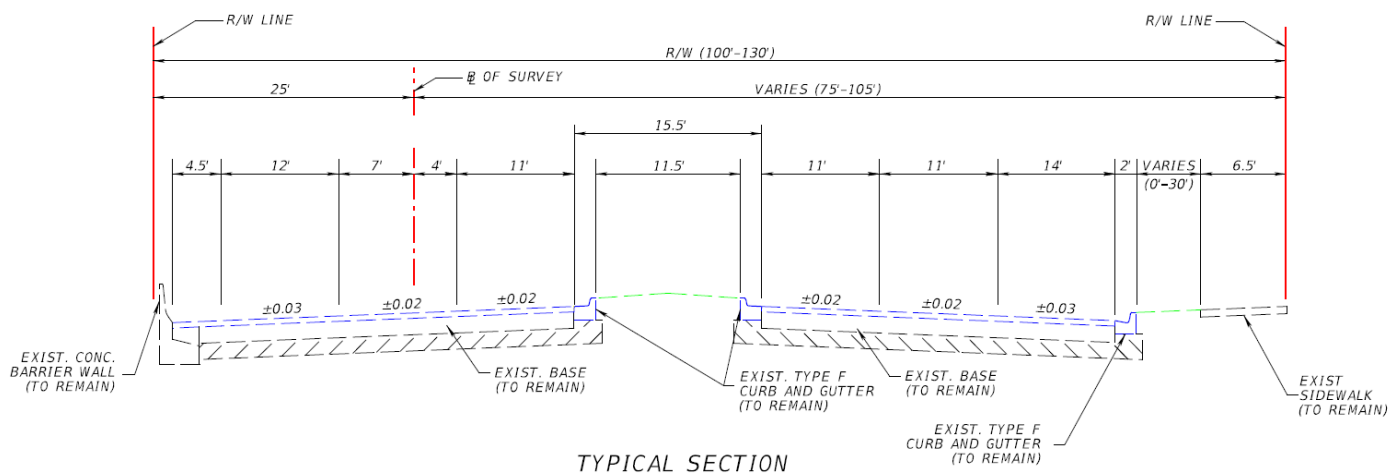
**Figure 2-1 Existing Typical Section**

Existing Typical Section 1 (from NW 186 St to 180' S of NW 199 St): This segment is a six-lane divided roadway with 15.5-foot raised median, 11-foot inside travel lanes, 12-foot outside travel lane, 2-foot-curb and gutters, 6.5-foot concrete sidewalk on the east side, 4.5-foot paved shoulder and concrete barrier wall on the west side.

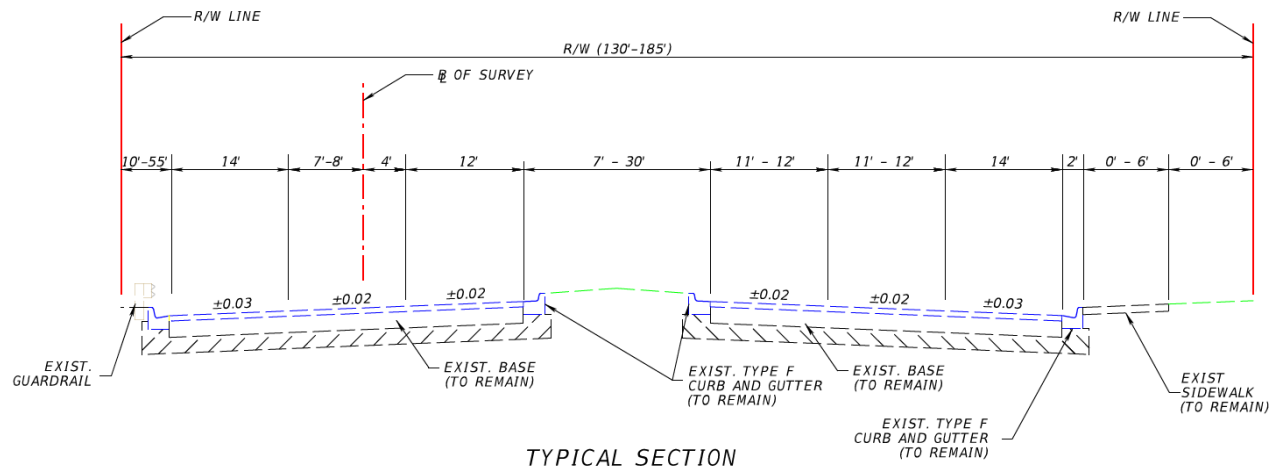
**Figure 2-2 Existing Typical Section**

Existing Typical Section 2 (from 180' S of NW 199 St to Bridge 870950 and from Bridge 870950 to 170' S of SW 45th Street): This segment is a six-lane divided roadway with 18-20-foot raised median, 12-foot inside travel lanes, 14-foot outside travel lanes, 2-foot-curb and gutter, 6-foot concrete sidewalk on the east side, and guardrail on the west side.

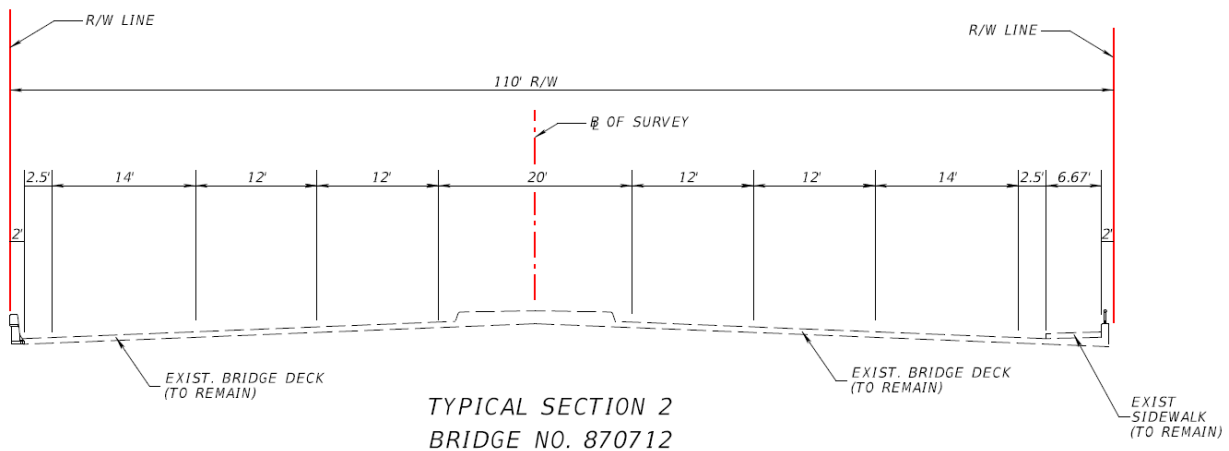
**Figure 2-3 Existing Typical Section**

Existing Typical Section 3 (Bridge 870950): This segment is a six-lane divided roadway with 20-foot raised median, 12-foot inside travel lanes, 14-foot outside travel lanes, 2.5-foot outside shoulders, 5-foot concrete sidewalk with parapet mounted pedestrian railing on the east side, and a concrete traffic railing of the west side.

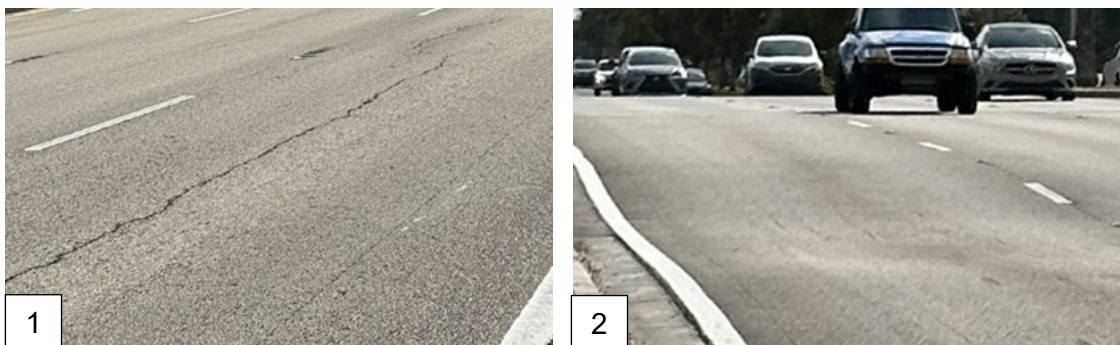
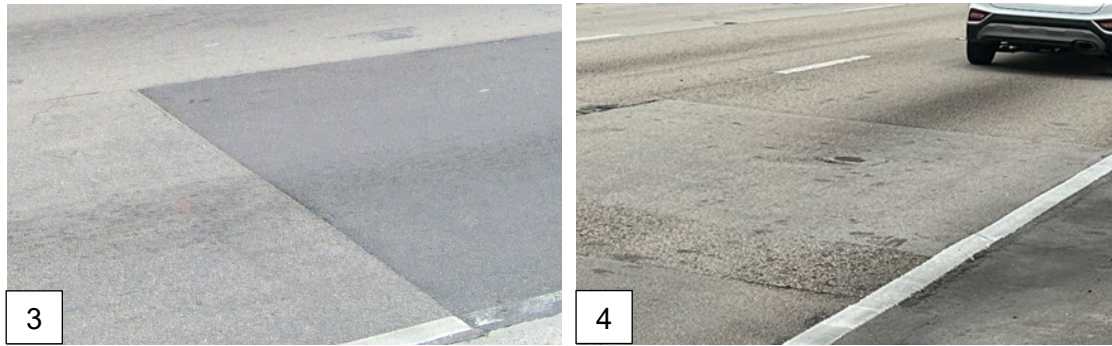
After conducting a visual inspection of the pavement condition during our field review, the existing pavement condition presents surface deteriorations such as minor cracking, raveling, utility cuts, pavement depression around manholes, and pavement depression 150' north of Bridge 870950. The field review was conducted in January 2024. Figure 2-4 illustrates samples of the surface deteriorations encountered during the field review.

**Figure 2-4 Existing Pavement Condition**  
(1. Cracking, 2. Pavement Depression, 3. Raveling, 4. Utility Cut)

Assume milling and resurfacing 2.5 inches for the purpose of this scoping report. Milling recommendation is to be provided by the FDOT State Materials Office.

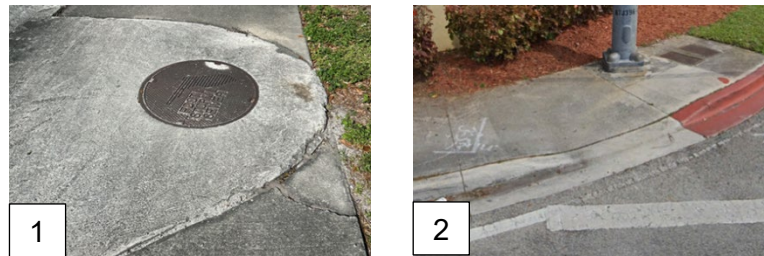
**Figure 2-5 Sidewalk Deficiencies**

There are standard concrete sidewalks on the east side of the project. The width of the existing concrete sidewalk ranges from 6 feet to 6.5 feet as indicated in the existing typical section. Under the FDM for RRR projects, unaltered sidewalks with a width of four feet or greater may be retained within any context classification. During the field review, minor cracking and trip hazards were observed on sidewalks. Sidewalk repair is considered a maintenance item, and deficiencies were reported to the District Maintenance Office. See Appendix E. Project exhibits show the locations where the unobstructed sidewalk width does not meet the minimum 48 inches for clear width of sidewalk. Where feasible, objects obstructing clear width of sidewalks should be relocated to meet FDM/ADA requirements. A Design Variation for Unobstructed Sidewalk Width is not required for existing objects to remain, but it is required for new features when the

sidewalk is modified (i.e., NW 189 Street). See exhibits in Section 3.9. Figure 2-5 illustrates samples of the sidewalk deficiencies encountered during the field review.

(1-2. Trip Hazard, Cracking and No Detectable Warning)

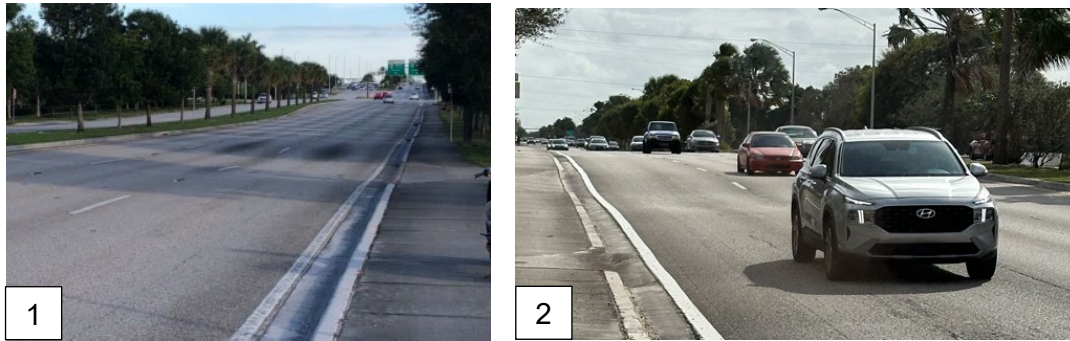
**Figure 3-1 Pavement Depression (1-2. Pavement Depression)**

- Overbuild to correct the pavement depression on northbound NW 57th Avenue, beginning approximately 150 feet north of Bridge No. 870950.

The Scoping Committee has limited the overbuild area to a maximum length of 150 feet. If full-depth reconstruction is determined to be necessary to correct the pavement depression, this requirement can be omitted. For additional information, refer to Appendix A-1, which contains detailed correspondence with Jose Guevara of FDOT North Maintenance.

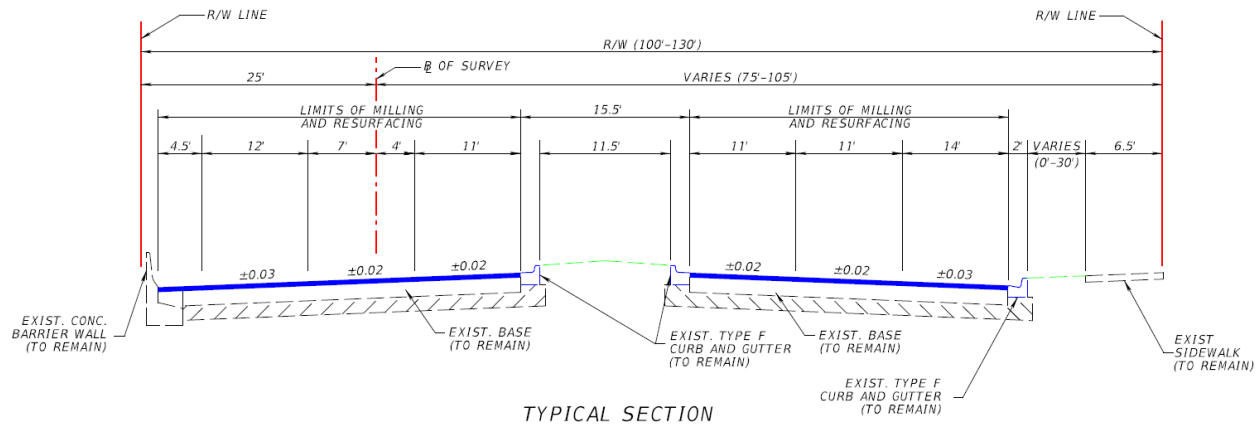
**Figure 3-2 Recommended Typical Section 1**

This segment of SR 823/NW 57 Avenue is composed of three (3) typical sections: two roadway sections and one bridge section. The existing cross-sectional elements for the roadway and bridge typical sections are recommended to remain as shown in Figure 3-2, to Figure 3-4.

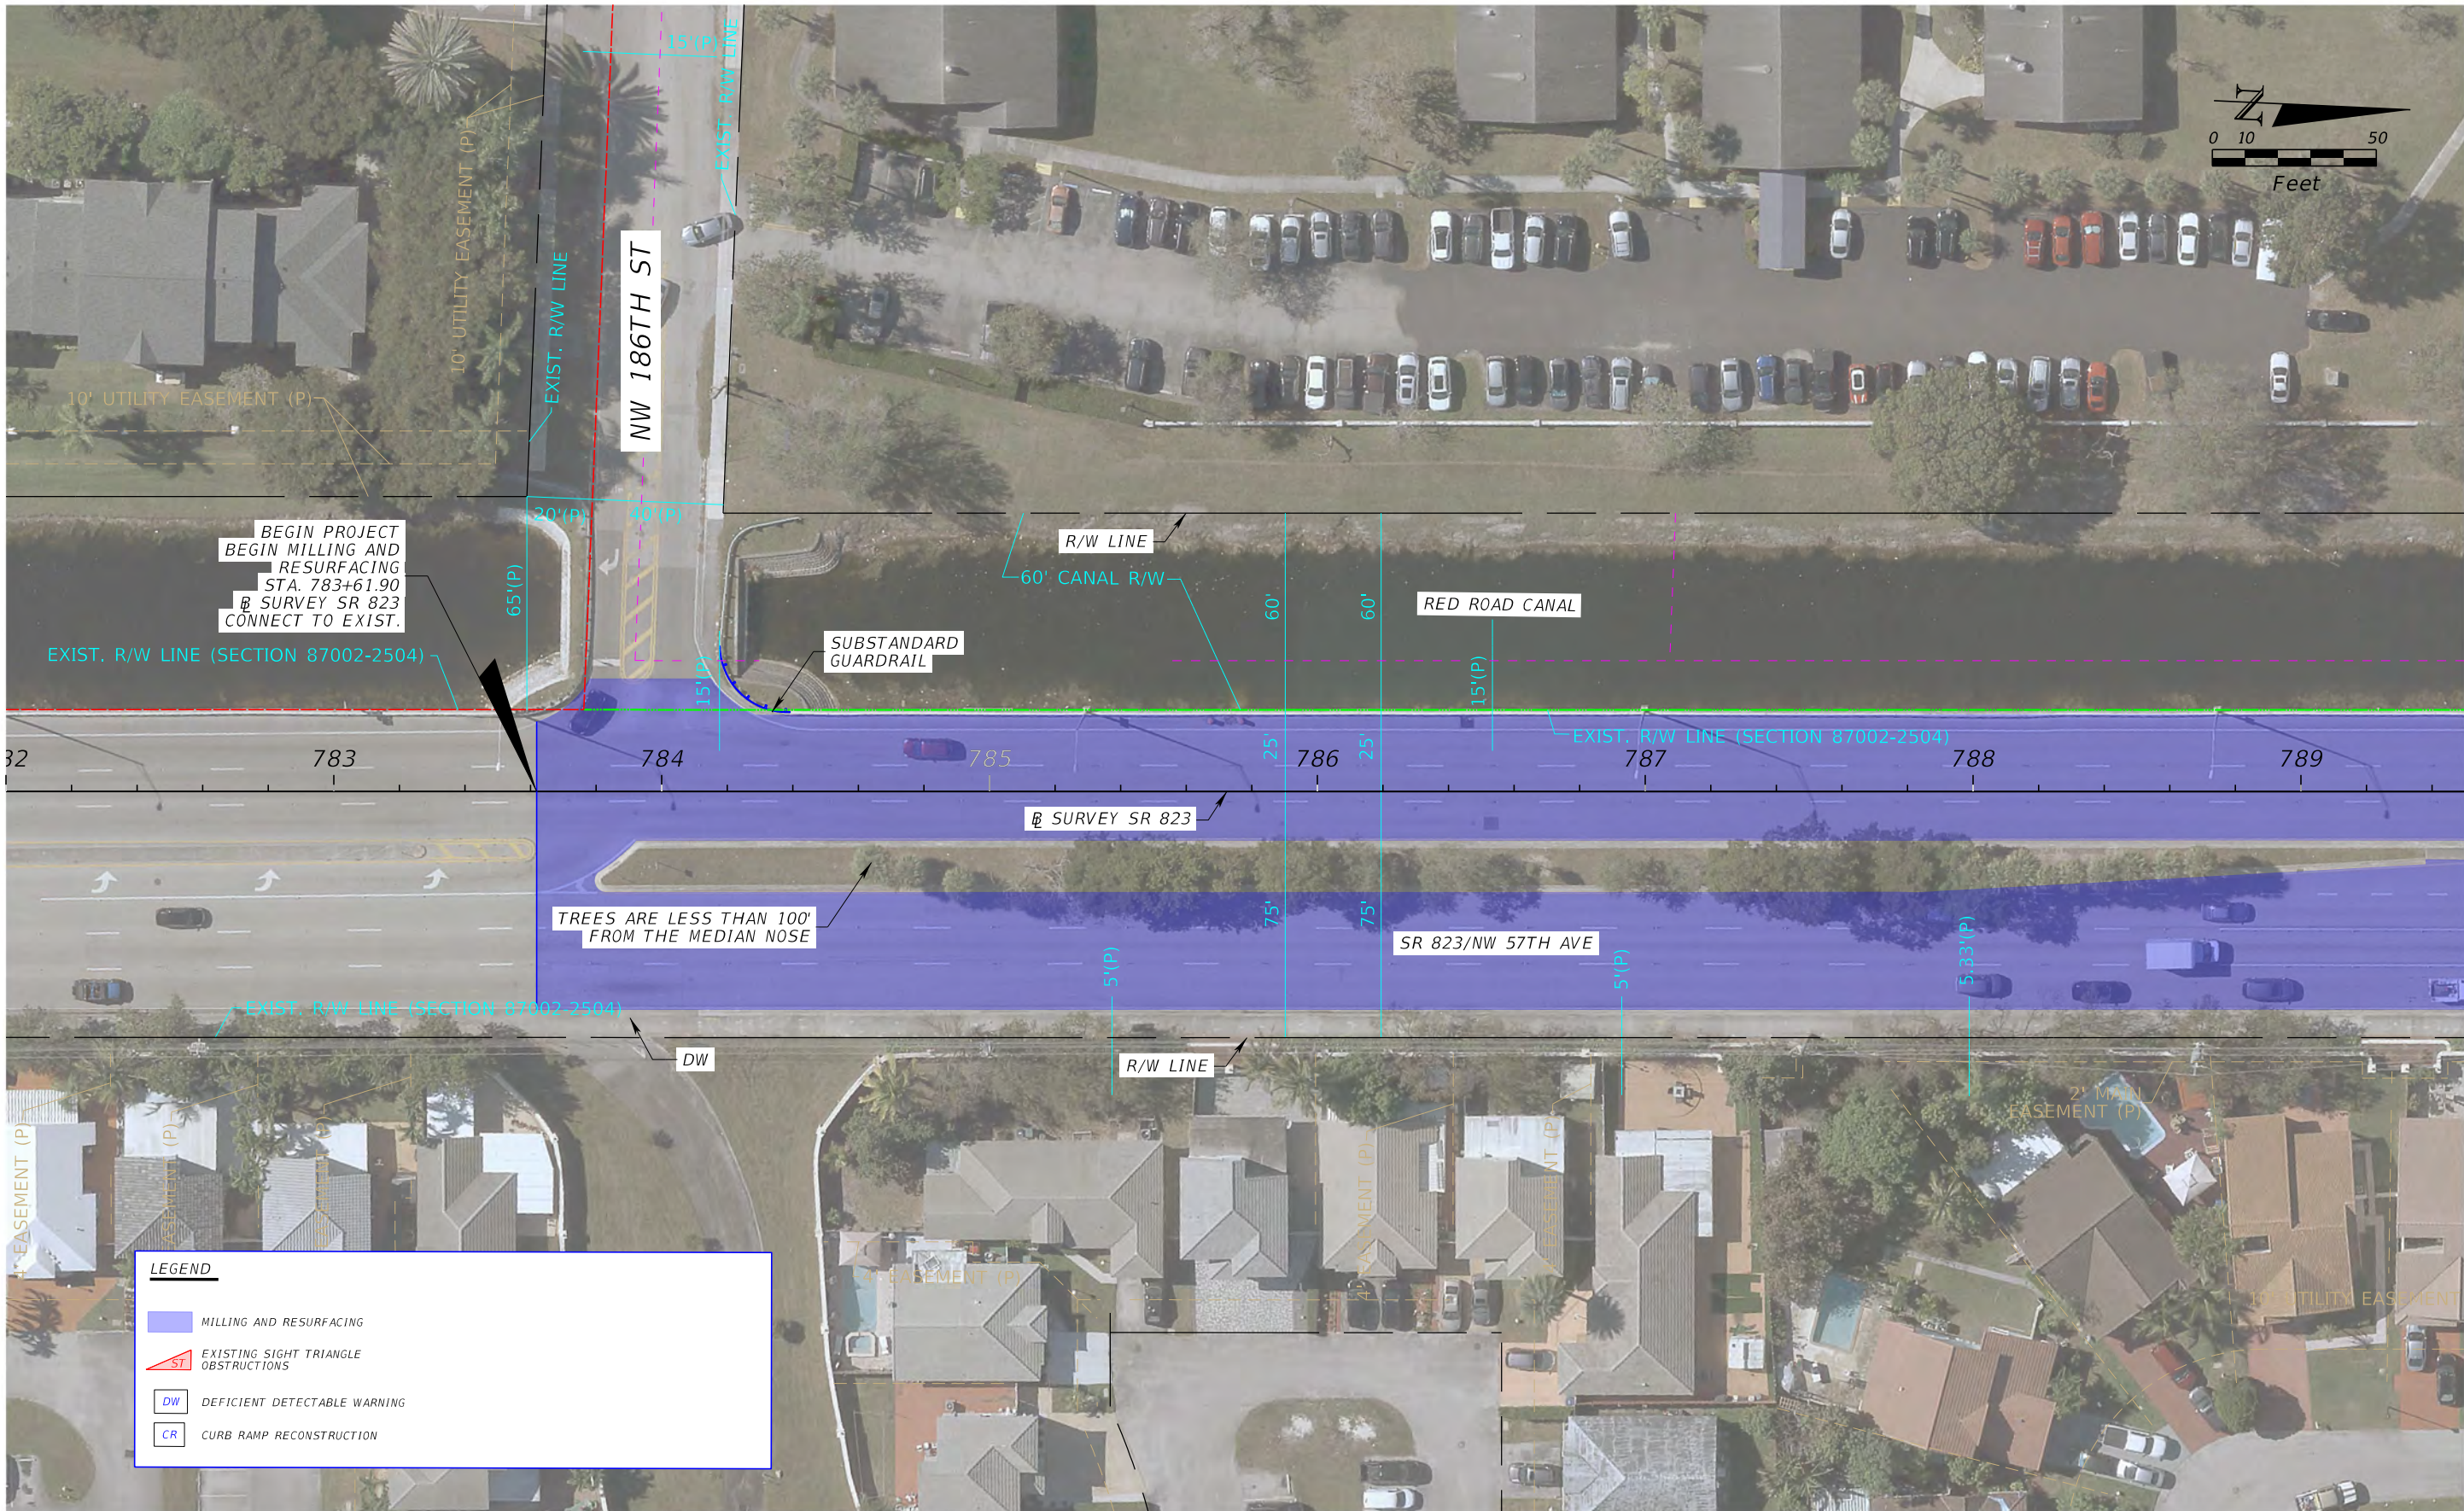
EXHIBIT 1 DEFICIENCIES AND RECOMMENDATIONS		SHEET NO.
		1

Exhibit 1 presents conceptual plans summarizing the existing deficiencies and recommended improvements.

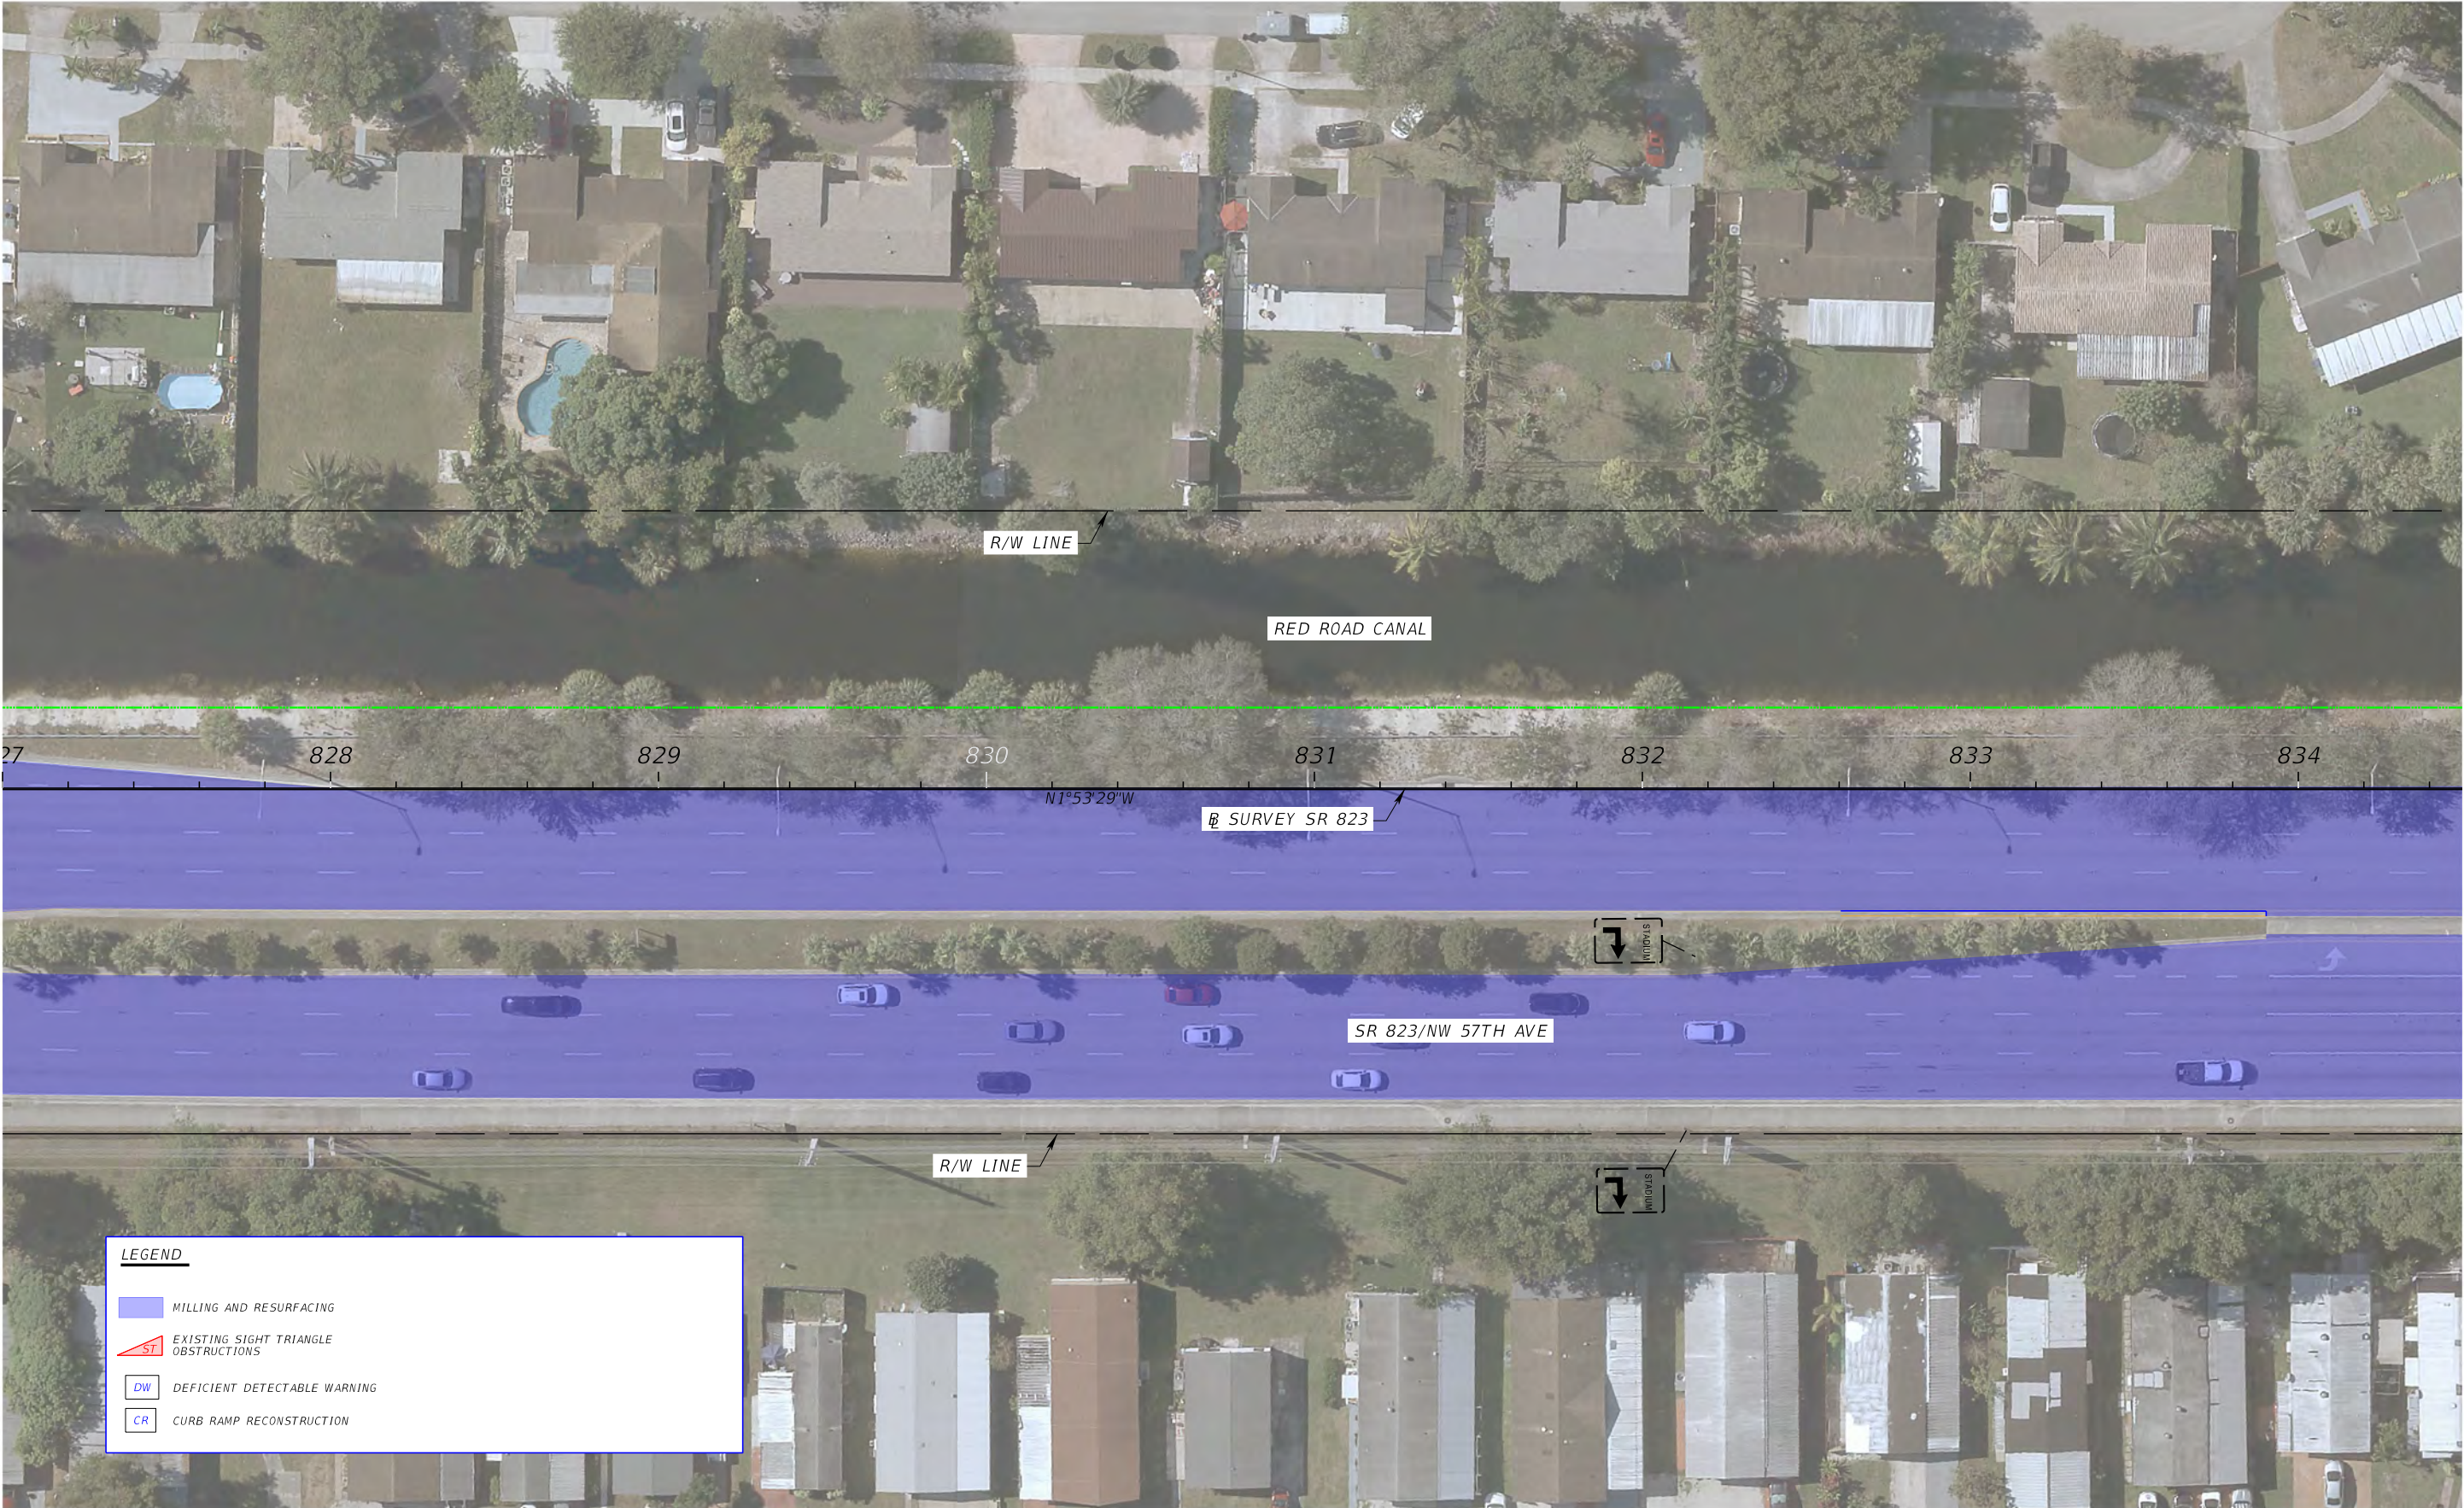
SHEET NO.
6

- MILLING AND RESURFACING
- EXISTING SIGHT TRIANGLE OBSTRUCTIONS
- DEFICIENT DETECTABLE WARNING
- CURB RAMP RECONSTRUCTION
