# **Pedestrian Mid-Block Crossing Study**

**FM# 446239-1**

**SR 826 Frontage Road  
At NW 77th Court  
(87260524 | MP 0.153 – 0.746)  
Miami-Dade County, Florida**

Prepared for  
Florida Department of Transportation District 6  
Planning and Environmental Management Office  
1000 NW 111th Avenue  
Miami, Florida 33172

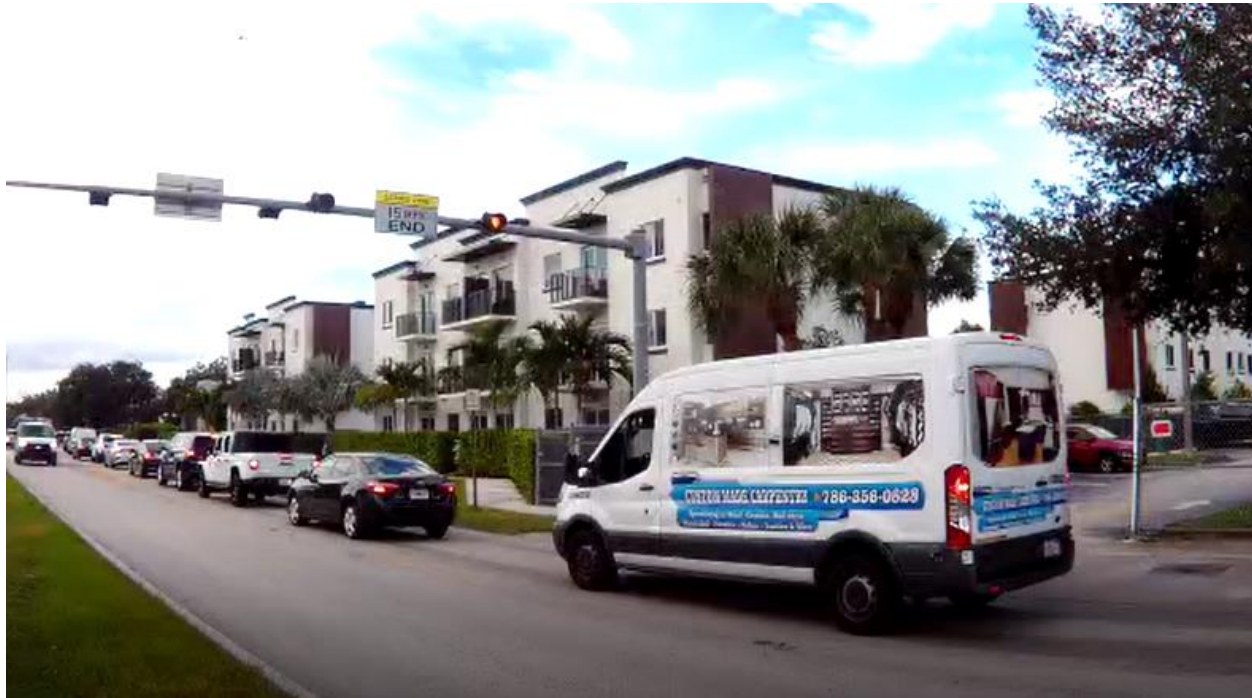
Traffic backing up along the southbound lane during morning drop-off period. Long queues originating from the intersection of NW 77th Court and NW 154th Street during the morning peak period. This queue sometimes extends south entrance to the school.

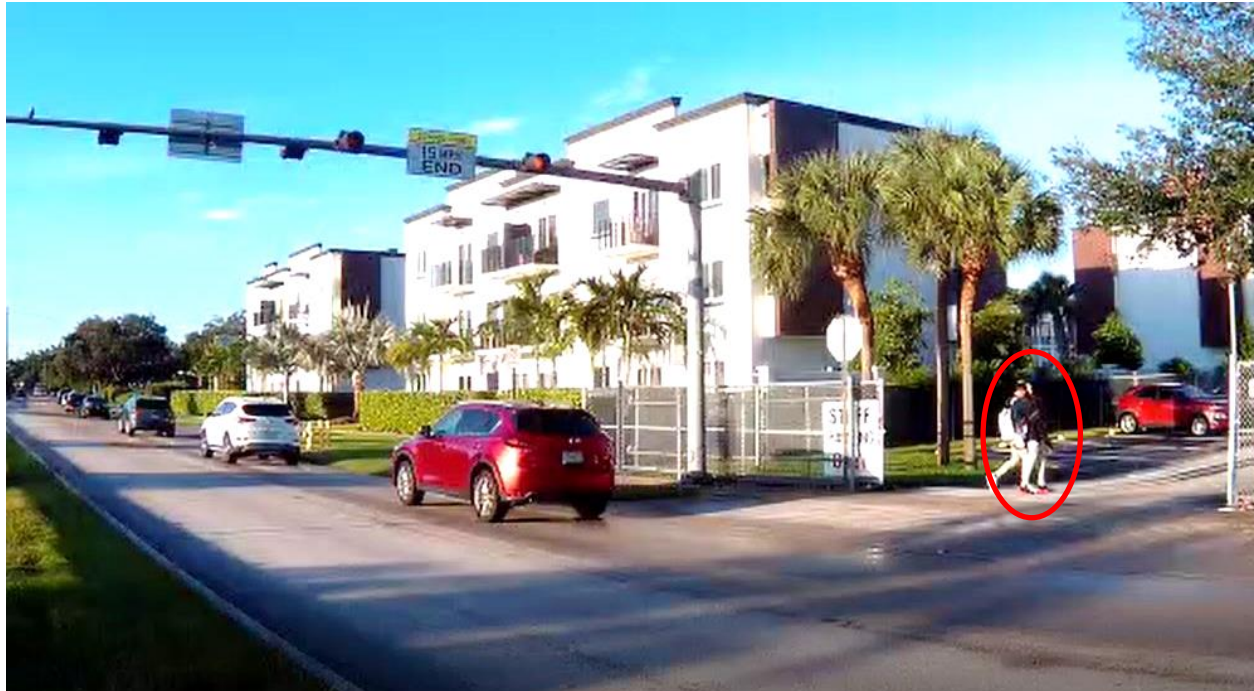
Students observed walking to school during morning drop-off period using the sidewalk on the south side of the school. The Lucida Residential Apartments are located just south of the Bob Graham Education Center.

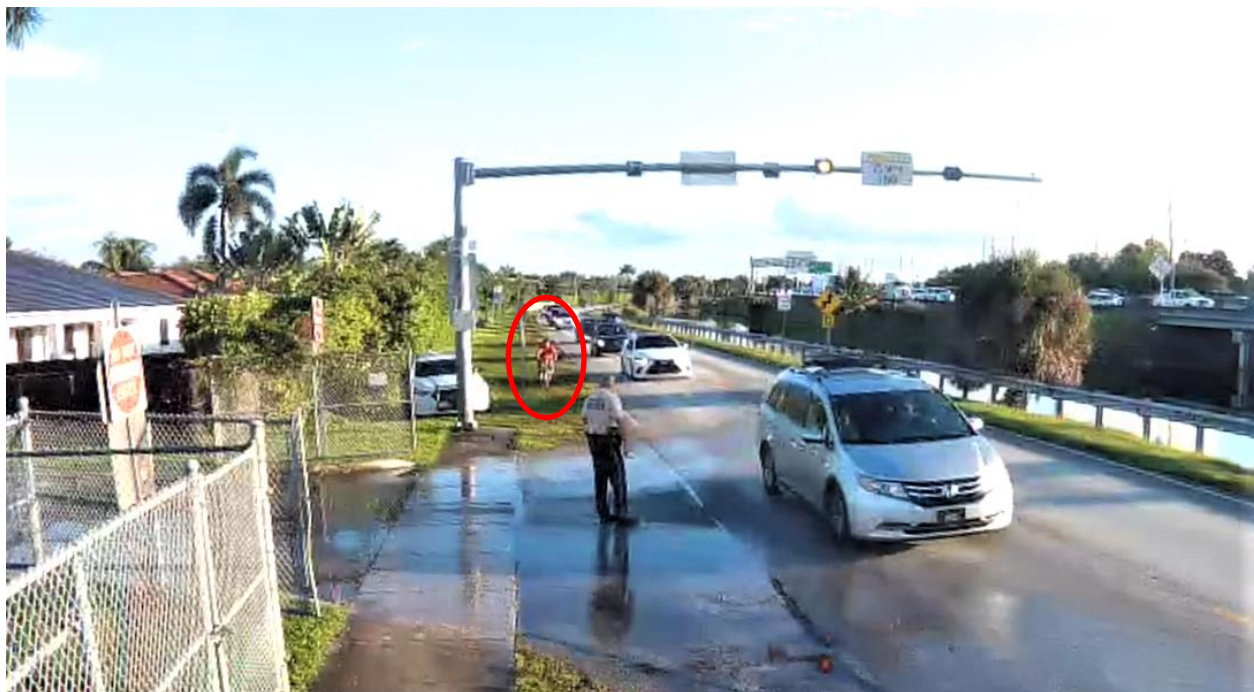
Bicyclist observed riding on the grass shoulder adjacent to the southbound lanes during the morning peak period. The bicyclist transitioned to the sidewalk on the south side and continued south to NW 154th Street.

Based on the context classification of “C4 Urban General”, the pedestrian volume demand threshold does not need to be met for the study roadway. One bicyclist was observed during morning peak period riding on the grass shoulder adjacent to the southbound lanes. In addition, 14 pedestrians were observed during the morning drop off period and 3 pedestrians crossing the roadway was observed during the pickup period.

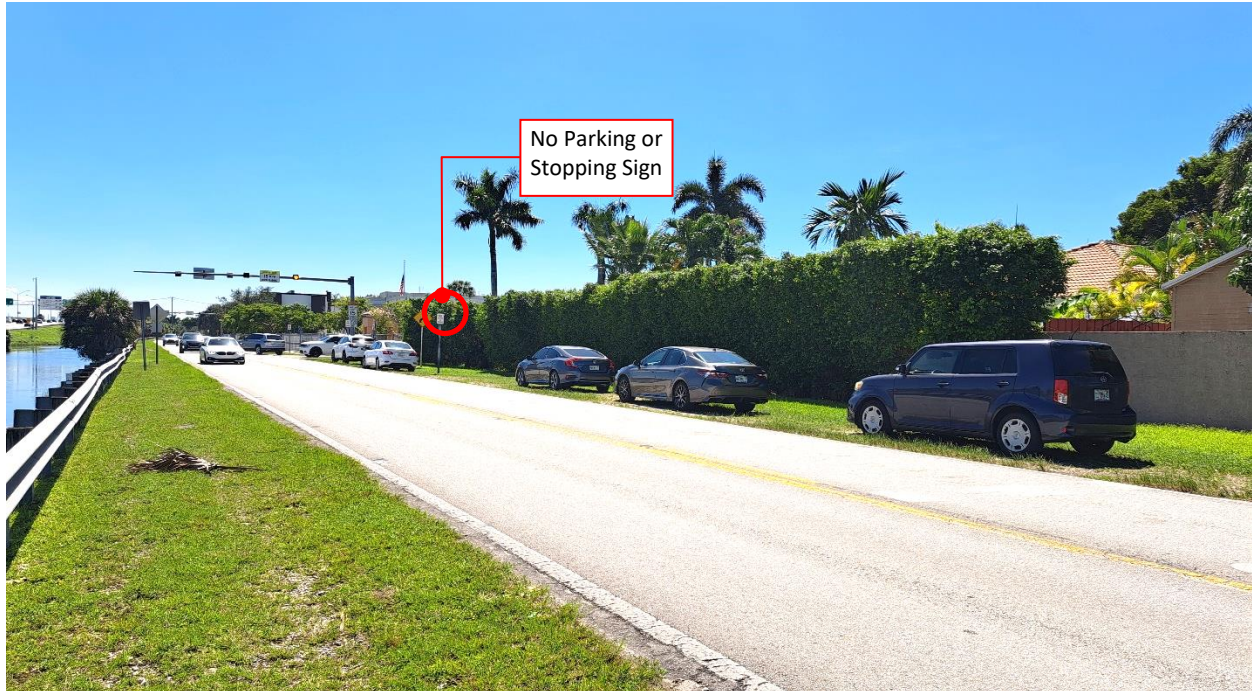
Several cars parked on the southbound shoulder along the NW 77th Court prior to the school the pick-up time even though there are no parking or stopping signs along this area. Some parents were observed parking their cars and walking to the school to pick up their children.

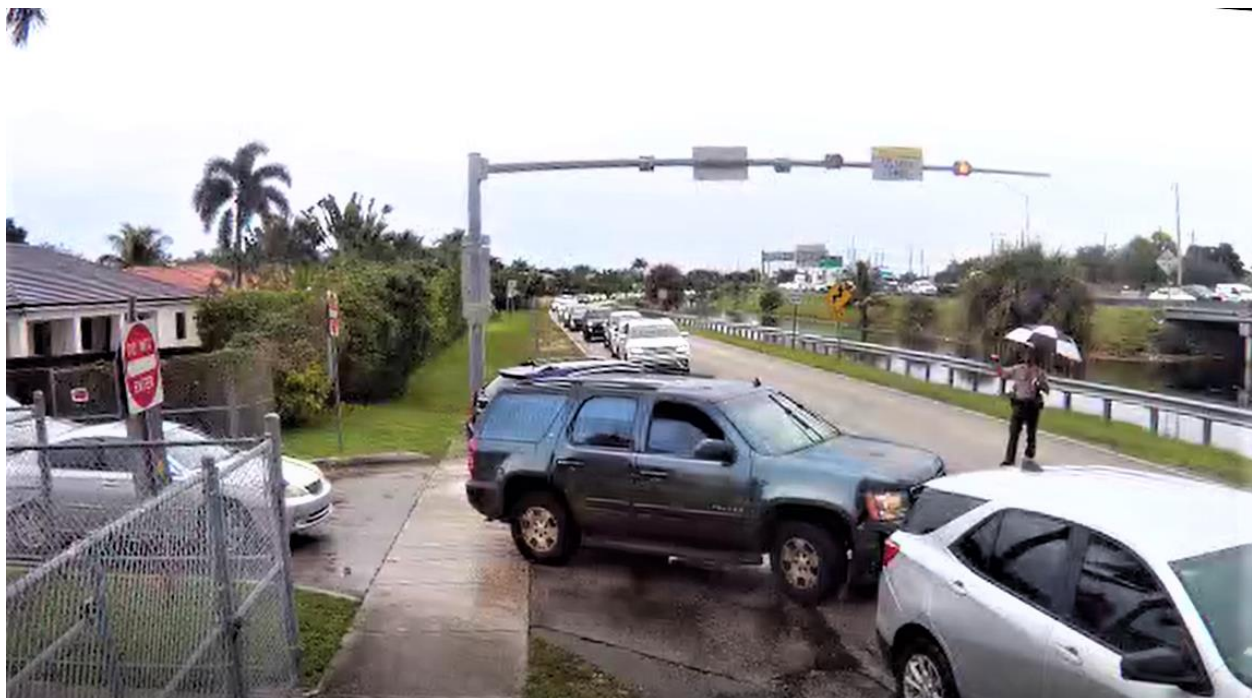
Traffic queue along the southbound direction during the afternoon pick-up period with traffic control police officer. The traffic queue extends north through the curve but typically dissipates within 15-20 minutes after the school ends.

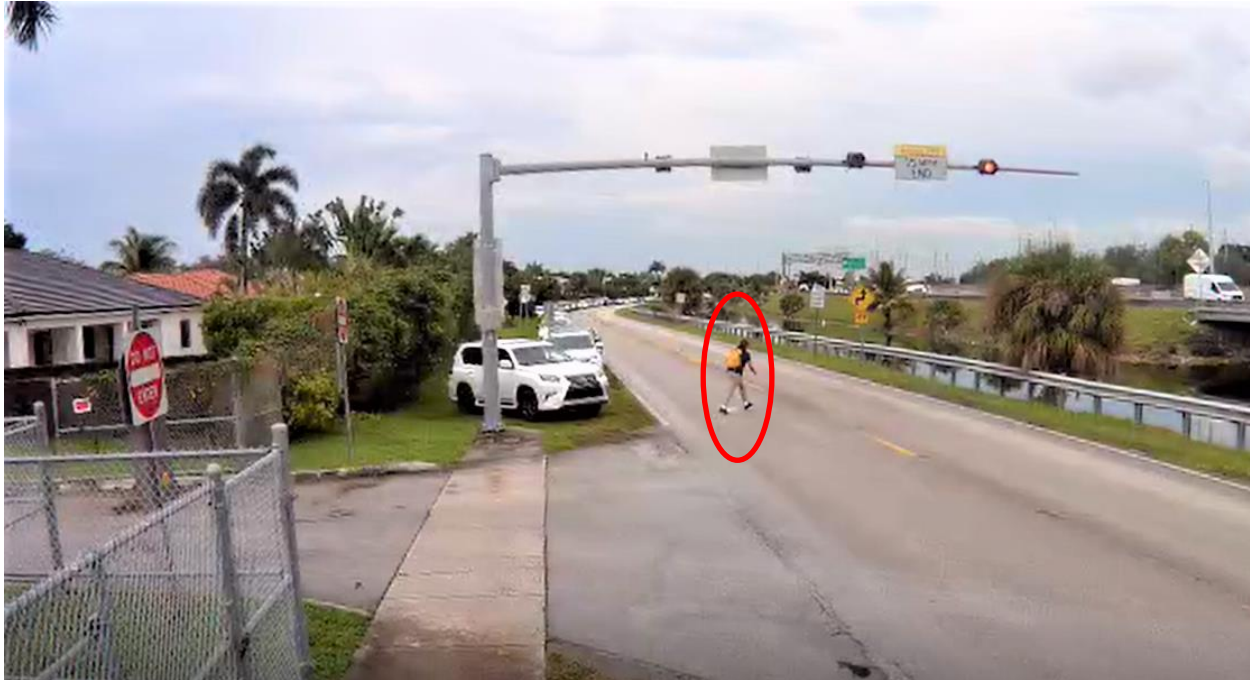
Student observed walking home after school and crossing NW 77th Court north of the Bob Graham Education Center. The residential community located northeast of the school has no sidewalk connection to the school.

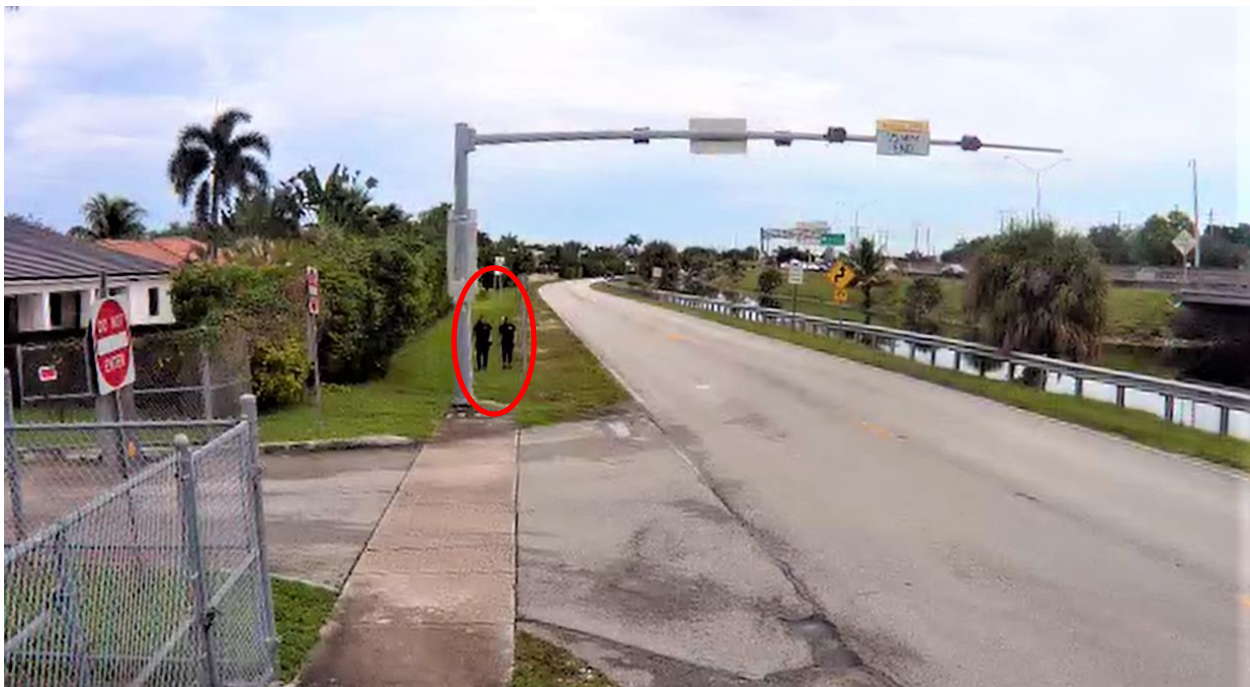
Pedestrians observed walking along the southbound shoulder with no existing sidewalk. The pedestrians were observed coming from the residential community on the northeast side and going to the Royal Oaks Shopping Plaza.

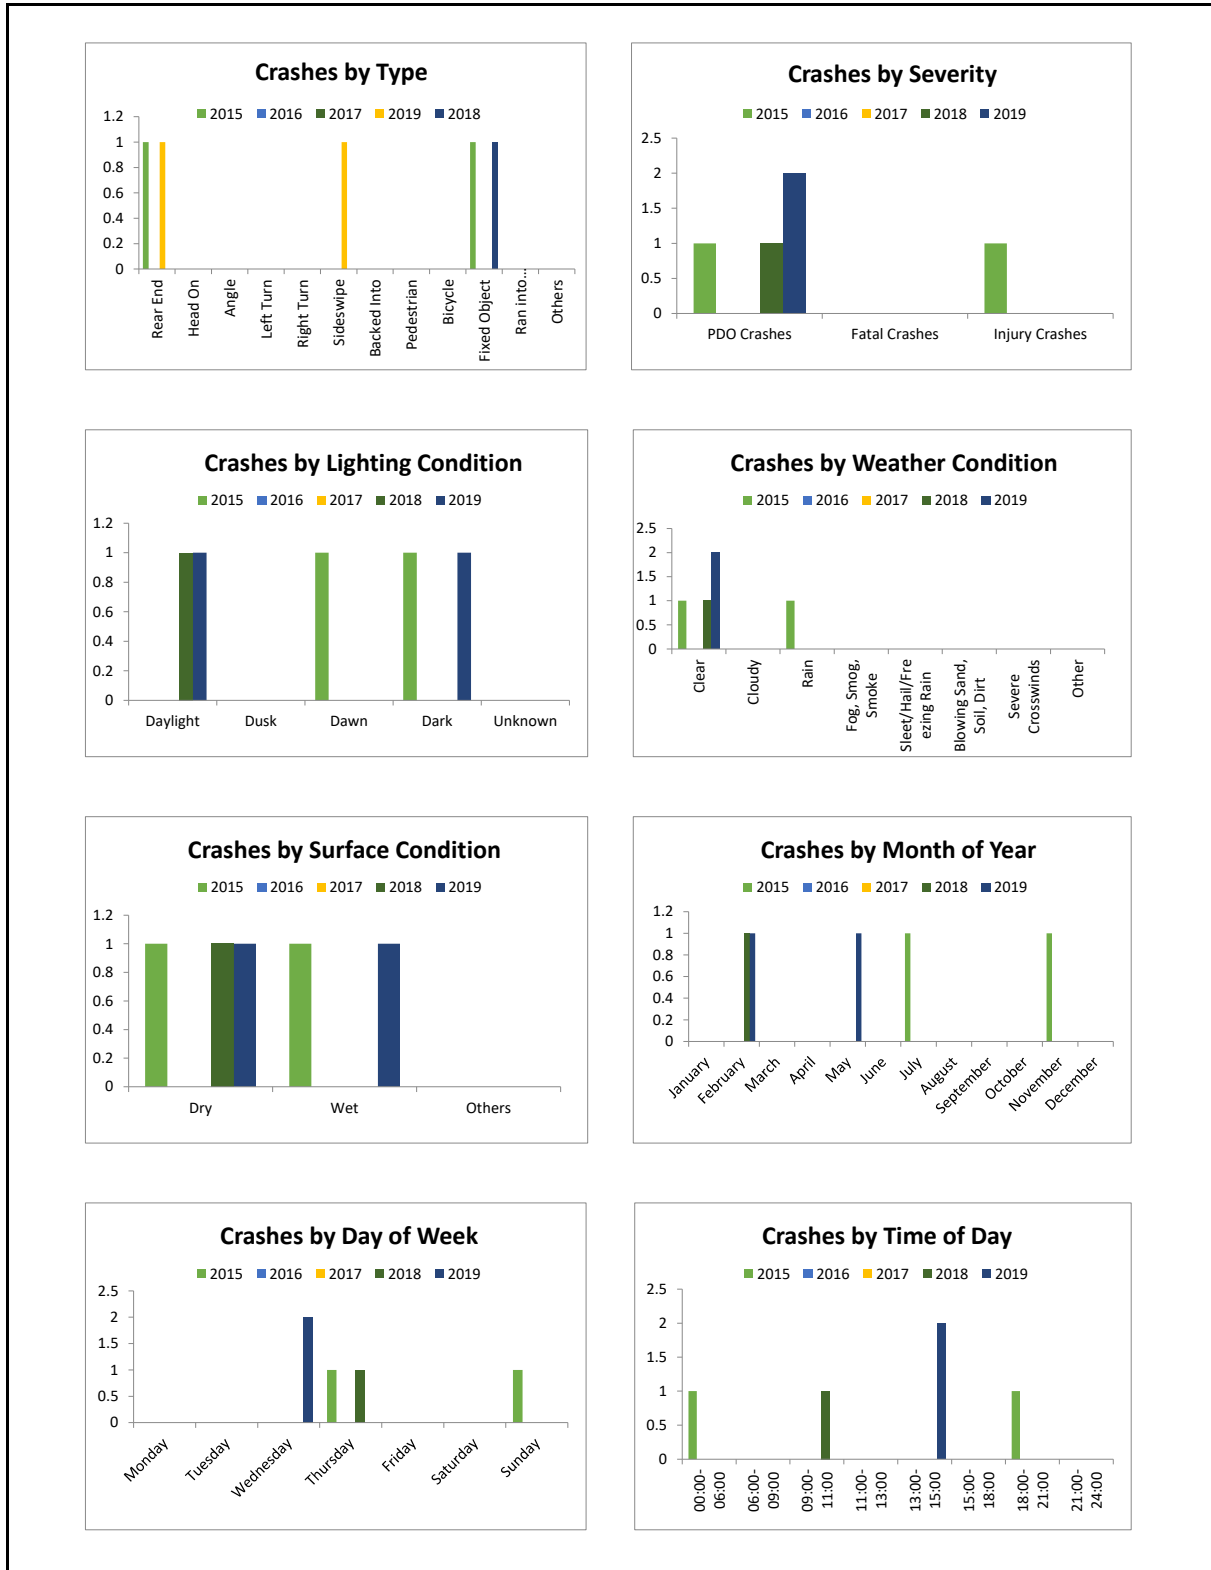
Figure 4-1: Histograms of Crash Summaries

**Table 4.2** presents a summary by crash type for the segment, and **Table 4.3** presents a crash summary by different categories, such as lighting conditions, surface conditions, and weather conditions. The same information is depicted graphically in **Figure 4-1** for visual comparison. Collision Diagrams were prepared for the above locations for the analysis period of January 1, 2017, through December 31, 2019, and are presented in **Appendix A**. The raw crash data for the segment is also presented in **Appendix B**.

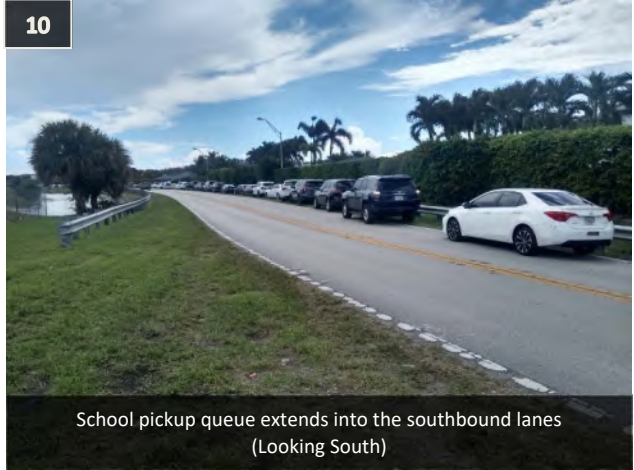
School pickup queue extends into the southbound lanes (Looking South)

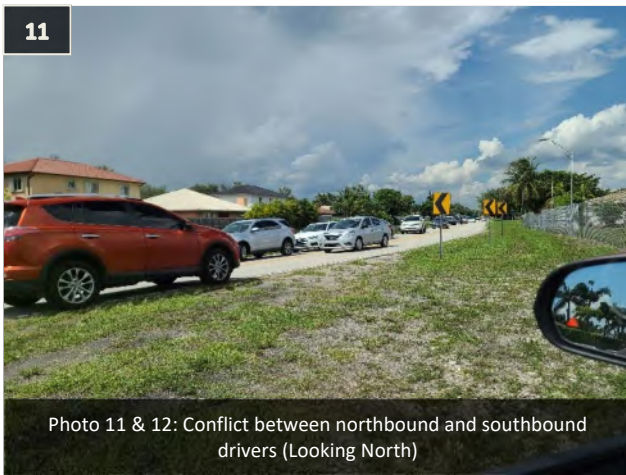
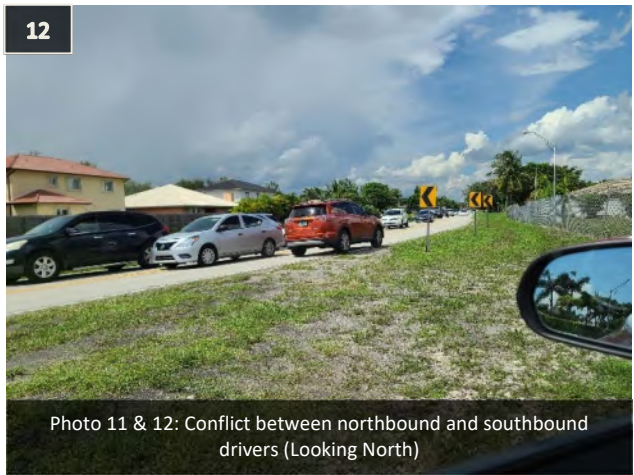
- Several conflicts between northbound drivers in the northbound lane and southbound drivers attempting to pass the queue were observed, with some drivers swerving onto the grass shoulder to avoid a crash.

Photo 11 & 12: Conflict between northbound and southbound drivers (Looking North)

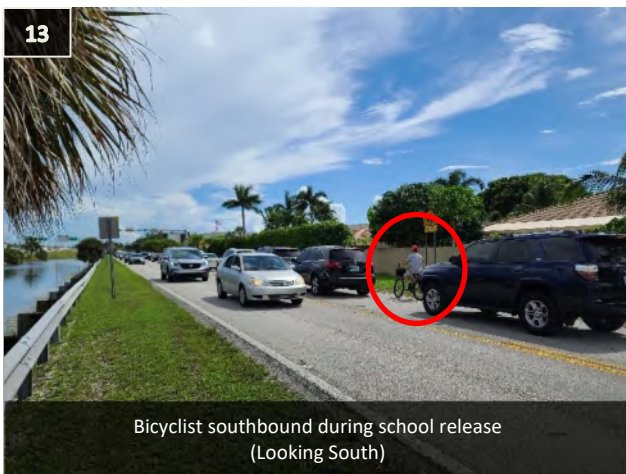
Bicyclist southbound during school release (Looking South)

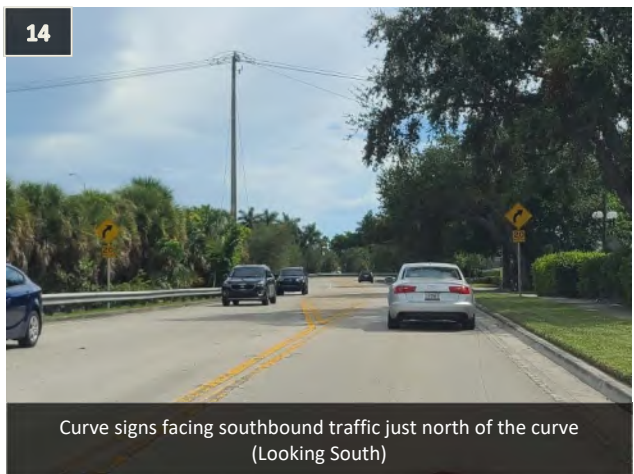
Curve signs facing southbound traffic just north of the curve (Looking South)

- Consider installing a “Right Turn Only” (R3-5R) signs facing eastbound at the Royal Oaks Plaza Center Driveway.
- Consider removing the Curve (W1-2) signs on the northbound and southbound approaches to the curve at the south end of the segment and install a Turn (W1-1) signs.
- Consider replacing the worn out “School Exit” sign at the Bob Graham Education Center Pick-up/Drop-off Exit.
- Consider trimming the vegetation obstructing the speed limit sign facing southbound just north of Bob Graham Education Center.
- Consider installing a “Speed Limit 35” (R2-1) facing southbound just north of the curve at Royal Oaks Plaza.
- Consider widening the roadway north of Peter’s Pike Canal.

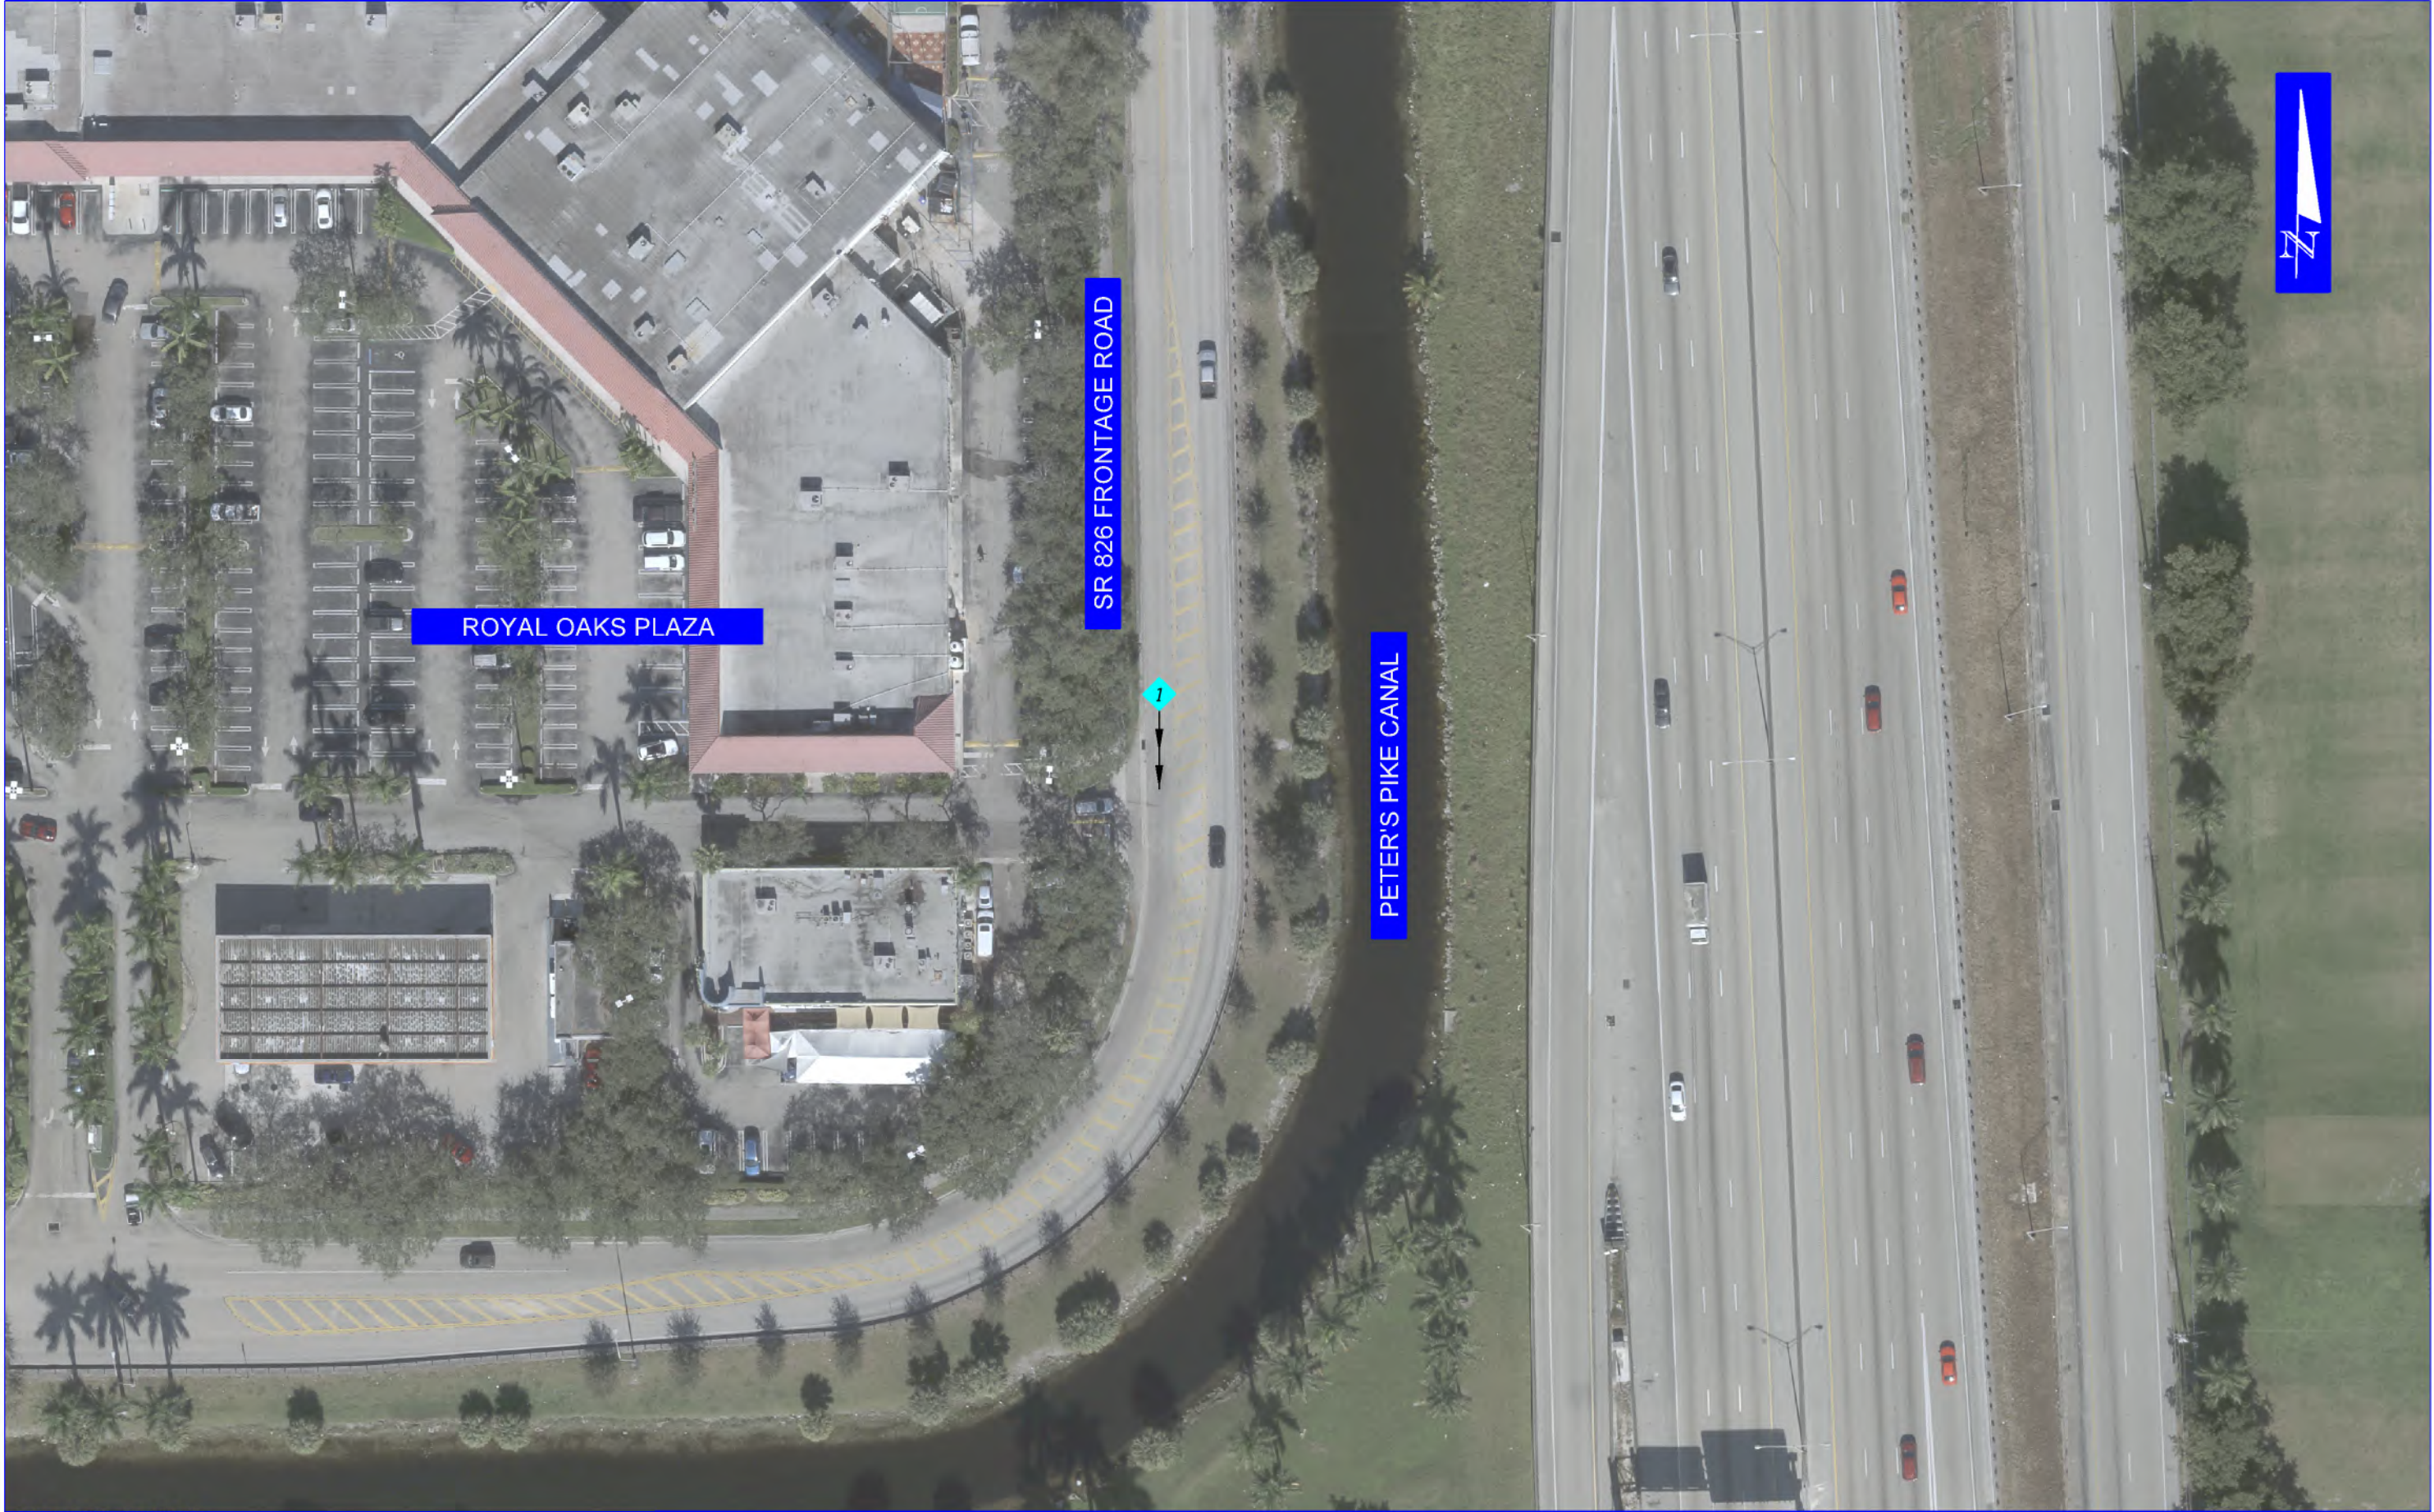
**C-1**

① RECORD NUMBER	🚲 BICYCLIST	➡️ □️ FIXED OBJECT	↙️ LEFT TURN	➡️➡️ HEAD ON	* CARGO LOSS/DEBRIS	▲ YR 2015	▼ YR 2018
○ INJURY	🚶 PEDESTRIAN	➡️ ◻️ PARKED CAR	🌀 OUT OF CONTROL	↘️ ANGLE	↻ U-TURN	● YR 2016	◆ YR 2019
● FATAL	↔️ BACKING VEHICLE	➡️➡️ REAR END	↘️ RIGHT TURN	↔️ SIDE SWIPE	🚗 OVERTURNED	■ YR 2017
