RRR Scoping Report

FM# 446239-1

**SR 826 Frontage Road
At NW 77th Court
(87260524 | MP 0.153 – 0.746)
Miami-Dade County, Florida**

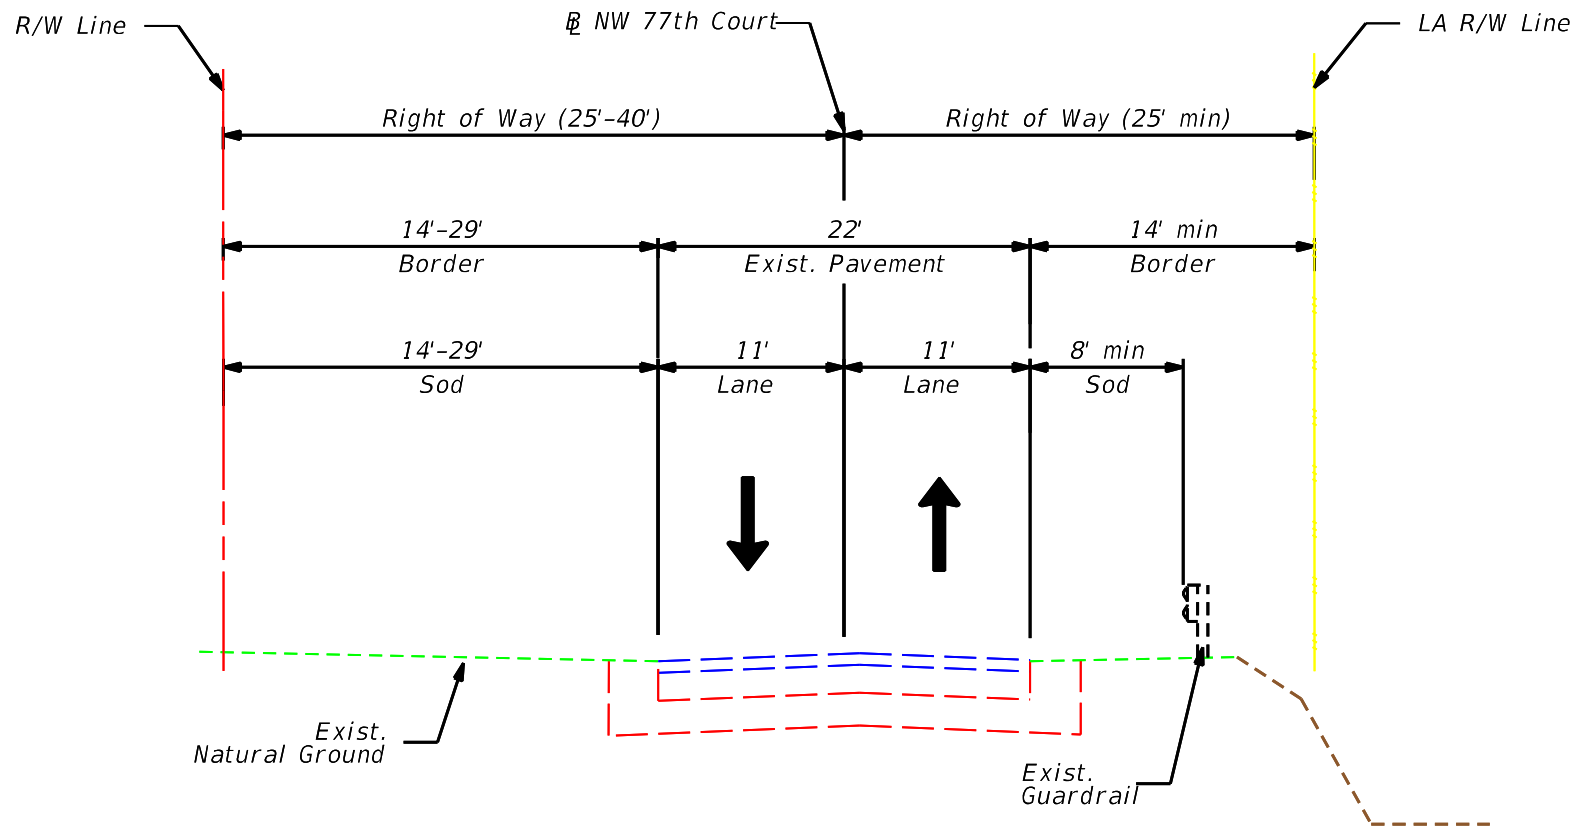
Figure 2-2 Existing Typical Section NW 77th Court from MP 0.385 to MP 0.696

The second typical section consists of a two-lane undivided roadway from MP 0.385 to MP 0.696 with no paved shoulders, guardrails on the east side of the roadway. There is existing sidewalk on the west side from MP 0.385 to MP 0.509; however, the remainder of the segment has no sidewalks.

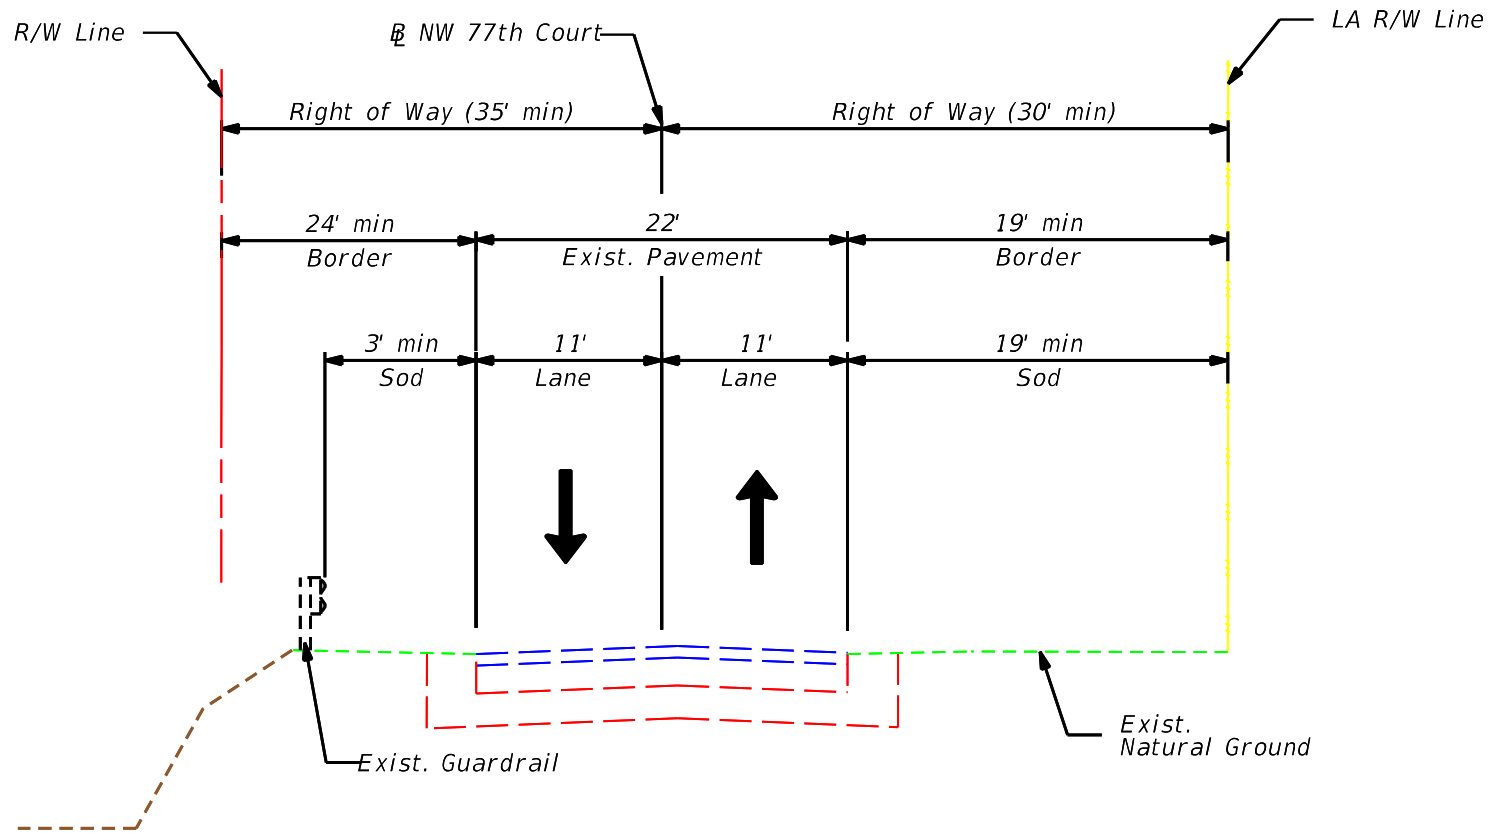
Figure 2-3 Existing Typical Section NW 77th Court from MP 0.696 to MP 0.746

The third typical section consist of a two-lane undivided roadway from MP 0.696 to MP 0.746 with no paved shoulders, guardrails on the west side of the roadway and no sidewalks.

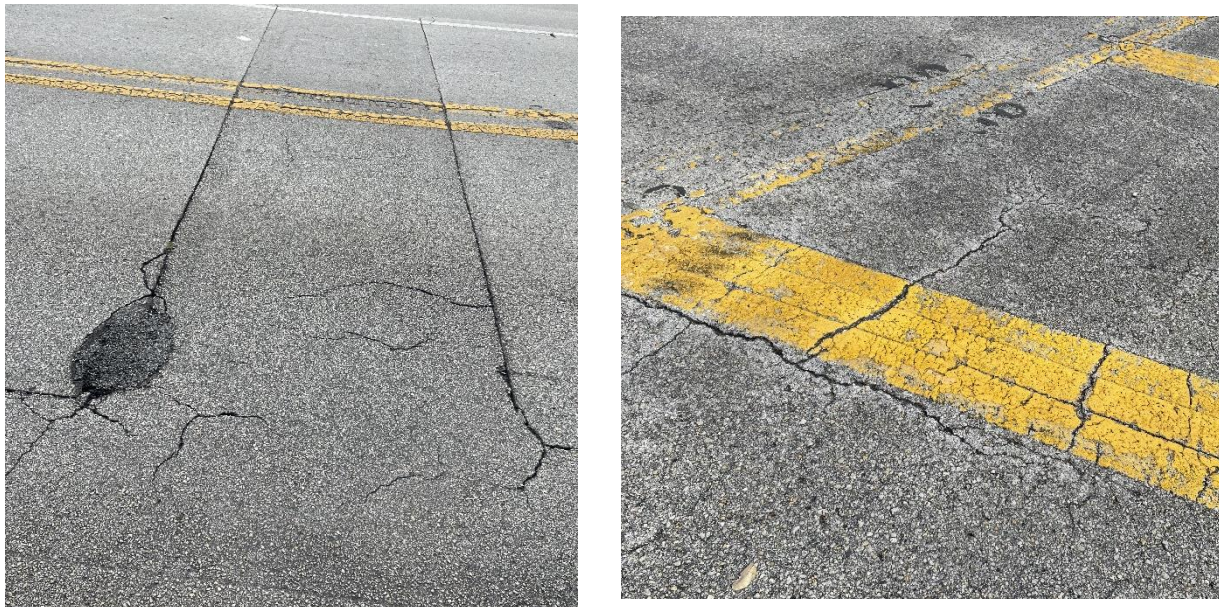
Figure 2-4 Existing Pavement Conditions

Based on a visual inspection of the pavement during our field reviews, the existing pavement condition appears to be poor with severe longitudinal and transverse cracking, rutting and utility cuts observed at several locations within the limits of the project; examples are shown in **Figure 2-4**.

The project corridor is not on the state highway system, as such, the District conducted a pavement condition survey for only cracking and identified the segment as deficient for the 35-mph posted speed limit on the left and right sides of the roadway. No pavement ratings for ride or rut were performed for this project segment. The PCS rating from 2019 is listed in **Table 2-2**.

- Correct the deficient pavement conditions by milling and resurfacing.

- Mill and resurface the existing pavement.
- Provide 5 feet paved shoulder on both sides of the roadway between MP 0.385 to MP 0.746.
- Upgrade the existing drainage system to accommodate the additional impervious area and repair/replace damaged drainage inlet tops.
- Adjust the existing storm drain manholes, utility manhole tops, and valves within the limits of milling & resurfacing or sidewalk reconstruction, as necessary.
- Replace existing guardrails along the existing canal including the appropriate end anchorages to meet standards.
- Regrade and stabilize the existing canal front slopes along the project corridor.
- Repair the damaged headwall for the culvert on the east side of the roadway

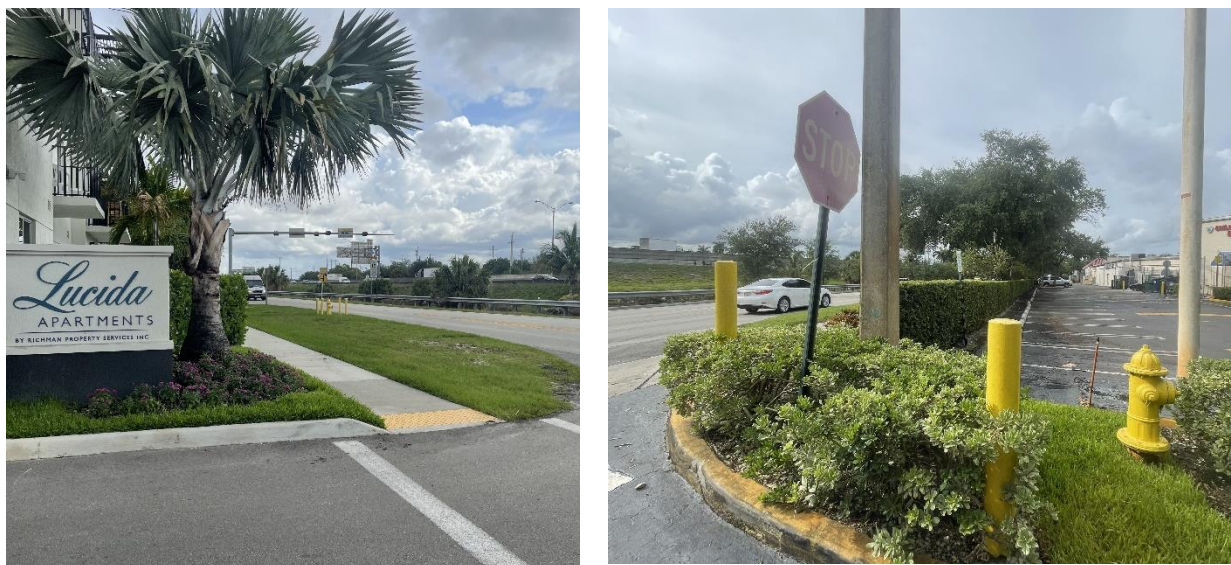
Figure 2-5 Clear Sight obstructions at intersections

Clear sight triangles were evaluated at the intersections and driveways within the project limits. Based on field observations and an office review, obstructions to intersection sight distance were identified at several locations within the project limits as shown on the Roadway Plans. **Figure 2-5** shows examples of existing intersection sight distance issues within the project limits.

Sight triangle obstructions consist of trees, light poles, and signposts. At the time of this Scoping Report submittal, the District Traffic Operations Office has not documented any specific

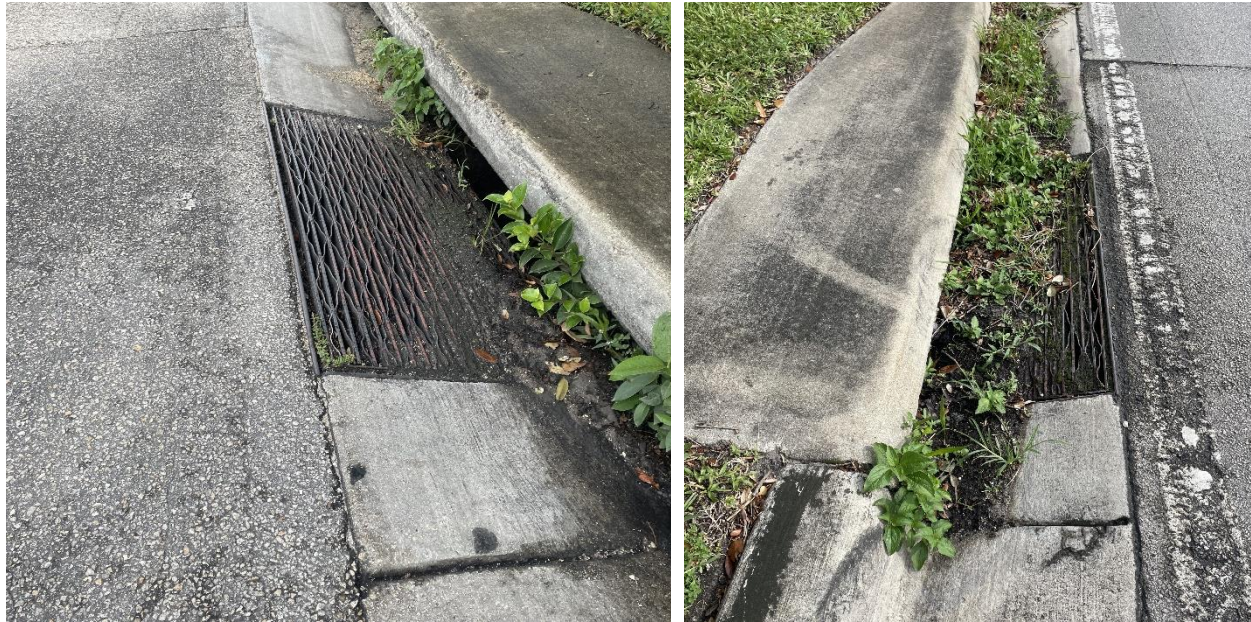
Figure 2-6 Existing Drainage Issues

The existing drainage within the project limits typically consists of a combination of open and closed drainage systems. The first segment of the project from MP 0.153 – 0.385, includes curb and gutter with curb inlets and ditch-bottom/curb inlets at side-street intersections. The second segment from MP 0.385 – 0.746 has flush shoulders with flat swales that drain into the adjacent Peter’s Pike canal. **Figure 2-6** shows some drainage inlets with debris encountered during the field review.

There is an existing culvert that crosses the roadway at the north end of the corridor that connects the Peter’s Pikes Canal on either side of the roadway. The headwall for the culvert on the east side is damaged and needs to be repaired. This Scoping Report does not include an evaluation of the hydraulic, safety and physical adequacies of the existing drainage system. However, the proposed improvements include providing 5 feet paved shoulders along the project corridor. This will require an evaluation of the drainage system to provide adequate water quality and quantity for the additional impervious area.

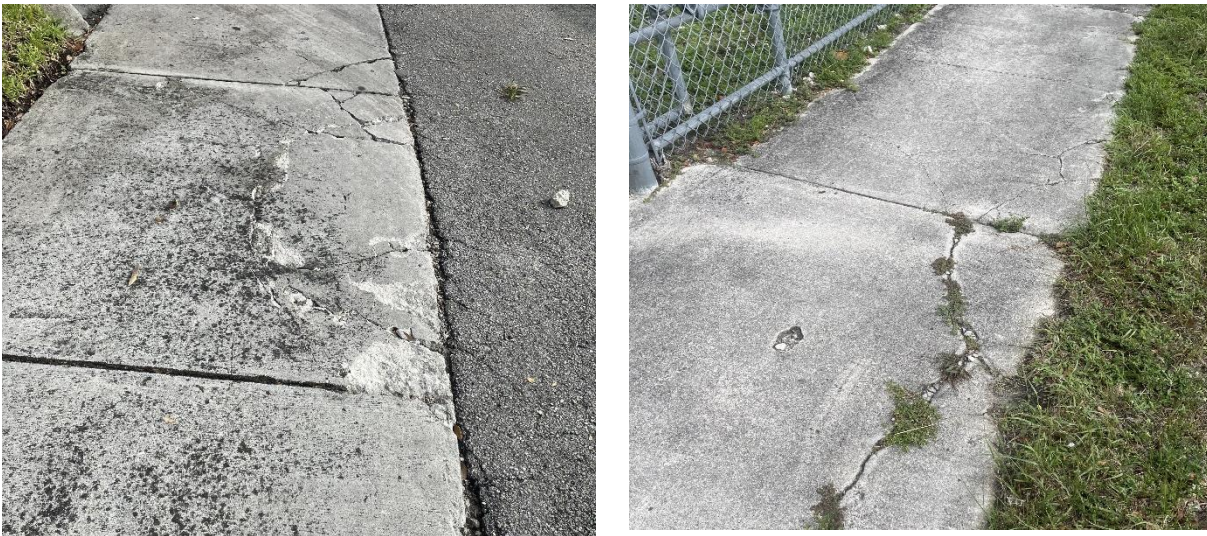
Figure 2-7 Damaged or Uneven Sidewalks

Locations of uneven and damaged sidewalks were identified at some locations within the project limits. **Figure 2-7** shows some of the deficiencies encountered during the field review.

For RRR projects, the FDM recommends that unaltered sidewalk with a width of 4 feet or greater may be retained within any context classification. As such, the existing sidewalk widths are recommended to remain. However, the following are substandard conditions identified.

- Reconstruct damaged sidewalk segments (lifted, sunken or broken sidewalk) and address the cause of said damage (tree roots etc.).
- Construct additional sidewalk areas at the mast arm pole locations to provide 48 inches unobstructed sidewalk width.

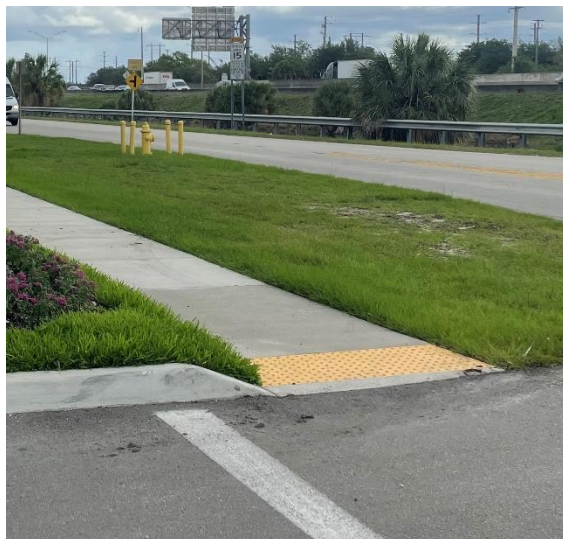
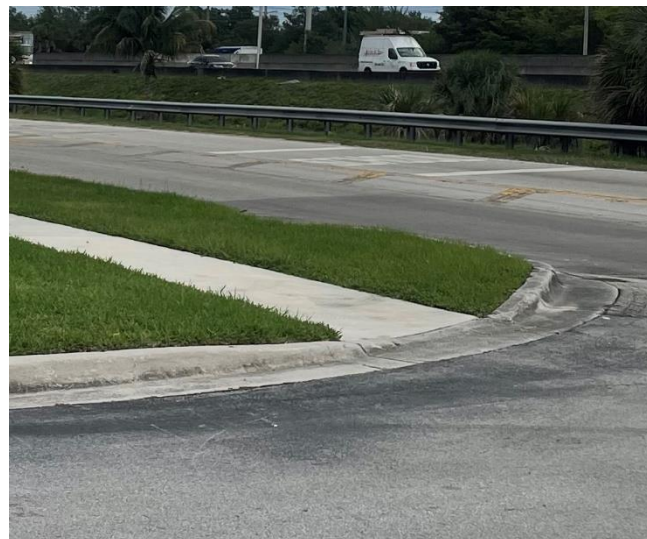
Figure 2-9 Existing Curb Ramps

Existing pedestrian blended transitions ramps are located at three intersections within the project limits. The existing pedestrian ramps were evaluated for compliance with the FDOT Standard Plans and ADA Standards. Based on our field review, several curb ramp deficiencies were identified including missing/worn out detectable warnings and substandard transition slopes at commercial driveways and side streets. **Figure 2-9** shows examples of the deficiencies encountered within the project limits. It is recommended to upgrade all the deficient curb ramps within the project limits.

- Upgrade deficient pedestrian curb ramps and related components such as detectable warning surfaces, pavement markings, pedestrian crossing signs and plaques.

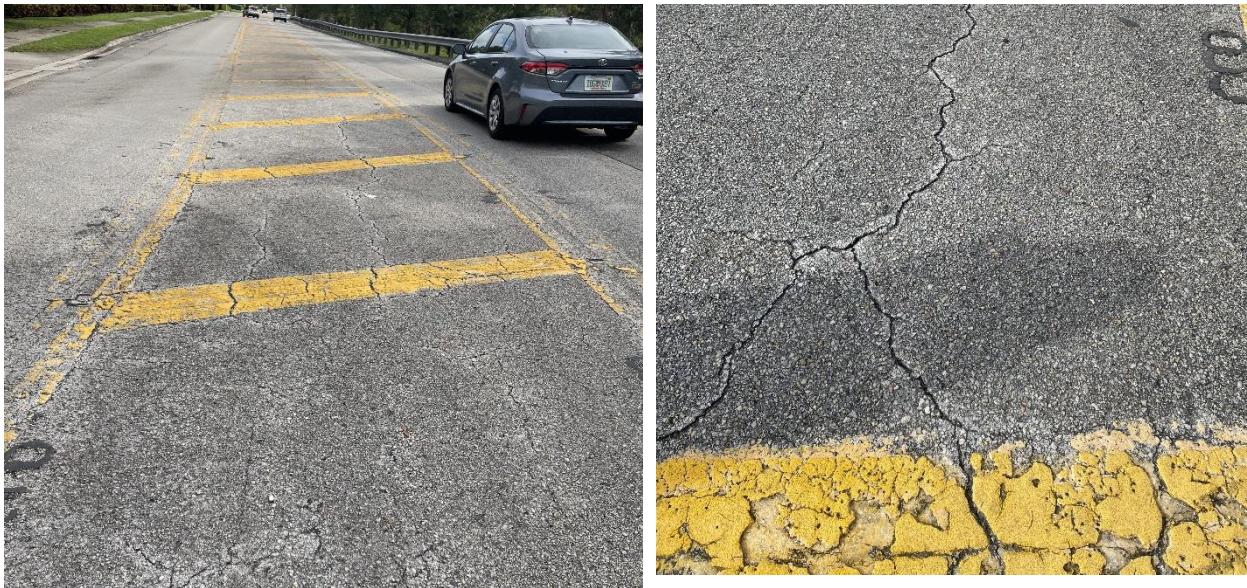
Figure 2-10 Existing Signs and Pavement Markings

Existing signing includes ground-mounted signs on the shoulders along the project corridor. There are also signs mounted on overhead mast-arms of the school zone. Faded, broken or substandard signs were observed within the project limits.

Based on field observations, the existing pavement markings are generally in poor condition, with faded striping as well as raised reflective pavement markers that are missing or with low reflectivity. **Figure 2-10** illustrates examples of substandard signing and pavement markings within the project limits.

An existing sign inventory is not included in this Scoping Report. A review of all existing signage with the Manual on Uniform Traffic Control Devices (MUTCD), the FDOT Traffic Engineering Manual (TEM) and FDOT Speed Zone Manual criteria should be conducted at the Design Phase. Based on field observations, there are some existing signs within the project limits that are defaced/damaged, and therefore do not comply with the latest standards. Most of the existing single-post signs along the roadside comply with the standard placement per Index 700-101. In addition, school zone signing, and pavement markings need to be upgraded to comply with FDOT's Speed Zoning Manual.

- Upgrade all broken and substandard ground-mounted signs to comply with the latest editions of the FDOT Standard Plans, the FDOT Traffic Engineering Manual (TEM), and the Manual on Uniform Traffic Control Devices (MUTCD).

- Replace and upgrade all pavement markings to meet the latest FDOT Standard Plans for Road Construction.
- Replace the existing 35 mph speed limit signs with 30 mph speed limit signs.
- Provide speed feedback signs along the project corridor.
- Install transverse raised rumble strips as per Standard Plans Index 546-001 in the northbound and southbound directions in advance of the mid-block crossing.
- Upgrade the school zone signing and pavement markings to comply with FDOT's Speed Zoning Manual.
- Provide a new mid-block pedestrian crossing at approximately MP 0.696 where the roadway crosses the canal.

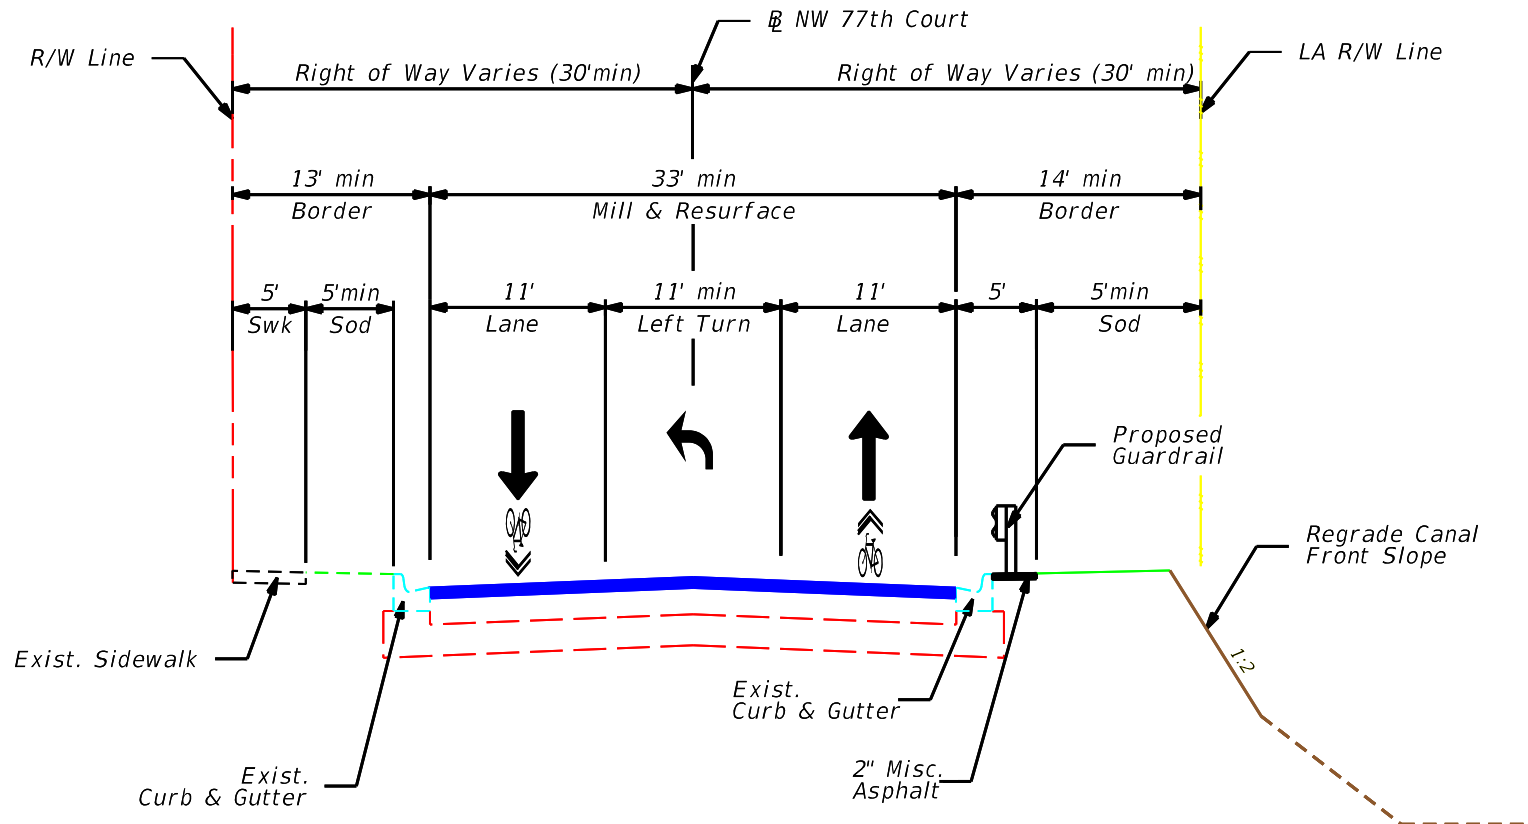
Figure 3-1 Recommended Typical Section NW 77th Court from MP 0.153 to MP 0.385

The existing cross sectional elements for the roadway typical section are recommended to remain the same as shown in **Figure 3-1** to **Figure 3-4**.
