Technical Memorandum

March 8, 2017

Re: Public Rest Area Truck Parking

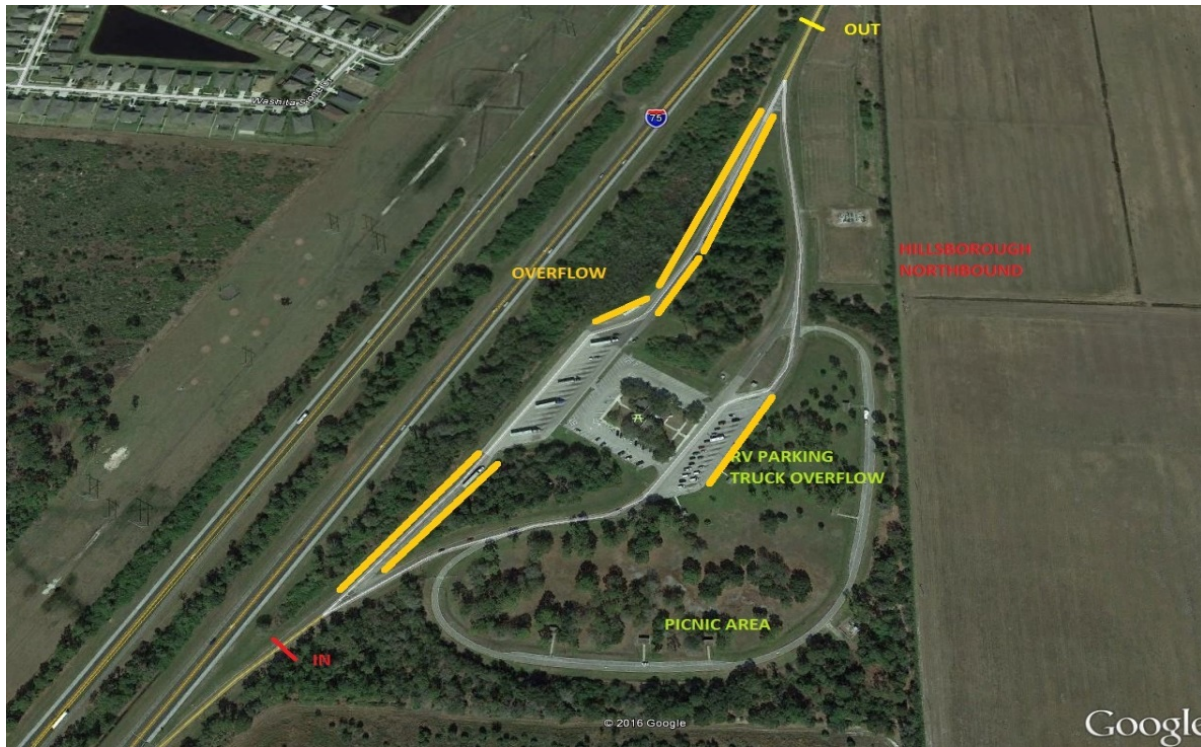
FIGURE 1
NORTHBOUND HILLSBOROUGH REST AREA OVERFLOW PARKING

Both graphs show a clear pattern of limited to overcapacity parking between the hours of approximately 8:00 p.m. and 8:00 a.m. (shown in red). The blue lines show the number of available large vehicle parking slots during the various time periods. Note that the maximum number of available large vehicle spaces in this rest area is 36 even though the graphs might indicate more availability. The excesses are due to counting errors that affected the totals. Except for a lengthy period of time from mid Tuesday morning to later that evening, the truck parking was at or above capacity for the 19 available spaces. As a result, some trucks were probably parked in the RV area and others were parked on the inbound and outbound shoulders as shown on **Figure 1**.

On 12/1/2016 this rest area was visited at approximately 6:00 a.m. in order to validate parking overages and determine where the trucks were illegally parked. At that time 54 trucks were counted within the rest area and on the inbound and outbound shoulders within the truck parking area as shown in **Figure 1** above. The available truck spaces were exceeded by 35 vehicles and the total large vehicle parking was exceeded by 18 vehicles.

FDOT should consider, where feasible, providing a “go-around” for trucks that pass through the truck-only parking area to access the additional large vehicle parking spaces in the RV area when available to reduce the illegal parking on ramp areas and on the mainline.

Another consideration should be adding hard shoulders within the rest areas to provide for legal overcapacity parking. Additionally, in deference to the trucking industry, the truck-only parking areas should be signed as “**Commercial Trucks Only-Strictly Enforced**” and the RV areas should be signed to permit truck overflow.

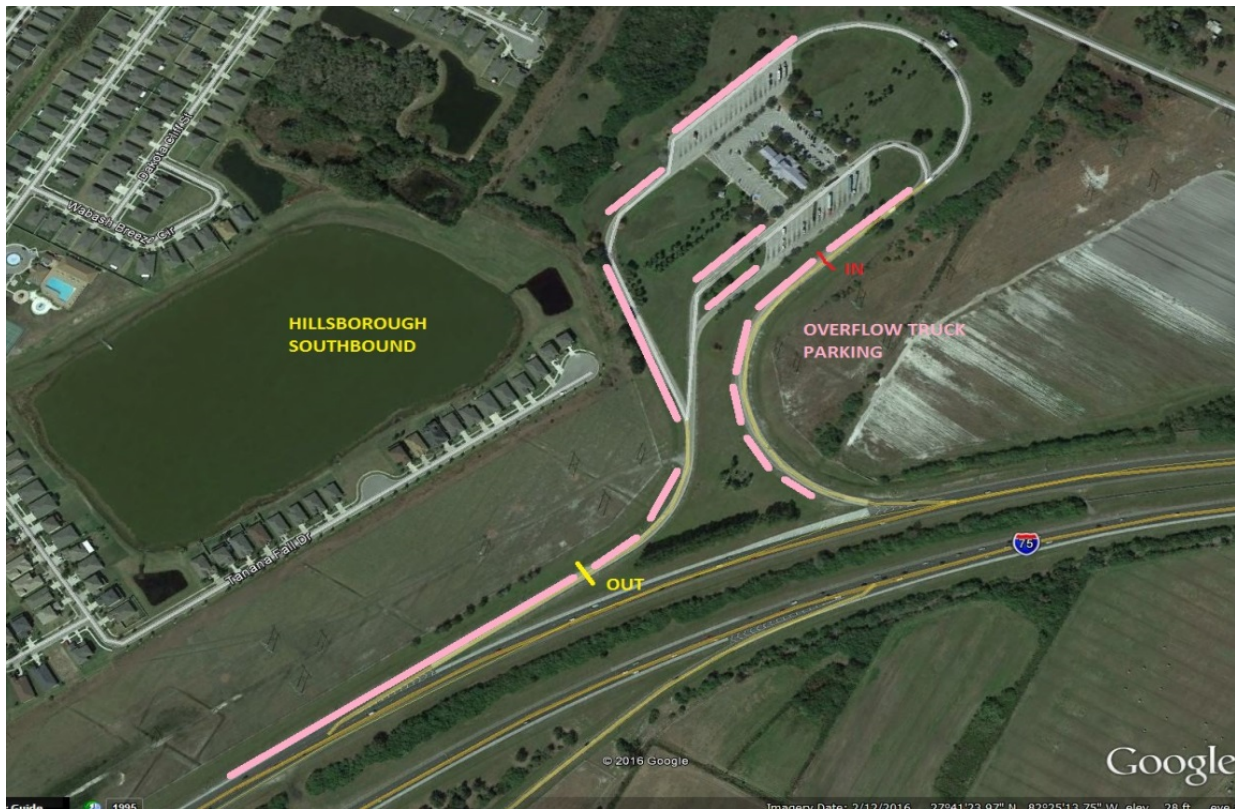
**FIGURE 2
SOUTHBOUND HILLSBOROUGH REST AREA OVERFLOW PARKING**

The field team noted several trucks parked on the inbound shoulder within the rest area at the time of tube deployment (11/14/2016 between 10:50 a.m. - 11:10 a.m.), even though there appeared to be several open spaces in the truck parking area. The assumption is that these trucks arrived in the early morning hours when the lot was full and remained for their required rest period after the usual morning departures. The day the count tubes were retrieved, there were still trucks parked on the shoulder as far south as the merge lane to SB I-75 (11/17/2016 from 8:10 a.m. - 8:30 a.m.). Note that there is a lot more available shoulder parking in the Southbound rest area than in the Northbound area (**Figure 2**).

A visit on 12/1/2016 at 5:40 a.m. revealed 71 trucks parked in available spaces along the inbound and outbound ramps, along the back shoulder of the RV parking area, and on the exit ramps to SB I-75. The total trucks exceeded all the available large vehicle parking by 30 vehicles.

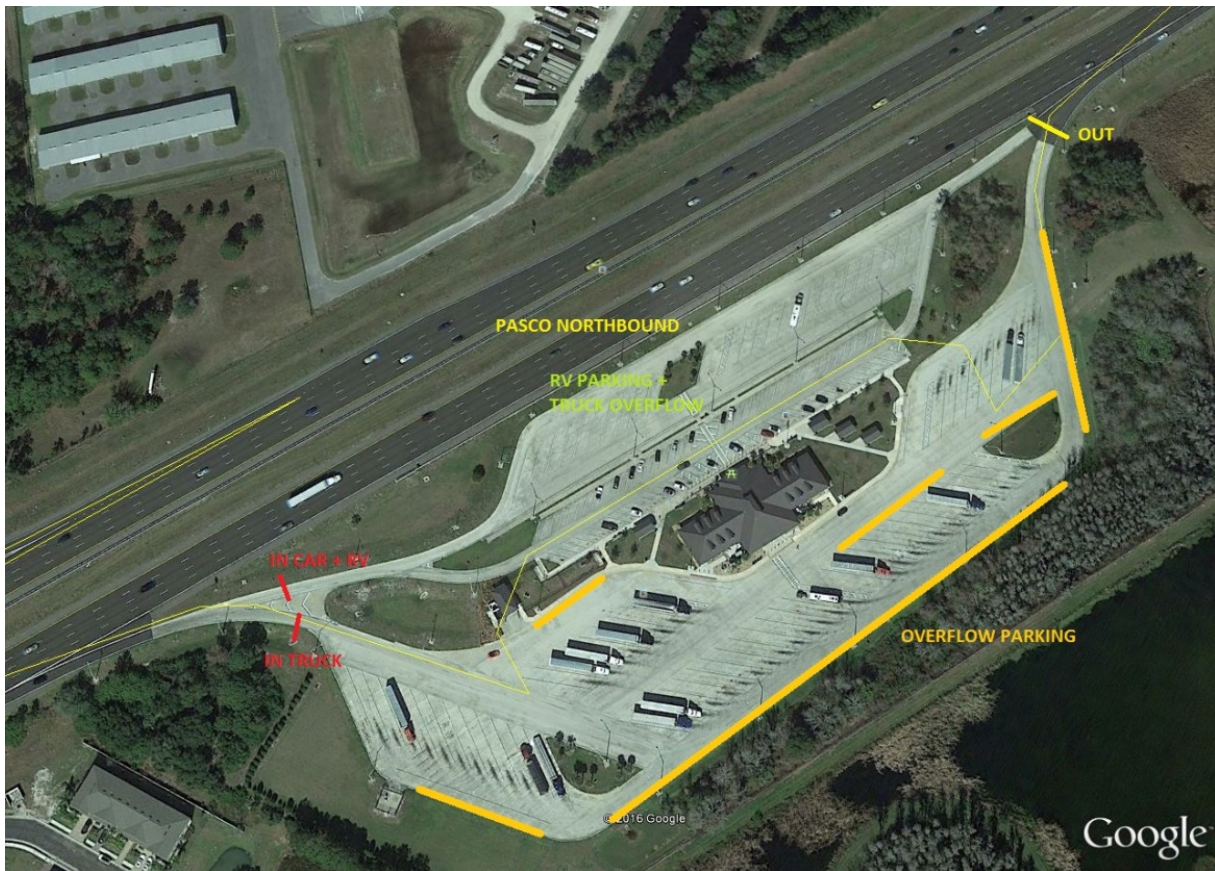
**FIGURE 3
NORTHBOUND I-75 PASCO REST AREA OVERFLOW PARKING**

and an additional 26 spaces for RVs for a total large vehicle capacity of 83 spaces. **Attachment 5** shows that even with this number of parking spaces, capacity is routinely exceeded. However, unlike the Hillsborough rest areas, the overcapacity periods were from the late afternoon to early morning. During the count period, there appears to be a small anomaly from Tuesday evening to Wednesday morning where the lot was crowded but capacity was not exceeded. Static counts taken at the time of counter deployment and pick up both during the late morning were 20 and 37, respectively. **Figure 3** shows where the overflow parking occurs in addition to the RV spaces.

Additional visits were made on 12/6/2016 at 5:15 a.m. and on 12/28/2016 at 10:30 p.m. During the first visit, the truck lot was not full (38 vehicles). However, a maintenance worker interviewed in the rest area stated that the truck parking is completely full by 2 a.m. daily. The second visit resulted in a truck count of 69 vehicles. Within the truck-only area, four trucks were illegally parked in back of the trucks occupying legal spaces and one truck was parked in the deceleration lane about two-hundred feet from the entrance. The remaining seven trucks were parked in the RV area.

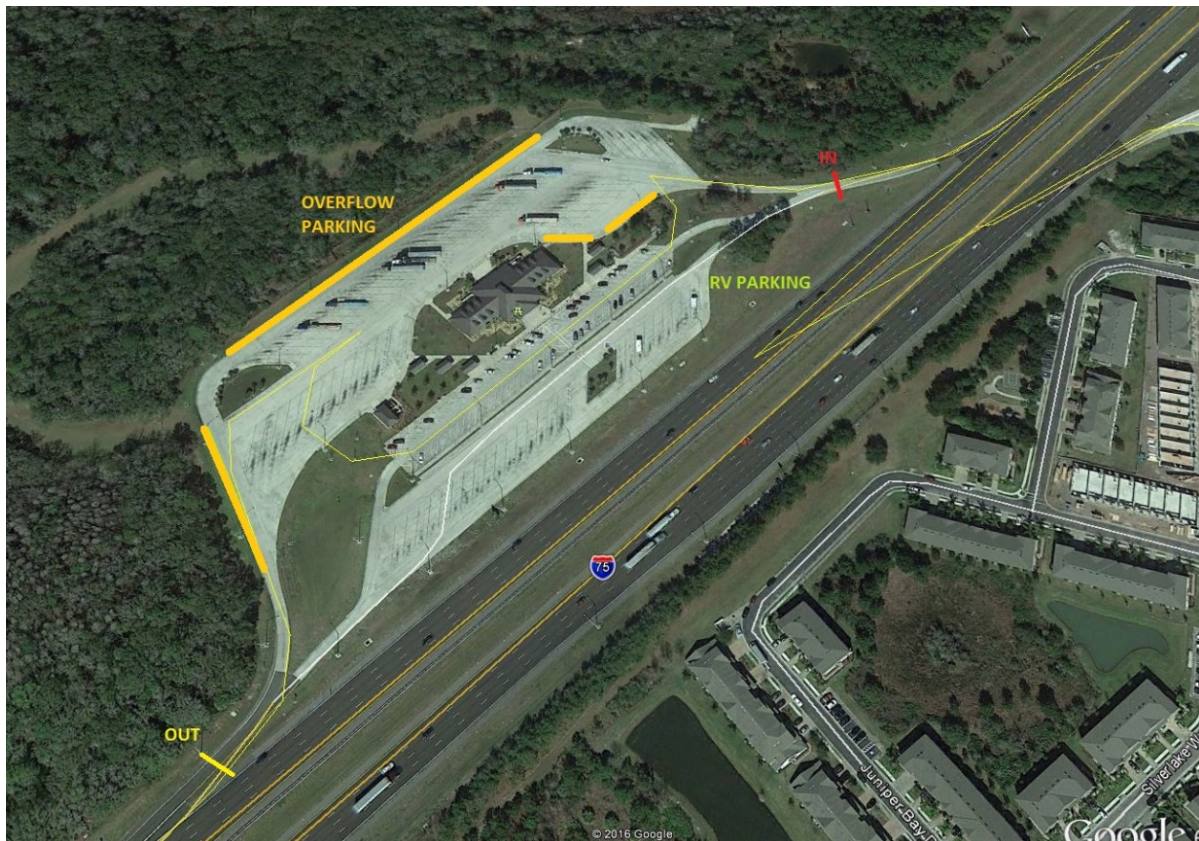
FIGURE 4
SOUTHBOUND I-75 PASCO REST AREA OVERFLOW PARKING

pattern for illegally parked vehicles appears to follow a regular pattern from approximately 8:00 p.m. to 8:00 a.m.; however, there was a counting error introduced in the Southbound Pasco rest area where the inbound counts were higher than the outbound, which compounded as the time period progressed. For this reason, graphics of the Southbound truck parking are not presented. Also, the Southbound counts were conducted on a different set of days than the counts at the other Southbound rest areas. This was due to a hose failure during the original counts. The Southbound Pasco rest area shows a similar pattern to that of the Northbound rest area with overflows occurring between early evening and early morning the following day. From mid-morning to mid-afternoon there are plenty of truck spaces available. **Figure 4** shows where most of the overflow parking occurs in addition to the RV spaces.

The rest area was visited on 11/28/2016 at 11:15 p.m. and on 12/6/2016 at 5:35 a.m. to validate the excessive truck parking indicated during the count period. During the first visit, there were 58 trucks parked within the rest area including three parked parallel behind the legally parked trucks, three on the shoulder, and one on the shoulder south of the southbound merge lane to I-75. At the time of the second visit, 70 trucks were parked within the rest area including 12 parked in the RV area, five parked parallel behind the legally parked trucks, one on the shoulder, and one on the main line merge shoulder.

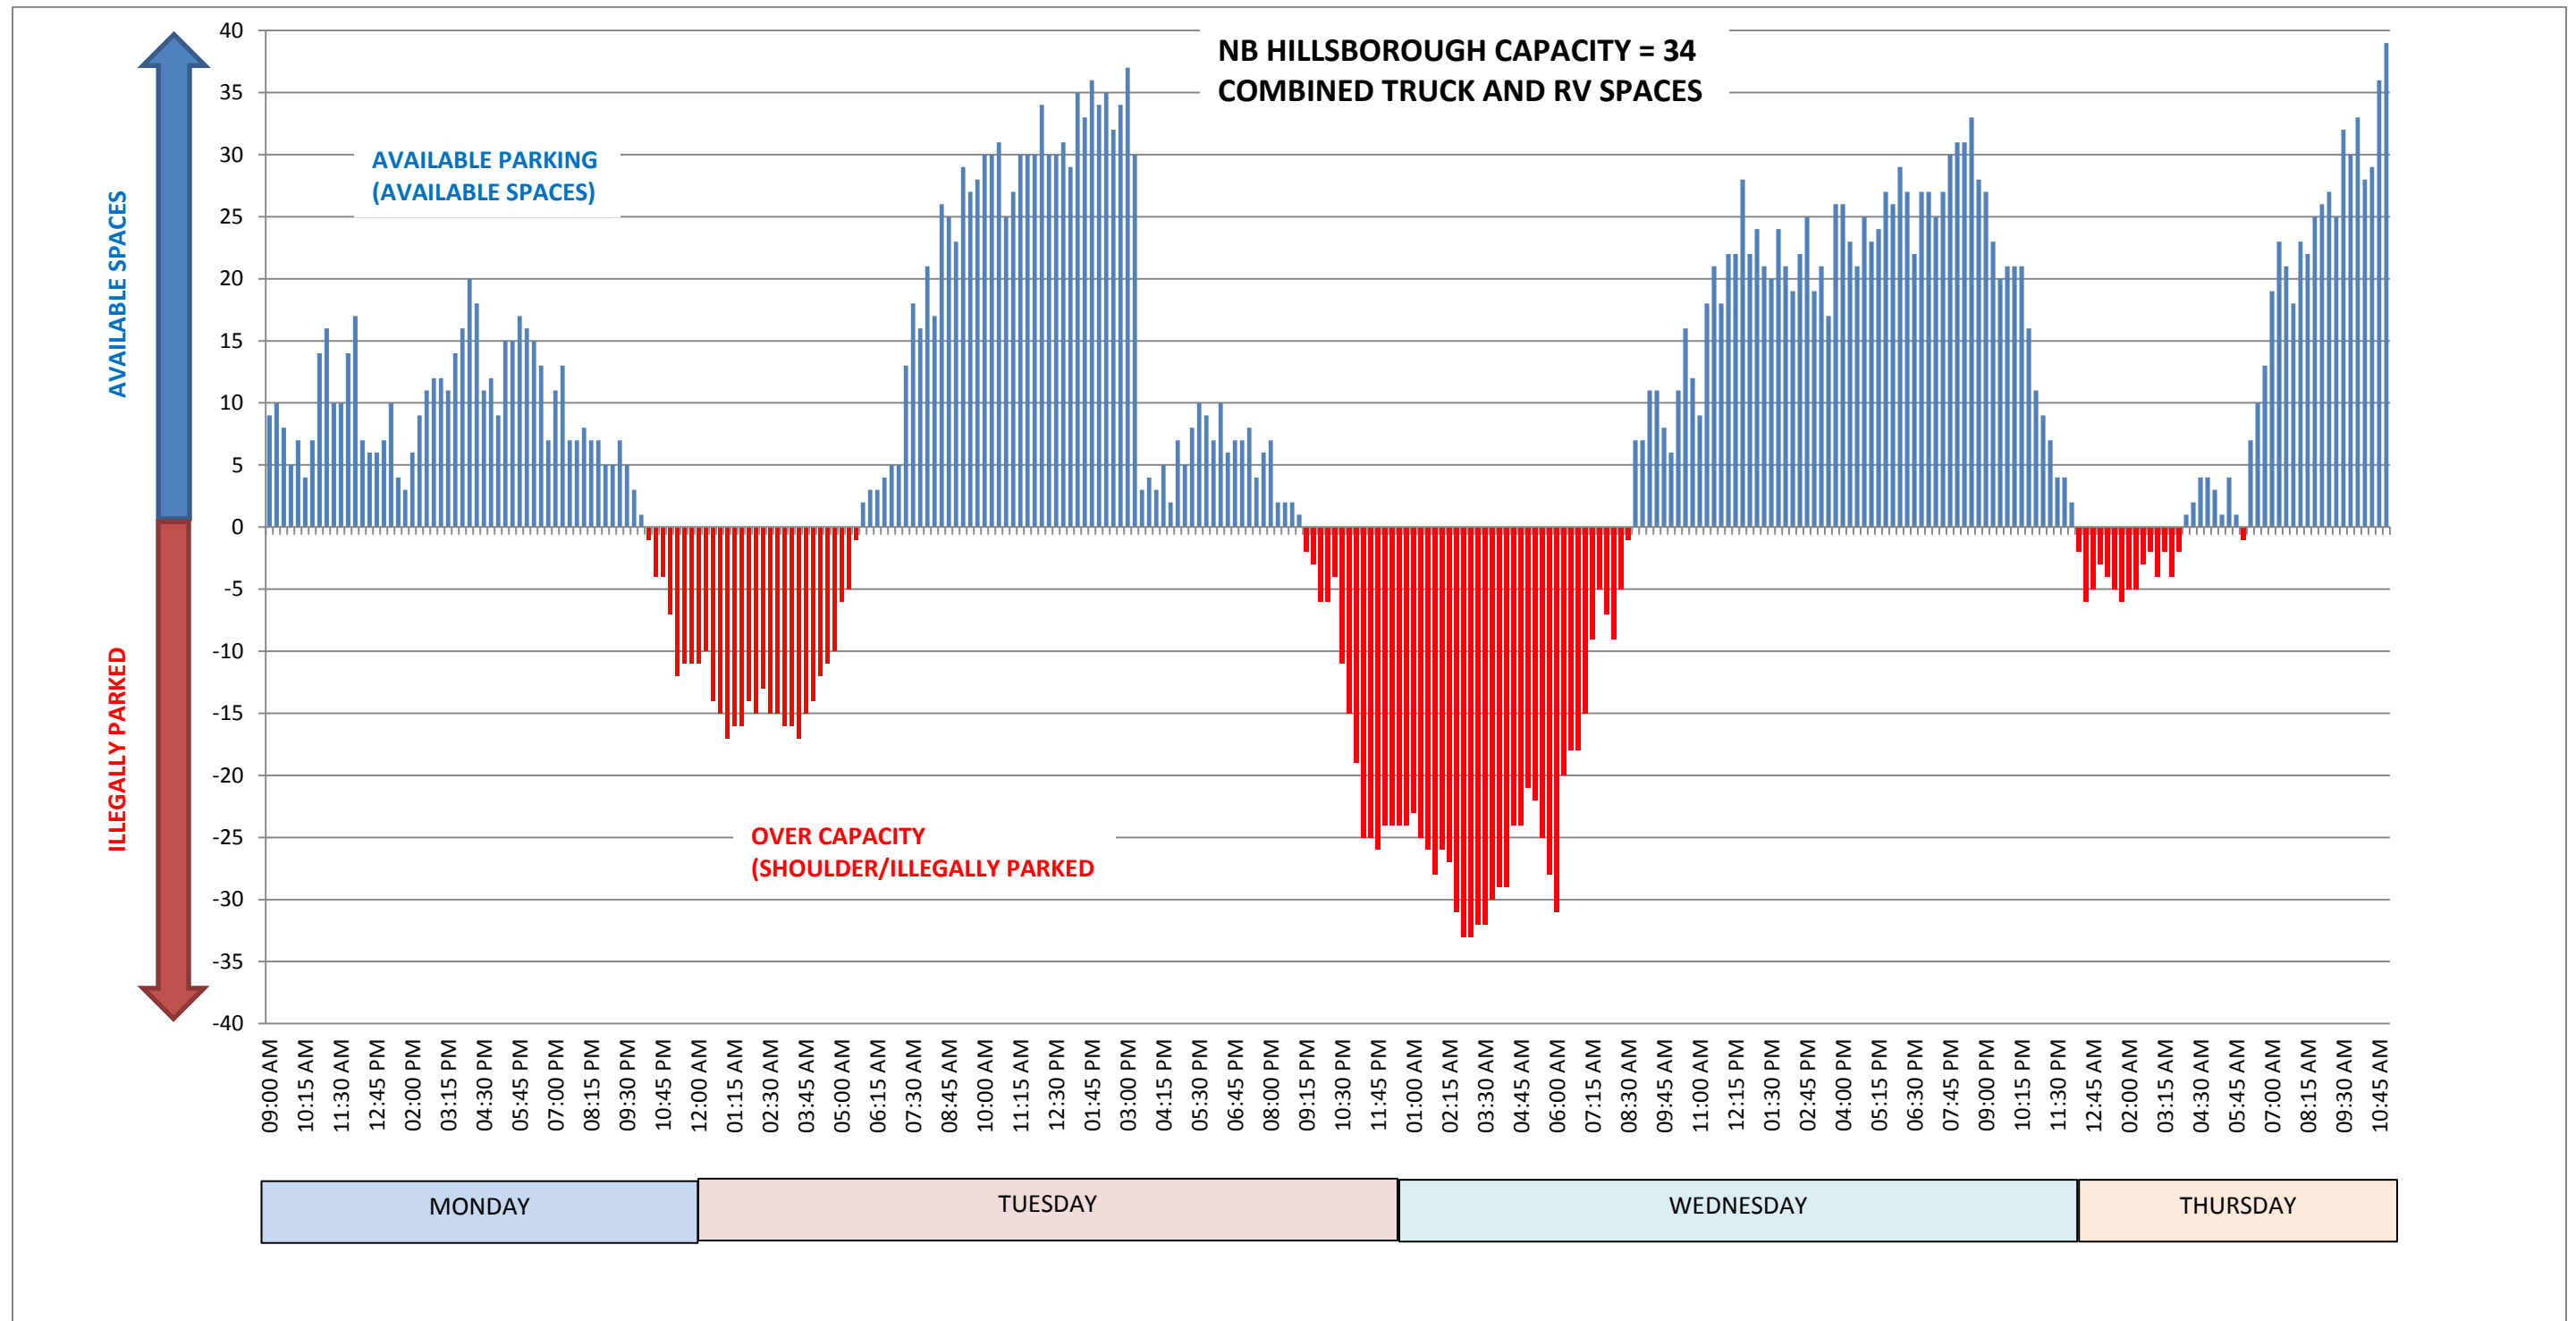
NORTHBOUND HILLSBOROUGH REST STOP

The Hillsborough northbound rest area is located approximately 3 miles south of SR 674 (Sun City Center Blvd). There are two graphs located in **Attachment 3**. The first includes both the truck-only plus RV spaces, and the second shows the truck-only spaces.

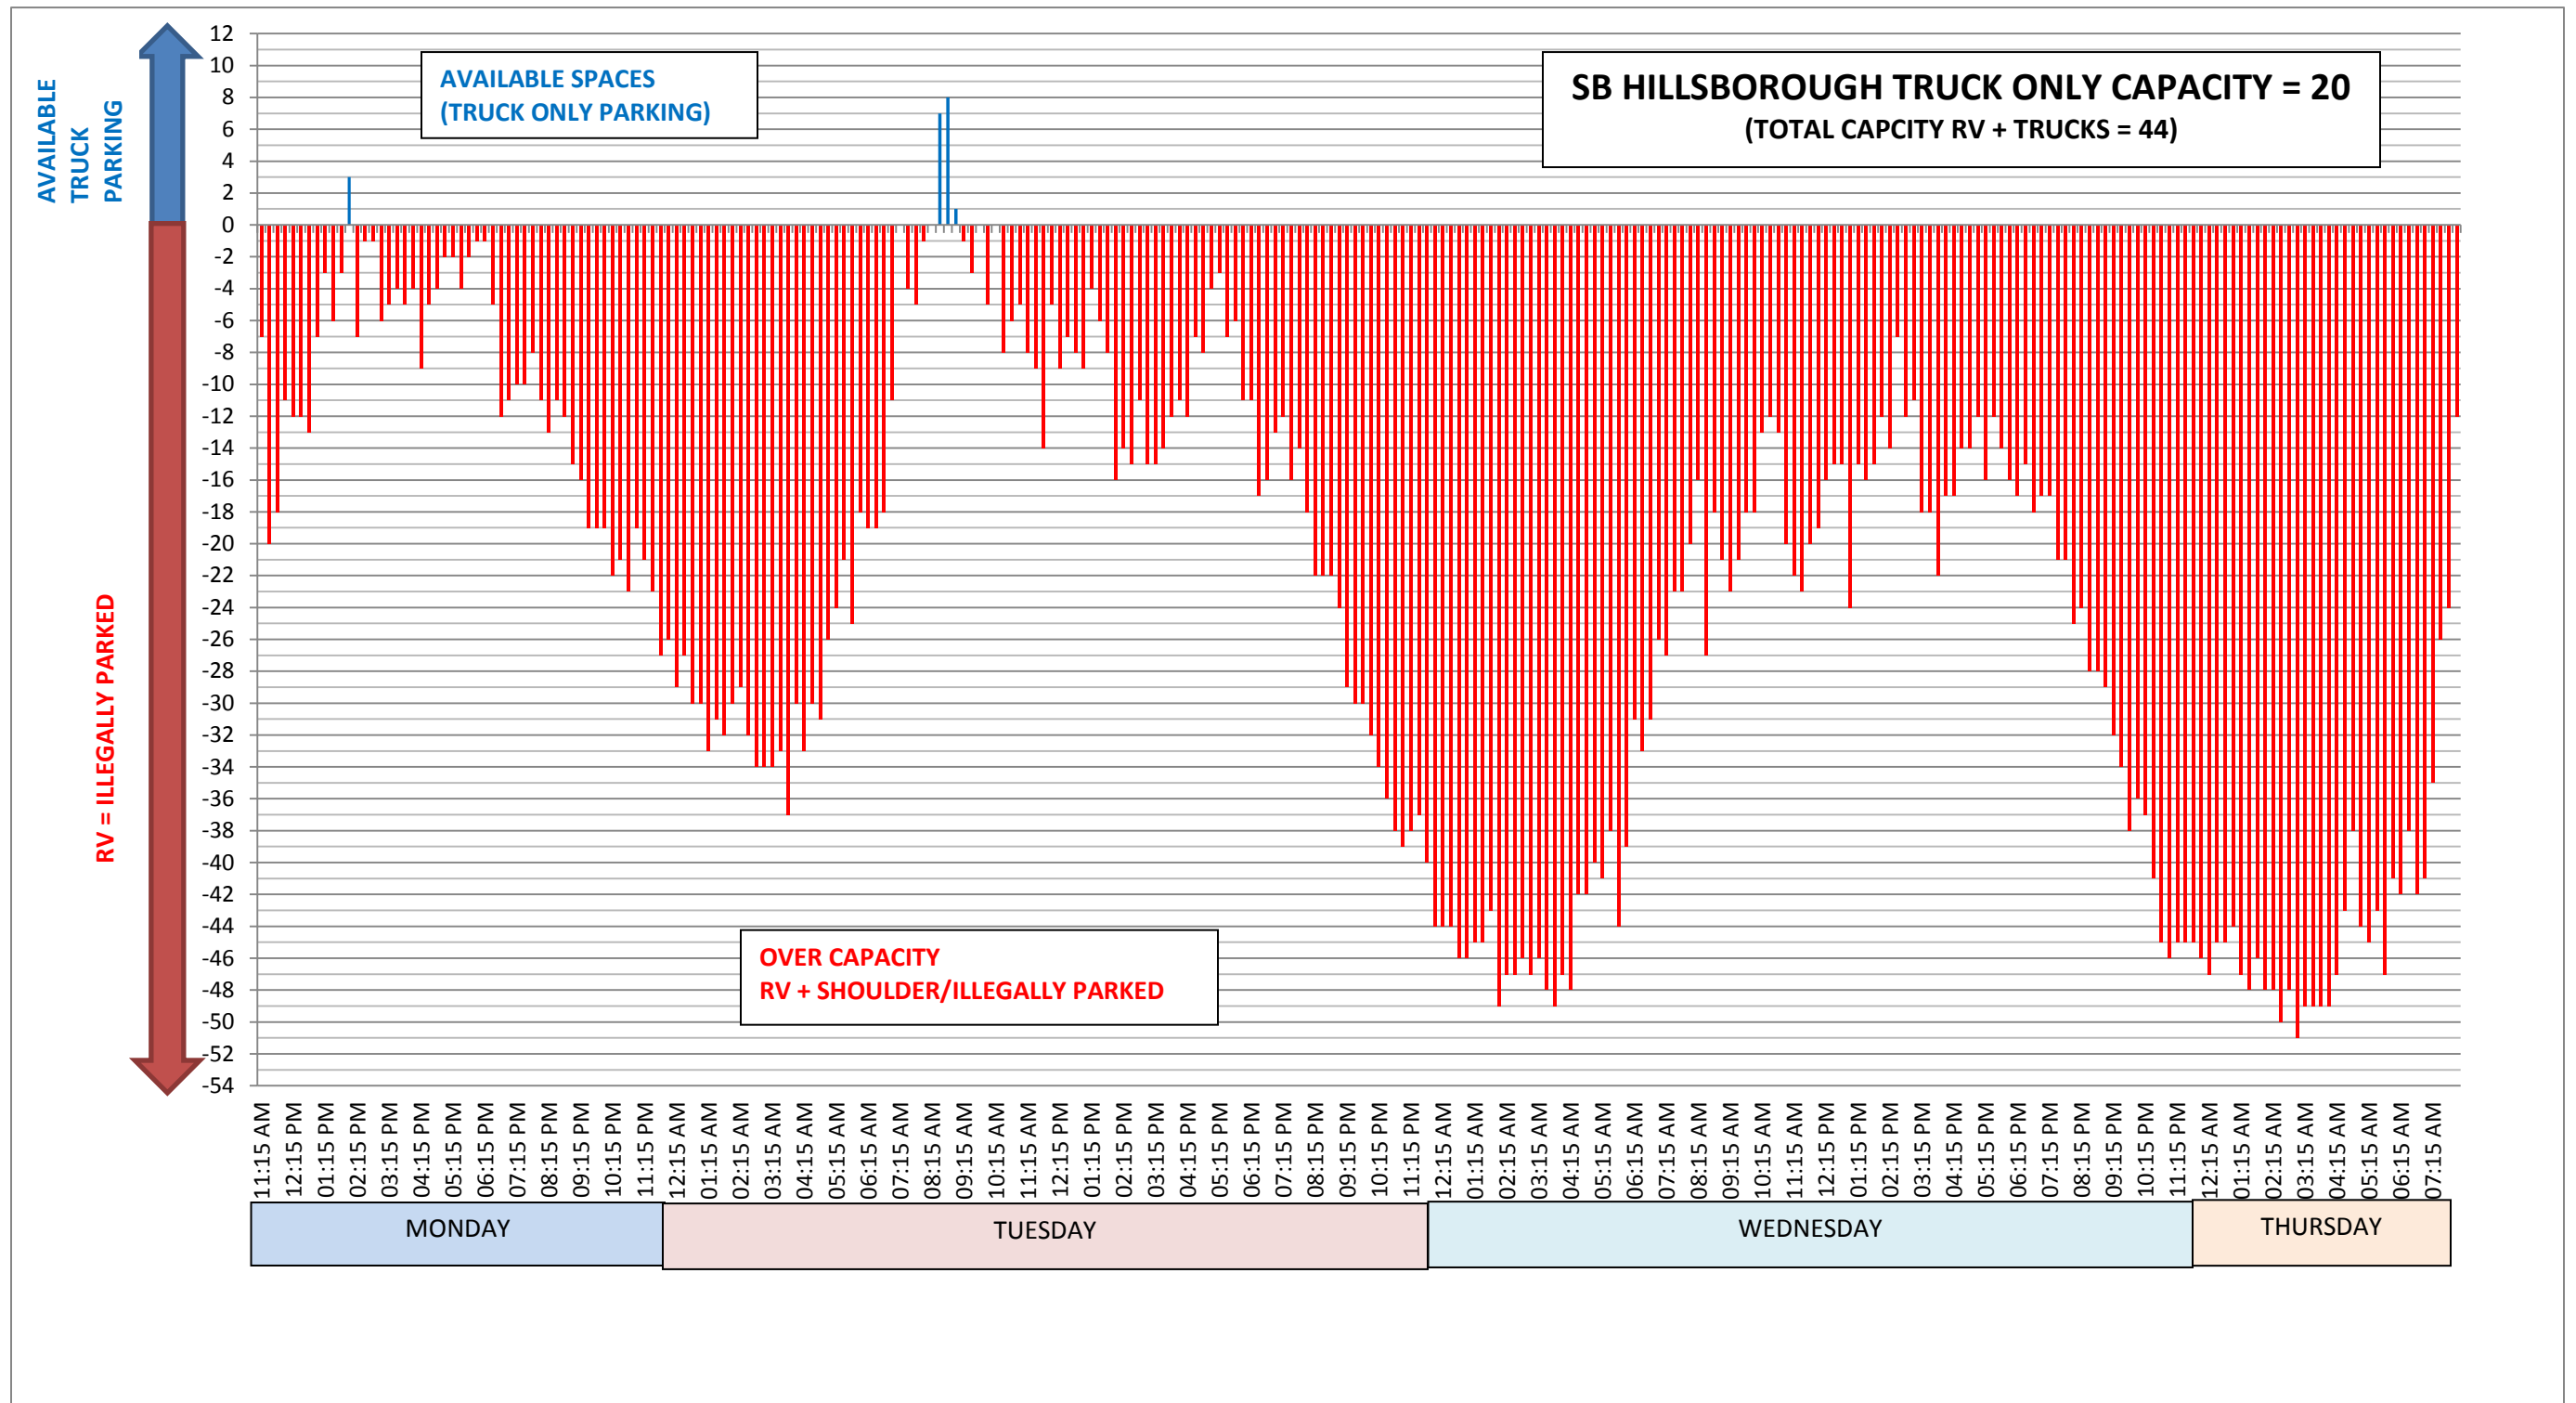
SOUTHBOUND HILLSBOROUGH TRUCK ONLY PARKING

The Hillsborough Southbound rest area is located approximately 2.5 miles south of SR 674. The two graphs associated with this rest area are shown in **Attachment 4**. Both the large vehicle parking and the truck-only parking graphs show a similar pattern to the Hillsborough Northbound rest area with overcapacity parking during the late evening to early morning hours and a large amount of spaces available during the daytime hours. However, the truck-only graph shows a much different story than

the Northbound rest area, with trucks exceeding the available truck spaces throughout the entire day especially during the heavy use hours. The worst case conditions suggest that trucks exceeded all available parking by as many as 30 trucks.

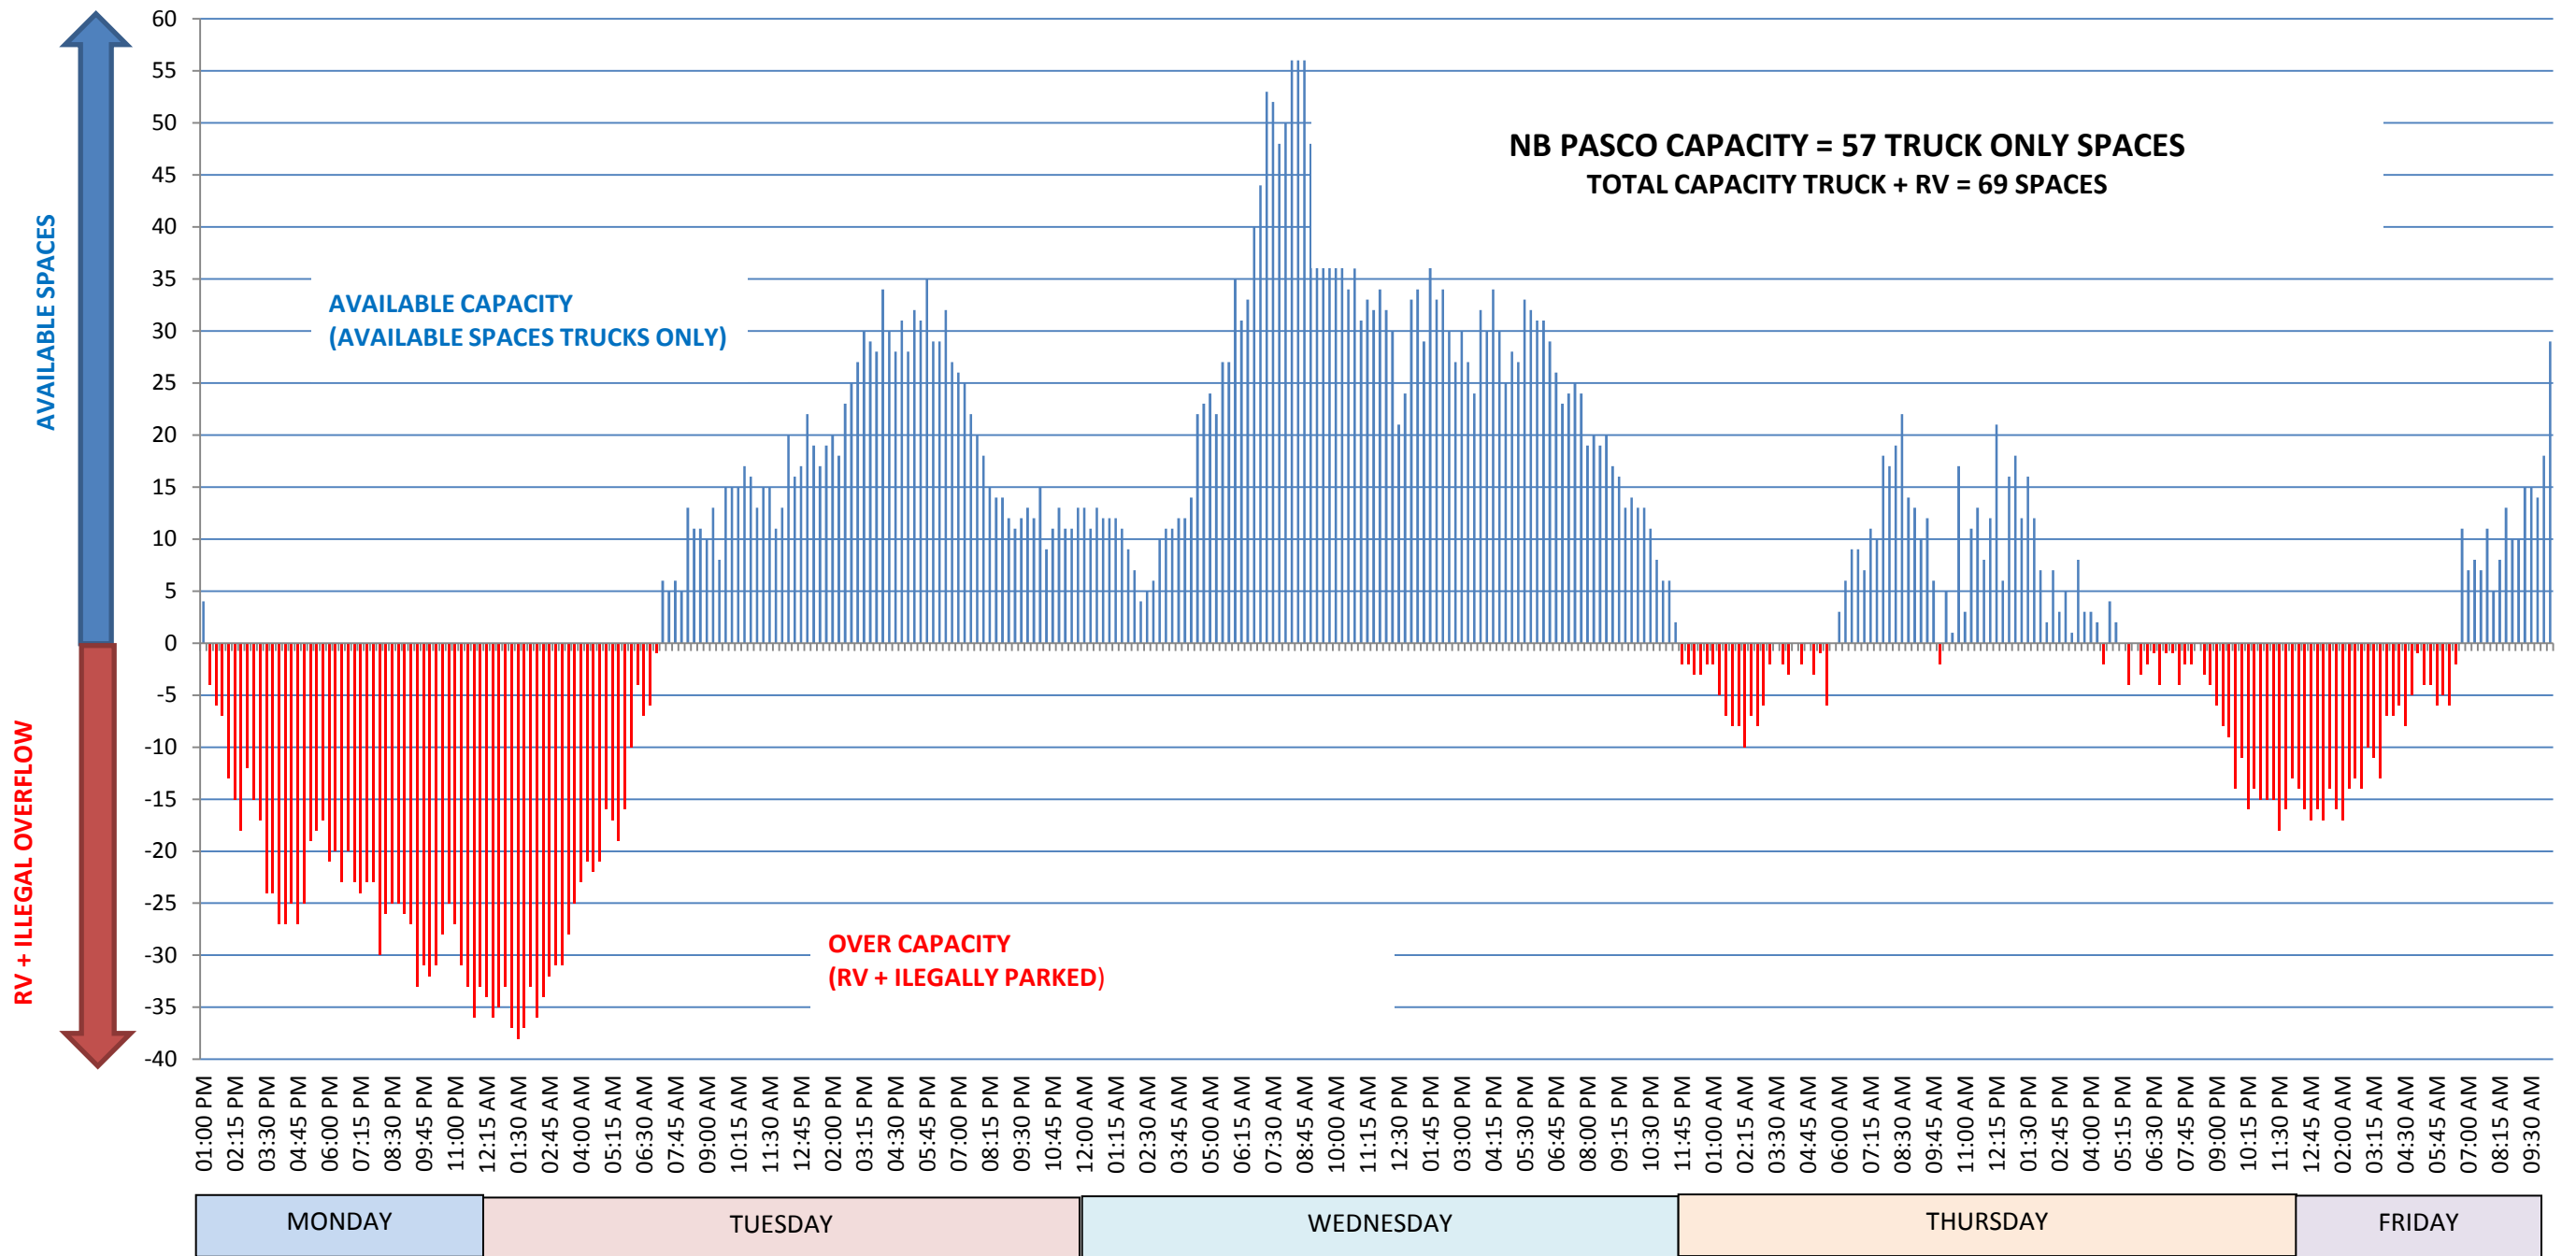
NORTHBOUND PASCO REST AREA TRUCK ONLY SPACES

NB PASCO CAPACITY = 57 TRUCK ONLY SPACES
TOTAL CAPACITY TRUCK + RV = 69 SPACES
