STRATEGIES FOR REDUCING RAILROAD TRESPASSING

Florida East Coast Railway Corridor -
Cocoa to Miami

August 6, 2021

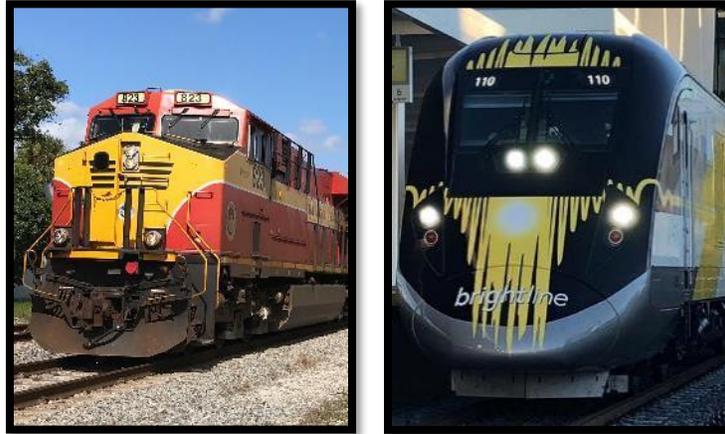
Figure 3: FECR Freight and Brightline Passenger Trains

The study corridor is owned by FECR and extends 195 miles from Cocoa (Milepost (MP) 170) to Miami (MP 365). In addition to FECR freight trains, Brightline operated on the 65 miles between West Palm Beach (MP 300) and Miami from May 19th, 2018 until suspending operations on March 25th, 2020 due to COVID-19 with operations anticipated to resume in the fourth quarter of 2021. Construction is currently underway to extend Brightline's operation 130 miles north to Cocoa, where the FECR freight traffic to Jacksonville and Brightline passenger traffic to Orlando will split. From West Palm Beach to Miami, Brightline operates up to 17 trains per day with a top speed of 79 mph, with FECR operating on average 14 trains per day⁶ with a top speed of 60 mph. The extension to Cocoa, projected to be completed in 2022, will have a top passenger speed of 110 mph.

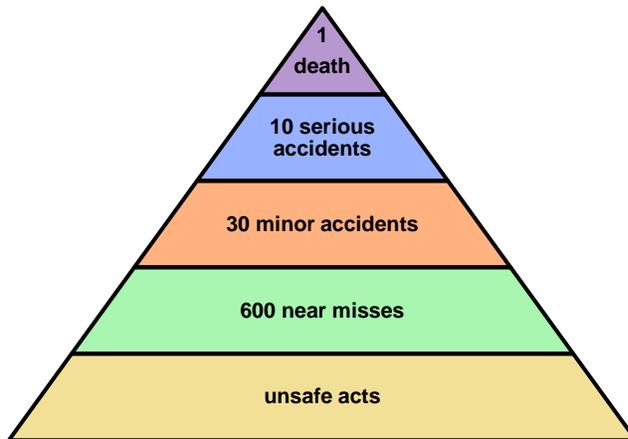
Figure 7: Heinrich's Accident Triangle

Trespassing incidents that result in a fatality are not isolated events. As depicted in Heinrich's Accident Triangle¹⁴ (Figure 7), a relationship exists between the number of serious and minor incidents. For every fatality, there are hundreds of unreported incidents. Accordingly, it is likely that efforts to reduce the number of minor trespassing violations will reduce the number of fatalities.

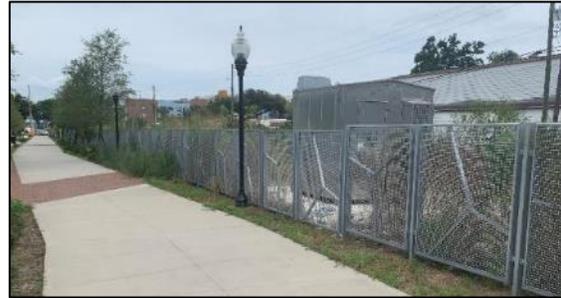
Figure 8: Channelization and Decorative Hardened Fencing on the CFRC

An application of a CPTED concept is channelization: directing pedestrian traffic from current trespassing paths to safer crossing points. This concept realizes the necessity of persons requiring access to and from specific locations on either side of the tracks. This type of engineering control consists of constructing a footpath or sidewalk parallel to the railroad right-of-way with a barrier or fence between the sidewalk and the tracks to guide the pedestrians to a protected crossing. This method can also create a visually appealing urban sidewalk (Figure 8) that discourages trespassing and enhances the railroad corridor and surrounding metropolitan area.

Hardened Fencing: Hardened fencing is designed to be difficult to climb or cut. This fencing is best utilized in high-traffic trespassing areas where there are visible signs of repeated trespassing or evidence that existing fencing has been cut or climbed over. Hardened fencing can look similar to chain link fencing (Figure 22), or can have decorative steel with masonry posts (Figure 8). While hardened fencing is the most effective barrier type, it is the most expensive.

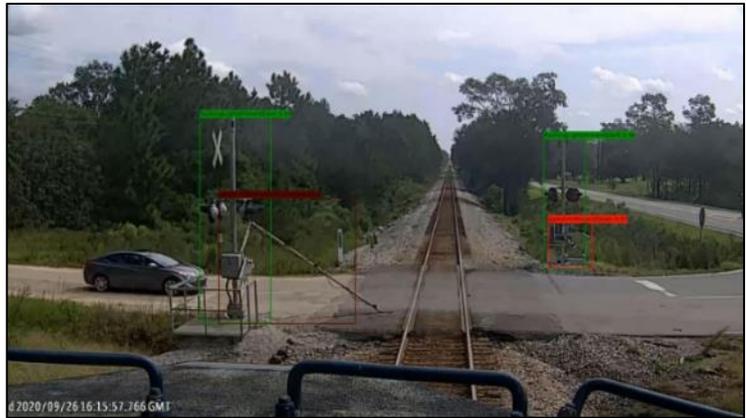
Figure 9: Video Detection Algorithm - Wi-Tronix using Locomotive Camera

This data is limiting, since, as seen in Heinrich’s Accident Triangle, there are many more trespassing actions and near misses for every one of the casualties. A location may have a large amount of trespassing but never have had a casualty. Accurate data is critical to determining the best method to reduce trespassing. Several vendors have developed cameras with automated detection algorithms to identify trespassing along a rail corridor. These cameras can be installed at grade crossings, along the corridor, or utilizing a forward-facing camera on a locomotive as shown in Figure 9. These systems will enable more accurate data collection at all hours. This technology will allow better detection of areas with high amounts of trespassing and help determine the root causes at each location.

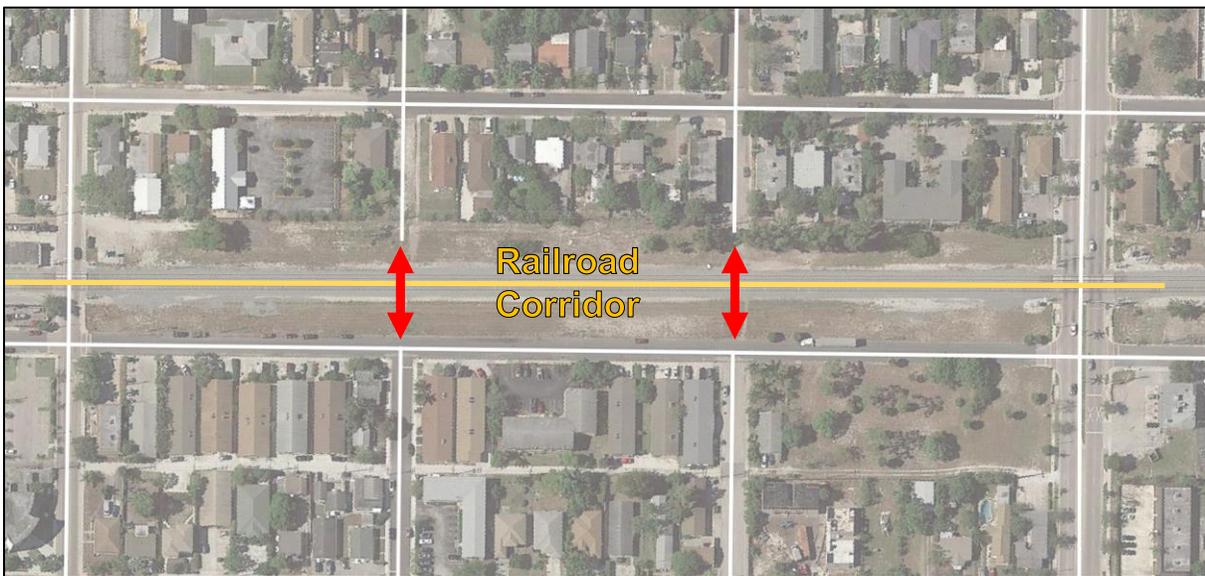
Figure 16: Trespassing Encouraged by Grid Pattern Road Design

It is common for neighborhoods to be laid out in a traditional grid pattern on the southern end of the corridor. This design was popular in older developments. Over time, grade crossings have been closed. Some of the roads, which used to be through routes for vehicles and pedestrians, are now blocked to cars, but pedestrians continue to use the route and trespass across the rail corridor. Over time, as seen in Lake Worth (Figure 16), well established trespassing trails have developed. While reducing the number of crossings reduces vehicle traffic risk, if no mitigation

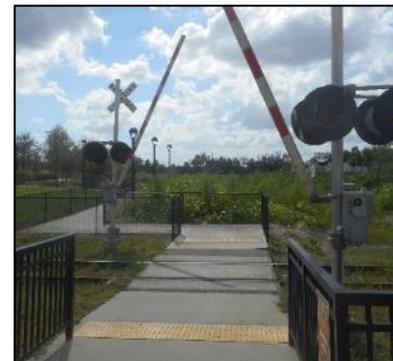
Figure 17: Pedestrian Crossing on SunRail¹⁸

Pedestrian grade crossings can be at-grade with a fully automatic pedestrian crossing consisting of pedestrian gates, bells, and flashing lights, or grade-separated. Pedestrian crossings are safer alternatives that allow for crossing at a location while informing pedestrians of oncoming trains. Pedestrian crossings must follow the Manual on Uniform Traffic Control Devices (MUTCD) and host railroad standards. It is recommended that new pedestrian grade crossings be used when there is evidence of a well-established trespassing path, long distances to any existing crossings, and robust origin-destination pairs.

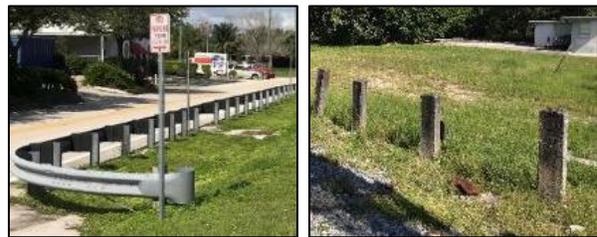
Figure 18: Guardrail and Bollard Barriers

Vehicle Barriers: Vehicle barriers include guardrail, bollards or curbs used to deter vehicle encroachment along the corridor. While they do not provide an effective barrier to pedestrian trespassing, it is effective at the end of dead-end streets and prevents vehicles from parking on the right-of-way. These barriers should only be used when there is no evidence of pedestrian trespassing or a clear origin-destination pair.

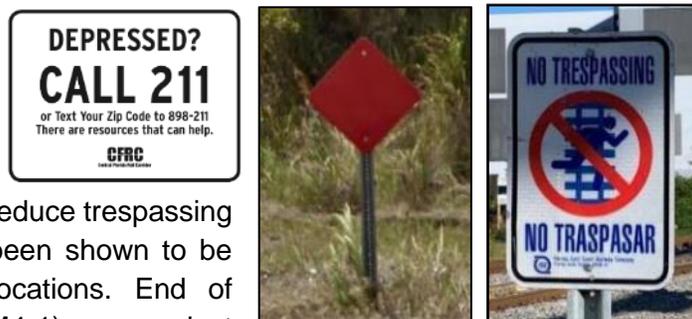
Figure 23:
Anti-Trespass Signage

Anti-trespassing signs or suicide crisis signage installed at strategic locations provide a passive method to reduce trespassing or collisions with trains. Anti-trespassing signage was shown in one study to reduce trespassing by 30%²⁰, and crisis signage has been shown to be effective on bridges and other locations. End of roadway object markers (MUTCD OM4-1) warn against someone accidentally driving onto the tracks and are

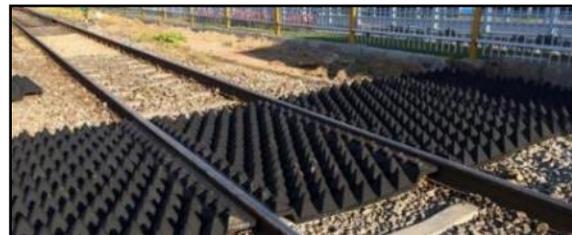
Figure 24: Anti-Trespass Panels

Anti-trespass panels make walking almost impossible because of the panel's surface profile. The panels prevent access where fencing is infeasible or ineffective, including at the ends of at-grade crossings and station platforms²¹. However, the panels make it more difficult for authorized personnel to access the corridor.

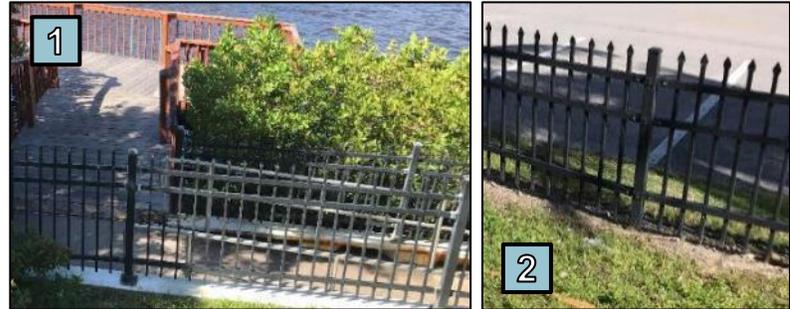
Figure 25: Trespassing Mitigation in Stuart, FL

The City of Stuart has installed several methods that reduce trespassing across the railroad. The city has built a path and boardwalk that goes under the railroad (Figure 25, photo 1), providing access to the park from the west side and a pleasant path along the St. Lucie River. The deterrent (fencing) and channelization (path) discourage individuals from crossing the tracks at an unsafe location. Further south, there is the 4 ft. aluminum fencing on one or both sides of the track through downtown Stuart (Figure 25, photo 2). This design discourages pedestrians from taking shortcuts and encourages using the many existing at-grade crossings in the area.

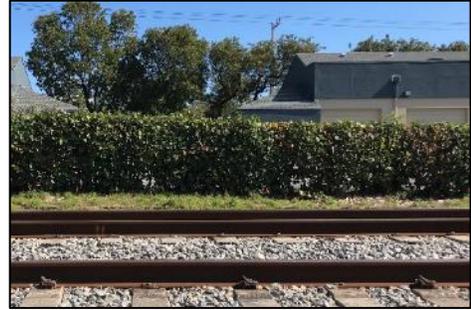
Figure 27: Vegetation in Boca Raton, FL

The Boca Business Center in Boca Raton planted hedges between the parking lot and the railroad corridor south of Yamato Rd. This location has industrial and warehouse buildings on both sides of the railroad with no strong origin-destination pairs. The area makes trespassing less likely and is an excellent example of vegetation used as a trespassing barrier (Figure 27).

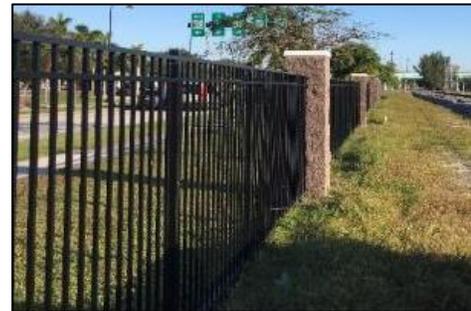
Figure 28: Decorative Hardened Fencing in Deerfield Beach, FL

In 2020, Deerfield Beach installed hardened fencing between Hillsboro Blvd. and 10th St., where two prior trespassing fatalities occurred. The decorative hardened fencing provides a barrier to trespassing. A parallel sidewalk channelizes pedestrians to the existing grade crossings (Figure 28).

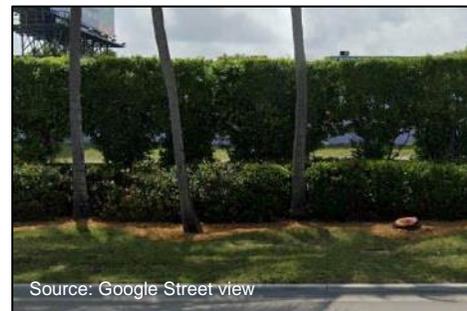
Figure 29: Vegetation in Aventura, FL²²

Vegetation has been used to provide a trespassing and visual barrier between the roadway and railroad corridor along Biscayne Blvd. in Aventura. A mix of vegetation is used that grows to different heights to provide a complete barrier while not creating hidden locations that could draw loitering or homeless activity (Figure 29). The tall bushes in the back provide visual barriers, but others are trimmed near the ground to prevent hidden spaces. Shorter vegetation is used to prevent anyone from moving through the gaps. The vegetation is a lower height as it approaches at-grade crossings to avoid line-of-sight issues.

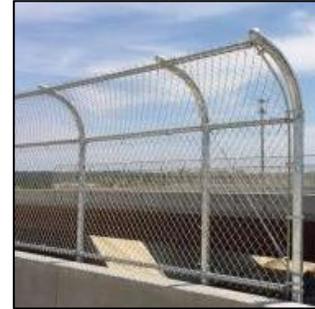
Figure 30: FDOT Standard Bridge Fencing

Railroad bridges are inviting locations to trespassers. They are shortcuts across waterways and inviting places to loiter on for recreation including, sitting, fishing, or swimming. Fencing on both sides limits the ability to use the bridge for these purposes and reduces the trespassing threat (Figure 30). Bridges that would benefit from bridge fencing and are not incorporated in another project are listed in Table 5.

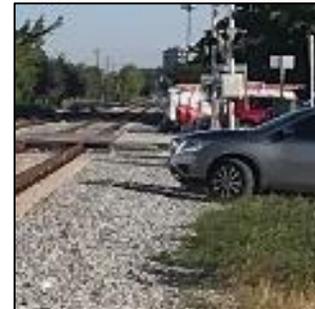
Figure 31: Parked Vehicle Encroachment

- At dead-end streets, motorists may not know that they have reached the end of a roadway and could continue onto the railroad tracks.
- When a road is parallel to the tracks, and the road gets close to the tracks, it would be easy for a vehicle to end up on the tracks during a motor vehicle accident or unwittingly drive too close to the tracks.
- In parking lots, a vehicle or truck backing up could foul the tracks and be struck by a passing train.

Guardrail or other barriers should be considered to protect against any incursion from a vehicle. When the roadways or parking lots are close enough to be adjacent to the railroad ballast, a curb should be installed to provide a visual edge to the roadway.

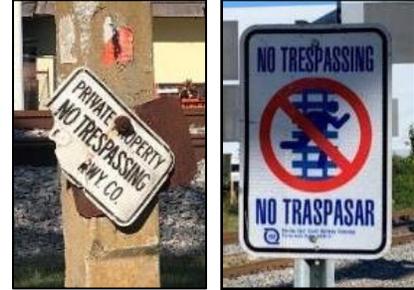
Figure 32: Anti-Trespass Signage Along FECR Corridor

The signs make it clear to the community that the corridor is not public property. While signs only reduce the actions of those who abide by the rules and are not aware that trespassing is prohibited, they provide a low-cost deterrent. Signs can be installed if other mitigation methods are not selected. Installing signs along the property line and at dead-end streets can define the corridor similar to a fence or vegetation.

Existing signs that have become illegible or damaged should be replaced. New signs show active management and patrolling of the corridor.

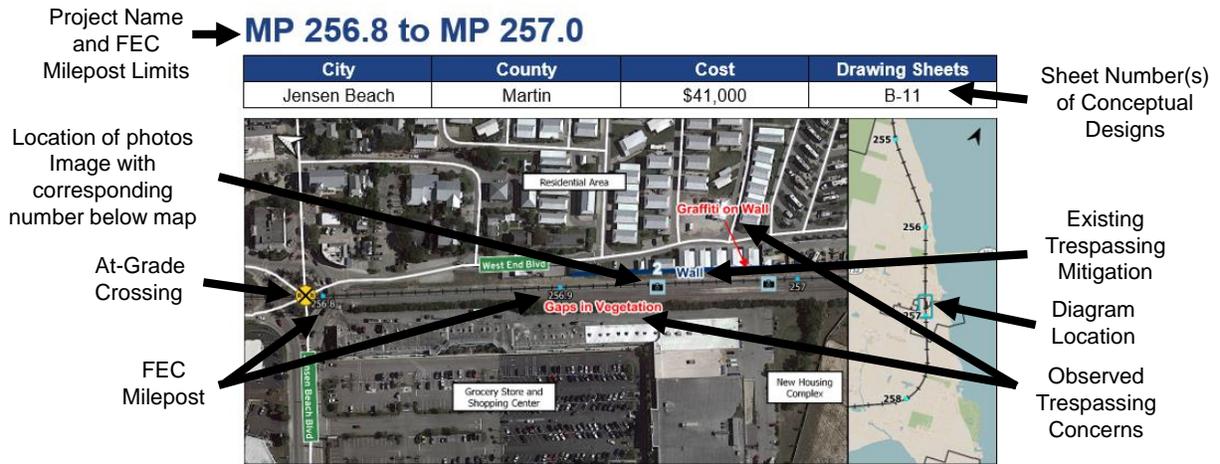
Figure 35: Information shown in Project Narratives Maps

A short description of findings and recommended mitigation methods are provided for each project. The map for each project includes key landmarks, grade crossings, existing trespassing mitigation, and indications of trespassing (Figure 35). Any locations referred to in the narratives but not shown in the maps are referred to by milepost. Full limits of each project, and conceptual designs of the proposed mitigation projects can be found in the design sheets referenced in the header.

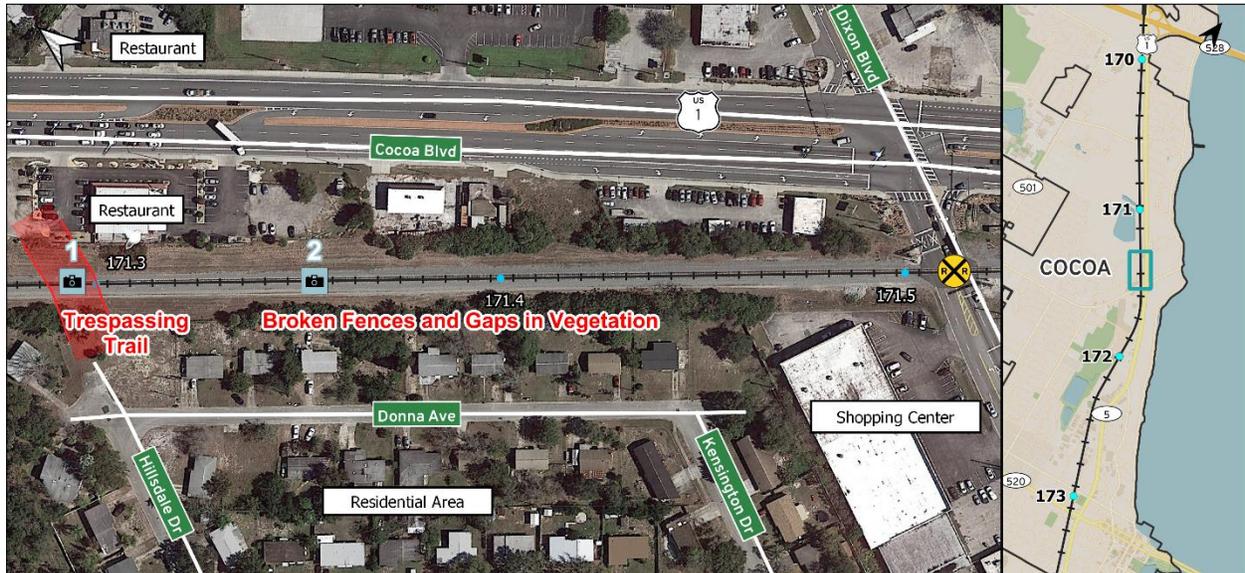
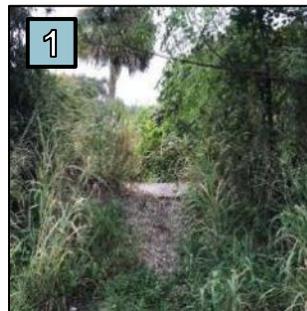
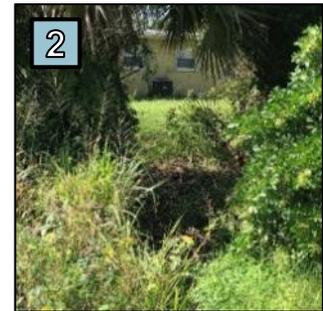
MP 171.3 to MP 171.5

In Cocoa, several signs of repeated trespassing exist just north of Dixon Blvd. A defined trespassing path connecting the Hillside Dr. dead end to the parking lot of a restaurant along Cocoa Blvd. (US 1) is well defined (photo 1). Additionally, between the path and Dixon Blvd., numerous gaps occur in the existing fencing and vegetation between the homes and right-of-way along the corridor (photo 2). There was a trespassing fatality at this location in February 2020.

Several restaurants are across the railroad tracks from this neighborhood. To reach the trespassing destinations, trespassers are taking the shortcut across the railroad tracks instead of walking to the front of the community and then along Dixon Blvd. Pedestrians are also walking along the right-of-way to Dixon Blvd. to reach various retail stores (e.g. Big Lots, Dollar General, and Tractor Supply) across the street.

Recommendation: Construct **8 ft. hardened fencing** along the west side of the right-of-way from just north of Hillside Dr. to Dixon Blvd. because of the strong draw from the large differences in travel distance and gaps in existing residential fencing.

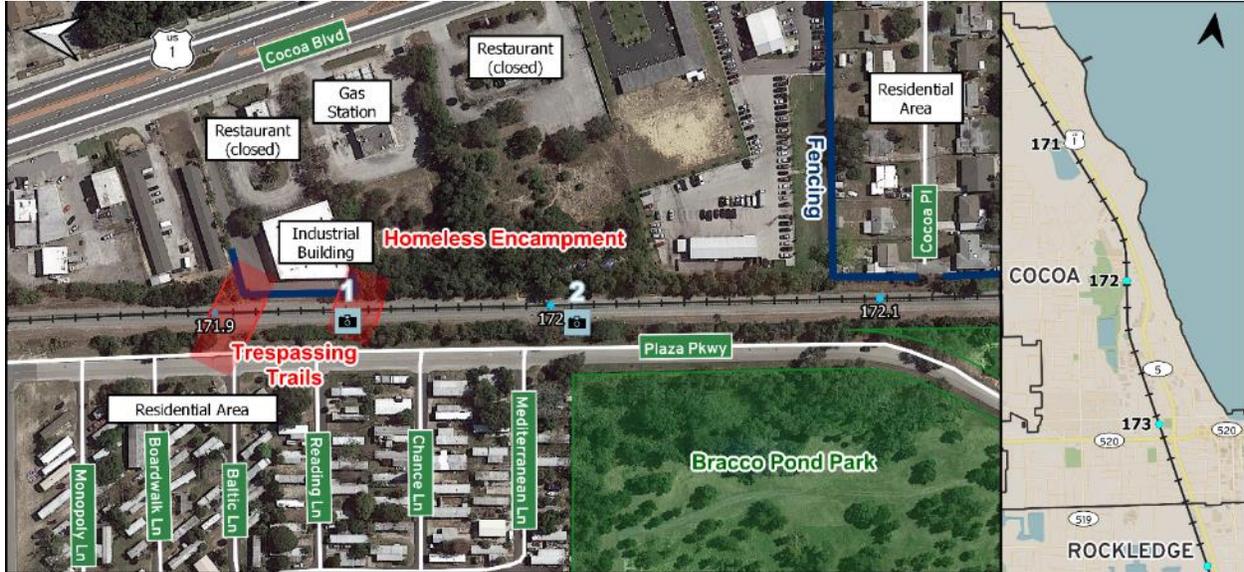
In Cocoa, evidence of repeated trespassing exists along Plaza Pkwy. A defined trespassing path was found connecting the residential area to commercial buildings along Cocoa Blvd. (US 1) (photo 1). In the wooded area, an existing homeless encampment was identified (photo 2).

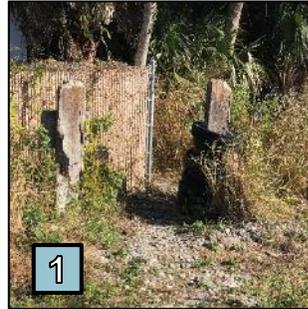
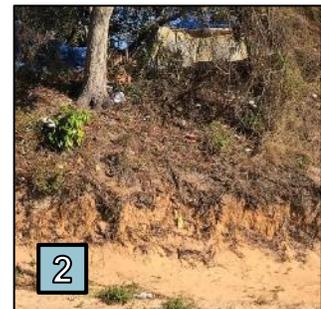
Evidence suggests trespassers are walking across the tracks to reach a gas station. Two fast-food restaurants now closed could become an additional draw to trespassing if they were to reopen. There is existing fencing on the east side of the right-of-way north and south of the path and encampment.

Recommendation: Construct **8 ft. hardened fencing** along the east side of the right-of-way, connecting the existing fencing across from Crestview Rd. (not shown, MP 171.83) to the fencing along the residential area. The fencing limits access across the corridor from the neighborhood and the homeless encampment.

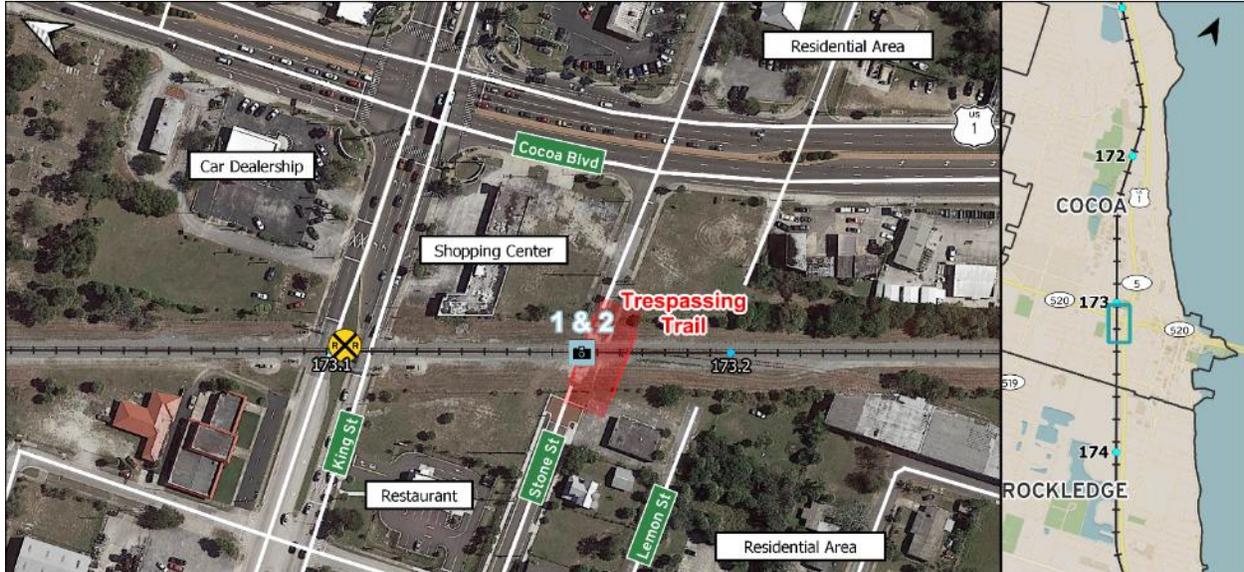
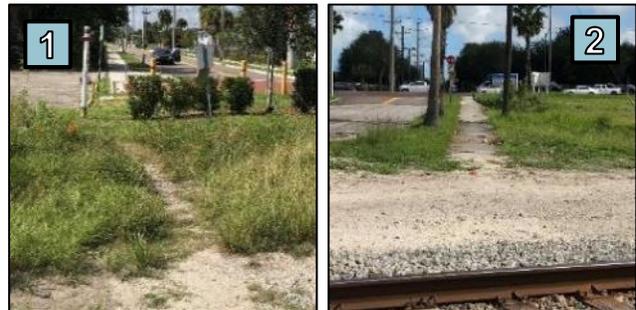
MP 173.1 to MP 173.3

In Cocoa, a well-defined footpath crosses the tracks at the dead end street, Stone St. In 2007, the grade crossing was closed, and the crossing panels and sidewalks were removed. However, a trespassing trail developed in its place between the remaining sidewalks on either side of the crossing (photos 1 and 2).

Like many closed crossings along the corridor, pedestrian movements are unaffected by the grade crossing's closure, and trespassers continue to use the area for crossing the tracks. Since Stone St. does not have a crosswalk at Cocoa Blvd. (US 1), any trespasser coming from across Cocoa Blvd. is either jaywalking or has to walk to King St.

Recommendation: Construct **4 ft. aluminum fencing** from King St. to Lemon St. The barrier will divert trespassing away from Stone St. to King St. Since there is an available crossing location nearby, 4 ft. fencing can provide sufficient deterrence without the adverse visual effects of a less appealing chain link fence.

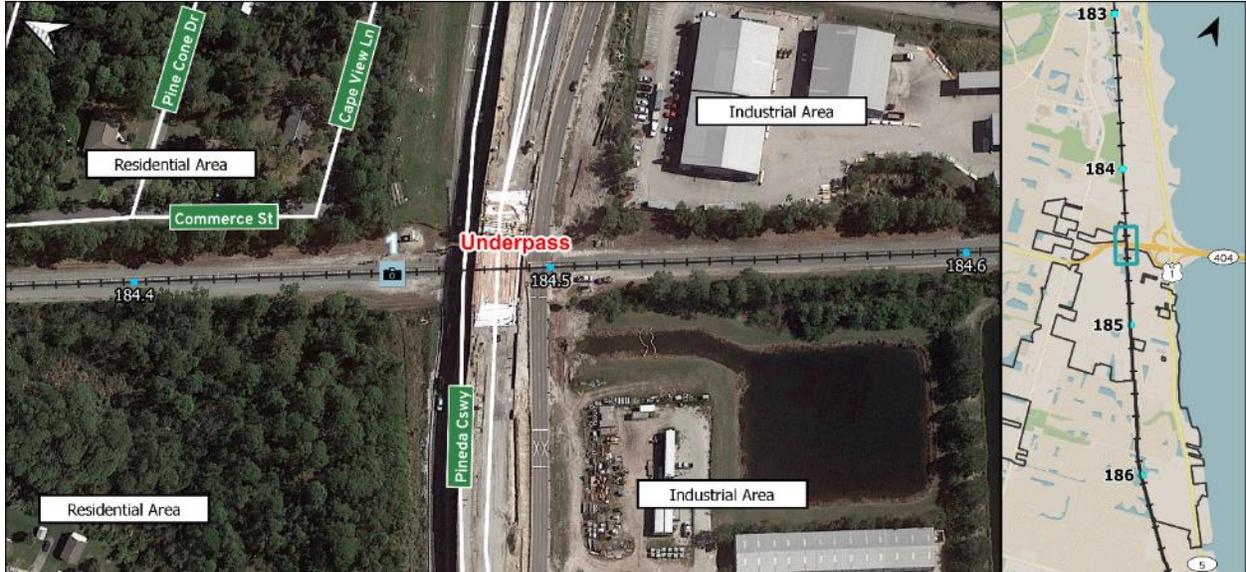
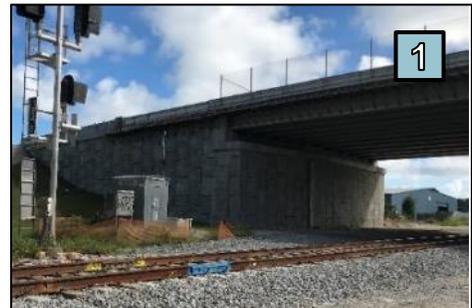
In Palm Shores, a bridge has recently been completed at the Pineda Cswy. to replace the previous grade crossing. Currently, no evidence of trespassing was observed, possibly because the construction has just been completed.

Recommendation: Install **motion actuated cameras with speakers and lights** under the bridge to discourage congregating and use of the location as a trespassing destination.

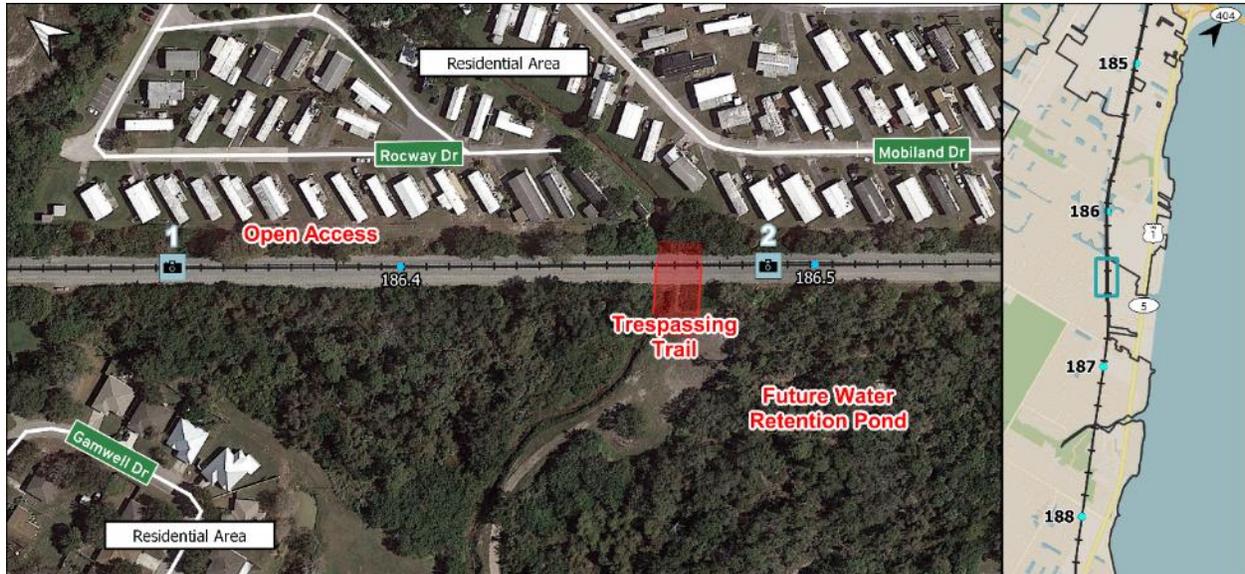
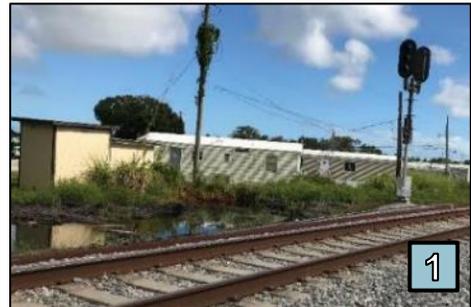
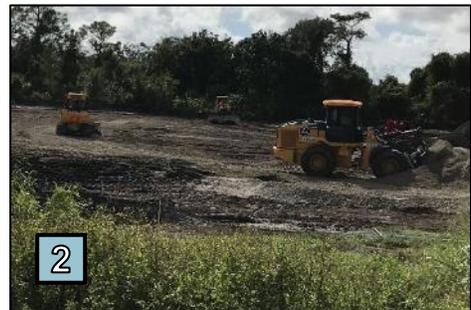
The neighborhood in Melbourne has access to the railroad right-of-way. During the field investigation, the area between the corridor and homes was found to have standing water and tall grass that temporarily discourages access to the corridor.

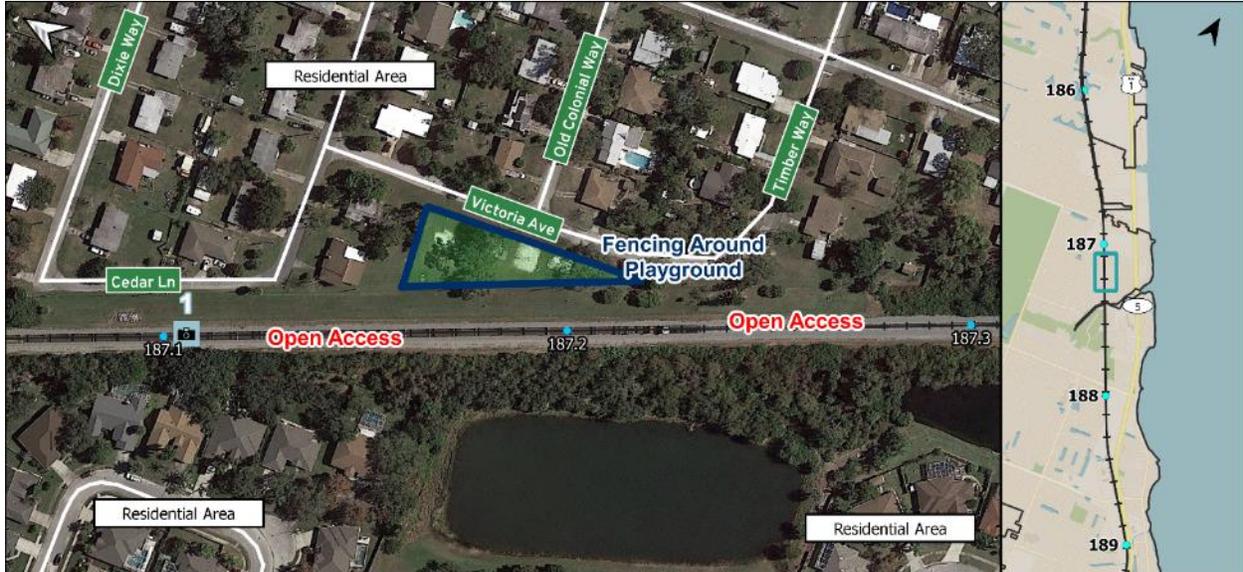
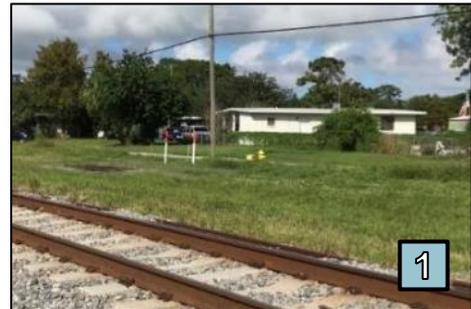
A residential neighborhood in Melbourne has open access to the railroad right-of-way (photo 1). A playground was identified that is fenced from the rail corridor; however, the remaining area is a grassy field that provides no barrier between the housing development and the railroad.

Recommendation: Install a **vegetation barrier** along the right-of-way to discourage access to the corridor. The proposed vegetation would stay below eye level, not disturbing the maintained visual look that the neighborhood has created.

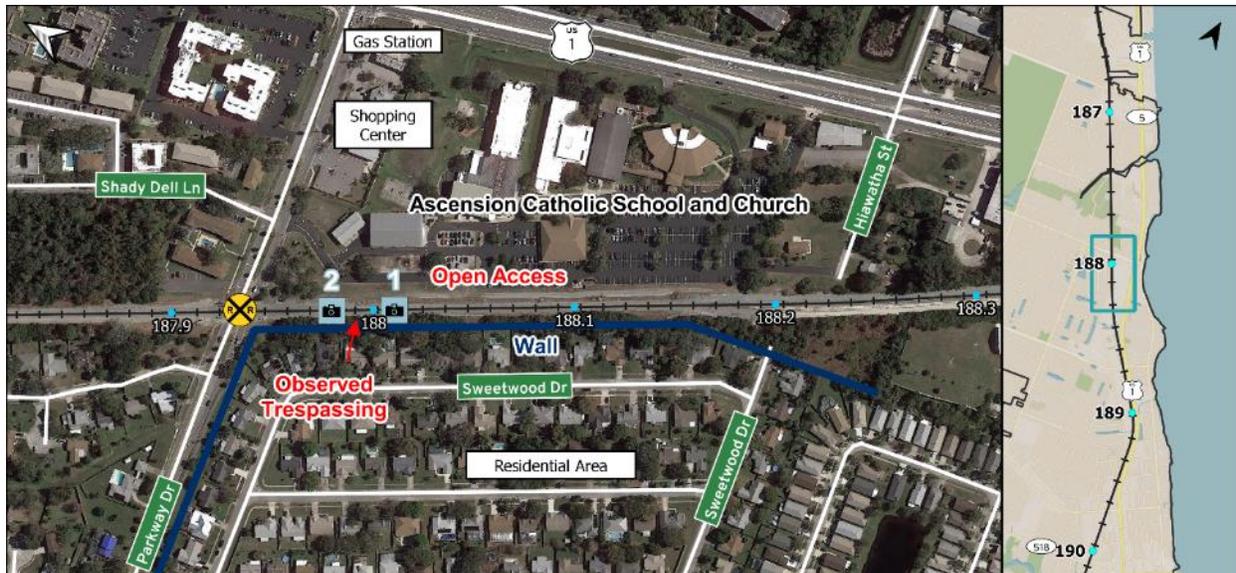
Just south of Parkway Dr. in Melbourne is a housing development and Ascension Catholic School and Church. A trespasser was observed climbing over the wall separating the neighborhood from the railroad right-of-way. Disregard for staying out of the right-of-way was found and photographed in the form of a ladder to make it easy for someone to climb over the wall (photo 1).

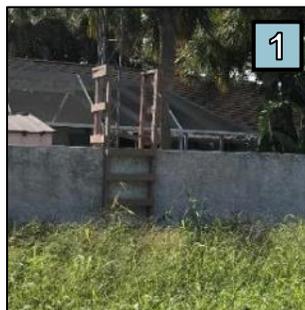
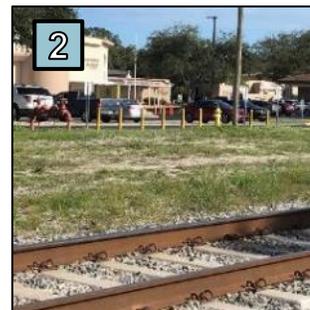
To the east on Parkway Dr. are several retail stores. These retail establishments are a draw for trespassers as the entrance to their neighborhood is farther to the west and requires a much longer walk. Ascension Catholic School located on the east side of the corridor, is open to the railroad right-of-way with no barriers allowing for eastern access from the rail corridor to the school.

Recommendation: Install a **vegetation barrier** to separate the school and railroad tracks. Considering the existing wall is already in place and actively by-passed between the neighborhood and the right-of-way, it is further recommended that letters be sent to all landowners along the right-of-way providing information about trespassing and requiring the removal of the ladder.

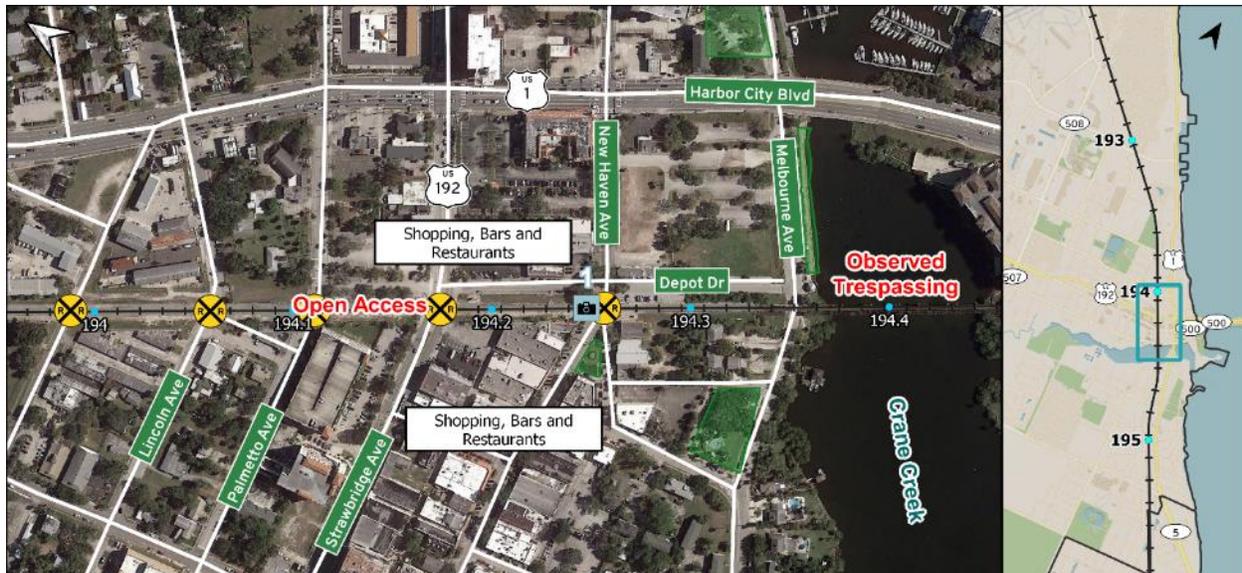
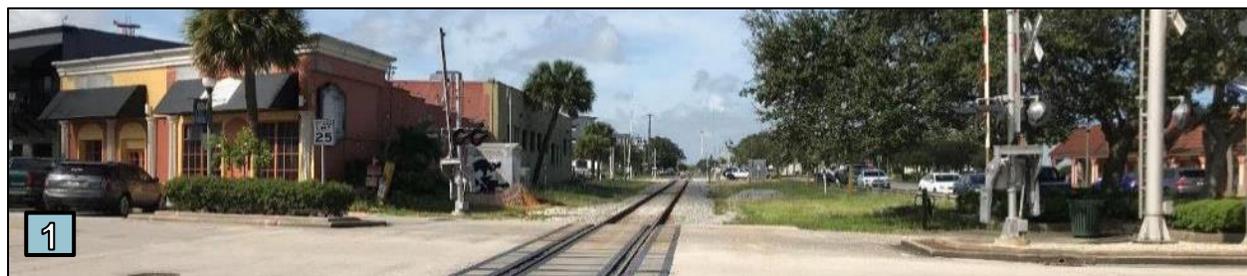
MP 194.0 to MP 194.5

Like other downtown areas along the corridor, downtown Melbourne has open access across the tracks with five at-grade crossings, shopping, bars, and restaurants on both sides. There are designated parking spots along Depot Dr., which runs parallel to the railroad. Construction workers at the Crane Creek Bridge reported of repeated trespassing over the bridge.

Since research has shown that intoxication is a leading cause of trespassing casualties, the local restaurants and bars are an area of concern. While there is a high density of at-grade crossings for people to cross safely, there is parking on the along the tracks, and people can be drawn to take shortcuts across the right-of-way.

Recommendation: Construct **4 ft. aluminum fencing** on west side of the corridor from Strawbridge Ave. to New Haven Ave, and on both sides from New Haven to the bridge. Since there is a high density of grade crossings, trespassers can be channeled to existing crossings without the need for substantial barriers. To discourage trespassing across the Crane Creek bridge, it is recommended that **motion actuated cameras with speakers** be installed on both sides of the bridge.

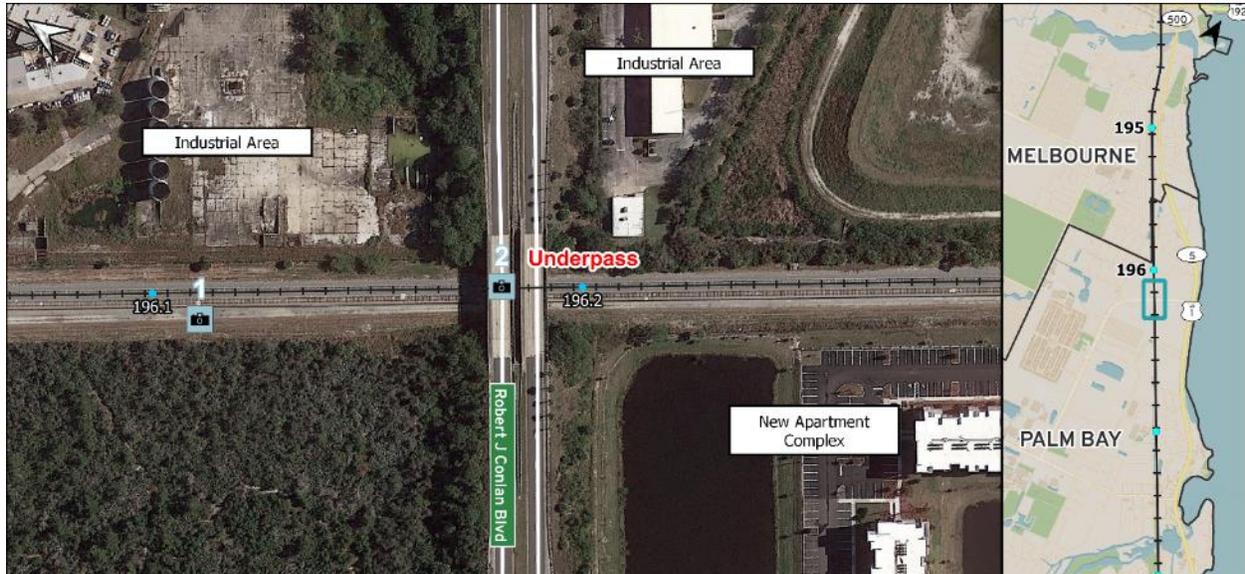
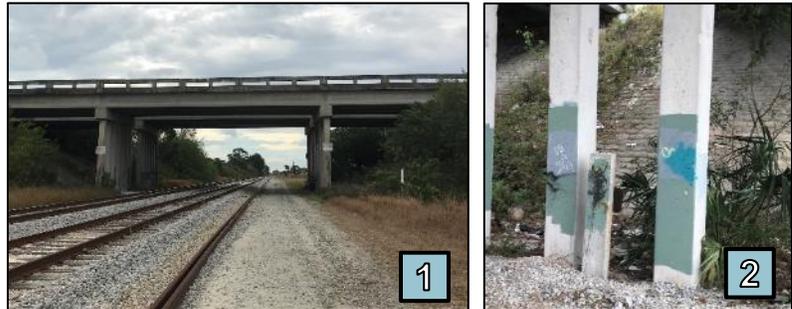
In Palm Bay, Robert J. Conlan Blvd. is grade-separated from the FECR corridor (photo 1). Graffiti was observed on the support columns (photo 2). A new apartment complex was also identified in the southwest quadrant. Both a wall and fence separate the property from the railroad.

In 2018, a trespasser used the underpass to try and jump aboard a moving train. Underpasses are draws for loitering and illegal activities. The darkness, out of sight from observers, encourages potential illicit behavior.

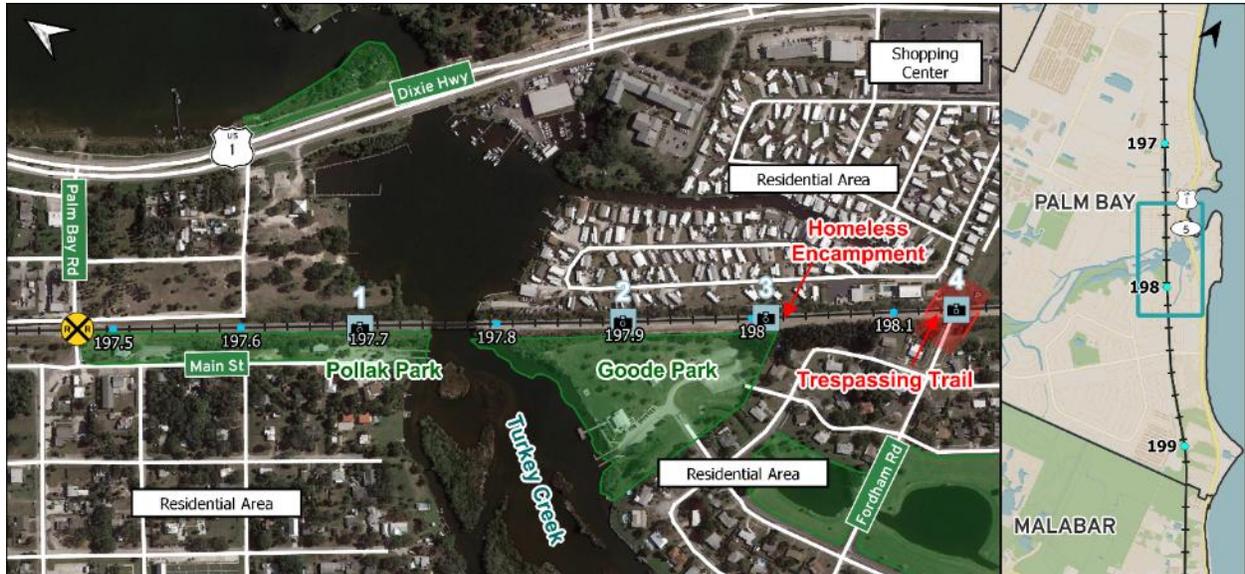
Multiple areas of trespassing concern were identified on either side of the Turkey Creek bridge in Palm Bay. Pollack Park is located on the north side of the creek and has a playground and pavilion separated from the railroad by only sparse vegetation (photo 1). Easy access to the bridge was also found over Turkey Creek. On the south side of the creek is Goode Park, which has dense vegetation between the railroad and the park; however, there are gaps with clear trespassing evidence (photo 2). There is also evidence of a homeless encampment in a wooded area at the south end of Goode Park (photo 3). Fordham Rd., on the west side of the railroad corridor, dead ends with a sidewalk that leads to a trespassing trail across the tracks (photo 4).

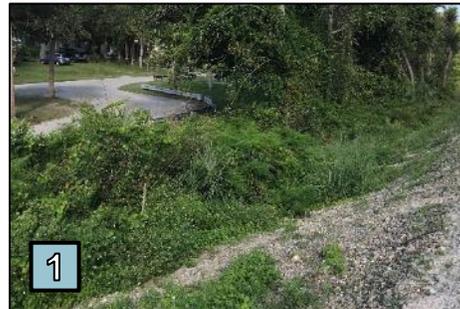
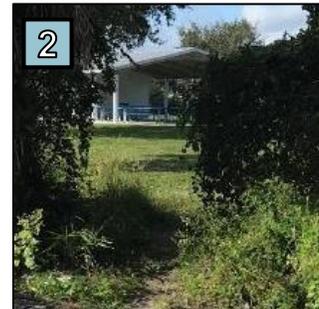
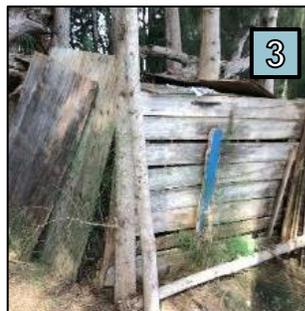
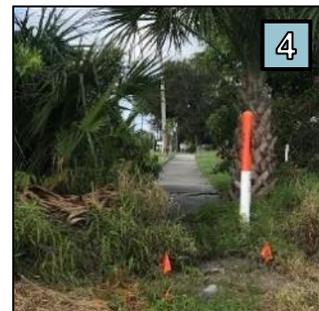
The nearest existing grade crossing to Fordham Rd. is Port Malabar Rd. (not shown, MP 198.4), 0.3 miles to the south. Due to the road configuration a pedestrian traveling from Goode Park saves nearly 0.7 miles by cutting across the tracks at Fordham Rd. This trespassing has multiple potential origin-destination pairs, including Goode park and shopping destinations along Dixie Hwy. (US 1).

Recommendation: Construct **6 ft. chain link fencing** on the west side of the corridor along Pollak Park and from the south end of the bridge to just south of Fordham Rd. to divide the parks from the railroad. The fencing on the south bank will channelize trespasses to a new **pedestrian crossing** at Fordham Rd. Adding **motion actuated cameras and speakers**, and **bridge fencing** can discourage illegal trespassing on and across the bridge.

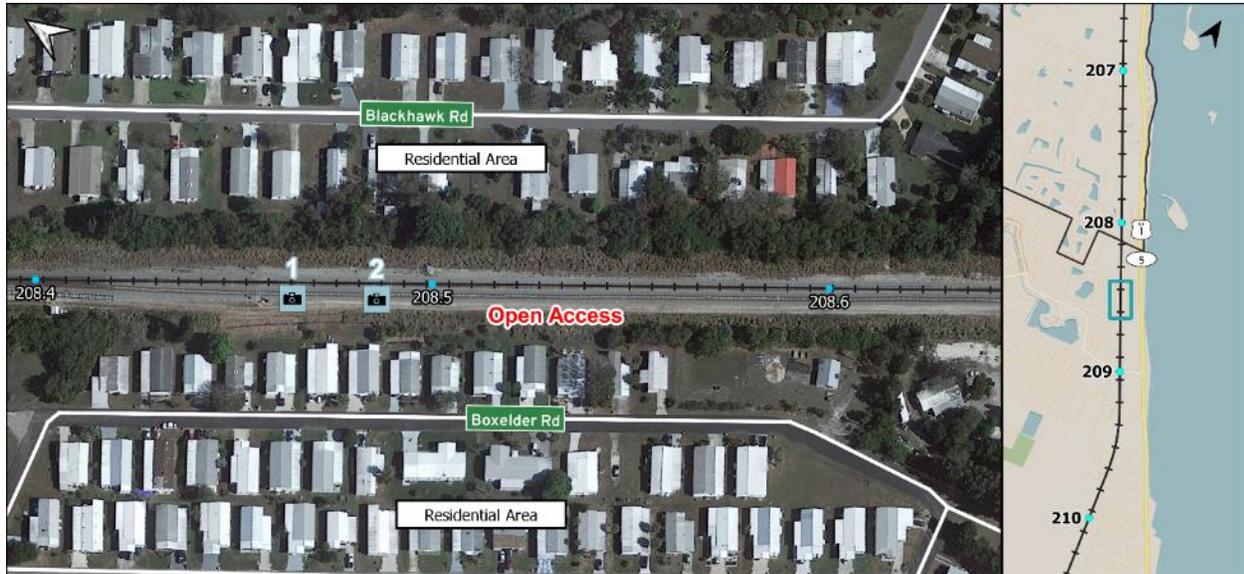
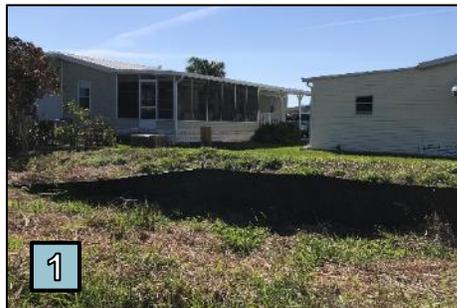
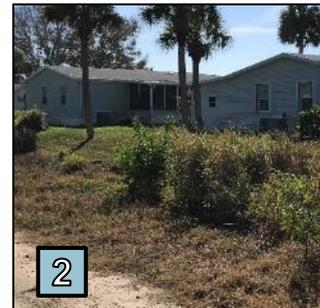
MP 208.4 to MP 208.6

The backyards of homes on the west side of the corridor have open access to the railroad tracks in Micco.

While the field review found no evidence of trespassers crossing the corridor; it is essential to define the railroad corridor to deter accidental access or encroachment on the tracks.

Recommendation: Install a **vegetation barrier** along the west side of the right-of-way to discourage access to the corridor. The vegetation defines the corridor and limits access to the tracks. Since there are no visible signs of trespassing, no strong deterrent is required.

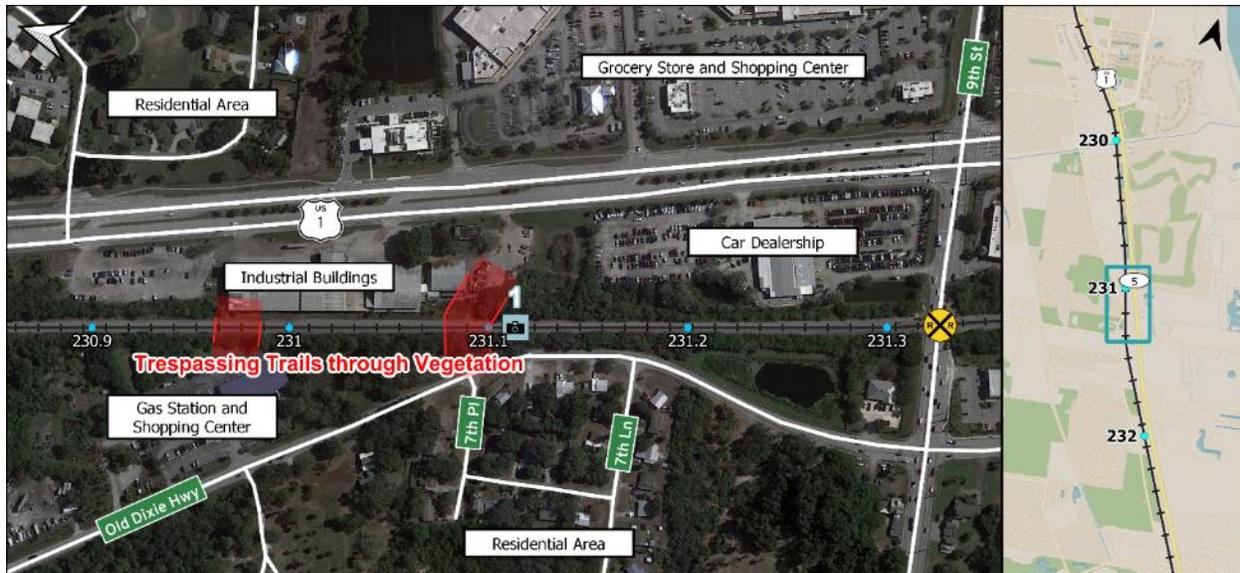
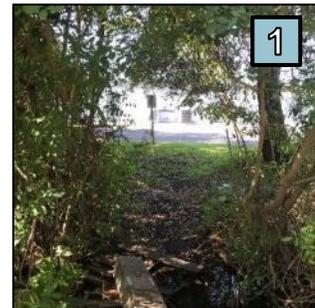
MP 230.9 to MP 231.2

Dense vegetation at this location limits access to the corridor north of 9th St. in Florida Ridge, but gaps have been made that lead to clear trespassing trails across the tracks and through an industrial property (photo 1). Potential trespassing destinations include a shopping center with a grocery store on the east side of US 1 and a gas station along Old Dixie Hwy. Residential areas exist east and west of the corridor. The industrial property has doorways leading directly onto the railroad right-of-way.

The trespassing trails have clear origin-destination pairs. One trespassing trail leads from a residential area located to the west of the tracks to US 1, a shopping center, and grocery store on the east side. The second trespassing trail connects a gas station and shopping center on the west side of the corridor with a residential area across US 1 on the east side (photo 1).

Recommendation: Install a **vegetation barrier** along the west side of the right-of-way to supplement the existing vegetation. Except for the gaps, the existing vegetation provides a barrier against trespassing. The additional mitigation will discourage trespassing across the tracks and channelize pedestrians to the existing at-grade crossing at 9th St.

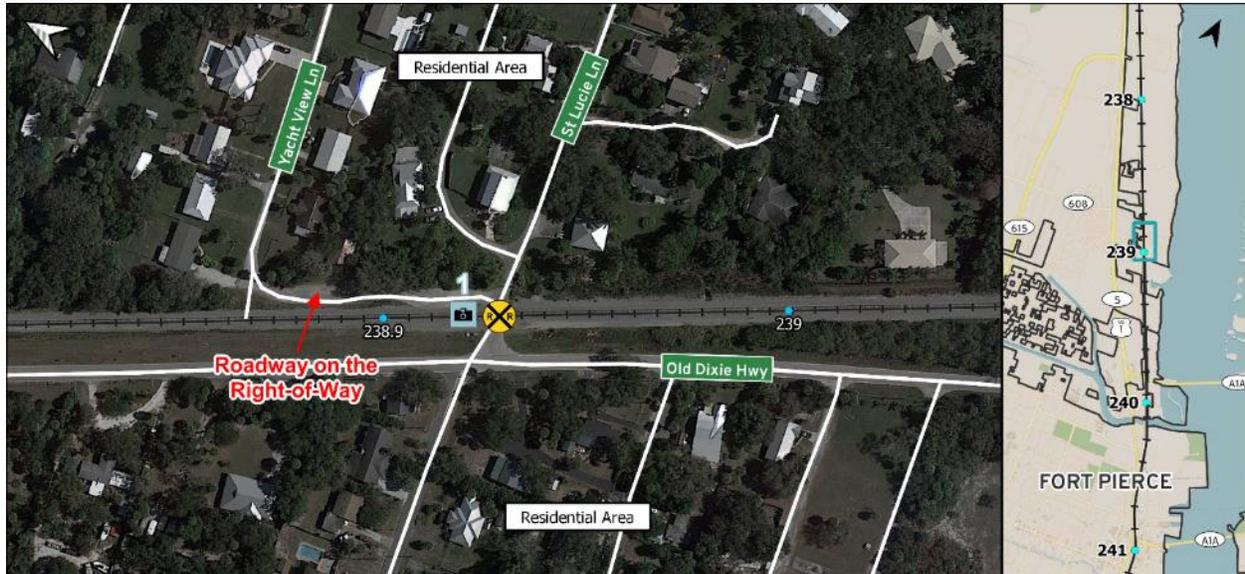
In St. Lucie Village, on the east side of the corridor, a dirt road connecting St. Lucie Ln. and Yacht View Ln. has been established on the railroad right-of-way. The only other access to Yacht View Ln. is from Indian River Dr. (not shown), 0.2 miles to the east of the rail corridor, adding 0.4 miles to the trip of the home nearest to the tracks.
