STRATEGIES FOR REDUCING RAILROAD TRESPASSING

Florida East Coast Railway Corridor -
Cocoa to Miami

August 6, 2021

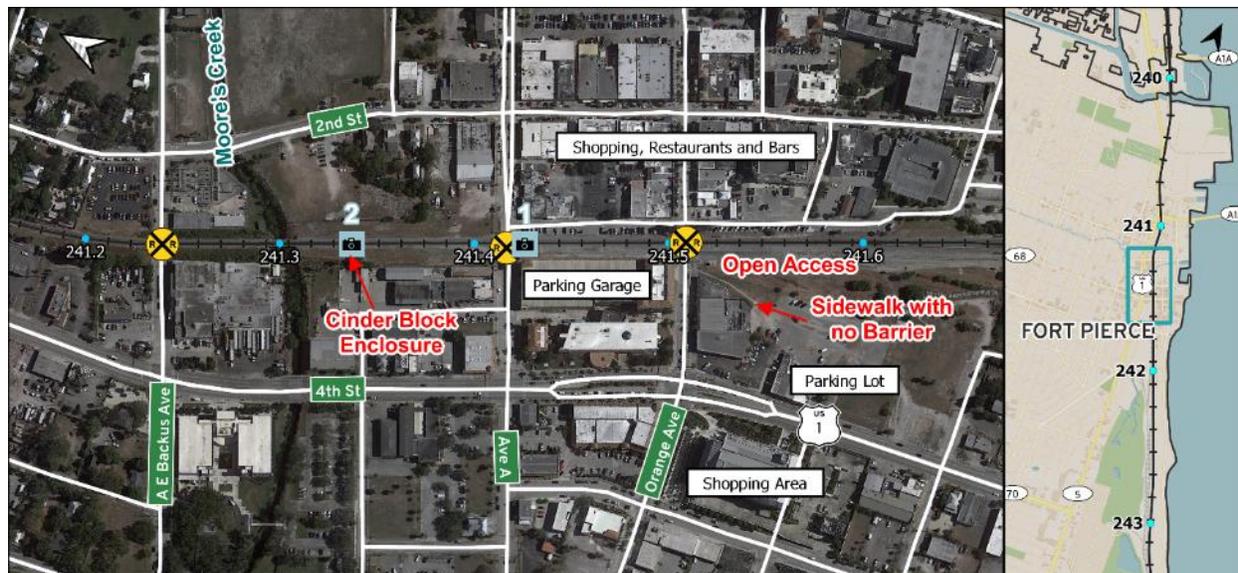
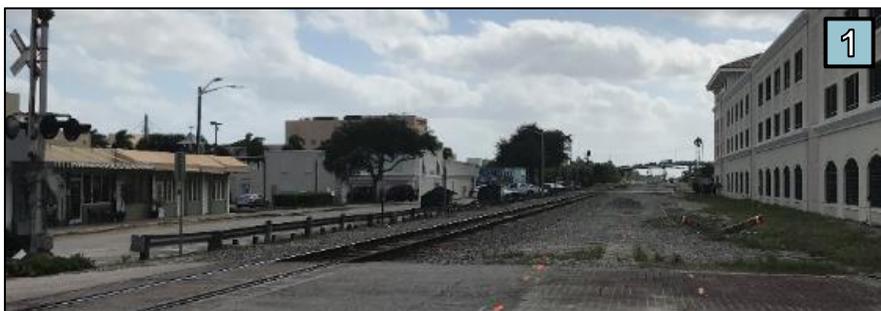
Like other downtown areas along the corridor, Downtown Fort Pierce has open access across the tracks with three at-grade crossings, shopping, bars, and restaurants on both sides (photo 1). A cinder block structure with evidence of trespassing is present north of the downtown area (photo 2). Additionally, south of Orange Ave. is a sidewalk with open access to the railroad corridor. In 2019, there was a trespassing fatality in this area.

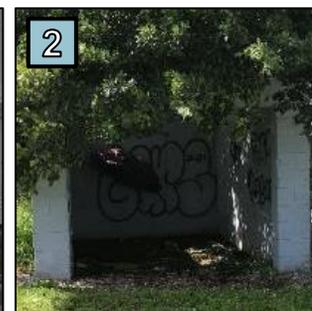
Since research has shown that intoxication is a leading cause of trespassing casualties, the local restaurants and bars are an area of concern. While there is a high density of at-grade crossings for people to cross safely, there is parking on the east side of the tracks, and people can be drawn to take shortcuts across the right-of-way.

Recommendation: Construct **4 ft. aluminum fencing** along both sides of the corridor from Moore's Creek to just south of Citrus Ave. (not shown, MP 241.8) between crossings. North of Moore's Creek to Avenue D (not shown, MP 241.1), **6 ft. chain link fencing** is recommended along the west side of the corridor. Demolishing the cinder block structure will eliminate a location for trespassers to loiter.

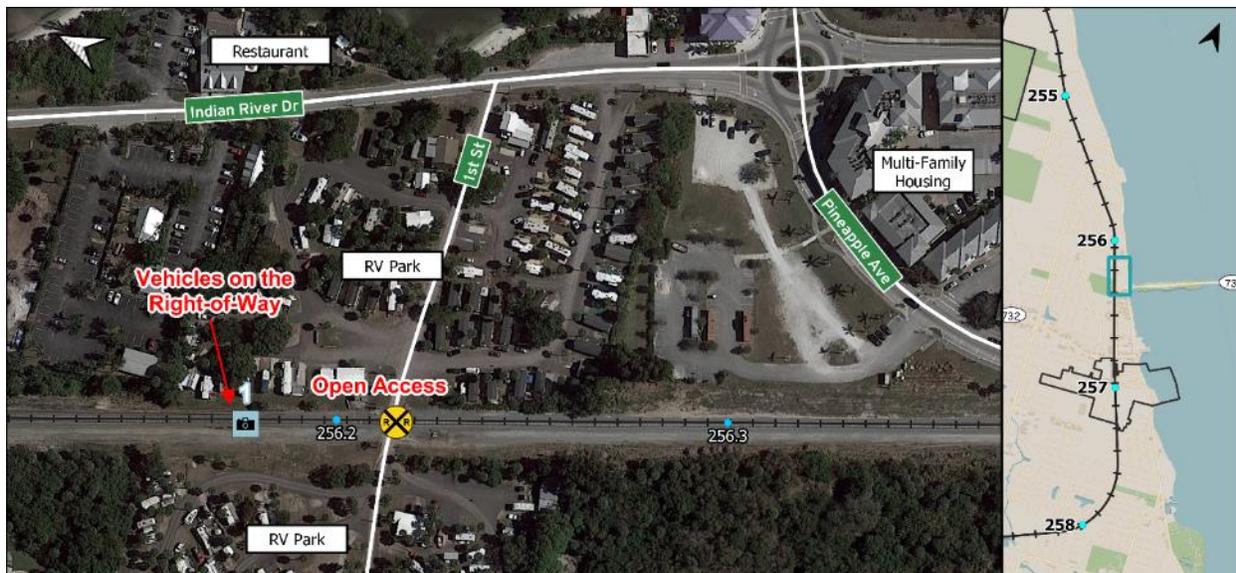
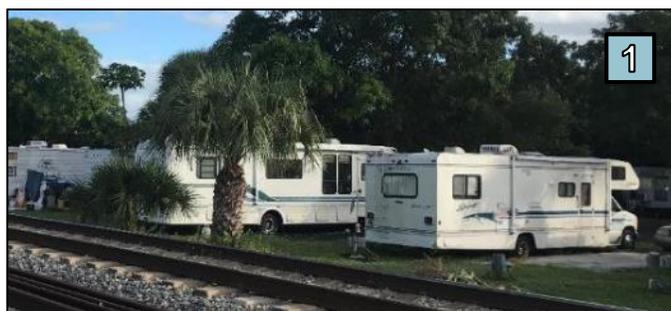
MP 256.1 to MP 256.3

An RV park straddles both sides of the corridor in Jensen Beach. Several parked vehicles are encroaching the railroad right-of-way. Dense vegetation exists on both sides of the corridor on the properties adjacent to the RV Park. Historical observations have identified this location as a trespassing hot spot.

Recommendation: Construct **4 ft.**

aluminum fencing on both sides of the corridor next to the RV park. The fencing will channelize trespassing to the existing grade crossing and prevent vehicles encroaching on the right-of-way. The local property owner should be contacted to inform them of the current encroachment and warn them of potential enforcement.

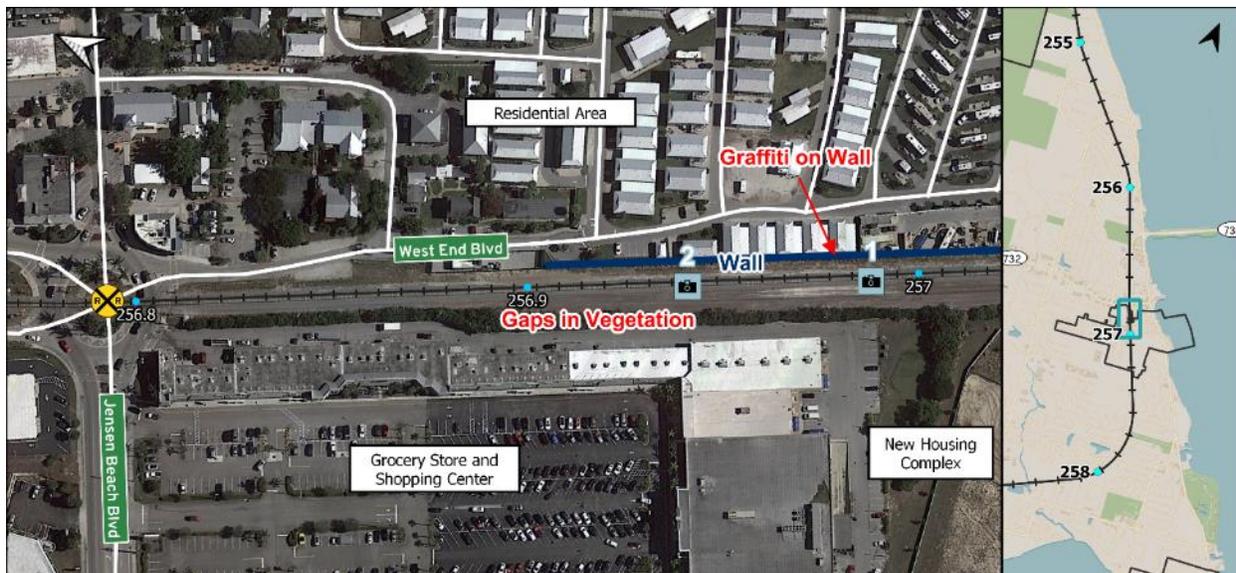
In Jensen Beach, graffiti was found on a wall separating the FECR corridor from a mobile home / RV park (photo 1). A shopping center is on the other side of the tracks and is a draw for trespassing. There are two gaps in the wall but are blocked by vegetation and a gate. The

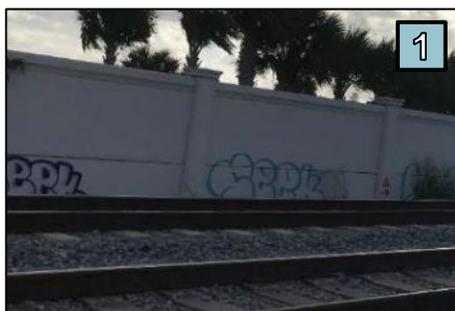
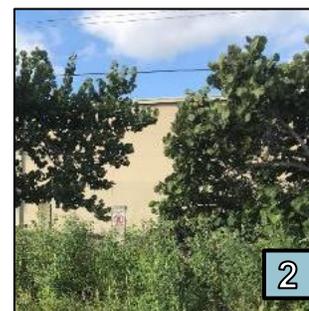
barrier between the shopping center and railroad consists of small trees and vegetation, but there are many gaps in the foliage (photo 2). Just to the south is a new housing complex under construction and more residential areas within walking distance of the shopping center.

The grocery store in the shopping center is also a destination for trespassing, especially from residential areas to the south. The graffiti is evidence that the shopping center area is a place of loitering.

Recommendation: Construct **4 ft. chain link fencing** from Jensen Beach Blvd. to the end of the shopping center to reduce the trespassing to the shopping center. It is recommended that the new housing development be responsible for installing their own fencing. If the fencing is not installed, the proposed fencing should be extended past the development. The graffiti should be removed promptly to discourage loitering in this area.

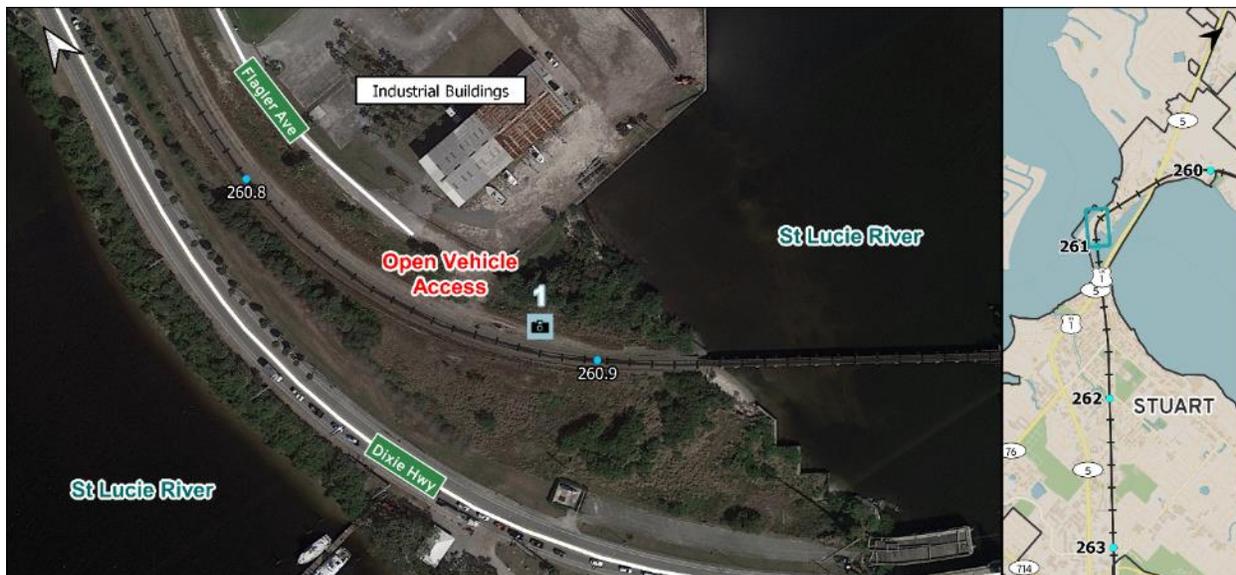
At the north bank of the St. Lucie River in Stuart, the corridor is open to Flagler Ave. allowing vehicles to access the right-of-way (photo 1). The location has a potential for loitering, but unauthorized vehicle access is the most likely form of trespassing.

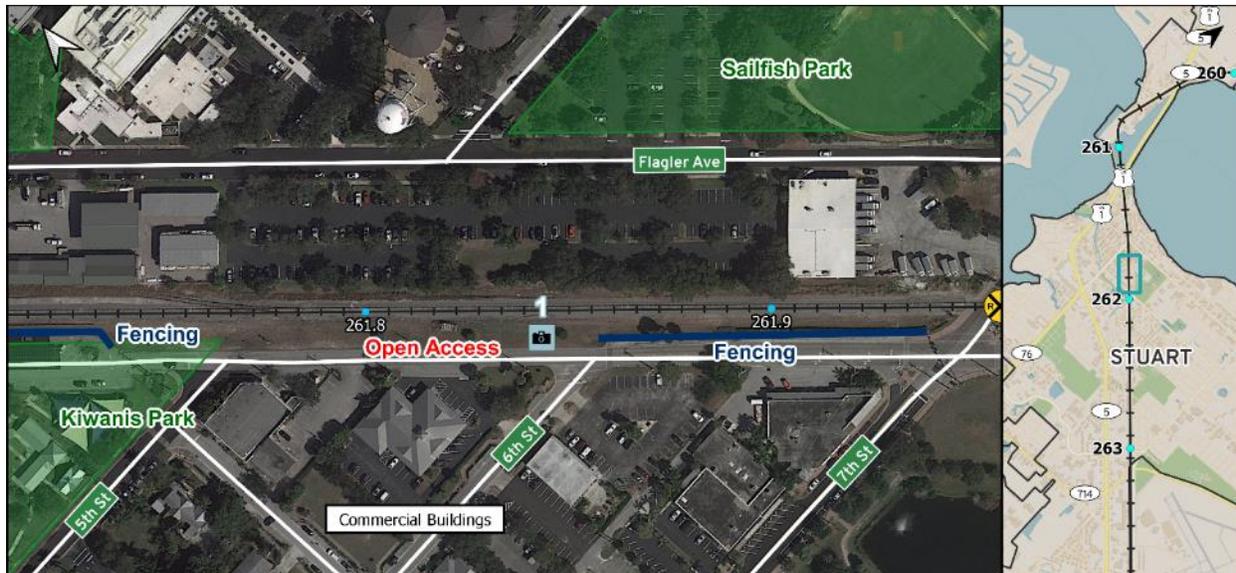
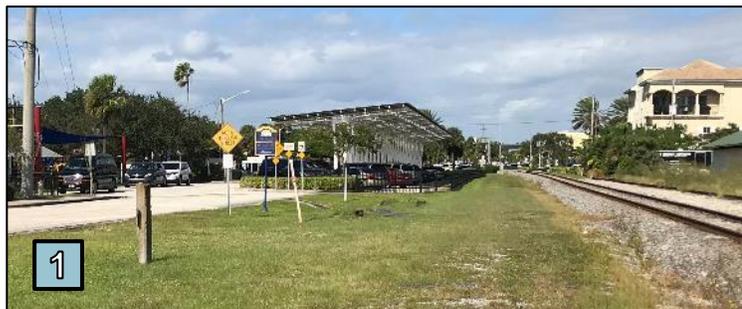
MP 261.7 to MP 261.9

In Downtown Stuart, a gap exists in the existing fencing allowing for open access to the railroad tracks (photo 1). Further north of the city, Stuart has provided a 4 ft. aluminum fence on both sides of the corridor that ends just to the south end of Kiwanis Park at 5th St. From 6th St. to 7th St., a 4 ft. chain link fence was installed, leaving a gap between 5th St. and 6th St.

Recommendation: Construct 4 ft. aluminum fencing between 5th St. and 6th St. The proposed fencing will complete the barrier through downtown, discouraging people walking from the parking lot on the east side of the corridor to the commercial buildings on the west side.

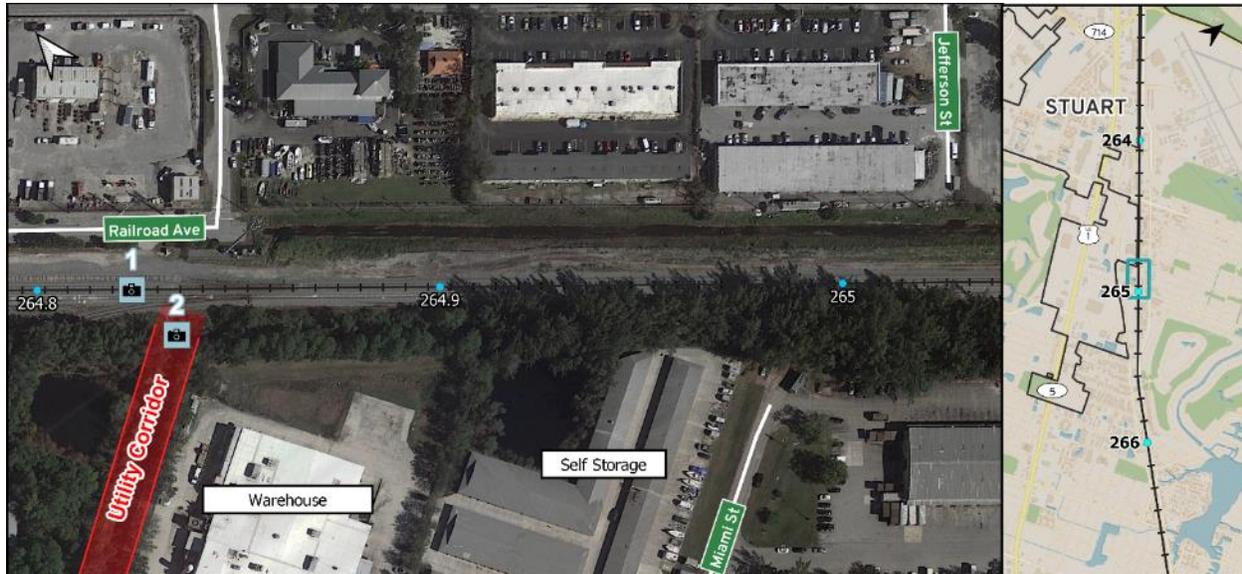
Trespassing was observed, and a well-established trail was found along a utility corridor at Railroad Ave. in Stuart (photos 1 and 2). The path provides access from a neighborhood on the east side of the tracks to stores and places of employment along Federal Hwy. to the west (not shown).

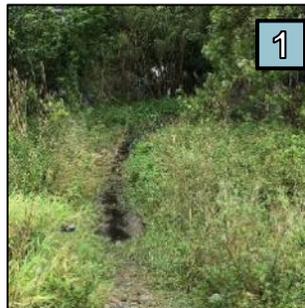
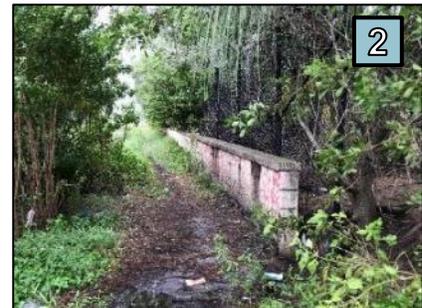
.05 miles to the north and Seaward St. 1.6 miles to the south (not shown). Due to the large distances required to cross the railroad safely, it will be difficult to discourage trespassing at this location entirely. It is not feasible to install a pedestrian crossing across from Railroad Ave. in the existing trail location. There are four tracks and turnouts to non-signalized track, making it a high-risk area for traversing at-grade over the tracks.

Recommendation: Construct **8 ft. hardened fencing** at the end of the utility corridor is recommended to deter use of the existing trespassing route. Add a new **pedestrian crossing** at Miami St. Trespassers will be channelized to the new crossing using a new **sidewalk** on Miami St. and along the corridor along with a **6 ft. chain link fence** from Railroad Ave. to Jefferson St.

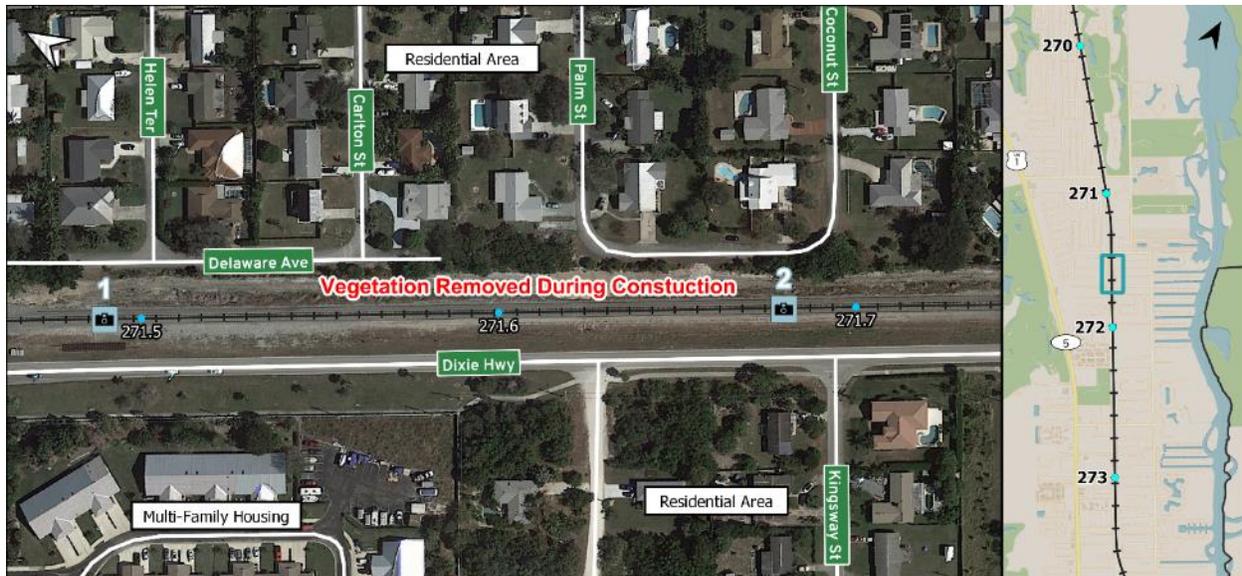
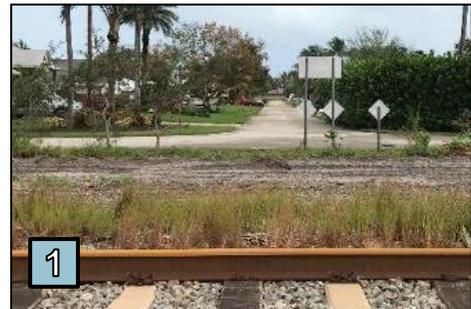
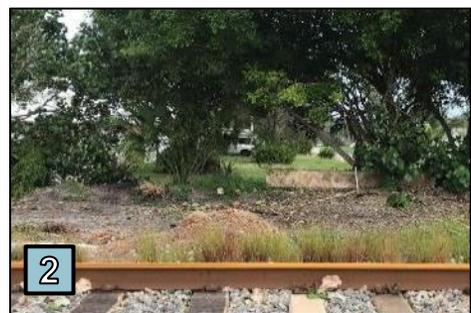
MP 271.4 to MP 272.0

The second main track construction has removed the vegetation between the residential neighborhood and the railroad tracks south of Crossrip Rd. (not shown, MP 271.4) in Hobe Sound. The construction disturbed any potential trespassing evidence (photo 1).

Without this vegetation, there is no barrier between the homes and the corridor. It is essential to define the railroad corridor to deter accidental access or encroachment on the tracks.

Recommendation: Install a **vegetation barrier** along the right-of-way from Crossrip Rd. to dense vegetation across from James Rd. (not shown, MP 272.0) to discourage access to the corridor. The proposed vegetation would stay below eye level so to create a maintained visual aesthetic and deter trespassing.

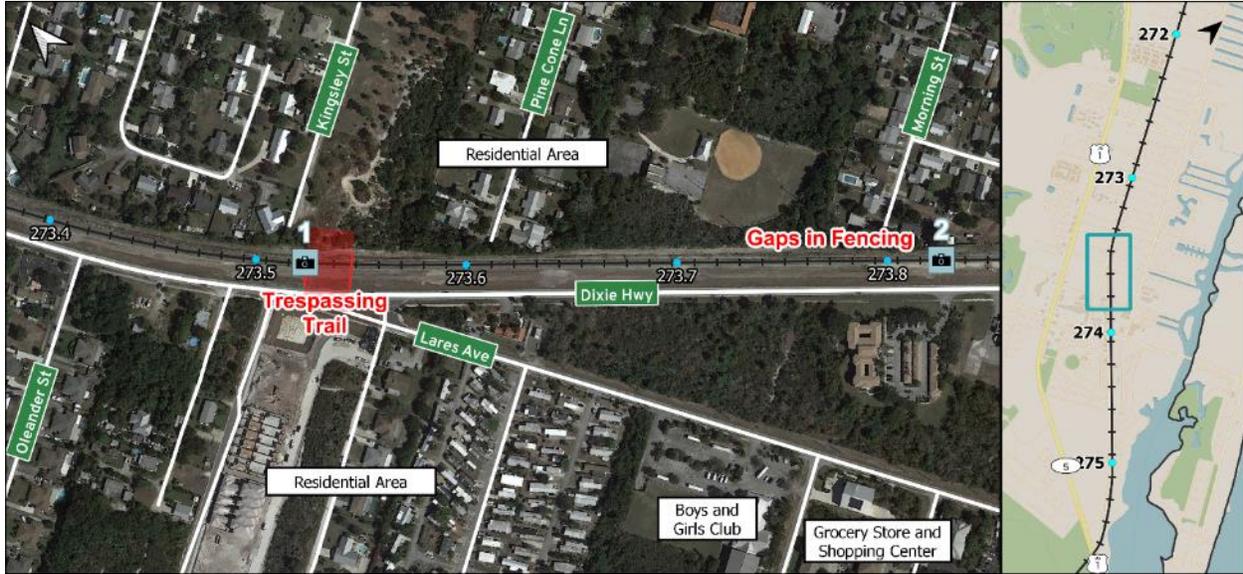
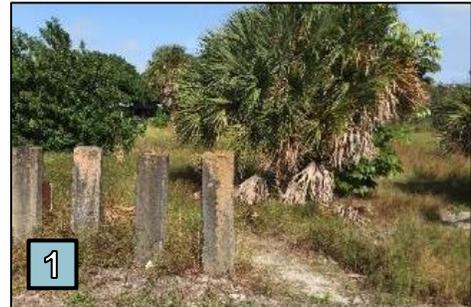
A trespasser was observed crossing the tracks on a well-defined trespassing trail (photo 1) near Kingsley St. in Hobe Sound. Further south, several gaps occur in the fencing along the east side of the corridor, but there is no other evidence of trespassing (photo 2). Open access also exists to the houses from the right-of-way. A Boys and Girls Club and a grocery store were identified on Lares Ave. south of Dixie Hwy. These establishments are trespassing destinations from the nearby neighborhoods.

The observed trespassing location is 0.9 miles from the nearest crossing to the north at Pettway St. and 0.5 miles from the nearest crossing to the south at Bridge Rd.

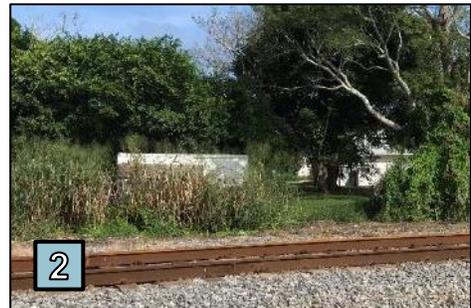
MP 281.0 to MP 281.6

A walking trail has been built along Old Dixie Hwy. next to the railroad corridor in Tequesta. Mixed vegetation exists along the 0.6 of a mile-long trail, but does not discourage trespassing along the railroad.

Recommendation: Plant **vegetation**, matching the current style of plants along the trail to provide a barrier between the sidewalk and railroad tracks.

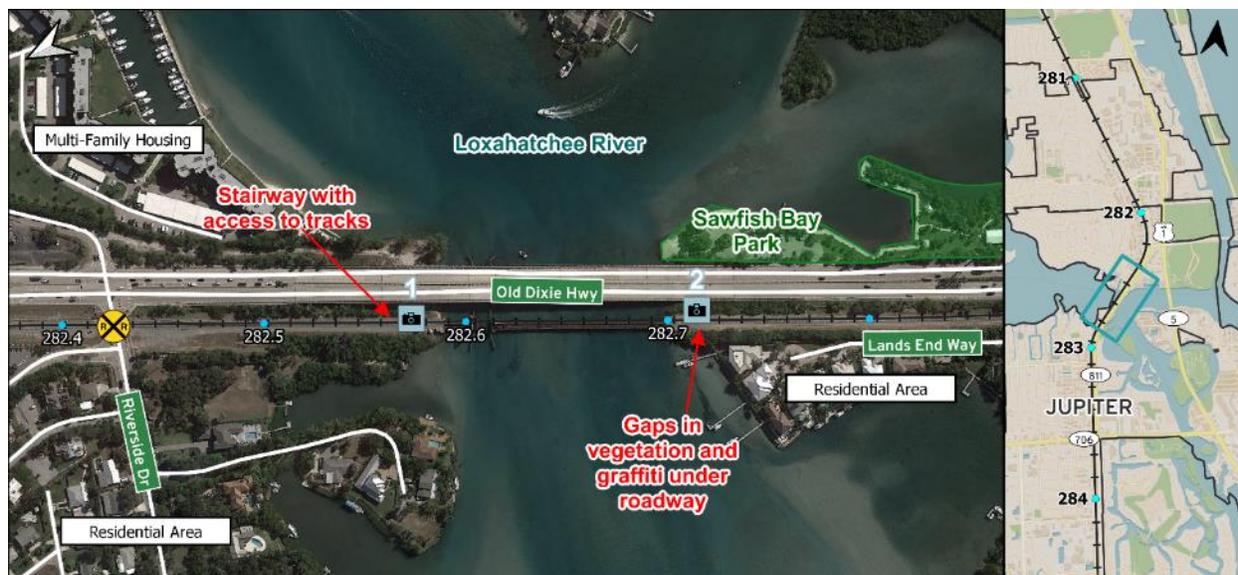
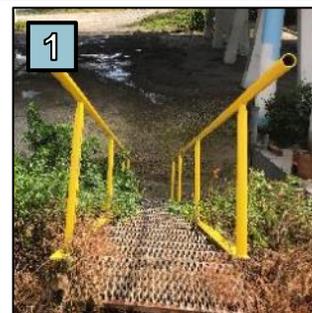
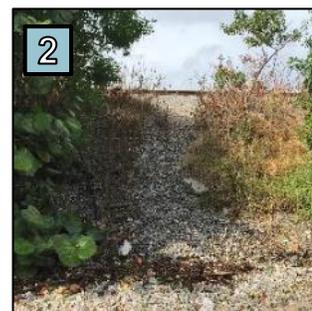
MP 282.5 to MP 282.9

On the northside of the Old Dixie Highway bridge over the Loxahatchee River, a stairway provides access to the tracks from under the bridge (photo 1). The stairway was recently installed, and it is unknown if it provides access for railroad employees or was used during the construction of the second bridge track.

On the southside, trespassers are tagging the underpass. A clear path has also developed, leading from under the bridge to the tracks (photo 2). The underpass is accessible from Sawfish Bay Park on the south bank, providing access to the railroad as well.

Recommendation: Construct **8 ft. hardened fencing** to deter access between the tracks and the underpass on the south bank. Install **motion actuated cameras with speakers** at both end of the bridge to discourage trespassing on the bridge and accessing the track from under the roadway. It is further recommended that “No Trespassing” signage and chain be added at the ladder’s base.

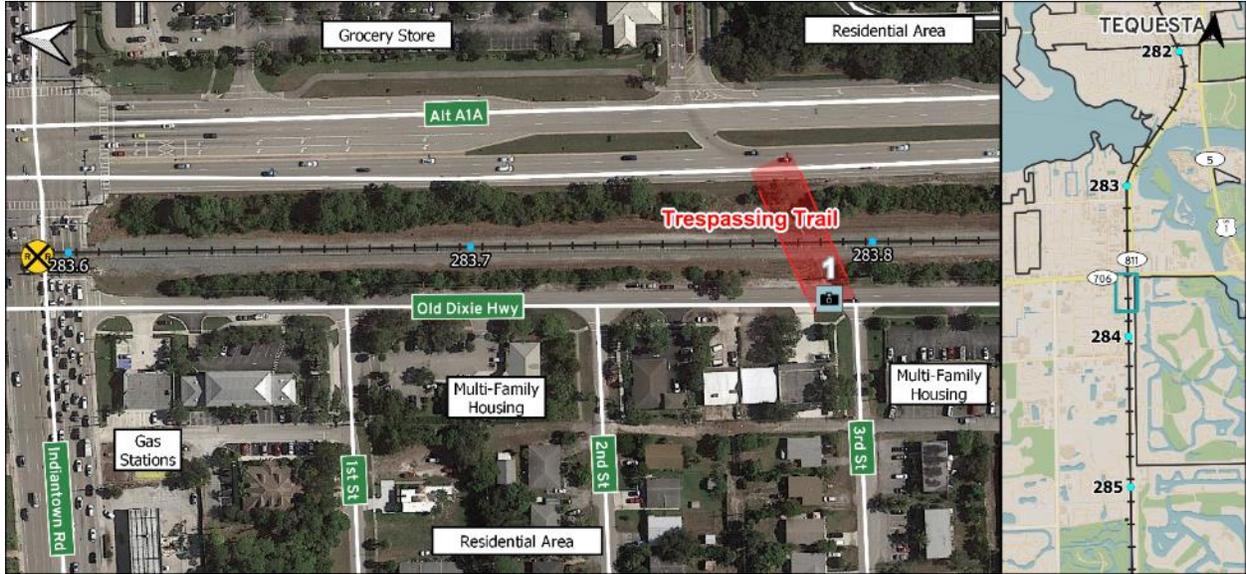
A trespassing trail was found along Old Dixie Hwy. south of Indiantown Rd. in Jupiter. There are many trees and vegetation along the corridor blocking any access from Alt A1A. to the railroad tracks, but a gap exists where the trespassing trail has developed. A grocery store is located at the southeast corner of Indiantown Rd. and Alt A1A. The trespassing trail connects the residential area and the grocery store, shortening the walking distance by about 0.20 miles.

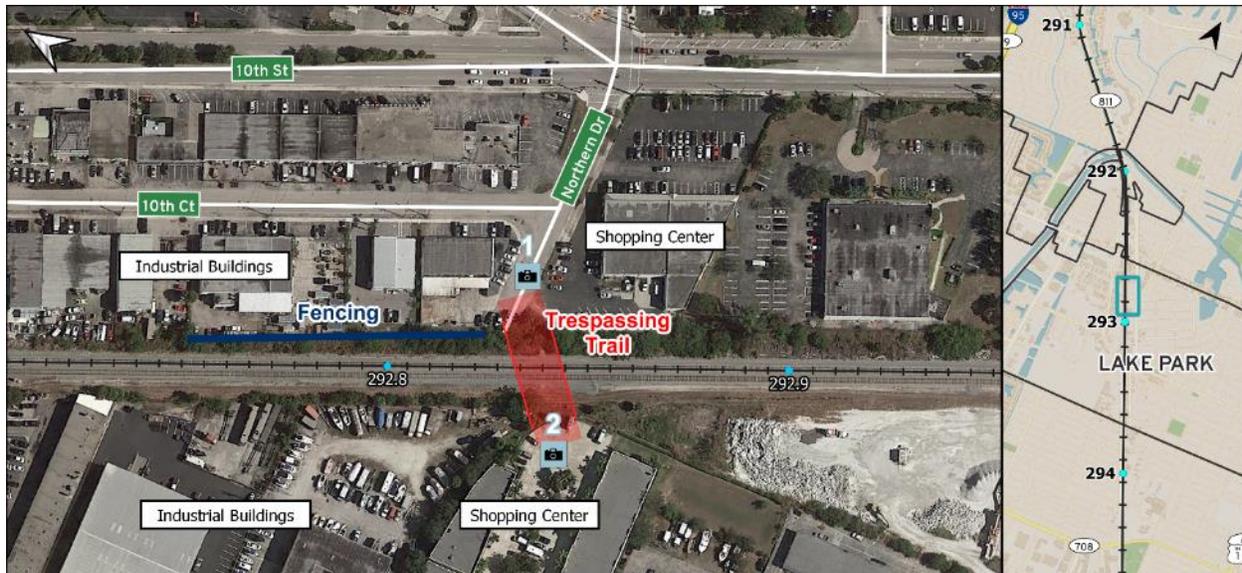
A trespassing trail was found in Lake Park, connecting the dead-end of Northern Dr. to a shopping center.

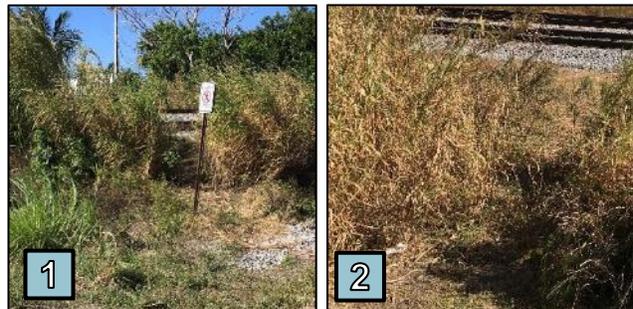
MP 292.8 to MP 292.9

The trespassing trail provides access to the industrial buildings and shopping centers on both sides of the tracks. The residential area on the east side of 10th St. is a potential origin for trespassing. The trail is 0.25 miles from the nearest existing grade crossing to the north at Northlake Blvd. (not shown, MP 292.6) and 0.4 miles from the nearest existing grade crossing to the south at Park Ave. (not shown, MP 293.3). The relatively short distance between grade crossings suggested minimal deterrent is required.

Recommendation: Construct **6 ft. chain link fencing** along the parking lot on the east side of the corridor south of Northern Dr. The fencing will block the gap in the vegetation and divert trespassers. Besides the trail, the right-of-way has dense vegetation that provides an effective barrier. The fencing will allow for the vegetation to grow, adding further deterrent.

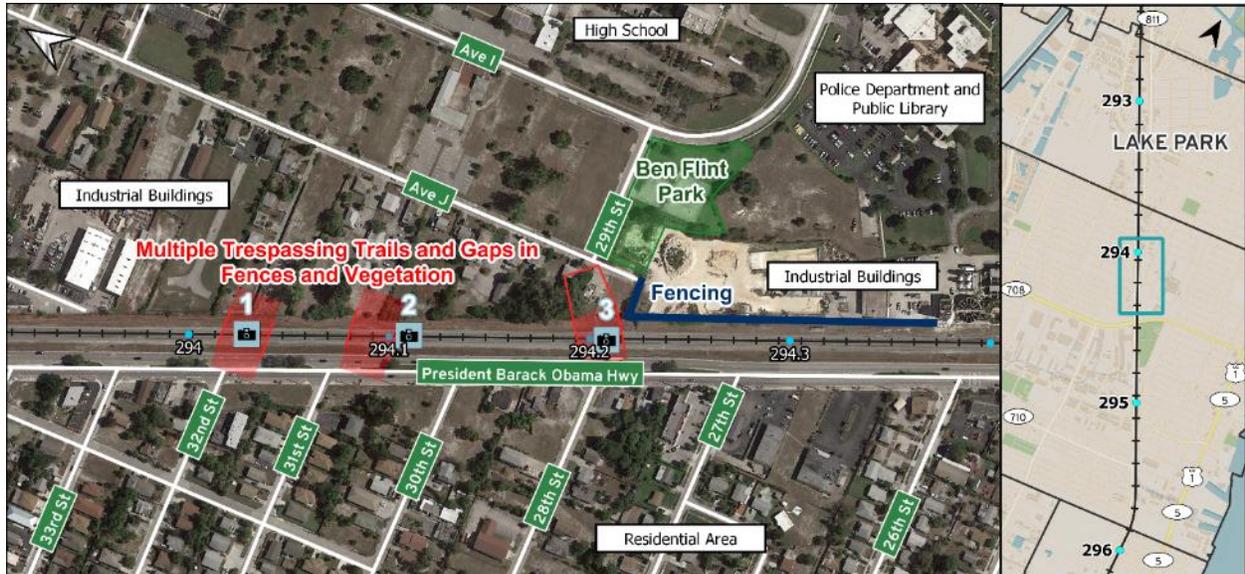
Multiple trespassing examples exist between Silver Beach Rd. (no shown, MP 293.7) and Blue Heron Blvd. (not shown, MP 294.5) in Riviera Beach, such as gaps in vegetation (photo 1), damaged fencing, (photo 2) and clear entrenched paths (photo 3).

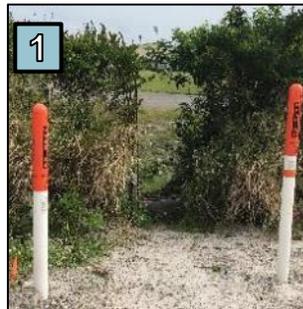
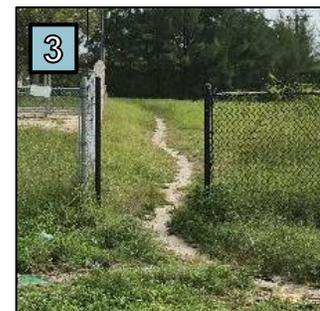
MP 293.8 to MP 294.3

There are strong origin-destination pairs from the residential area to the west of the tracks to a high school, public library, and small park on the east side. Well-defined paths and multiple cut fences make it clear that there has been a prolonged and repeated trespassing history.

Recommendation: Construct **8 ft. hardened fencing** on the east side of the corridor from Avenue K (not shown, MP 293.8) to the existing fencing at the industrial building near 29th St. The hardened fencing is recommended due to well-established trespassing trails, strong origin-destination pairs, and previously cut fencing. The trespassing will be channelized to Blue Heron Blvd. to the south.

The repeated trespassing and 0.75 miles between the grade crossings at Silver Beach Rd. and Blue Heron Blvd. make this location a candidate for a pedestrian crossing. However, there is no public access through the properties between Ave. J and the railroad. This location should be monitored, and if trespassing is not reduced, then property acquisition for an at-grade pedestrian crossing or pedestrian overpass is recommended.

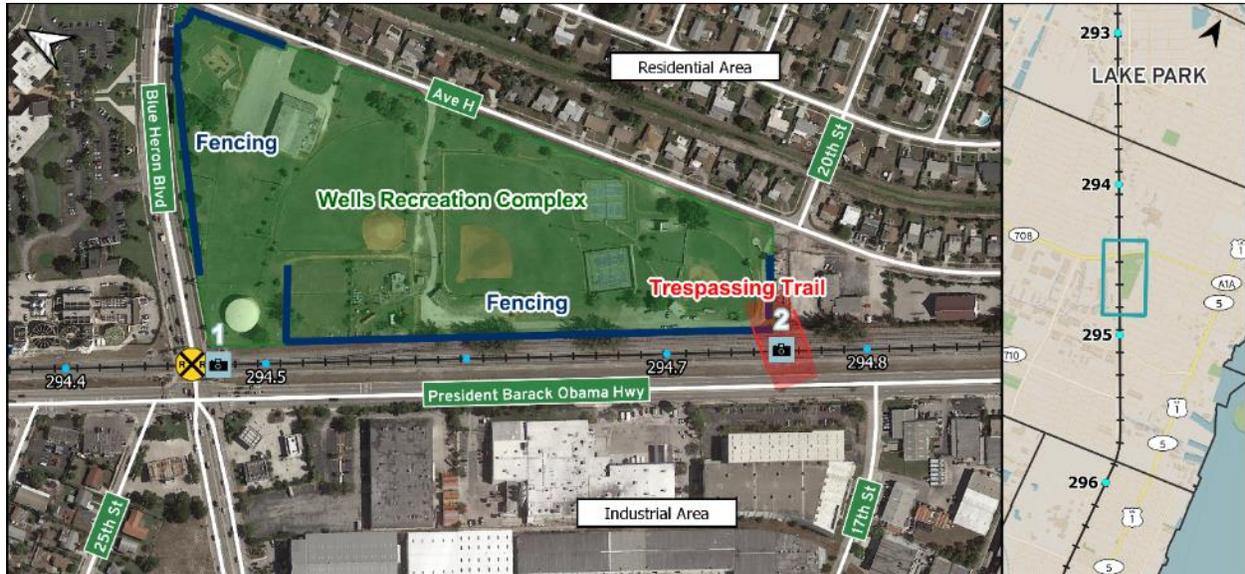
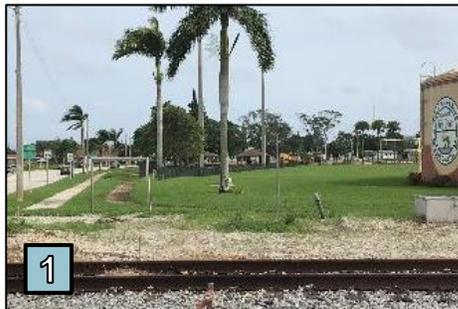
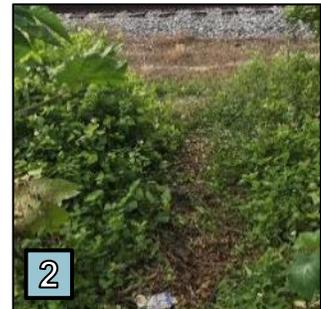
MP 294.5 to MP 294.8

The Wells Recreation Complex is directly adjacent to the railroad in Riviera Beach. The park is fenced along Blue Heron Blvd. and the railroad right-of-way except for the park's northwest corner (photo 1). At the south end of the park is a clear trespassing trail around the end of the fencing (photo 2).

Recommendation: Construct **6 ft. chain link fencing** at the corner of the park near the Blue Heron Blvd. grade crossing. The fencing should match the style around the rest of the park. This fencing will provide a separation between the park and the railroad. If access is needed, a gate can be added along Blue Heron Blvd. At the south end of the park, adding **8 ft. hardened fencing** connecting to the existing fence is recommended to stop trespassers from accessing the park via the railroad near 17th St.

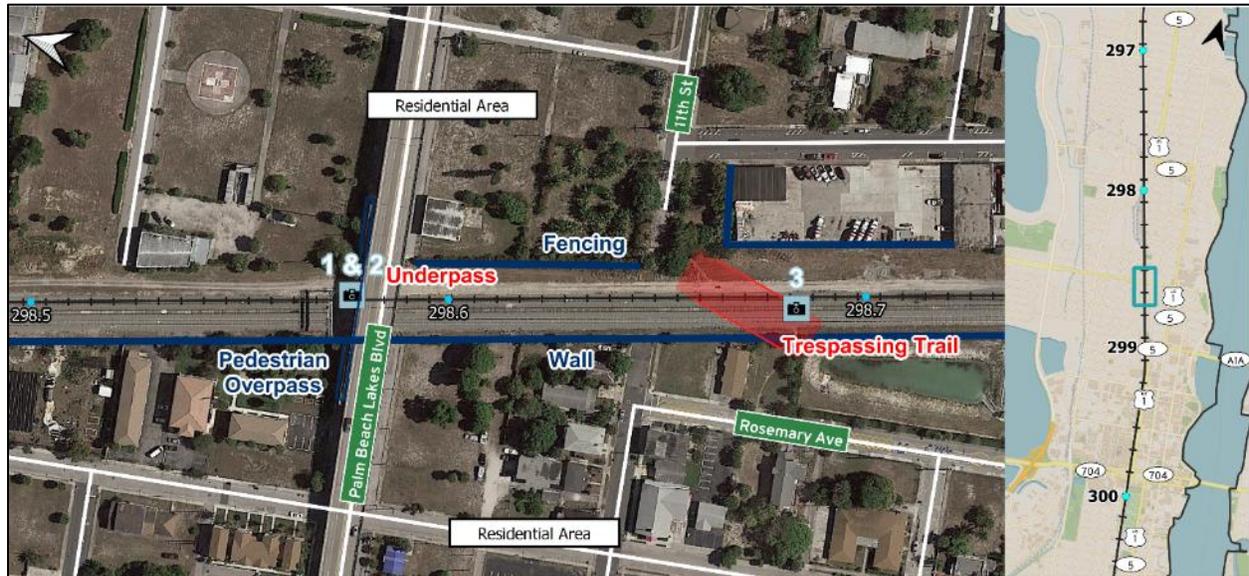
The Palm Beach Lakes Blvd. overpass in West Palm Beach has clear indications of trespassing. The east side of the corridor under the overpass has no barrier (photo 1). Graffiti was found on the walls under the overpass (photo 2). A block south of the overpass there are openings with clearly defined trails and observed trespassing (photo 3).

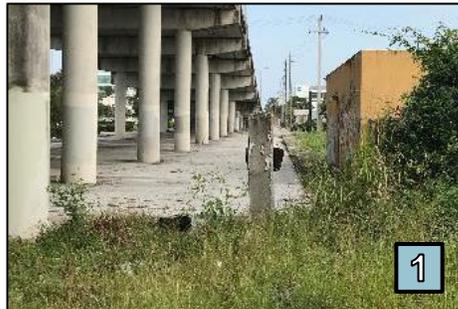
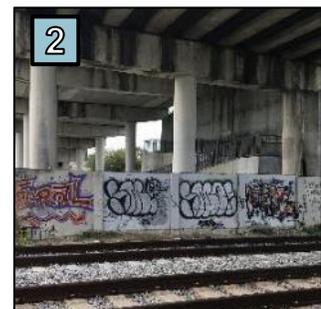
MP 298.5 to MP 298.7

Palm Beach Lakes Blvd. has a pedestrian overpass to provide a safe alternative to trespassing. However, since access is not as direct as existing trespassing trail, the trespassing persists.

Recommendation: Construct **8 ft. hardened fencing** at the openings on the east and west side of the corridor to channelize pedestrians to the pedestrian overpass. The addition of **motion actuated cameras with lights** is recommended under the bridge to discourage loitering.

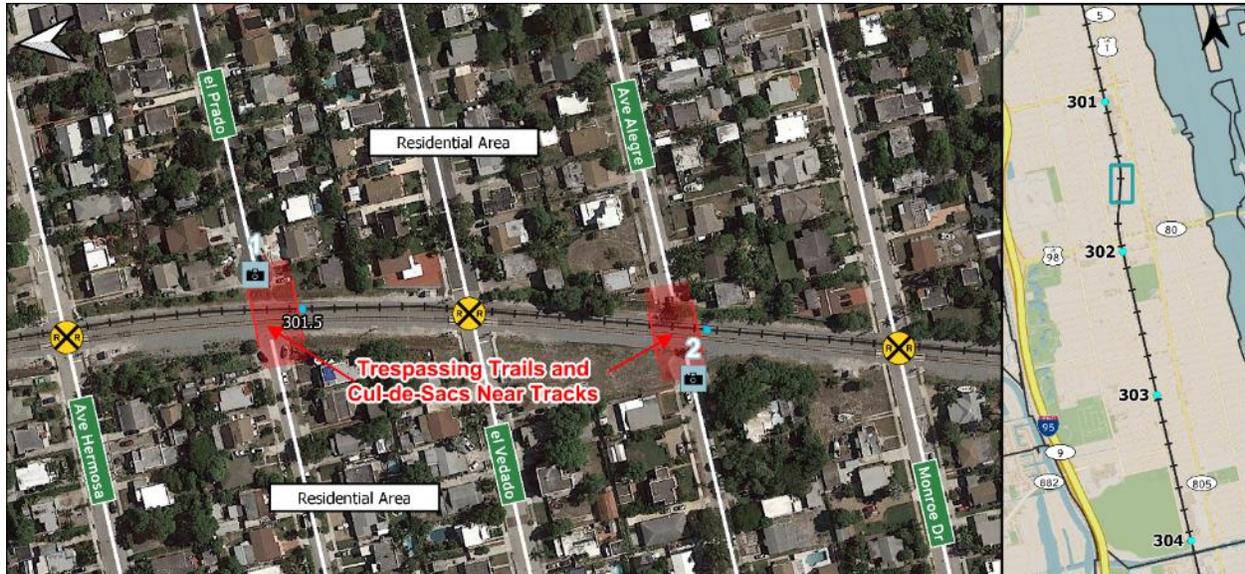
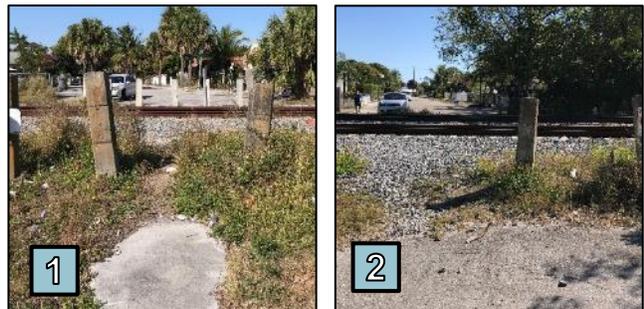
MP 301.4 to MP 301.6

Ave. Alegre and el Prado in West Palm Beach have trespassing trails across the railroad from cul-de-sacs on the west side near the railroad tracks. The area on both sides of the tracks is residential, and every other road has a grade crossing.

The trespassing routes are well entrenched and the distance from the cul-de-sacs to the outside rail is less than 10 ft. Existing bollards were constructed at the end of the cul-de-sacs to prevent vehicles from driving directly onto the corridor but does not deter pedestrian trespassing.

Recommendation: Construct **8 ft. hardened fencing** on the east side of the corridor between existing fencing at the ends of El Prado and Ave. Alegre. **Guardrail** is recommended around the cul-de-sacs on the west side. If necessary, **vehicle gates** for FECR personnel should be added on the west side to preserve FECR vehicle access to the corridor.

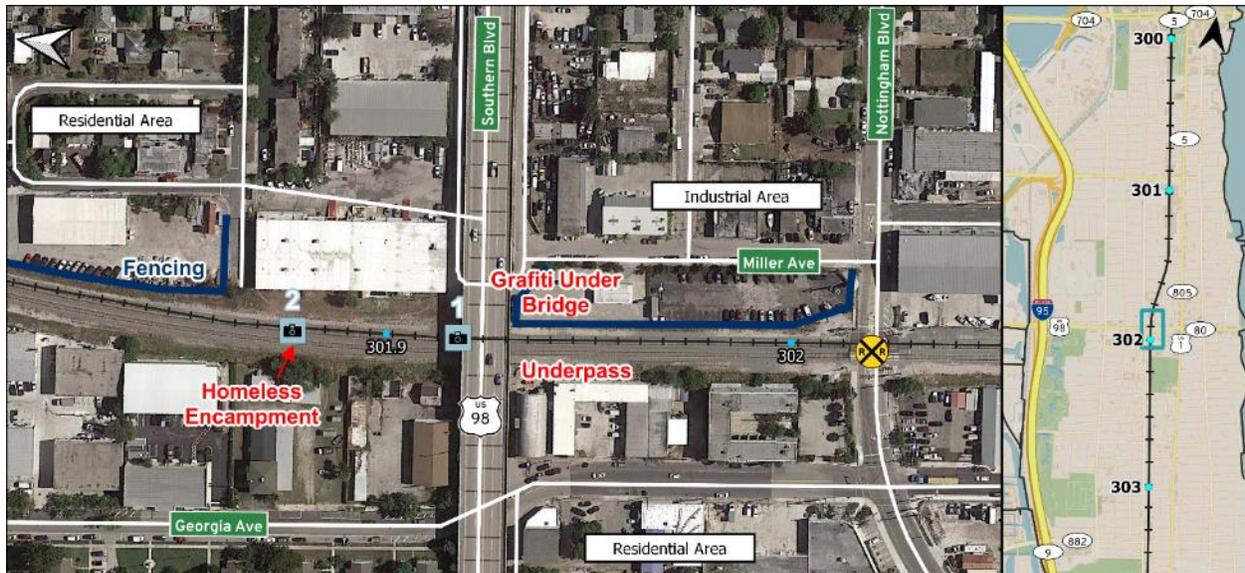
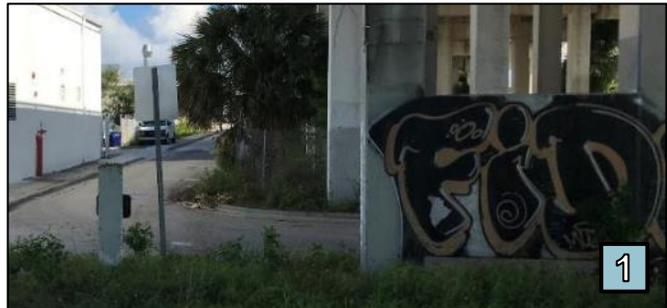
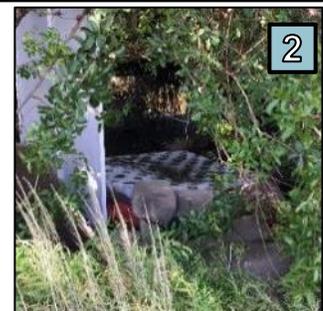
MP 301.7 to MP 302.0

The underpass at Southern Blvd. (US 98) in West Palm Beach is a trespassing source. There is evidence of homeless encampments (photo 2), graffiti on the bridge piers (photo 1), debris and trash. Between December 12, 2019, and Jan 28, 2020, three trespassing fatalities occurred within a tenth of a mile of the bridge.

The area under the bridge creates a location away from well-traveled areas for illicit activities. The vegetation is overgrown and the graffiti has not been removed when the field investigation was completed. This inattention encourages additional trespassing.

Recommendation: Construct **8 ft. hardened fencing** on the east side of the corridor under the bridge between the building to the north and the existing fencing to the south to remove access to this location. **6 ft. chain link fencing** should also be added along the west side of the right-of-way between Roseland Dr. (not shown, MP 301.7) and Nottingham Blvd. The graffiti, debris, and vegetation should be removed. Adding **motion actuated cameras with speakers and lights** is recommended to deter loitering.

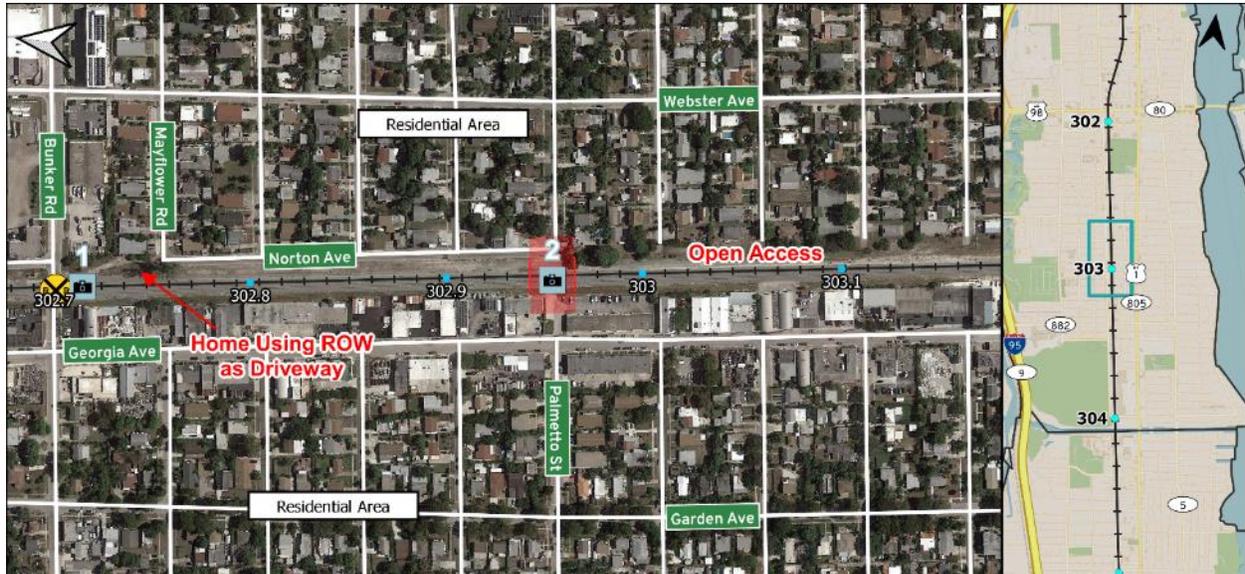
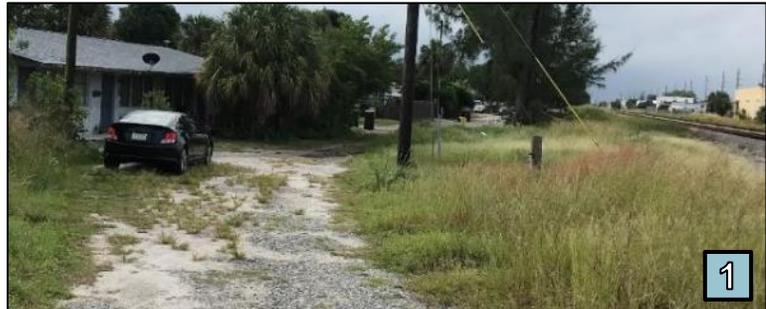
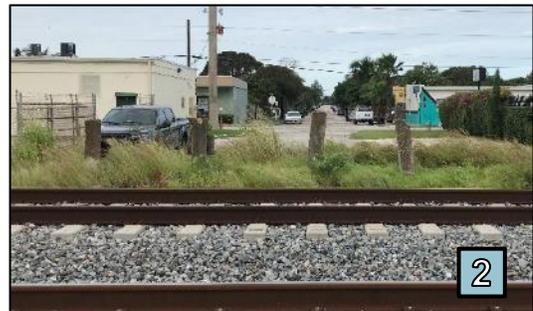
Between Bunker Rd. and Hunter St. (not shown, MP 303.2) in West Palm Beach is a section with open access to the corridor and encroachment on the right-of-way by local residences. A trespassing trail connects the two dead ends of Palmetto St. (photo 2). Trash was found in the overgrowth just south of Palmetto St. along the corridor. At Bunker Rd, a home has used the right-of-way as a secondary driveway (photo 1). The home's primary driveway is from Mayflower Rd., but the encroachment enables the vehicle to pull through from Bunker Rd.

Recommendation: Install a **vegetation barrier** along the east side of the corridor between Bunker Rd. and Hunter St. The corridor is open with few barriers to limit access; however, planting vegetation can define the corridor and discourage crossing. Adding **guardrail** is recommended along the right-of-way line to block use of the driveway at Bunker Rd. It is also suggested that any overgrown vegetation be trimmed that might be used to hide loitering within the existing right-of-way.

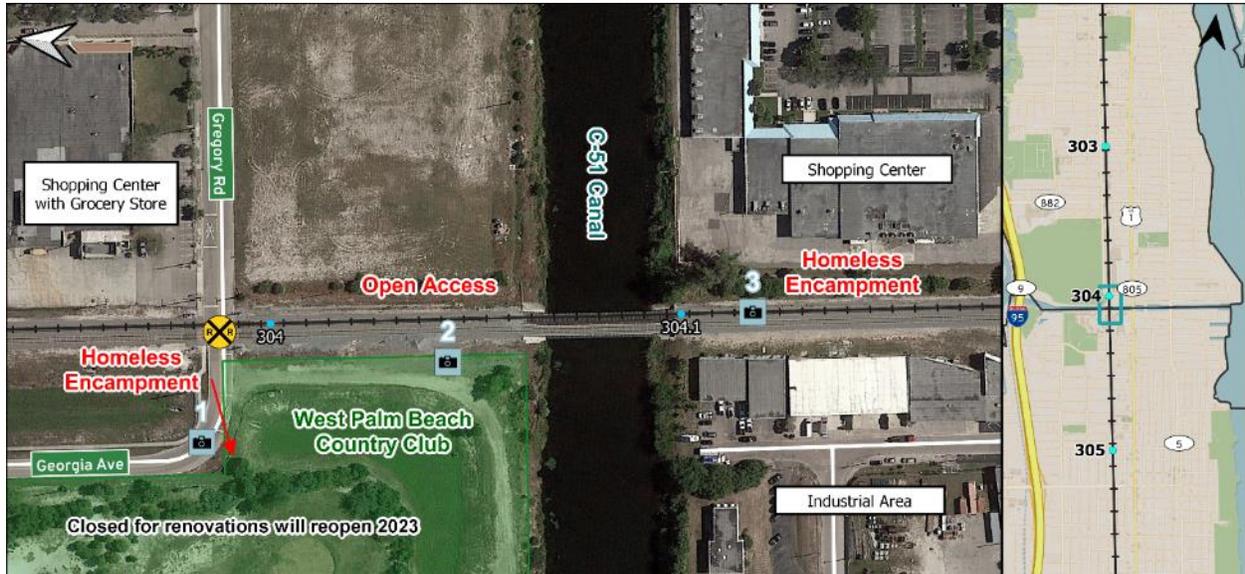
The bridge over the C-51 Canal in West Palm Beach (photo 2) has evidence of homeless encampments (photo 1 and 3). Possible trespassing origin-destination pairs also exist on either side of the canal. While no trespassing was observed or trails developed at either end of the bridge, trespassers likely use this bridge regularly. The nearest vehicle bridge that offers a safe pedestrian crossing is on Dixie Hwy. 0.2 miles to the east (not shown).

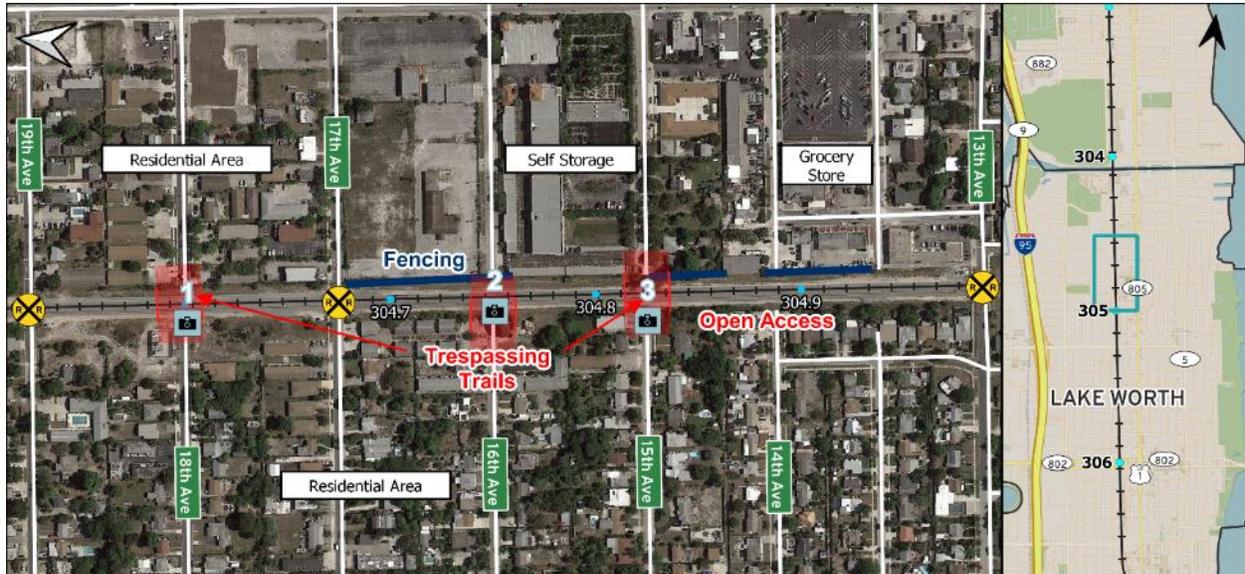
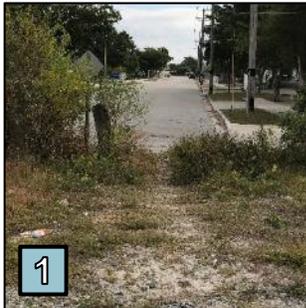
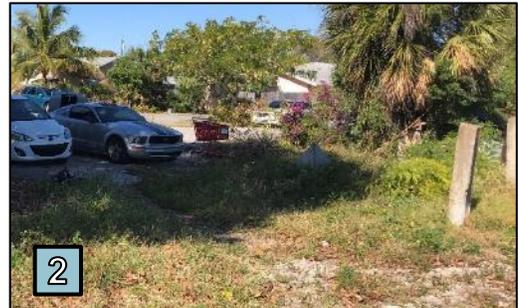
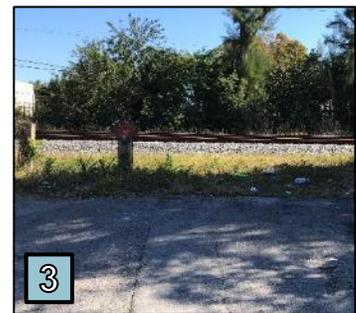
MP 304.5 to MP 305.0

From 19th Ave. to 13th Ave. in Lake Worth, the right-of-way has open access and multiple streets dead-end at the corridor. In 2018 a trespasser was struck just south of 17th Ave.

South of 19th Ave, the houses are parallel to the corridor with dead-end streets at the railroad corridor. These streets have clearly developed trespassing trails (photos 1-3). The area is mostly residential, but there are commercial businesses along Dixie Hwy. (US 1), 0.1 miles east of the corridor (not shown).

Recommendation: Construct **8 ft. hardened fencing** between 15th Ave. and 19th Ave. due to the well-established trails. This section of the corridor is open with few barriers for crossing or walking along the corridor. At 15th St., **guardrail** and signage is recommended at each dead-end street to protect against vehicle encroachment.
